45TH **TURBOMACHINERY** & 32ND **PUMP SYMPOSIA**
HOUSTON, TEXAS | SEPTEMBER 12 – 15, 2016
GEORGE R. BROWN CONVENTION CENTER

ELIMINATING DAMAGE OF RETAINING RINGS BY USING REDESIGNED “PROFILED” KEYS

Problem Statement

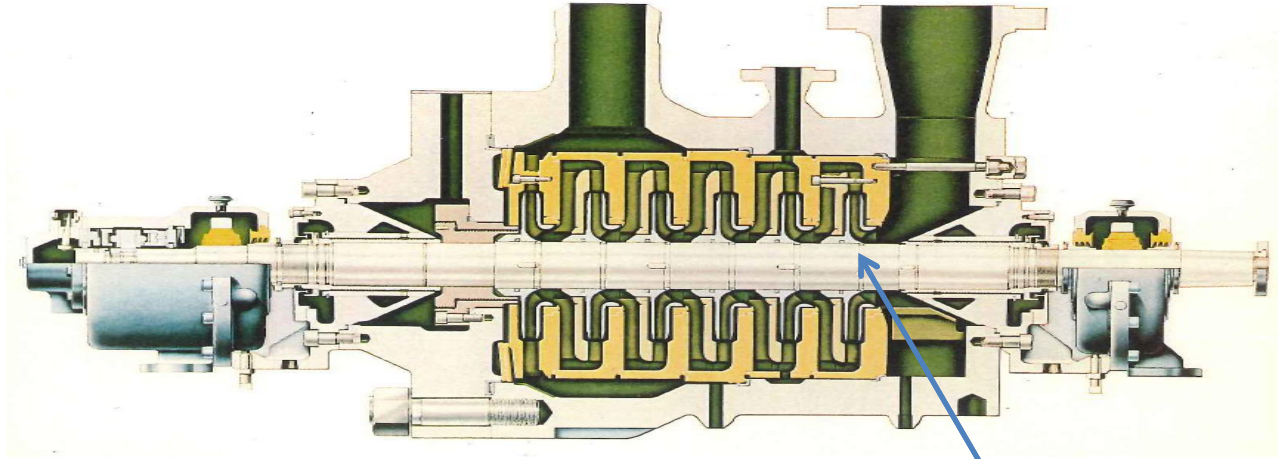
Boiler Feed Pump Showing the Location of the Retaining Rings

Retaining
Ring
Location,
Typical

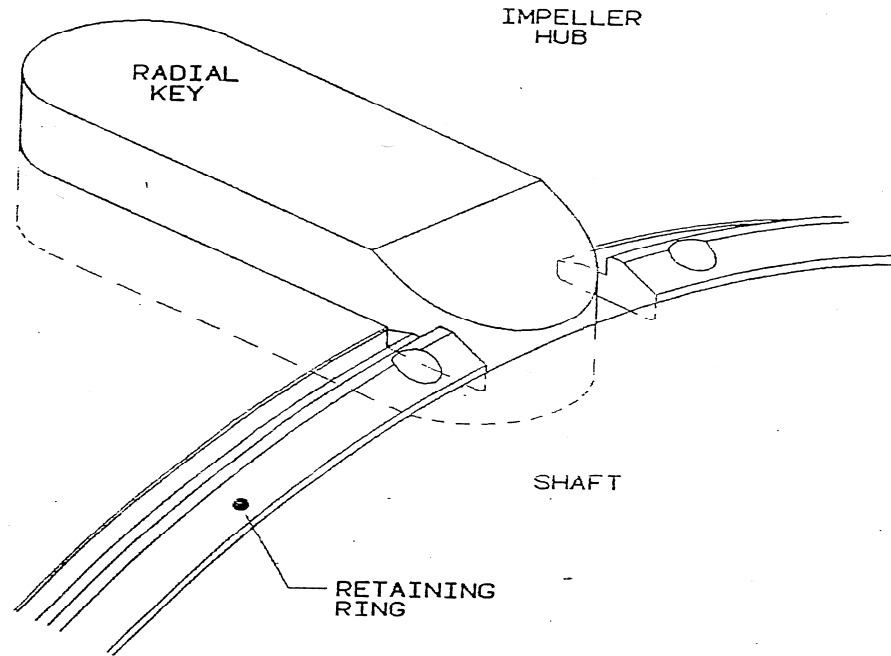
Retaining Ring and Key Area Which Locates the Impeller Relative to the Shaft

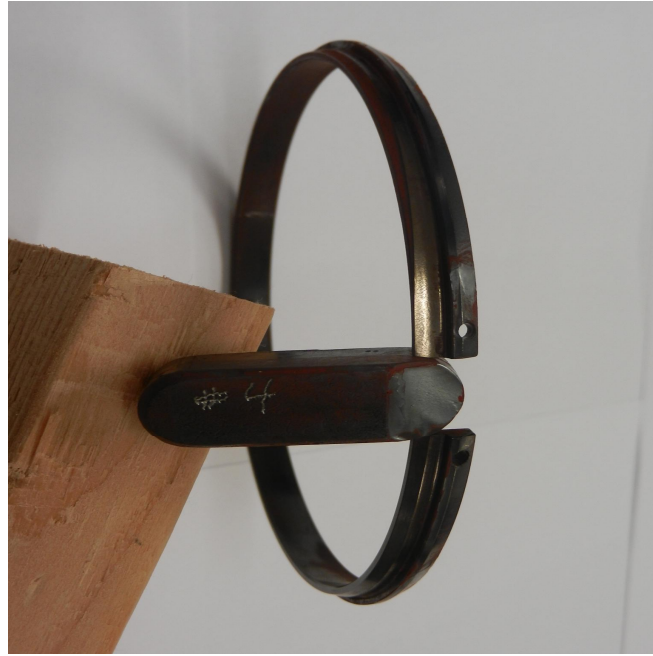
Wear Type Damage to the Retaining Ring

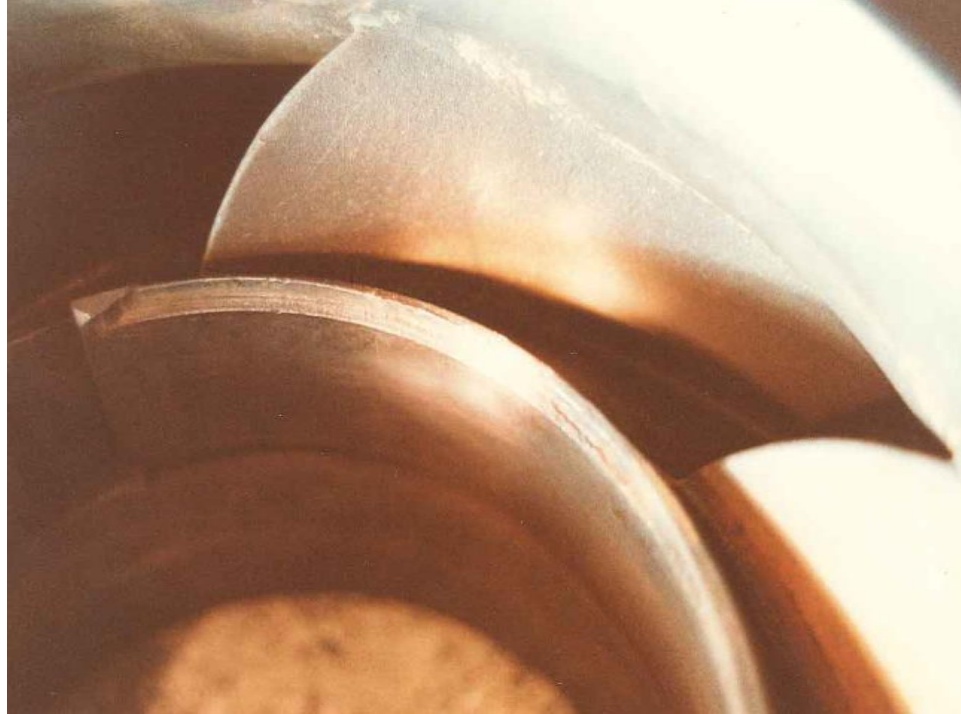
Wear Type Damage to the Impeller due to the Retaining Ring

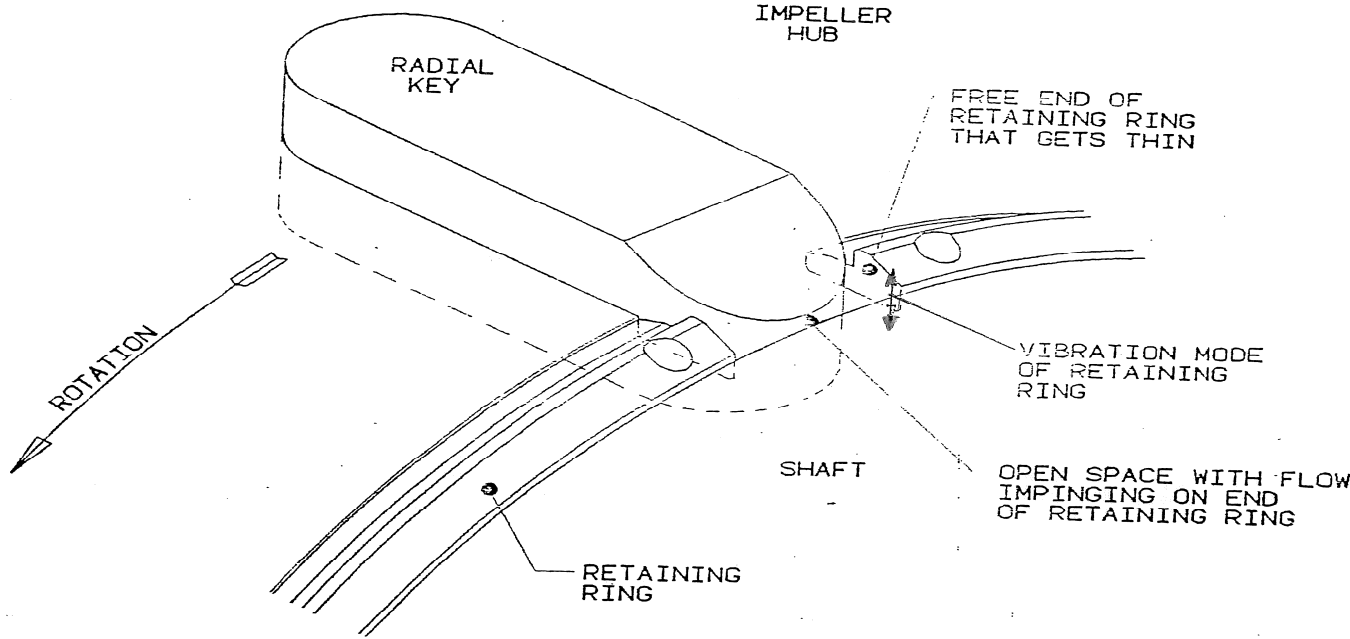
Retaining Ring and Key Area Showing the Potential For Retaining Ring Vibration

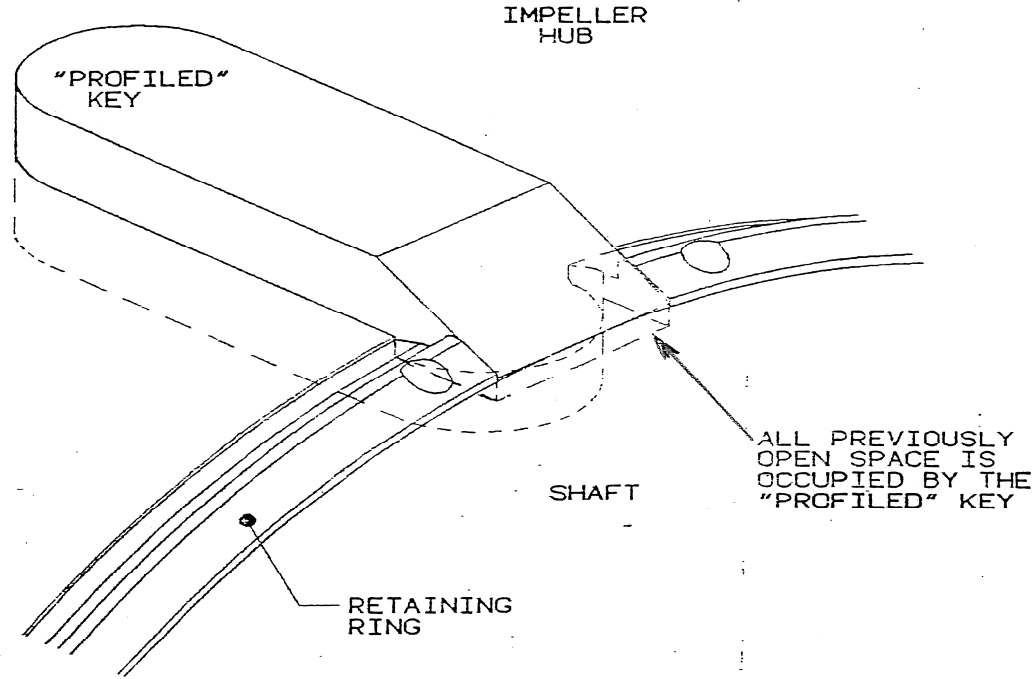
Retaining Ring and Key Area After the Key is Replaced With a "Profiled" Key

- Using the “profiled” key eliminated the wear and breakage of the retaining rings.

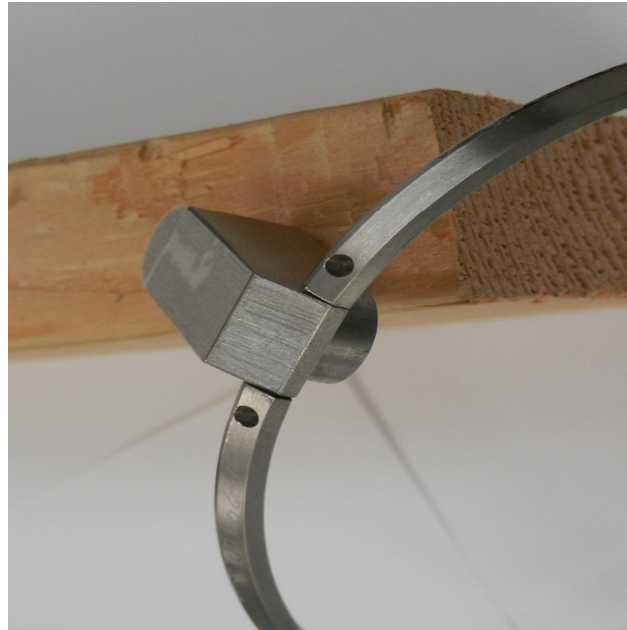
The new “profiled” Key and Ring
