45TH TURBOMACHINERY & 32ND PUMP SYMPOSIA
HOUSTON, TEXAS | SEPTEMBER 12 – 15, 2016
GEORGE R. BROWN CONVENTION CENTER

Vibration Analysis for Turbomachinery

Ed Wilcox

Consulting Machinery Engineer
Chevron Energy Technology Company
Houston, TX

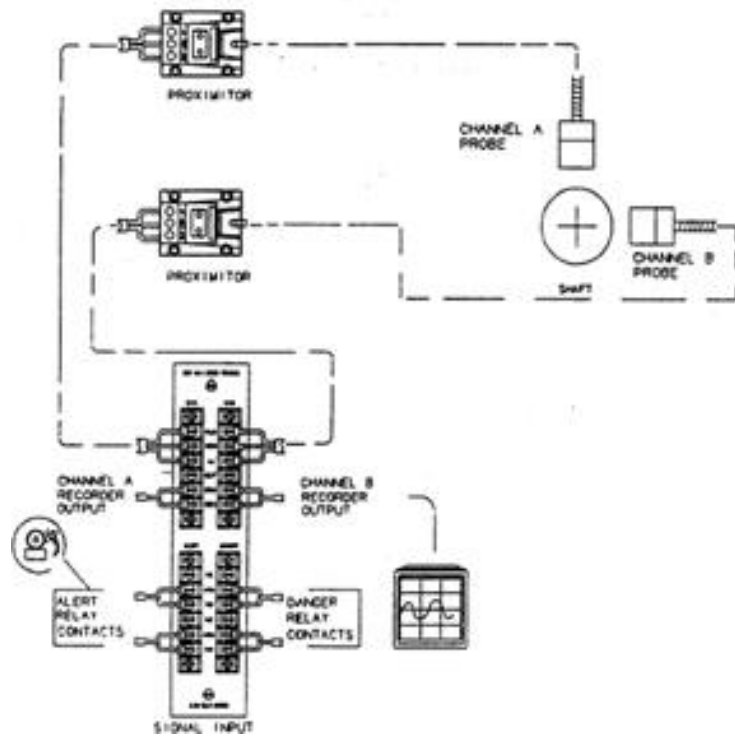
Figure 1. Eddy current probe/proximeter configuration (General Electric)

The basic configuration of a displacement probe is shown below in Figure 1. The system consists of a matched set of components

- Probe
- extension cable
- oscillator/demodulator (commonly called a proximeter).

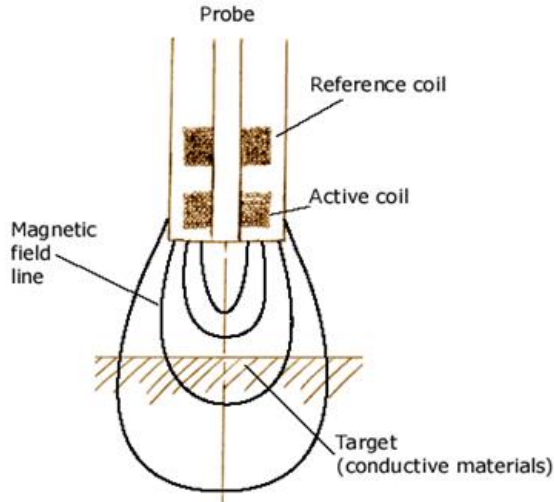
Figure 2. Illustration of proximity probe eddy current field (General Electric)

The proximeter excites the probe with a RF signal at approximately 2 MHz. This produces a magnetic field at the tip of the probe, see Figure 2. The proximeter demodulates the signal from the probe and provides a modulated DC voltage which is directly proportional to the distance between the probe tip and the target (commonly called the “gap”). A plot of the probe output voltage versus gap is shown in Figure 3. The AC portion of the signal is directly proportional to the vibration of the rotor. Therefore the proximity probe can provide both rotor position as well as vibration(displacement), see Figure 4. The rotor position can be used to determine the average journal position in a radial bearing or the axial position in a thrust bearing. This is a very important diagnostic tool since a change in shaft position in a radial bearing may indicate a damaged bearing.

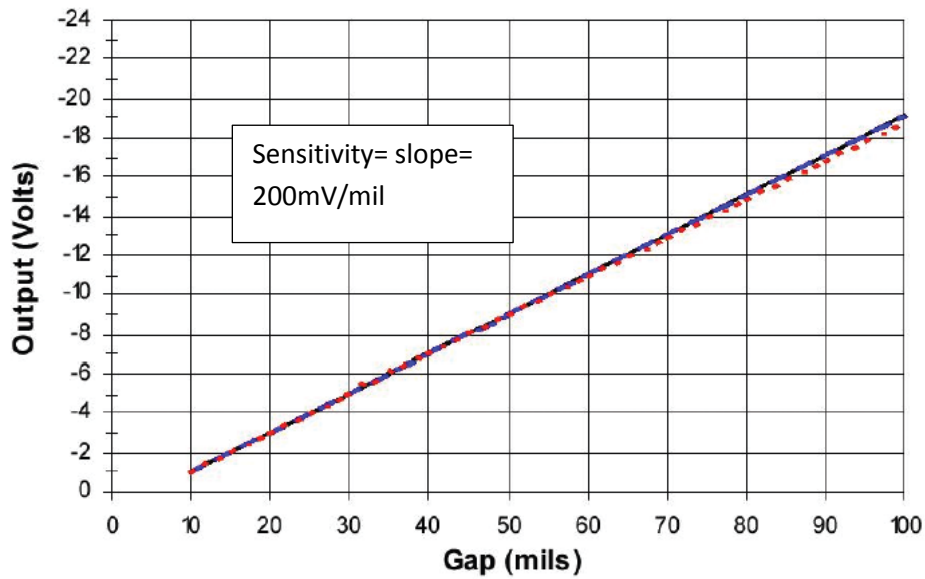
Figure 3. Typical proximity probe output voltage versus gap(mils) (General Electric)

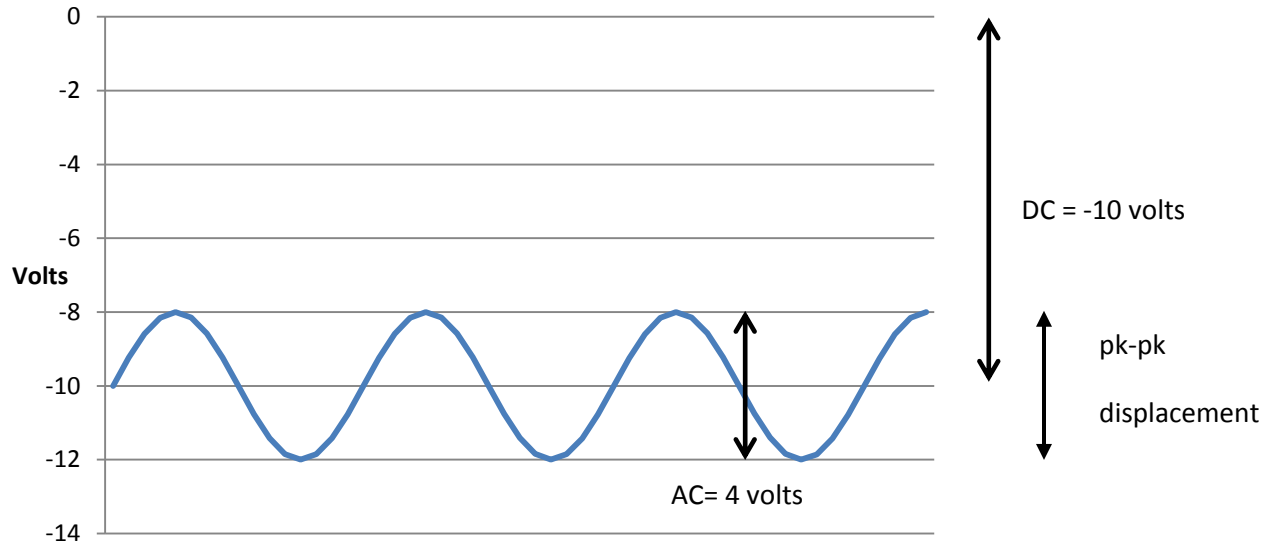
Figure 4. Typical proximity probe output showing gap(DC) and vibration(AC) components

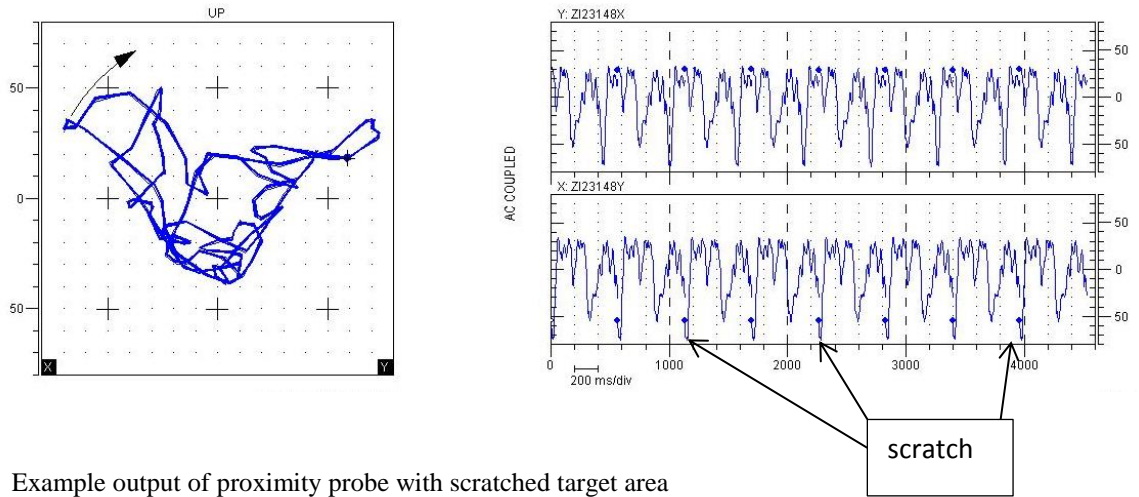
Figure 5. Example output of proximity probe with scratched target area

displacement vector (an example of this is provided in the next section). A more rigorous compensation of the vibration data is accomplished with actual waveform compensation, where a time waveform is recorded at low speed instead of just a vector. An example of a compensated time wave form is shown in Figure 6.

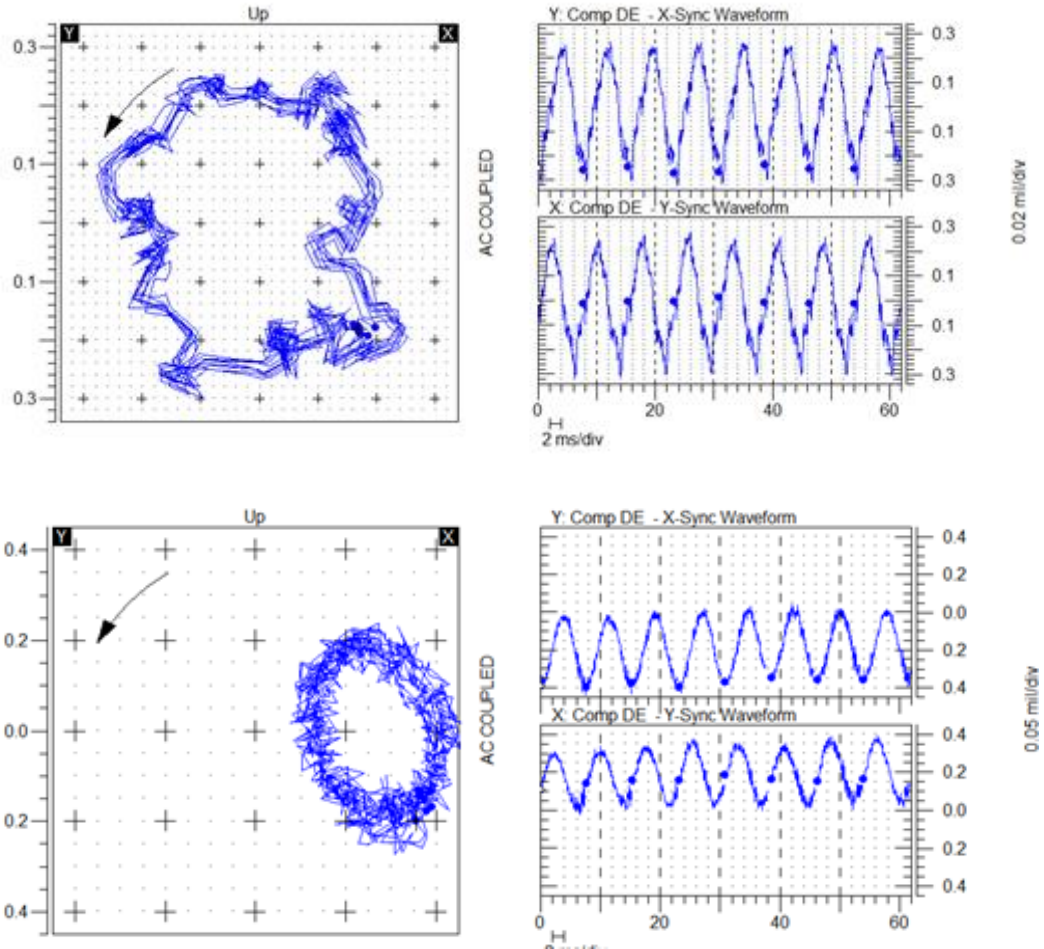
Figure 6. Direct orbit (upper) and orbit with waveform compensation (lower)

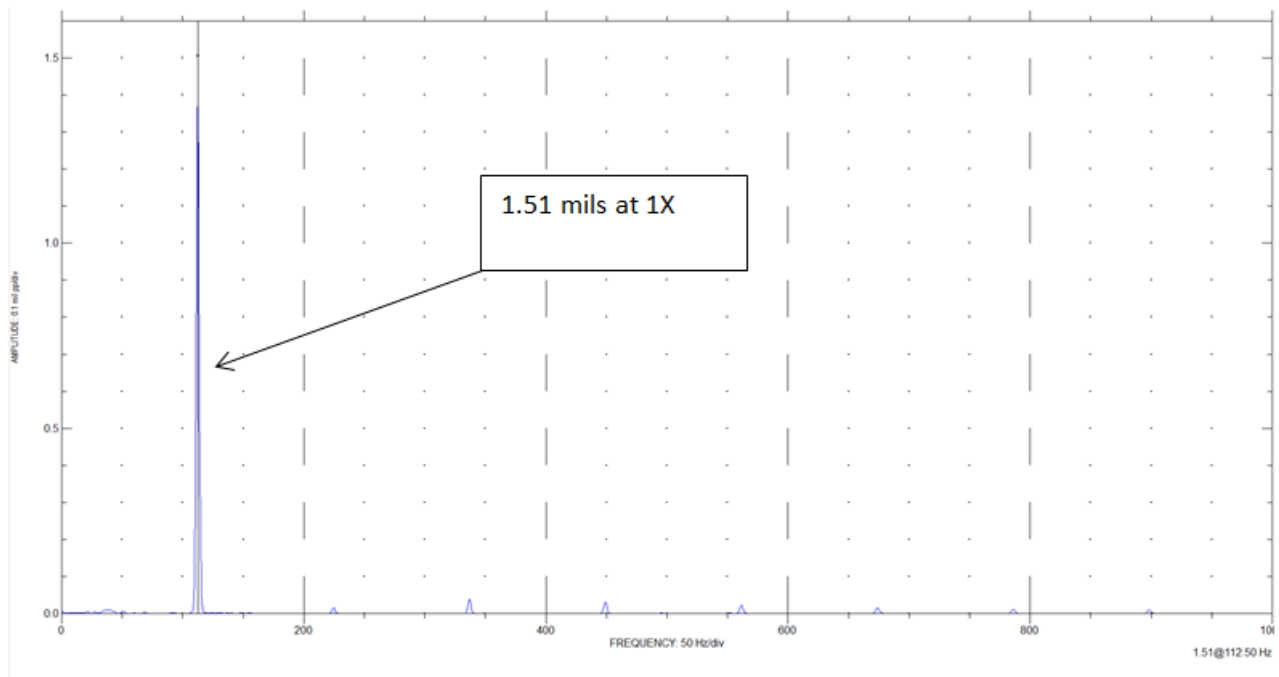
Figure 7. Spectrums taken with different extension cable lengths(none(top), 4m(middle), 8m(bottom)).

- Improper proximiter/cable/probe combinations - as mentioned above, the proximity probe system include three components(probe, extension cable, and proximiter). The cable on the probe itself is 1 m in length. The proximiter is tuned for a particular probe and extension cable length. Most proximiter probes are supplied in 1m, 5m, and 9m total length options (i.e. extension cable lengths of 0, 4, and 8 m respectively). If the extension cable is mis-matched with the incorrect proximiter it can cause erroneous results. Figure 7 shows three spectrums taken with an analyzer using a 1 m probe only, then 4 m, and 8 m extension cables. The proximiter was designed for the 1m probe (i.e. no extension cable). The author has also seen a centrifugal compressor factory acceptance test (FAT) where an incorrect extension cable/proximiter combination created a 2X peak that caused the OEM to suspect misalignment before determining the actual problem.

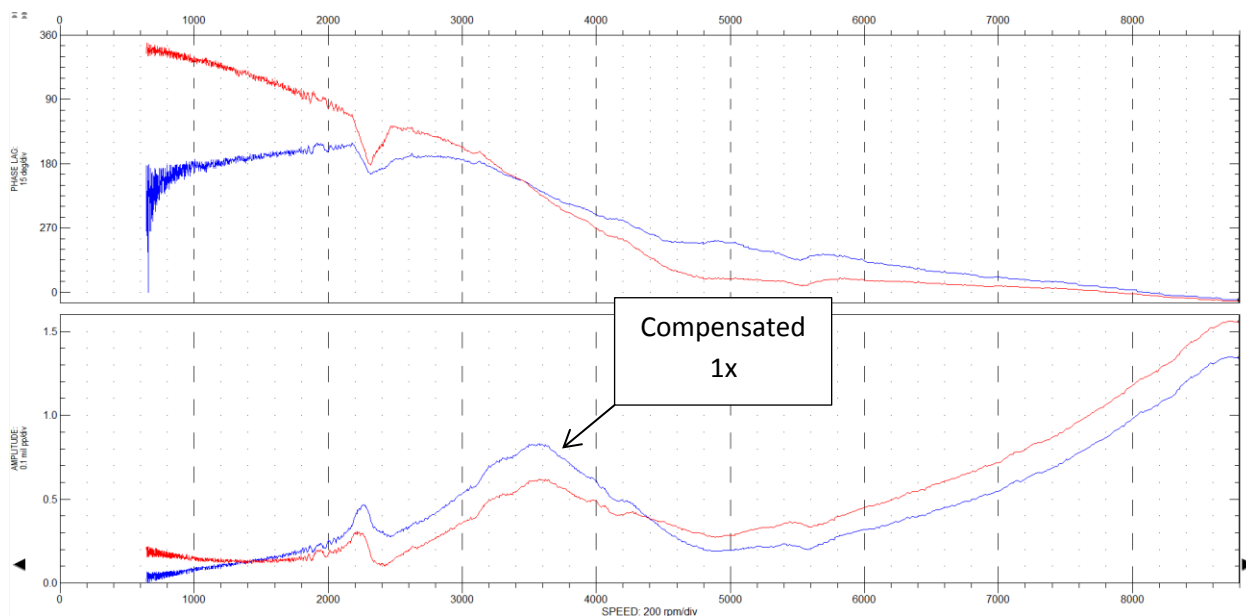
Figure 8. Bode plot showing both raw (red) and compensated (blue) synchronous vibration data

At the most basic level, the Bode plot is merely vibration amplitude and phase versus shaft speed, see Figure 8. However, it can potentially provide a wealth of information not available from steady state plots such as the FFT. The most common use of the Bode plot is the identification of natural frequencies present in the machinery. The most common of these are called “critical speeds” which occur when the shaft rotational speed coincides with a lateral mode and produces a resonance. This appears as an amplitude peak and phase shift in the Bode plot (approximately 3600 cpm in Figure 8). Identification of natural frequencies is especially critical in turbomachinery because unlike most general purpose equipment, they operate above or close to one if not more natural frequencies or modes. The Bode plot is most powerful in identifying high synchronous vibration. While overall vibration can be plotted versus shaft speed as well, the Bode plot is not really a tool for identifying non-synchronous vibration. This is a function that is best performed using a FFT in the form of either a cascade or waterfall plot, to be discussed later.

The importance of compensation and the affect it has on recorded vibration is shown in the Bode plot in Figure 8. As can be seen, the compensated vector magnitude (blue) starts at a zero value, in comparison to the uncompensated values that start at approximately 0.2 mils. The slow roll vector for this probe is approximately 0.22 mils at 21°. As mentioned above, it is extremely important to note that the compensated value is not always less than the raw value. As the phase of the synchronous vector changes, the vector subtraction both increases and decreases the magnitude of the compensated vector.

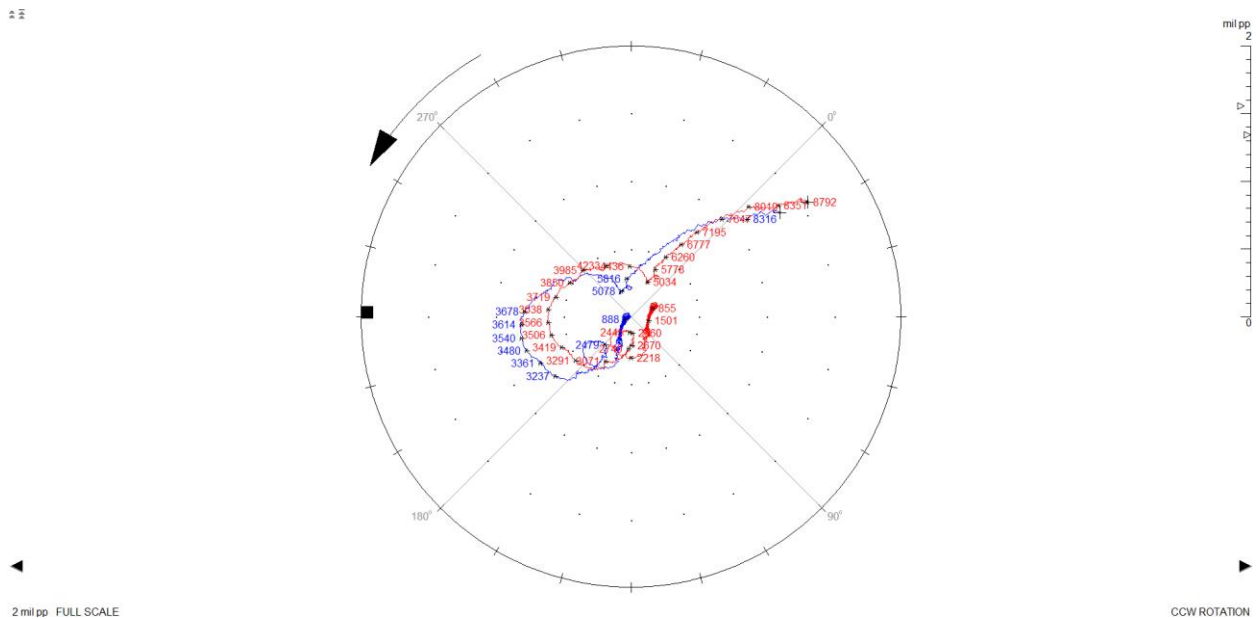
Figure 9. Polar plot showing both raw (red) and compensated (blue) synchronous vibration data (same data as Figure 8, just different format)

The polar plot presents the exact same data as the Bode plot, just in a different display format. In the polar plot the displacement vector magnitude is measured radially, from the center of the plot and the phase is plotted circumferentially. The same data from Figure 8 is plotted in Figure 9 below. A resonance is indicated in a polar plot by the speed at which amplitude is a maximum of a loop (i.e. approximately 180 degree phase shift). Additional background information about Bode and Polar plots are provided in Ref[4].

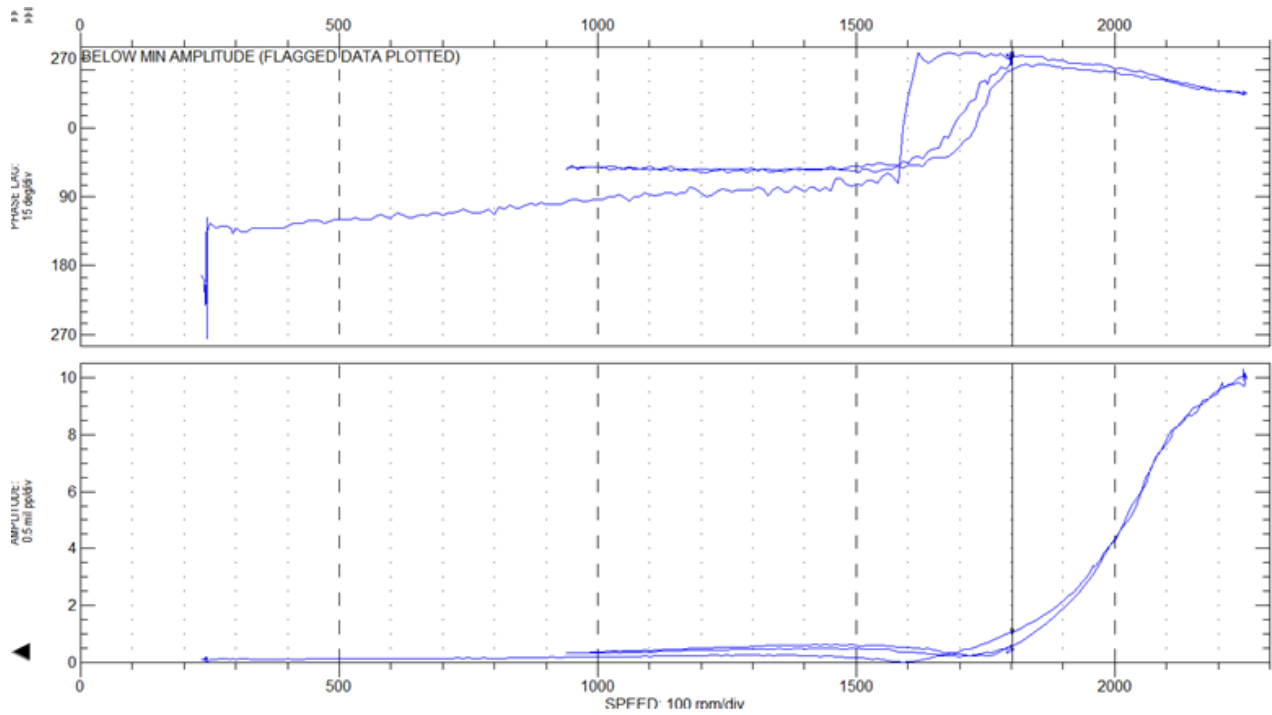
Figure 10a. Bode plot 4 pole generator FAT

An example of the importance of identifying resonance conditions is shown in the Bode plot of a 4 pole generator in Figure 10a. As can be seen, the radial vibration is relatively low (1.121 mils synchronous) at the generator’s operating speed (1800 rpm). However, as the speed of the generator is increased to approximately 20% over the synchronous operating speed, the magnitude of the vibration increases dramatically to over 10 mils. Undoubtedly, there is a lateral mode between 2200 and 2300 rpm on this particular machine. Note, that the phase change in the Bode plot appears to show the resonance at approximately 1800 rpm. However, review of the polar plot for the same date gives a better view of the phase change, indicating that at 2250 rpm the generator is right on top of a critical speed, see Figure 10b.

Since an electrical generator rarely operates above its synchronous speed, this would not appear to be a large concern. However, if the overall system stiffness were to be reduced in the future (i.e. the bearing clearance were to increase) then it is possible that this lateral mode could shift downward. The mode would not have to shift all the

way down to 1800 rpm to cause problems. If the mode just dropped to approximately 2000 rpm, the radial vibration at 1800 rpm might increase to approximately 5-6 mils on the skirt of the critical. This is an excellent example of the need to collect and store transient data during Factory Acceptance Testing (FAT) to be used in troubleshooting potential problems in the field.

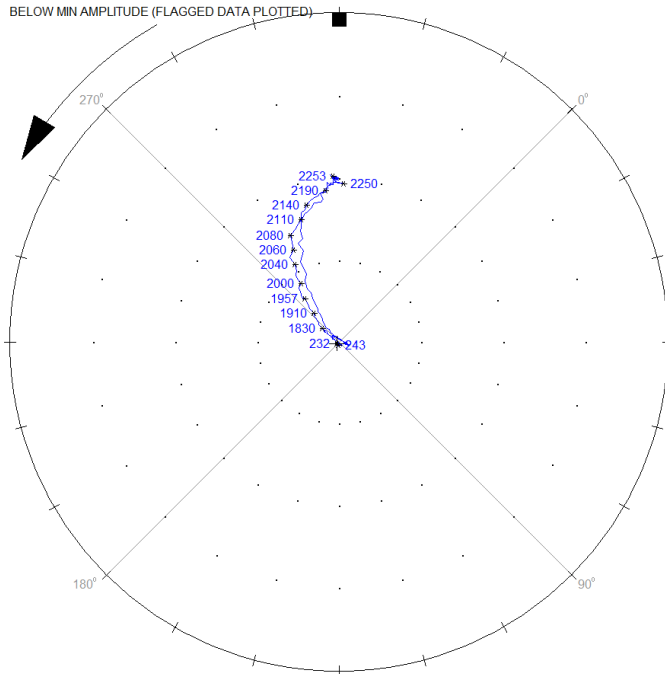
Figure 10b. Polar plot of 4 pole generator FAT

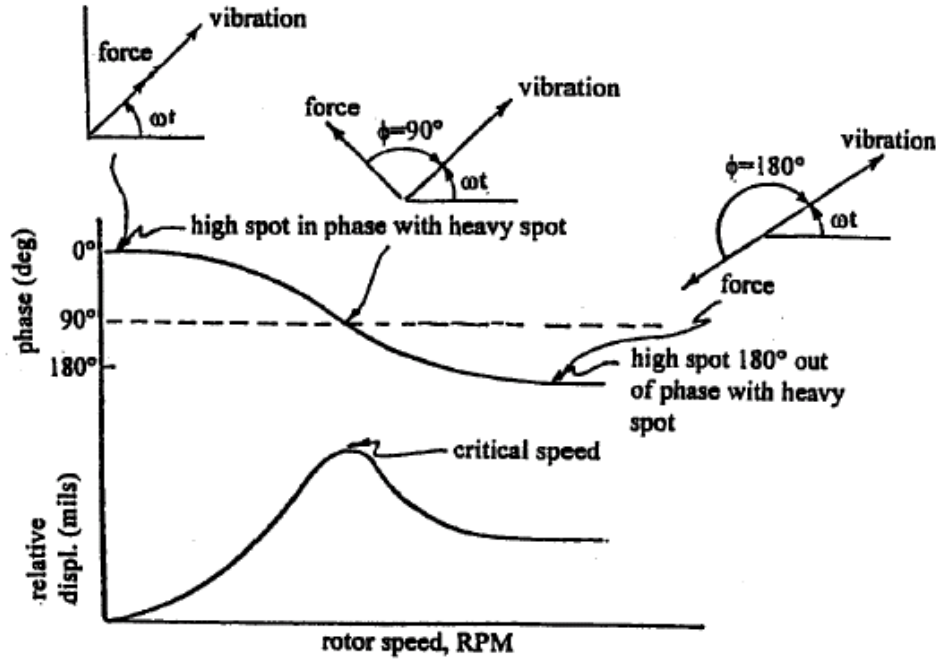
Figure 11. Relationship of high and heavy spot below, at, and above resonance (TPS)

One of the most basic concepts to understand is the relationship between the location of mass unbalance (heavy spot) and measured displacement (high spot) below, at, and above a critical speed, see Figure 11. Well below a rotor's critical speed, the high spot and heavy spot are very close together and the phase difference between the two is negligible. As the rotational speed of the machine increases, the force vector (caused by the heavy spot) begins leading the vibration. At the point of resonance, the force vector is leading the vibration by 90° . It should be noted that since velocity lags displacement by 90° the velocity vector is 180° opposite the force vector at resonance. This is very important because it indicates that the shaft stiffness (which acts on the displacement), cannot reduce the unbalance force at resonance. Only the velocity vector, which acts on the system damping can reduce the vibration produced by the force vector. For this reason, the measured response at resonance is a very strong indication of the damping present in the system, see Figure 12. As the rotational speed increases well above resonance, the force vector eventually leads the displacement vector by approximately 180° . The importance of this is that mass unbalance of the rotor is now 180° from the measured displacement. This is a result of the physical phenomena that the rotor whirls about its geometric center below the critical, but around its mass center above the critical. Well above the rotor's critical the displacement approaches the unbalance level (i.e. $d \rightarrow e$). This is why many rotors operate at lower displacement levels above their 1st critical speed. This has the obvious affect that balance corrections (relative to the measured vibration) are made in the opposite location depending on if the rotor operates above or below, it's critical. It should be remembered, that weight is always removed opposite the heavy spot, regardless of operating below or above the critical.

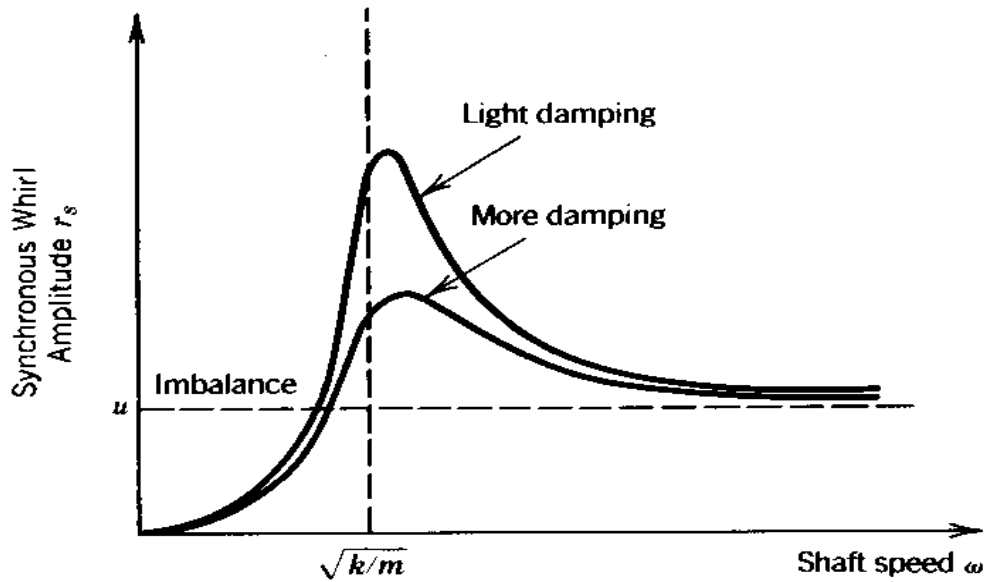
Figure 12. Amplitude response at resonance for different amounts of damping (TPS)

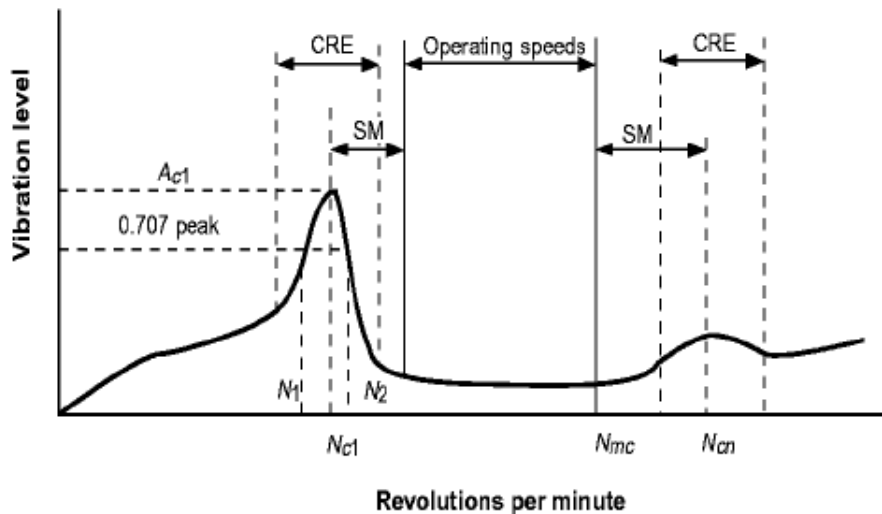
- N_{c1} = Rotor first critical, center frequency, cycles per minute.
- N_{cn} = Critical speed, n th.
- N_{mc} = Maximum continuous speed, 105%.
- N_1 = Initial (lesser) speed at $0.707 \times$ peak amplitude (critical).
- N_2 = Final (greater) speed at $0.707 \times$ peak amplitude (critical).
- $N_2 - N_1$ = Peak width at the half-power point.
- AF = Amplification factor.

$$= \frac{N_{c1}}{N_2 - N_1}$$
- SM = Separation margin.
- CRE = Critical response envelope.
- A_{c1} = Amplitude at N_{c1} .
- A_{cn} = Amplitude at N_{cn} .

Figure 13. Synchronous amplification factor (AF) by half-power method (TPS)

The synchronous amplification factor (AF) is a non-dimensional factor that is a strong indicator of the damping present in the rotor system. A common method of defining AF is the half-power method, see Figure 13 below. Most turbomachinery operate on hydrodynamic bearings of some type which provide a large amount of the damping present in the system. For this reason changes in AF normally indicate changes in the damping provided by the bearings, which can indicate damage to the bearings. If a tilt-pad style bearing has been damaged or “wiped”, then the stiffness and damping characteristics are both normally reduced. However, it is very common for the damping to be reduced more than the stiffness, which results in an increase in AF. This is commonly referred to as a decrease in the “effective” damping. This can be used to distinguish between damaged bearings and other potential causes of high synchronous vibration, such as unbalance or misalignment.

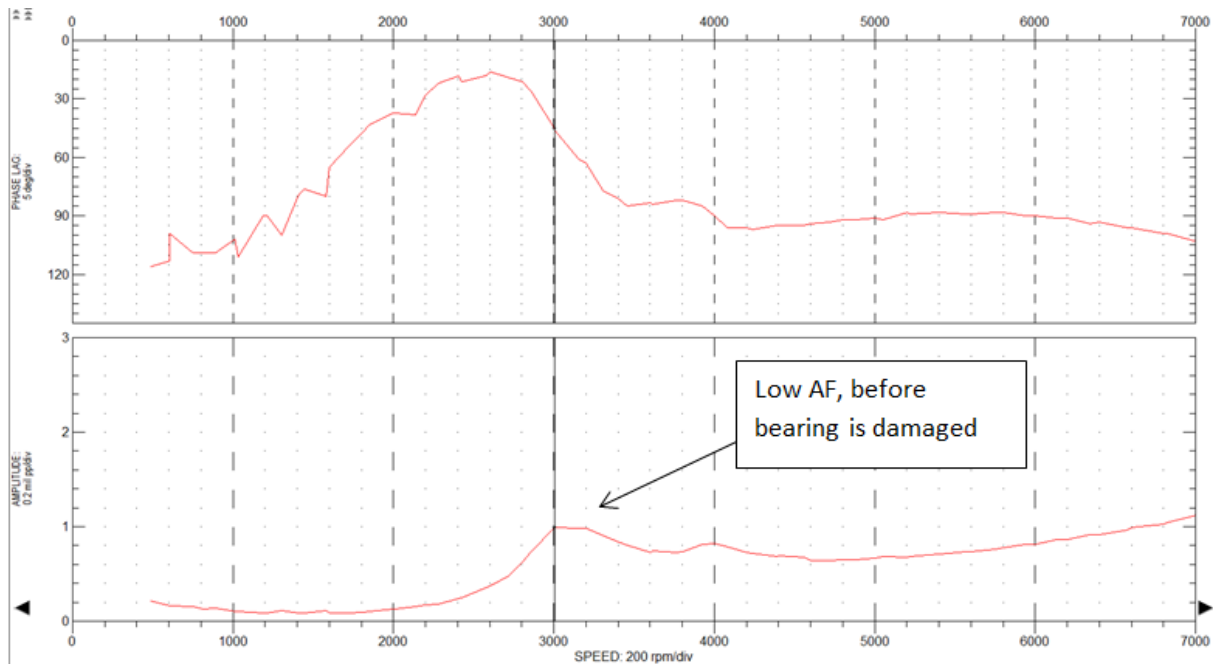
Figure 14. Bode plot from shutdown of reformer recycle hydrogen compressor (no issues)

An example of the change in AF due to changes in system damping is discussed below. Figure 14 is a Bode plot from the shutdown of a reformer hydrogen recycle compressor in good condition. At some time later an event occurred and the overall vibration at running speed increased from approximately 1.0 to 3.0 mils pk-pk. The Bode plot from the subsequent shutdown is seen in Figure 15. As can be seen, the shape of the plot has changed considerably, the AF has increased substantially, and the first critical has dropped approximately 150 rpm. All of these changes indicate a reduction in stiffness and relative damping in the system. This particular compressor has floating ring oil seals, which do provide some damping as well, however it operates at relatively low pressures (approx.. 30 psig suction), so the seals are not a major contributor to the rotordynamics. Because of the change in AF, the compressor was shutdown at the next available opportunity and the bearings removed and inspected. As can be seen in Figure 16, the pads have indeed been damaged. The bearings were replaced and the compressor restarted. The recorded Bode plot is shown in Figure 17 and indicates that the AF has returned to its previous value.

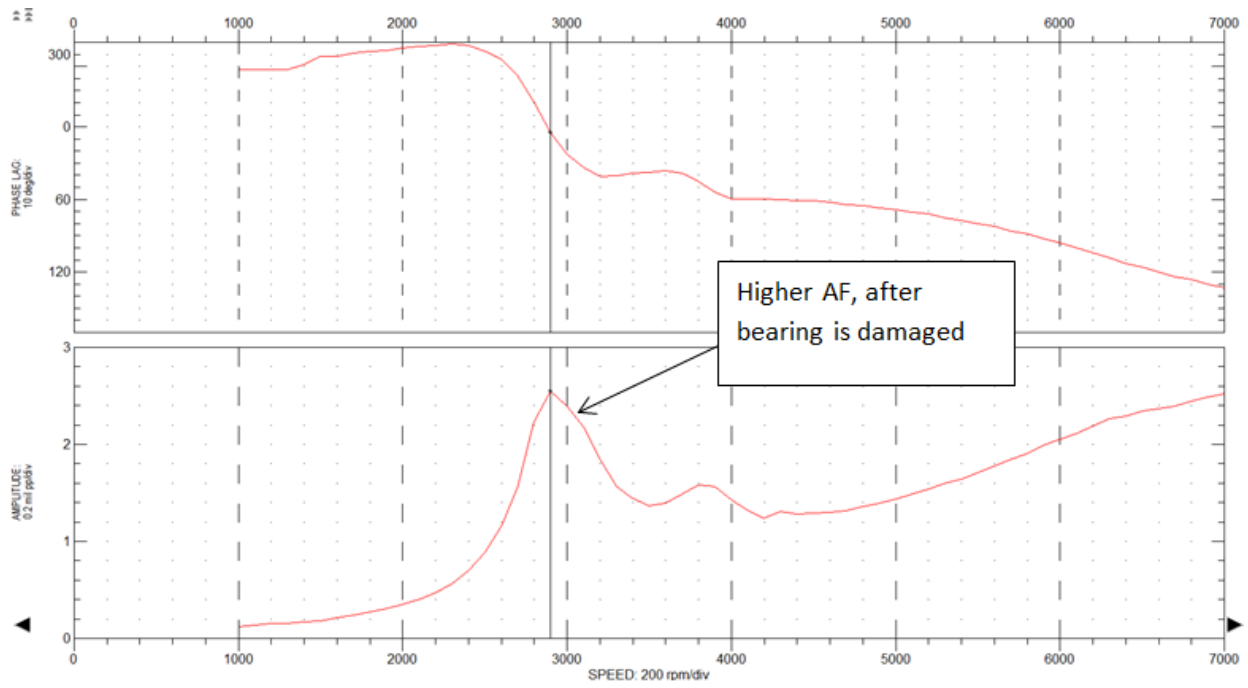
Figure 15. Bode plot from shutdown of reformer recycle hydrogen compressor, after event

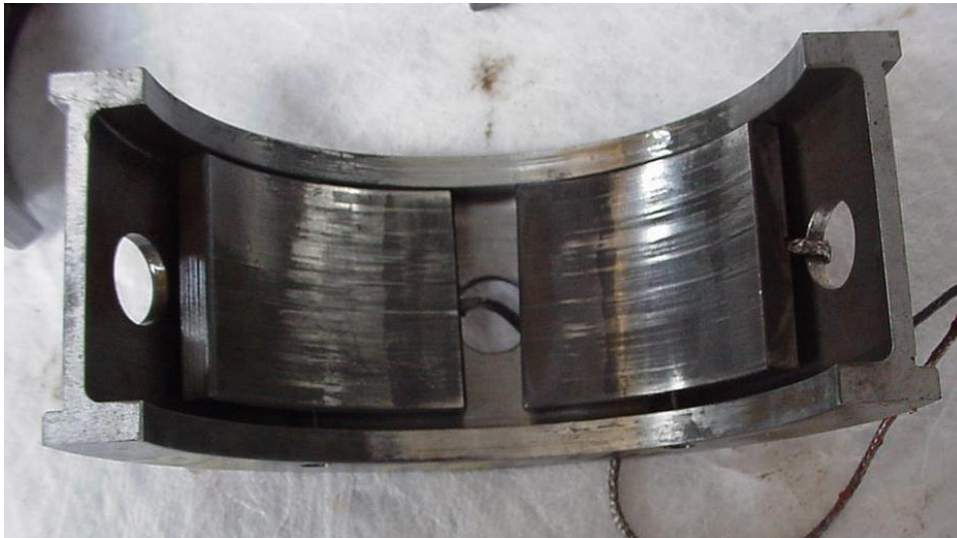
Figure 16. Wiped tilt-pad bearing (due to insufficient lubrication) from reformer recycle hydrogen compressor

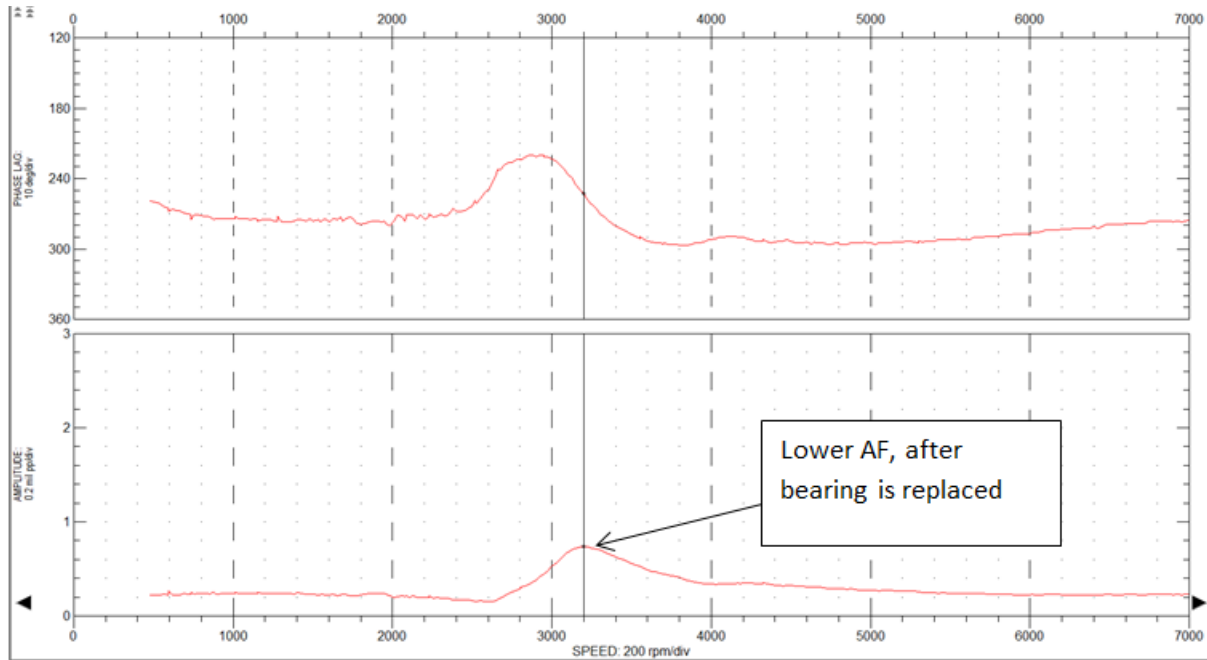
Figure 17. Subsequent start-up of reformer recycle hydrogen compressor after bearings were replaced.

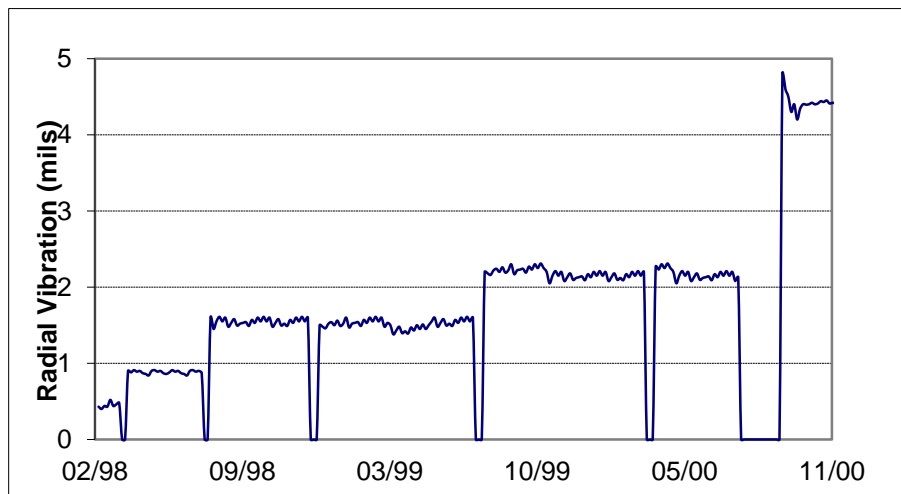
Figure 18. Trend of barrel compressor overall vibration, drive-end horizontal for 2-3 year period

An opposite example to the one above is another barrel compressor in the same refinery. A trend of the overall radial vibration from the drive end horizontal probe is shown below in Figure 18. As can be seen the radial vibration increased sometimes after a re-start. The overall level had increased from approximately 0.5 to over 4 mils in two years. A review of the mechanical shop test from the OEM, showed that the measured AF was approximately 4.5 when the compressor was new, see Figure 19.

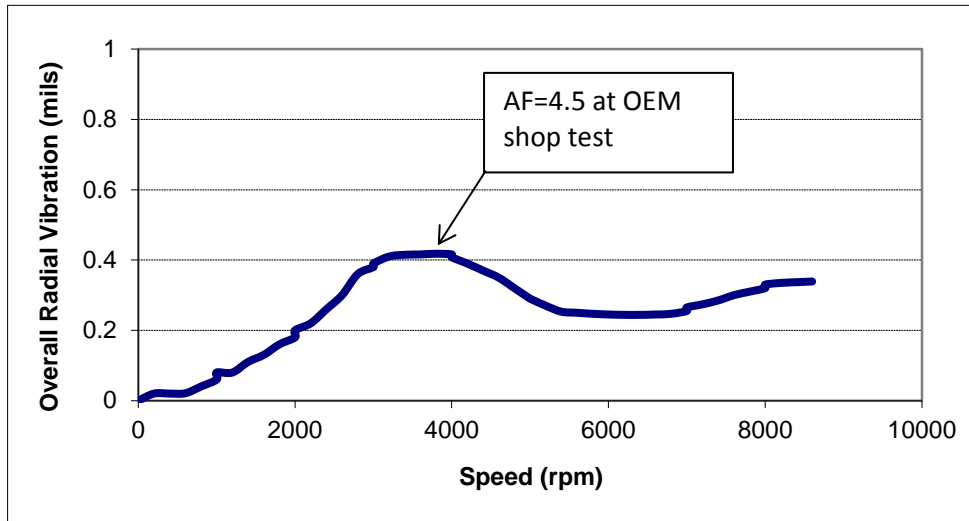
Figure 19. Overall vibration data from OEM shop test, compressor DE horizontal (AF=4.5)

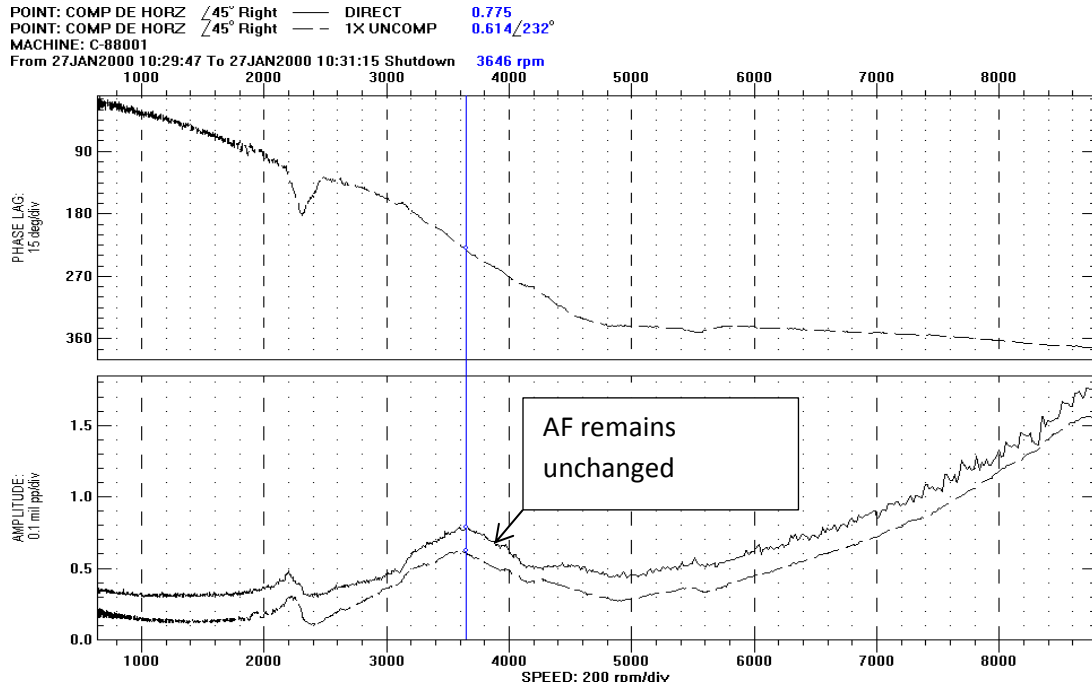
Figure 20 Barrel compressor drive end horizontal vibration, 01/2000 (AF = 5.0)

Transient data was recorded during a start-up of the compressor which showed that while the vibration level was substantially higher, the amplification factor had not changed substantially, see Figure 20. Therefore, the increase in synchronous vibration was thought to have been the result of something other than bearing damage. This was not immediately obvious, since the increases in vibration shown in Figure 18 only occurred when the compressor was re-started, a common symptom of bearing damage from loss of lubrication. An extensive refinery wide shutdown approximately 9 months later resulted in the compressor being shutdown for one month. During the subsequent restart, the synchronous vibration had doubled to approximately 4 mils pk-pk; however, the measured amplification factor still remained relatively un-changed, see Figure 21. Likewise the slope of the phase change at resonance is very similar in both Figures 20 and 21. This further confirmed that the relative damping in the rotor system had not changed, indicating that the bearings had not been damaged. The compressor inner cartridge was pulled and found to be severely contaminated with porous media from the upstream process unit. The rotor was cleaned and re-installed with the same bearings and the maximum vibration levels at running speed returned to approximately 0.5 mils.

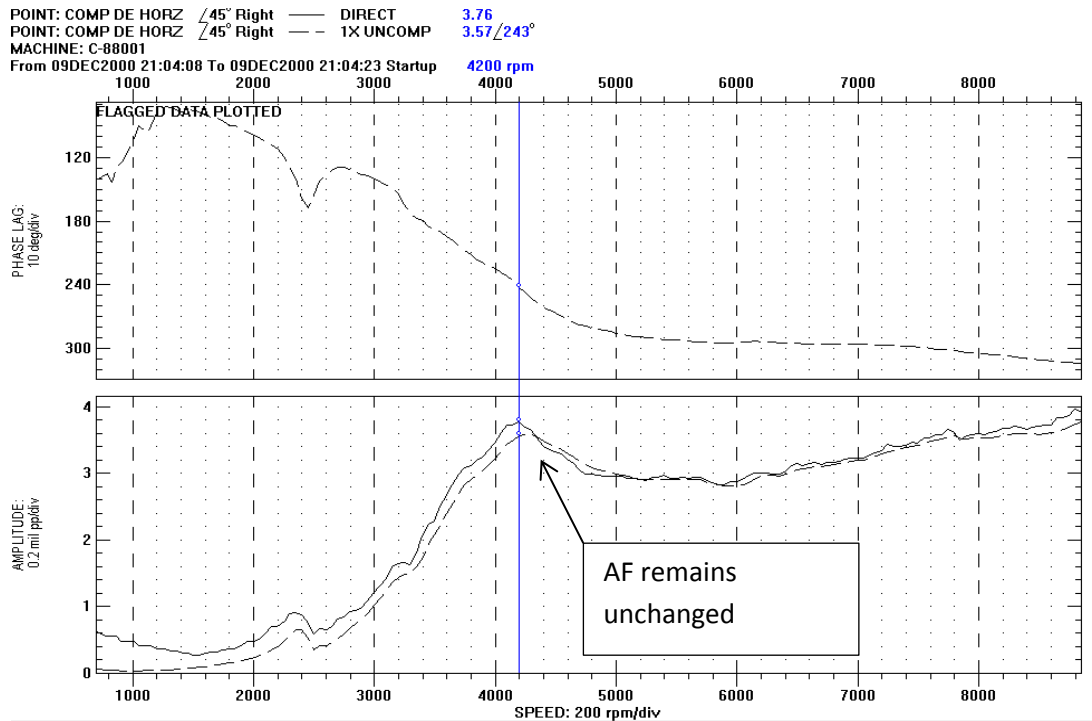
Figure 21 Barrel compressor drive end horizontal vibration, 12/2000 (AF = 5.1)

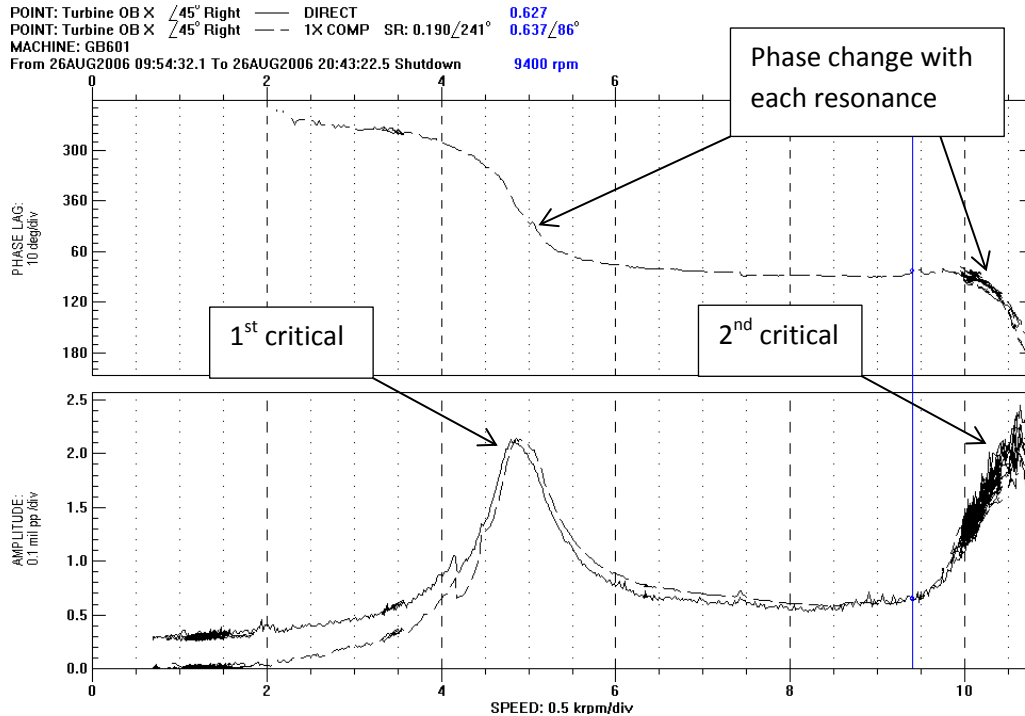
Figure 22. High speed steam turbine drive start-up, during over-speed trip test

As describe above, the ability to measure and predict natural frequencies in turbomachinery is extremely critical since most modern turbomachinery operates above at least one natural mode. This is obviously important, because when operating close to a resonance, the vibration can increase dramatically. Since the most common forcing function is the un-balance force, improved rotor balance many times has negligible benefits if operating close to a resonance. Typically, the best way to reduce vibration close to a resonance is to eliminate the resonance by moving the natural frequency. An example of this type of scenario occurred in an ethylene cracker unit in 2006. The unit had been shutdown for a 2 week turnaround to address some non-machinery issues. While the unit was down, an overspeed trip test was conducted on the steam turbine driver for the ethylene refrigeration compressor. The turbine's normal operating range was from 9,000-10,000 rpm; however, the maximum governor speed was 10,700 rpm. During the trip test the vibration on the turbine outboard increased dramatically above 10,000 rpm, see Figure 22. The vibration on the turbine prior to shutdown had been very low (approximately 0.5 mils), so the high vibration was certainly a surprise to the plant personnel. The second peak on Figure 22 along with the corresponding change in phase is an indicator of a resonance condition in the turbine. As a first step to investigate the problem, both radial bearings on the turbine were removed and the clearances checked. The clearance on the inboard bearing was within tolerance but the outboard bearing was 0.0005 in over the maximum. A rotordynamics model of the turbine was built to examine the problem further, see Figure 23.

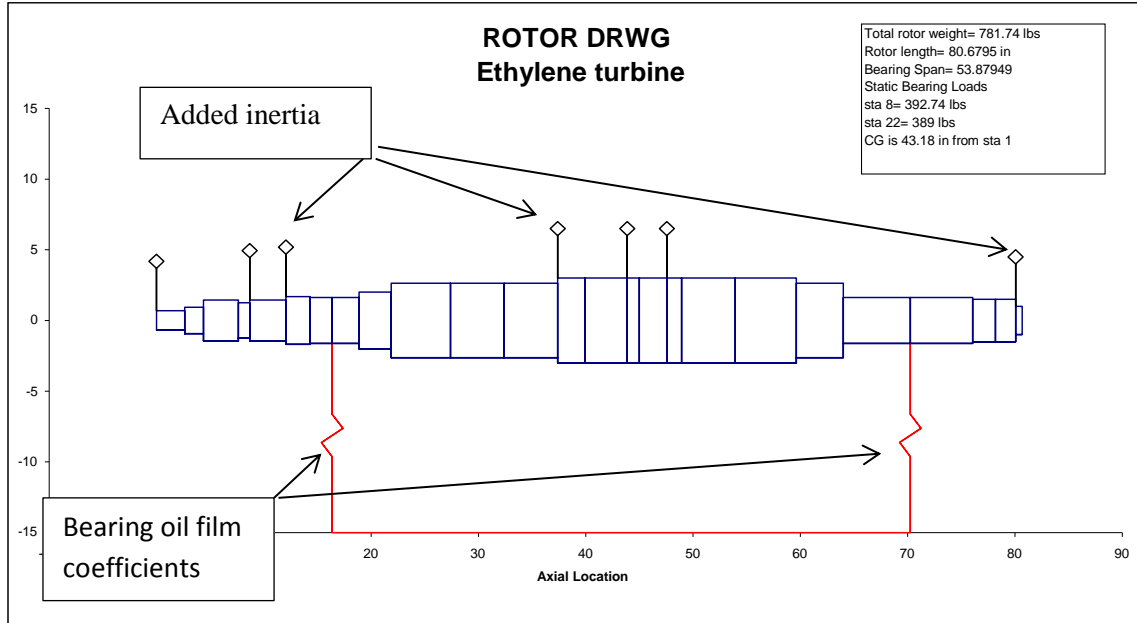
Figure 23. Graphical representation of ethylene turbine model with rigid bearing supports

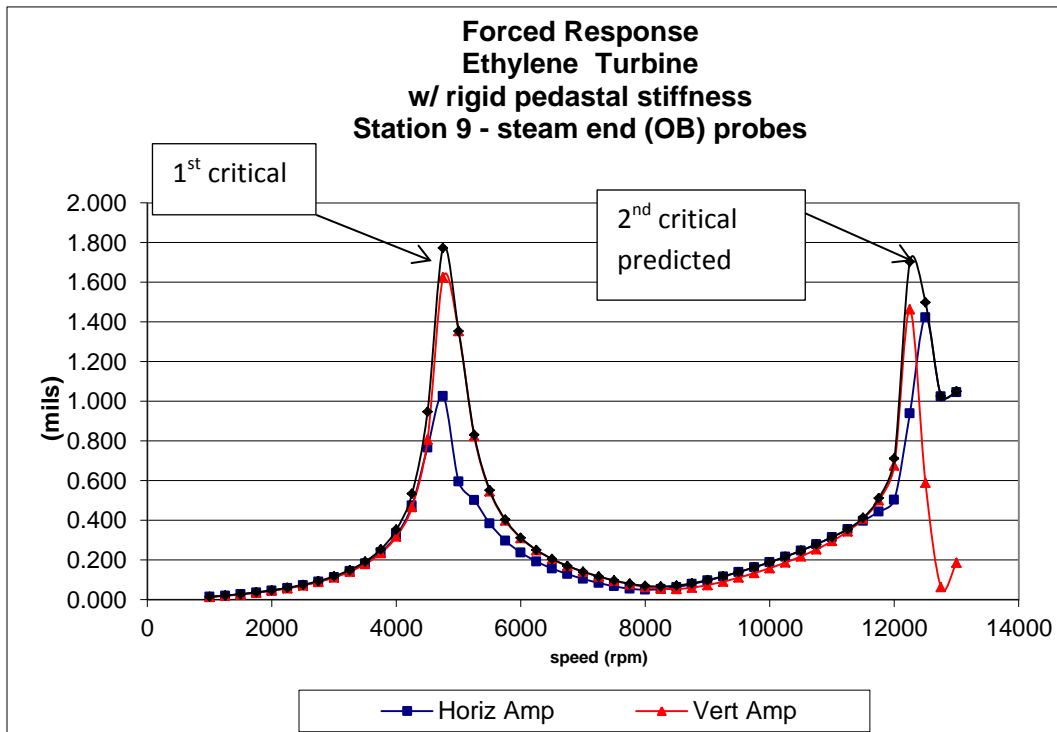
Figure 24. Ethylene turbine rotor model predictions w/o support stiffness effects (bearings on rigid supports)

The forced response calculations from the rotor model showed that the turbine's 2nd critical was approximately 12,200 rpm (see Figure 24), which was much higher than the value of 10,600 rpm shown in Figure 22. As is common on most steam turbines, the bearing support on the OB end is designed to be more flexible in the axial direction to allow for transient temperature gradients during start-up, see Figure 25. Sometimes this can result in a lower radial stiffness as well. To "tune" the rotor model to the actual vibration, the outboard end bearing housing support stiffness was calculated and added to the rotor model, see Figure 26. A detailed explanation of this is covered in Ref[7]. The resultant forced response calculations reflected were much closer to the actual vibration response, see Figure 27. To address the problem the plant personnel installed a radial bearing that was actually 0.0005 in under the minimum design range of the bearing (the pads were shimmed to reduce the clearance). The Bode plot of the resulting start-up of the turbine after the outboard bearing modification is shown in Figure 28. The lower bearing clearance had increased the system support stiffness enough to move the 2nd critical above the turbine's operating speed range.

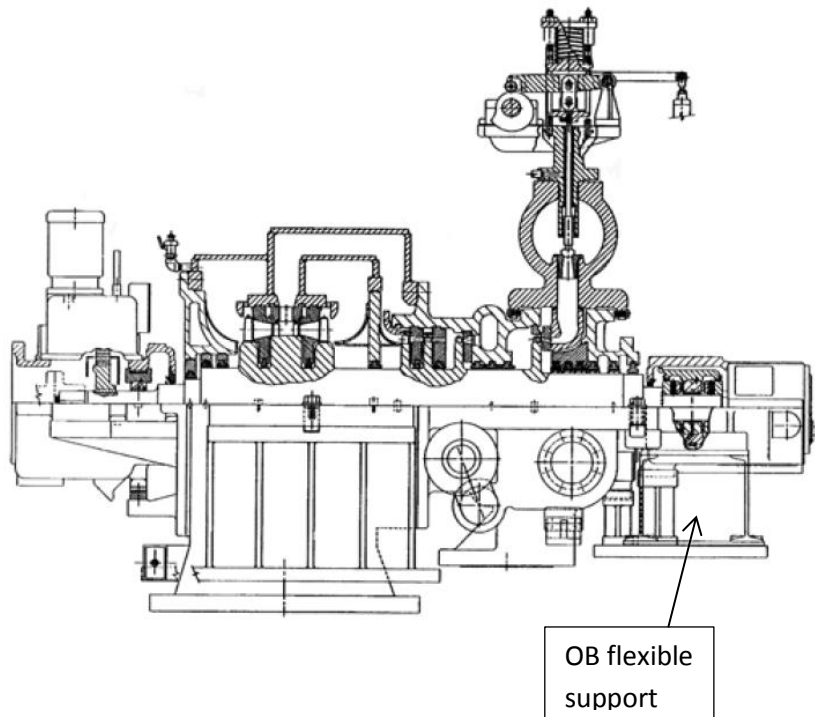
Figure 25. Typical mechanical drive steam turbine cross-section (TPS)
