45TH TURBOMACHINERY & 32ND PUMP SYMPOSIA
HOUSTON, TEXAS | SEPTEMBER 12 – 15, 2016
GEORGE R. BROWN CONVENTION CENTER

Vibration Analysis for Turbomachinery

Ed Wilcox

Consulting Machinery Engineer
Chevron Energy Technology Company
Houston, TX

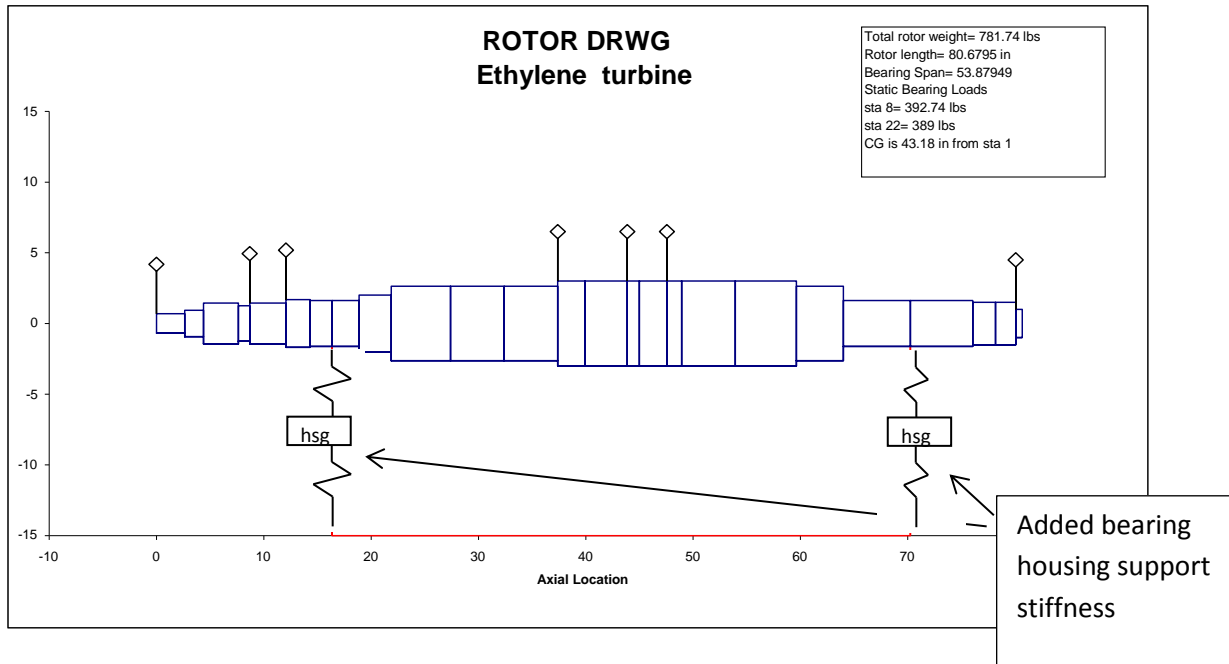
Figure 26. Graphical representation of ethylene turbine model with bearings on flexible supports

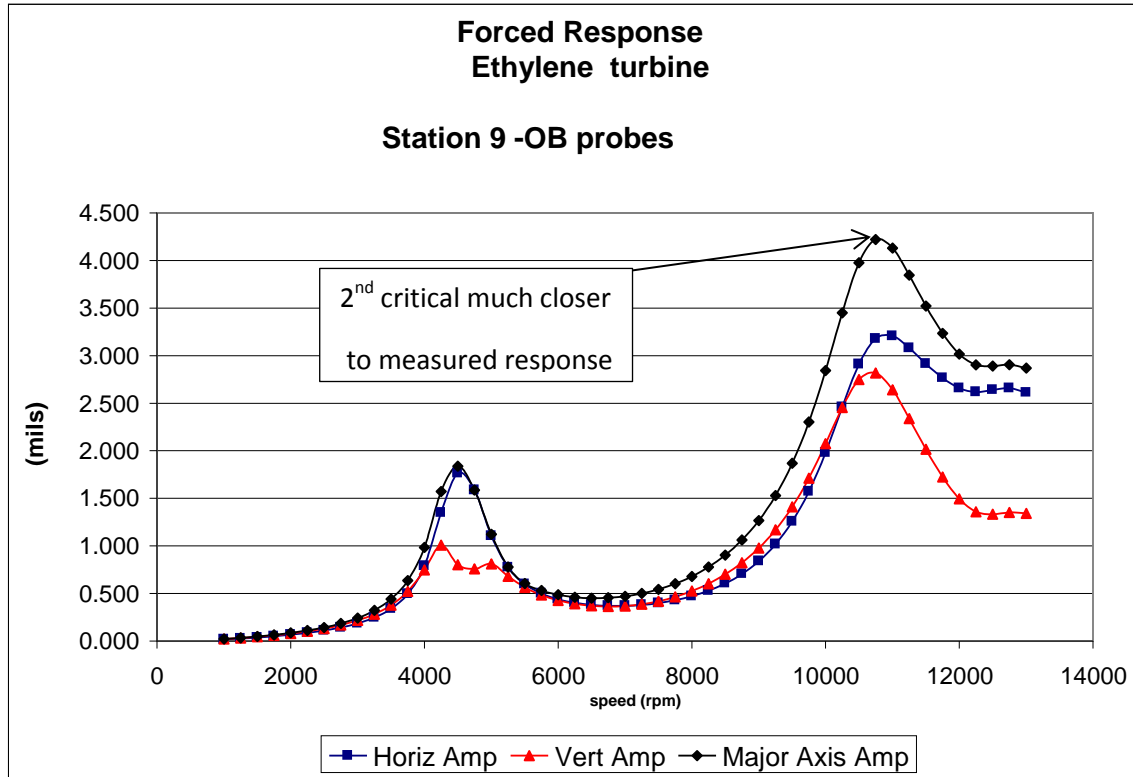
Figure 27. Ethylene turbine rotor model predictions w/ support stiffness effects (bearings on flexible supports)

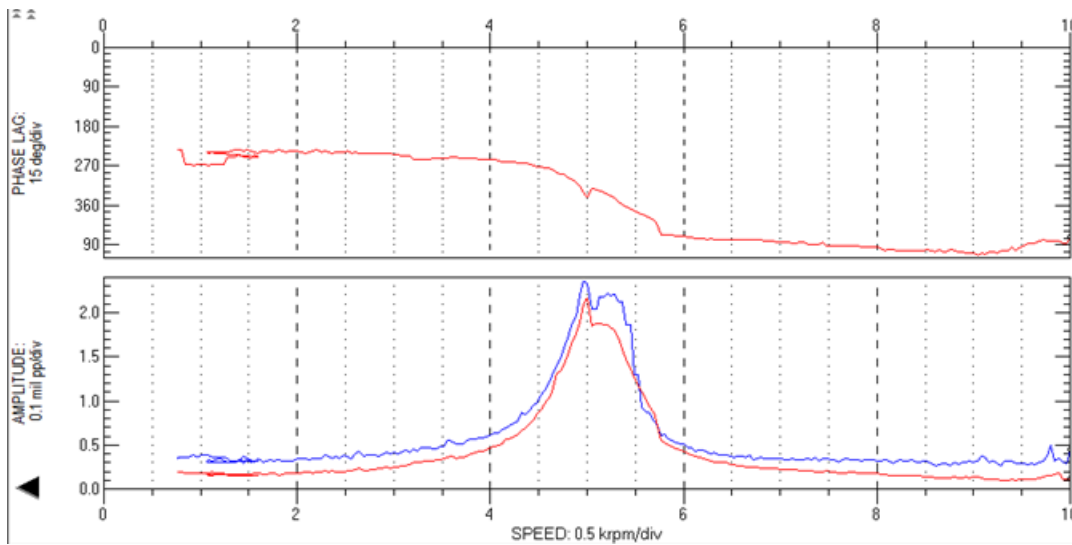
Figure 28. Steam turbine bode plot after outboard bearing was replaced (reduced clearance)

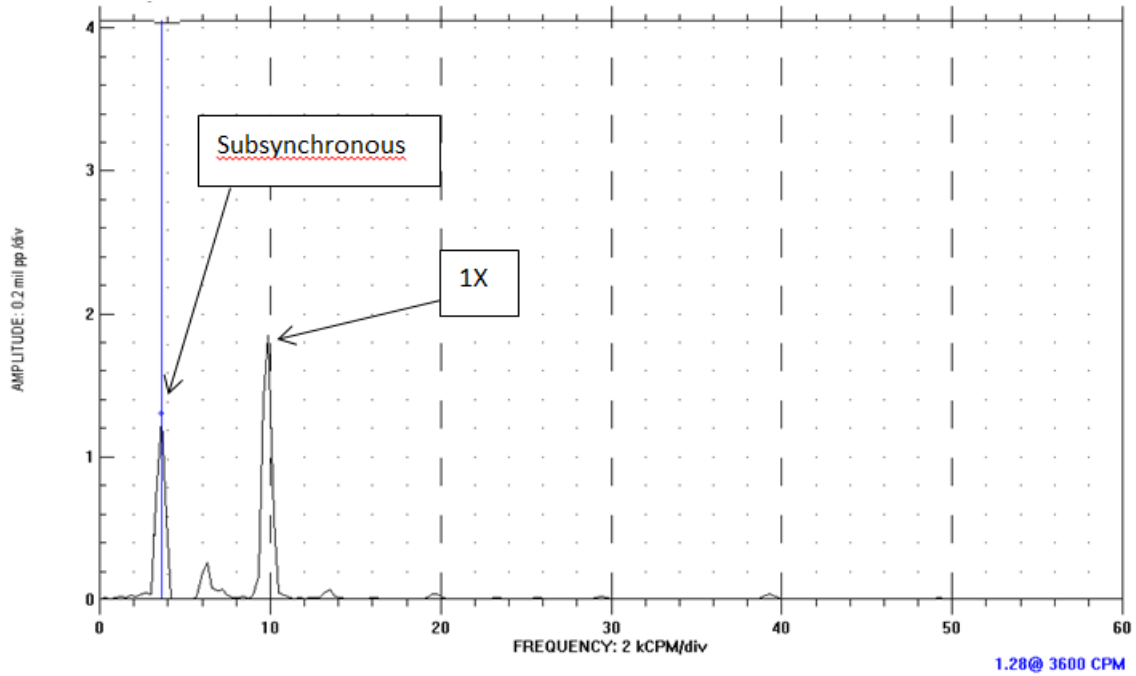
Figure 29. Compressor drive end vertical spectrum after overhaul

An example of using advanced vibration analysis to troubleshoot multiple problems on a propylene export compressor is described below. The compressor is a horizontally split design that operates at 9800 rpm and contains 5 impellers in a single section. It compresses propylene from approximately 30 to 280 psig. After an inspection overhaul, the start-up vibration on the compressor had increased dramatically in comparison to the values at shutdown. The synchronous amplitude was high but steady; however, the sub-synchronous component at 37% of running speed was very erratic, see Figure 29. The sub-synchronous frequency of 3600 cpm was very close to the compressor's measured first critical speed. This all pointed to an excitation frequency close to the first critical, however, the waterfall plot shown in Figure 30 shows that the subsynchronous component did not appear until the compressor was almost up to full speed. This particular compressor has 5 pad, LBP bearings, and dry gas seals which eliminates oil whirl as a potential excitation. Likewise, oil whirl would typically begin tracking once the rotor speed was 2X the rotors 1st critical (i.e. about 7000 rpm). Troubleshooting the compressor revealed that the sub-synchronous component was very dependent on discharge pressure, see Figure 31. This also coincided with why the sub-synchronous vibration didn't appear until the compressor was up to full speed.

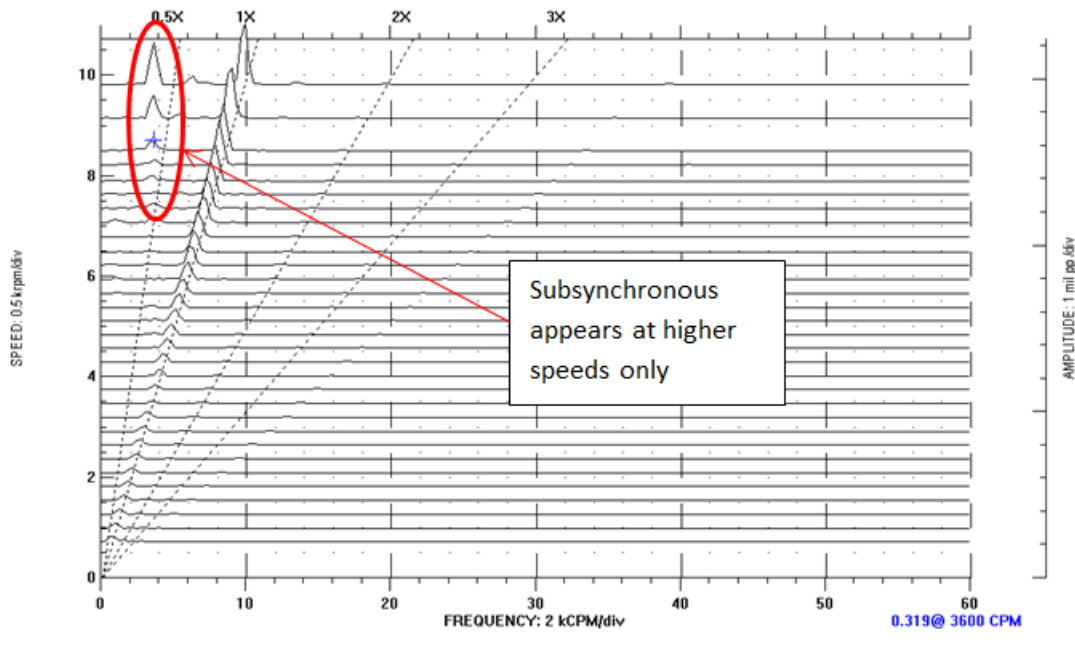
Figure 30. Cascade plot of compressor drive-end vertical

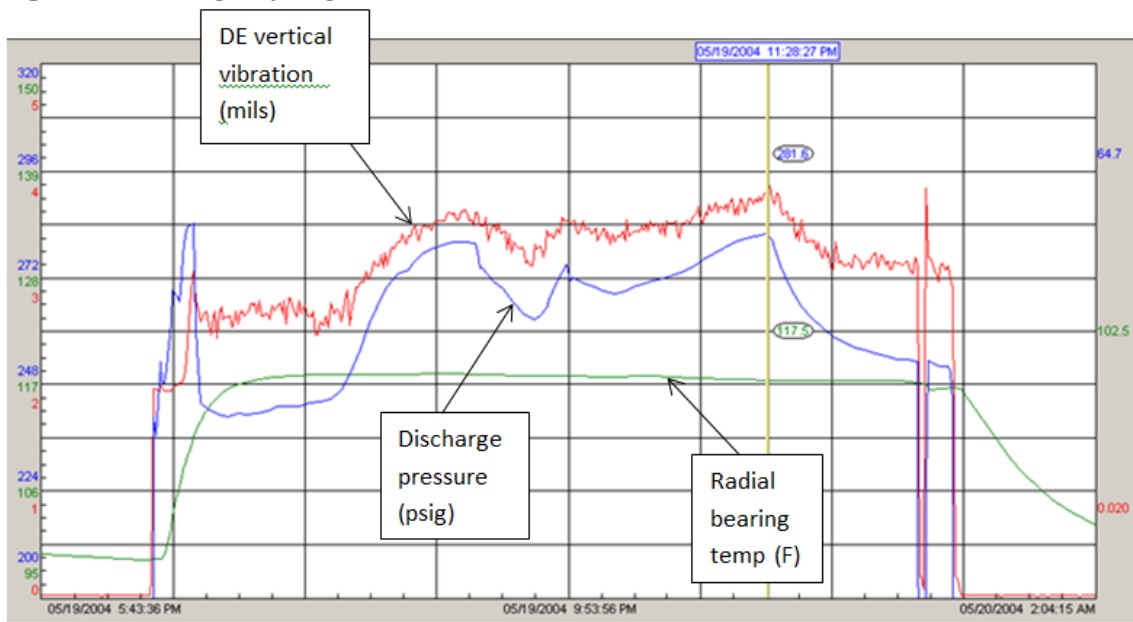
Figure 31. Trend showing discharge pressure(blue), drive end radial bearing temperature(green), and overall drive end horizontal vibration(red)

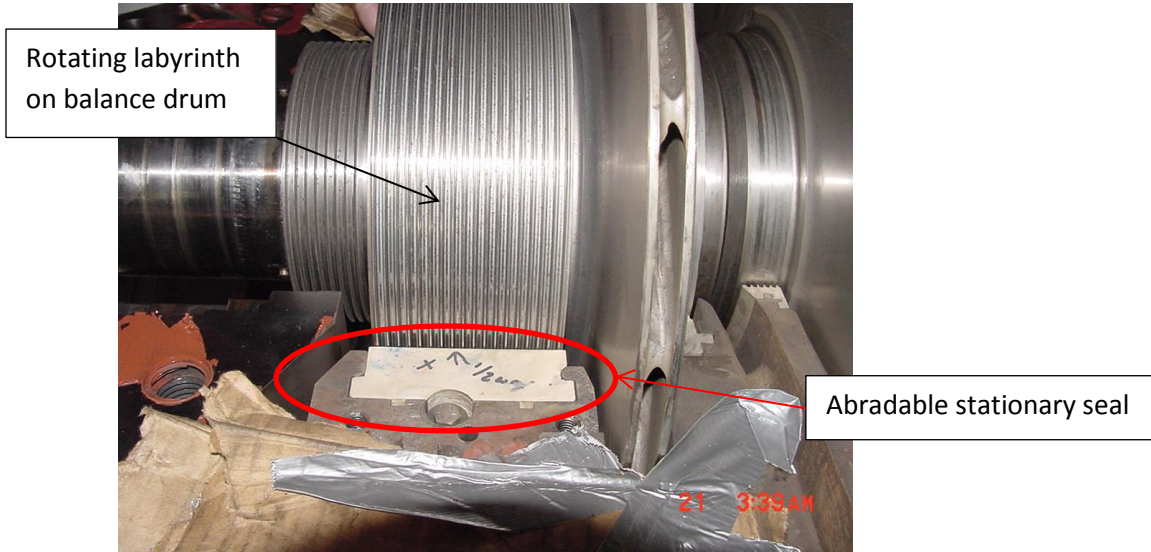
Figure 32. Rotating labyrinth seal on balance drum with abradable stationary

A rotordynamic study was conducted to help determine the cause of the high sub-synchronous vibration. For a compressor of this pressure level, the aerodynamic effects of the impellers and interstage labyrinth seals are normally not that significant. The largest destabilizing forces are normally contributed by the balance drum seal for a compressor of this caliber and this machine was no exception. The balance drum seal on this machine incorporated a rotating labyrinth versus an abradable stationary, see Figure 32. An illustration of the rotor model is shown in Figure 33 and the calculated 1st eigenvector w/o aerodynamic effects is shown in Figure 34. The balance drum seal was added to the rotor model and the log decrement of the 1st mode for a range of discharge pressure was calculated, see Figure 35. This stability map strongly supported the correlation between vibration and discharge pressure shown in Figure 30 above. Additionally, the original reason for the overhaul was to inspect the abradable stationary on the balance drum seal. Several failures of the abradable stationary seal due to thermal expansion had occurred in the previous ten years see Figure 36. During the most recent overhaul, the end gap clearance on the seal was increased to prevent these types of failures. Reviewing the previous inspection records and failure analysis after the vibration problem determined that the end gap may have been increased too much, causing excessive leakage through the balance drum seal. This was supported by the rotor's axial position after the overhaul, which indicated that the rotor was running on the inactive or "discharge" side. All indications pointed to the cross-coupled stiffness produced by the balance drum seal as the source of the destabilizing forces which excited the rotor's 1st mode.

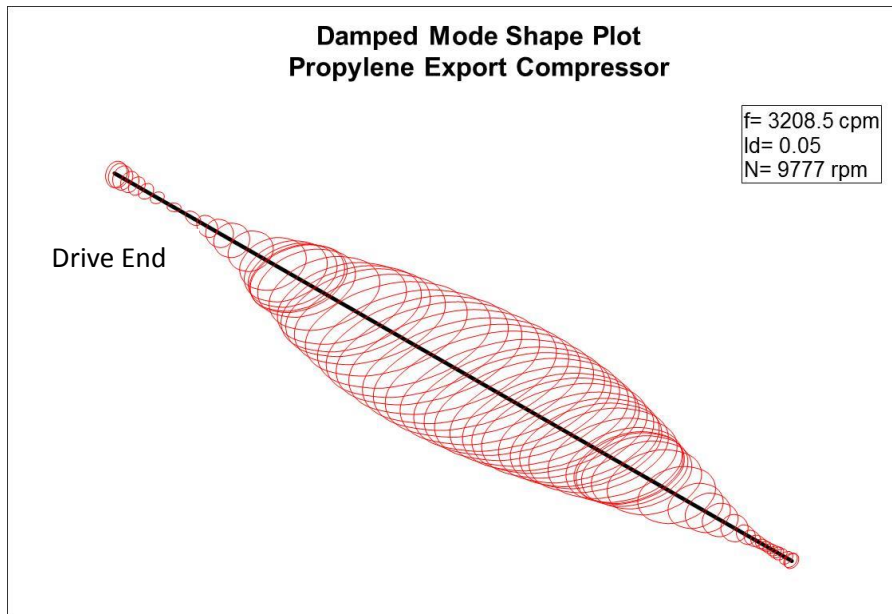
Figure 34. Calculated 1st mode for propylene export compressor with original bearing (5 pad, LBP, $C_d=0.005$, $m=0.35$, $L/D=0.36$), w/o aerodynamic effects of balance drum seal

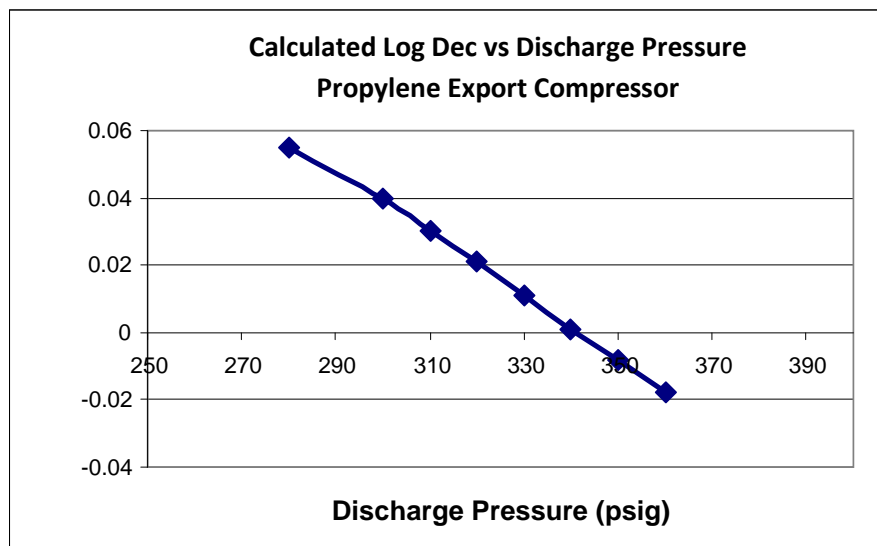
Figure 35. Calculated stability as function of discharge pressure with original bearing (5 pad, LBP, $C_d=0.005$, $m=0.35$, $L/D=0.3$)

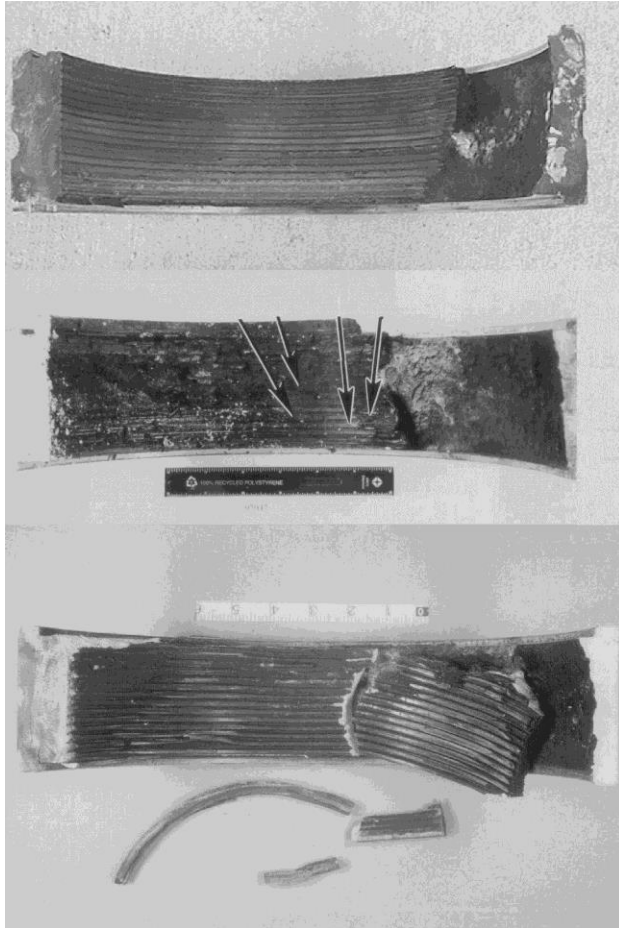
Figure 36. Failed abradable balance drum seals from 2001(upper), 1997(mid), and 1994 (lower)

The most direct method to address the problem would be to reduce the cross-coupled stiffness produced in the balance drum seal. An alternative design with swirl brakes on the inlet was designed and fabricated. However, replacement of the balance drum seal would have required a substantial outage and the vibration was kept somewhat under control by limiting the compressor discharge pressure.

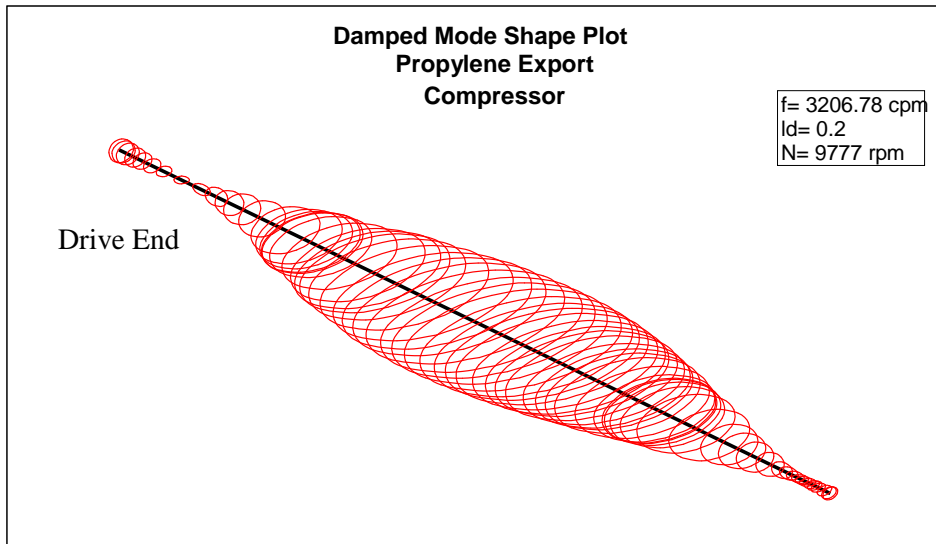
Figure 37. Calculated 1st mode with modified bearings (5 pad, LOP, Cd=0.006, m=0.2, L/D=0.4) and 360 psig discharge pressure

As an immediate stop-gap type repair, an improved tilt-pad bearing was designed that changed the bearing design from a LBP to a LOP, increased the L/D, and lowered the pre-load slightly. A more detailed background of the methodology of these changes can be found in Ref[8,9]. These design changes increased the effective damping in the bearing and improved the calculated log decrement from 0.05 to 0.2, see Figure 37. To confirm the stability predictions, during an at-speed balance check of the spare rotor, the transient data was recorded with the original and the optimized bearing designs. As can be seen in Figures 38 and 39 the amplification factor is significantly higher with the original bearing design in comparison to the optimized. The optimized bearing was installed during a short outage and the overall vibration was reduced from approximately 1.9 to 0.4 mils, see Figure 40.

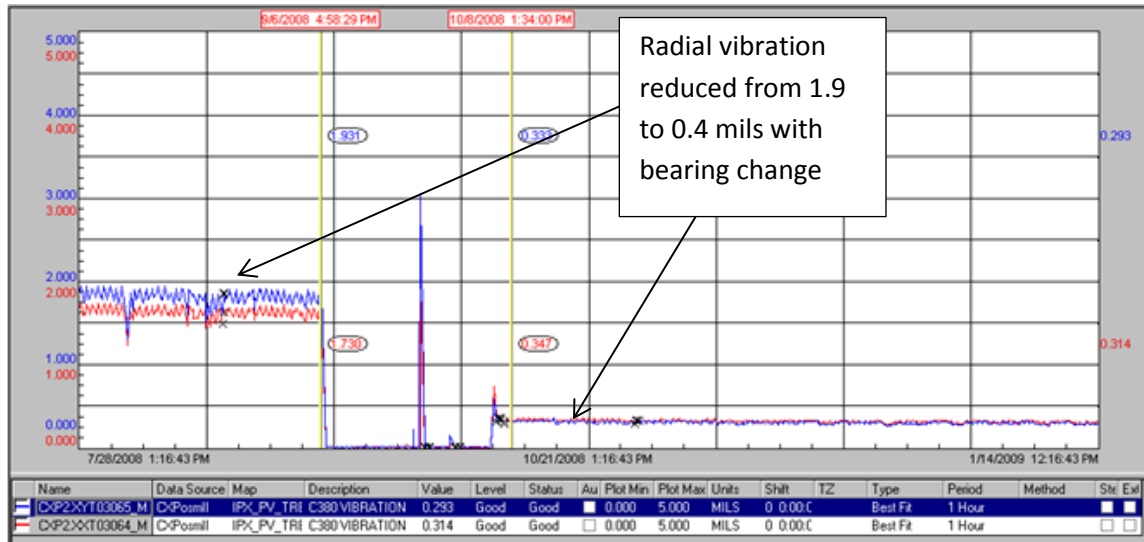
Figure 40. Trend of propylene compressor drive end vibration before and after bearing change

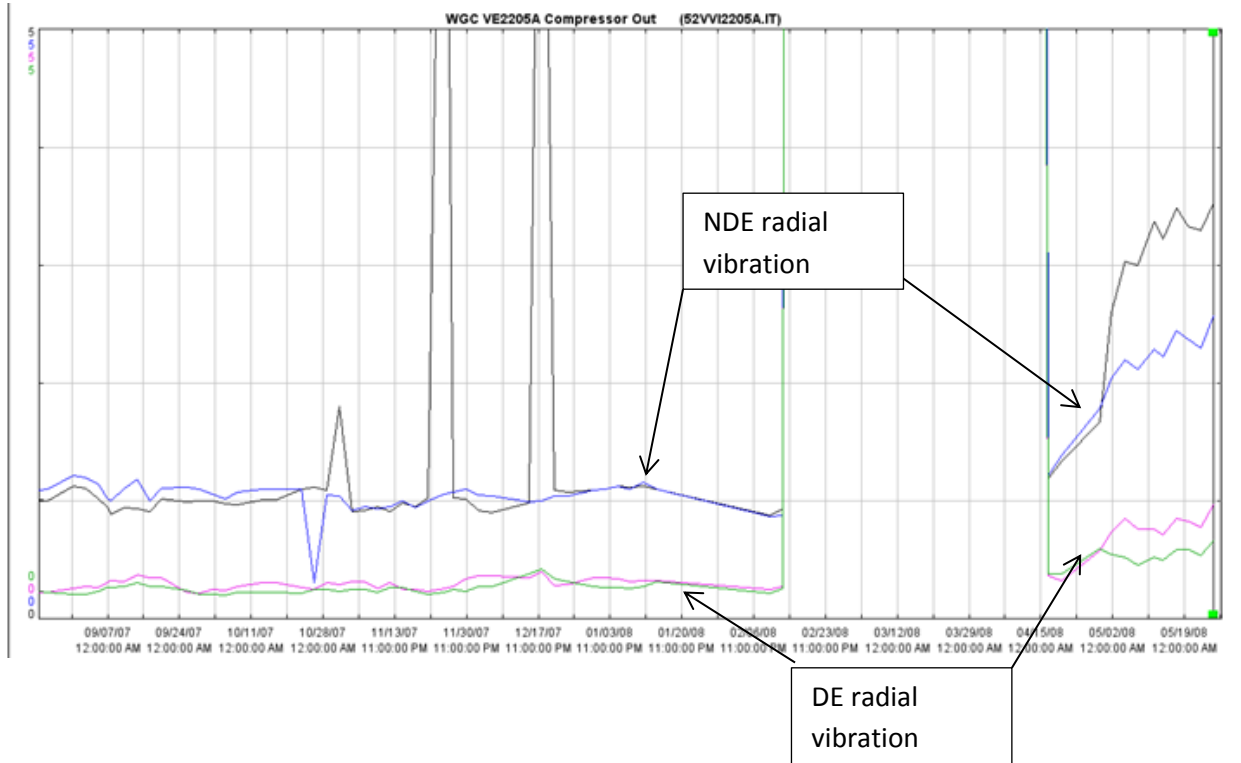
Figure 41. Trend of FCC wet gas compressor overall radial vibration before and after unit outage (blue/black NDE, green/pink DE)

As discussed above, the proximity of a rotor’s speed to a natural mode can have a dramatic effect on the produced vibration. The frequency of the rotor’s natural modes must be well known and the corresponding mode shapes understood. An example of not understanding the deflected mode shape is revealed when a refinery FCC wet gas compressor experienced an increase in vibration, see Figure 41. The compressor was a two section design with oil seals and was relatively old, see Figure 42. The increase in vibration was thought to have been caused by foulant falling off the compressor rotor while it was down. The largest increase in vibration was on the non-drive (thrust) end of the compressor. Since this was also the 1st section of the compressor (rhs of Figure 42), it was assumed that a solvent wash in the inlet of the compressor might improve the vibration. Repeated attempts to “clean” the rotor on-line were un-successful. The compressor was operated a short while longer until a maintenance outage could be scheduled. Inspection of the compressor internals revealed that fouling was not the cause of the high vibration. The front cover on the 5th stage wheel (1st impeller in the 2nd section) had failed at the rivet, see Figure 43 which resulted in a substantial unbalance. Even though the 5th stage impeller was closer to the drive end of the compressor, the radial vibration had been substantially higher on the non-drive end because of the displaced mode shape of the rotor at operating speed. The amount of missing impeller cover was measured and the unbalance effect was calculated to be approximately 20 oz-in. The calculated displacement at both drive end and non-drive end probes due to the estimated unbalance on impeller #5 is shown in Figures 44 and 45. As can be seen the predicted values on the non-drive end are substantially higher even though the unbalance is quite far away from those probes.

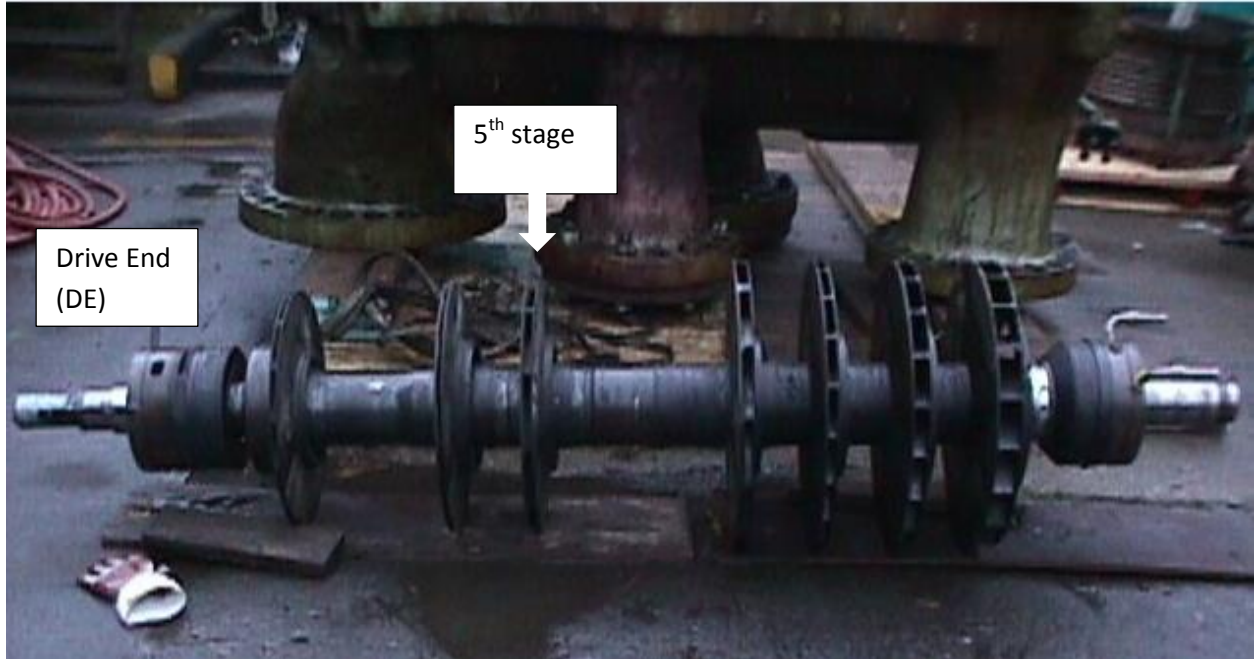
Figure 42. FCC wet gas compressor rotor during previous overhaul

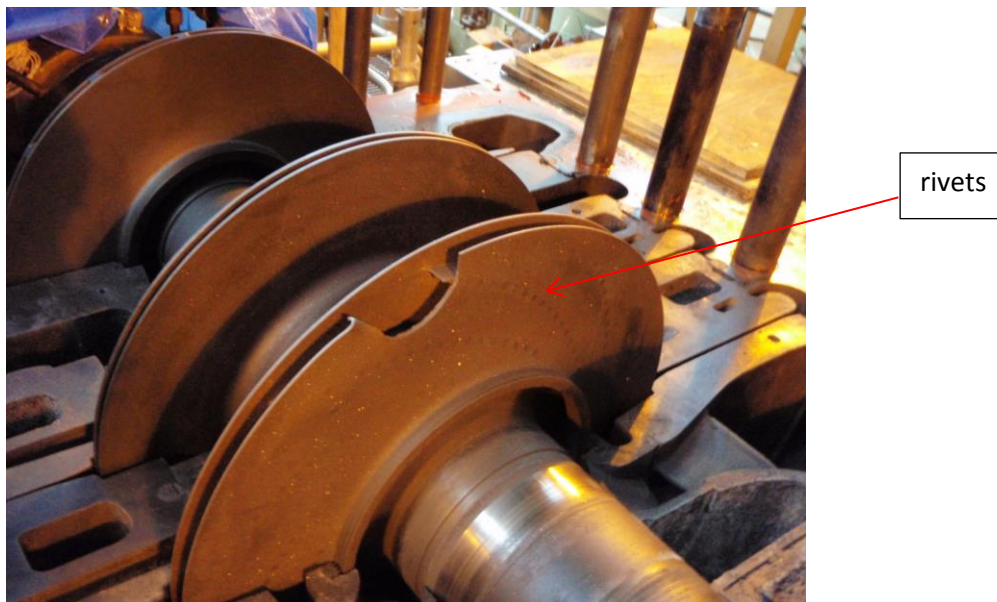
Figure 43. FCC wet gas compressor failed 5th stage impeller, note rivets

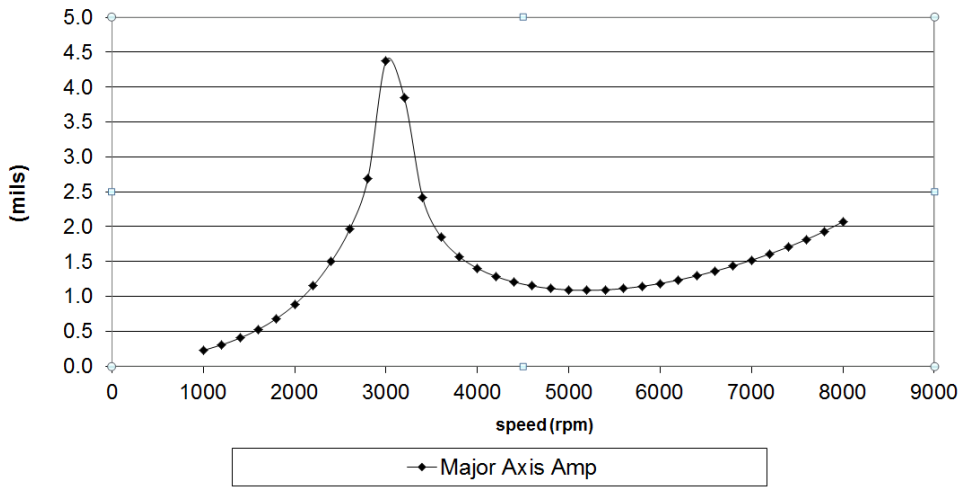
**Forced Response
FCC Wet Gas Compressor
20 oz-in unbalance at 5th stage impeller
Station 7 - DE probes**

Figure 44. FCC wet gas compressor forced response calculations on drive end probes for calculated unbalance

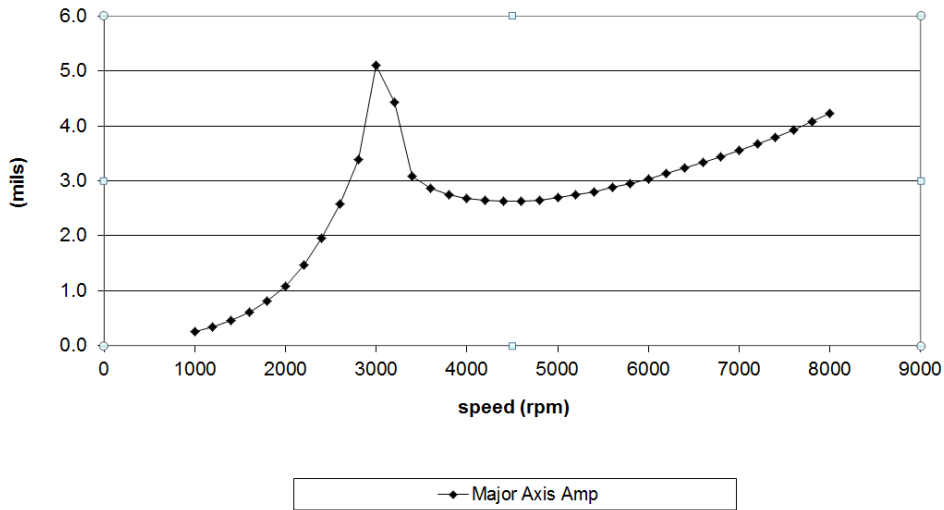
**Forced Response
FCC Wet Gas Compressor
20 oz-in unbalance at 5th stage impeller
Station 34 - TE probes**

Figure 45. FCC wet gas compressor forced response calculations on non-drive end probes for calculated unbalance

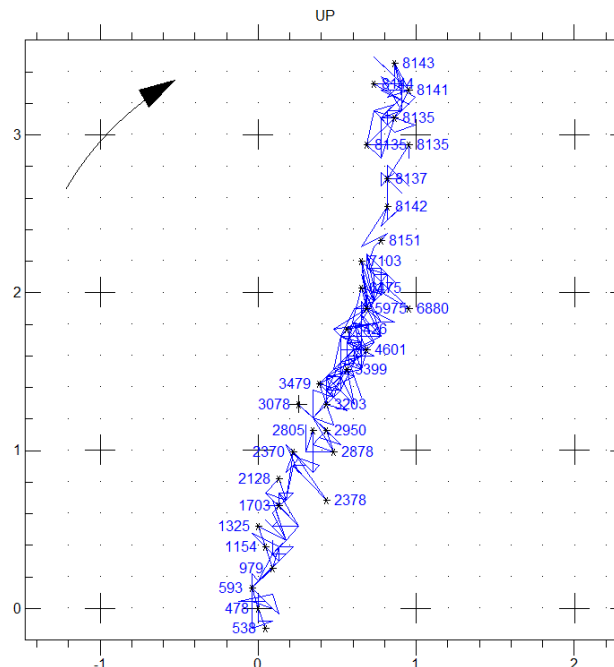
Figure 46. Typical shaft centerline plot of a start-up of a centrifugal compressor on tilt-pad bearings

Two vibration diagnostic plots that are only available for proximity probes are the shaft centerline and orbit plots. As described above the proximity probe system produces both a DC and AC signal. If two orthogonal probes are used, the signals from these two probes can be combined to provide significant insight into the machine behavior. The DC signal represents the average shaft position from the proximity probe tip. The most common application is when the shaft speed is changing (typically start-up and shutdown). Since the shaft rides on a film of oil, it rises up from the bottom of the bearing as the speed increases. A typical shaft centerline plot for the start-up of a centrifugal compressor is shown in Figure 46. The characteristic of this plot is very dependent on the individual machine type, bearing design, and application. Shaft centerline plots are very good for determining if the rotor is obstructed by a stationary component or if the bearing clearance is out of tolerance (either too low or high). Likewise, trends of shaft position over time can be used to determine if a bearing has been damaged, allowing the rotor to drop down in the bearings. The shaft orbit plot is created by plotting the time waveform (i.e. AC components) of two orthogonal probes versus each other, which represents the whirling motion of the shaft inside the bearing. A separate illustration of how the shaft orbit is produced from two proximity probe signals is shown in Figure 47. Additionally, an illustration of the shaft centerline and orbit plots is shown in Figure 48.

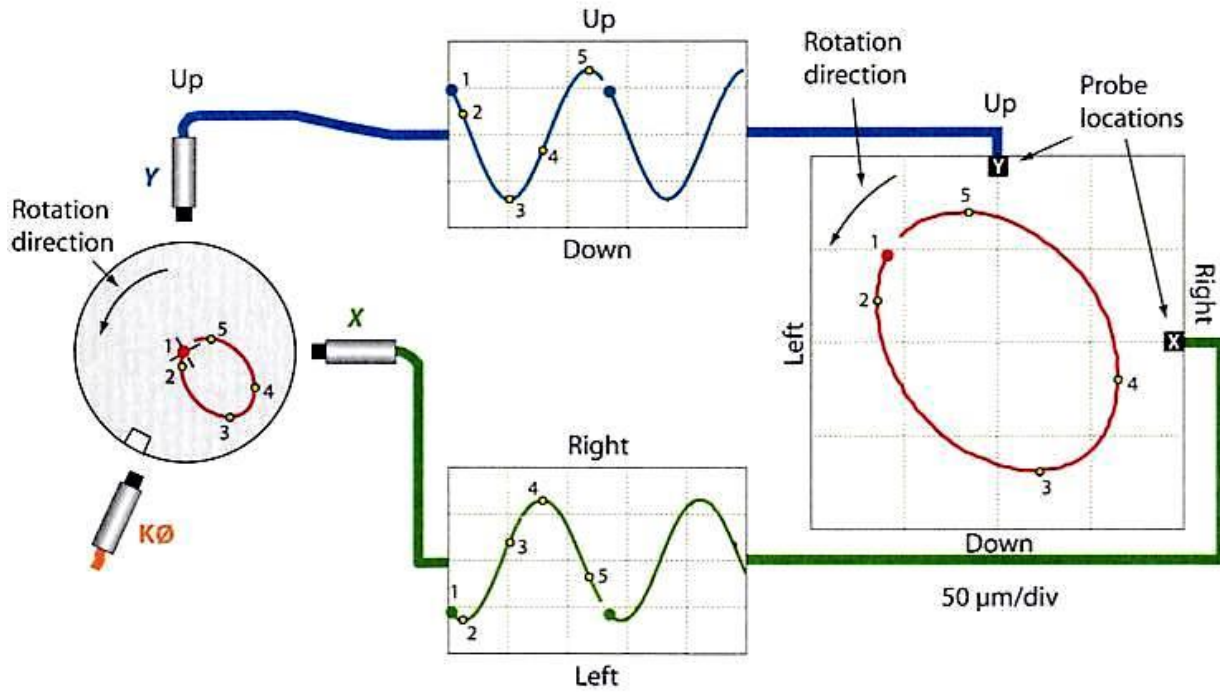
Figure 47. Relationship between time waveforms and shaft orbit (General Electric)

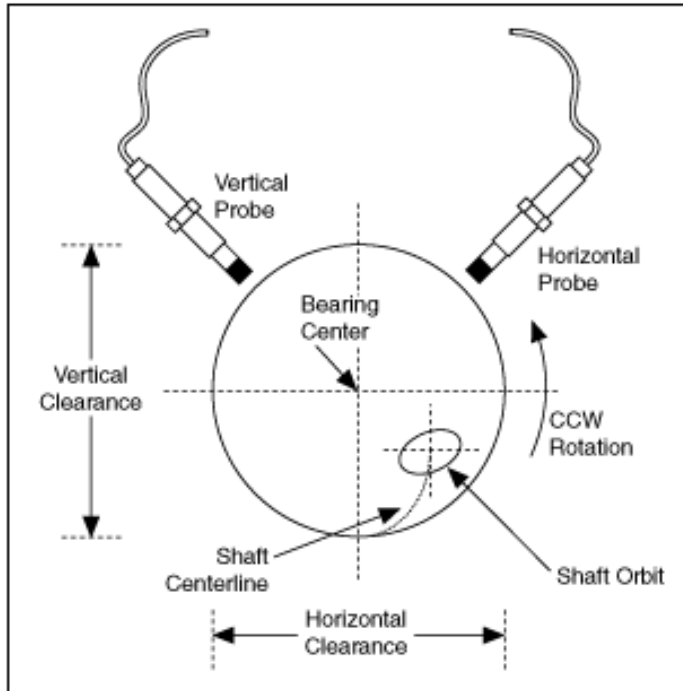
Figure 48. Illustration of shaft centerline and shaft orbit plots (General Electric)

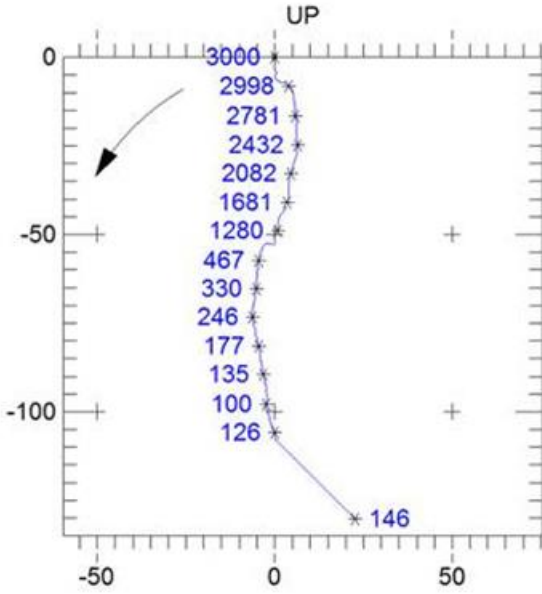
Figure 49. Turbine bearing #3 shaft centerline plot, before major overhaul

A good example of the utilization of both shaft centerline and orbit plots is an industrial gas turbine generator exhibiting higher than normal vibration after a major inspection. The #2 and #3 bearings had been replaced, along with the blades on all three turbine stages. The initial thoughts were that there was a balance problem since the blade arrangement is very critical and nearly all of the vibration was synchronous. However, comparison of the shaft centerline plots of a previous start-up and the most recent showed a marked change. While the previous start-up (Figure 49) is very typical of a machine on tilt-pad bearings, Figure 50 shows that a rub of some type occurs sometime above 2340 rpm. This causes the rotor to be pushed back down as the speed is increased. This can be observed in the orbit plots as well. Figures 51 and 52 show higher amounts of pre-load on the rotor, which causes the orbit to become more elliptical/distorted. A short inspection of the #3 bearing after the overhaul revealed that the rub/preload may have damaged one of the pads in the #3 bearing, see Figure 53.

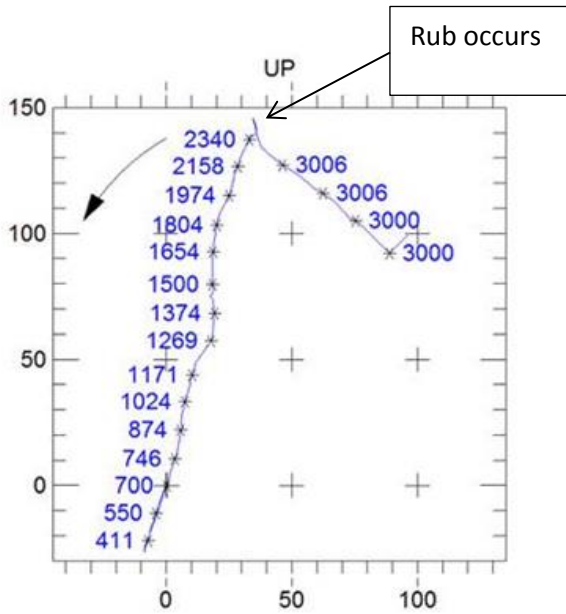
Figure 50. Turbine bearing #3 shaft centerline plot, after major overhaul

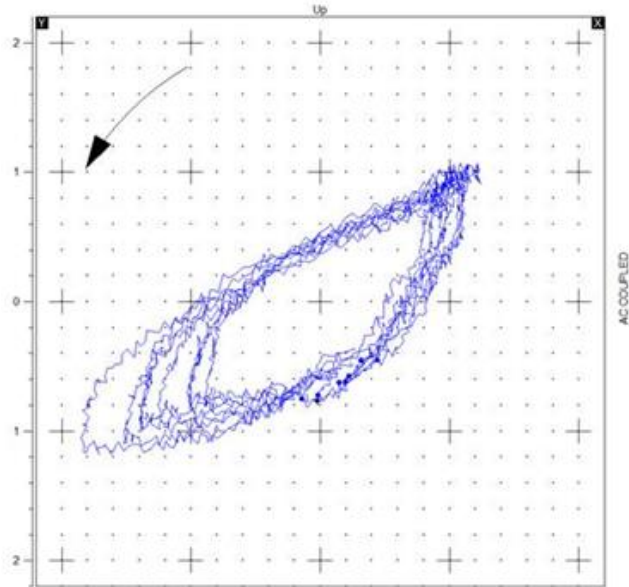
Figure 51. Turbine #3 bearing shaft orbit with preload after overhaul

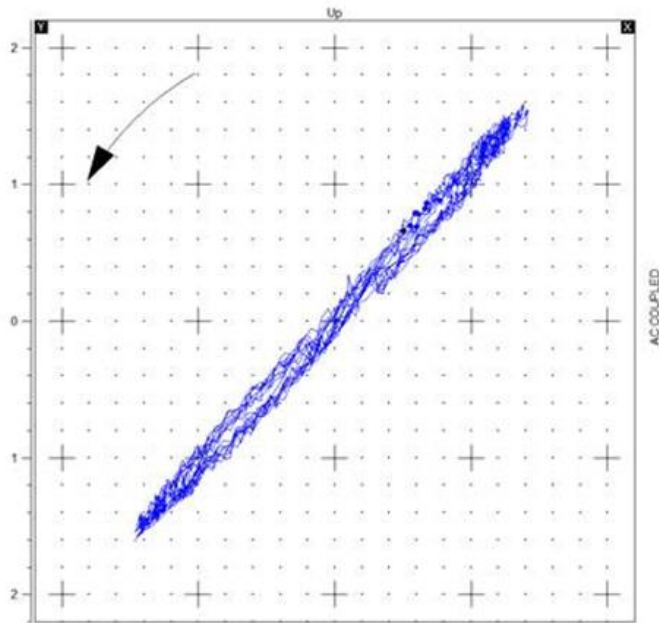
Figure 52. Turbine #3 bearing shaft orbit showing extreme preload after overhaul

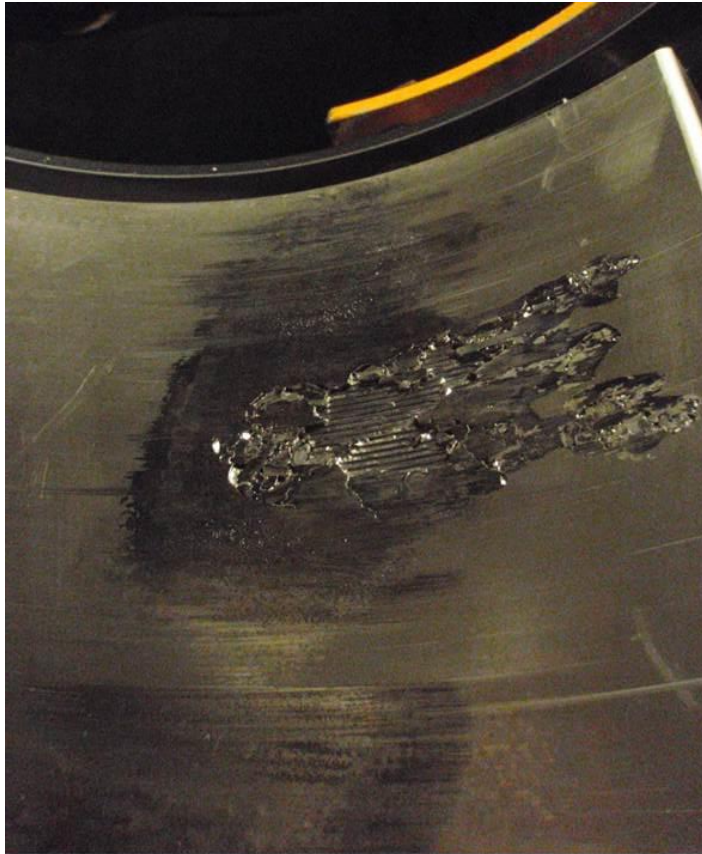
Figure 53. Damaged pad from #3 bearing found during bearing inspection after overhaul

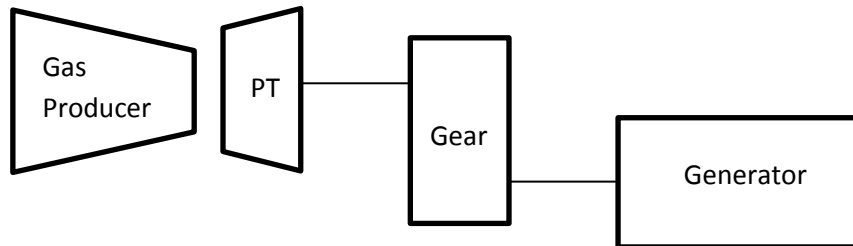
Figure 54. Schematic of two shaft gas turbine generator with speed reducing gearbox

Another example of using a cascade, bode, orbit, and shaft centerline plots to troubleshoot machinery issues centers around a 30 MW gas turbine generator. The application is a two-shaft aeroderivative gas turbine that drives a 4-pole electrical generator through a parallel shaft reduction gearbox, see schematic in Figure 54. During a FAT, a very high (approximately 12 mils) radial vibration was observed on the pinion drive end (DE) bearing, see Figure 55. This only occurred during a tripped breaker test at full load (i.e. the breaker on the generator was opened when the generator was operating at full load). This is normally performed to test the package controls ability to trip in a rapid fashion and prevent a rotor overspeed event. The very high vibration occurred during coastdown and only for a narrow speed range. Initial concern was that this was a torsional resonance, being excited during the transient event. However, the OEM measured the torsional vibration on both the bull gear and pinion shafts and the amplitudes were all low. Likewise, there was no component at the 41 hz shown below in Figure 56. Examination of the shaft centerline plots during the test led to the final solution. The generator load was increased and decreased multiple times during the FAT, this change in power resulted in corresponding changes in radial gear load, which are represented by the multiple lines up and down in Figure 57. The gear radial load is a direct function of the power being transmitted and acts along the gear load angle, which is approximately 20 degrees from vertical. This radial gear load pushes down on the bull gear and up on the pinion, see Figure 58. The relatively high radial gear

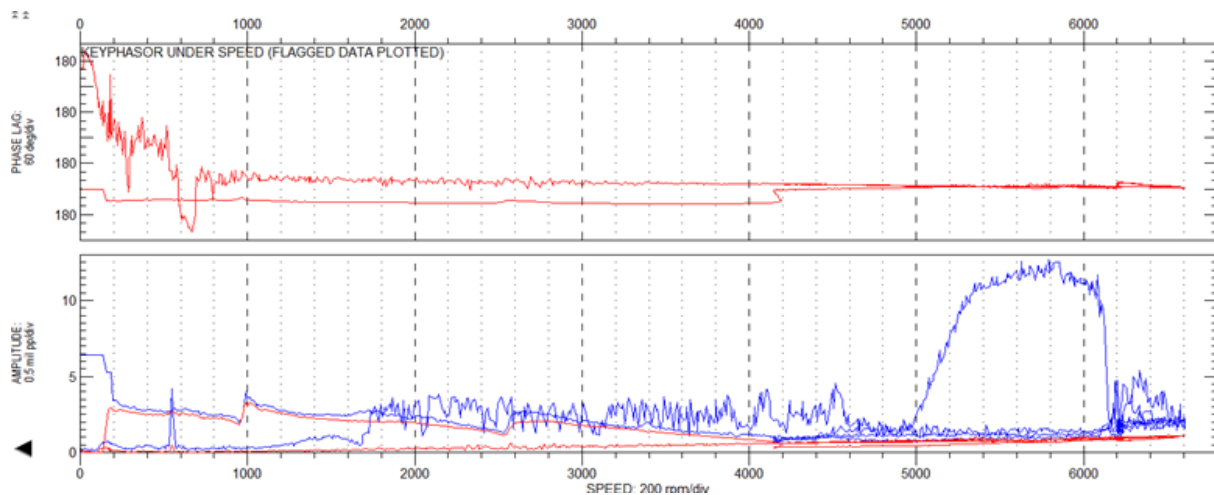
Figure 55. Bode plot of gearbox pinion radial overall (blue) and 1x(red) vibration on gas turbine generator

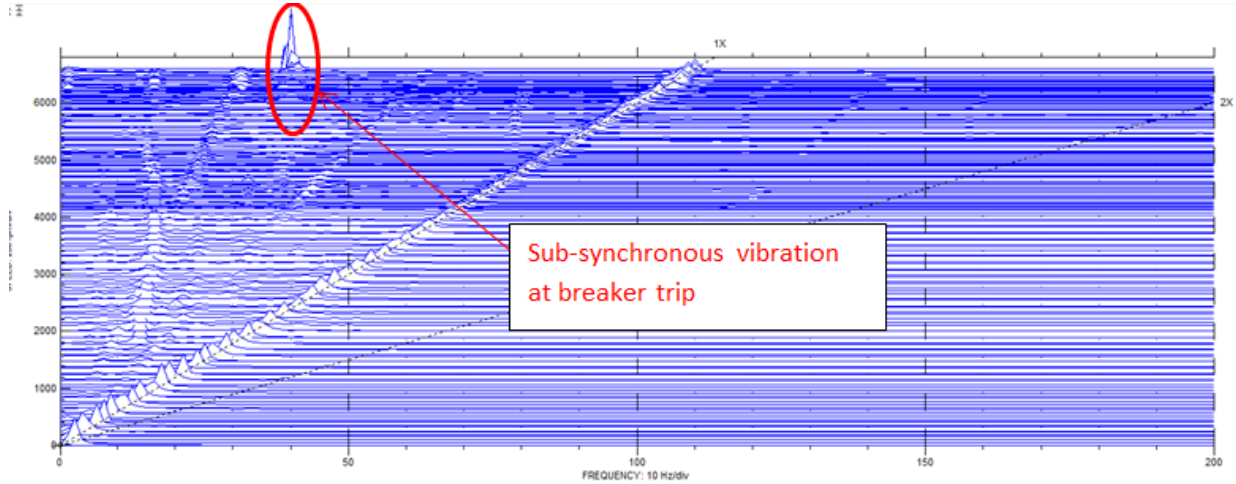
Figure 56. Cascade plot of GTG pinion radial vibration

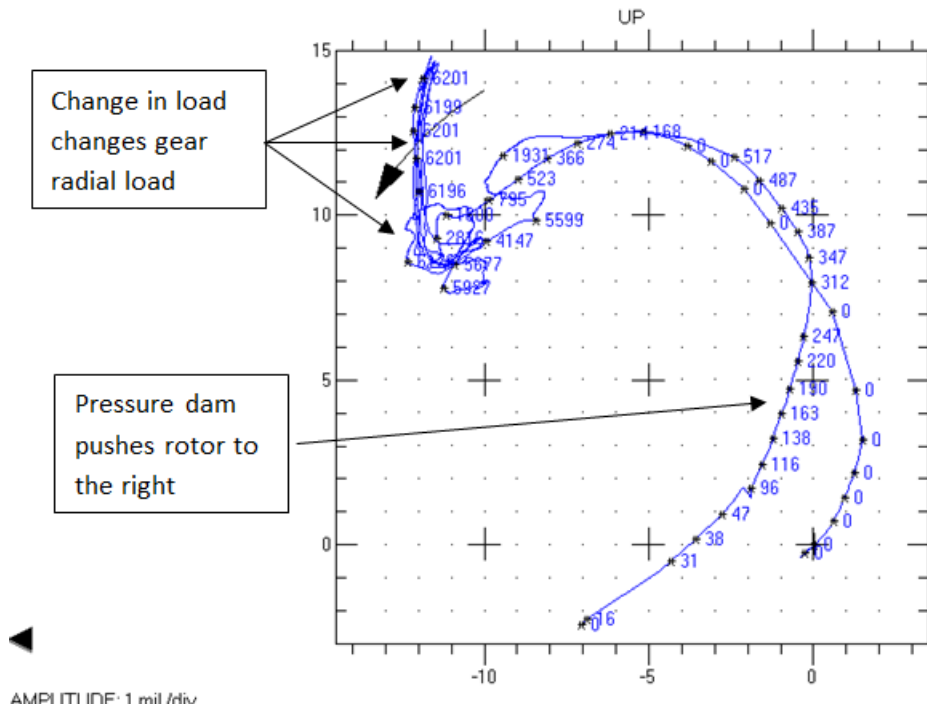
Figure 57. GTG gearbox pinion DE shaft centerline plot

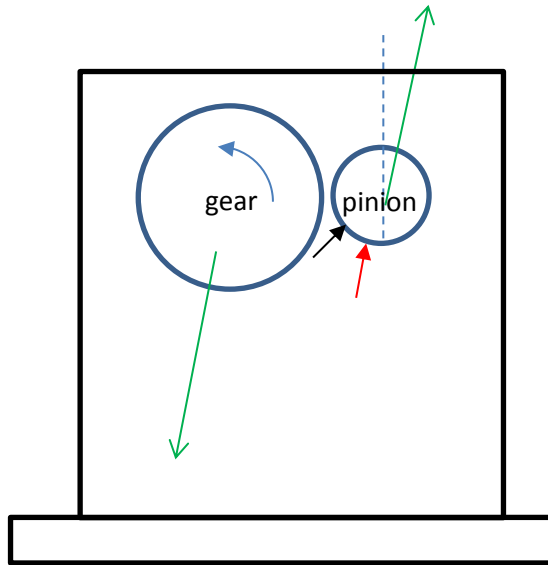
Figure 58. Generator gearbox showing design gear loads vectors (green), original pressured dam location (black), and modified (red) on pinion

load keeps the pinion very stable in the top half of the pinion bearings when power is being transmitted. To handle low power (and subsequent low gear load) situations, the gearbox was designed with a pressure dam in the lower half of the pinion bearings. Normally, this pressure dam creates an upward radial load on the pinion to keep it stable when the gear load is not sufficient. During the open-breaker test, the gear load was dramatically reduced. Likewise, for a short period of time, the inertia of the large four pole generator acted as a flywheel to prevent the relatively light power turbine rotor from slowing down, see Figure 59. This inertial breaking affect, reversed the transmitted radial load within the gerset, which tried to lift the bull gear and pull the pinion down. The transient reverse gear load is not enough to lift the bull gear, but it is enough to cause the pinion shaft to become unstable and whirl, causing the very high vibration shown in Figure 55. The pressure dam bearing design was changed by increasing the dam width and changing the dam location from 45 degrees off bottom dead center to only 15 degrees. This change not only increased the load produced by the dam, but changed the load angle so that it was more in-line with the gear load at 20 degrees. The subsequent open breaker trip of the generator after the bearing design changes, showed that the shaft centerline plot had changed and the high vibration had been eliminated, see Figures 60, 61, and 62. The high vibration on the extreme left of Figure 61 was caused by the jacking oil pumps being started on the generator at 100 rpm and being transmitted through the gear mesh. Since the shaft speed was so low, the energy is very low and it is not a concern other than the vibration trip that may occur.

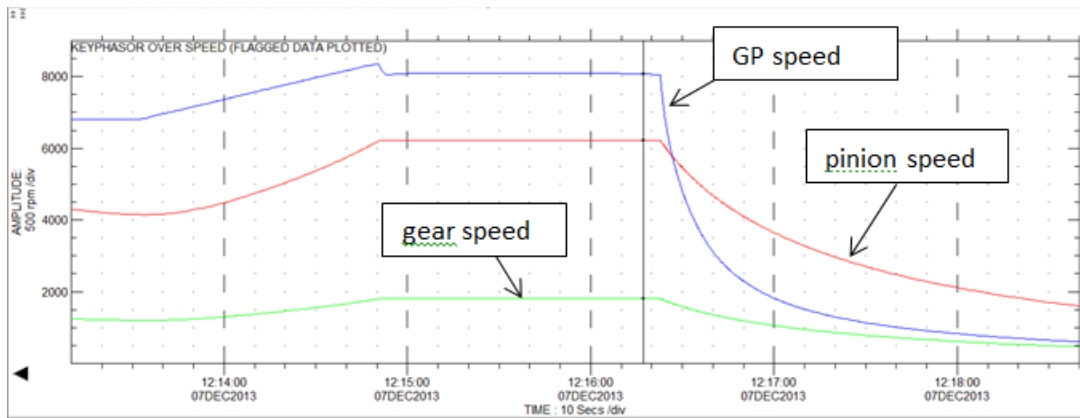
Figure 59. Speed trend during open breaker trip, gas producer(blue), pinion(red), gear(green)
