45TH TURBOMACHINERY & 32ND PUMP SYMPOSIA
HOUSTON, TEXAS | SEPTEMBER 12 – 15, 2016
GEORGE R. BROWN CONVENTION CENTER

Vibration Analysis for Turbomachinery

Ed Wilcox

Consulting Machinery Engineer
Chevron Energy Technology Company
Houston, TX

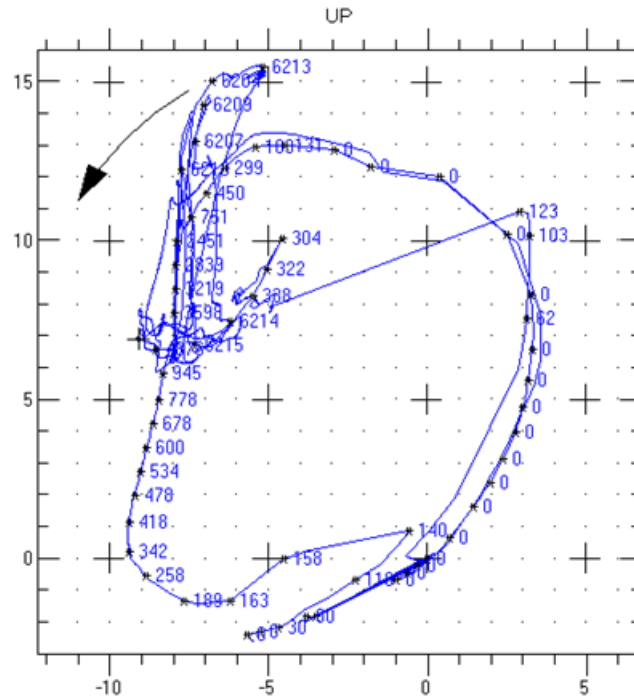
Figure 60. Shaft centerline plot after bearing modification

load keeps the pinion very stable in the top half of the pinion bearings when power is being transmitted. To handle low power (and subsequent low gear load) situations, the gearbox was designed with a pressure dam in the lower half of the pinion bearings. Normally, this pressure dam creates an upward radial load on the pinion to keep it stable when the gear load is not sufficient. During the open-breaker test, the gear load was dramatically reduced. Likewise, for a short period of time, the inertia of the large four pole generator acted as a flywheel to prevent the relatively light power turbine rotor from slowing down, see Figure 59. This inertial breaking affect, reversed the transmitted radial load within the gerset, which tried to lift the bull gear and pull the pinion down. The transient reverse gear load is not enough to lift the bull gear, but it is enough to cause the pinion shaft to become unstable and whirl, causing the very high vibration shown in Figure 55. The pressure dam bearing design was changed by increasing the dam width and changing the dam location from 45 degrees off bottom dead center to only 15 degrees. This change not only increased the load produced by the dam, but changed the load angle so that it was more in-line with the gear load at 20 degrees. The subsequent open breaker trip of the generator after the bearing design changes, showed that the shaft centerline plot had changed and the high vibration had been eliminated, see Figures 60, 61, and 62. The high vibration on the extreme left of Figure 61 was caused by the jacking oil pumps being started on the generator at 100 rpm and being transmitted through the gear mesh. Since the shaft speed was so low, the energy is very low and it is not a concern other than the vibration trip that may occur.

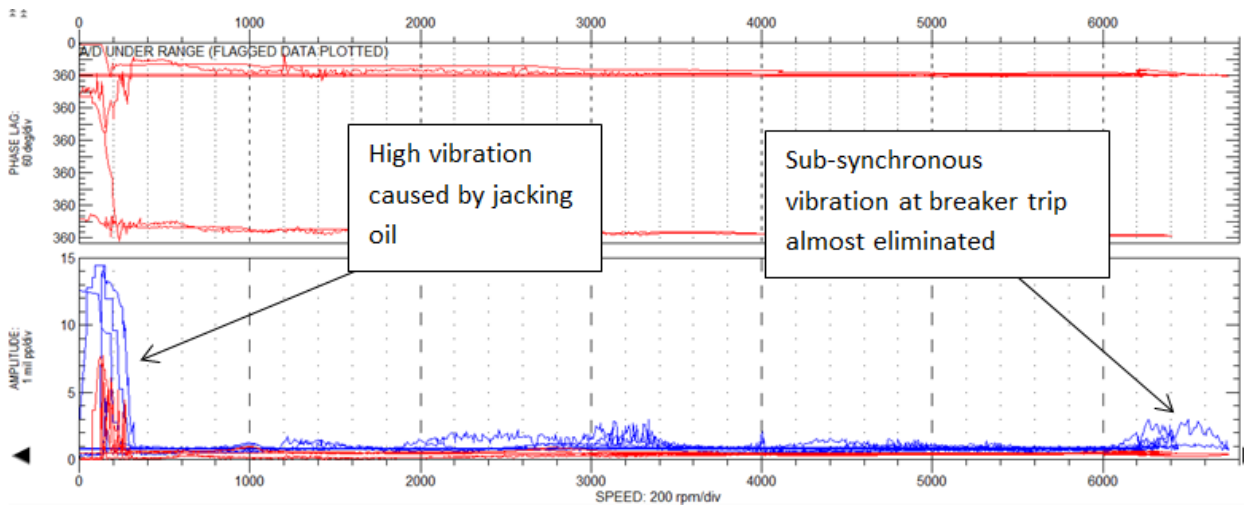
Figure 61. GTG pinon DE radial vibration after bearing modification

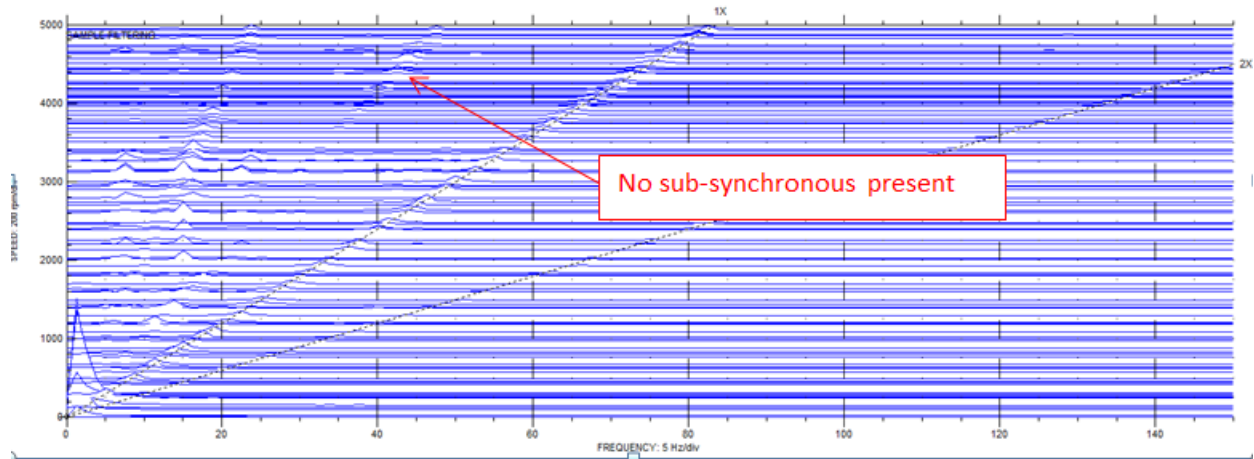
Figure 62. GTG pinion DE cascade plot after bearing modification
