ASIA TURBOMACHINERY & PUMP SYMPOSIUM
SINGAPORE | 22 - 25 FEBRUARY 2016
M A R I N A B A Y S A N D S

REMAINING LIFE ASSESSMENT OF STEAM TURBINE AND HOT GAS EXPANDER COMPONENTS

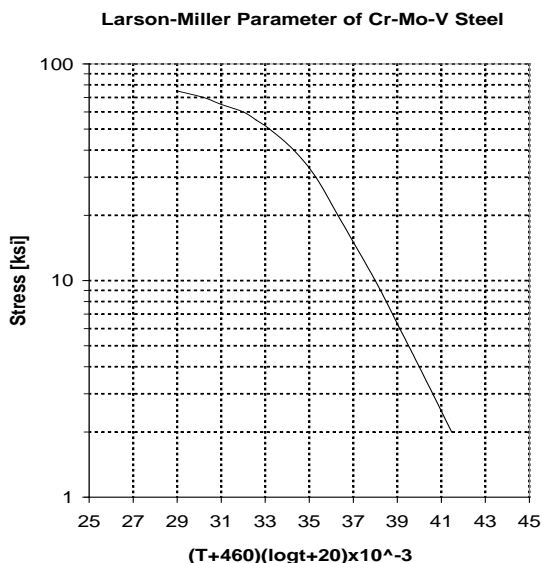
Figure 1. Larson-Miller Curve of Cr-Mo-V alloy steel (ASTM A470 Class 8)

Evidence of creep damage in the high temperature regions of blade attachment areas of rotors has been observed in some instances (Bush, 1982). The rim stresses and metal temperature at these locations are assessed against the creep rupture data for that particular grade of steel/or material. Traditionally one has used a Larson Miller (LM) plot of the type shown in Figure 1.

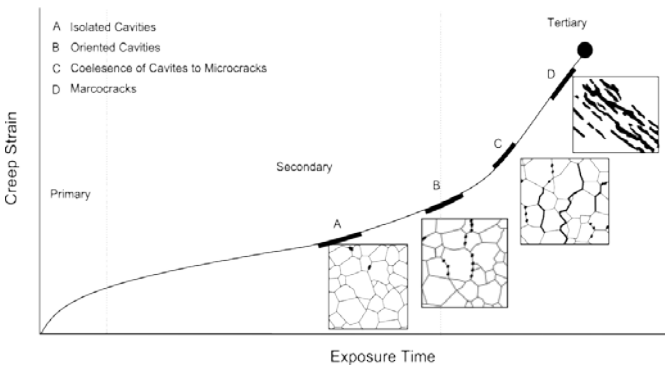
Figure 2. Replicas for Remaining Life Assessment.

The figure 2 shows the location of the four stages on the creep strain/exposure time curve (Neubauer and Wadel, 1983).

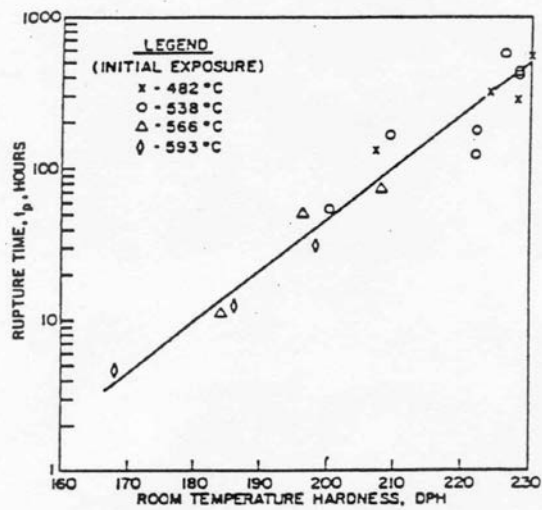
Figure 3. Correlation between post-exposure rupture time in the standard test at 538°C and 240 MPa and room temperature hardness for Cr-Mo-V rotor steel.

room temperature hardness measured on exposed creep specimens and the post exposure rupture life, Figure 3.

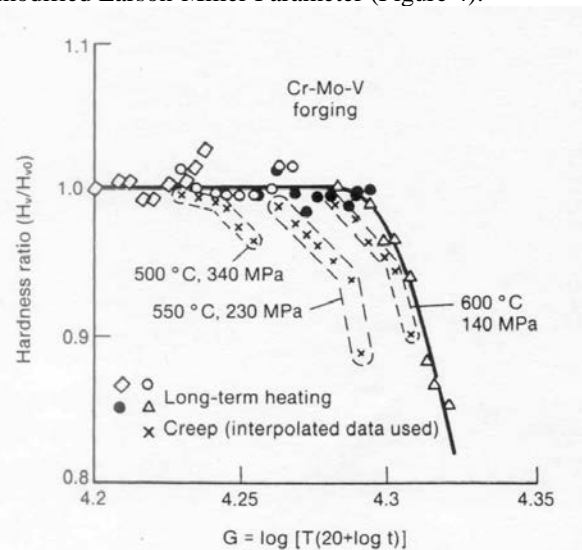
Figure 4. Plot of hardness ratio vs. G parameter for long-term heating and creep of Cr-Mo-V rotor steel.

If similar calibration could be established between prior creep life expended or the remaining life fraction in the post exposure test and the hardness values for a range of CrMoV steels, this method could be applied to estimation of remaining life. However, data of this nature are not available in sufficient quantity. Other work done by Viswanathan and Gehl (1992) showed a lot of promise where he attempted to use the hardness technique as a stress indication. He observed that the application of stress accelerated the softening process and shifted the hardness to lower parameter values compared with the case of simple thermal softening on a plot of hardness vs. a modified Larson-Miller Parameter (Figure 4).

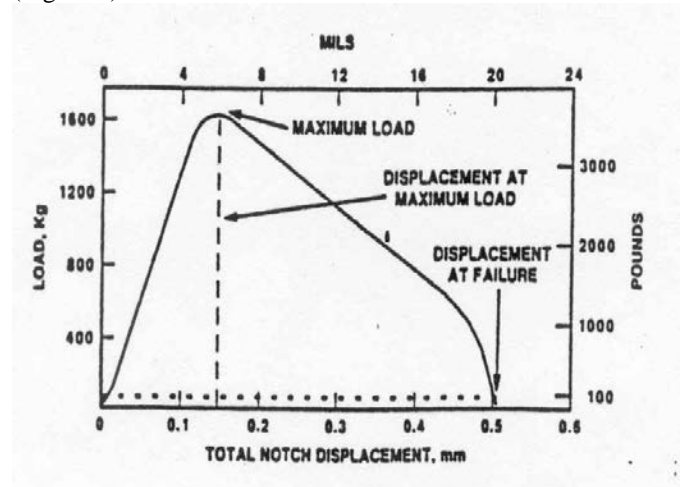
Figure 5. Example of Load Displacement Curve from CDR Tests at 1200°F and 2 mils/in/hr.

For a valid CDR test, the criteria for failure was considered to be the value of "displacement at fracture" was defined as the point of intersection of the 100 pound load line and the descending load displacement curve. The "displacement at failure" is measured from the start of the test to the point where the load displacement curve decreases below 100 pounds (Figure 5).

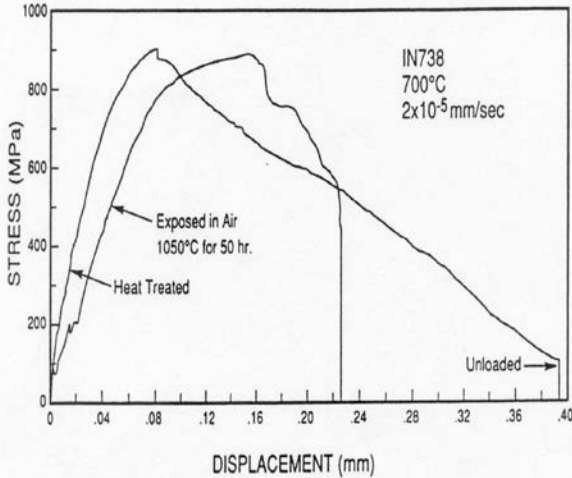
Figure 6. Constant Displacement Rate Tests Comparing Crack Growth Resistance in Heat Treated and Oxygen Embrittled Specimens.

An example of how the environment can affect the notch sensitivity of the material is indicated by Figure 6. This example illustrates the effect of air exposure on IN738.

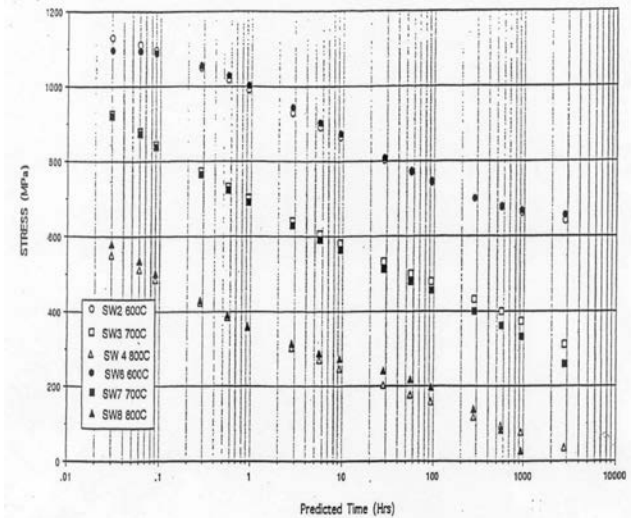
Figure 7. Stress vs. Predicted Times to 1% Creep for Standard Waspaloy.

in Figure 7 for Waspaloy material. This shows stress vs. predicted time to one percent creep for Waspaloy. By utilizing this data one can plot a stress vs. Larson-Miller parameter for one percent predicted creep of Waspaloy compared to rupture data (Figure 8). From the data shown on the curve, the stress relaxation test can generate creep-stress rupture data in less than a few weeks as compared to traditional approach which incorporates long time testing.

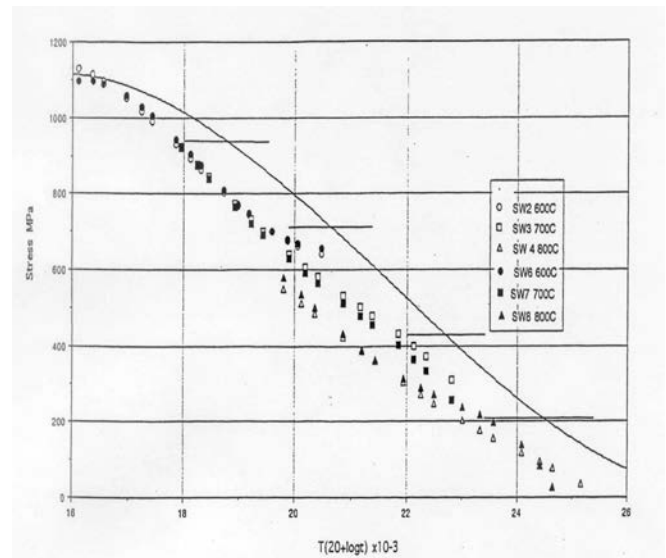
Figure 8. Stress vs. Larson-Miller Parameter for 1% Predicted Creep of Standard Waspaloy Compared with Rupture Data.

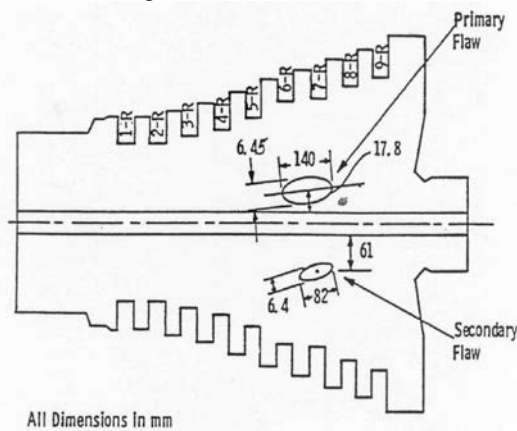
Figure 9. Schematic of the intermediate pressure (IP) section of the rotor showing the size and location of the primary and secondary flaws beneath the seventh row (7-R) of blades.

The Gallatin rotor was operated for 106,000 hours and had incurred 105 cold starts and 183 hot starts. The material was 1 CR- 1 Mo – 0.25V forging and had operated at a temperature of 800°F. The cracks originated from several MnS clusters with the original flaw size of 0.254" x 5.51" and 0.7" from the bore of the rotor (Figure 9).

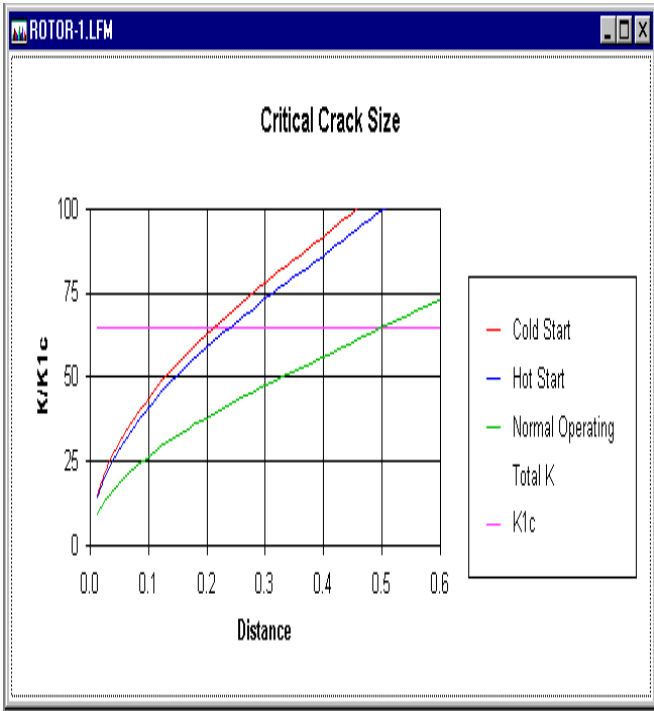
Figure 12. Critical Crack Size Calculation: The Critical Crack Size a_c is 0.42” for Cold Start and 0.48” for Hot Start.

verses crack depth was done. Based on the plane strain fracture toughness of the material, the critical crack size 0.42” for cold start and 0.48” for hot start were determined, Figure 12.

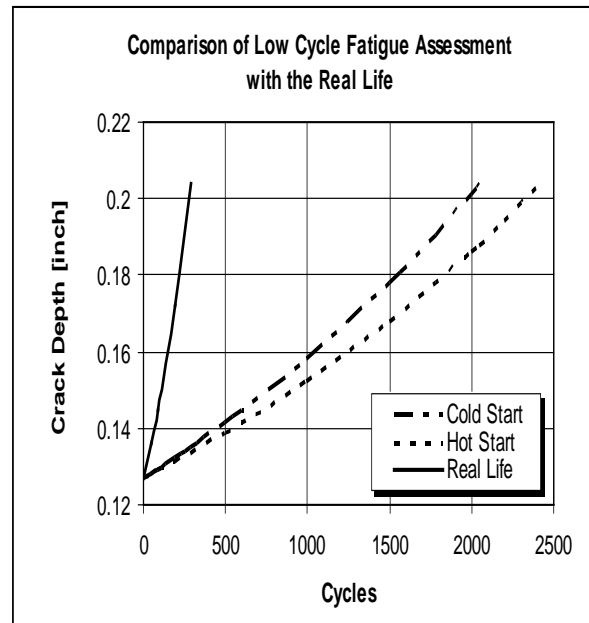
Figure 15. Shows Low Cycle Fatigue Crack Growth for Cold and Hot Starts Compared to Real Life.

Figure 15 shows the low cycle fatigue crack growth which does not compare very well with that of the real life.

The reason for the calculated life being much longer than the real life is that the hold time effect (or creep cracking effect) is not taken into account. Consequently, one must run a creep-fatigue remaining life assessment. The principle is that high temperature crack propagation is the summation of high

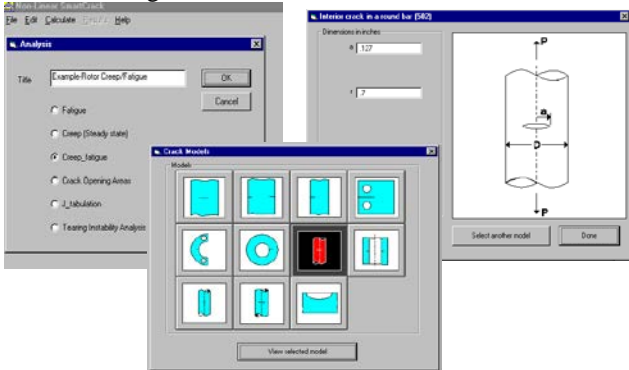
Figure 16. Creep/Fatigue Model.

The data that is inputted into the code is shown in Figure 16 and Figure 17. The calculation shows that, with accounting the creep effect, the creep-fatigue crack growth is much closer to the real life, Figure 18.

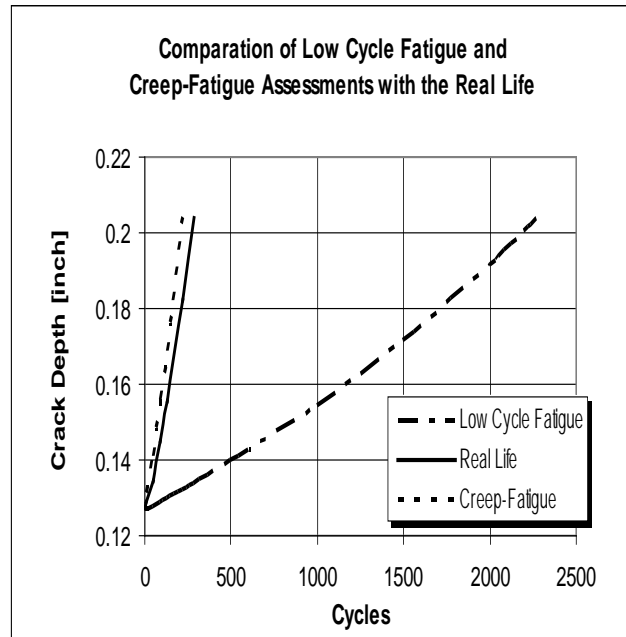
Figure 18. Compares Low Cycle Fatigue and Creep-Fatigue Crack Growth to the Real Crack Growth.

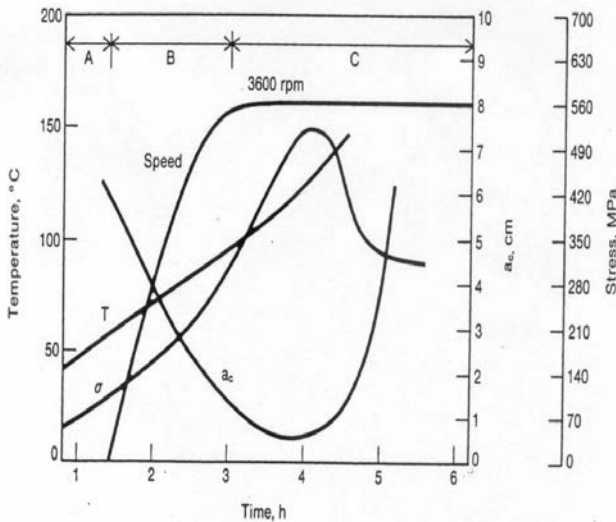
Figure 19. Illustration of cold-start sequence and associated variations in stress (σ), temperature (T), and critical flaw size (a_c) as functions of time from start.

A typical loading sequence for turbine rotors shows variation in temperature and stress and their effect on critical flaw size a_c for cold start sequence (Viswanathan and Jaffee, 1983). Figure 19 shows the cold start sequence and associated variations in stress (σ), temperature (T) and critical flaw size (a_c) as function of time for the Gallatin rotor which failed catastrophically.

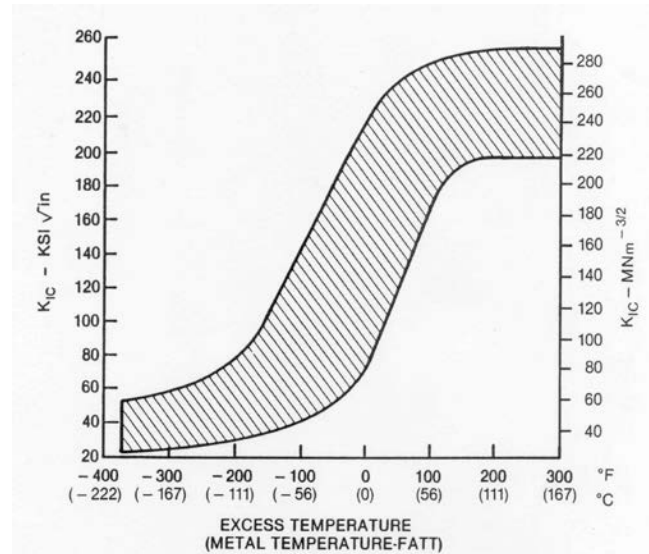
Figure 20. Turbine Rotor and Wheel Toughness Data.

This can be done by using lower scatter band values of K_{IC} . However, to determine K_{IC} for rotors, large specimens need to be taken to satisfy the plane strain conditions required for a valid test. A more common practice is to determine the ductile-brittle fracture at transition temperature, FATT, using samples extracted from the periphery of a rotor and converting the FATT into K_{IC} using a correlation such as the one shown in Figure 20 (Schwant and Timo, 1985).

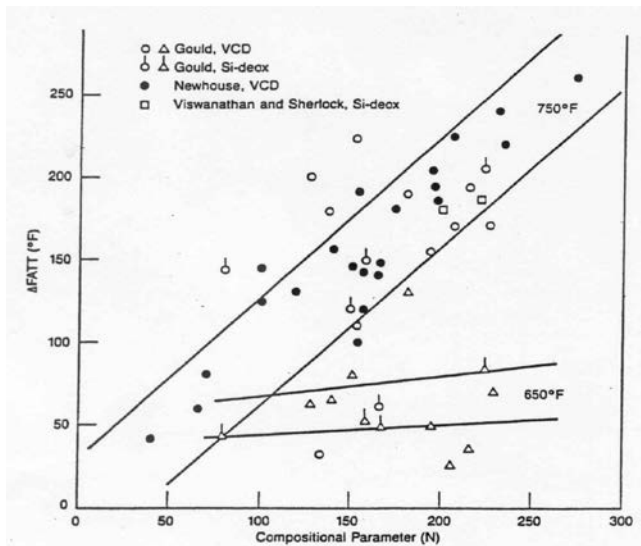
Figure 21. Correlation between compositional parameter “N” and the shift in FATT of NiCrMoV steels following exposure at 650°F and 750°F for 8800 hours.

All available 10,000 hour embrittlement data are plotted in Figure 21 as a function of calculated Δ FATT using Equation (10), (Newhouse, et al. 1972). A good correlation is observed between calculated and experimental Δ FATT. The scatter for this data is approximately $\pm 30^\circ\text{F}$ for 750°F exposure and $\pm 15^\circ\text{F}$ for the 650°F exposure.

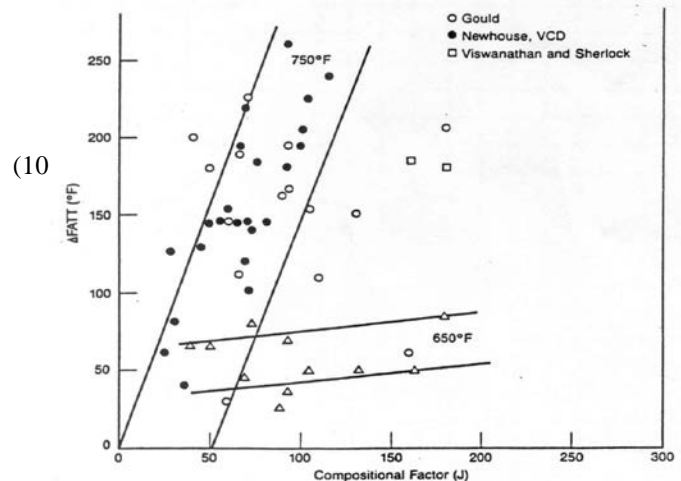
Figure 22. Correlation between compositional factor “J” and the shift in FATT of NiCrMoV Steels following exposure at 650°F and 750°F for 8800 hours.

The Figure 22 and 23 show relationship between increase of FATT and J Factor and \bar{X} Factor at 399°C for a 3.5 percent NiCrMoV steel.

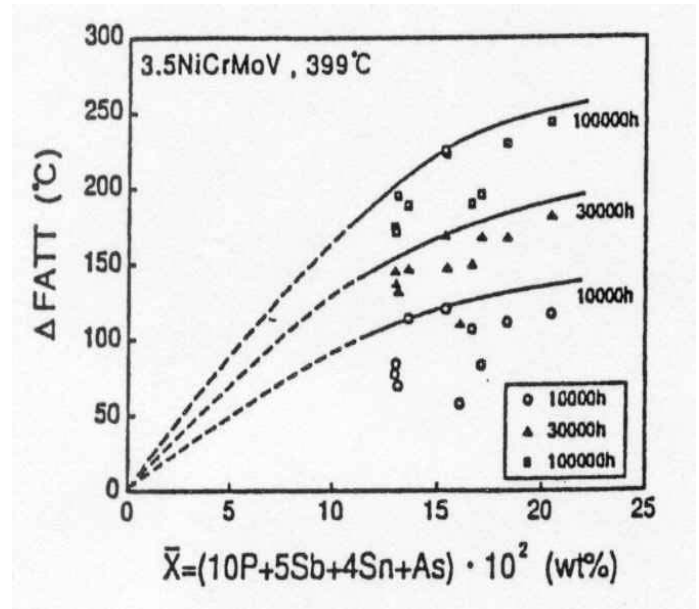
Figure 23. Relationship Between Increase of FATT and \bar{X} .

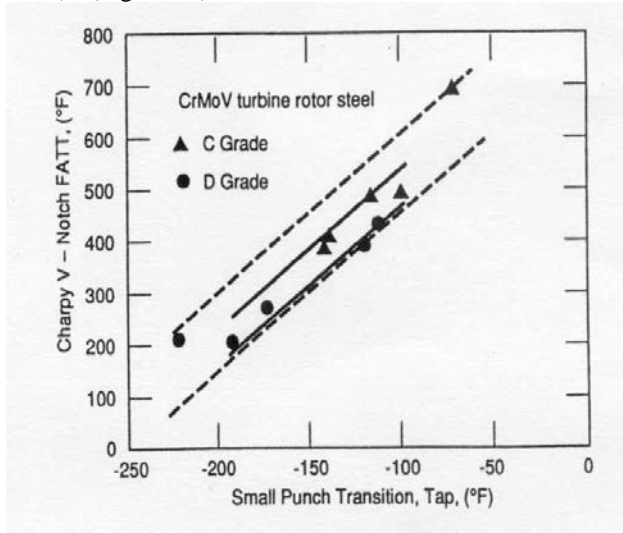
Figure 24. Correlation Between Charpy FATT and Small Punch Transition Temperature.

procedure consists of thin plate 0.4 x 0.4 x 0.02 inch is subjected to a punch deformation with a 0.09 inch diameter steel ball in a specially designed specimen holder. The test is performed at various temperatures and from the load deflector curves obtained at various temperatures, the fracture energy is calculated. The fracture energy is plotted as a function of test temperature to determine the ductile-to-brittle transition temperature. The area under the deflector curve denotes the energy absorbed during the test. This test procedure has been used successfully on a number of retired rotor samples to determine the T_{SP} (ductile-to-brittle transition) and found to correlate well with the Charpy FATT values (Foulds, et al. 1991). (Figure 24).

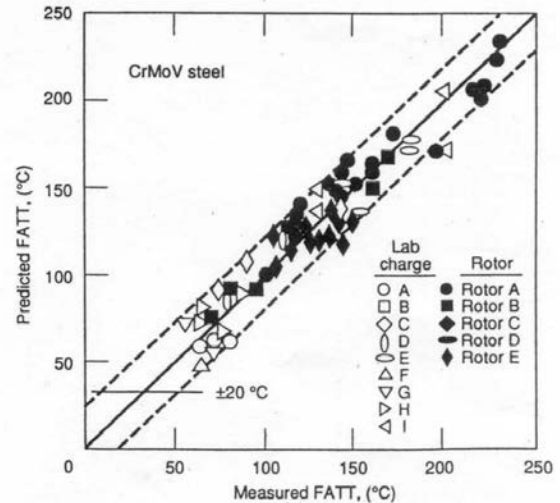
Figure 25. Comparison Between Measured FATT and Predicted FATT Using the Method of Etching.

By utilizing this equation, the calculated FATT values were compared with critical FATT values and the results were very attractive (Figure 25).

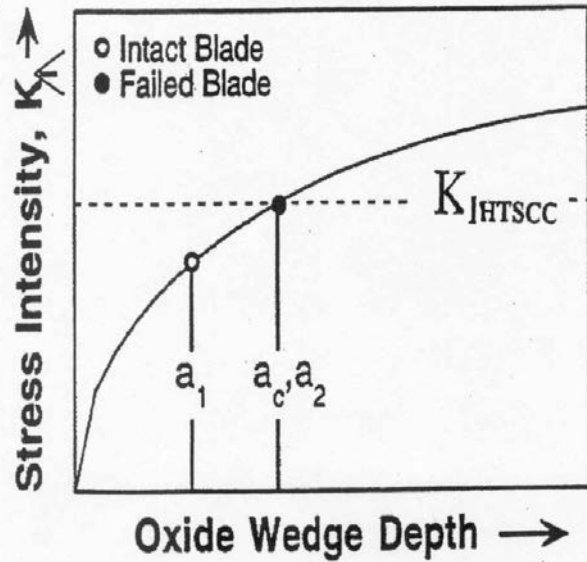
Figure 26. Stress intensity profile vs. oxide wedge depth for unit A. Critical oxide wedge depth for failure was defined as a_c . In the failed blade, a_2 was found to exceed a_c . In an intact blade, a_1 was less than a_c .

failure. Generally, if the catalyst is active, then high temperature corrosion will occur. Consequently, a blade will be removed from the unit and examined metallographically to determine the oxide wedge depth. Based upon the depth and time of operation, the remaining life can be estimated, Figure 26.

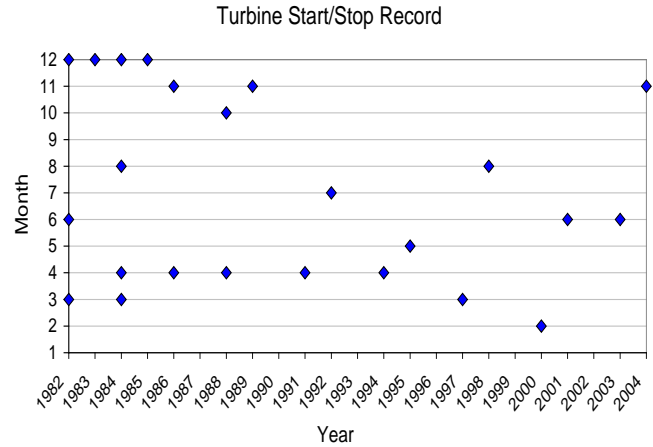
Figure 27. Turbine Start/Stop Record.

According to the plant logbook, in the past 23 years, the turbine was started/stopped 24 times, which are plotted in Figure 27.

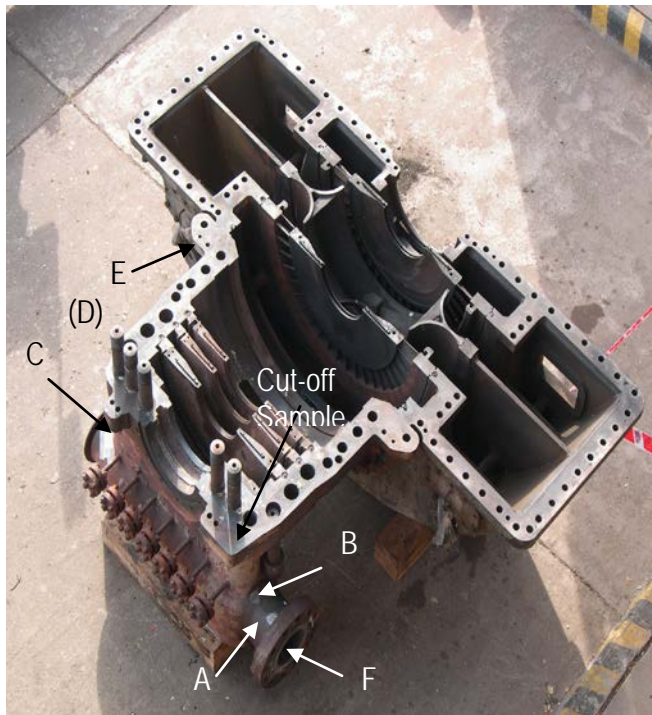
Figure 28. The turbine casing and the replication/cut-off locations. F represented the hottest spot, while E represented the coolest spot. D was at the transition radius of steam chest to casing barrel, which was invisible from this photo.

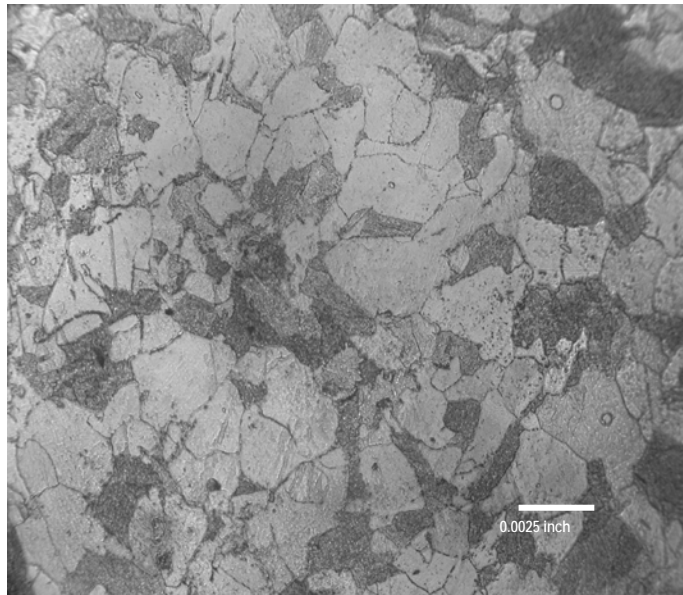
Figure 29. Micrograph of a replica taken from spot D. Carbides precipitated and partially networked at grain boundaries. However, no creep voids were observed there. 5% Nital etched.

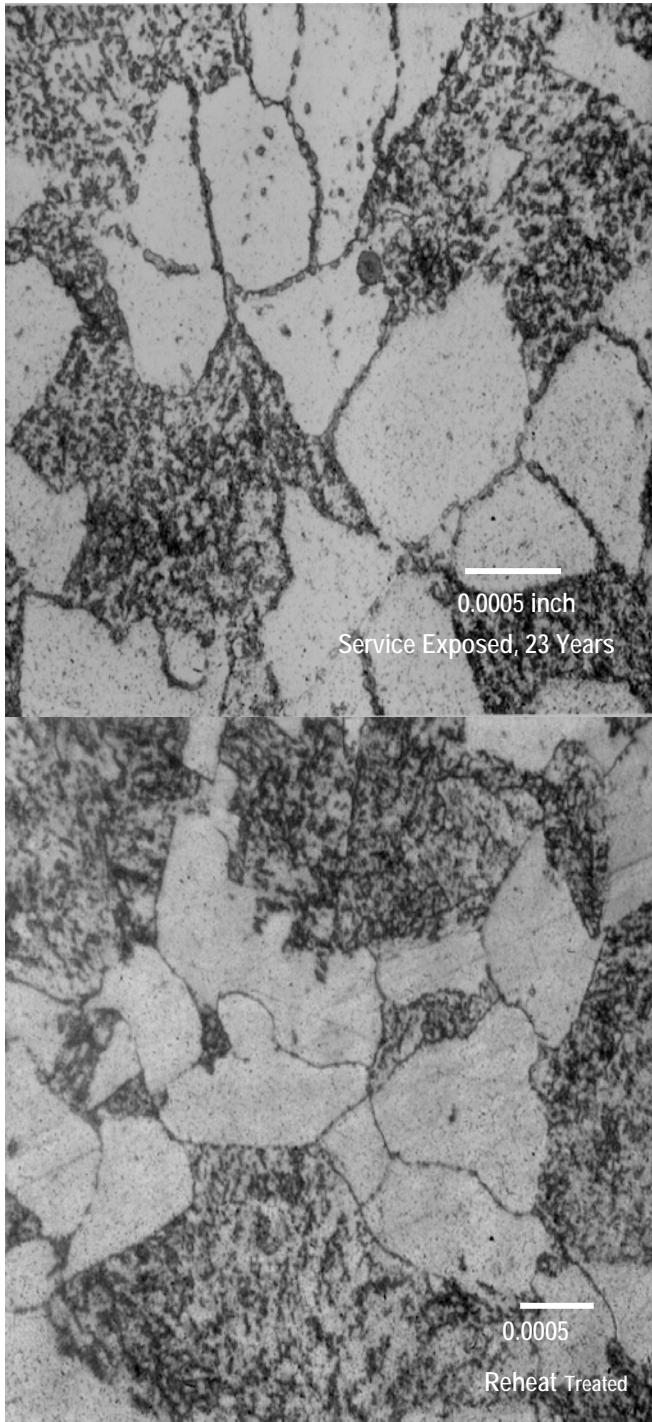
Figure 30. The service-exposed sample (Top) showed partially networked carbides at grain boundaries and degradation in bainite (dark phase), comparing with the reheat treated (restored) microstructure. It can also be seen that carbides precipitated inside the proeutectoid ferrite (white phase) in service-exposed condition. 5% Nital etched.

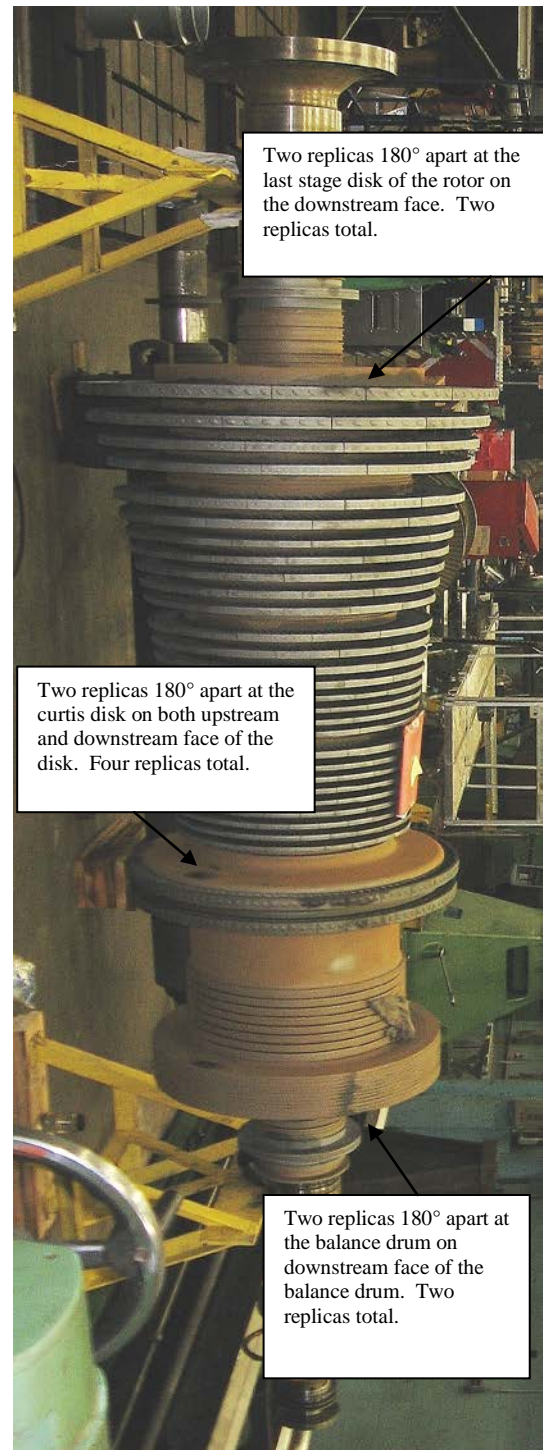
Figure 31. Areas of Metallographic Replication

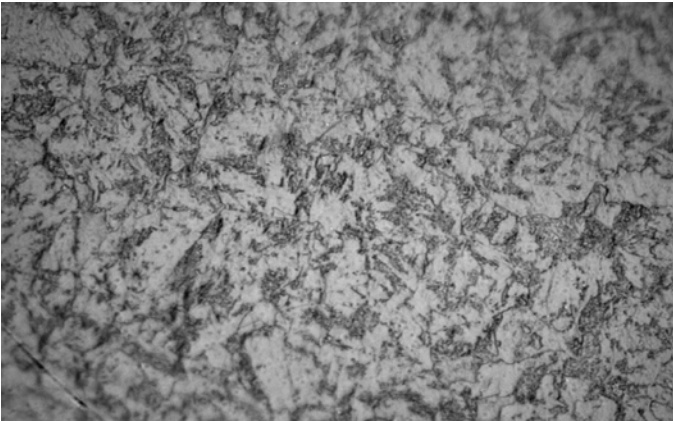
Figure 32. Metallographic Replica, on the Downstream Face of the balance drum, Showing Slight Bainite Degradation Due to Prolonged High Temperature Service. Etched in 5% Nital. 200X

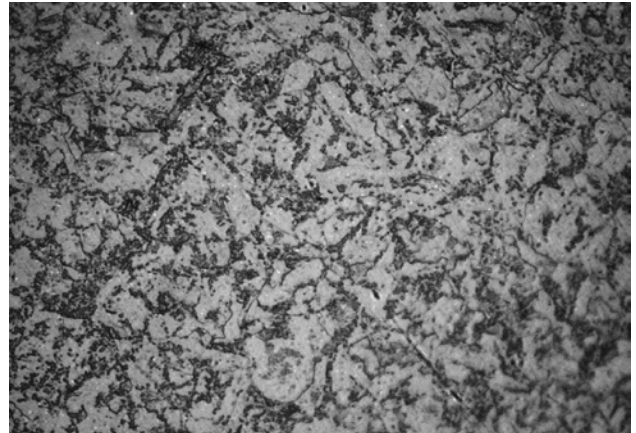
Figure 35. Metallographic Replica, on the Downstream Face of the Last Stage Disk, Showing Less Degradation When Compared to the High Temperature Locations. Etched in 5% Nital. 200X

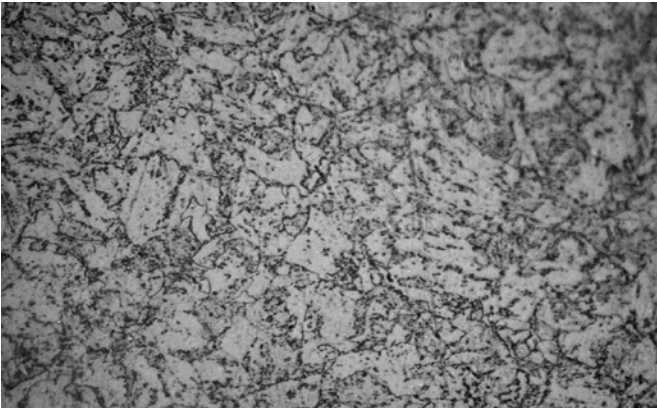
Figure 33. Metallographic Replica, on the Upstream Face of the Curtis Disk, Showing Slight Bainite Degradation Due to Prolonged High Temperature Service. Etched in 5% Nital. 200X

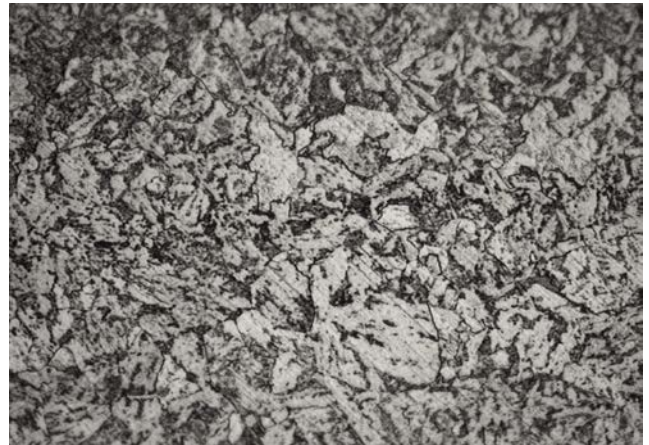
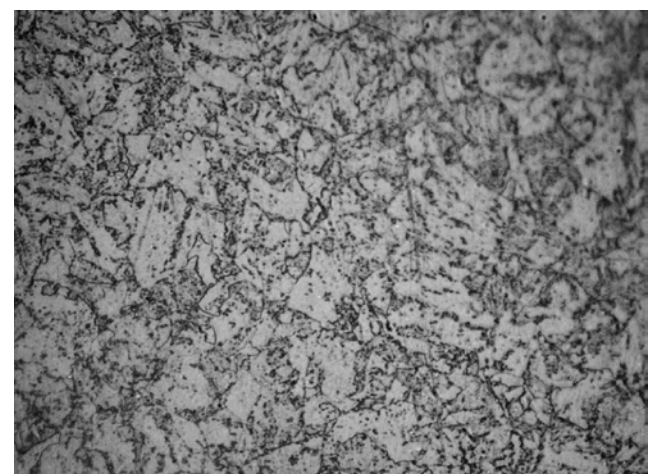
Figure 36. Comparing virgin Ni-Mo-V rotor steel (top) and the replica of the upstream face of the Curtis disk taken from the service rotor steel. The degradation of the bainite phase is observed due to the transformation of cementite (M_3C) into different carbides (M_2C and M_7C_3).

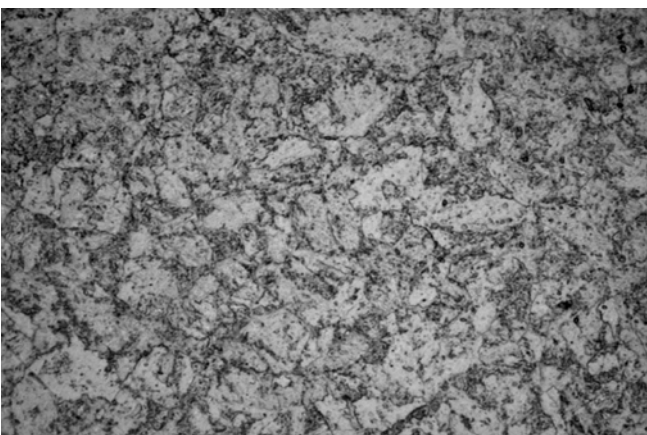
Figure 34. Metallographic Replica, on the Downstream Face of the Curtis Disk, Showing Slight Bainite Degradation Due to Prolonged High Temperature Service. Etched in 5% Nital. 200X

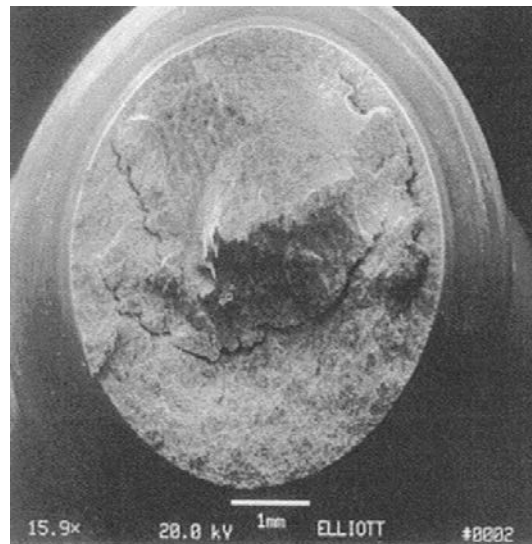
Figure 37. of Specimen W2

Both W1 & W2 fractures were examined using a scanning electron microscope (SEM) and the morphology was found to be intergranular for both fractures (Figures 37-39). Corrosion wedges were found on the surface at the notch of both specimens (Figure 40).

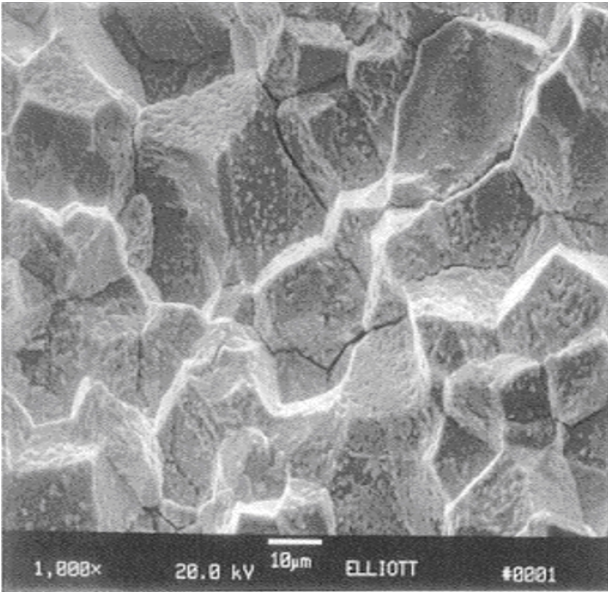
Figure 38. SEM of Specimen W2 with dominant intergranular feature

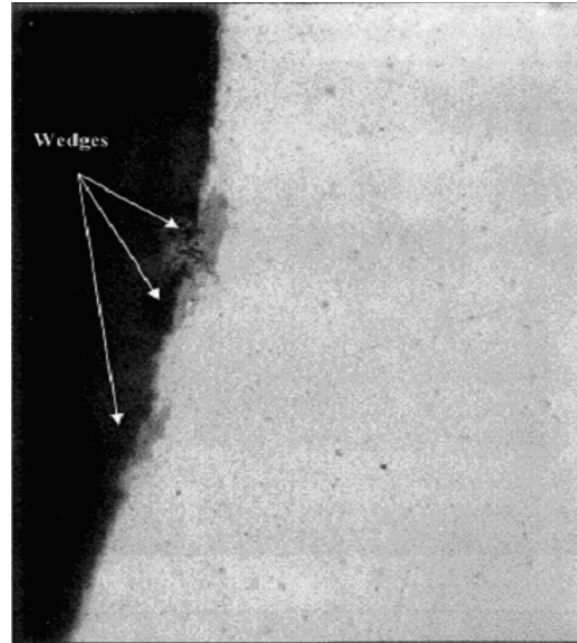
Figure 40. Cross-section of specimen Note the sulfidation corrosion wedges found on the notch surfaces where the stress was concentrated.

SEM/EDS indicated that the corrosion product was sulfide. This sulfide evidence is a strong indication of high temperature sulfidation corrosion. Figure 41 shows setup for catalyst test.

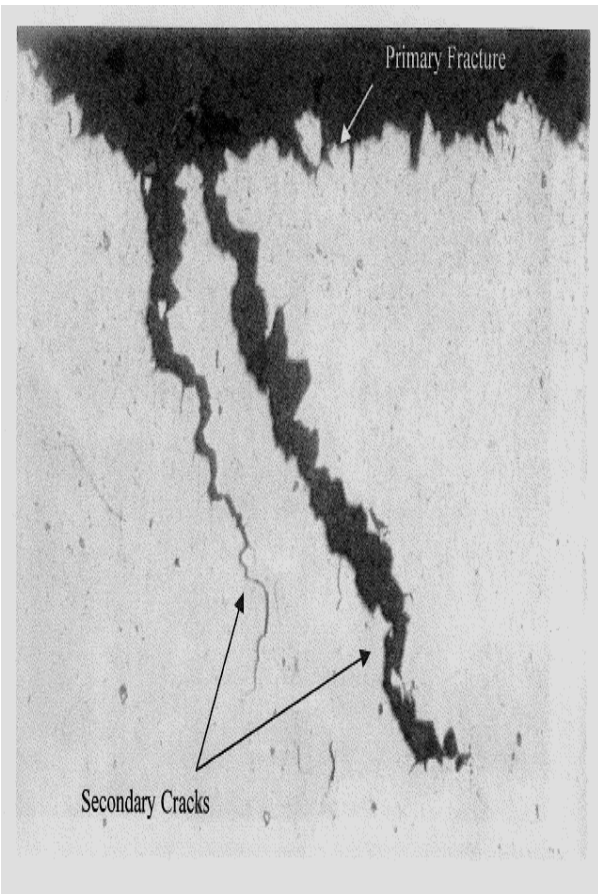
Figure 39. Cross-section of the fracture of specimen W2. Intergranular secondary cracks, located near the center of axis, were evident.

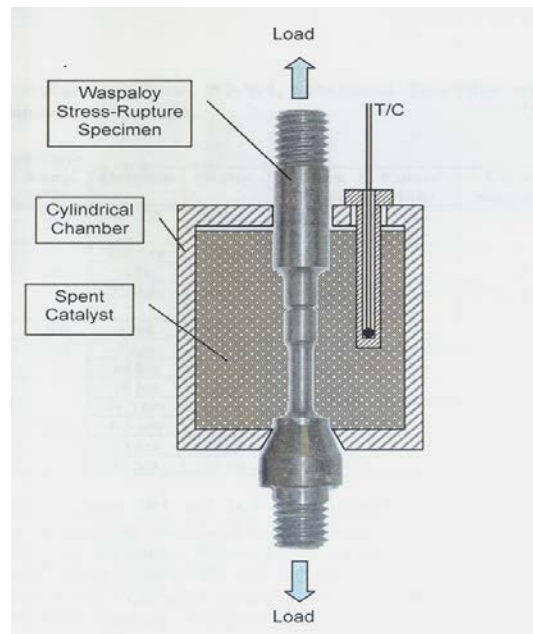
Figure 41. Setup of Stress-Rupture Rig for Catalyst Testing

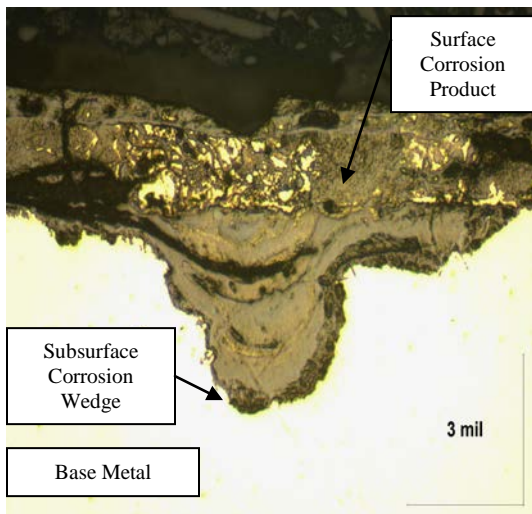
Figure 42. Photomicrograph of deepest corrosion wedge found in the blade root

The depth of the corrosion product was measured by taking cross-sectional samples along the top inside radius of the blade root. The five samples were mounted and polished for examination under an optical microscope. Corrosion wedges, as seen in Figure 42 were found along this inside radius. The deepest corrosion wedge found at any location along this inside radius is shown in Figure 42, and depth of the corrosion wedge is 0.0043 inches (4.3 mils).

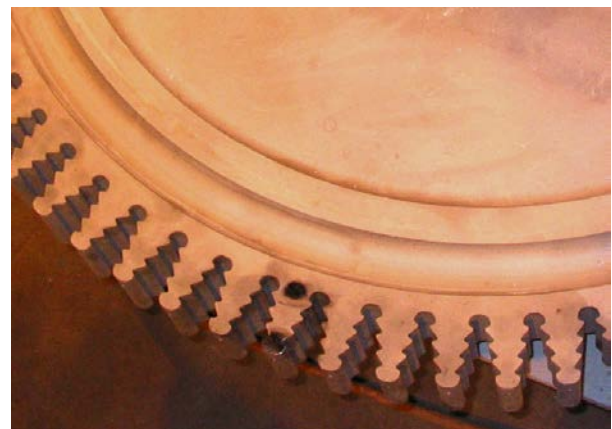
Figure 43. Diagram illustrating the locations of the disk from which replicas were taken. Areas were examined on both the inlet and exhaust faces of the disk

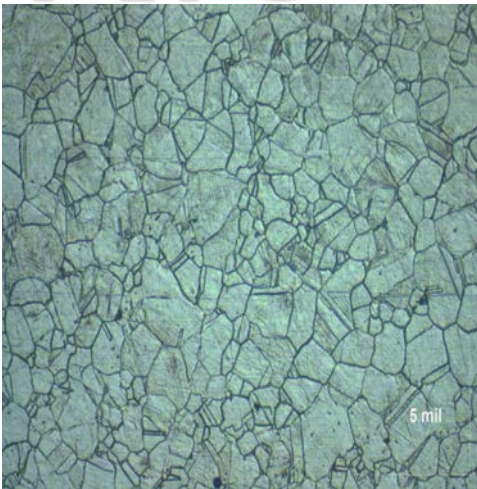
*Figure 44. Inlet Face – Tip of Disk Root.
Photomicrograph taken from Replica*

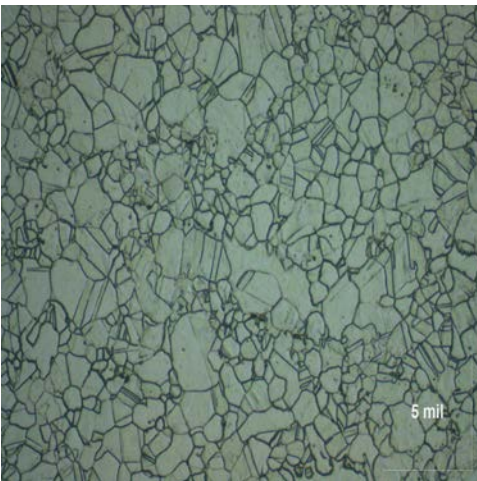
*Figure 45. Exhaust Face – Tip of Disk Root.
Photomicrograph taken from Replica*

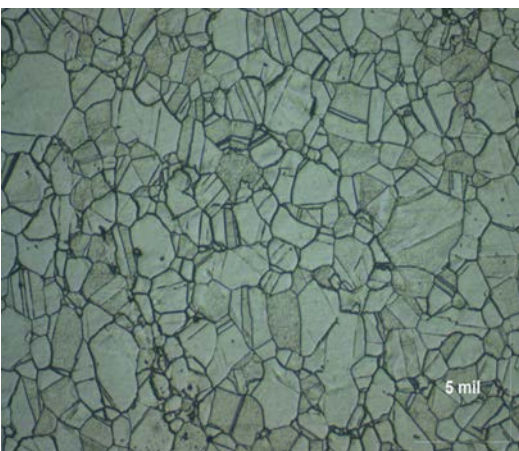
*Figure 46. Inlet and Exhaust Face.
Photomicrograph taken from Replica.*

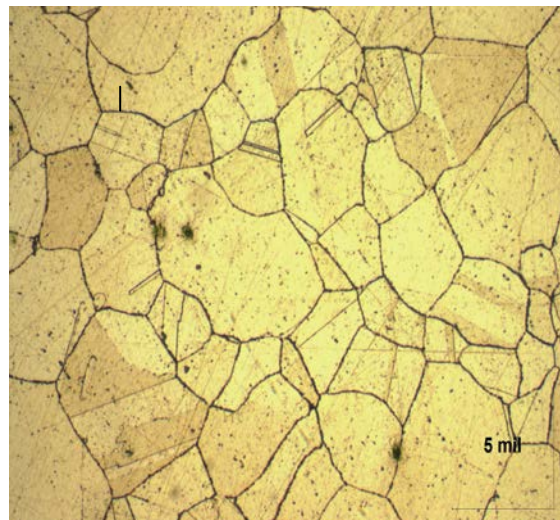
Figure 47. Photomicrograph of Service Condition Blade Root

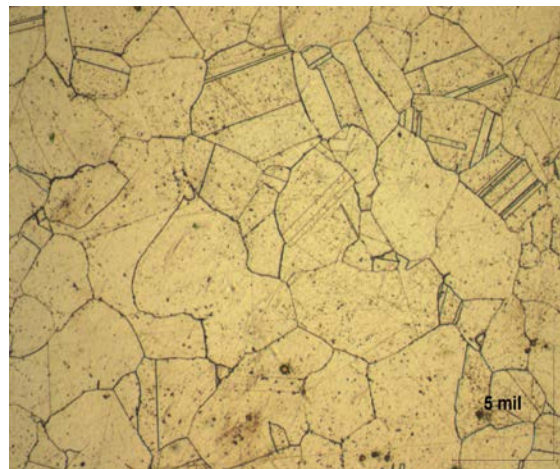
Figure 48. Photomicrograph of Re-Heat Treated Blade Root

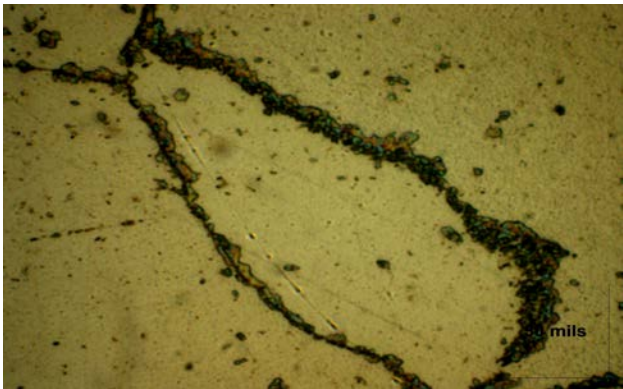
Figure 49. Photomicrograph of Grain Boundary on Service Condition Blade Root

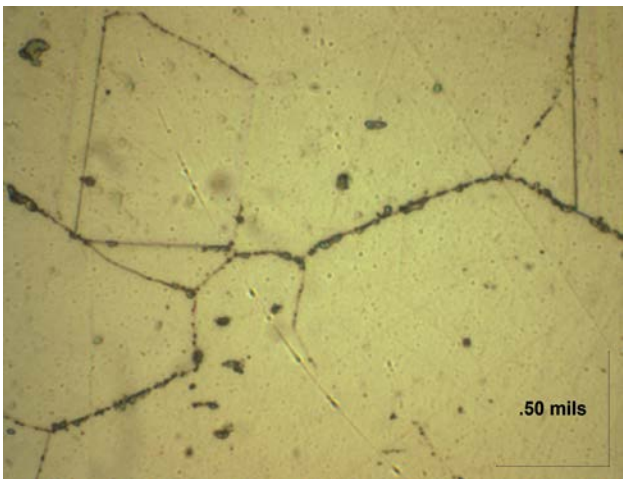
Figure 50. Photomicrograph of Grain Boundary on Re-Heat Treated Blade

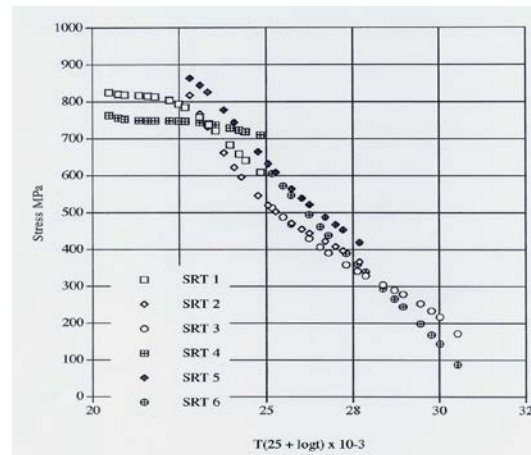
Figure 51. Stress vs. Larson Miller Parameter for 1% Creep of Service Condition Blade and Re-Heat Treated Blade

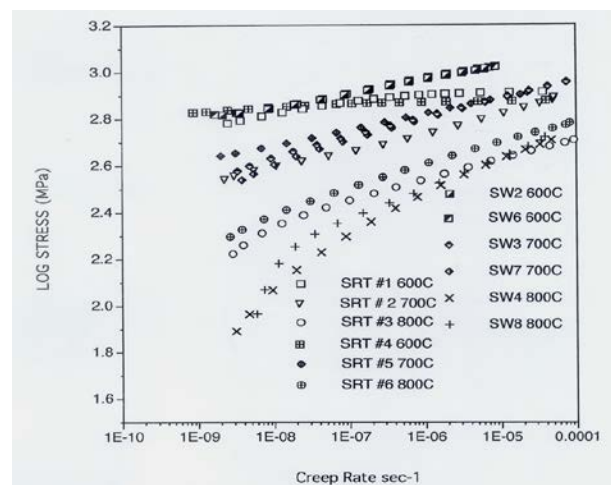
Figure 52. log Stress vs. Creep Rate Curves Comparing the Service Condition Blade and the Re-Heat Treated Blade with Standard Waspaloy Samples

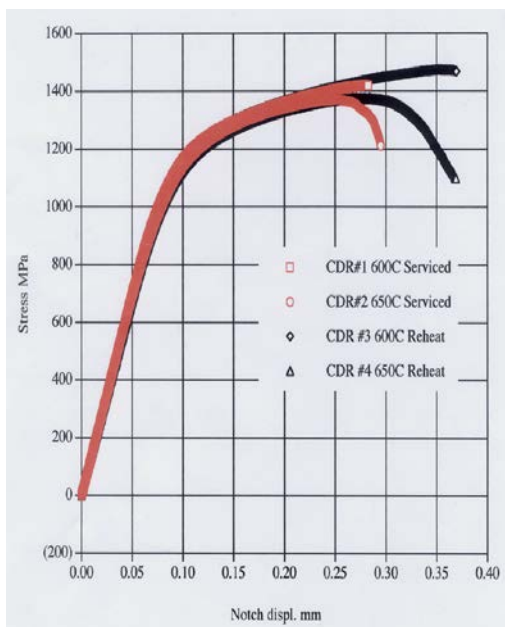
Figure 53. CDR Results at 600°C and 650°C for Service Condition Blade and Re-Heat Treated Blade
