**43rd Turbomachinery
30th Pump SYMPOSIA**

RTD FAILURE IN HYDRODYNAMIC THRUST BEARING

HATEM MOHAMED
TURBO MACHINERY SENIOR ENG.,
MISR FERTILIZER PRODUCTION COMPANY

The compressor type is a synthesis gas (gas mix) compressor barrel type that has been in service since 2008

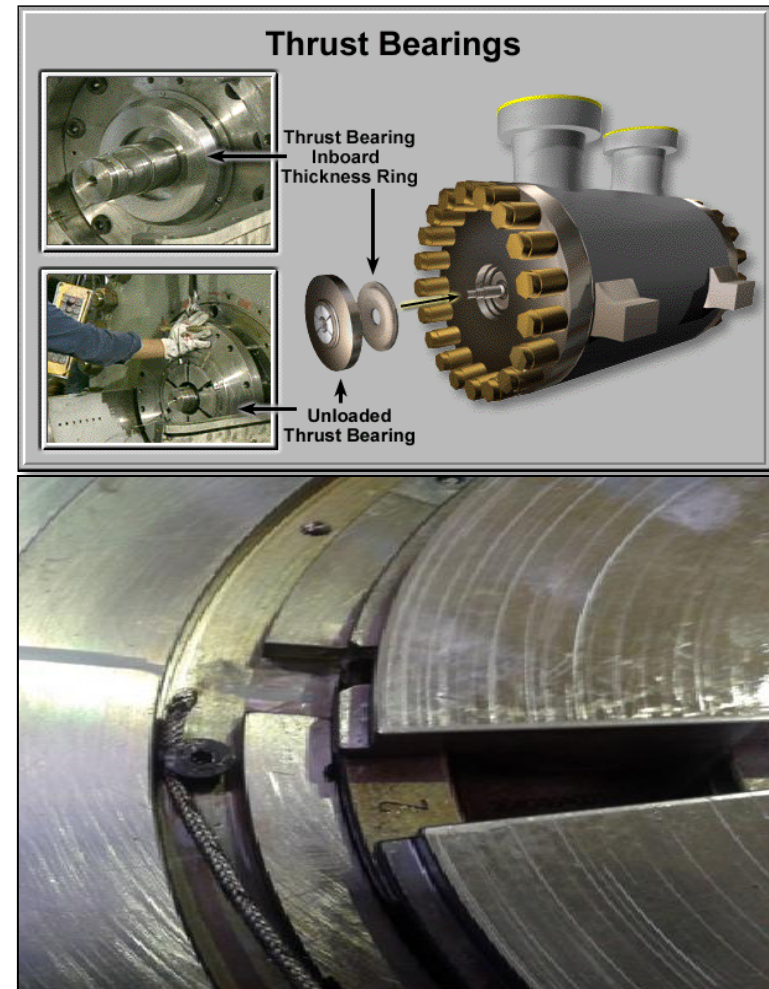
Equalizing thrust bearing

Transmit the load through a self-renewing film of oil during operation and a-unique force – balancing action distributes the load across the shoes, working surfaces are separated by the fluid film

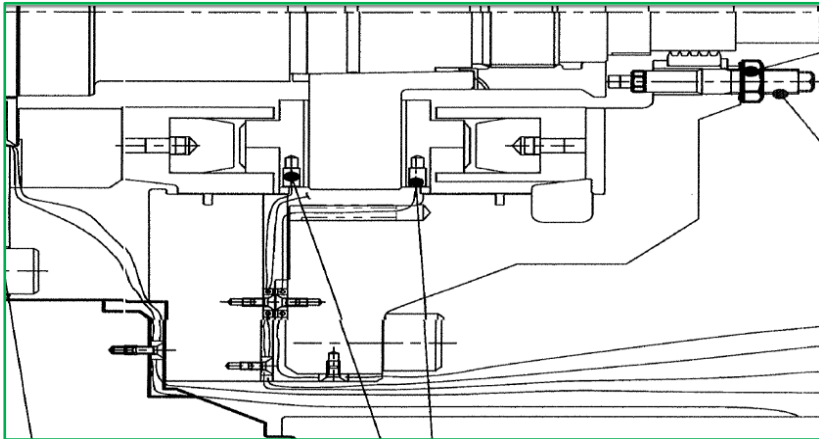
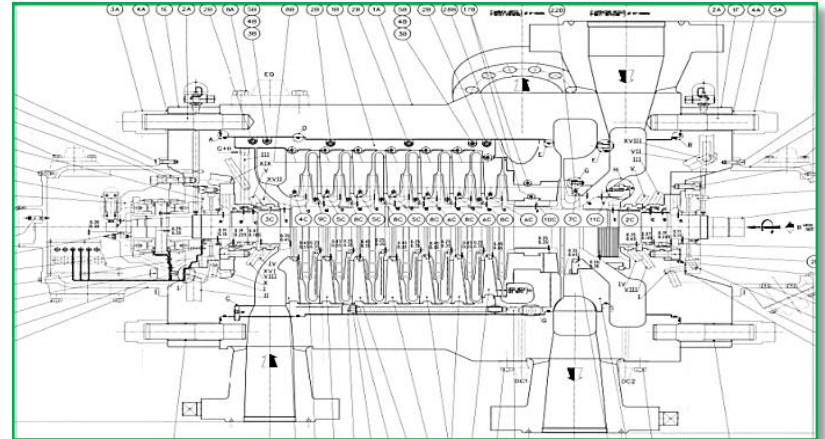
Thrust bearing RTD arrangement

Thrust bearing is JJ Style self-equalizing tilting pad bearing

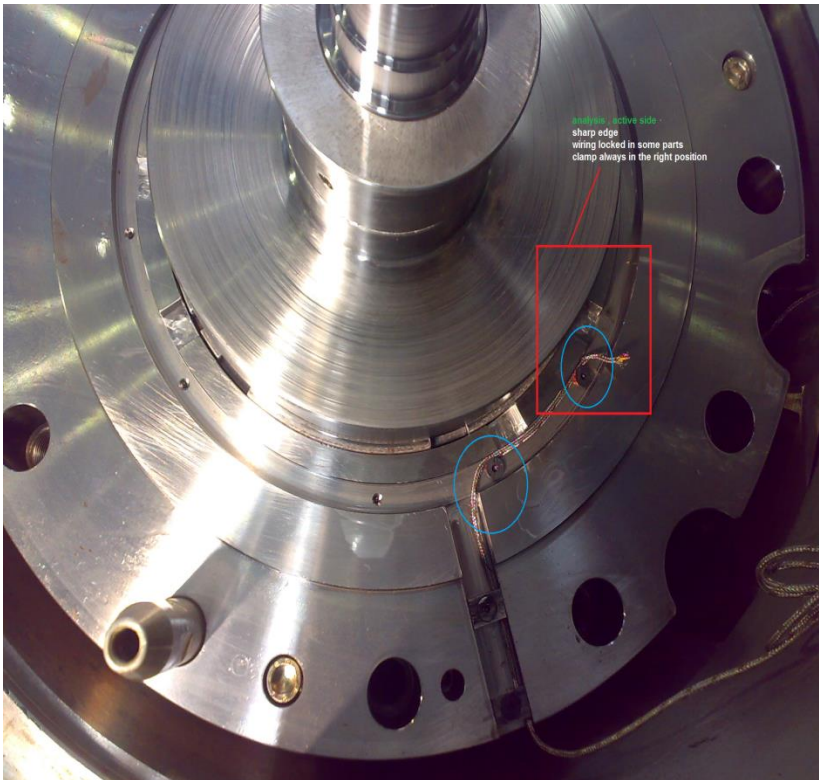
Active side

The analysis of 2BCL 408 Compressor thrust bearing RTD repeated failure during 4years analysis

- 1- Several sharp edges on both active and non- active sides
- 2- Possibility contact between bearing housing surface and wiring leading to friction and wiring reduced movement capability
- 3- Clamps not always in the right position
- 4- Signs of compression on the wiring
- 5- Wiring locked in some parts
- 6- Clamp sometimes far from pad

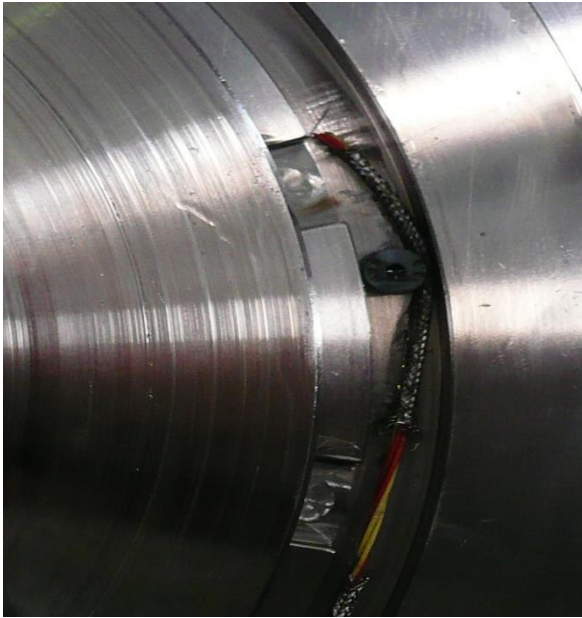
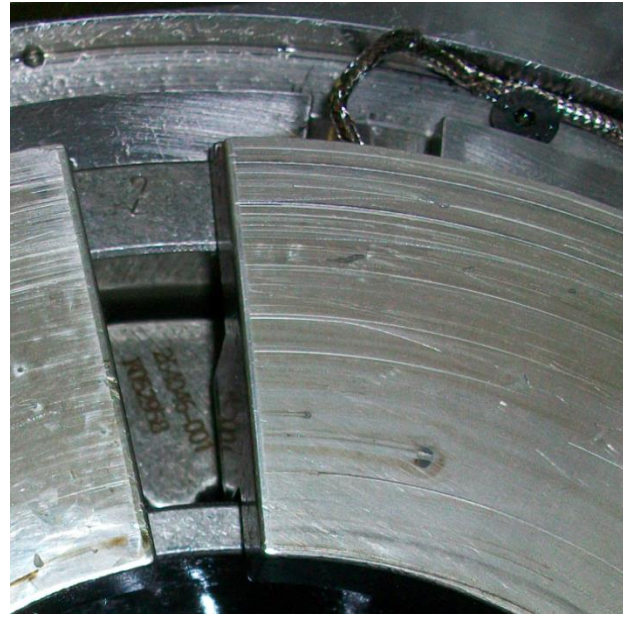
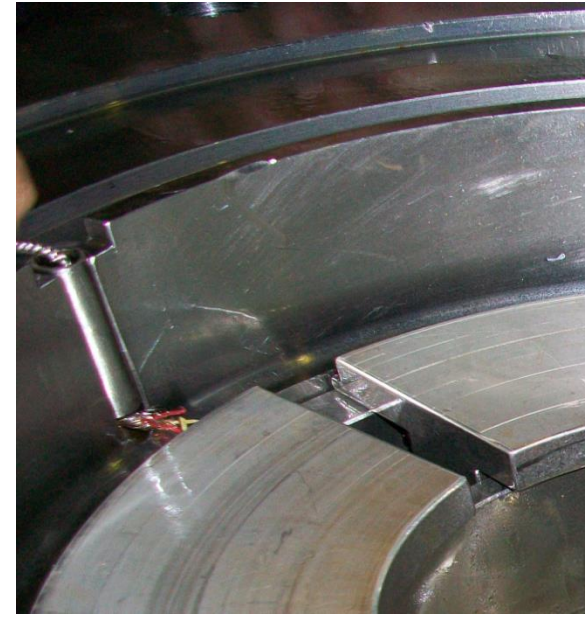
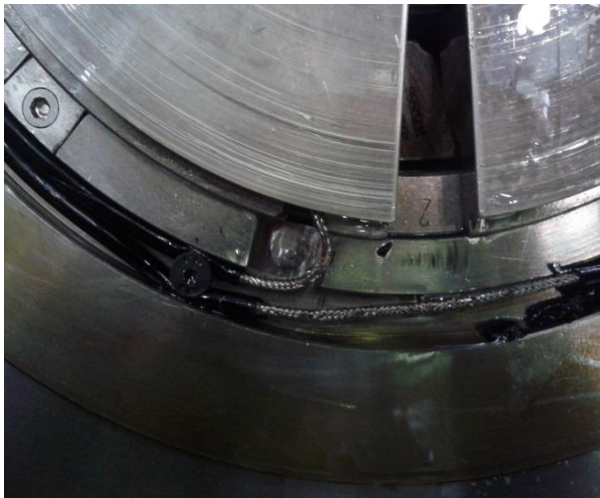
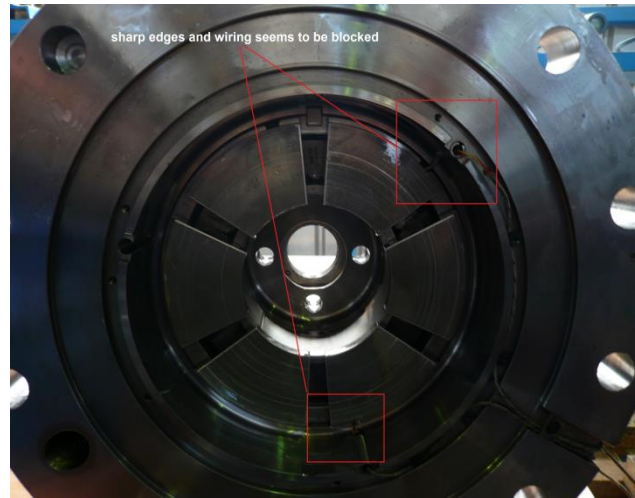
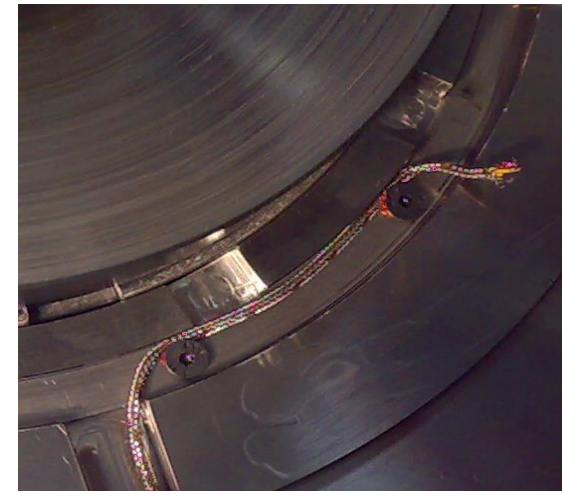
Some figures for failure of RTD during 4 years in both active and non active side

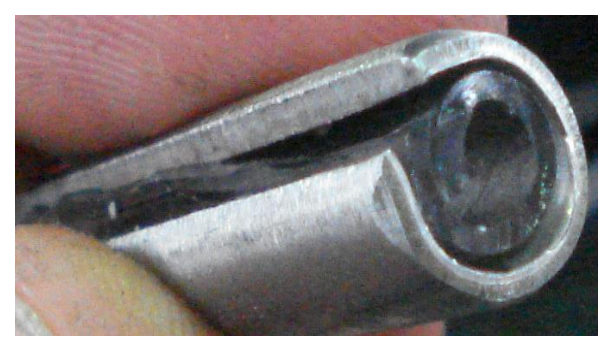
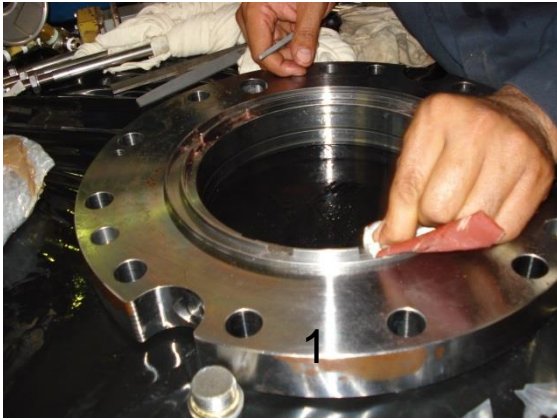
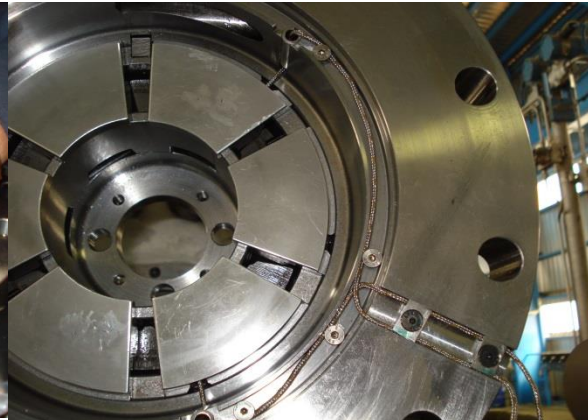
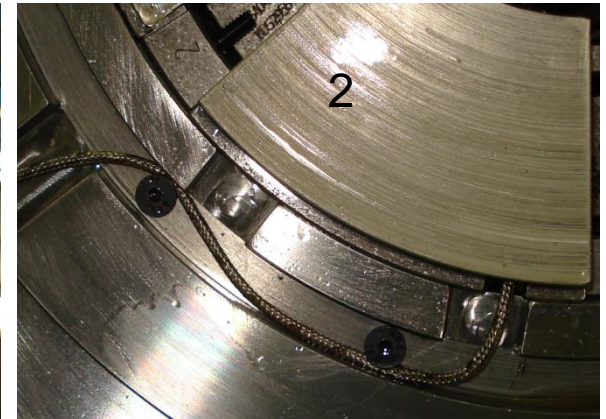
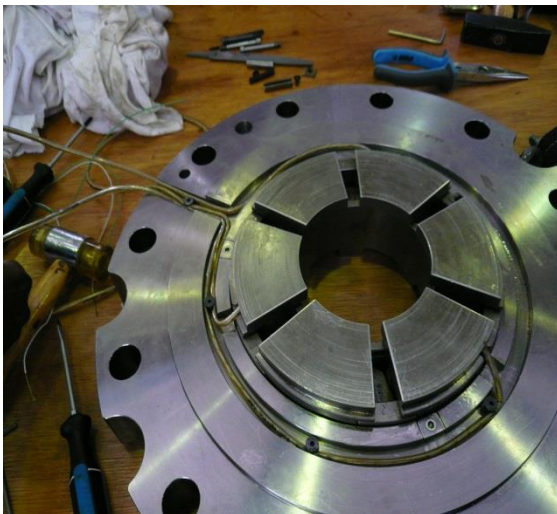
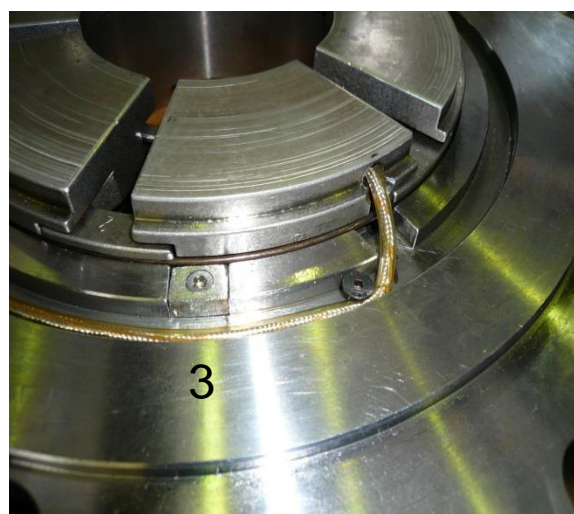
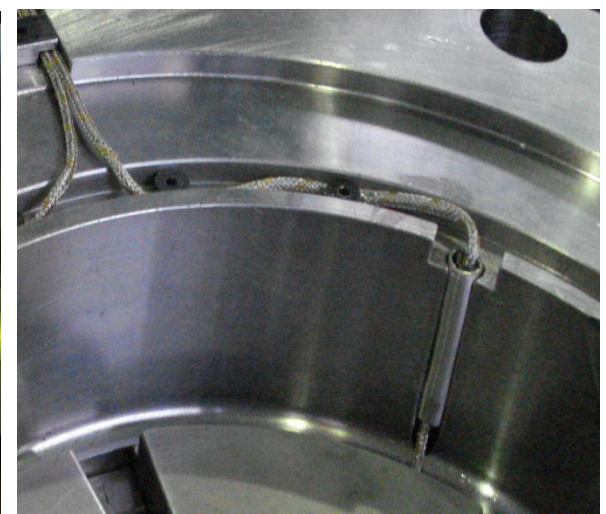
Corrective actions done during the past 4 years

Previously mentioned corrective actions have not been successful to prevent failure reoccurrence

- 1-Rounded corners realize on the edges
- 2-Clamp position changes
- 3-Covering the elements by plastic hose

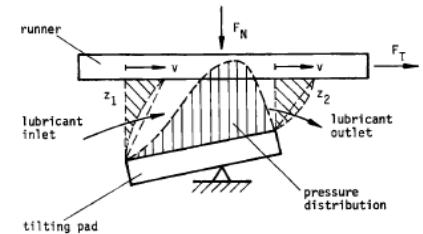
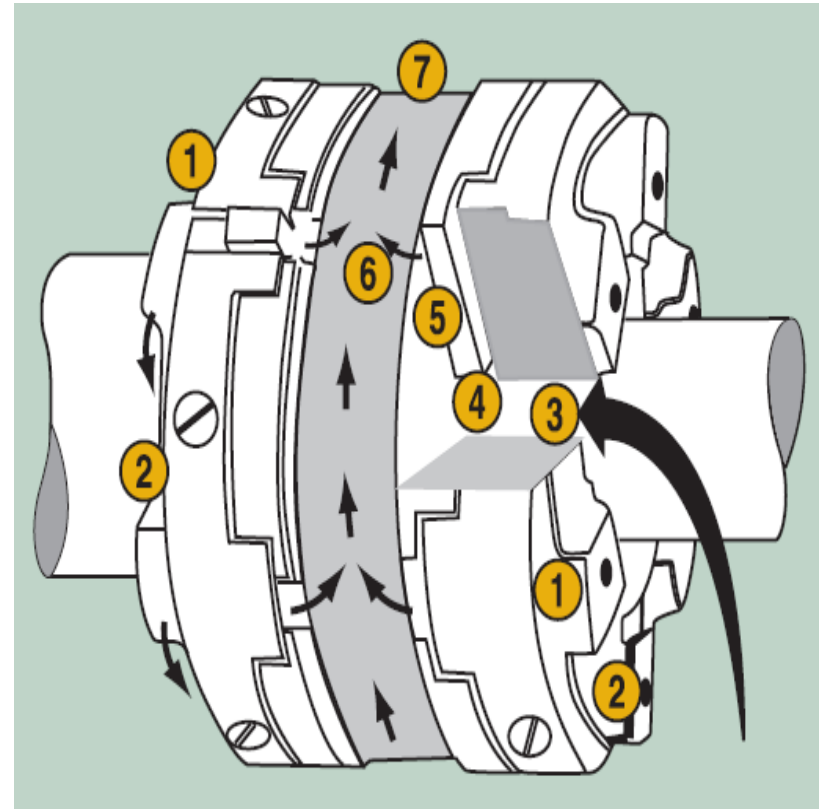
Self-equalizing thrust bearing flooded type lubrication theory

The oil velocity and profile pressure inside the thrust bearing differ according to the size and oil viscosity and speed of collar mainly

1. Oil enters the annulus in the base ring
2. Oil passes through radial slots in the back face of the base ring.
3. Oil flows through the clearance between the base ring bore and shaft.
4. Oil flows to the inner diameter of the rotating thrust collar.
5. Oil flows between the shoes and into the films.
6. At the collar rim, oil is thrown off into the space around the collar.
7. Oil exits tangentially through the discharge opening.
8. Oil enters the sump and is pumped through a filter and cooler.
9. Oil passes through the inlet orifice, which controls flow rate.

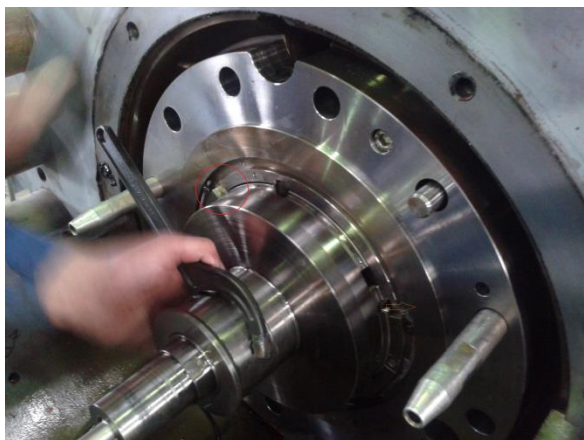
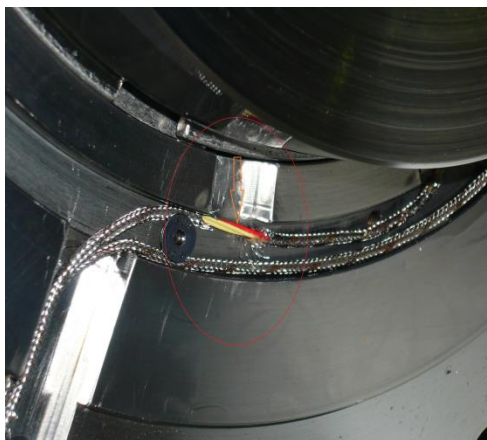
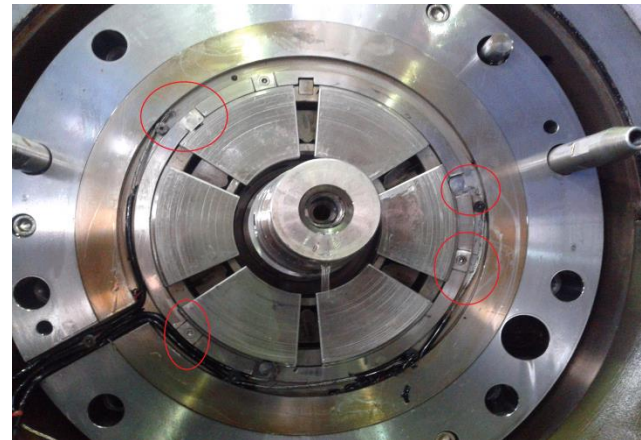
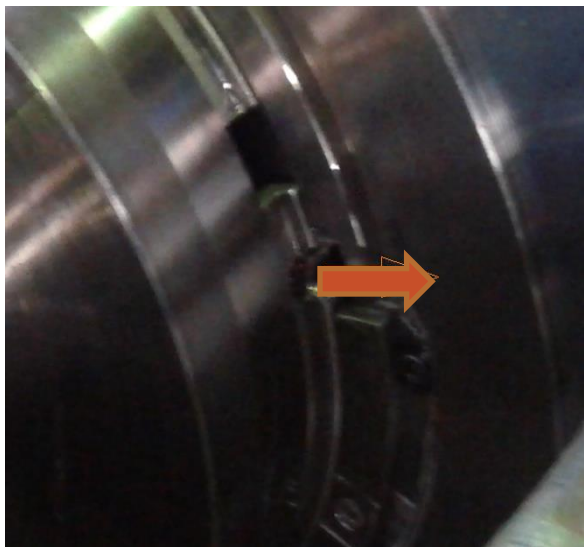
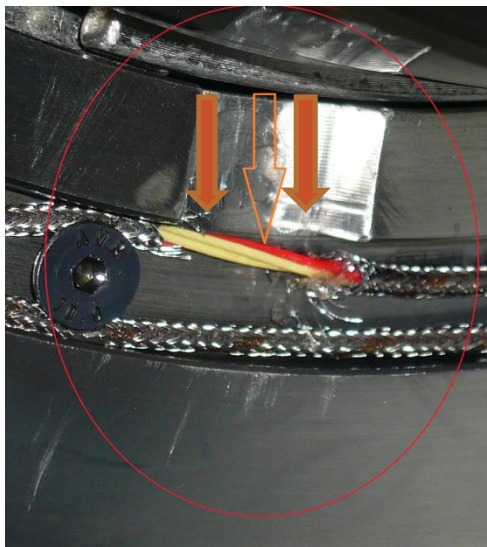
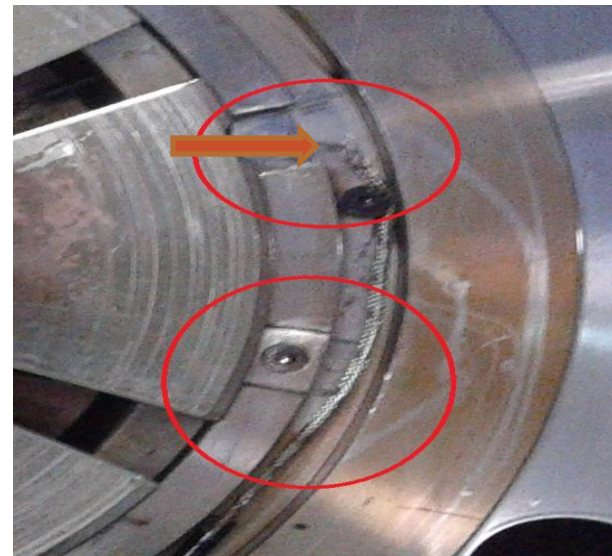
We discovered that the damage of the RTD element in active side is due to the high pressurized oil which escape at the sharp edge area concerning the outlet of RTD element

The configuration of RTD outlet pass works as a nozzle where the pressurized oil out causing damage o RTD shield body per time till failure

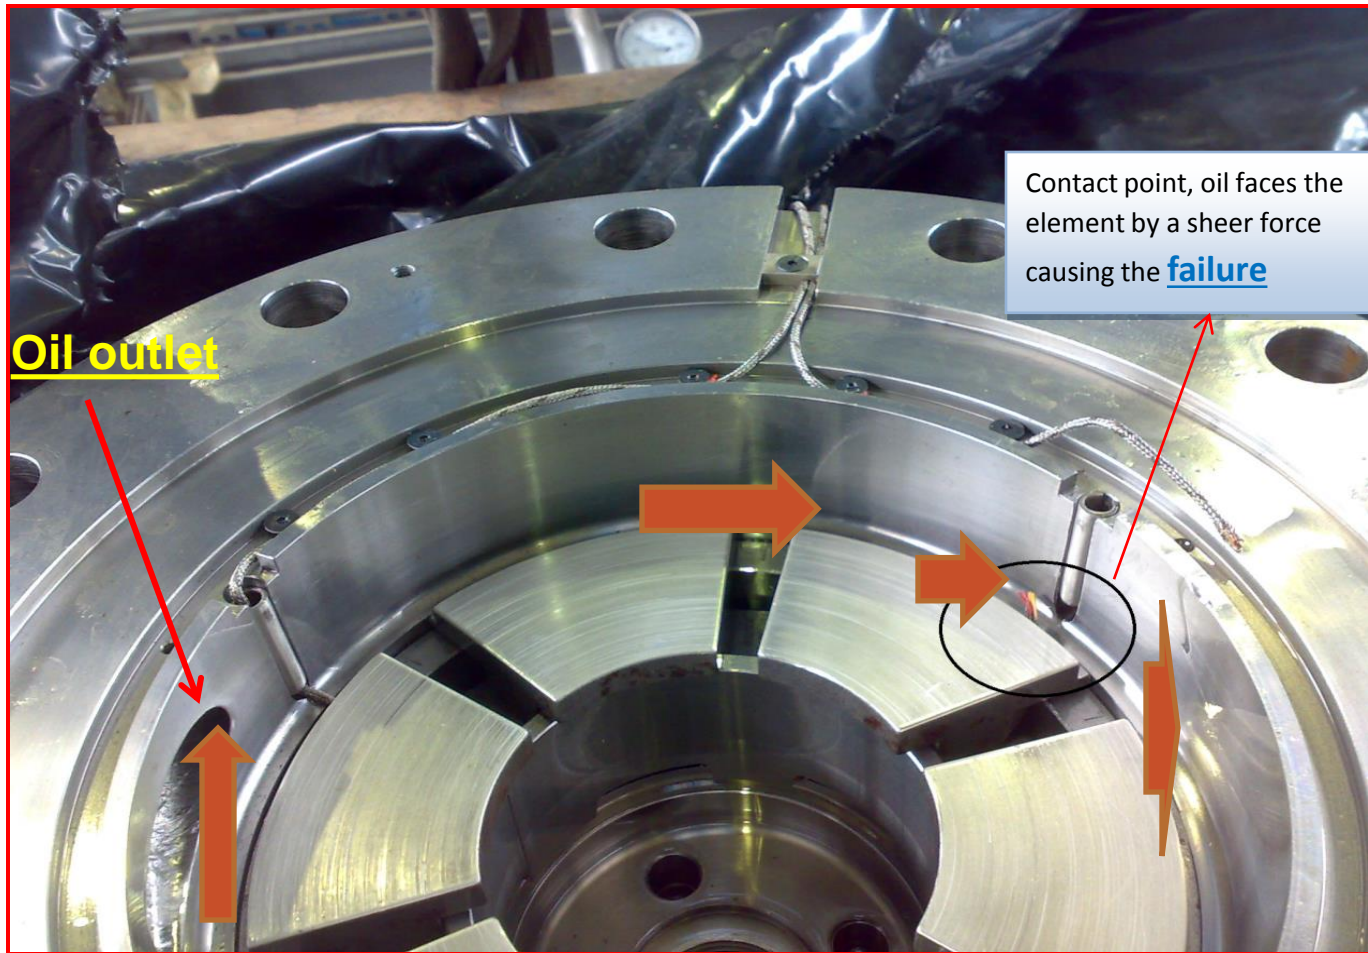
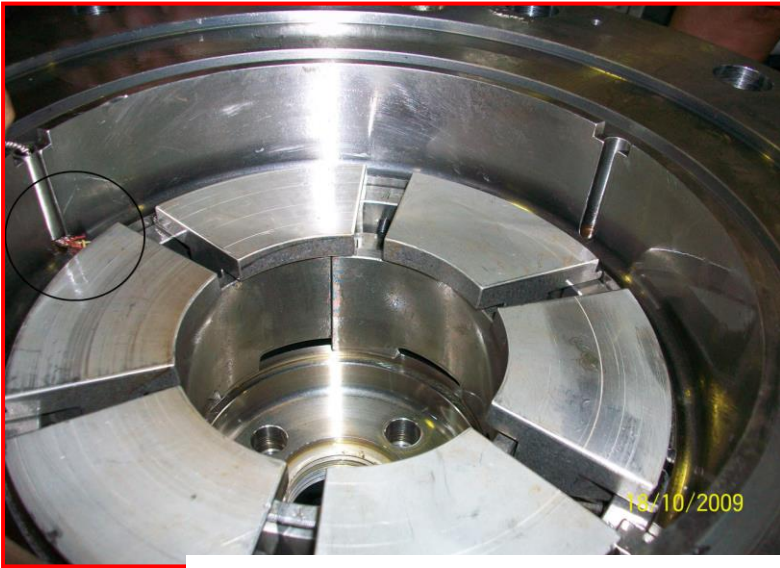
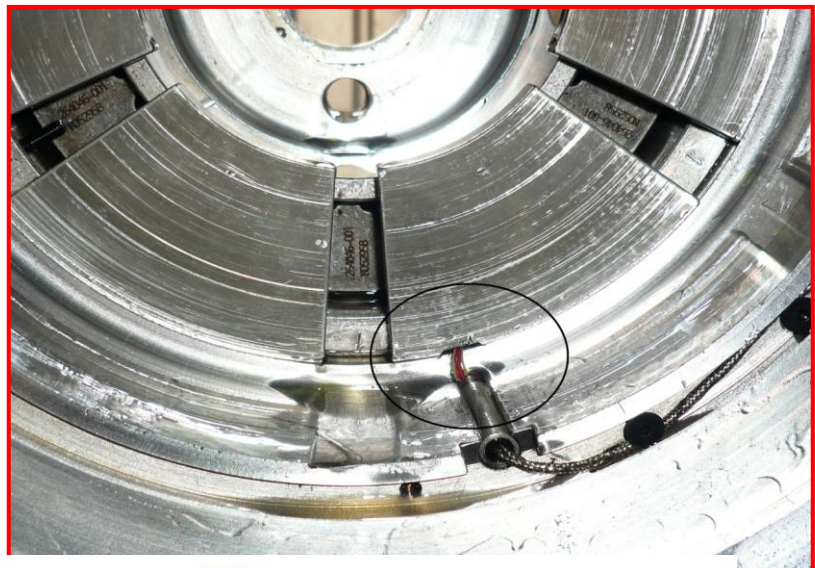
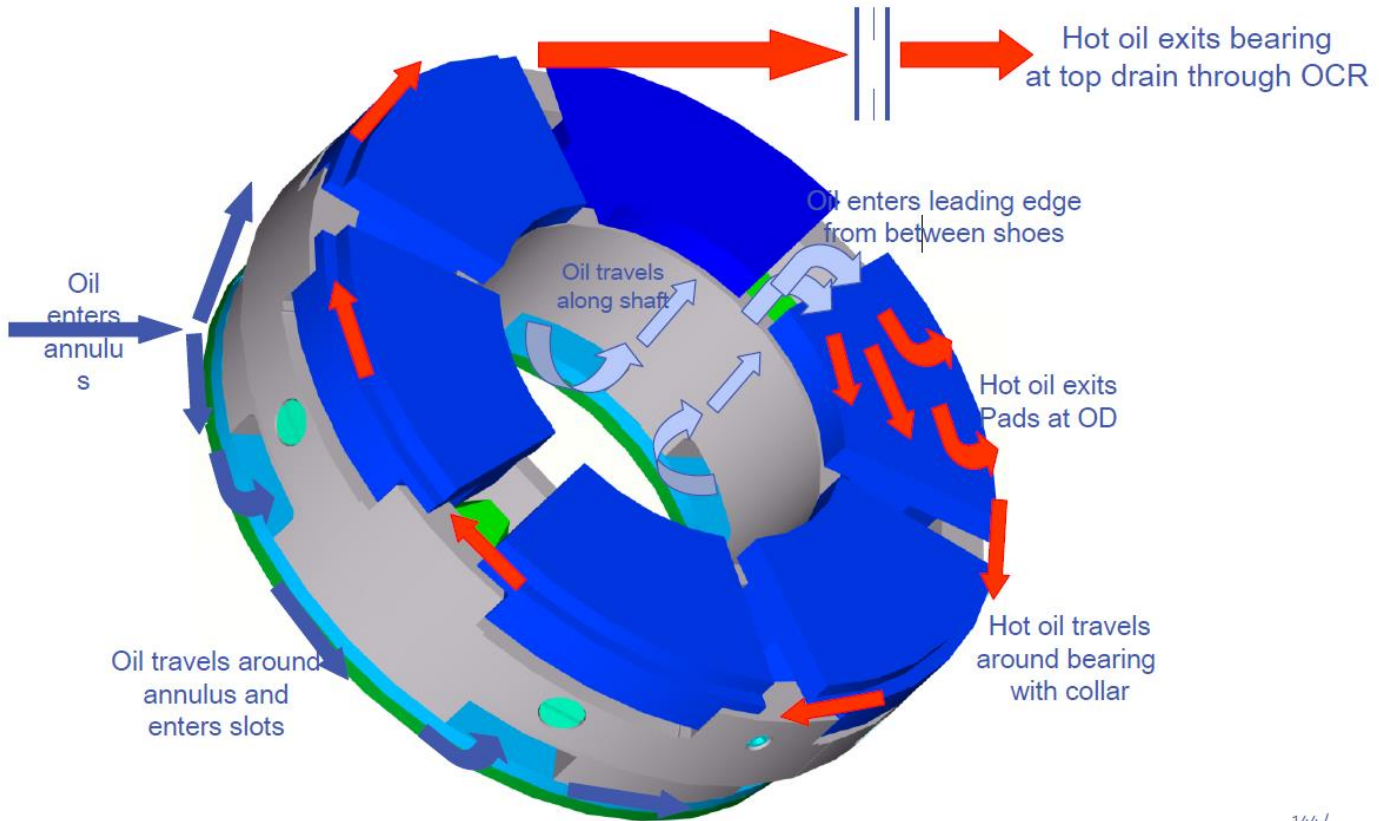
In non active side

The oil outlet dragged by the thrust collar rotation towards the bearing outlet causing shear force on the RTD shield body causing the failure of the RTD per time

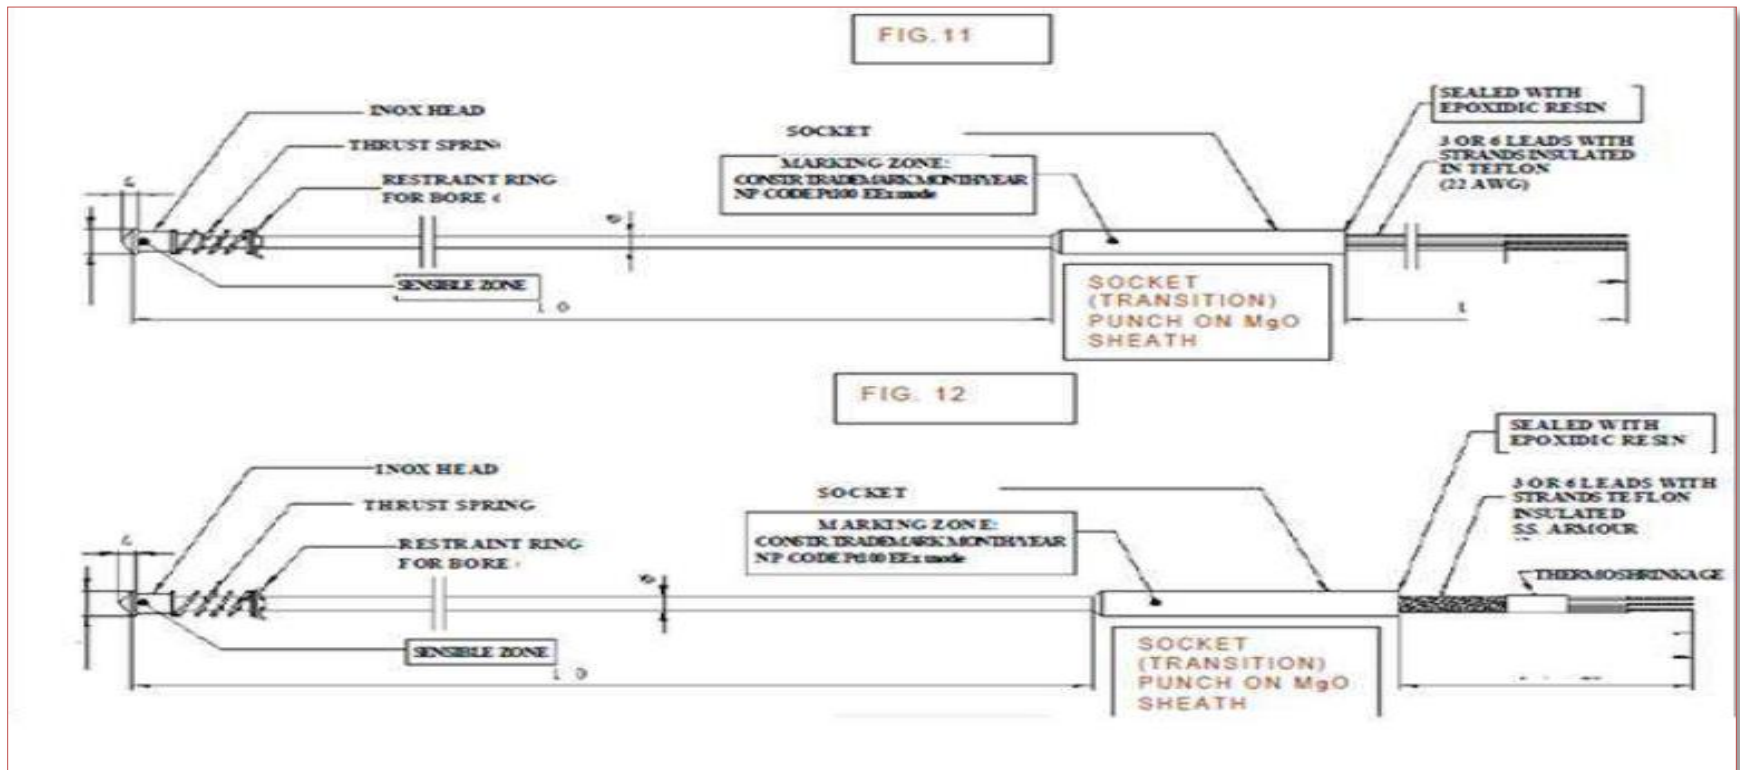
It became clear that woven shield RTD element failed due to it being snapped off from the oil launching at very high speeds.

Manufacture suggest to replace the original TE (thrust bearing only) with new type having a rigid shield made by 3 mm stainless steel capillary tube.

It is be assembled since 2012 in many machines without any problems
