39th Turbomachinery Symposium

PREVENTION OF SHAFT
END DAMAGE DUE TO
HIGH CONTACT PRESSURE

Introduction

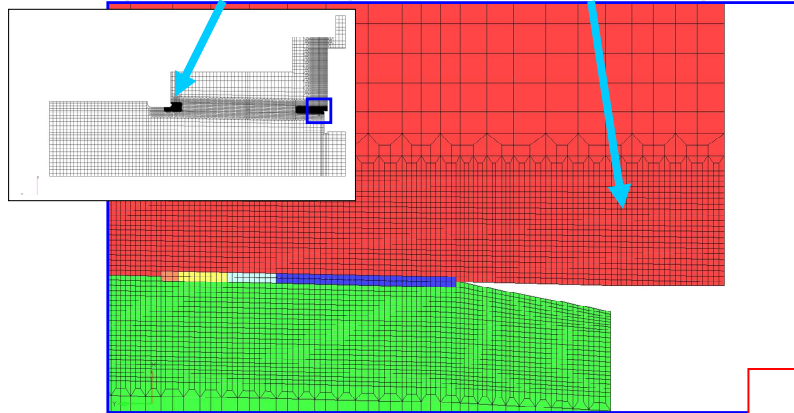
Current Configuration

A comparison of two models was made, focusing on contact pressure at the bore.

(With groove at large end and overhung mass)

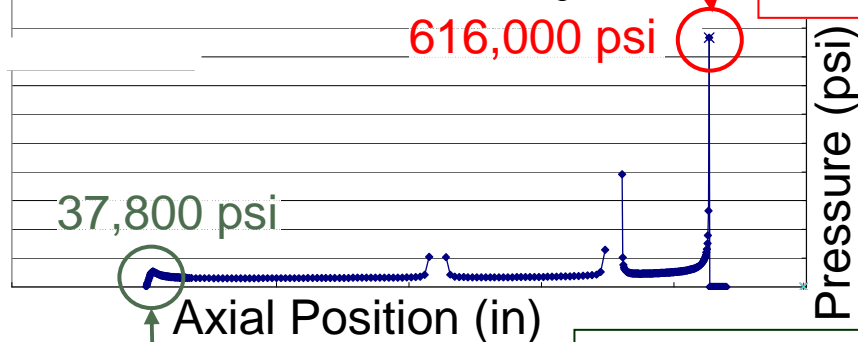
Contact Pressure vs Length

Influence of overhung mass

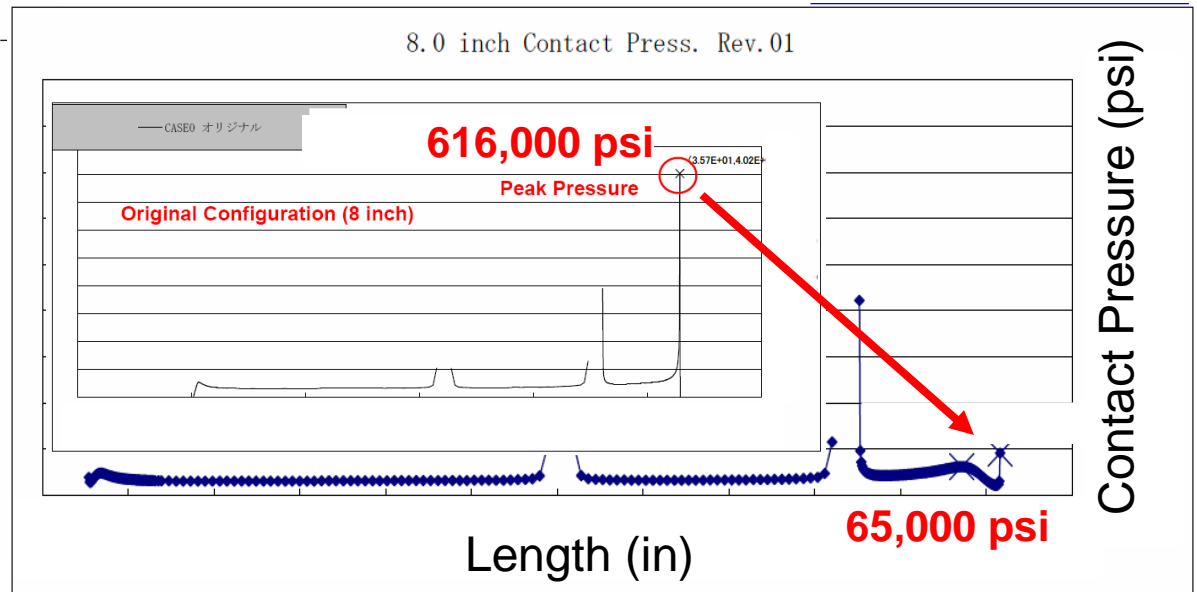
Hub Modification Plan

Solution: Reduce the shaft edge contact pressure (Area "A")

- Reduce overhung mass and apply groove at small end of bore
- Reduce bump up mass

Both ideas would be applied

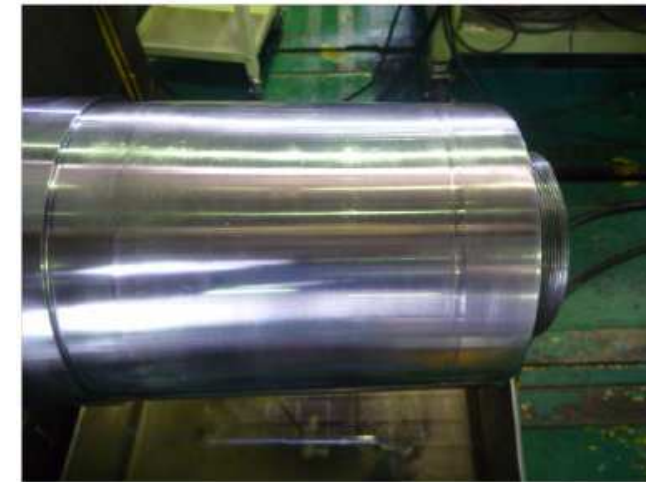
Dummy shaft

Study for Effect of Shaft Geometry

Relief groove depth was increased to prevent damage.
