Bearing Issues with a Flooded Screw Compressor

Introduction

- Flooded screw compressor on offshore platform had thrust and journal bearing failures
- Redesigned high case thrust bearings to run with “pressurized cavity”
- Redesigned journal bearings to increase reliability

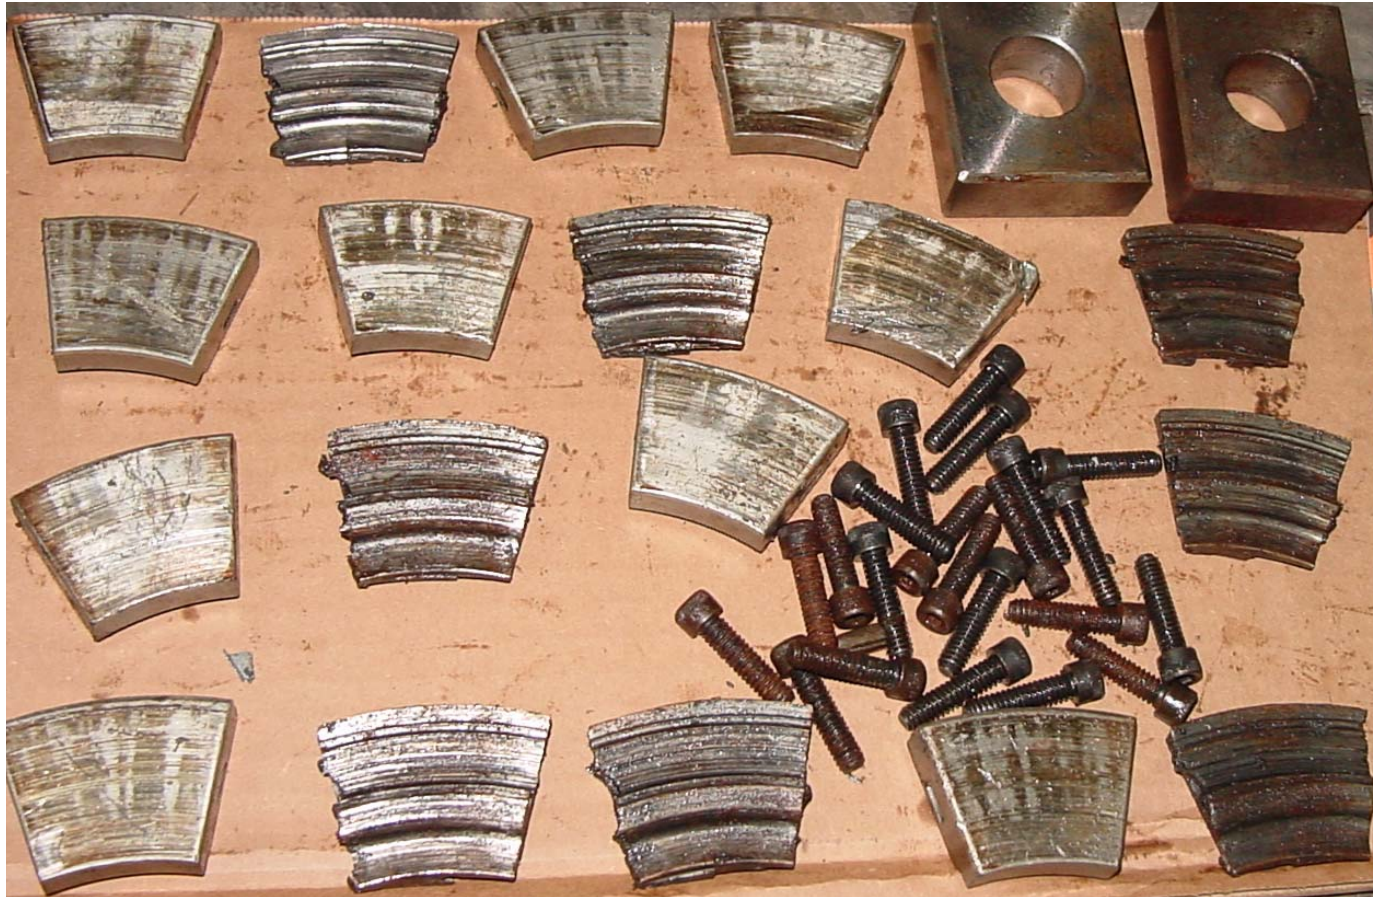
HC Thrust Bearing Pads

Severe
failure of
active
pads
(male and
female)

- LC and HC Bearings were different design
 - Both were equalized tilting pad
- LC did not fail - HC did fail
- Recorded step increases in HC rotor position
 - February had 12-15 mils float
 - June had 30 mils float
 - July – tripped on high axial movement

- Decision made to duplicate LC design aspects in the HC thrust bearings and upgrade bearing design
 - Main difference was LC has drain orifice control and the HC had supply orifice control
 - Upgraded HC bearings to utilize copper pads
 - Also upgraded HC to offset pivots

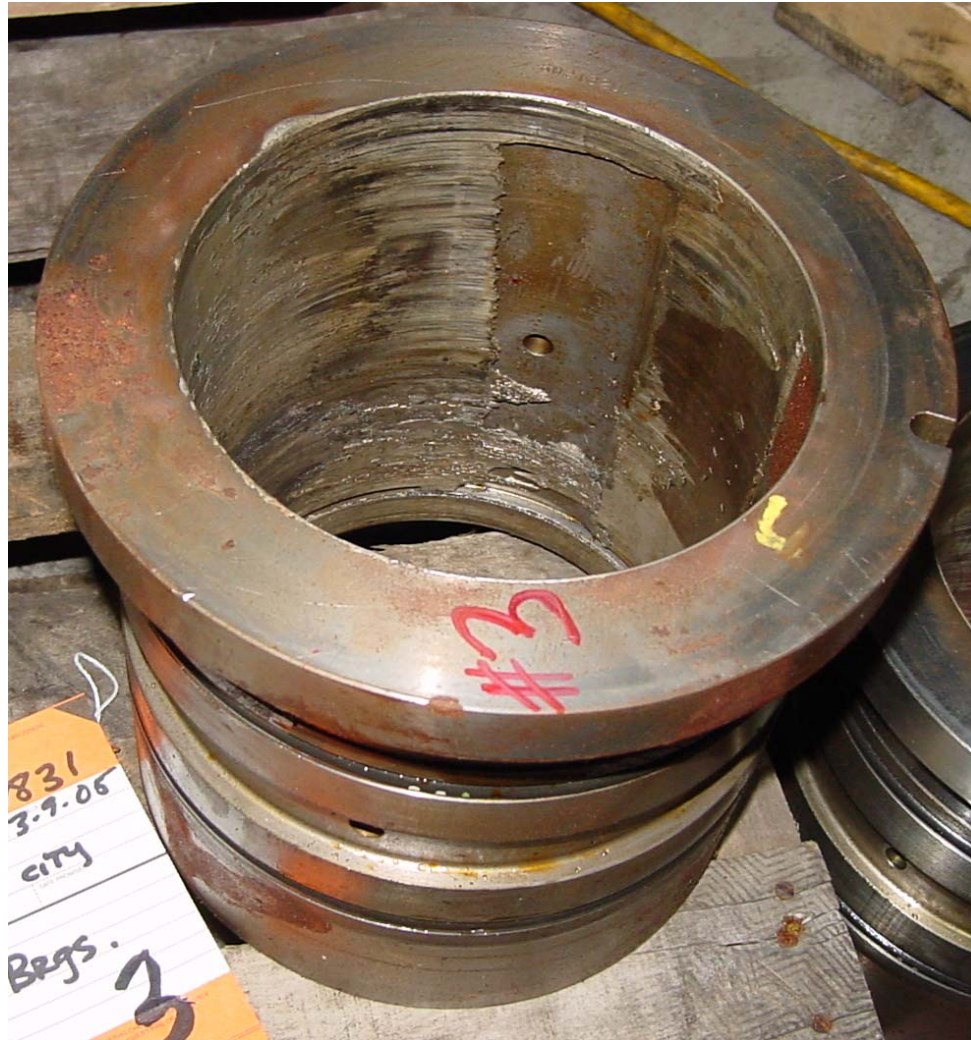
Journal bearings

- All 8 journal bearings wiped
- All bearings had same design concepts
- Oil flow through bearings contributed to lobe lubrication
- Improved reliability by increased clearance and increased oil flow (by opening flow passages in bearing bores)

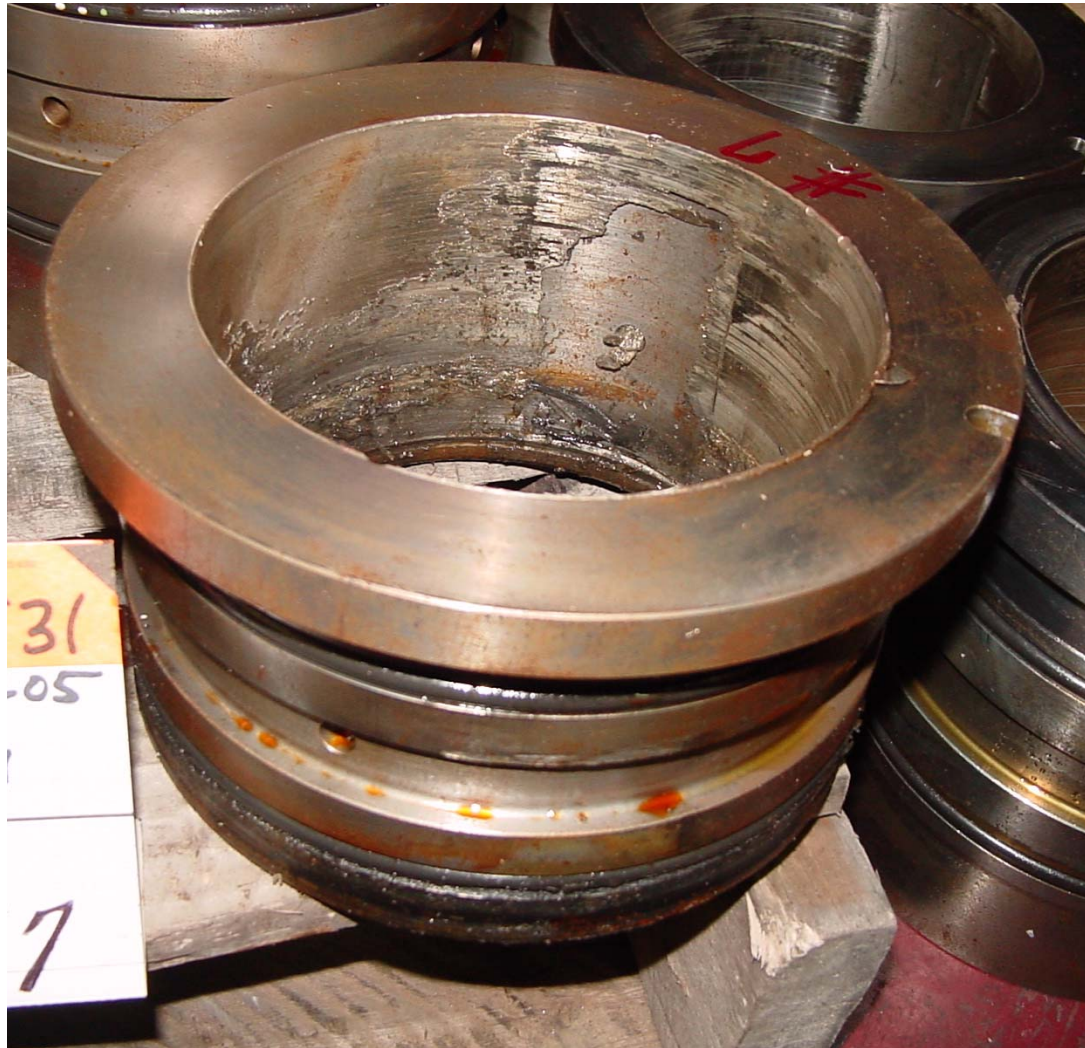
Journal Bearings

- Clearances ran about $\frac{3}{4}$ mils per inch
 - Decided to open closer to 1 mil per inch
- Axial oil distributions grooves had “Bleed off” notches (chamfers) to control oil flow
 - Increased number and size of these chamfers

- Oil flow through a journal bearing consists of:
 - Side Leakage
 - Chamfer flow
- Increasing clearance increases side leakage
- Increasing chamfer size and/or number increases chamfer flow

- Journal Bearing failure pointed to inadequate clearance and lack of lubrication
- Redesign to increase clearance improved reliability but introduced process gas condensation problem.
- Analysis of bearing clearance and oil flow allowed optimum bearing design.
 - No more journal bearing failures
 - Minimize condensation issues

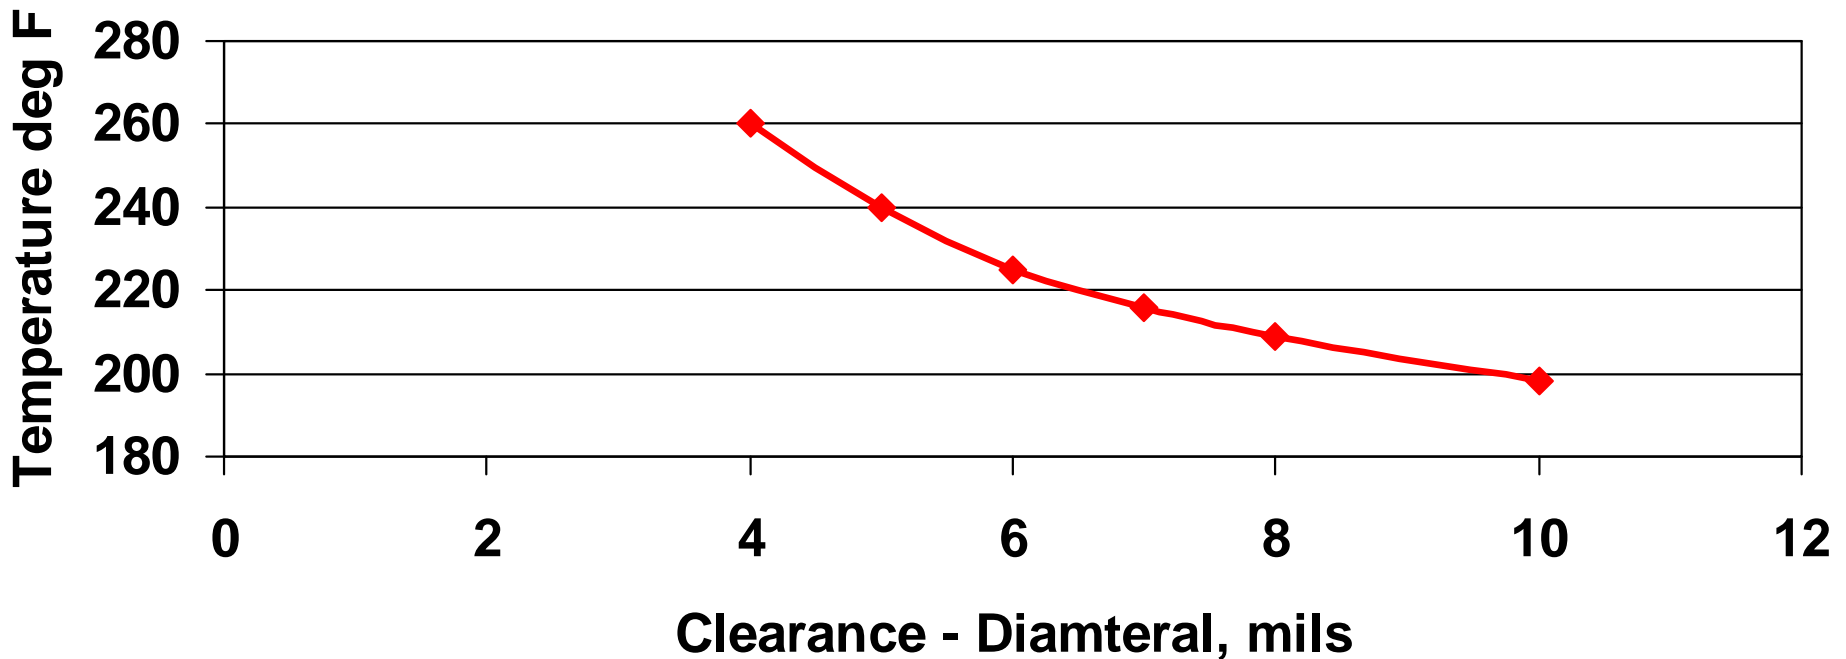
Effect of Clearance on Metal Temperature

Assumed load of 200 psi, no chamfer flow

- Opted to retain OEM notch configurations and increase bearing clearances
- Result is improved bearing reliability with reduced process gas condensation problems
- Demonstrated use of computerized analysis to determine best design configuration

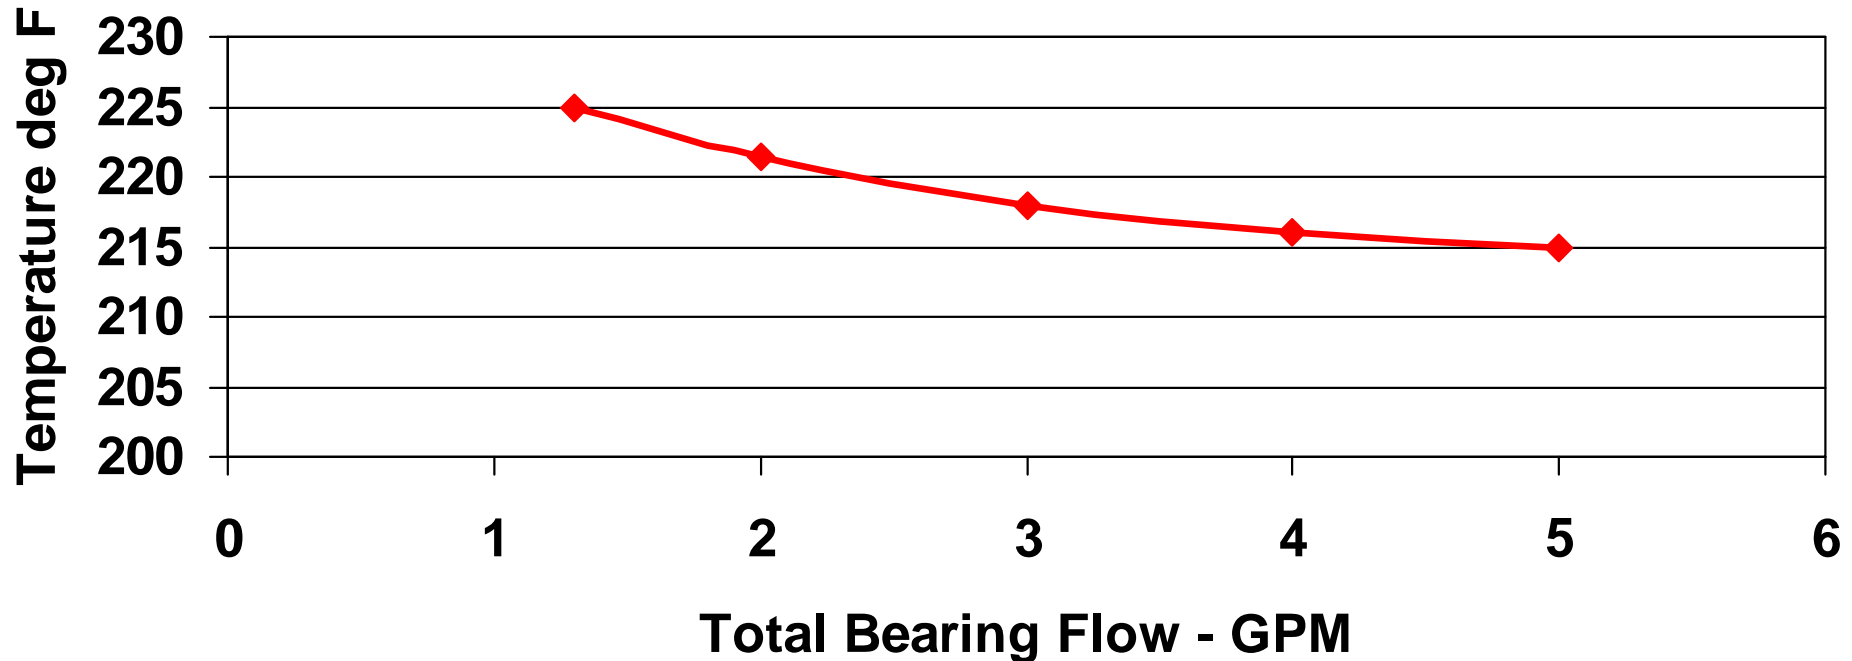
Effect of Flow on Metal Temperature

Assumed load of 200 psi, 6 mils diametral clearance
