The Evaluation of the Coefficient of Friction Used to Calculate Hub Slip Torque

Field Problems which Initiated Testing:

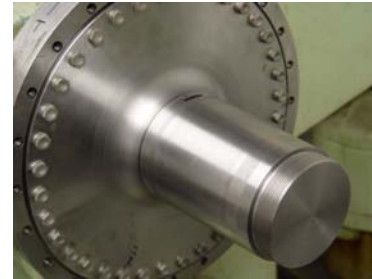
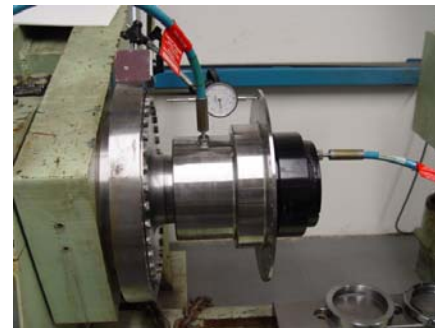
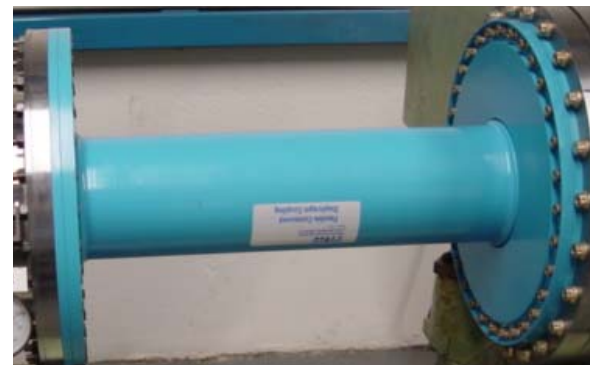
Test Components

- Replicated Machinery Shaft End
- Hydraulically Installed Taper Bore Hub
 - With 2 Buna-N O-Rings & 2 Teflon Back Up Rings
- Contoured Flexible Diaphragm Coupling (to take up misalignments in test equipment)

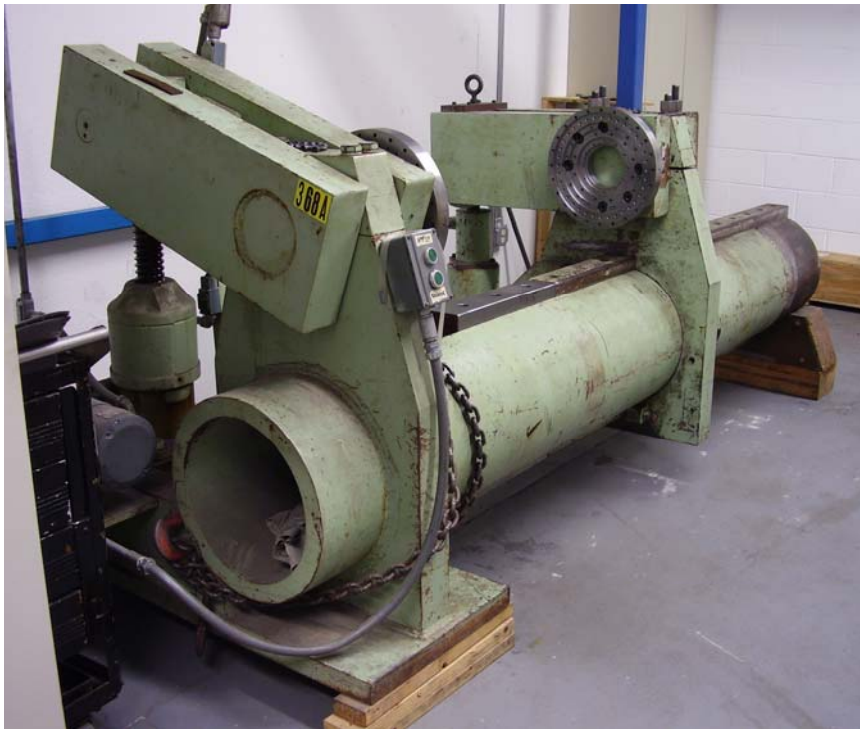
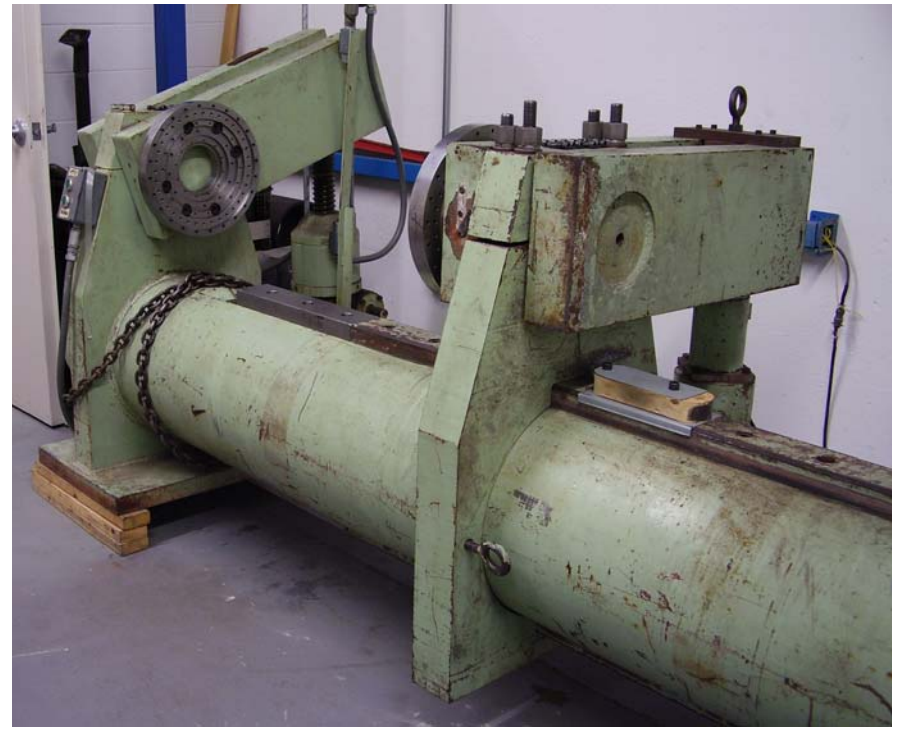
Test Equipment

- Million-Inch Pound Static Torque Test Stand

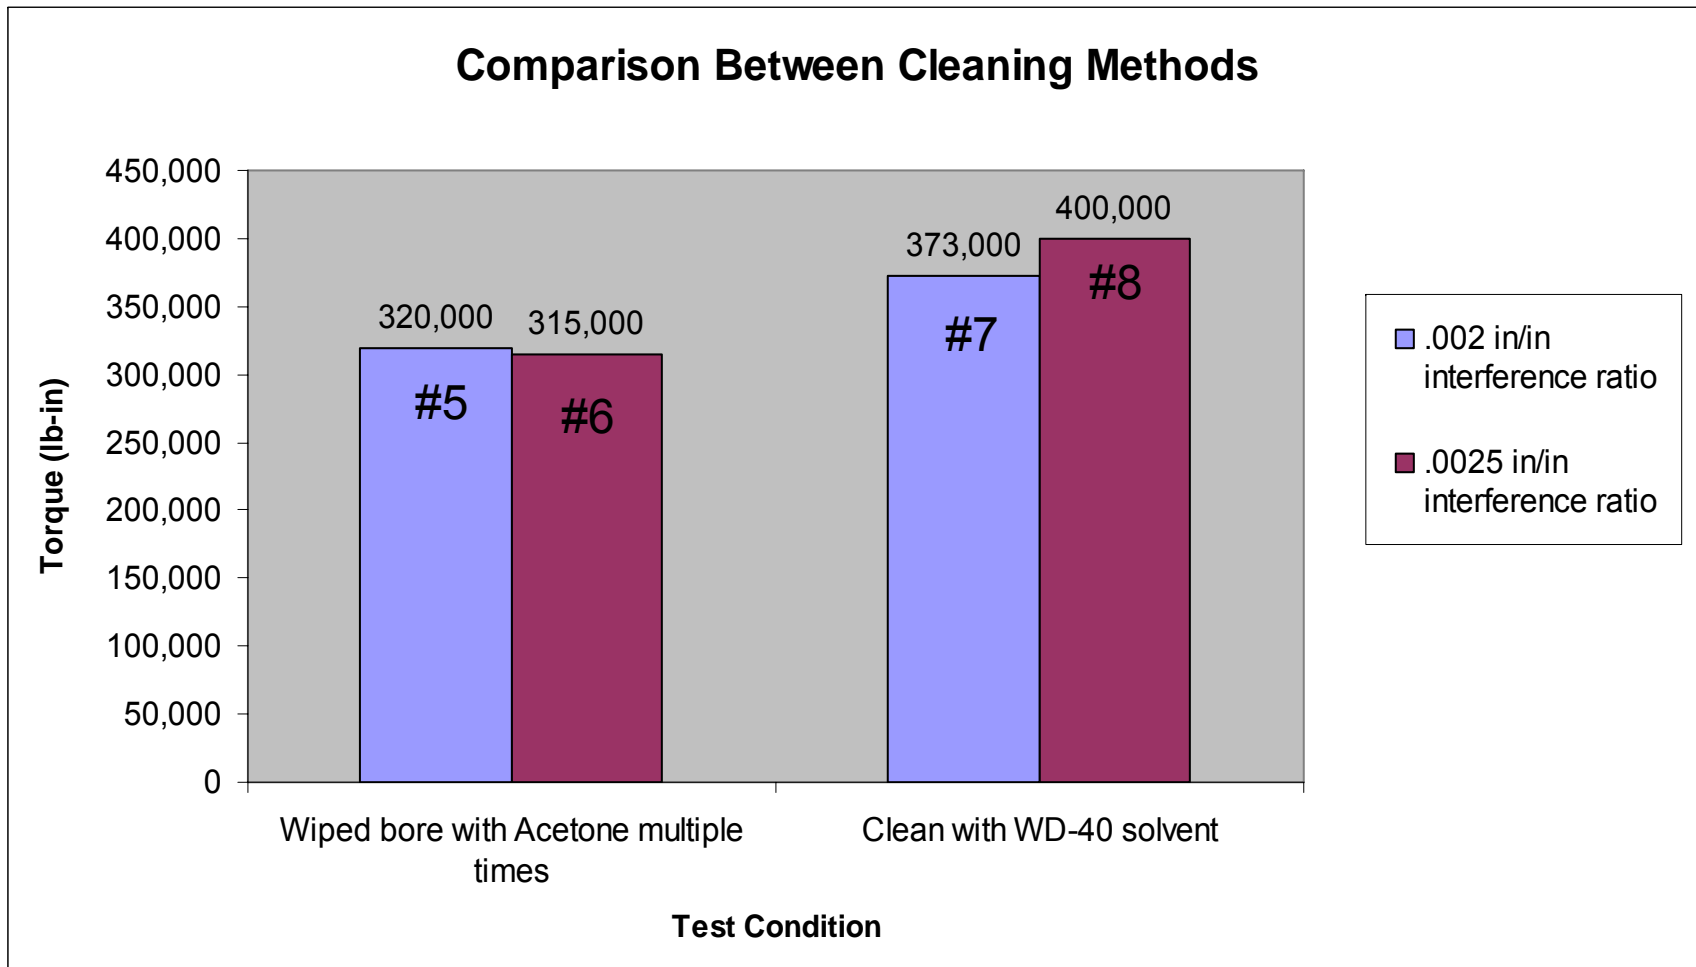
Results (Tests #5-8)

Note: data is based on newly machined components in a clean environment

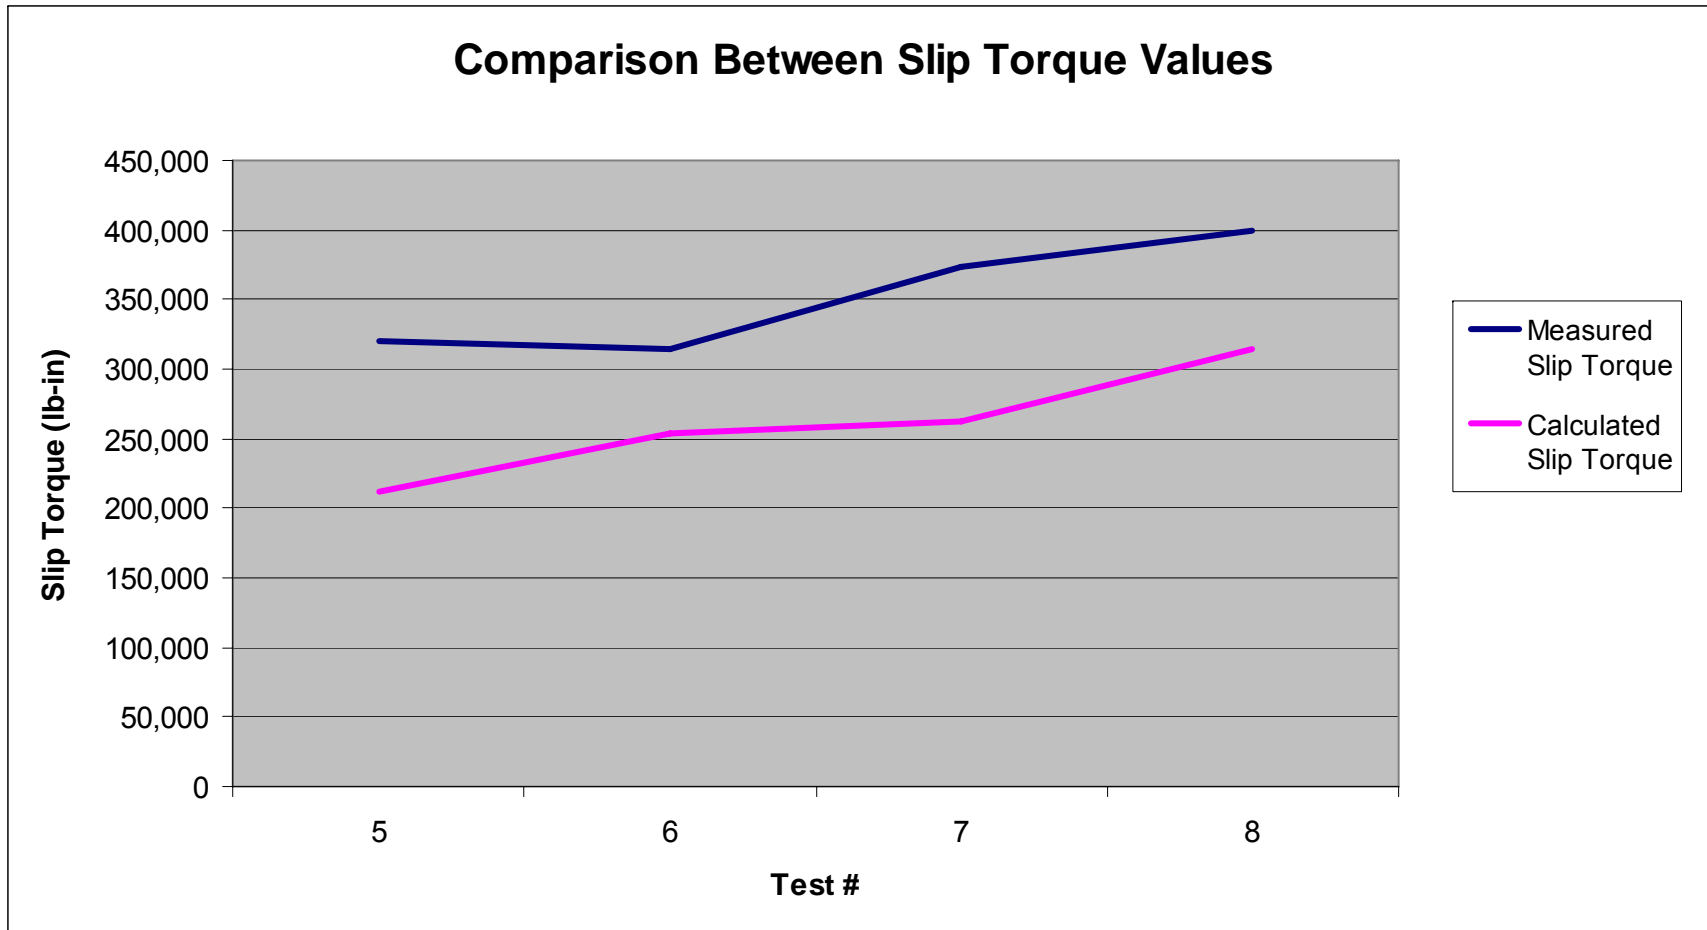
Results (Tests #5-8)

Coefficient of friction solved from actual test data = 0.18 average

Note: data is based on newly machined components in a clean environment
