NON-METALLIC BRUSH SEAL IN HEAVY DUTY GT UNITS, GE-MADE FRAME NO 7, MODEL EA

**Steve Ingistov
BP/WCC/USA**

This Paper describes design, fabrication, installation and operational experience with non-metallic brush seals installed in all four GT Units, GE-made, Frame No 7, Model EA, presently operating at Watson Cogeneration Company, Carson, California, USA. First non-metallic brush seal was installed early 2002 and is currently in operation. Non-metallic brush seal serves in particular application to reduce the leakage of lubrication oil into the axial compressor suction. At the time of installation, it was the first application[1], to author's knowledge, where the non-metallic bristle brush seal was used in heavy duty industrial gas turbine. Non-metallic brush seal can be successfully used where the local temperatures and pressures allow their safe usage. Compressor bearing number one is close to its suction where the air temperatures are low enough to enable the usage of non-metallic bristles which in turn are the core of the brush seals.

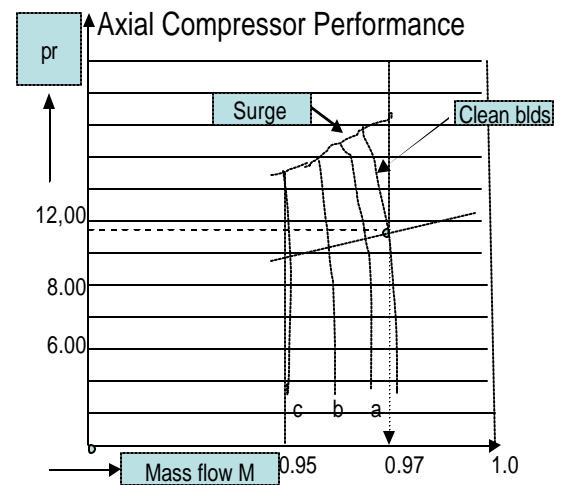
Figure 1 shows clean compressor performance, GTE-150 LMZ [5]. The lines labeled as **a**, **b** and **c**, show performance degradation when the early stages of compression are contaminated with dirt.

Figure 1 Axial compressor performance when the blades are clean (phantom line) and when the blades are fouled [5].

Phantom curve represents brand-new, clean compressor.

Curve **a** shows fouled IGV and 1st stage of compression.

Curve **b** represents fouled IGV plus 1st stage of compression and second stage of compression, and so on.

Solid, straight, inclined line represents the line of compressor-turbine work.

Figure 1 also shows pressure ratio dropping from 11.50 (clean compressor) to 9.0, a case when all three stages of compression are dirty.

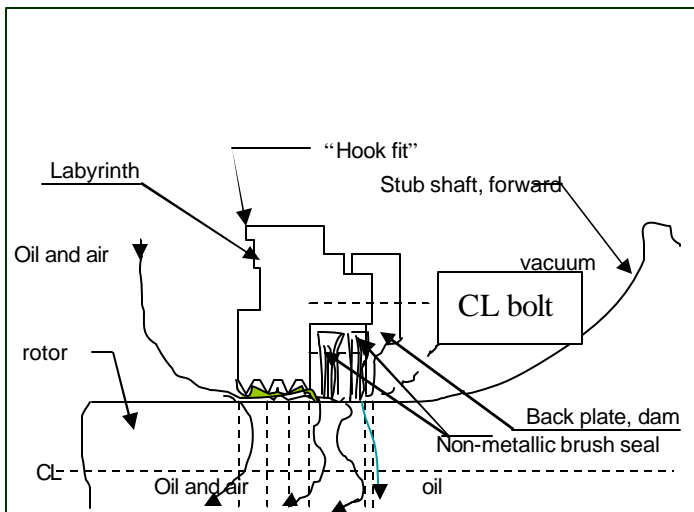
The holder of the brush seal was re-designed in order to maintain portion of the upstream labyrinth seal and also to hold the brush seal in the firm position. The brush seal was manufactured in two halves, each sliding into the "hook fit" cross section slot. Figure 3 shows the design concept of non-metallic brush seals.

There are two identical brush seals in tandem configuration in order to arrest as much as possible lubricating oil which is mixed with ambient air.

Figure 3 Standard labyrinth seal augmented by tandem non-metallic brush seals.

A brush seal-modified metallic labyrinth serves the following purposes:

- It is the first barrier to oily ambient air
- It drains accumulated oil, and
- It houses both non-metallic brush seals.

In order to further retard the leakage of oily air, the labyrinth teeth were also modified. Its "hook fit" was replicated to fit into the existing compressor bell-mouth casting.

The last tooth of the labyrinth seal was provided with angle-drilled oil drain holes at the 6 o'clock position. If the drainage is inadequate, oil will form a dam and start flooding the bristles which may cause them to swell. In addition, the accumulated oil may start to coke up due to friction heat generated by brushes contacting the shaft. Carbon formation may further aggravate the performance of the brush seal and the stub shaft journal may suffer grooving damage due to a grinding effect.

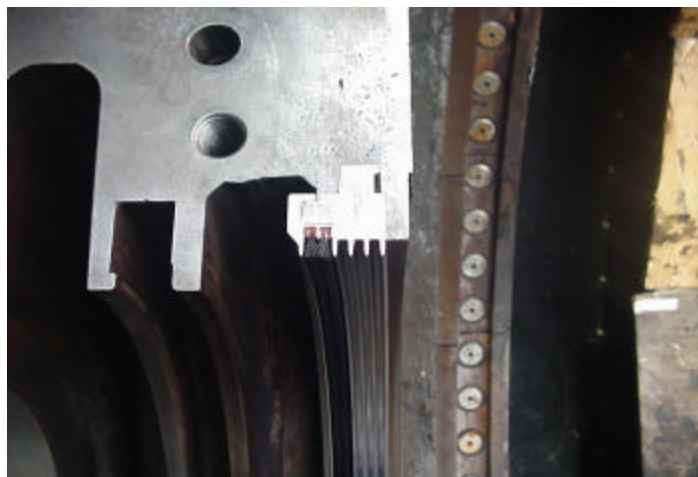
Figure 4 Bearing No1, lower half of labyrinth seal and non-metallic brush seal. Bristles are black colored.

The non-metallic bristles are of black color and are precisely cut to apply slight desired pre-load on the shaft journal.

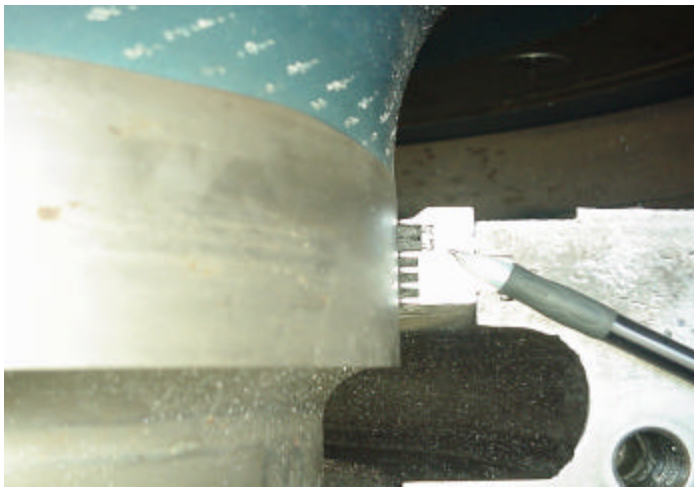
Figure 5 shows blue coating protecting the stub shaft forward from corrosion attacks. The particular brush seal was in operation slightly less than a year and yet one could not discern typical streaks of oil fouling on the stub shaft. However, the compressor blades were found to be significantly fouled, including obvious deposits of lubricating oil. Close examination of the possible leakage paths revealed some oil seepage along the horizontal bell-mouth split. It is noteworthy that even a relatively small amount of lubricating oil leakage can have a significant impact on axial compressor performance.

Figure 5 Brush seal contacting the journal of stub shaft forward. Blue coating is protecting the base material of the stub shaft forward.

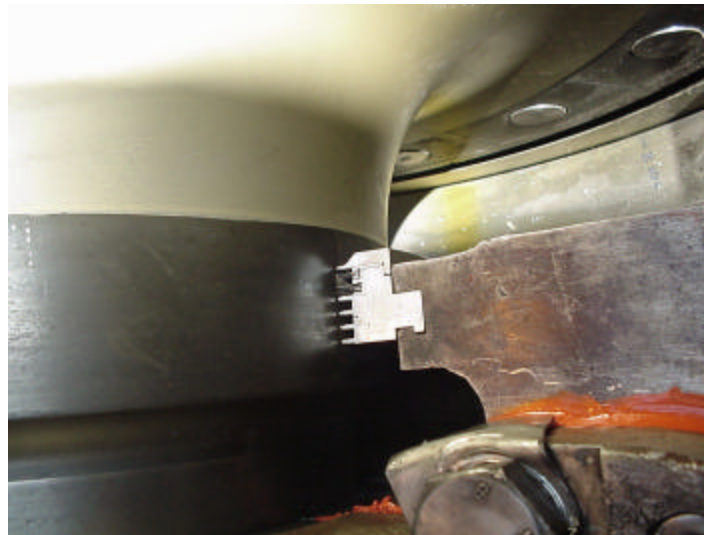
Figure 6 shows brand-new non-metallic brush seal installed during March 2004 Major Inspection of GT Unit. The radius of the compressor rotor stub shaft forward is protected with corrosion-resistant coating of cream color.

Red color sealing compound (RTV) is used to prevent lubricating oil by-passing from horizontal splits of the bearing No 1 housing. Unfortunately, generous application of RTV actually separated the sealing surfaces encouraging the oil to leak. The use of non-metallic bristles allows slight pre-loading in cold static condition. Examination of all four GT Units operating in WCC revealed only slight burnishing of the mating rotor cylindrical areas which were not protected with any kind of coating.

Figure 6 Brand-new non-metallic brush seal.

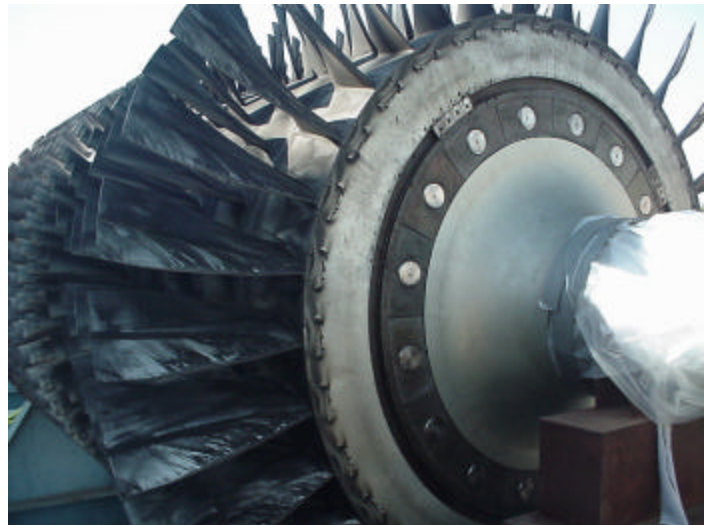
Figure 7 shows compressor rotor assembly just pulled out from the casing during October 2006 MI. First stage rotor blades were found seriously contaminated with dirt deposit. White streaks represent removal of dirt layer during on-line and off-line cleaning efforts. The stub shaft area is free of typical radial lubricating oil traces indicating good performance of non-metallic brush seal. The fouling of the rotor blades is then due to the leakages of oil, dirty air and moisture via other paths of possible contamination already described.

Figure 7 Contamination of the first stages of compression. Note the cleanness of the stub shaft.

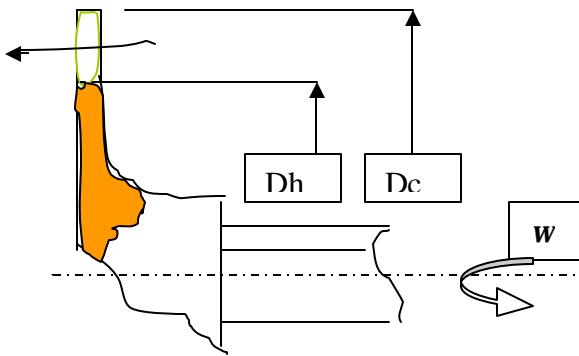
Figure 1A shows simplified geometry of 1st stage rotor blade. Diameters of the hub and the blade tip are instrumental to compute ISF.

Certain assumptions are taken such as the typical inlet air temperature at the bell mouth of the compressor, the magnitude of the vacuum that exists just before first stage rotor blades and the pressure ratio across the first stage of compression. It is also assumed that equal work of compression is done between the rotor and the stator blades, in other words the “reactivity” of the blades is about 50%.

Figure 1A Dimensional parameters necessary to compute ISF.

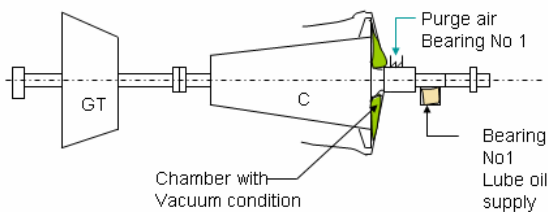
Figure 2A Turbine-compressor rotor showing the proximity of the journal bearing No 1 to compressor suction.

Journal bearing number one is next to the thrust bearing and the combination of these two require significant amount of lubricating oil. In addition, both journal and thrust bearing are in the vicinity of the compressor suction. Figure 2A from Appendix illustrates the proximity of the lubrication oil supply point to the compressor suction bell mouth. If the lubricating oil is allowed to entrain the compressor suction it will be atomized by the main air stream and the oil mist particles having negligible weight will tend to stick to the roughened and already dirt-deposited blade surface. Sub-micron particles of ambient dust and the moisture from atmosphere, combined with the moisture carried-over from the intake air evaporative cooler and from the fog generator, form a fine paste of dirt which sticks to the blades surfaces. Users frequently apply on-line cleaners which must be environmentally friendly but may not be effective in removing the oily deposits.
