THE ROLE OF ONLINE AERODYNAMIC PERFORMANCE ANALYSIS

Robert L. De Maria

M. Theodore Gresh

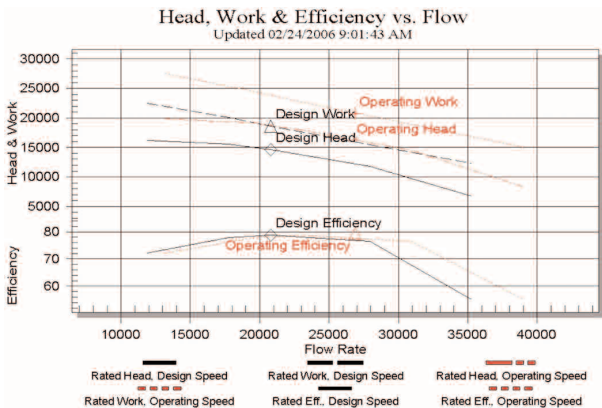
Figure 3. Head, Efficiency, and Work for GB1701 Methanation Compressor. Data Shows Compressor to Be Operating as Expected.

Along with head and efficiency, the work input is also calculated. By monitoring the work input, it is possible to monitor the quality of the compressor data being collected. Work input is representative of the energy transferred from the compressor impeller blades to the gas. Any degradation in the interstage seals, corrosion, or fouling will show up as a loss in efficiency and head, but the work input is fixed and remains the same regardless of these losses. Thus, monitoring work input is a good means to confirm that the input data are accurate.

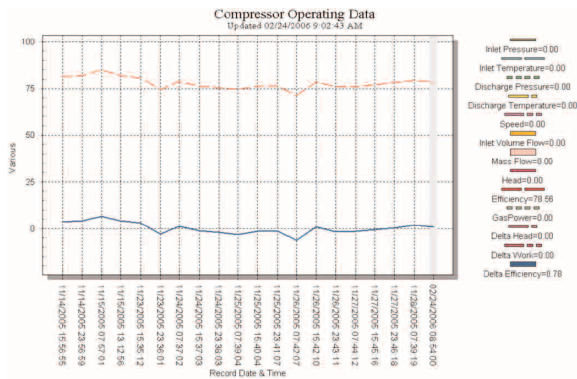
Figure 4. Historical Data Chart for GB 1701 Methanation Compressor Showing Efficiency (Upper Curve) and Delta Efficiency (Lower Curve).

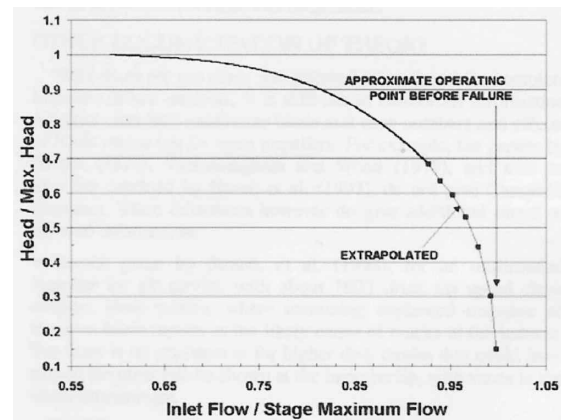
Figure 6. Head Ratio Versus Inlet Flow Ratio for Last (Fifth) Stage Impeller of Propylene Compressor. (Courtesy Kushner, et al., 2000)

The second section of the compressor and specifically the last stage impeller were found to be operating well beyond the end of the curve, in deep choke conditions (Figure 6).

Flow through the compressor's second section during this 20 hour period was calculated to be 7950 icfm. This is 5 percent beyond the end of the OEM performance curve and 15 percent higher than the original rated flow.

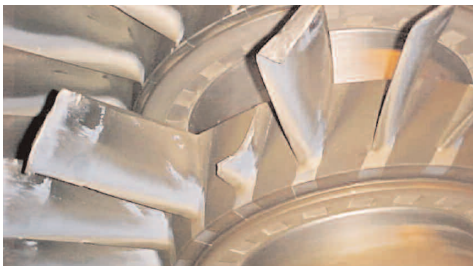
Figure 10. Axial Air Compressor Blade Failure. The Second in the Compressor's 22 Year Operating History.

In June 2002, an axial air compressor blade failed catastrophically in the first row of the low pressure section (Figure 10). The compressor is driven by a 30,000 hp fixed speed synchronous motor through a parallel shaft gear increaser at an operating speed of 4530 rpm. This compressor is one of two machines operated in the air separation facility for oxygen production used in the plant gasifiers and thus crucial to plant operation. The other machine is direct driven by a steam turbine. Both machines were placed in continuous operation in 1984. These machines operate at about 140,000 scfm and a discharge pressure of 90 psia. A similar failure had also occurred in the motor driven train in 1995. Subsequent to this failure a protective coating was installed on the low pressure blading to protect it from erosion and corrosion. The impact to plant revenue of this second failure prompted an extensive investigation into the root cause.

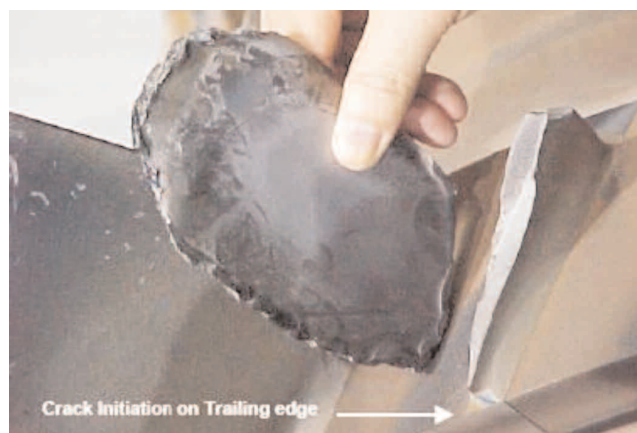
Figure 12. Failed Axial Blade. Crack Initiated on High Pressure, Trailing Edge of Blade.

A thrust bearing failure on the steam turbine train in 1993 resulted in an upgrade to a directed lube tilt pad design in both compressors. In 1994 the speed was increased from 4425 rpm to 4530 rpm, which increased capacity by 12 percent. There were no incidents of high vibration, or high thrust bearing or journal bearing temperatures prior to the blade failure. Analysis of the failed blade showed it to be of the correct material and mechanical properties and was not the result of foreign object damage, corrosion, or erosion. Since only one minute averaged data were available from the plant historian, the operating point on a dynamic basis was not available making it difficult to determine that the machine had been operating in a choke condition. A finite element analysis (FEA, Figure 11) was performed to determine the structural response for the defined load conditions. Metallurgical examination suggested that the failure was due to fatigue associated with a relatively high mean stress. In addition, blade vibrations and plastic strain above the tolerance limit most likely assisted in the fatigue failure. It was the contention of the investigator that the crack leading to the blade failure was initiated from the concave (high pressure) side of the thin blade edge and progressed in the transverse direction (opposite direction to airflow) along about 60 percent of the fracture surface until the blade succumbed to ductile overload (Figure 12).

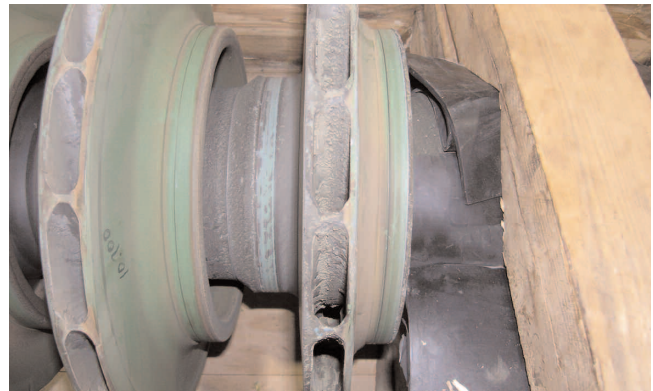
Figure 16. Synthetic Natural Gas Compressor Rotor. Note Fouling in Impellers. Monitoring Compressor Performance Helps Track this Condition and Aids Scheduling of Maintenance.

A scheduled overhaul of the compressor revealed fouling. Random flaking off of the fouling explained the higher vibration. Analysis of the deposits showed it to be predominantly iron oxide. An inspection of the carbon steel suction piping revealed significant corrosion on the bottom of the pipe. The first attempt to mitigate the fouling problem was to install a nonstick coating on the rotors. This did not solve the problem because the coating was eventually abraded and the fouling reoccurred.

An analysis of the process gas showed it to be saturated. Furthermore, the piping from methanation to the suction of the compressor is outside and not traced or insulated. Ambient conditions can range from -40°F to 110°F. It was realized that particularly in the winter, the cold piping was causing condensate to form in the bottom of the piping, which reacted with the gas to form carbonic acid. The acid formed then corroded the steel pipe. The corrosion products were transferred to the compressor by the high gas velocities. A suction knockout pot on the line to the compressor has not been effective in preventing the carryover from reaching the compressor. A glycol water removal unit is located between the first and second compressor cases to knockout the water before exporting the gas.
