DEVELOPMENT OF ANTIFOULING AND CORROSION RESISTANT COATINGS FOR PETROCHEMICAL COMPRESSORS

Elliott Company

Nova Chemicals Corporation

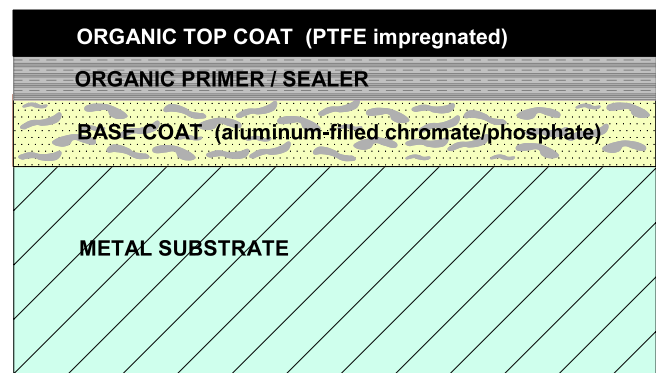
The most commonly used coating on hydrocarbon compressors is a three-part system. The base coat consists of an aluminum-filled chromate/phosphate composite, which is commonly used as a corrosion and oxidation resistant coating for turbines and compressors. The aluminum particles embedded in the structure function as a galvanic sacrificial phase to corrode themselves and protect the base metal. In order to improve the galvanic protection, this layer is burnished after curing, which “bridges” the aluminum particles and increases the conductivity of this coat. Some coating vendors may apply an additional unburnished base coat to make a four-layer coating, but it is optional. The middle coat is an ion-reactive organic primer, which inhibits corrosion of the base coat, and, more importantly, enhances bond strength of the topcoat. The topcoat consists of a PTFE impregnated organic coat, which provides a nonstick feature as well as an impervious barrier to corrosive media. This three-part coating system is illustrated in Figure 1.

Figure 1. Illustration of Three-Part Construction of Multilayer Composite Coating.

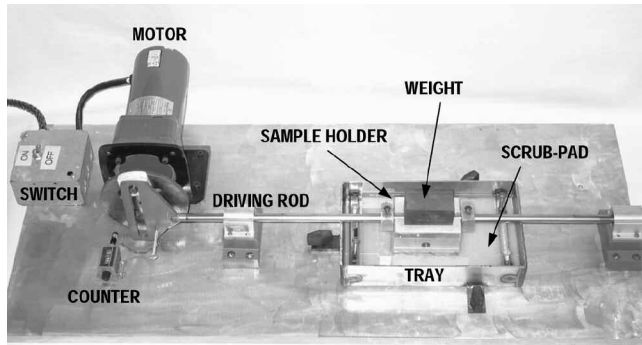
In order to evaluate antifouling performance of different coatings, the lead author's company has designed a foulant-release test procedure. The principle of this test is to apply a specially formulated foulant (or so-called gunk) on the surfaces of a number of coated samples, then try to scrub it off. The antifouling performance is considered better if it takes fewer cycles to scrub-off the foulant. To quantify the performance, an automatic test rig has been developed, as shown in Figure 2. The device consists of three parts:

- A scrub-pad being placed in a tray filled with water and detergent;
- A sample-holder block, which holds the sample facing down on the scrub-pad;
- An electric motor, which drives the block through a rod to scrub the sample back-and-forth on the pad.

A counter is connected with the driving rod to record the number of scrub cycles. After certain cycles, the sample is removed and weighed. The weight-loss represents the extent of foulant release.

Figure 2. Foulant-Release Test Rig.

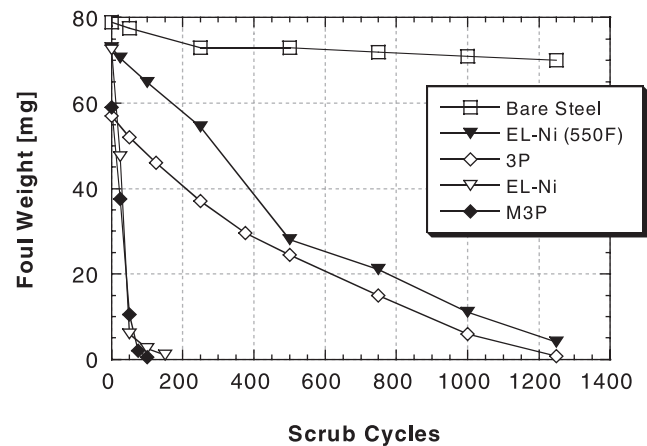
All the coated panels showed a dramatic improvement of fouling-release capacities as compared to the bare steel panels, as shown in Table 3 and Figure 3. Among the coated samples, the coating M3P demonstrated superior fouling-release performance to the coating 3P. The coating M3P could be completely cleaned in less than 100 cycles, while it took about 1250 cycles to scrub-off the foulant on the coating 3P. In contrast, the foulant on the bare steel remained almost constant after 1500 scrub

cycles. Another interesting thing to notice is that the EL-Ni, in as-coated condition, exhibited an excellent fouling-release capacity, which was as good as that of the coating M3P. Although this capacity had been greatly decreased after the coating was baked at 550°F (288°C) for one hour, the performance was still at a comparable level to the coating 3P, and far superior to the bare steel.

Figure 3. Comparison of Fouling-Release Performance of Bare Steel and Coated Panels.

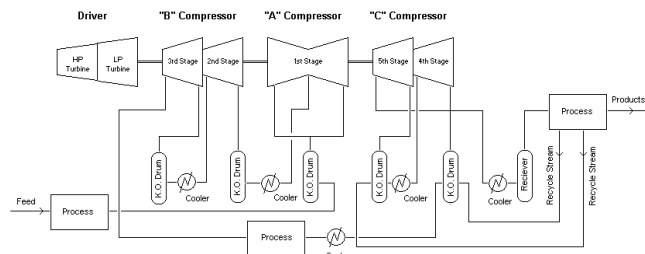
compressed to the pressure required for the product distillation and conversion in the downstream process facilities. The compressor string is composed of five process compression stages accommodated in three axially split compressors in tandem arrangement and driven by a 64,000 hp single extraction condensing steam turbine. Figure 4 is a schematic diagram of the charge gas compressor CGC. The compressors are designed for plant operation with various feedstocks. Table 5 summarizes its design operating conditions for the light feed case.

Figure 4. Schematic Diagram of CGC at Corunna Plant. ("C" compressor (fourth/fifth stage) is centrifugal compressor discussed in case study.)

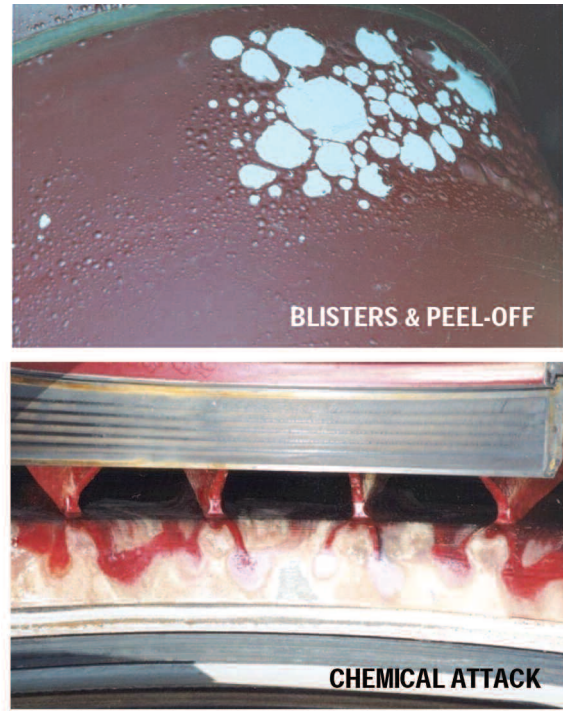
The analysis of the deterioration incident in 1999 revealed extensive coating blisters and peel-off throughout the compressor. Chemical attack was also observed on the impellers and diaphragms, as shown in Figure 6. It was believed that the blisters and peel-off resulted from the steam-cleaning operation, in which hot steam was purged into the compressor to remove the fouling substance prior to opening the casing. The hot steam had caused benzene, which had been absorbed by the coating and substrate during operation, rapidly evaporated, and produced the blisters. The chemical attack was probably due to the aggressive chemical additives, such as amine, that were injected to the cleaning process during the running period, or the possible caustic carryover from the upstream process. The caustic carryover could increase the pH value of the process beyond the safe range for the organic topcoat, which was four to nine, and consequently damaged the coating. This incident was a typical example to show that the organic composite coating was vulnerable to the aggressive washing and cleaning processes.

Figure 6. Deterioration of Organic Topcoat of Coating 3P with Benzene Blisters and Chemical Attack from Amine.

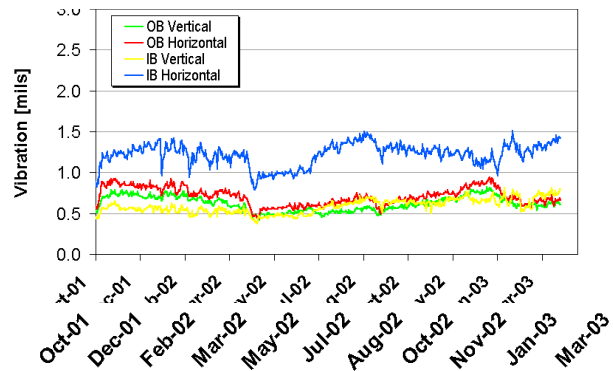
The compressor with EL-Ni coating has been successfully operated since the 2001 turnaround. The rotor vibration has been monitored at a much lower level than the previous run periods, as shown in Figure 7, which indicates that the fouling has been effectively controlled. Comparing these vibration data with the previous one shown in Figure 5, a significant improvement can be seen. This improvement is attributed to the better endurance of EL-Ni to the heavy washing operation than that of the coating 3P, because the oil washing and chemical injections have been kept in the same manner as in the previous operating periods. Although the data are preliminary, the Corunna plant feels that the EL-Ni has successfully functioned as an antifouling coating in this unit.

Figure 7. Vibration Trend of "C" Compressor Rotor Coated with Electroless Nickel and Operated from October 2001 to Date.
