# MOTOR CURRENT SIGNATURE ANALYSIS TO DETECT FAULTS IN INDUCTION MOTOR DRIVES—FUNDAMENTALS, DATA INTERPRETATION, AND INDUSTRIAL CASE HISTORIES

## ABSTRACT

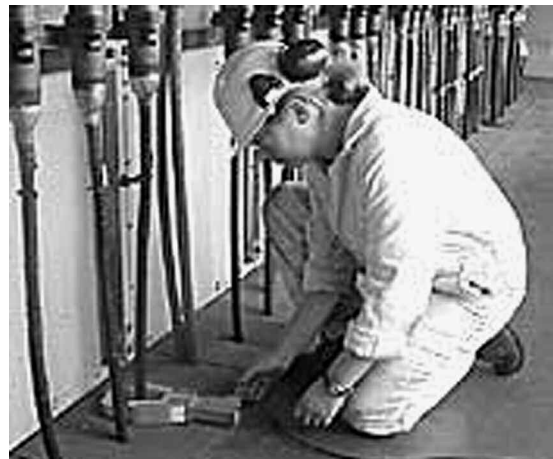
Figure 3. Clip-on CT Around Supply Cable.

The high frequency response is required to cover the frequency range of components that can be induced due to different fault mechanisms found in a wide range of designs of three-phase induction motors and also to cater for inverter fed (variable speed) induction motor drives. If necessary, more technical details on in situ instrumentation CTs and clip-on CTs of the type shown in Figures 3 and 4 will be provided at the actual tutorial presentation.

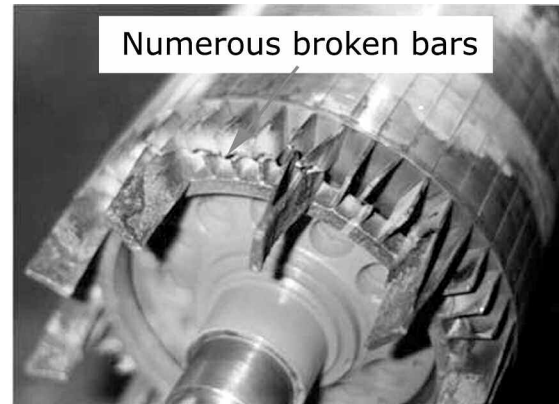
Additional examples of broken rotor bar failure are shown in Figures 9 and 10. The rotor in Figure 9 was from a crane motor subjected to DOL starts and had a long run up time (45 sec!). This rotor was not fit for purpose and was not producing sufficient starting torque for the load starting condition. Note the narrow bars and the classic crescent-shape breaks of the actual bars. Figure 10 shows a rotor from a food mixer motor that was being subjected to 24 starts per hour, which again was just too arduous a duty cycle for the rotor design. New designs were implemented and the problems were eliminated.

Figure 9. Crane Motor—Broken Rotor Bars.

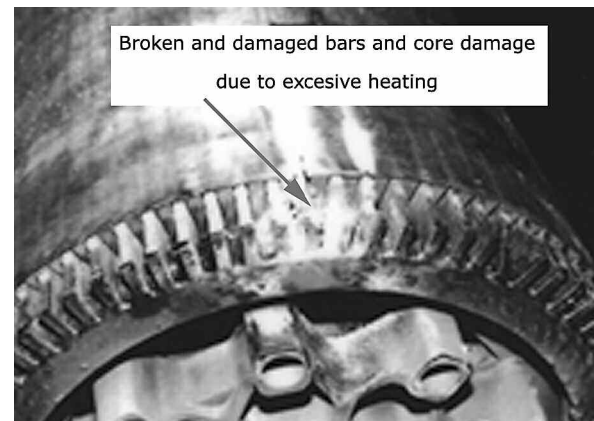
Figure 10. Food Mixer Motor—Broken Rotor Bars.

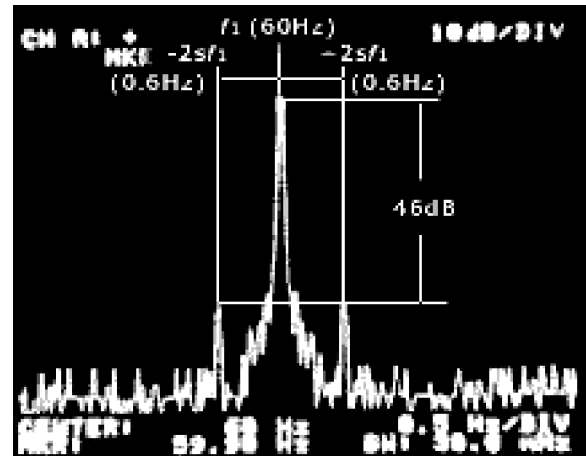
Figure 11. Current Spectrum—Healthy Rotor.

Examination of Figure 11 shows that there are sidebands at  $\pm 0.6\text{Hz}$  around  $f_1$  the supply frequency that was 59.9 Hz and not 60 Hz. The measured sidebands therefore correspond to within less than 10 percent of the predicted values using full-load nameplate data since the motor was actually operating at full-load current. In Figure 11 the sidebands are greater than 45 dB down on the supply current, and this corresponds to a healthy working unit for a two-pole motor of this design and rating having 46 rotor bars. Although there are sidebands, it means the rotor is not perfect and there is some rotor asymmetry due to inherent differences in the bar to end ring joints.

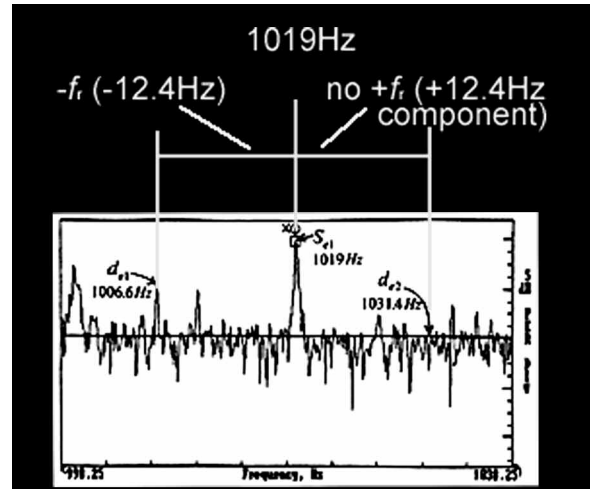
Figure 19. Current Spectrum, Normal Level of Airgap Eccentricity.

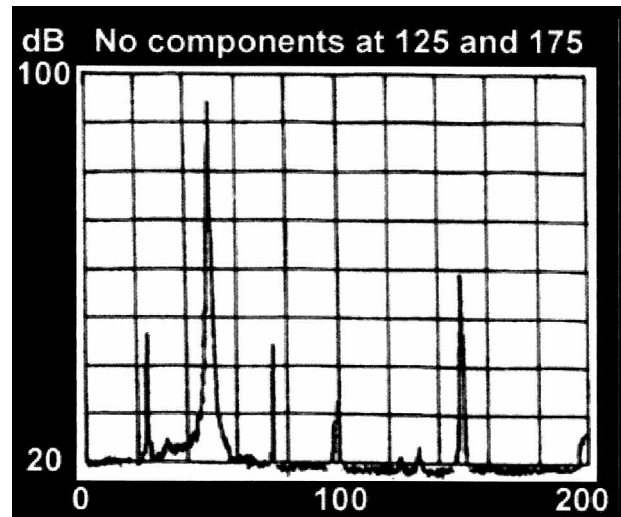
Results from an 11 kW, 415/420 V, 20.5 A, 1440 rpm, 50 Hz, SCIM, delta connected motor are now reported. The stator winding was a three tier concentric winding with random wound coils in 36 slots. There were two coils per group, four groups per phase, and each group had coils of 15 and 30 turns, respectively, giving 180 turns per phase. Figures 20 and 21 show the current spectra with no fault and the case with actual shorted turns. The components that are clearly indicative of shorted turns under no-load are 125 Hz and 175 Hz, as per Equation (6), with  $k = 1$ ,  $n = 3$ , and  $k = 1$ ,  $n = 5$ . Note that the components at 25 Hz and 75 Hz are present under normal operation (the  $\pm$  rotational speed frequency components) and cannot be used as indicators of shorted turns even

although they are predicted from Equation (6). There are no current components at 125 and 175 Hz (no-load slip is approximately zero for Equation (6)) with no stator fault, but they are very evident at 56.6 and 42.3 dB, respectively, in the case with direct shorted turns. Thomson (2001) has shown that these components could also be detected at 27.7 and 23.6 dB, respectively, with one shorted turn via a current limiting resistor to avoid initial burnout.

Figure 20. Current Spectrum—Healthy Stator.

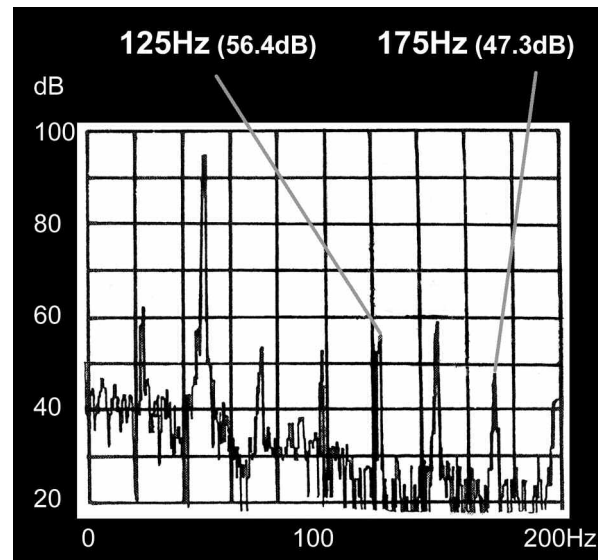
Figure 21. Current Spectrum—Shorted Turns.

Figure 22 shows the faulty stator winding. This demonstrates that these two components are good indicators for detecting shorted turns in four-pole SCIMs with random wound, concentric coils. Note that these components will change in frequency as a function of load and speed, as reported by Thomson (2001). Note that a continuous MCSA system must be used to detect shorted turns.
