RECYCLE GAS COMPRESSOR DESIGNED FOR HIGH UNBALANCE TOLERANCE AND STABILITY

Stephen R. Locke

Wolfgang Faller

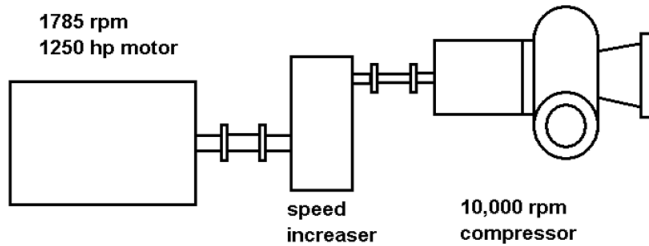
A single-stage overhung compressor is driven by an induction motor through double helical gears and mounted on a base frame via a bearing pedestal (Figure 1, motor not shown). The oil system is integrated on the base frame (Figure 2, serves also as oil

Figure 1. Compressor Configuration.

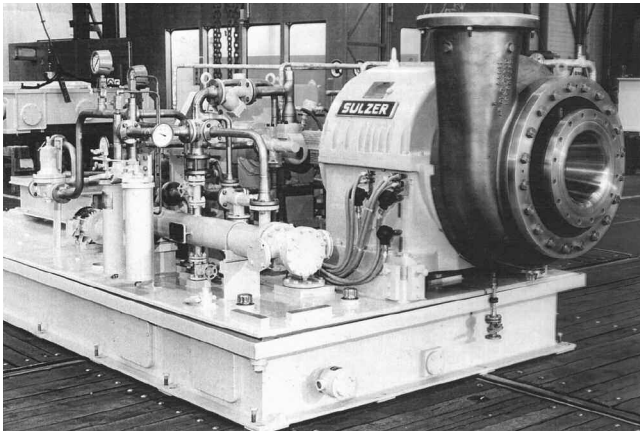
Figure 2. Compressor on Base Frame.

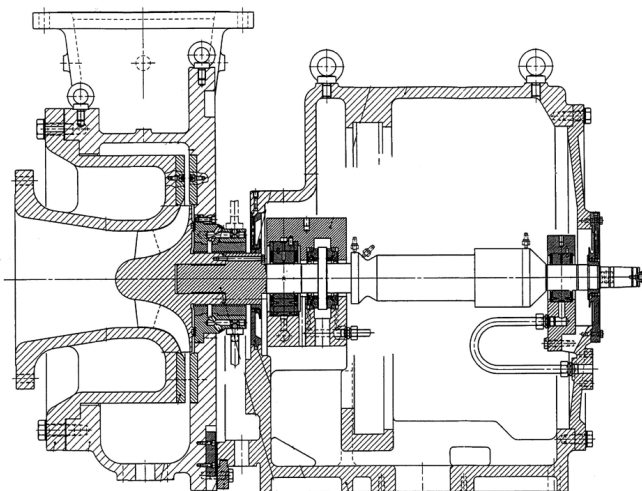
In order to meet the customer's requirements, a custom compressor design was conducted, adapting only a few existing components within the manufacturer's line of integral gear compressors. Figure 3 gives a cut view through the compressor with its bearing pedestal. The main challenges of this project were linked to the nature of the compressed medium as well as to the known extreme operating conditions linked to the process. A number of design features linked to the medium are noted below. The other rationale driving this design is linked to the rotordynamic behavior of the machine under all operating conditions.

Figure 3. Longitudinal Cut Through Compressor.

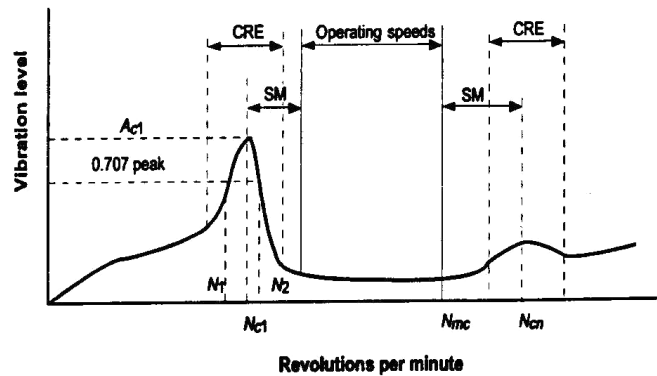
Overhung compressors (i.e., compressor impellers are located outside the bearings) are widely used in various industries—API 672-type (1996) machines for air compressors have been used for many years. Recently, applications in the process industry can cite API 617 (2002) in its newest edition where these machines are addressed specifically. The basic design principles are well understood. Operation above certain critical speeds is common and usually leads to a very smooth running behavior. During startup and coastdown, the existence of these critical speeds is usually noticeable through the vibration monitoring equipment. The observed peak vibratory displacement (Figure 4) is linked to the general balance condition of the rotor and the so-called amplification factor. For well-balanced rotors, even a large amplification factor can be tolerated. However, this feature can lead to rather undesirable situations if the balance condition changes during normal operation—and changes are usually deteriorations. Even if the vibratory level at operating speed has increased but is not critical, it will mean almost certain destruction of vital machine components when the machine is shut down and has to pass through the amplification factor region while coasting down.

Figure 4. Vibration Amplitude Versus Speed. (Courtesy API 617, 2002)

A solution to this dilemma is obviously to design a machine that exhibits no noticeable amplification factor.

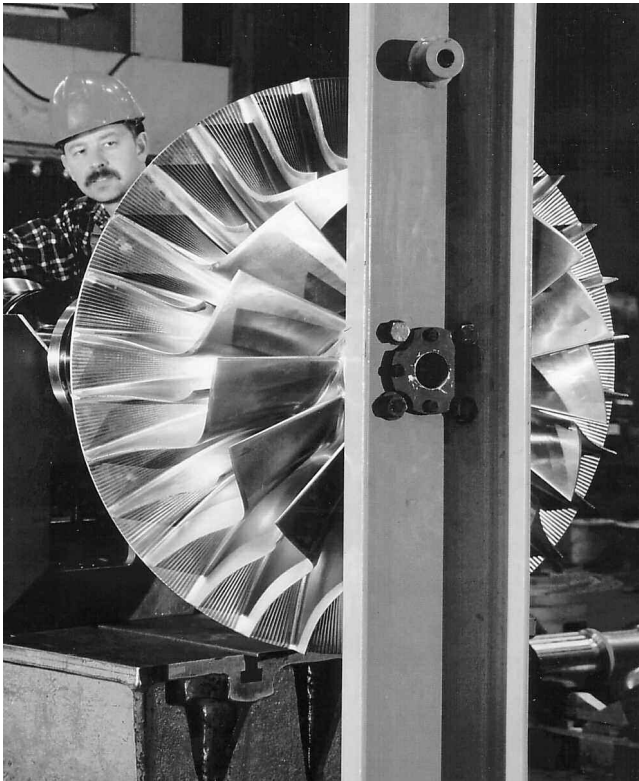
Figure 5. Radial Discharge Impeller.

Contrary to many other designs, this machine was not primarily optimized for aerodynamic performance but for reliability and robustness. The customer specifically advised radial discharge blades for the impeller, vaneless diffusers, and a volute designed for minimal dead spaces, which might lead to the accumulation of dust. Subsequently, an existing zero-backsweep impeller (Figure 5) was adapted by increasing the blade thickness to provide more material against the abrasive nature of the process. The effect on flow capacity due to the blade thickness increase was estimated and compensated for by an increase in blade height. This change was checked during the shop test—it turned out that the compensation was adequate, so no remachining of the impeller contour was found to be necessary.

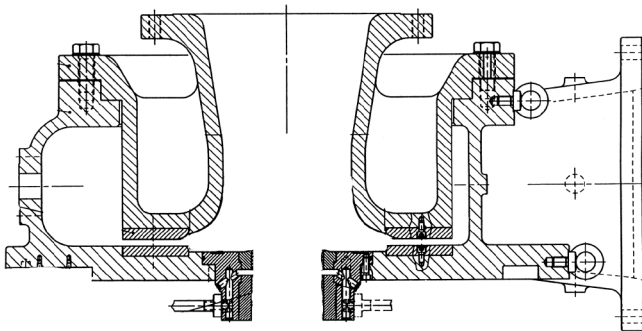
The volute was developed to provide a simple flow collecting space without the usual emphasis on optimum aerodynamic performance. During outages, the unit is washed off-line by water injection regularly (Figure 7), therefore it was imperative to avoid any dead spaces that might lead to accumulation of dust and/or fluids with increased potential for chemical activity.

Figure 7. Volute and Seal Cartridge.

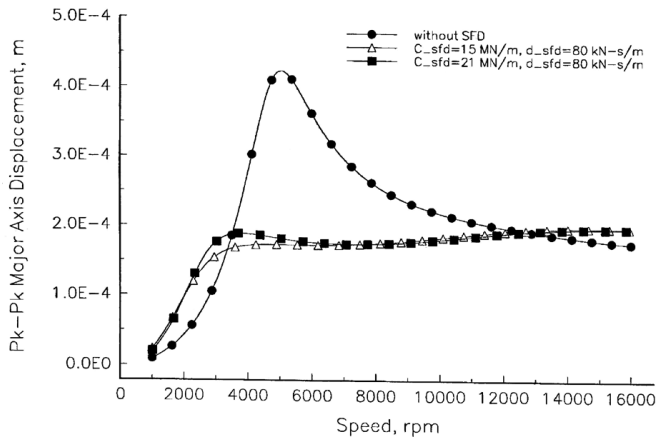
Figure 8. Predicted Vibration Characteristics with and without Squeeze Film Damper.

As has been noted above, the suppression of the amplification factor is a necessary feature for this application. As with all resonance phenomena, damping is crucial to achieve this. While the hydrodynamic bearings provide a certain amount of damping, it is not sufficient for this application. Additional damping can be provided by squeeze film dampers (Zeidan, 1995). These dampers can be incorporated in the bearing body design. Together with springs that provide for centering of the bearing under the rotor weight (static displacement), the system’s rotordynamic characteristics can be tailored to achieve the desired shape (Figure 8). The remainder of the bearing system employed usual components: four-pad flexure pivot pad journal bearings for the radial bearings, eight-pad tilting pad axial bearings arranged around a thrust collar. The oil quality is specified for ISO VG 32. Figure 9 gives a cut through the bearing with integrated squeeze film damper; Figure 10 shows one half of the bearing. Note the spring elements connecting the outer and inner bearing body. The bearing is of the “closed” design (flood-lubricated with labyrinths on both sides limiting the oil release). Total containment of the squeeze film inside the labyrinths eliminates the need for piston rings or O-rings that often prove troublesome for reliable squeeze film applications. The impeller end bearing stiffness and damping characteristics are shown in Figures 11 and 12, and the resulting rotorbearing system critical speed map is shown in Figure 13.

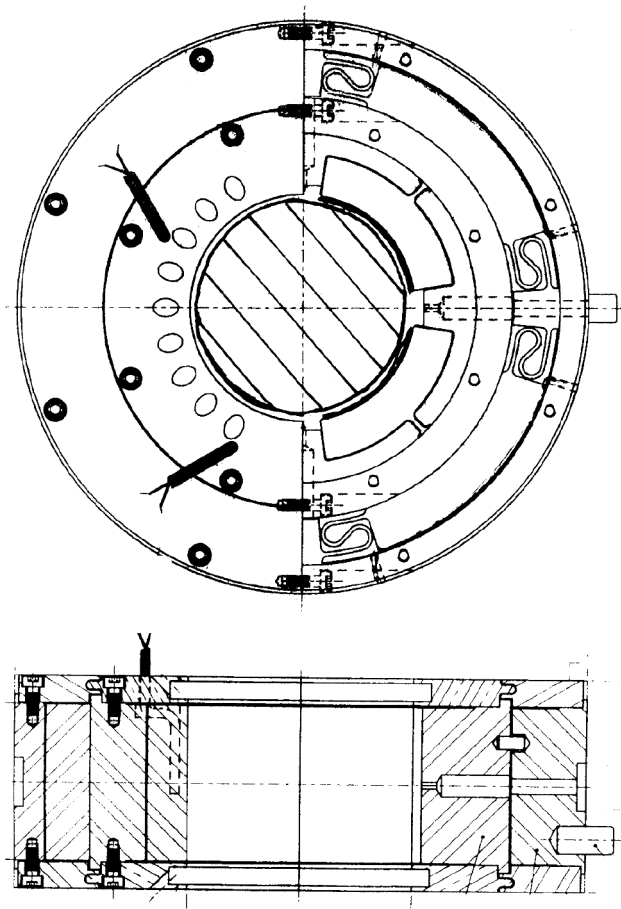
Figure 9. Bearing with Integrated Squeeze Film Damper.

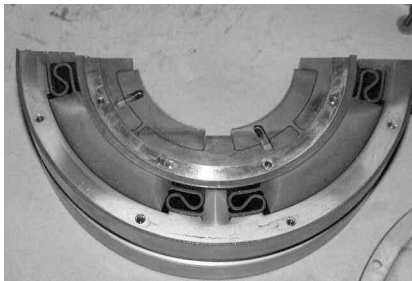
Figure 10. Bearing Half.

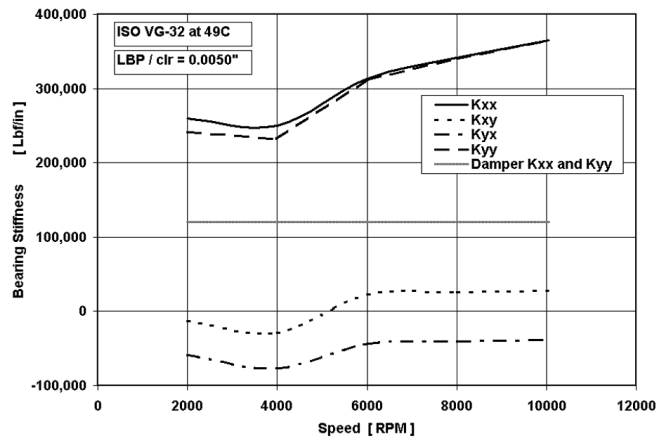
Figure 11. Impeller End Bearing Stiffness.

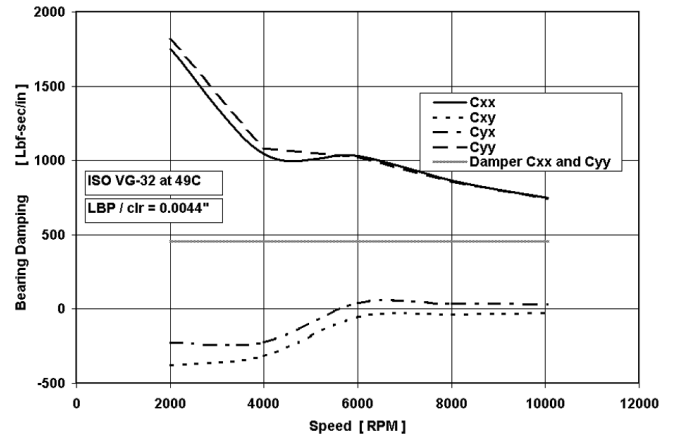
Figure 12. Impeller End Bearing Damping.

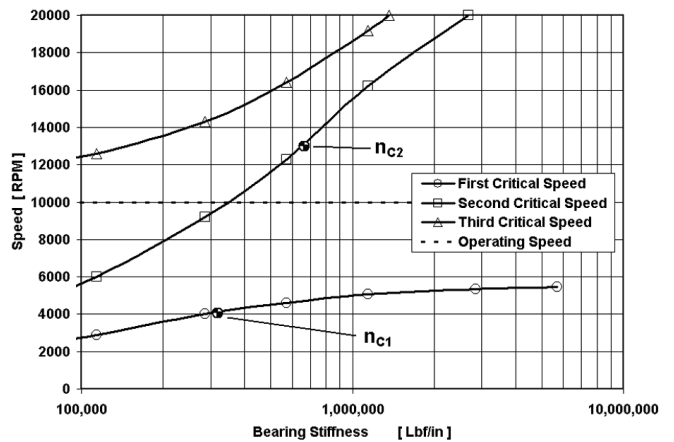
Figure 13. Rotorbearing Critical Speed Map.

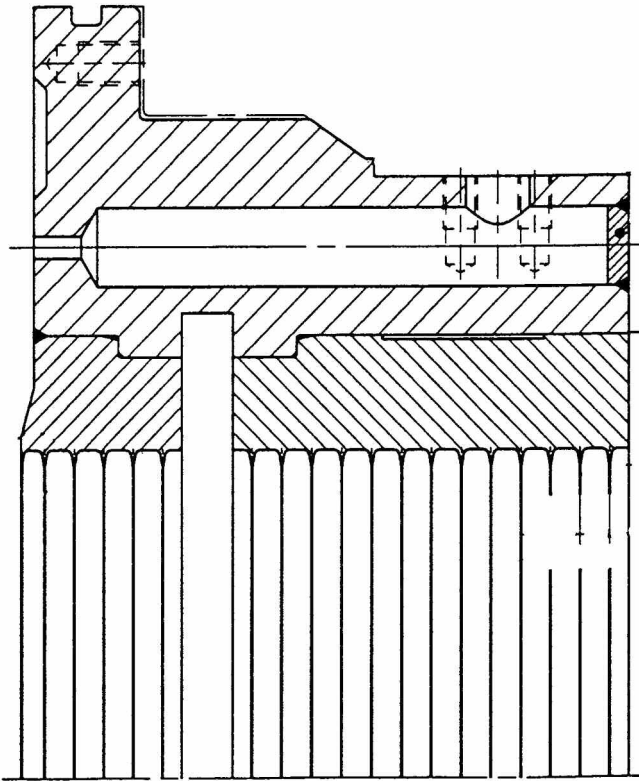
The seal design had to address the media requirements, which require positive process separation from the environment as well as from the low alloy, steel components of the shaft. Due to the bearing concept, the chosen rotor system with relatively large static deflections leads to large clearances. To top this off, the seal must be operational during washing in standstill without contamination of the environment. Figure 14 indicates the chosen configuration: nitrogen is introduced as a purge into a single chamber. The stationary labyrinths are cut out of a nickel-base alloy insert. A jet connected to an external water line allows in situ washing of the backface of the impeller (during standstill). Drain lines both in the

Figure 14. Seal Details.

low point of the purge chamber as well as in the low points of the labyrinth area closest to the impeller backface allow defined removal of excess water and their liquid reaction products. The seal system is augmented by a nitrogen feed line, a water line for washing, and a drain line together with the necessary valving.

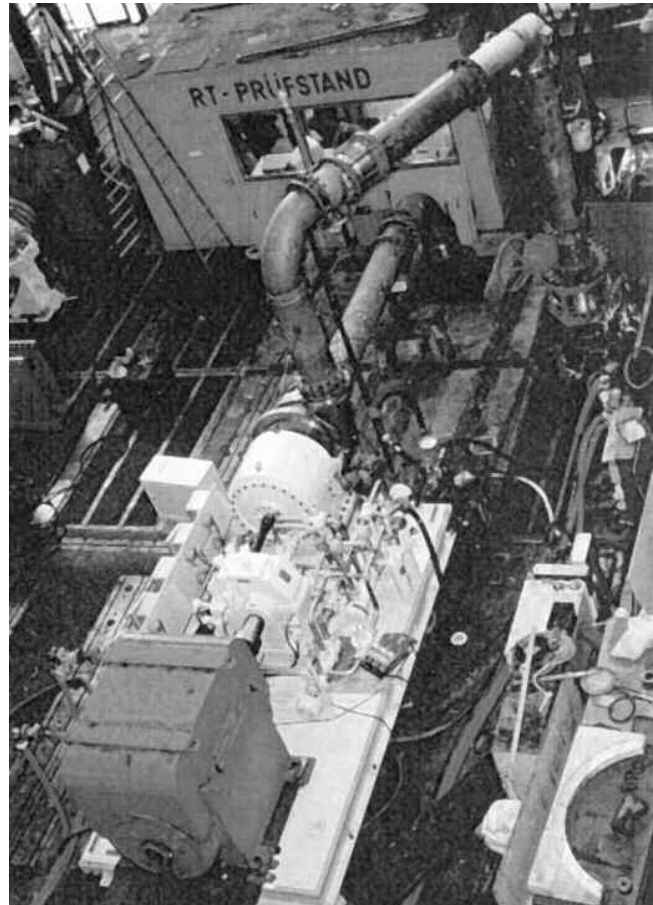
Obviously, the most important result of the shop test (Figure 15) outside the usual topics was the behavior of the squeeze film damper bearings. After the normal balance condition was tested, additional unbalance weights of 4000 gmm (gram-millimeters) were attached to the balancing groove. This unbalance corresponds

Figure 15. Shop Test Setup.

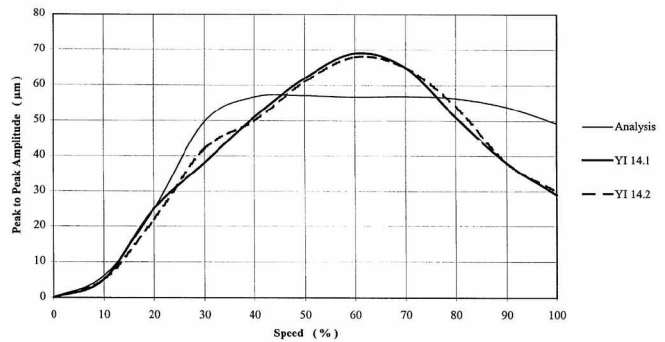
to deterioration by a factor of more than 10 with respect to the normal balance quality. As can be seen in Figure 16, the desired characteristic was not quite reached: the rotor does exhibit a range of speeds below the operating speed with a significantly increased vibration level. A subsequent check of base frame vibratory interaction did not reveal any obvious contribution to these observations. A numerical study conducted afterward in order to simulate the observed behavior led to the postulation of an effective damping coefficient of the squeeze film damper of about four times the design value. The location of the critical speed (was predicted at 40 percent of operating speed but was actually just below 60 percent as observed by phase shift during test) also leaves some open questions with the current ability to accurately predict characteristics of such combined configurations. For the actual application, however, the results were satisfying as the actual damping capability of the rotor was almost as predicted (the maximum vibrations were about 10 percent above the predictions). Due to the larger than expected differences in vibration level at operating speed (significantly lower than predicted), the alarm and shutdown levels for the operating speed regime had to be adjusted accordingly.

Figure 16. Measured Vibration Characteristics with 4000 GMM Unbalance.

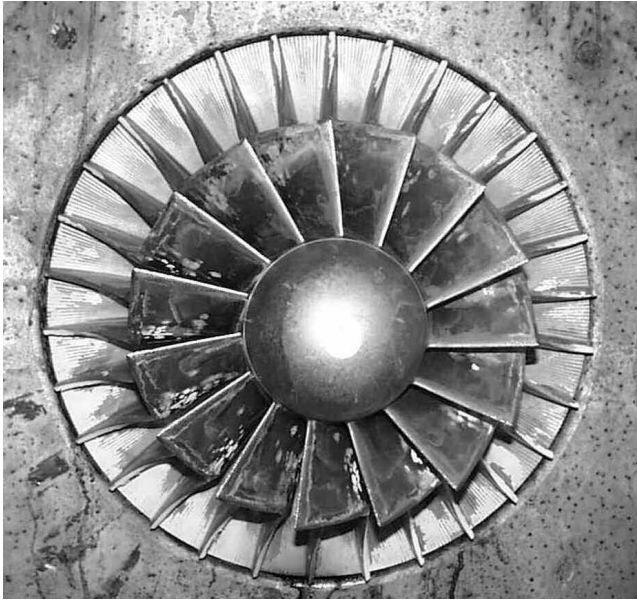
Figure 17. Impeller after Washing—Impeller Still in Good Condition.

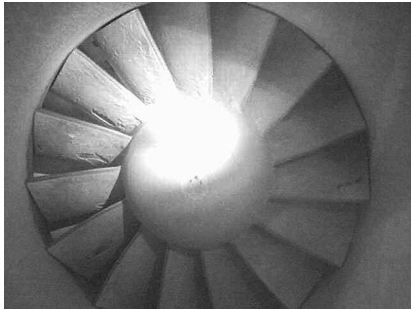
Buildups on the impeller routinely occur in this line, and the rotor and squeeze film damper bearing design has been proven in tolerating the routine buildups much better than a similar single-stage machine on another process line. The normal buildups do not cause any significant wear on impeller and stationary parts. Although the buildups sometimes cause vibration to go over one mil on this 10,000 rpm rotor, the squeeze film damper absorbs the energy sufficiently to avoid excessive bearing temperatures and allows operation to continue until the rotor and casing can be cleaned during scheduled outages.

Figure 18. Normal Dirt Buildups on Impeller—Vibration Can Move Up and Down Somewhat Depending on How Dirt Sheds. Impeller Still in Good Shape Here.

Buildups shown above (Figure 18) are normal for this process and the rotorbearing system tolerated the unbalance very well for three years with little erosion. The high quality filtration upstream of the compressor is normally very reliable in this process. For example, one production line has had over 10 years of operation without major impeller damage.

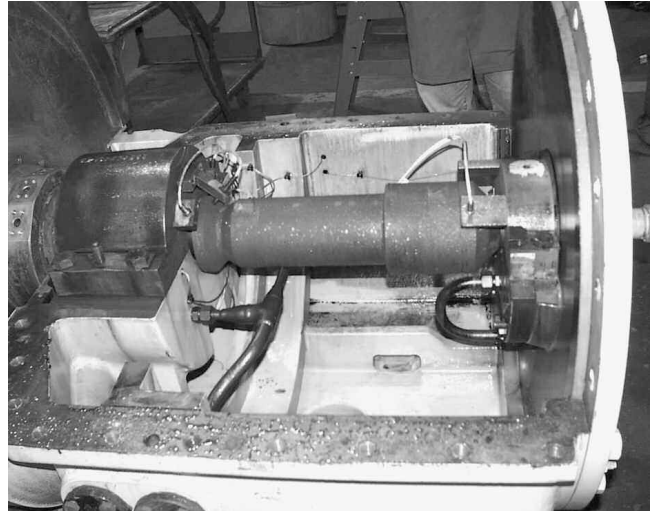
operation, it became apparent that we were getting backflow of process material into the lube oil system during machine shutdowns via the nitrogen purge gas line. Although the process labyrinth seal and the bearing labyrinth seals were fed from the nitrogen header through different regulators, operator valving error and inability to completely deinventory the process piping conspired to create the backflow from the process labyrinth seal into the bearing labyrinths (Figures 19, 20, and 21). This caused rapid, severe corrosion damage to the bearings, shafts, and gears, and several changes were required to prevent contamination:

Figure 19. Corrosion Due to Oil Wetted Side Contamination—Oil Was Contaminated by Process Backflow from Process Shaft Labyrinth Seal into Bearing Labyrinth Nitrogen Purge System.

- A valve configuration changed to adequately deinventory the process
- Added a check valve to the purge gas feed to the process shaft laby seal
- Removed the handle from a valve to prevent use in normal operation
- Converted from one common header for the bearing labyrinth purges to individual regulators

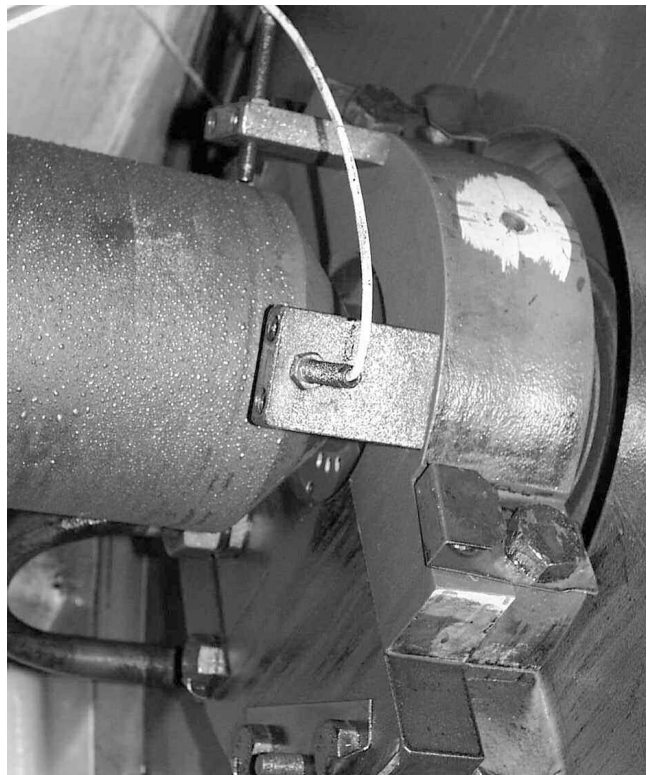
Figure 20. Corrosion Due to Oil Wetted Side Contamination—Note Heavy Scale on Steel Parts.

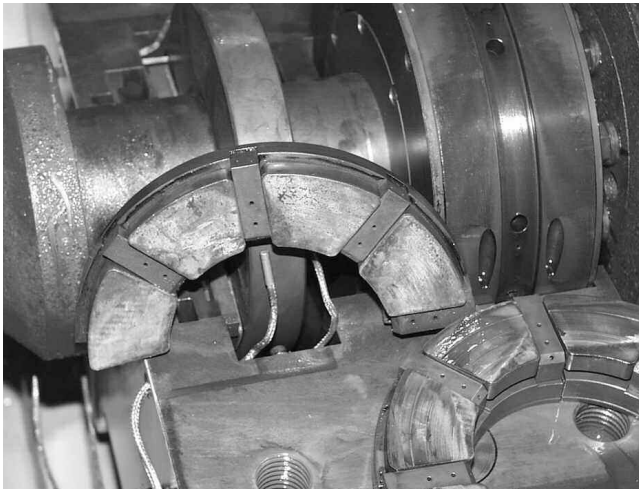
Figure 21. Thrust Bearing Heavy Babbitt Corrosion Due to Oil Contamination.

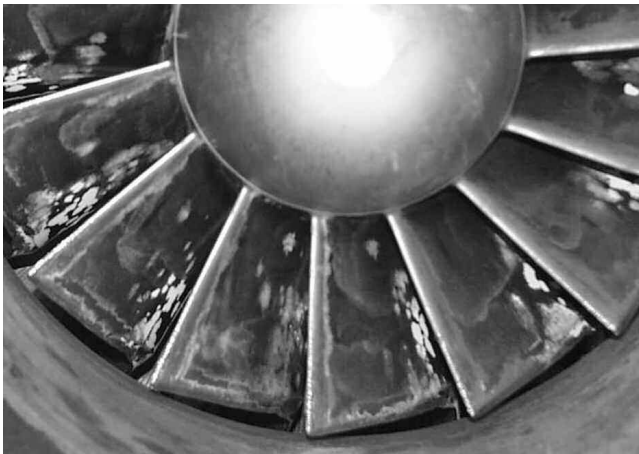
Figure 22. Impeller Inducer Just after Cleaning, but before Heavy Erosion.

While infrequent, when the upstream filtration fails, impeller damage is rapid and severe. Based on washing inspections, the extraordinary erosion damage shown here took place in just 10 days. Contrast the end view of the normal impeller appearance (Figure 22) with the severely eroded impeller (Figures 23, 24, and 25). Repairs were extensive enough to require complete replacement of most of the blade material (Figures 26 and 27). This happened twice to this compressor in 2002, yet despite the huge amount of wear on the impeller, the compressor was able to run below interlock vibration and temperature levels until scheduled outages for this product line. Fortunately a complete spare casing was ready to install for each of these major events.

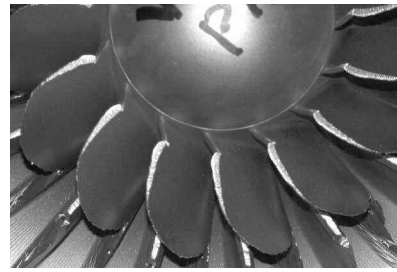
Figure 23. Impeller Inducer after 10 Days of Heavy Erosion.

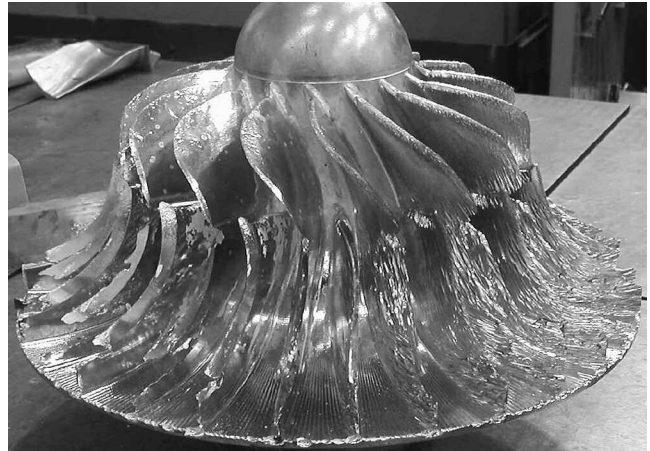
Figure 24. Impeller Side View—after Heavy Erosion Damage.

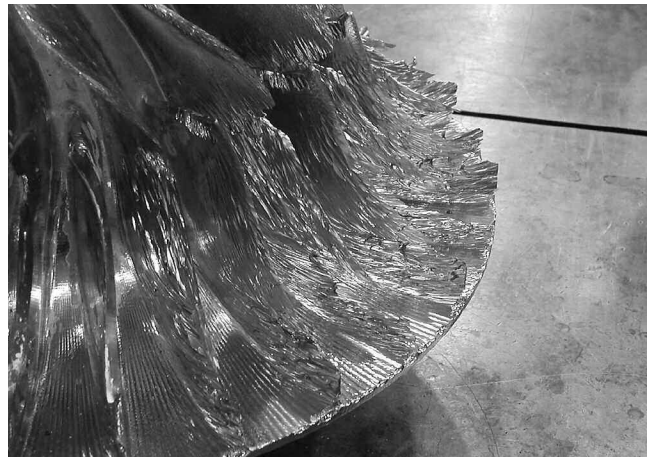
Figure 25. Impeller Closeup View—after Heavy Erosion Damage.

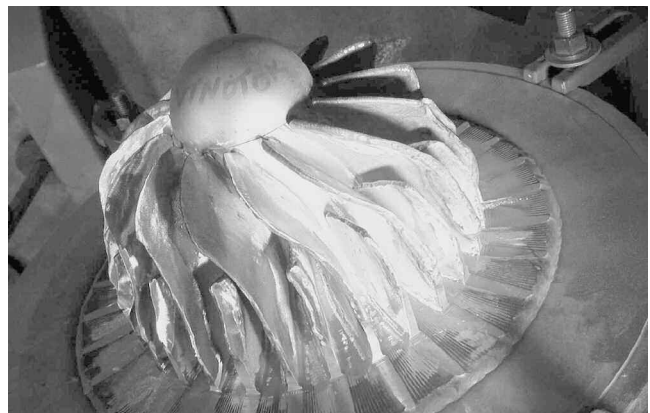
Figure 26. Impeller in Repair via Coupon Method.

The diffusers also suffered heavy erosion (Figure 28). Although the impeller and casing repair were quite expensive, one round of bag filter replacements actually costs more than a new impeller. The impeller repair costs were essentially equal to the cost of a new rotor, but much faster than the time to fabricate a new rotor. While repair costs were very high, the production lines were sold out on both occasions and running until scheduled outages maximized the production.

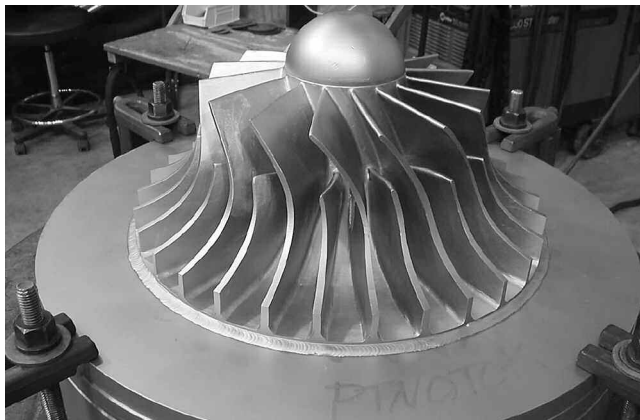
Figure 27. Nearly Finished Repaired Impeller.

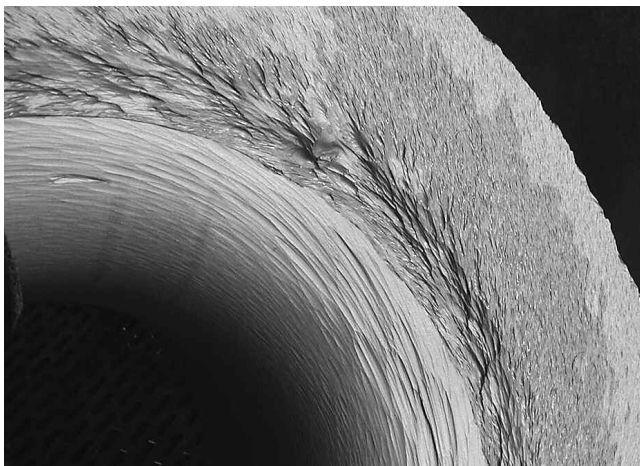
Figure 28. Diffuser Erosion Damage.
