# TROUBLESHOOTING TURBINE STEAM PATH DAMAGE MECHANISMS

**Thomas H. McCloskey**

**APTECH Engineering Services, Inc.**

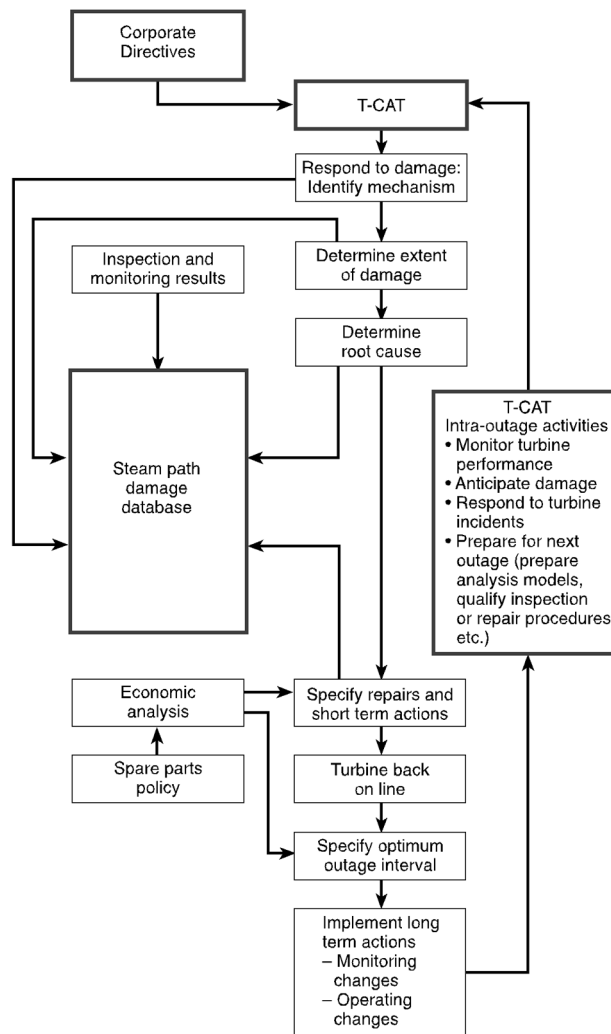
Figure 3. Steam Turbine Root Failure Cause Analysis Flowchart.

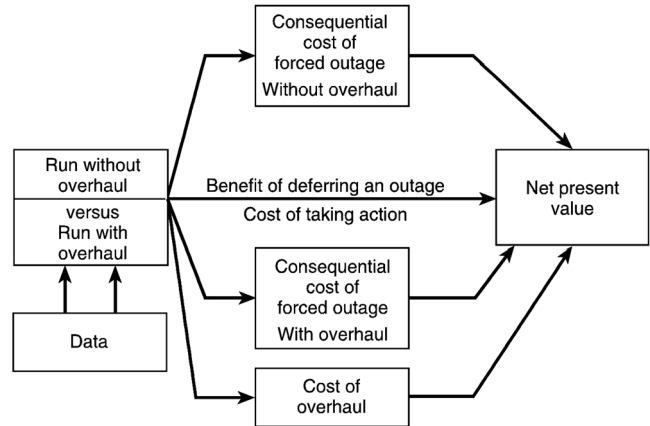
Figure 5. Determination of Net Present Value as Function of Scheduled Versus Forced Outages.

The calculation of net present value will be constrained by maintenance budget and forced outage rate limit. Figure 5 indicates schematically the analytical methodology of this level of analysis. Using such an approach, a net present value curve is calculated by analysis; however, choice of outage interval is further constrained by limits on the probability of failure.

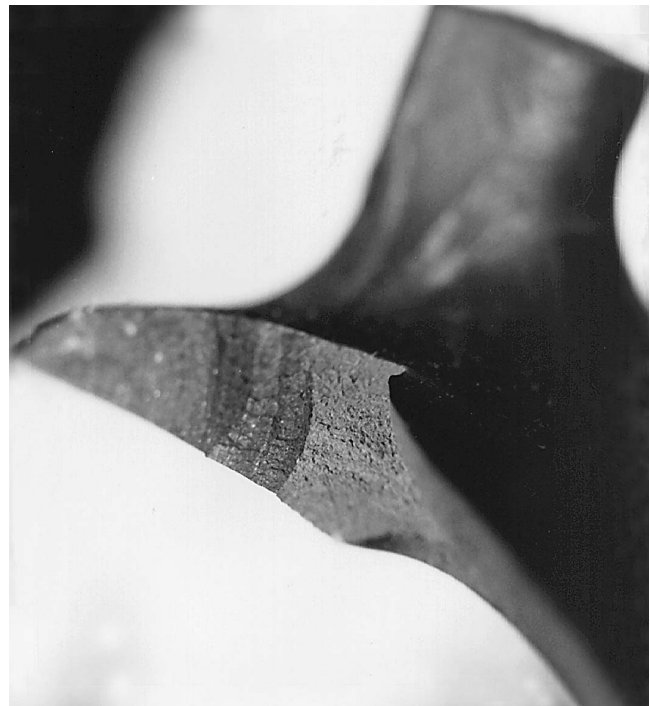
Figure 6. Combination of Pitting, Corrosion Fatigue, High Cycle Fatigue in Low Pressure Blade Airfoil Section.

Figures 6 and 7 are typical generic examples of the diagnosis of cracking and damage of blades in the LP turbines of fossil and nuclear units. APPENDIX A Figure A-5 provides screening questions to direct an investigator to quickly determine the most probable damage mechanism. Then, in the relevant chapter(s) of McCloskey, et al. (1999), the investigator will find additional means to confirm the initial diagnosis.

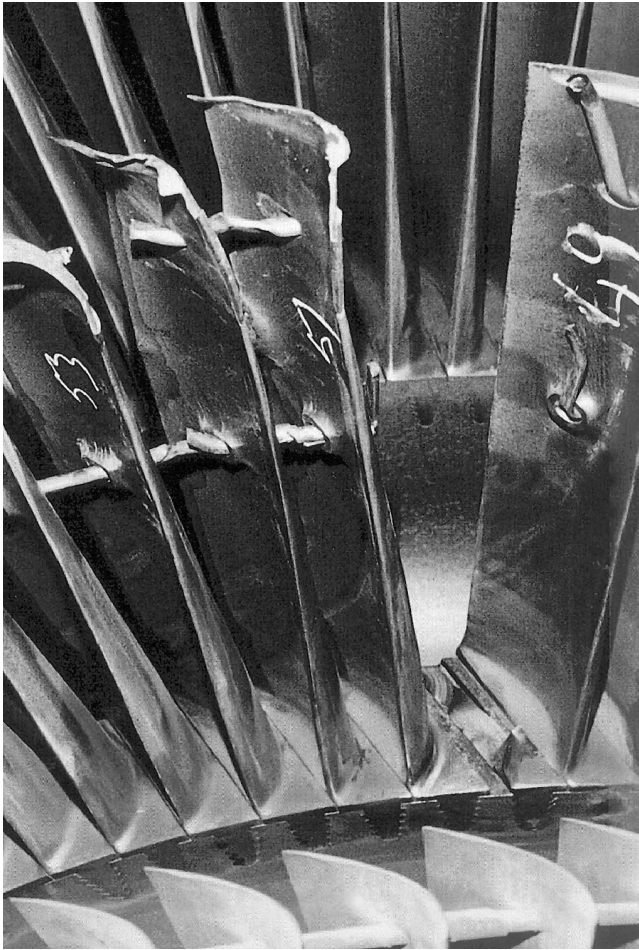
Figure 9. L-1 (Next to Last) Stage Blade Failure at Base of Airfoil Due to Low Cycle Fatigue.

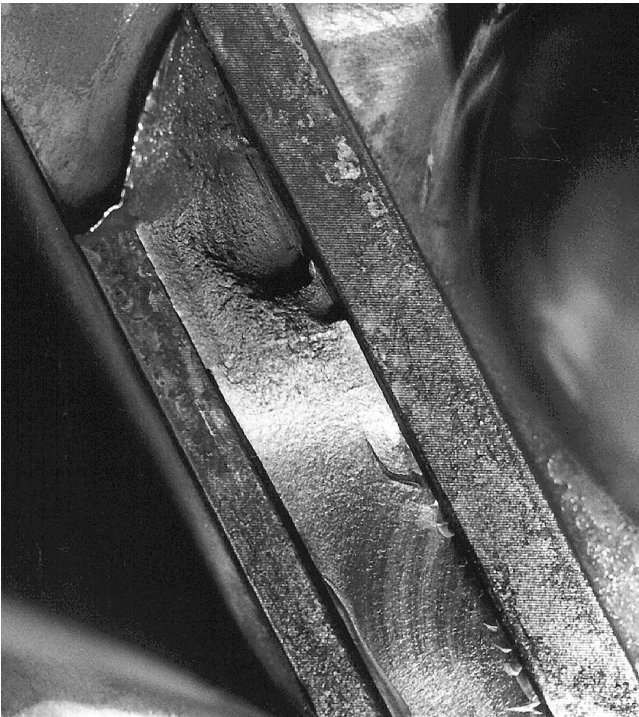
Figure 10. Closeup of Low Cycle Fatigue Failure Shown in Figure 9.

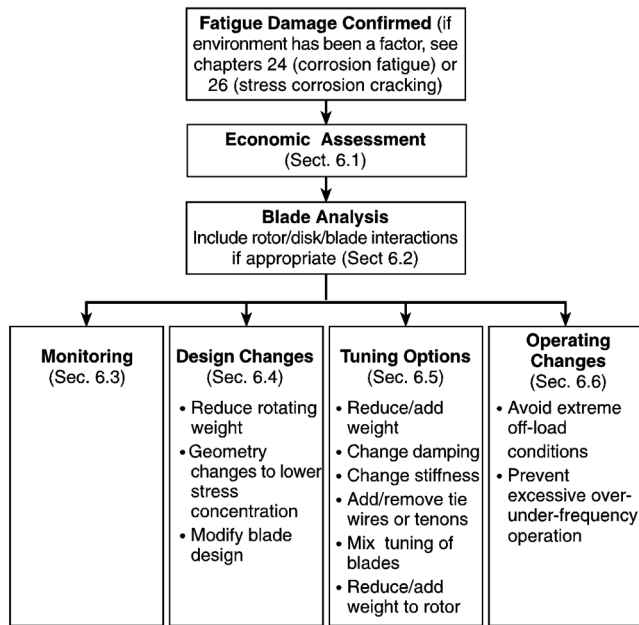
Shaded boxes indicate those which an owner will typically be able to execute; unshaded boxes may require outside assistance from OEM or consultant.

Figure 16 provides a generic list of options for addressing fatigue failures in LP turbine blades. The shaded boxes indicate those steps or options that can typically be executed by a user; the others may require outside assistance. It is important that the underlying loading problem be clearly identified so that the proper choice of preventive action can be taken. An economic evaluation of the various options should be the first step in the process.

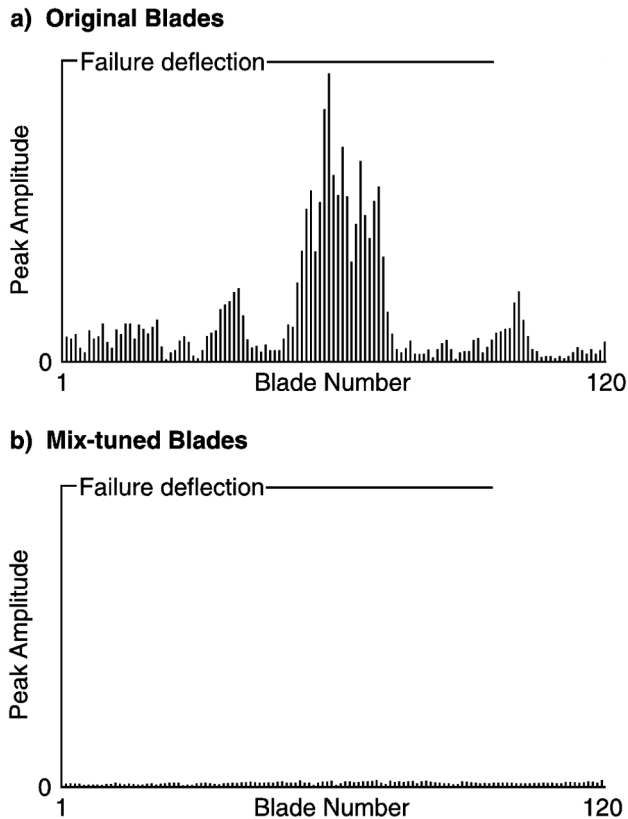
Figure 19. Comparison of Original and Mixed Tuned Rotating Blade Vibration Amplitudes to Reduced HCF Failures from Unstalled Flutter.

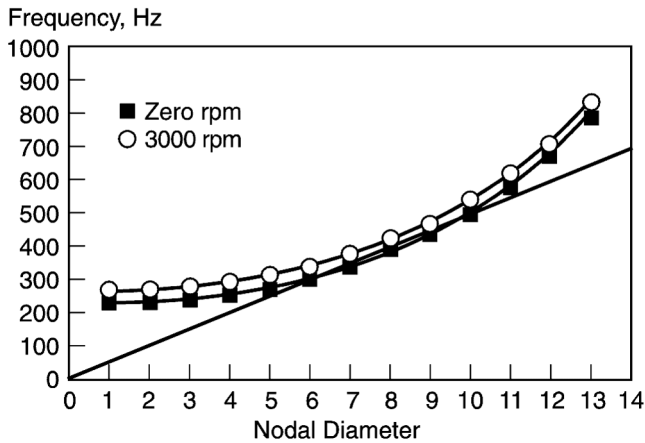
**Interference Diagram: L-2 Blade Row**  
 Predicted: Zero RPM and 3000 RPM

Figure 21. Axial Mode Natural Frequencies and Nodal Diameters in Interferenced Diagram Format.

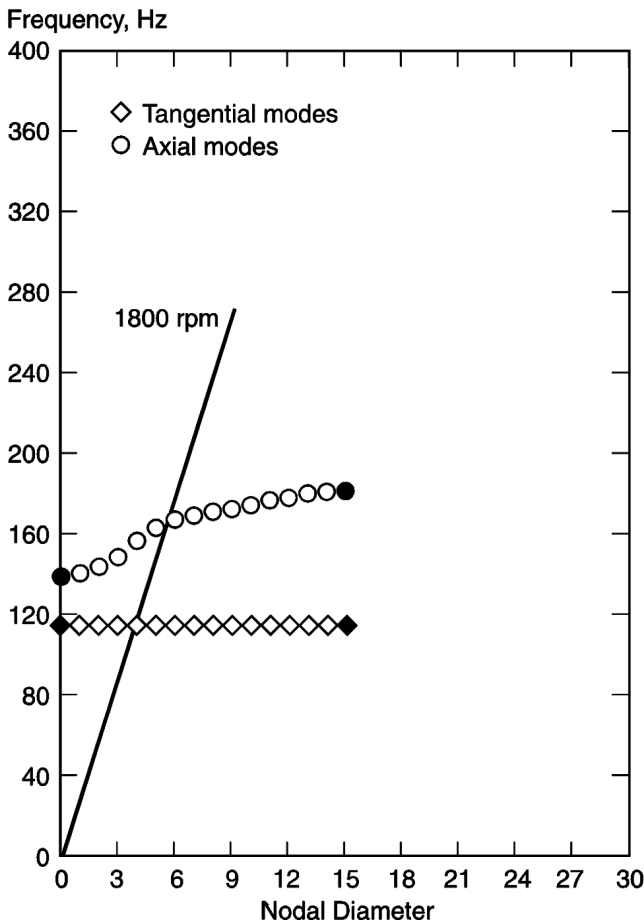
Figure 24. Interference Diagram for Six Blade Group Operating at 1800 RPM (30 Hz) for Case Study II.

*Modal Analysis and Testing Results.* An interference diagram for the six blade group is shown in Figure 24. Wherever the 1800 rpm constant speed line crosses a set of nodal diameter modes, a resonant condition is possible. In the six blade group, as shown in Figure 24, this occurs near the fourth nodal diameter of the first tangential mode set, suggesting that this harmonic may have been the cause of the L-1 blade failures. This conclusion is supported by the observation that tangential mode vibration produces high stresses at the location of observed cracking and that the crack propagation was clearly indicative of tangential mode vibration. The Campbell diagram would not have identified the potential resonance since it does not include disc effects or the relation between nodal diameter and per-rev excitation. Although, as shown in Figure 25, the Campbell diagram does indicate the possibility of resonance at 120 and 180 Hz with the second and third modes of vibration, respectively.

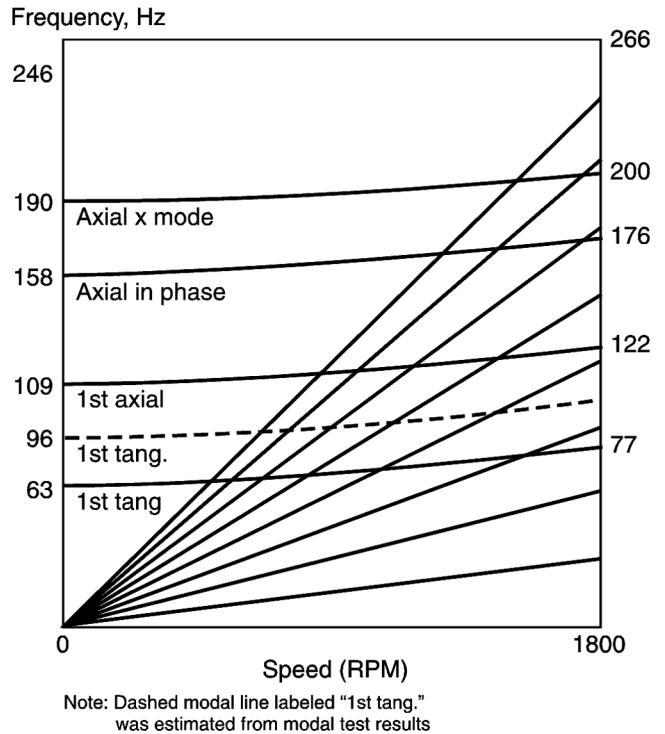
Figure 25. Campbell Diagram of Six Blade Group Indicating Tangential and Axial Modes of Vibration.

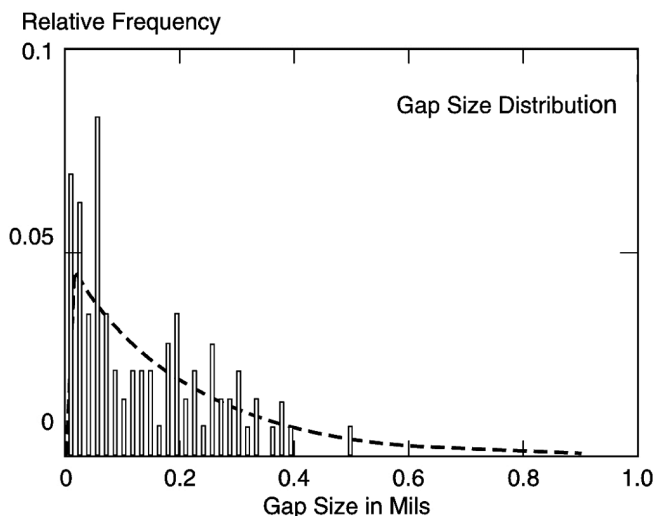
Figure 26. Statistical Distribution of Gap Sizes for Root Attachment in Case Study III.

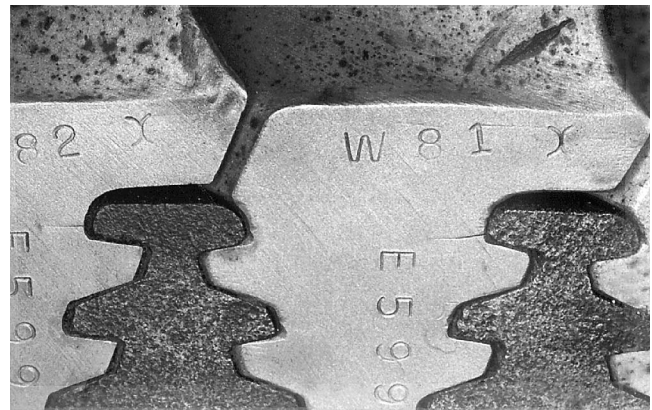
Figure 27. Corrosion Fatigue in L-1 Blade. (Crack initiation and propagation can be seen in first hook (serration) of two blade roots shown.)

Figure 27 shows developing corrosion fatigue cracks originating from the roots of two adjacent L-1 blades. Figure 28 shows another location in the same row in which a final overload and completed fracture have occurred just below the platform after initiation from the first hook. Corrosion fatigue and SCC occur under similar circumstances and may coexist on the same fracture.

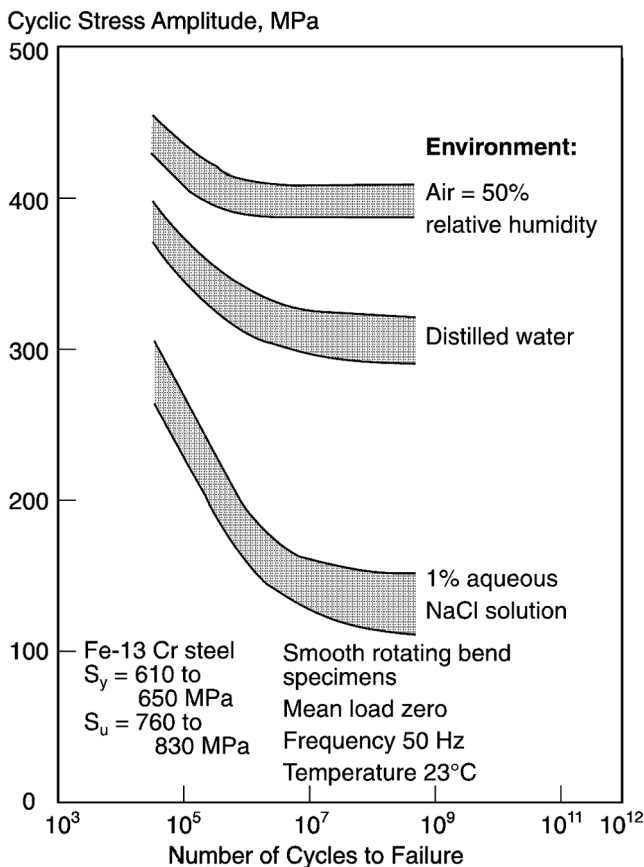
Figure 31. Corrosion Fatigue Curves of Smooth Specimens of 13 Percent Chromium SS, Exposed to Different Steam and Water Chemistry Environments.

Figure 31 shows how environment affects the fatigue behavior of a 13 Cr steel (AISI Type 403) on smooth specimens. Figure 31 is typical of a wide range of materials. There is an obvious decrease in the cyclic stress amplitude needed to cause failure (termed the corrosion fatigue strength) for a given number of cycles,  $N$ , with worsening environment.

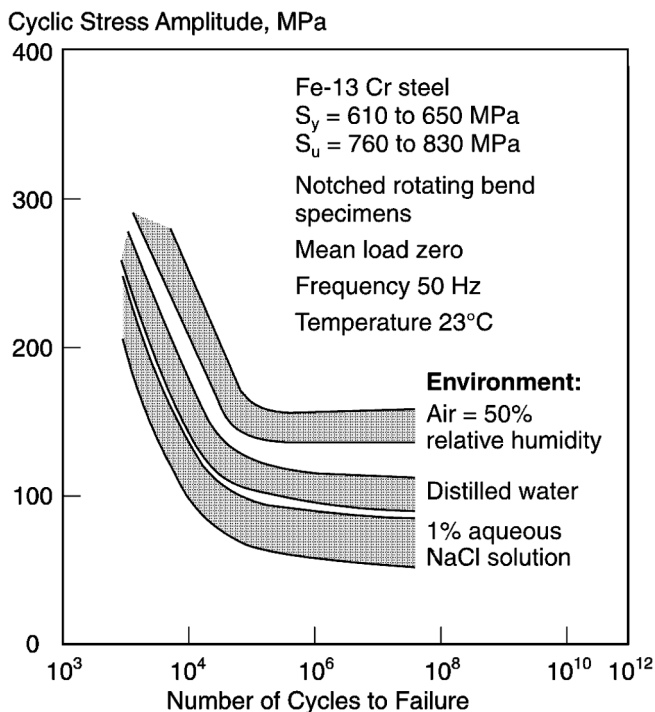
Figure 32. Corrosion Fatigue Curves of Notched Specimens of 13 Percent Chromium SS, Exposed to Different Steam and Water Chemistry Environments.

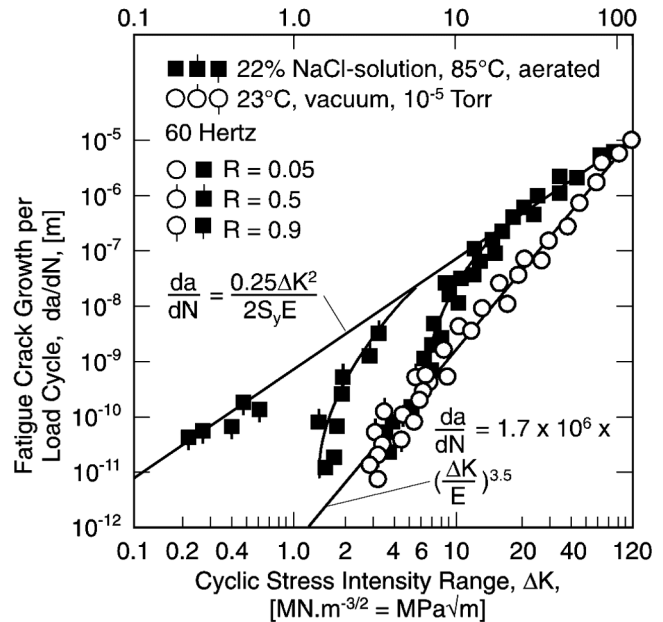
Figure 34. Growth Rate of Fatigue Cracks in 12 Percent Chromium SS as Function of Steam and Water Chemistry, and Cyclic Stress Intensity Range.

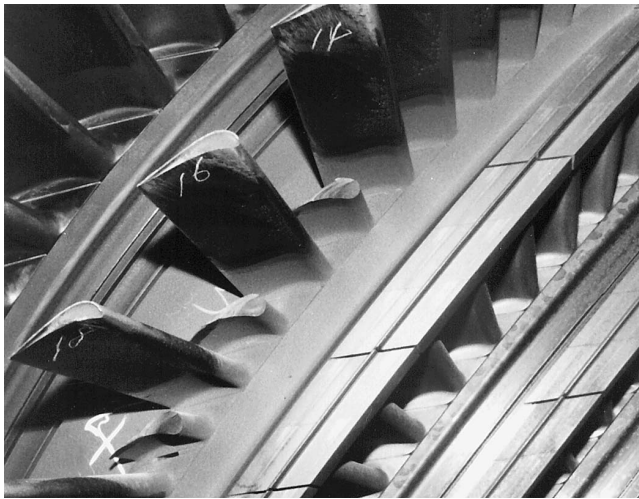
Figure 43. Five Broken Freestanding L-2 Blades Broken Off at location of Phase Transition Zone.

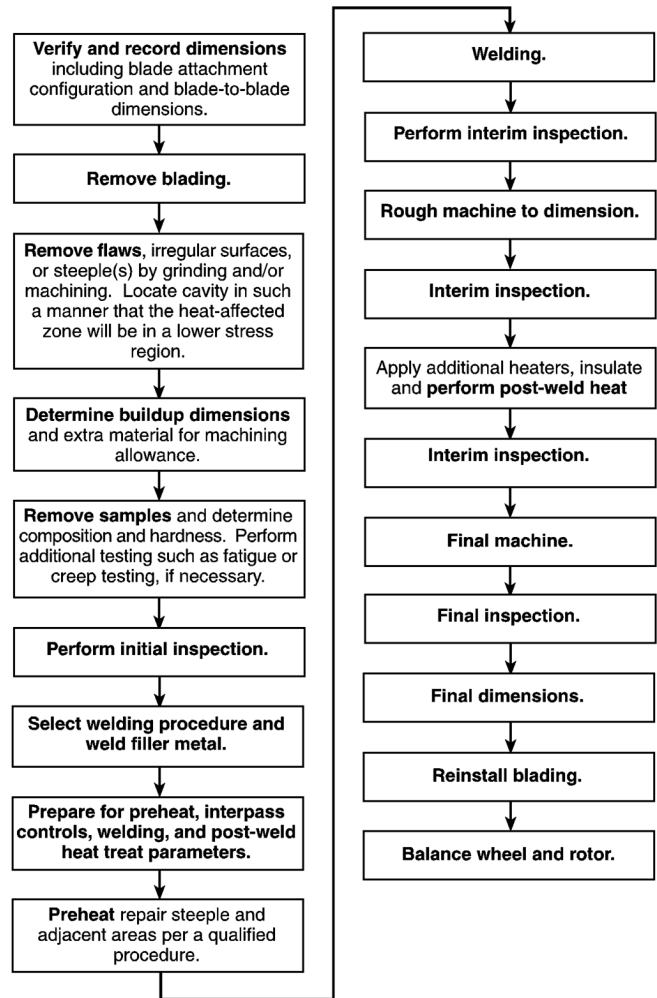
Figure 49. Roadmap of Turbine Disc/Rotor Weld Repair.

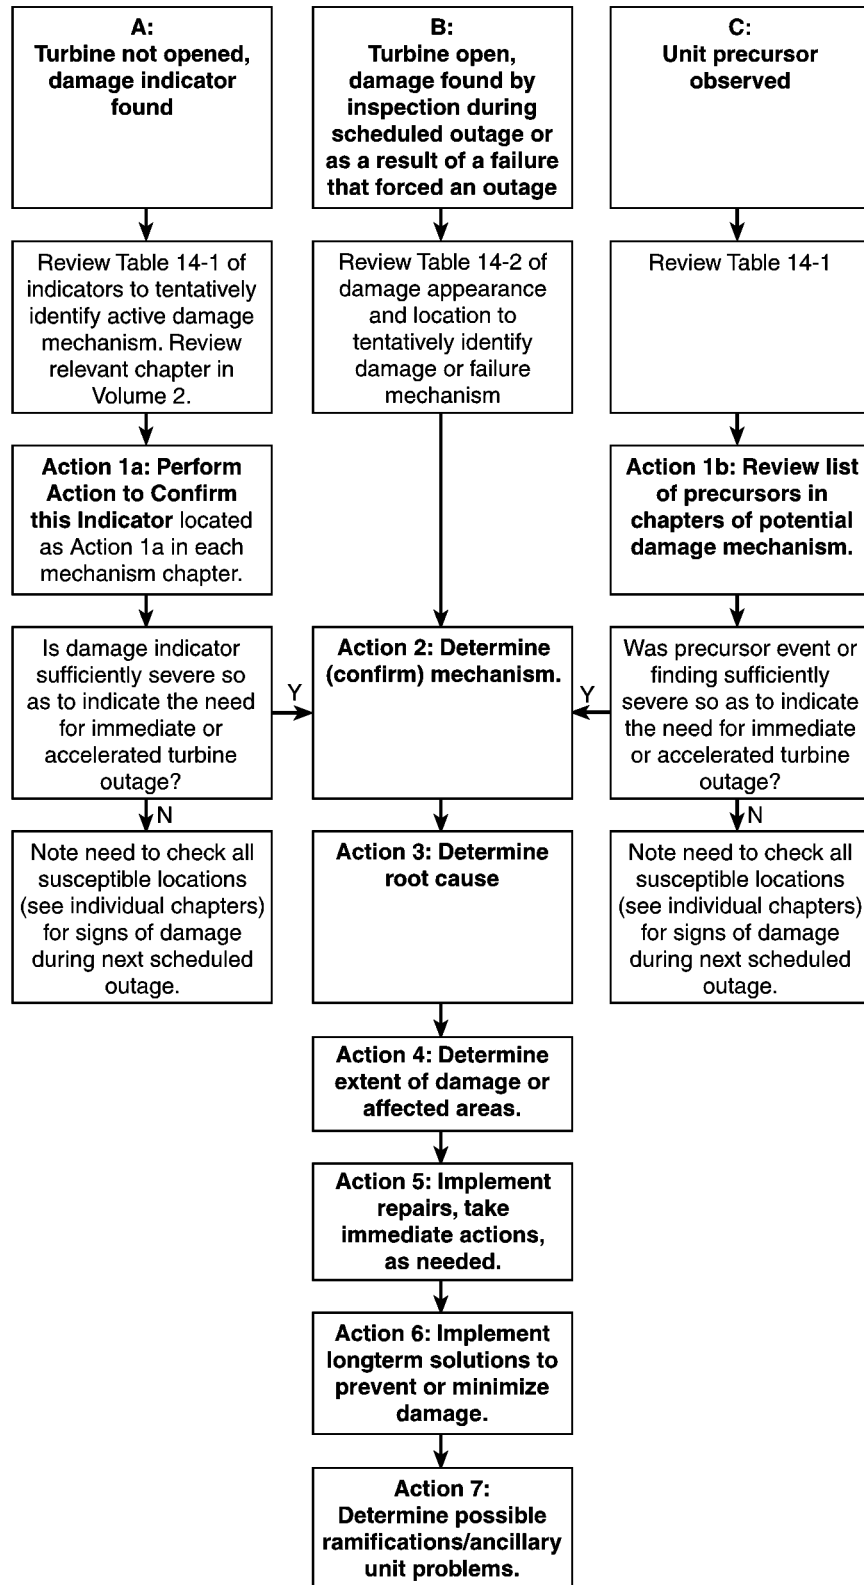
Figure A-4. Turbine Steam Path Damage Investigation Flowchart.

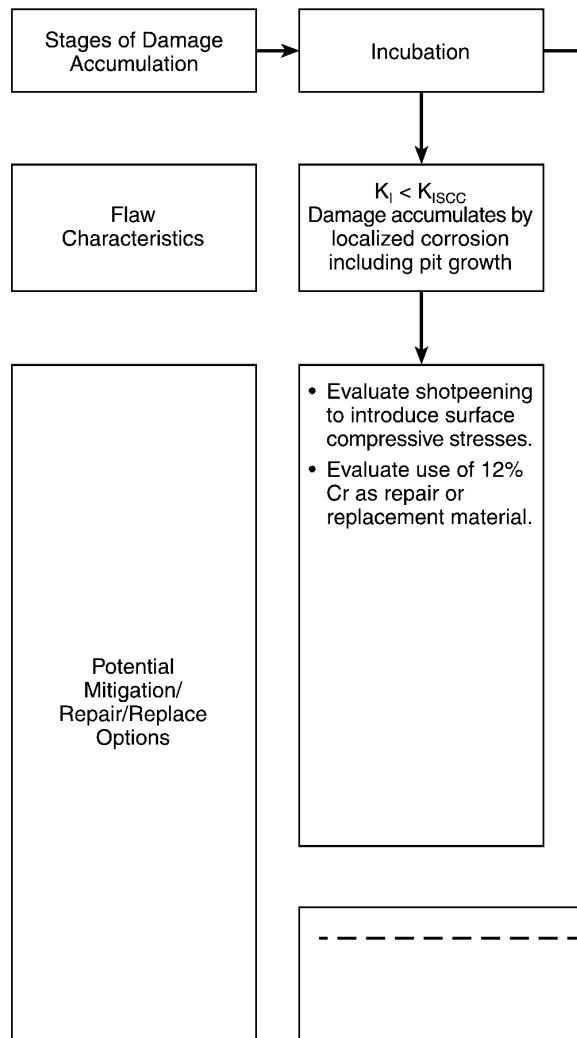
Figure A-9. Five Stages (Steps) of Damage Accumulation by Stress Corrosion Cracking in Discs and Blades (A).
