CORROSION CONTROL IN INDUSTRIAL AXIAL FLOW COMPRESSORS

David H. Linden

D.H.Linden Associates, Inc.

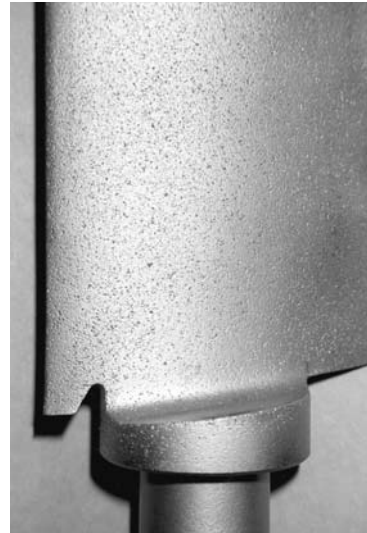
Figure 3. Corrosion Pitting on 410 Stainless Steel Inlet Guide Vane.

Figure 3 shows severe corrosion pitting of a 410 stainless steel variable inlet guide vane.

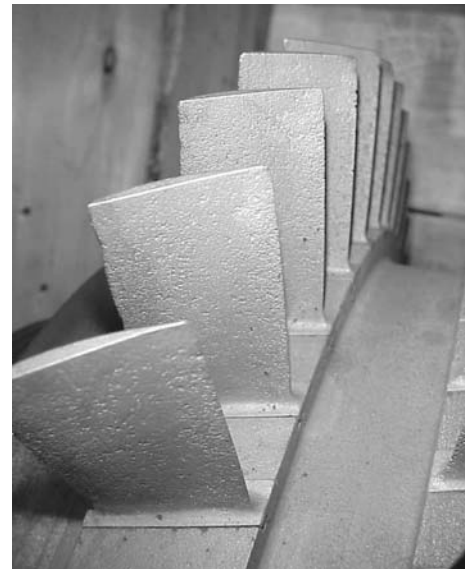
Figure 4. Corrosion Pitting on 403 Stainless Steel Rotor Blades.

high-pressure ratio compressors with high discharge temperatures may utilize super alloys such as A-286 or Inconel[®] 718. Figure 4 shows significant corrosion damage to uncoated 403 stainless steel blading.

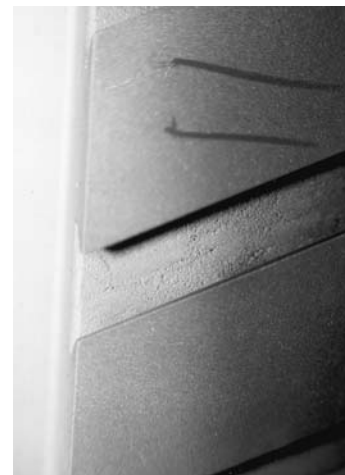
Figure 5. Corrosion Pitting in an Alloy Steel Dovetail Blade Attachment Region.

The corrosion potential of the blade attachment region is further accentuated due to the fact that most blade attachment designs do not allow for a thorough cleaning and inspection of the region during normal rotor overhauls and refurbishment and are often overlooked. This leaves the corrosive products and compounds in the attachment regions during subsequent rotor runs and allows for further corrosion damage to occur. It is well documented that corroded materials experience a significant reduction in material fatigue strength. Figure 5 shows corrosion damage in the dovetail attachment region of an alloy steel rotor disk. Figure 6 shows corrosion damage in the balance piston seal region.

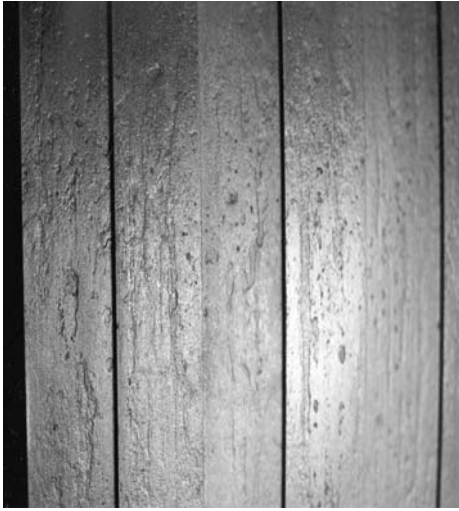
Figure 6. Corrosion of 4140 Alloy Steel Balance Piston Region.

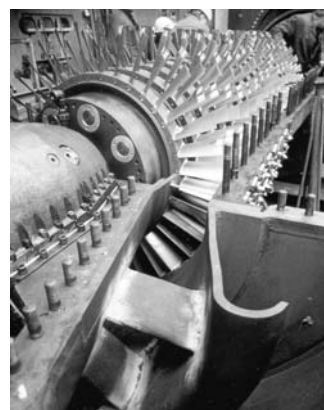
Figure 8. Upgraded Rotor Assembly Utilizing Titanium Alloy and C450 Blades, and a Coated Rotor Body.

The rotor blade and stator vane materials were upgraded to an uncoated Carpenter® Custom 450 material in several applications with good success. In one installation, the extremely aggressive corrosive environment also caused severe pitting of the Custom 450 material (Figure 7). Titanium alloy flow path components were implemented in this application with excellent success (Figure 8). Rotors that were experiencing significant corrosion damage in as little as 18 months of operation have now been able to achieve operating campaigns in excess of five years with minimal if any corrosion damage.
