ELIMINATING A RUB-INDUCED STARTUP VIBRATION PROBLEM IN AN ETHYLENE DRIVE STEAM TURBINE

ABSTRACT

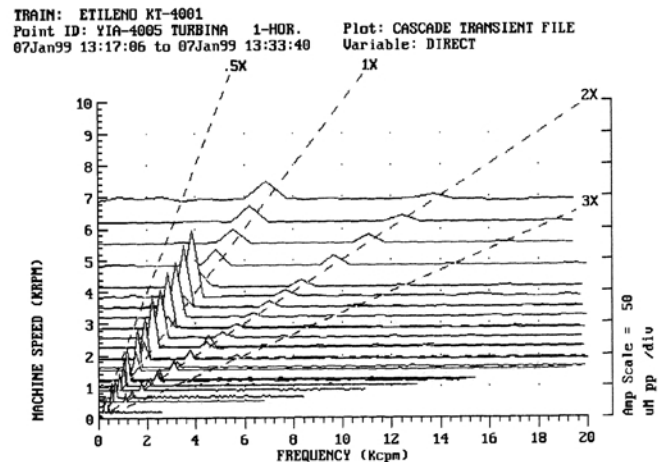
Figure 2. Steam End Horizontal Displacement Probe Vibration – 07Jan99.

The turbine, built and installed in 1973, operates between a minimum governor speed of 6500 rpm and maximum continuous speed of 8400 rpm. A typical startup is illustrated in Figure 2, in which the turbine's steam end horizontal displacement probe vibration increases to 120 microns peak-to-peak (4.7 mils peak-to-peak) at 3800 rpm. At 4200 rpm, the vibration suddenly drops to 30 microns peak-to-peak (1.2 mils peak-to-peak) and remains at that

level as the turbine accelerates up to 6800 rpm. In this case, it appears that the rotor locked into a hard rub at low speed and then suddenly dropped out of the rub right after passing through the first critical speed.

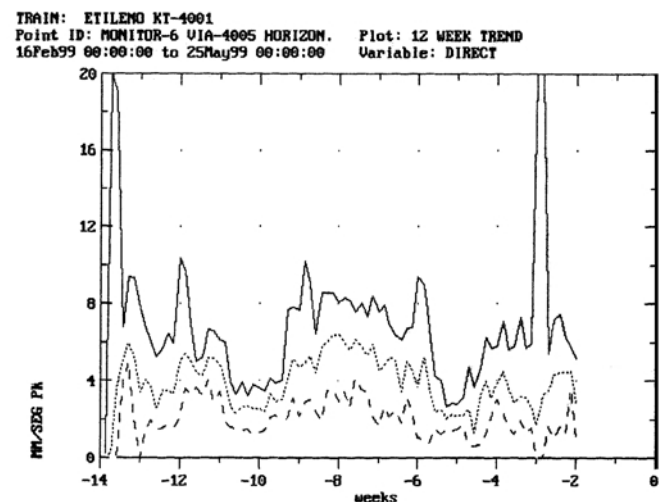
Figure 7. Time Trend of Steam End Horizontal Displacement Probe Vibration Before Overhaul.

Time histories of turbine vibration from February 1999 until May 1999 are illustrated in Figures 7 and 8. From Figure 7, the steam end horizontal displacement probe's normal vibration level is around 40 microns peak-to-peak (1.6 mils peak-to-peak) with peaks spiking up to 125 microns peak-to-peak (4.9 mils peak-to-peak). Casing readings for the exhaust end horizontal velocity probe are shown in Figure 8. Normal velocity levels between 4.0 and 8.0 mm/s zero-to-peak (0.16 and 0.32 in/s zero-to-peak) are evident with peaks spiking up to 20 mm/s zero-to-peak (0.8 in/s zero-to-peak).

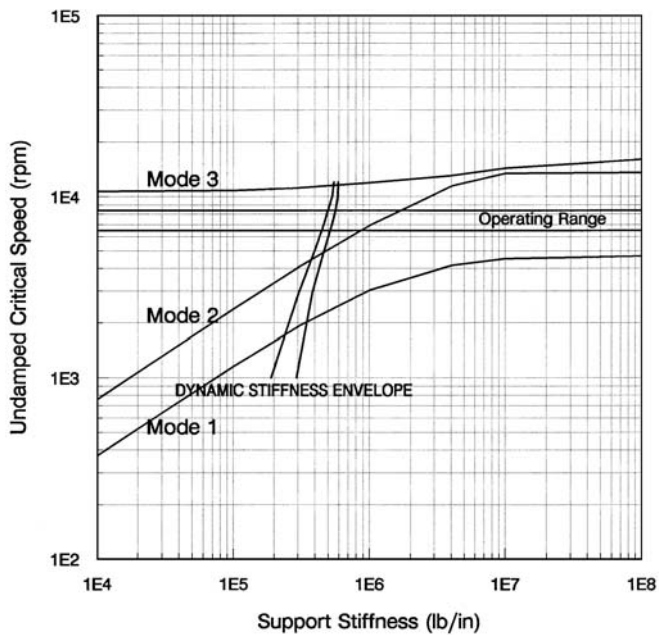
Figure 19. Undamped Critical Speed Map – Rotor with Reduced Overhung Moment.

The undamped critical speed map for the new rotor configuration with the reduced exhaust end overhung moment is given in Figure 19. Plotted on this map are the dynamic stiffness curves corresponding to the new four pad tilting pad bearing combined with the squeeze film damper. The resultant stiffness of the damper bearing is 437,000 lb/in, which is much lower compared to the original sleeve and initial five pad tilting pad designs. This stiffness is roughly one-fifth of the shaft stiffness and more than adequately meets the stiffness flexibility ratio rule.

Furthermore, with the reduced overhung moment, the third mode free-free asymptote of 10,670 cpm is now well above the maximum operating speed. Also evident from Figure 19 is that in order to reduce the second mode below the operating range, a bearing stiffness well below 800,000 lb/in is required. While this could not have been achieved with a conventional bearing (sleeve or tilting pad), this turned out to be a secondary benefit of adding the squeeze film damper.

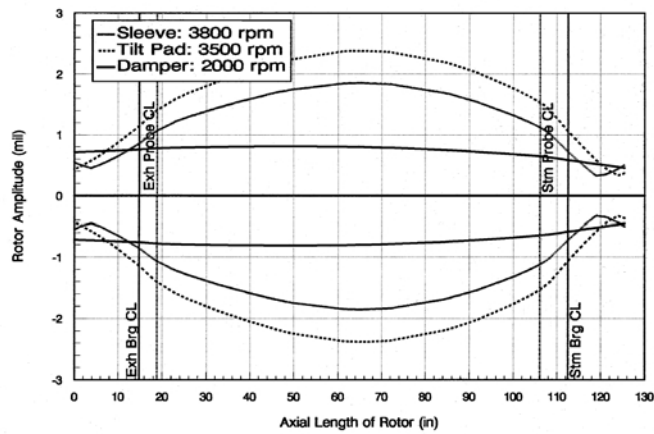
Figures 20 and 21 illustrate the response plots for a first mode unbalanced condition, and Figure 22 the deflected mode shapes at the respective peak response speeds. With the squeeze film damper, the first peak response speed is critically damped. The maximum amplitude at the probes is lower by at least 25 percent compared with the original sleeve and initial five pad tilting pad bearings.

Of more interest, however, is the rotor's general shape and reduction in midspan amplitude as shown in the deflected shape plot of Figure 22. The rotor's deflected shape with the damper bearing is almost purely straight, with a reduction in midspan amplitude of greater than 50 percent. In this condition, the possibility of an interstage rub is greatly reduced.

This plot also helps in explaining the difficulty of controlling the rotor's vibration with the conventional bearings. The locations of the nodal points are determined by the relative flexibility of the rotor compared with the resultant support flexibility, with two consequences as the nodal points move closer to the bearings. First, the effective bearing damping is greatly reduced due to the restricted motion in the bearings. Second, the response amplitude at the rotor's midspan is considerably greater than at the probe locations. This latter situation can lead to a potentially damaging

rub condition if the midspan vibration amplitude builds up sufficiently to exceed the running clearances at the interstage seals. With the squeeze film damper, however, the nodal points are now sufficiently away from the bearings with enough relative amplitude to allow the available bearing damping to be more effective.

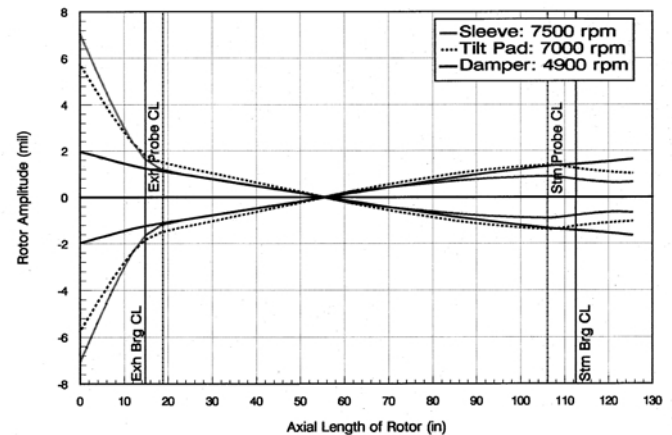
The second mode response plots are included in Figures 23 and 24, and the deflected shape at the respective peak response speeds in Figure 25. With the squeeze film damper, the second peak response is critically damped and well below the minimum operating speed. Although the response over the operating range at the probe locations indicates only a slight improvement, the deflected shape plot illustrates the primary benefit. With the damper, the new coupling, and the new turning gear wheel, the exhaust end overhung response is almost entirely eliminated with a reduction in shaft end amplitude by a factor of three. Furthermore, this mode is quickly passed through as the turbine is brought up to speed. With the conventional bearings, this mode was in the vicinity of the normal operating range and could be excited by any residual unbalance in the rotor assembly. A common source of overhung unbalance is from the coupling, which would greatly aggravate the overhung response of this mode. With the conventional bearings, heavy rub marks were often observed in the double flow section of the rotor, which could be indicative of this overhung mode being excited possibly from residual unbalance in either the coupling or coupling fit.

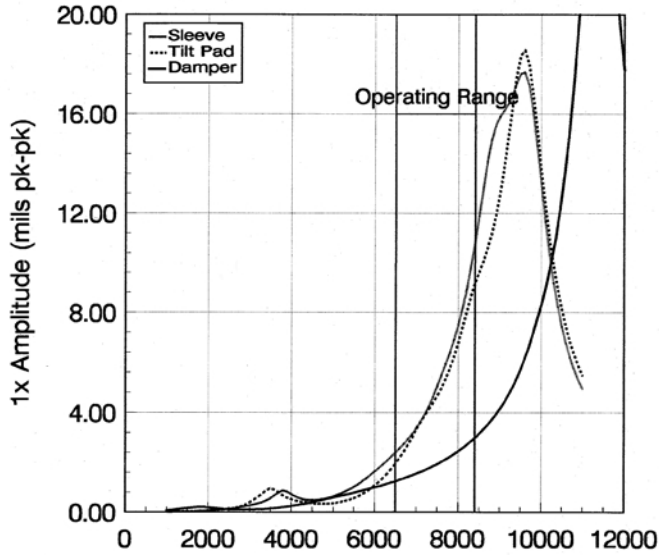
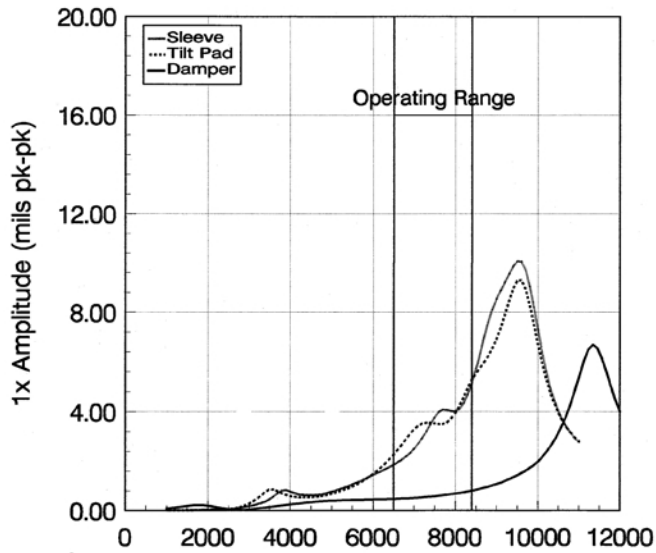
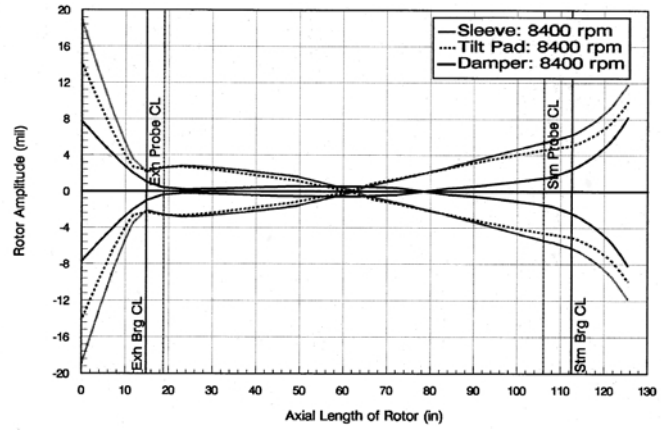
The third mode response plots of Figures 26 and 27 best illustrate the improvement with the reduced exhaust end overhung moment. The third critical speed is raised almost 2000 rpm and is well above the maximum operating speed. The response at the probe locations over the normal operating range are also lower, by a factor of two at the low end of the speed range and six at the high end.

The overhung influence is best illustrated in the deflected shape plot given in Figure 28. In this figure, the deflected shapes are all at the maximum operating speed of 8400 rpm, and not their respective peak response speeds. In the new configuration the maximum response, which is at the exhaust end, is lower by roughly a factor of two. Clearly, the reduced overhung moment resulting from the coupling change and turning gear wheel modification were necessary in successfully tuning the rotor's dynamic characteristics in relation to the operating speed range.

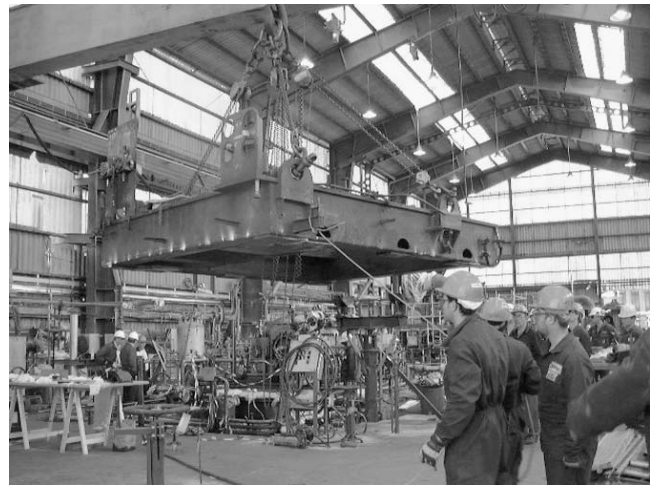
Figure 35. Baseplate Removed from Foundation.

Clearly, a foundation repair was necessary. While the rotor and turbine case were undergoing rework and repair, the 9500 lb baseplate was removed from its concrete pad (Figures 34 and 35). In order to ensure the correct position of the baseplate during reinstallation, optical references were taken by attaching reference plates to the bottom of the concrete foundation using drop-in anchors. In addition, leveling references were taken by means of a precision site level.

A deteriorated support was another possible contributor to the turbine's high vibration problems. The foundation was examined and some cracks were discovered in the concrete beams supporting the baseplate. Additionally, poor grout placement and degradation caused by oil and steam leakage over the years resulted in large gaps at the interface of the baseplate and concrete foundation. The overall poor condition of the concrete foundation and grout interface had the effect of increasing the foundation flexibility, thereby reducing the bearing's effective damping and increasing rotor vibration (Nicholas, et al., 1986).

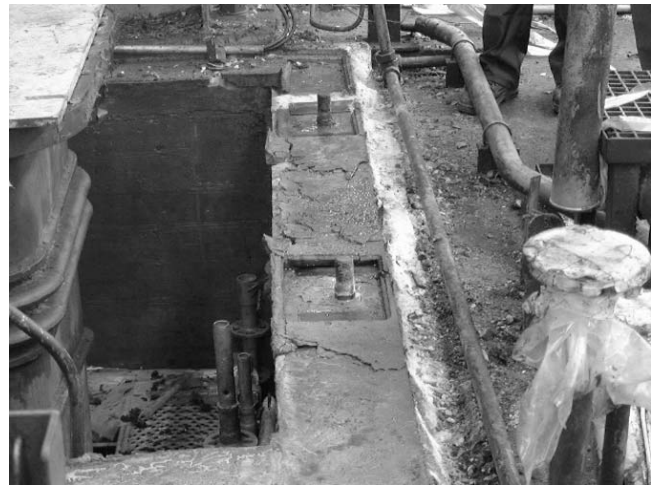
Figure 36. As-Found Deteriorated Condition of Foundation.

From Figure 36, the deterioration of the grout under the removed baseplate is evident. Furthermore, after a careful inspection, many cracks were observed in the concrete beams emanating from the anchoring bolts. The whole area was cleaned and sandblasted. A repair was made that comprised injecting the cracks with a pressure epoxy adhesive as shown in Figure 37.

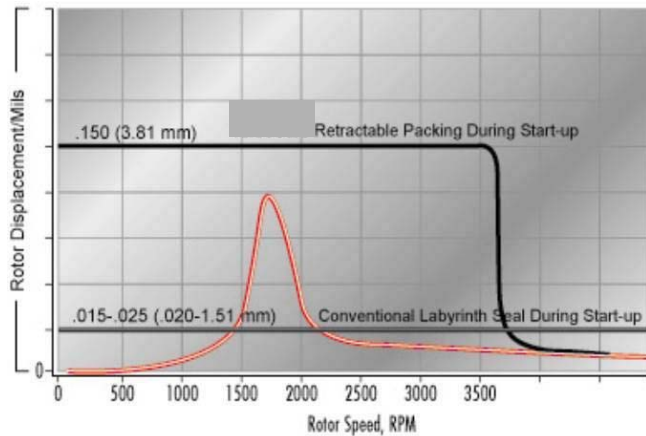
Figure 41. Rotor Vibration Characteristic During Startup.

By proper design of the coil springs between packing segments, the pressure forces acting on the packing can be utilized to cause the packing to move from a large clearance to a small clearance at a predetermined flow. The packing is designed to close beyond the point where thermal gradients occur and above the critical speed range. Figure 41 shows the typical difference in clearances for

conventional packing and retractable packing during startup when the rotor vibration increases while passing through the first critical speed.

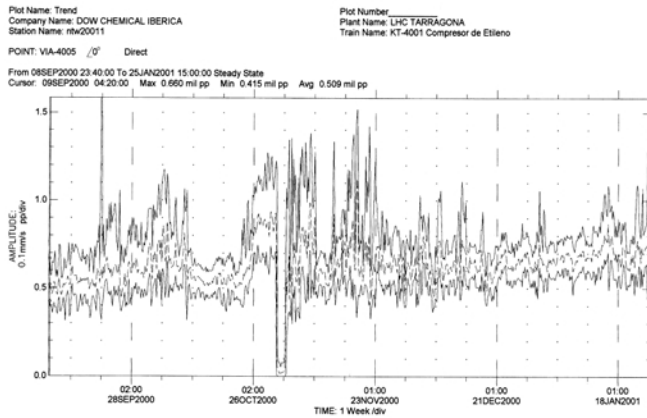
Figure 44. Time Trend of Steam End Horizontal Displacement Probe Vibration After Overhaul.

A time history of turbine vibration from September 2000 until January 2001 may be seen in Figures 44 and 45. From Figure 44, the steam end horizontal displacement probe's normal vibration levels are around 20 microns peak-to-peak (0.8 mils peak-to-peak). This is half the value from Figure 7 before the overhaul. There are a handful of vibration excursions that remained under 50 microns peak-to-peak (2.0 mils peak-to-peak) in Figure 44 compared to peaks ranging up to 125 microns peak-to-peak (4.9 mils peak-to-peak) from Figure 7.
