# MULTIPLE RESONANCE VIBRATION MITIGATION ON A 54,000 HP PARALLEL SHAFT DOUBLE HELICAL SPEED INCREASER

## ABSTRACT

Test stand vibration measurements on a partially loaded 54,000 hp, parallel shaft, double helical speed increaser revealed synchronous resonant vibrations near normal operating speed. Further testing confirmed the lateral critical speed of the pinion was lower than originally designed due to modifications applied while the gear unit was in the test stand, which were aimed at lowering bearing pad operating temperatures under full load field conditions. The lateral critical speed was seen to increase as expected by sequentially removing the coupling spacer, adapter plate, and the hub. However, resulting vibration measurements showed a resonance remained near running speed.

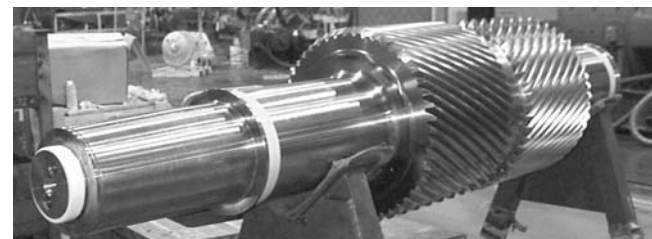
*Figure 2. Pinion Viewed from Drive End.*

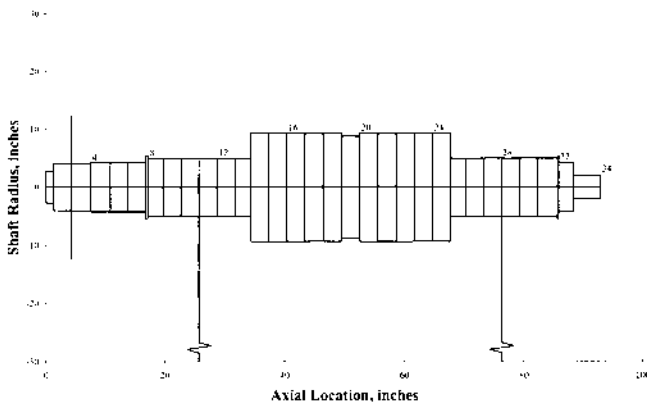
bearing design parameters to cover tolerances on preload and clearance as well as variation in applied load. The shaft was modeled, as shown in Figure 5, starting at the coupling end. The half coupling weight and inertia were modeled as added terms located at its center of gravity as determined by the coupling vendor. The undamped critical speed map is shown in Figure 6 with equivalent support stiffness curves superimposed for 100 percent load conditions in the field. These stiffness values are seen to be in the range of five to 10 million lb/in and are different for horizontal (xx) and vertical (yy) directions. This simplified analysis shows the first critical speed should be in the 7000 to 8000 rpm range, which is well beyond API 613 (1995) requirements for all critical speeds to be at least 20 percent above operating speed. Figure 7 is the undamped first critical speed mode shape at a support stiffness near expected values. It is an overhang mode of the extended (coupling) end of the shaft with a node near the blind end bearing. This mode would be very sensitive to coupling unbalance.

Figure 5. Rotordynamic Model of the Pinion.

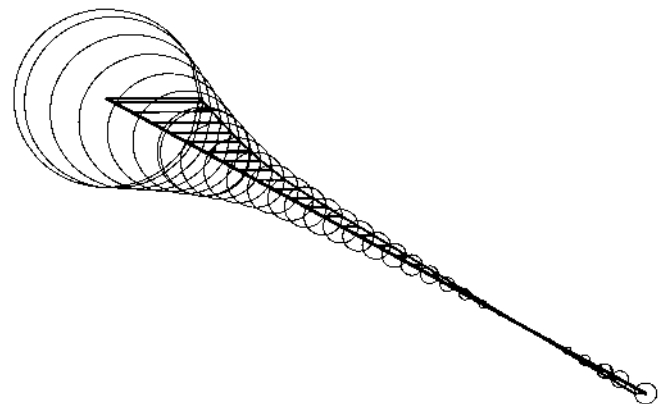
Figure 7. Pinion Undamped Mode Shape.

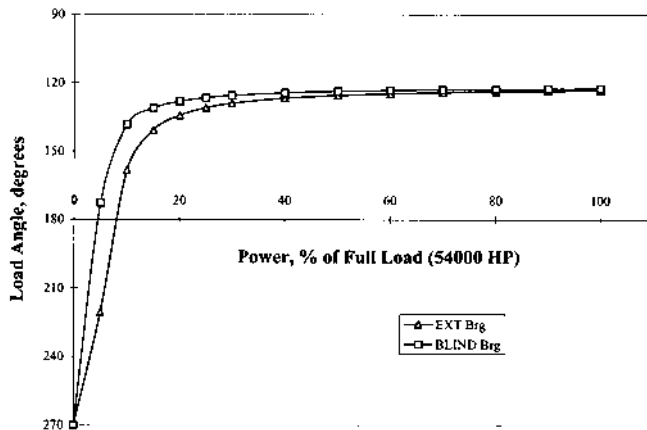
Figure 12. Pinion Bearing Load Angle Versus Percent Load.

Figures 12 and 13 reveal why measured vibration due to unbalance during test stand operation cannot be compared to rotordynamic calculations for even partial load field conditions that are provided as requirements of API 613 (1995).

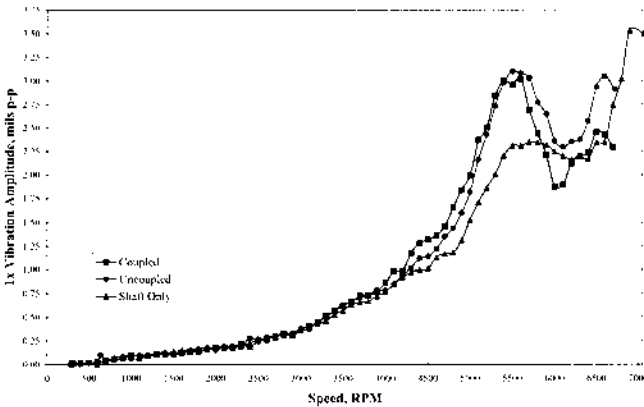
Response to unbalance for all four of the above referenced configurations was measured on the test stand. Figure 15 summarizes results for the extended end bearing 1x vibration versus speed for three of these cases. Two peaks are seen in each curve on the graph. The lower peak is in the 5500 to 5600 rpm range for each case and did not show the increase in frequency as would be expected of a critical speed based on rotordynamic calculations. The upper peak in each curve did respond as expected with incremental steps in peak frequency as the coupling parts were removed. Table 4 captures the results of the tests for each peak in horizontal and vertical directions for shop conditions with a 20 mil bearing clearance. An alarming result is evident. If these peaks represent the horizontal and vertical shaft critical speeds due to oil film and support stiffnesses, then the vertical values should

be higher than the horizontal values, but this was not the case. The horizontal values went from 6500 to 6900 rpm but the vertical values went from 5500 to 5600. Recalling that the data were only recorded approximately every 100 rpm indicates the vertical values are essentially constant. This fact, coupled with the inverse order between horizontal and vertical directional peaks, gave rise to the thought that the vertical direction peak may not be due to rotordynamics but could be structural in nature.

Figure 15. Measured Pinion Extended End 1x Response to Coupling Unbalance Comparison.

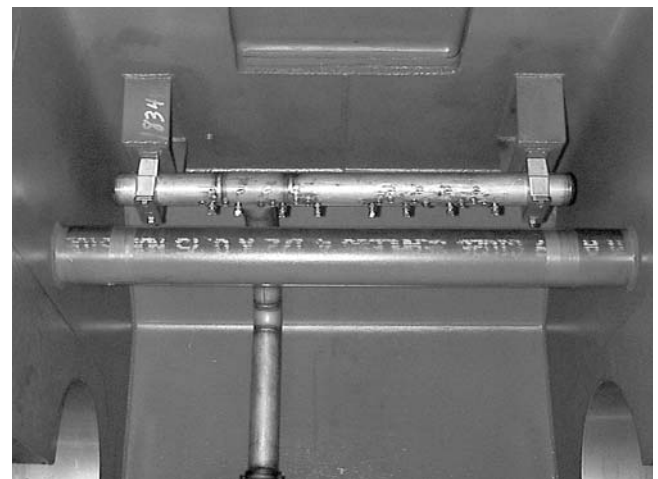
Figure 21. View of Inside of Gearcase Cover Showing Tie Bar Installed.

Based on the analyses described above, it was decided to install a tie bar axially across the gear case upper section. The tie bar assembly connected the gear case walls just above the gear mesh and bearings. It extended across the axial length of the inside of the gear case cover and was parallel to the pinion. It included a heavy wall steel tube between the casing walls with a steel rod inside the tube as shown in Figure 20. The tube was accurately fitted between machined pads in the casing to avoid distorting the casing when the assembly was tightened. Threaded portions of the rod protruded through the walls, with a nut at one end and a stud tensioner at the other. The tensioner had multiple jackbolts that held the entire assembly tight. O-ring seals at the ends of the tube prevented leakage of oil. Figure 21 shows a view inside the gear case cover with the tie bar installed. The gear mesh cooling oil spray nozzles can be seen near the tie bar, which blocks a portion of the spray. Figure 22 is an overall view of the gear unit on the test stand. The tie bar end can be seen just above the pinion bearing housing. Figure 23 is a closeup view of the stud tensioner being installed.

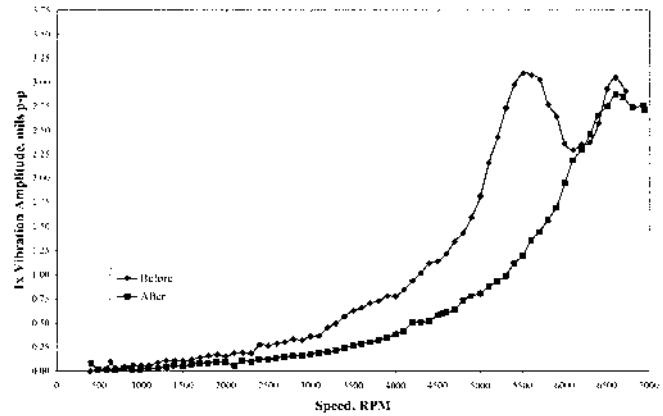
With the tie bar and the previously described and tested bearing modifications installed, the unit was assembled for test stand operation and tested as before. First a run was made with the shop coupling installed with a 2 percent load. Then the coupling was removed a piece at a time and runs were made to compare directly to previous data. Figure 24 shows a comparison of the uncoupled case before and after the modifications. The resonance previously near running speed was found to be much higher in frequency near 6600 to 6700 rpm, which was outside the 20 percent separation margin required. Bearing temperatures were within the specified limits. Mode eight was not seen in the measured data. Based upon successful completion of the tests the unit was accepted and shipped.

Figure 24. Comparison of 1x Vibration Before and After Tie Bar Installation.
