RETROFIT, UPGRADE, AND DEMOTHBALL OF TWO CENTRIFUGAL COMPRESSOR TRAINS

The design premise in upgrading two operating plants for more compression capability is discussed.

RETROFIT/UPGRADE OF STEAM TURBINE DRIVEN TWO CASING CO COMPRESSOR

DEMOTHBALL OF STEAM TURBINE DRIVEN CENTRIFUGAL COMPRESSOR

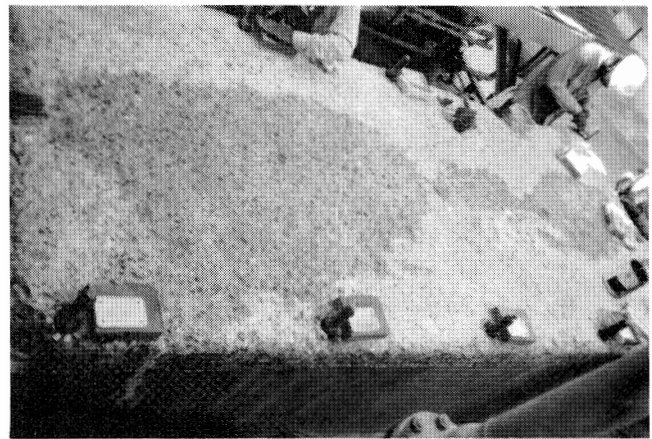
Figure 1. Concrete Mezzanine Base Prepared for Baseplate.

The fabricated baseplate would be built to rest on adequate (10) level plates using greased "jack-up-leveling" and "pull-down-anchor" bolting (Figure 1).

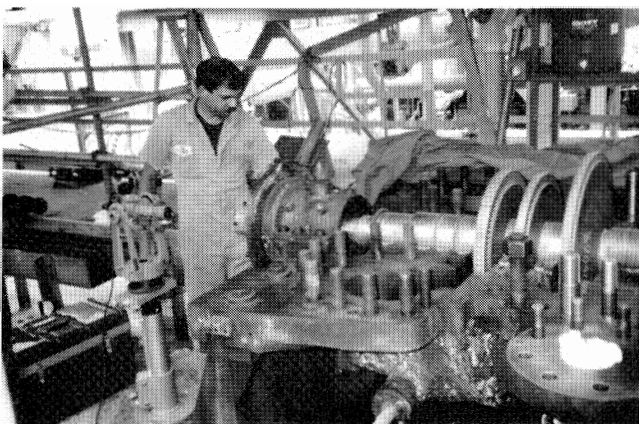
Figure 6. Optical Alignment with Mirror at Turbine Exhaust Shaft End.

- The owner would optically shoot the existing/repaired steam turbine rotor shaft for centerline projection and elevation. Owner to provide minimum 1/2 in thick plates at each anchor bolt/jack-up bolt location for the lifting bolts to seat against (Figure 6).

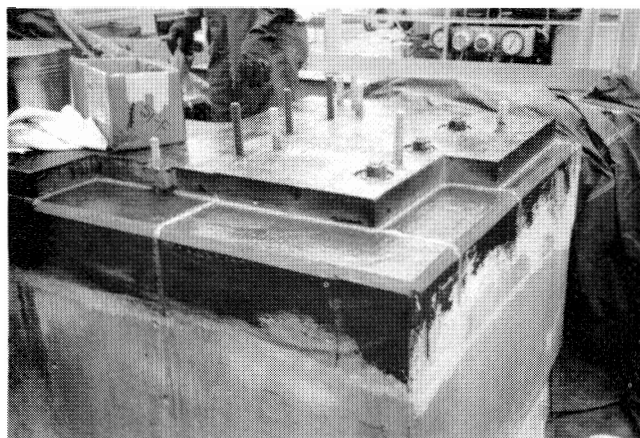
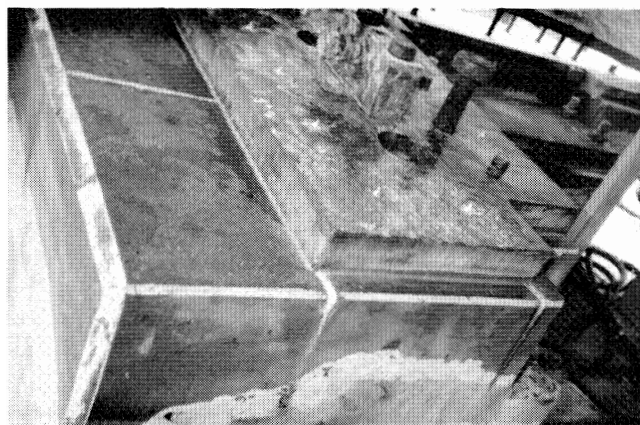
Figure 26. Regrouted Sole Plates in Field-Turbine and Compressor.

- Regrout the existing sole plates (4.0 in thick) for the compressor without removing or relocating the sole plate anchor bolts. Chip out regrot, recoat plates against rust, and provide expansion joints in the grout (rounded corners on all grouted plates) and pressure grout for any "voids" after pouring (Figure 26). Replace the anchor bolts and the large x-y-z alignment bolts with new ones. Precut and properly filed stainless steel shims for the full compressor feet to be at $\frac{1}{4}$ " thickness ($\frac{1}{8}$ in + $\frac{1}{16}$ in).
