# UNIQUE FAN VIBRATION PROBLEMS: THEIR CAUSES AND SOLUTIONS

**Donald R. Smith**

**Harold R. Simmons**

Southwest Research Institute

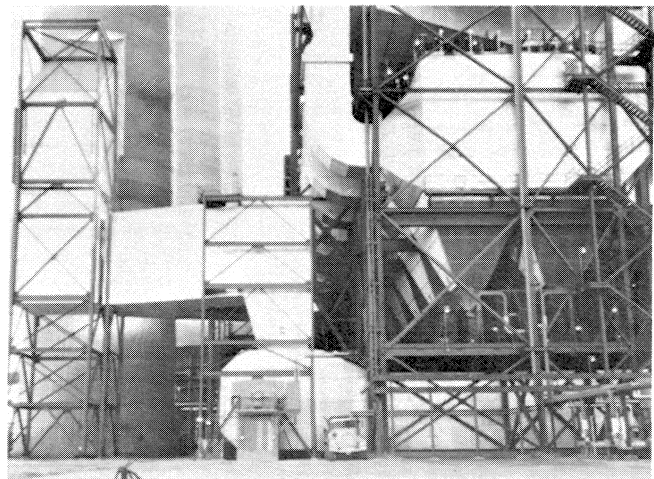
Figure 1. Typical Exhaust Duct System at a Coal Fired Power Plant.

The duct systems in today's coal fired power plants are complex and often include elaborate pollution control systems which require several fans (Figure 1). Vibrations in such

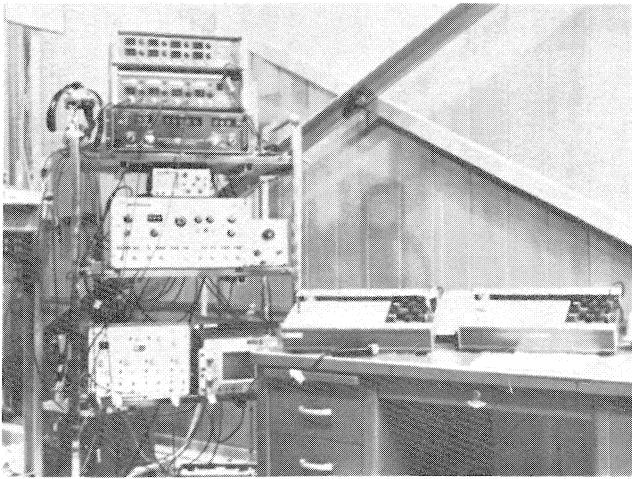
Figure 2. Analysis Equipment Used in Field Vibration Testing.

In recognition of these system interactions and the multiplicity of excitation sources, it is essential to have an extensive array of different transducers and analysis equipment for a field study (Figure 2). In addition to the usual accelerometers and proximity probes for vibration measurement, pressure transducers, shaft telemetry, strain gages, torsional transducers, and shakers are often necessary. Likewise, spectral analysis equipment is augmented with a spectral time history (raster plot) generator for event correlation and two-channel spectral analyzer for transmission path and source identification.

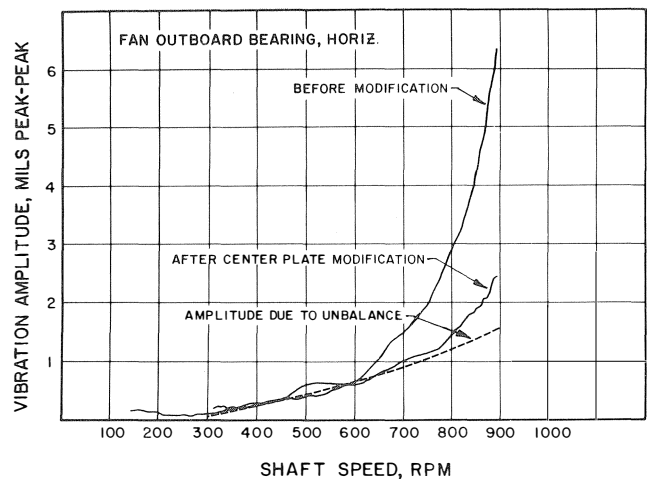
Figure 3. Bearing Housing Vibration Response During Startup.

Bearing and shaft vibration amplitudes and phase angles were plotted during several startups and shutdowns (Figure 3) to determine if the fan was operating near a critical speed. Vibration due to unbalance alone (discounting resonances) will increase as a function of the speed squared. It can be seen in Figure 3 that the vibration at 900 rpm was significantly greater than the level due to a pure unbalance. This indicates that the fan was operating near a resonance. The fact that there was no dramatic 180 degree phase shift of the bearing housing

vibrations indicated that this resonance was probably not a critical speed. The measured shaft torsional oscillations were low and not consistent with running speed; therefore, the torsional resonant coupling effects were negligible.

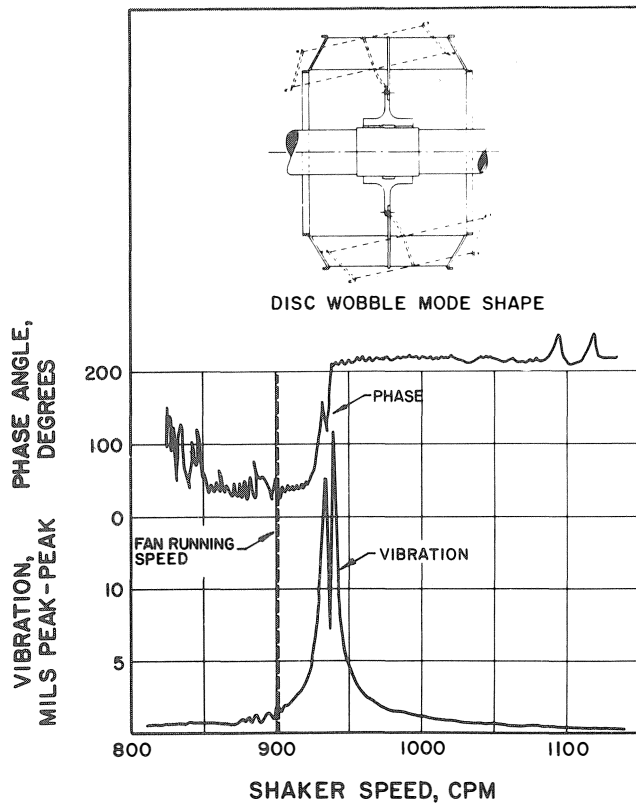
Figure 4. Disc-Wobble Mode Vibration Response to Shaker Excitation.

The disc resonance was identified by measurements from inside the impeller wheel during a shaker test. When the shaker speed reached 930 rpm, the whole wheel vibrated at 20 mils or more, but the shaft remained relatively calm. Measurement of the vibration at selected locations around the wheel with accelerometers revealed the disc wobble mode shape (Figure 4).

In this mode the wheel and disc act much like a single degree-of-freedom spring-mass system with the impeller wheel remaining rigid and pitching about the hub. The resonant frequency may be calculated by:

An evaluation was made of a plate stiffener that could be fabricated and bolted to the center disc in the field to increase the disc resonant mode. An estimated 50% stiffness improvement was found to be required based on equation (1). The proposed added plate stiffness improvement was checked with a scaled model which was constructed to give qualitative comparisons.

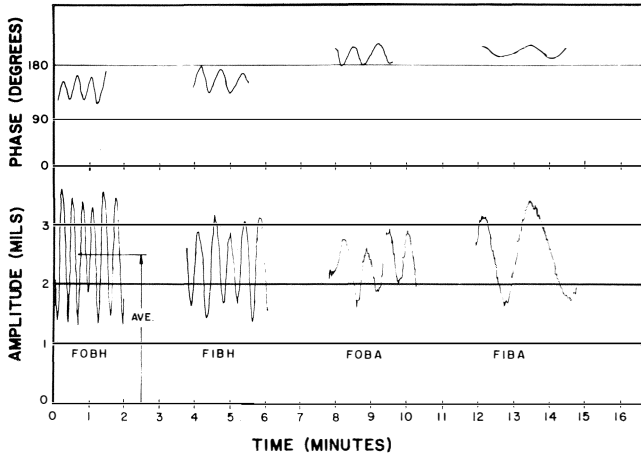
Figure 5. Horizontal and Axial Vibrations of Both Fan Bearings Showing Beating Effect of Adjacent Fan.

To eliminate other extraneous influence (vibration transmitted between fans), vibration amplitude and phase were plotted versus time (Figure 5). These figures illustrate that the slightly different speeds of the induction motors produce a beating effect on the vibration. The vibration of each fan caused by its own unbalance is the average data between maximum and minimum.

Using this data the fans were balanced using a two-plane least squares balancing technique programmed on a Hewlett-Packard HP 65 calculator. Two balance planes were required because the disc wobble resonance and shaft bending mode each required independent balance. The least squares technique [2] was necessary to minimize both horizontal and axial vibrations at both bearings (four points) while only using two balance planes of correction.

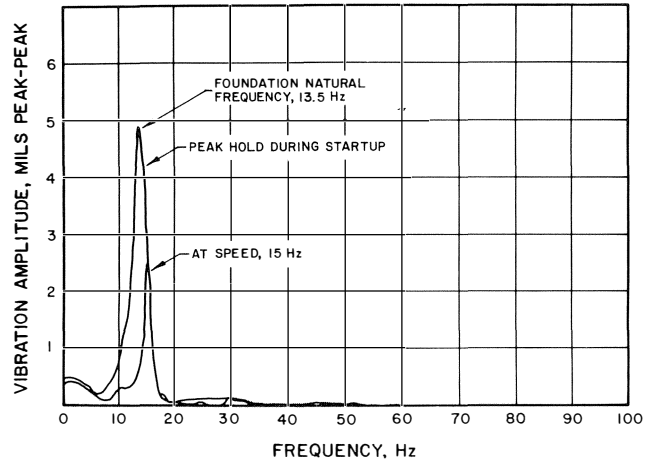
Figure 6. Spectral Analysis of Bearing Housing Vibrations During Startup.

Vibrations measured on the fan bearings during startup and coastdowns of the fans (Figure 6) revealed what appeared to be a foundation natural frequency near the running speed. These fans were designed to have their lowest foundation natural frequencies at least 70% above running speed, which should have been adequate. Further conservatism was included in the design calculations by using a lower limit value of Young's Modulus (E) of 500,000 psi for the sandstone formation

beneath the foundation. On three of the fans, the natural frequency was just below the running speed, but on the fourth fan the resonance was slightly above the running speed. To verify that these were foundation resonances, a variable speed mechanical shaker was attached to the foundation and run through a speed range of zero to 30 Hz. The shaker vibration response agreed with the coastdown data and verified that the first foundation natural frequency ranged from 12 to 16 Hz for these "identical" four fans.

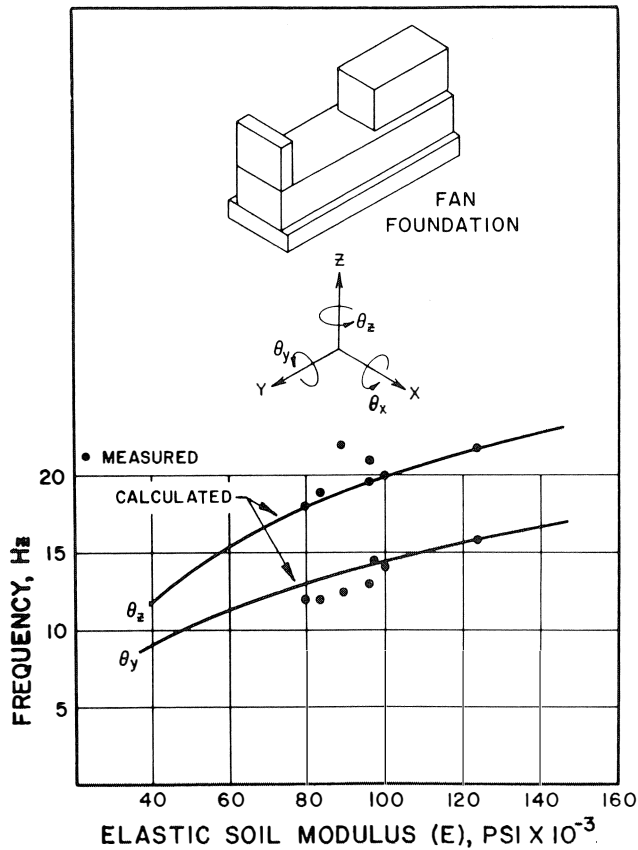
Figure 7. Comparison of Measured and Calculated Foundation Natural Frequencies.

To evaluate the discrepancy between measured and calculated foundation resonances, the foundation-soil dynamic system was modeled with a computer program developed by Southwest Research Institute (SwRI). Foundation natural frequencies were calculated for a range of soil moduli and compared with shaker data. As shown in Figure 7, the effective soil modulus must be from 80,000 to 120,000 psi to match the measured foundation natural frequencies. The lower than expected soil stiffness beneath the foundations was probably due to blasting, over-excavation, and backfill during construction.

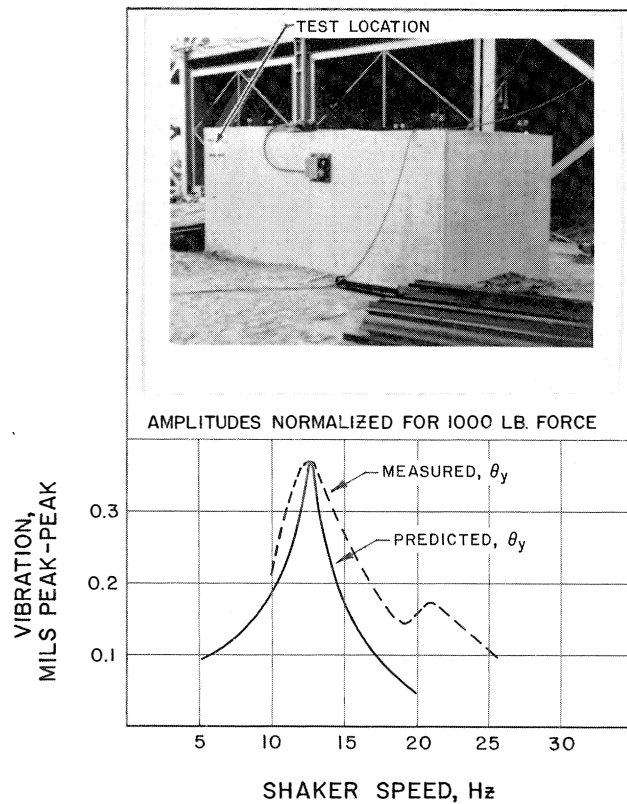
Figure 8. Comparison of Measured and Calculated Foundation Vibration Response.

A shaker test was conducted on the partially completed foundation block of an adjacent unit (Figure 8) to determine natural frequencies and vibration mode shapes. These tests showed that the effective soil modulus was similar to that obtained for Unit 1, which indicated that the Unit 2 ID fans would also have foundation natural frequencies near the running speed. Foundation modifications to reduce the vibration amplitudes were analyzed using the computer program. However, it was determined that most modifications investigated were impractical based on cost or space limitations and other methods were investigated to reduce the vibrations.

Shaker tests on one foundation revealed that the vibrations were increased by a factor of six when dirt was removed from the side of the foundation. Based upon this test, sand bags were temporarily placed against the side of the foundation to increase damping and lateral restraint on the foundation. The vibrations were reduced by a factor of approximately two to one.

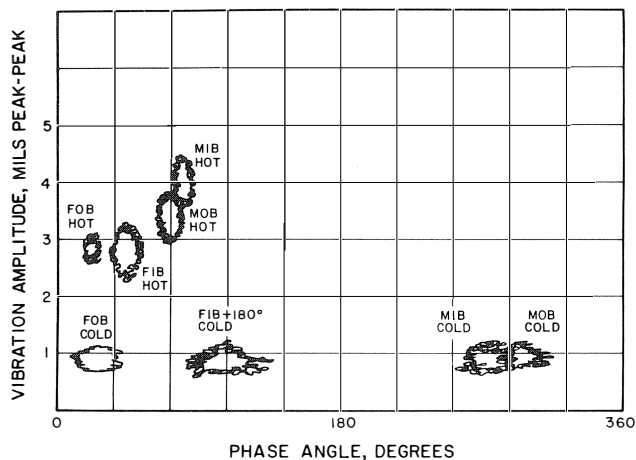
Figure 9. Variation of Motor and Fan Bearing Vibration During Hot and Cold Conditions.

Since the vibration amplitudes and phase angles changed with time, it was decided to plot these variables (Figure 9) to determine if they were repeatable. As shown, the amplitude and phase angle for each bearing traced out elliptical patterns as a function of time. These elliptical patterns were caused by interaction from adjacent fans. The best balance requiring the minimum number of balance trials was obtained by reading the vibration amplitude and phase angle at the center of each elliptical pattern. On one fan, a particularly strong interaction from an adjacent fan developed and a stable vibration phase angle could not be obtained. Fan vibrations immediately stabilized at all four bearing positions (Figure 10) when the adjacent fan was tripped.

All fans of the unit were balanced cold to within the 2 mil limit. When the boiler was fired and the flue gas temperatures increased to approximately 250° F, the vibrations on the bearing housings immediately began to increase and change phase angles (Figure 9). It is not unusual for the balance of a large ID fan to change due to thermal distortion; however, if the fan critical speed and foundation natural frequency are near the running speed, the small changes in unbalance may result in excessive vibration.

was accomplished by utilizing a least squares balancing technique. Using this procedure, it was possible to reduce vibration at all four bearing locations even though only two balance planes were used.

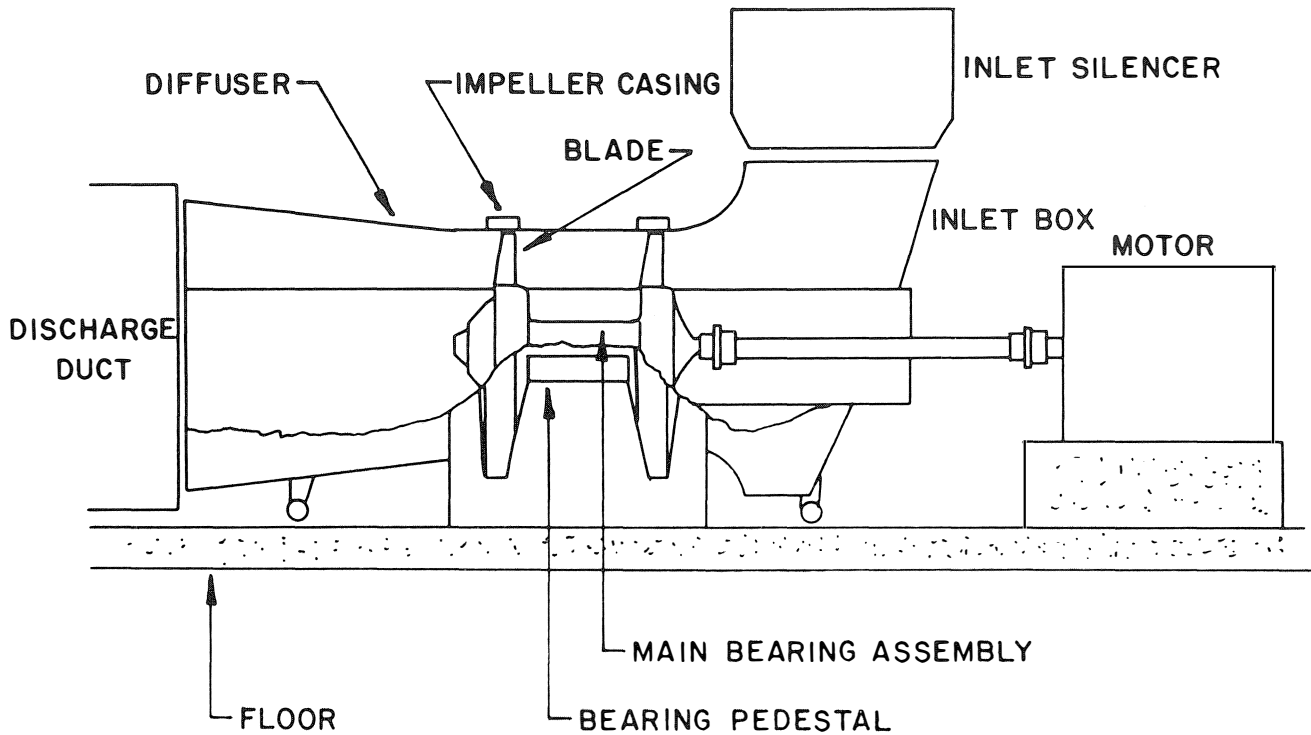
Figure 11. Cutaway View of Two-Stage Axial Fan.

Case resonances on fans can amplify shaft vibrations which can lead to blade and bearing fatigue failures. One such case was encountered on two axial forced draft (FD) fans (Figure 11) installed inside a power plant building. Excessive vibration levels were experienced on the fans, motors, and particularly on the floor between the fans. The fans were overly sensitive to changes in blade pitch and unbalance.

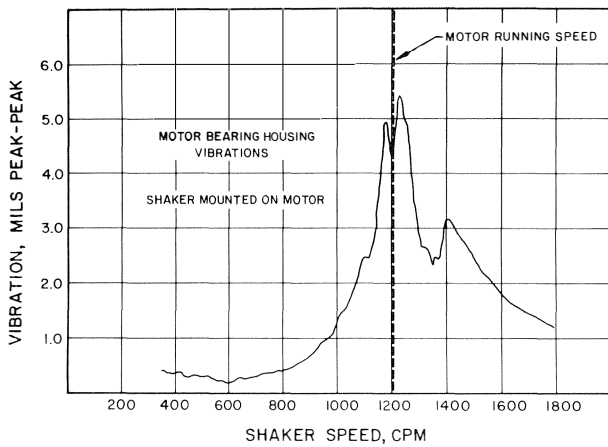
Figure 12. Motor Bearing Vibration Response to Shaker Excitation.

First, the motor-foundation natural frequency was identified at 1180 and 1220 cpm as shown in Figure 12. The experimentally measured mode shape indicated that the motor was rocking on top of the foundation and that the motor-to-foundation attachment appeared flexible. Additional tie-down bolts were added and the motor vibrations reduced by a factor of three.

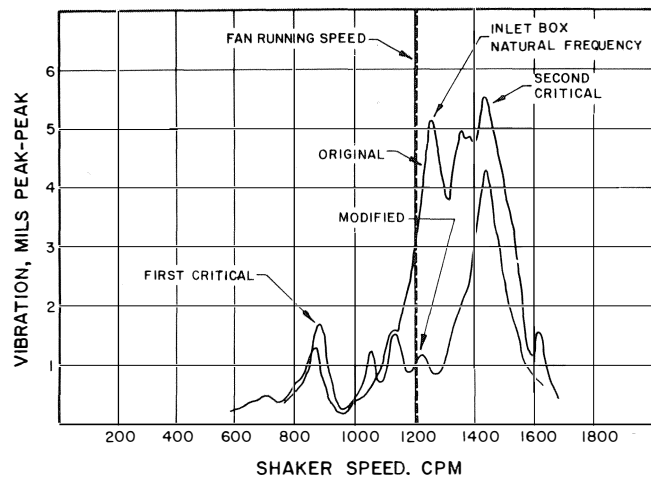
Figure 13. Fan Shaft Vibration Improvement Due to Bracing the Inlet Box.

Using impact and shaker tests, the shaft first lateral critical speed was measured to be 900 rpm at rest (Figure 13). The first critical speed increased to 1095 rpm with the fan running at 1200 rpm. The increase in critical speed was due to the gyroscopic effects of the large overhung wheels. The first lateral critical speed was less than 10% from the running speed which also increased the vibration sensitivity of the fans.

Initial shaker tests of the inlet box and diffuser indicated a strong response at 1240 cpm (Figure 13). To determine which part of the fan housing was resonant at 1240 cpm, the fan was systematically disassembled and shaker data was taken after each part was removed. The shaker tests were repeated with the inlet box totally isolated from the fan and the floor and the response at 1240 cpm was completely eliminated.

silencer with braces and additional anchor bolts were added between the motor and the foundation. After these modifications, the fans were no longer sensitive to load change and had normal balance sensitivity.

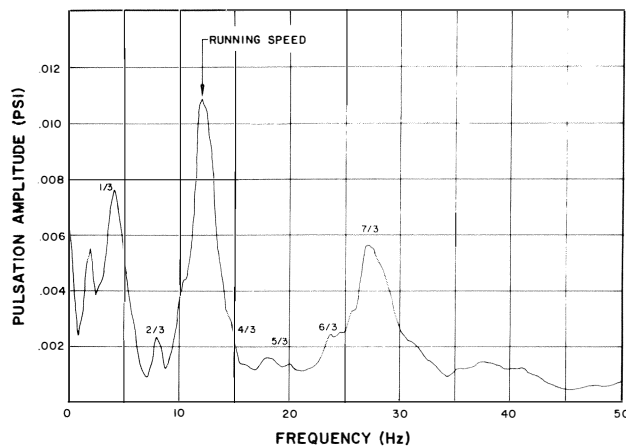
Figure 14. Spectral Analysis of Fan Inlet Pulsation Showing One-Third Multiples of Shaft Speed.

Another well documented acoustic excitation in fans is rotating stall [4]. This is caused by the air impinging on the fan blade at an improper angle resulting in flow separation and stall. Under some marginal flow or improper preswirl conditions, this stall affects only a few blades in a localized portion of the fan, forming what is called a stall cell. Multiple stall cells can be formed equally spaced around the impeller. As the impeller blades form a cascade whereby the pressure field of one blade affects that of its neighbor, the stall cells tend to precess around the impeller. It has been the authors' experience that the precession of stall cells is commonly at one-third shaft speed. A spectrum plot (Figure 14) of a fan inlet pulsation signal shows strong frequency components at exact multiples of one-third shaft speed. These multiples occur because of multiple stalls cells and pressure signal distortion creating higher harmonics.

Rotating stall has been found on many fans, but it seems to be most prevalent on systems with overdesigned fans that are highly throttled at the inlet. Variable inlet vanes tend to improve the air-to-blade incident angle at highly throttled conditions, but may not be the complete solution.

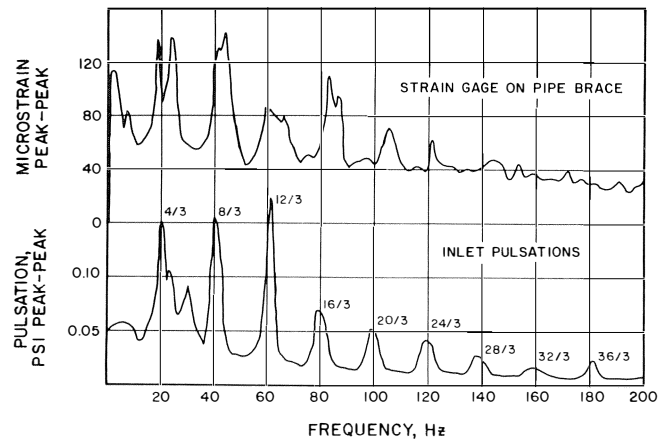
Figure 15. Inlet Pulsation and Strain Spectra Showing Multiples of Rotating Stall Frequencies.

Accelerometers, strain gages, and pressure transducers were installed at several critical locations on the fan housing to identify the source of excitation. It was found that the pulsation, vibration, and strain levels increased as a function of the damper position and the levels were excessive at a damper position of approximately 70% open. The predominant pulsation frequencies were 20, 40, and 60 Hz which coincides with 4, 8, and 12 times the rotating stall frequency (Figure 15). The inlet cone mechanical natural frequency was also found to occur very near 40 Hz and was excited by the pulsations at 40 Hz.

Several modifications were made to the ducts and turning vanes upstream of the fan to reduce the pulsations, but no reduction of pulsation or vibration occurred. Testing was then conducted to determine the effect of discharge throttle control. Flow through most fans is controlled on the inlet side and outlet dampers are used only for fan isolation. For this test, the outlet dampers were temporarily set up for manual control. The inlet dampers were opened to 45% which resulted in high pulsations and vibrations. The inlet dampers were left on automatic control and the outlet dampers were partially closed, keeping the flow rate constant. When the outlet dampers closed to 55%, the inlet opened to 51% and the vibrations and pulsations immediately reduced. This test suggested that a fixed orifice in the discharge duct could reduce the pulsations and vibrations, but its effects at full load were not known. A properly designed damper to control discharge flow was impossible to obtain and install in a reasonable time period; therefore, testing was continued to obtain another solution.

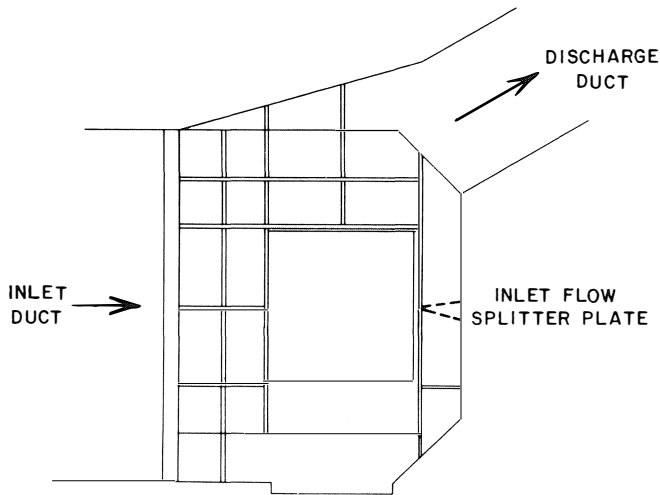
Figure 16. Inlet Flow Splitter Used to Reduce Inlet Vortex.

The discharge damper test suggested that an inlet box vortex could be created by the inlet dampers. The vortex velocity would increase as it passed through the impeller eye and could cause an incident angle mismatch at the blades and result in a rotating stall condition. In order to destroy any vortex forming tendencies, splitter plates were installed in each inlet box (Figure 16) directly opposite the inlet dampers. A significant improvement resulted. The vibrations, pulsations, strain, and noise levels were greatly reduced. In addition, the air flow at comparable vane settings was increased by a factor of 1.7 with a similar increase in motor

current. The vibration characteristics were significantly improved and the predominant pulsations components were virtually eliminated.

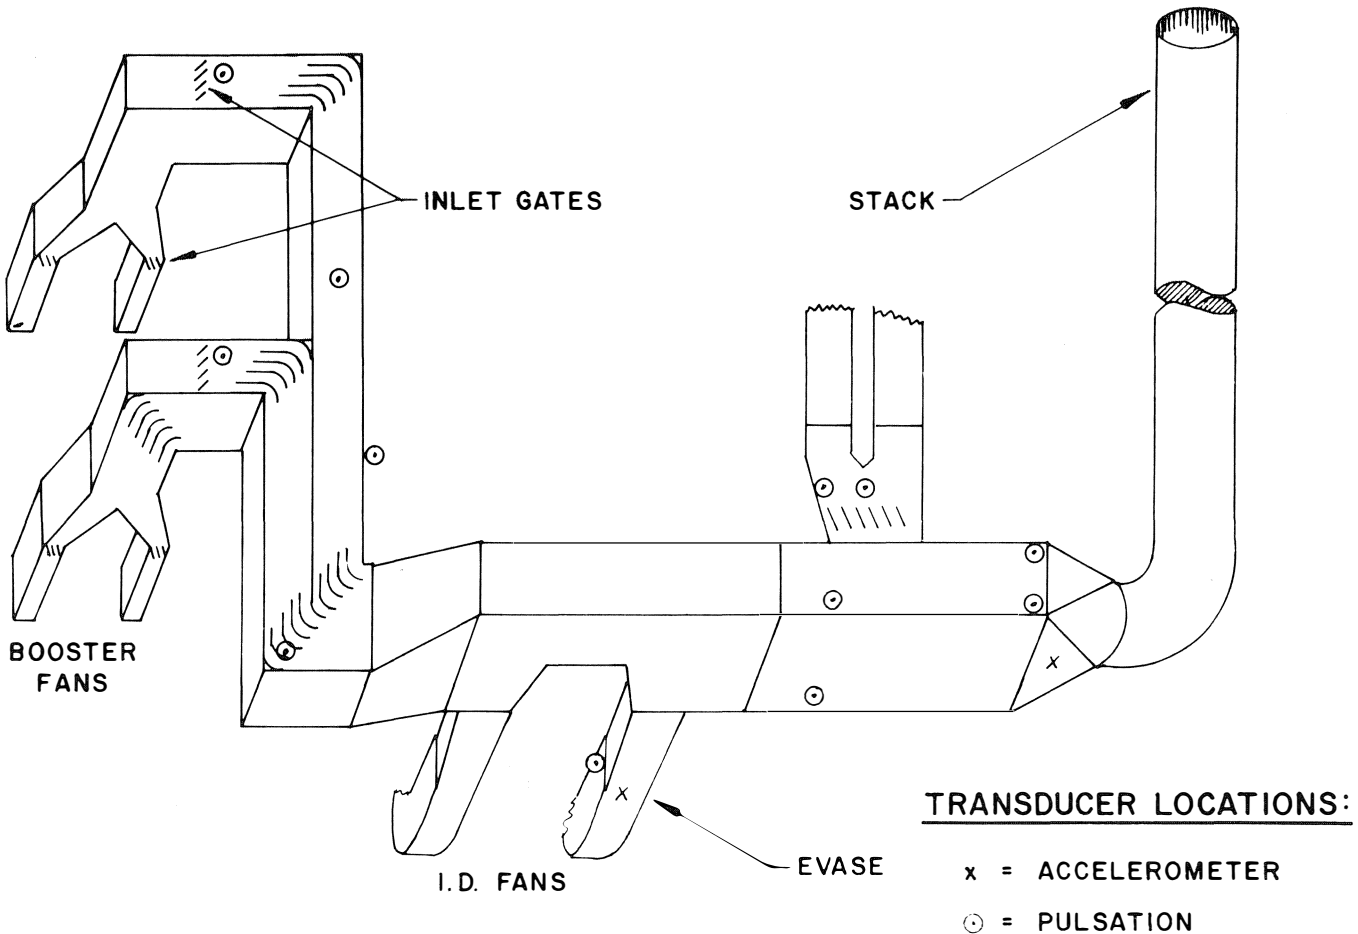
Figure 17. Exhaust Duct Schematic.

In the startup of one new installation, failures of the exhaust duct internal liner had occurred at the transition from rectangular to circular section (Figure 17) during cold flow conditions. The cracked liner was attached to a large unstiffened plate that had resonant vibrations of 90 mils at 5.76 Hz. As the pulsation levels were low (0.0015 psi), it was recommended that stiffening ribs be added to the plate. Since these modifications could not be installed for some time, an acoustical solution was also sought for cold flow operation.

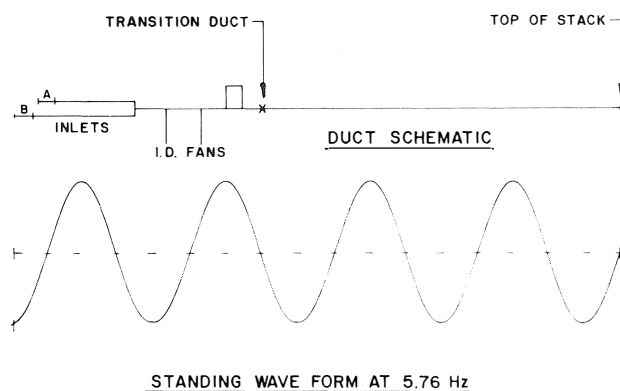
Figure 18. Seventeenth Harmonic Pulsation Mode Shape.

A two-channel spectrum analyzer was used to trace the vibration and pulsation transmission path throughout the exhaust duct system. The two-channel analyzer is well suited for this type of study as it can determine the causal relationship (coherence) between two signals. Using this technique, it was determined that the 5.76 Hz vibration was excited by acoustic pulsation and was related to many of the pulsation measurement points throughout the duct (Figure 17). The plates on opposite sides of the transition duct were also found to inflate and deflate together. This relationship suggested that an overall acoustic mode existed in the exhaust duct. The 5.76 Hz pulsation frequency was found to be the 17th harmonic of an exhaust duct fundamental frequency as the total duct length (Figure 18) corresponds exactly with 4.25 wave lengths. Acoustically modifying the system by selectively opening scrubber gates varied transition duct vibration amplitude by as much as  $\pm 40\%$ .

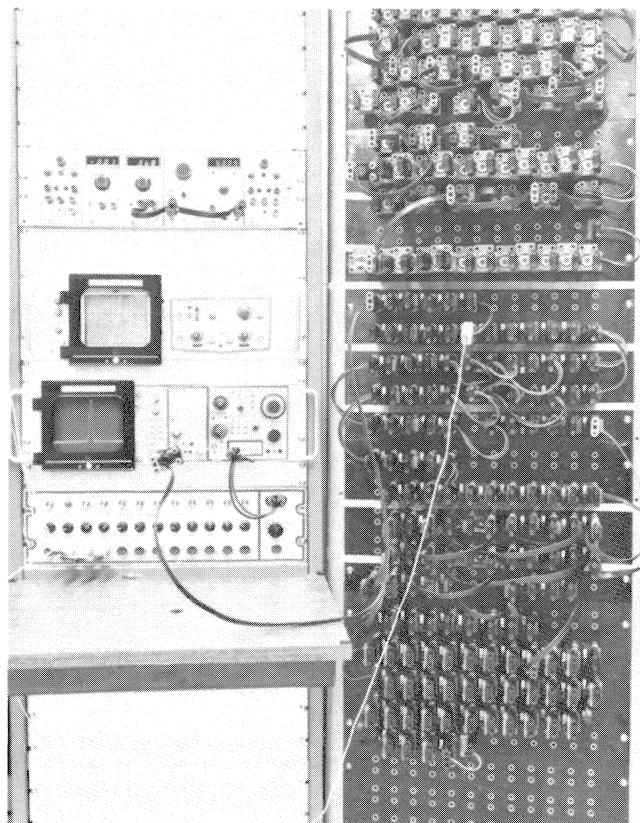
Figure 19. Electro-acoustic Analog of Duct System (Courtesy of Southern Gas Association Pipeline and Compressor Research Council.)

Duct systems can be acoustically modeled with an electronic analog (Figure 19) which has been used in designing

compressor and pump piping for over 25 years. One limiting factor in the simulation of large duct systems is the assumption of a one-dimensional model. This assumption requires that the acoustic wave lengths be long relative to duct widths. Therefore, a limit is established on the highest frequency mode that can be reliably simulated. Since many duct vibration problems occur at low frequencies, effective solutions can be developed using this technology.
