Effects of High Suction Energy in a Vacuum Tower Bottoms Pump Design

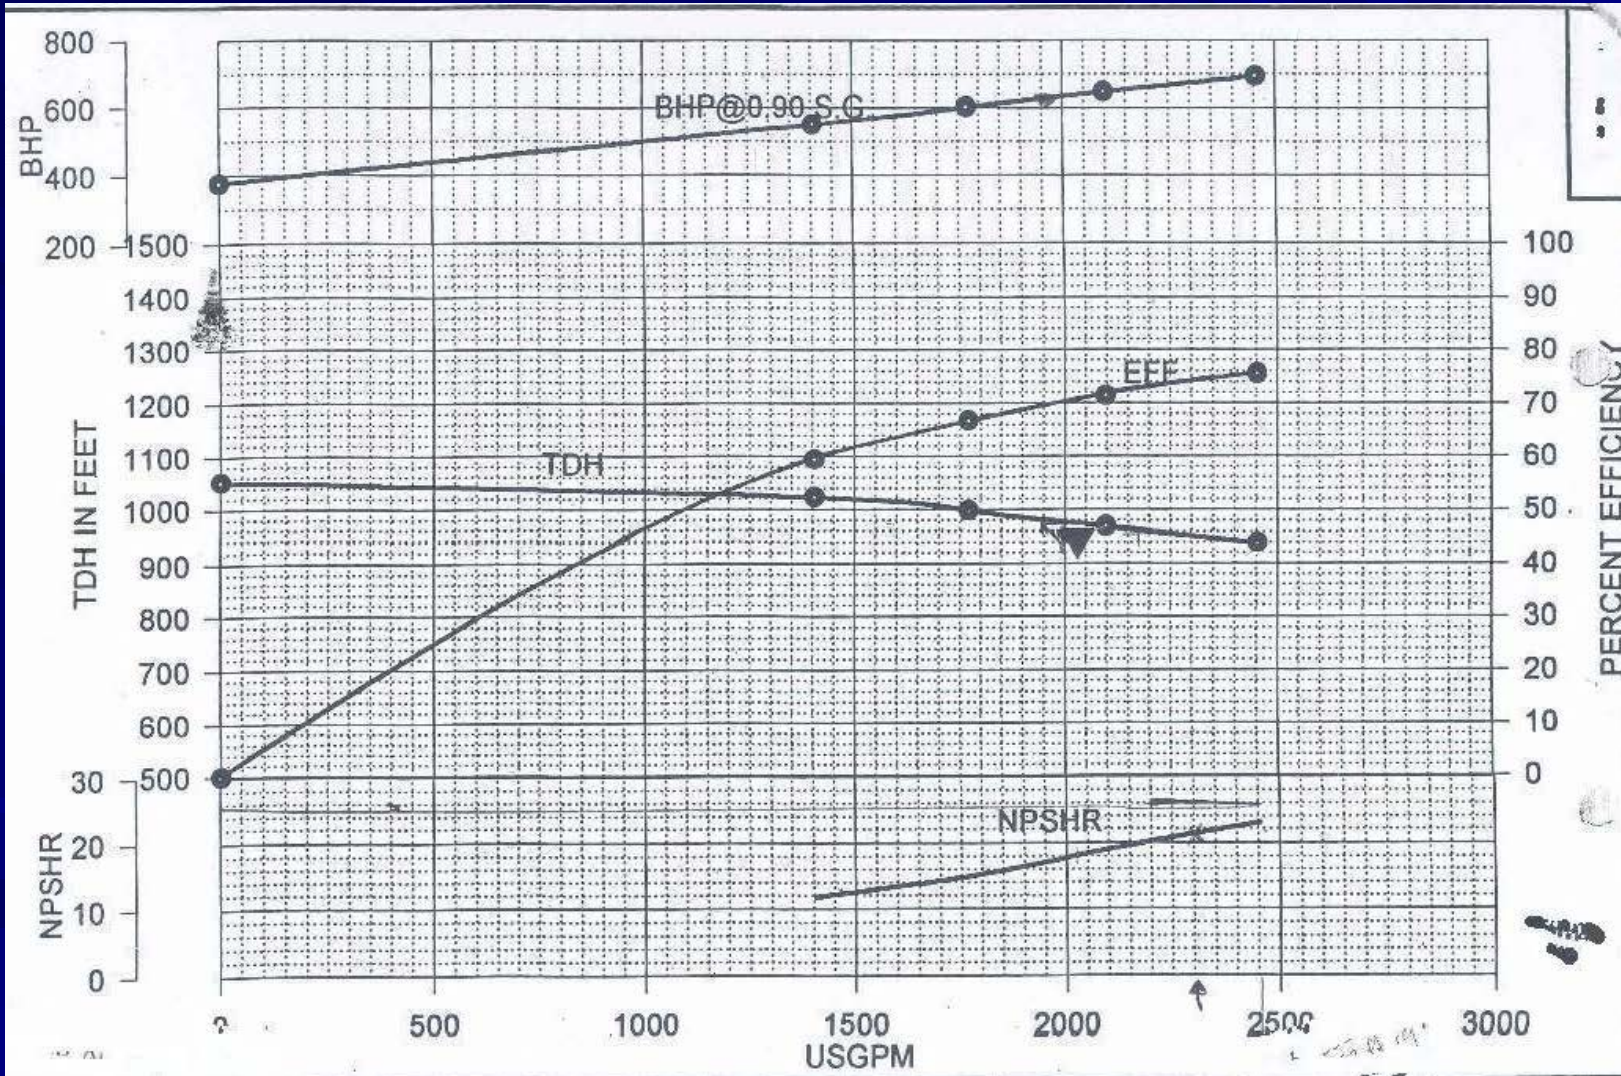
Supplied Pump Curve

- 8x10x16 Double Suction Pump
- Impeller has 5 vanes per side in a staggered pattern.
- Eye Diameter, $D_{eye} = 7.5$ inches.
- Peripheral Velocity, $U_{eye} = 117$ ft/s

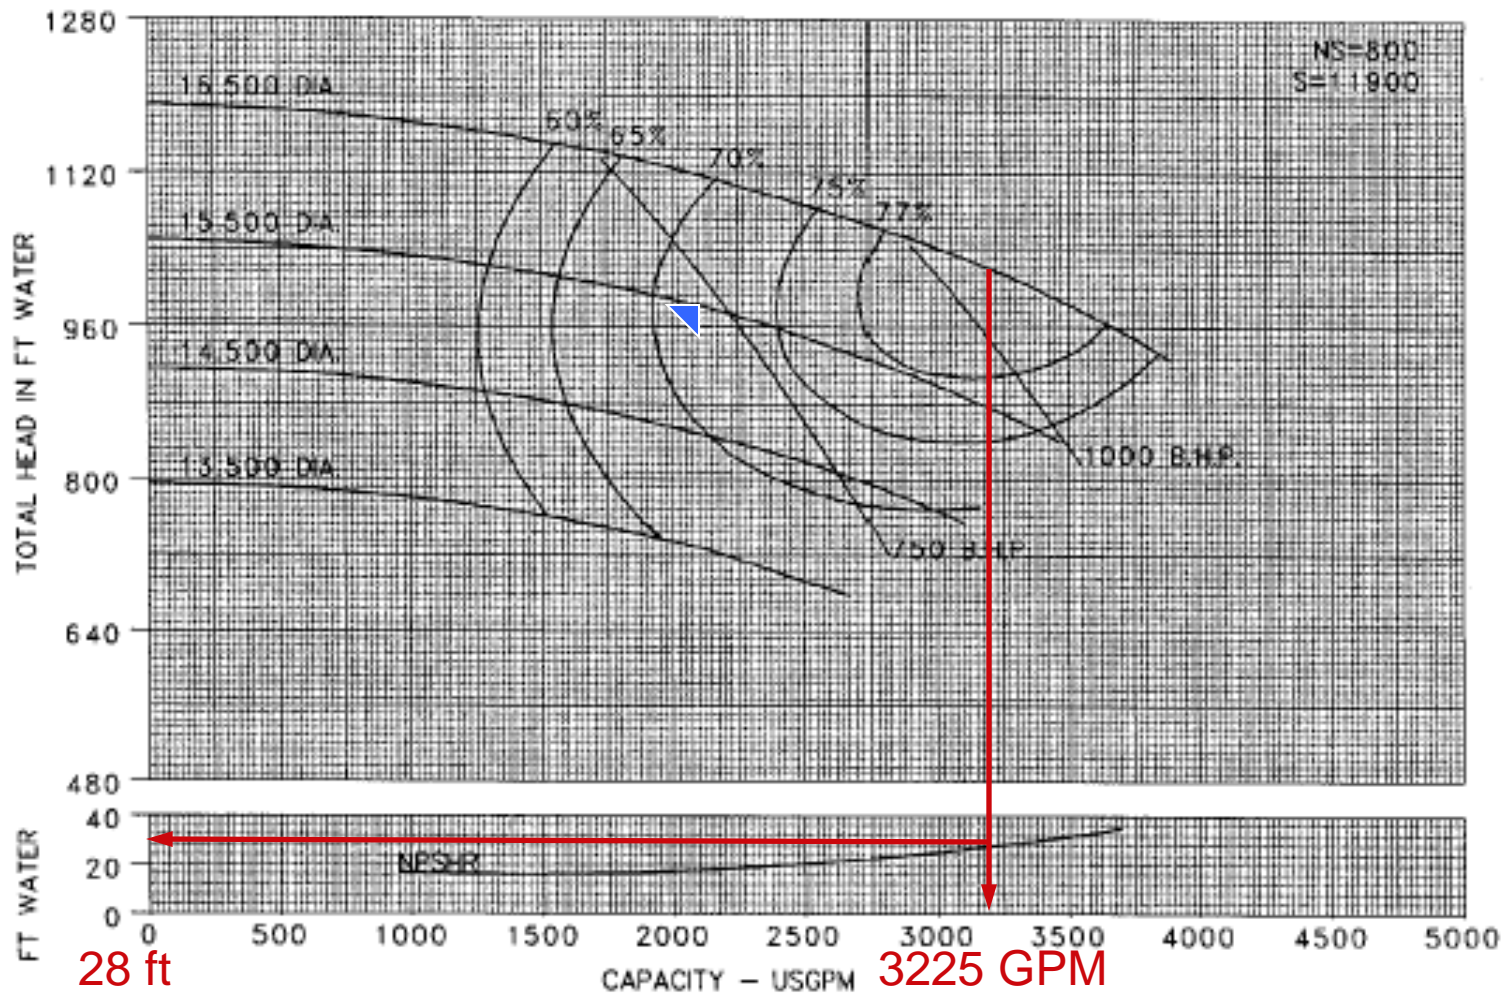
Book Curve

28 ft

3225 GPM

DRAWN	
JM	
APPROVED	
JW	
MAX. DIA.	I M P E L L E R
16.500	
MIN. DIA.	
13.000	
ACTUAL DIA.	D A T A
PART NO.	
D4805	
VOLUTE TYPE	
DOUBLE	
NO. VANES	
5	
ISSUE DATE	
07/01/80

$$N_{ss} = \frac{3580 \text{ RPM} \sqrt{(3225 \text{ GPM})/2}}{28 \text{ ft}^{3/4}}$$

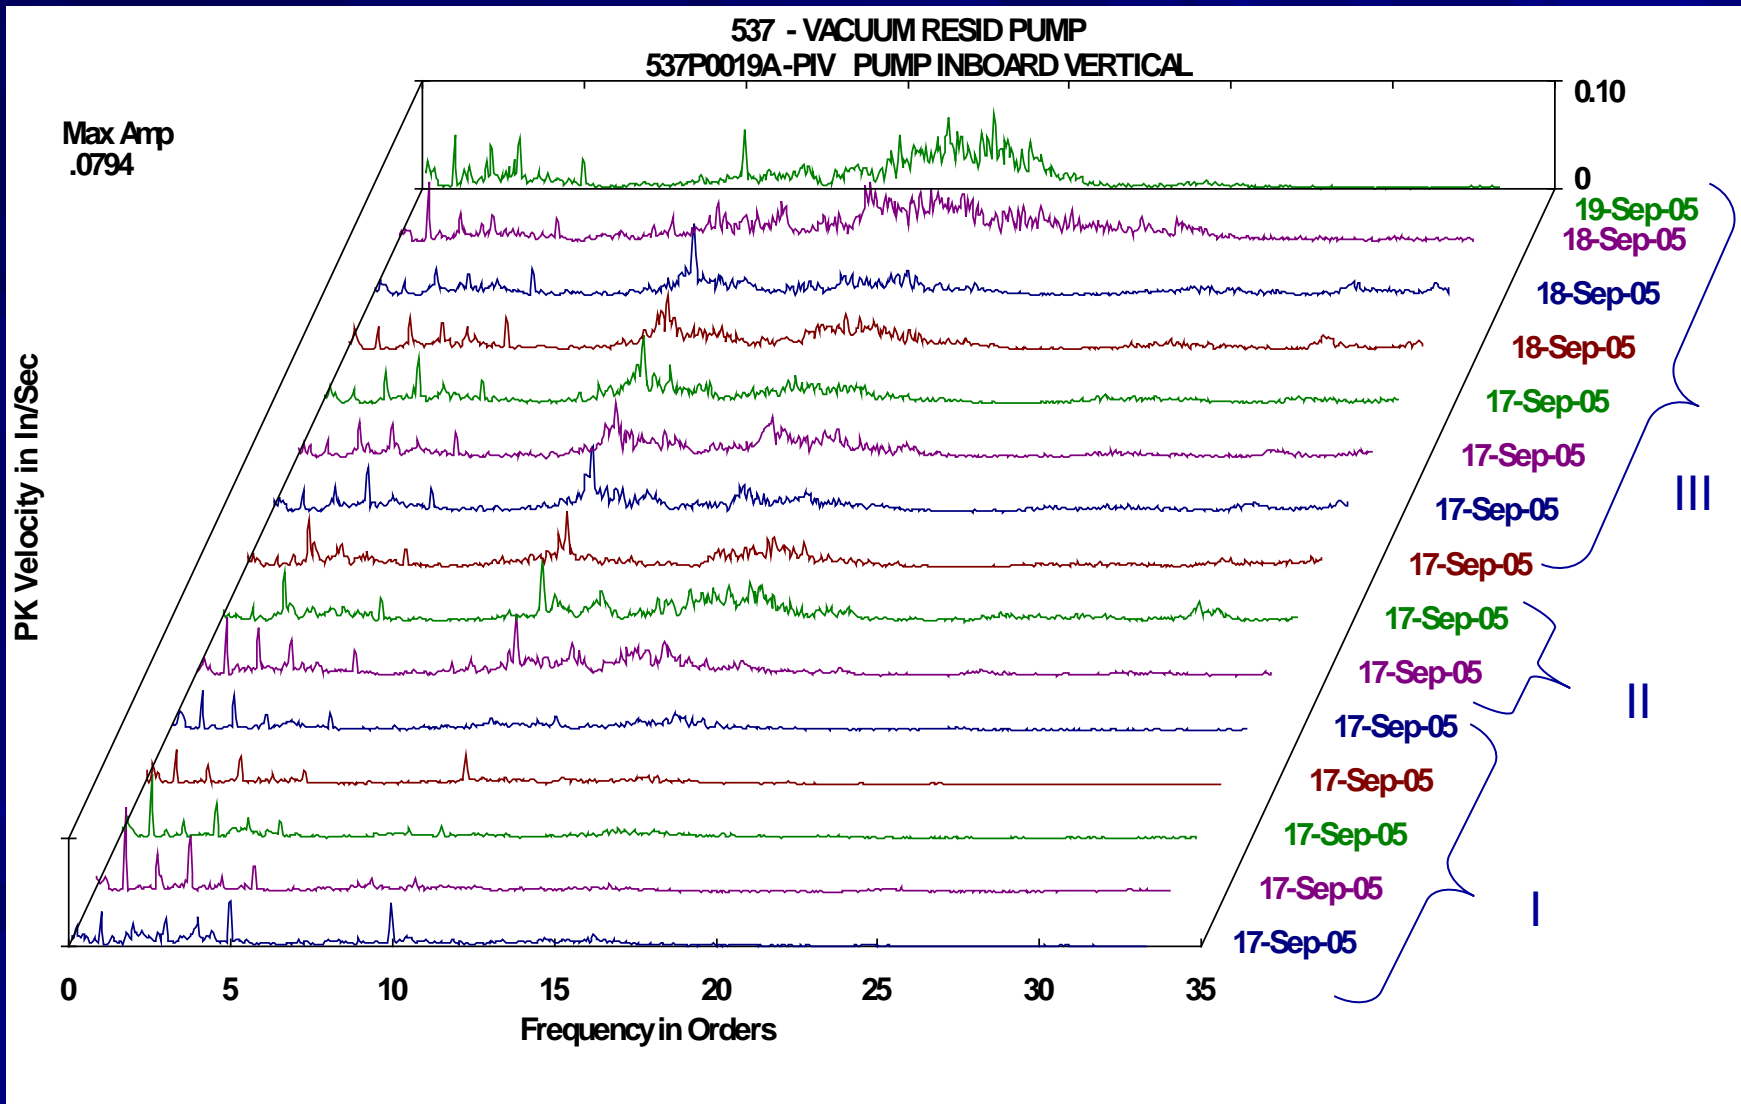
Waterfall Plot - PIV

- Waterfall plots of data taken during unit startup. The first plot is axial data and the second plot is taken on the inboard bearing in the vertical direction.
- Vacuum side is started by circulating and heating HGO to dry the tower. The HGO is sub-cooled and vacuum is not present in the tower. At around 600 degrees F, vacuum is pulled on the tower and atmospheric reduced crude is introduced.
- Points in Region I have estimated NPSH margins of 3 or greater.
- Points in Region II have margins that are estimated to be around 2. The tower is circulating under vacuum, but the bottom is sub-cooled.
- Points in Region III have margins between 1.8 and 2. The unit is operating at steady state.

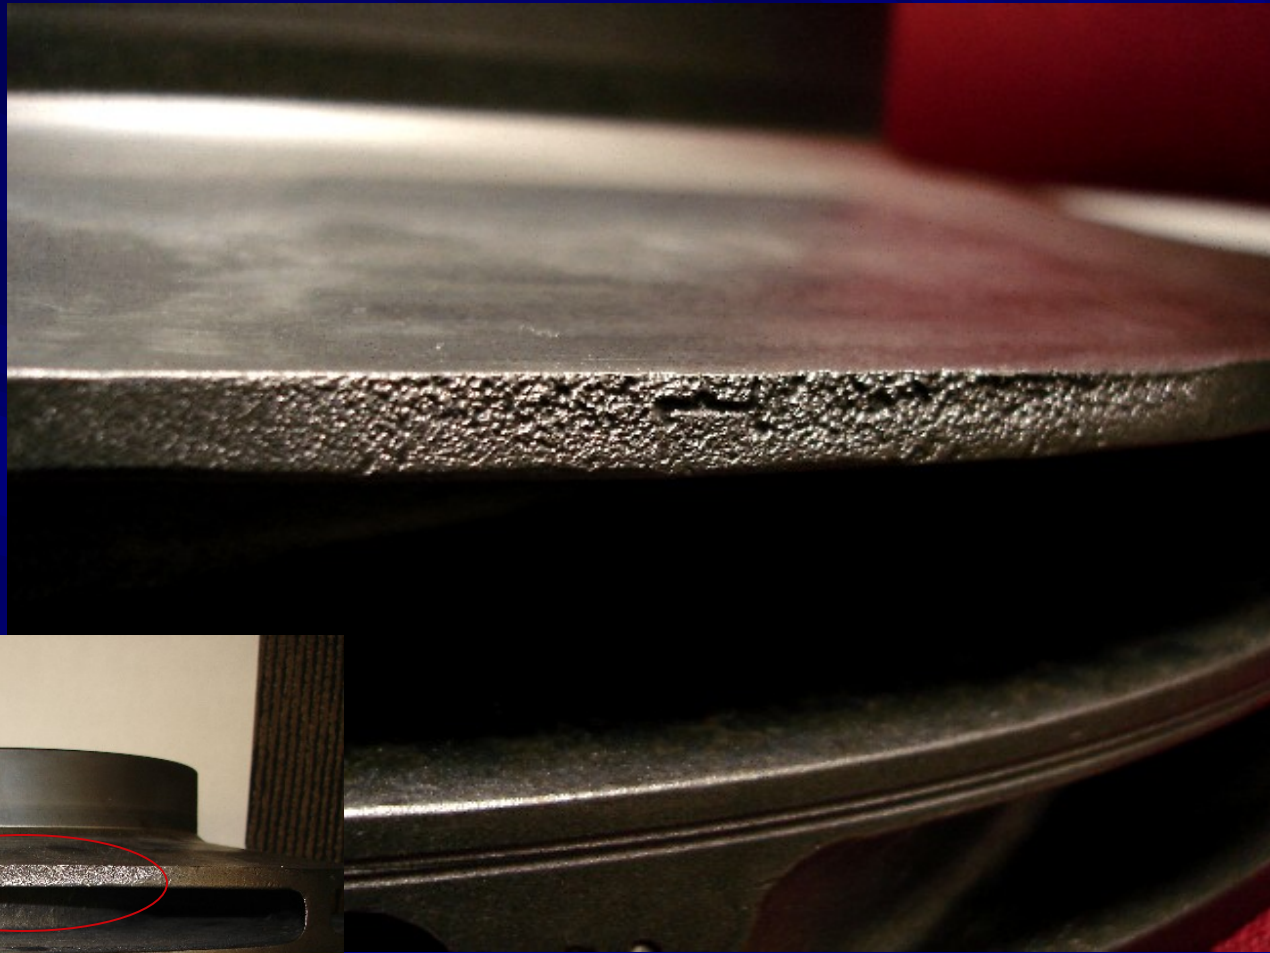
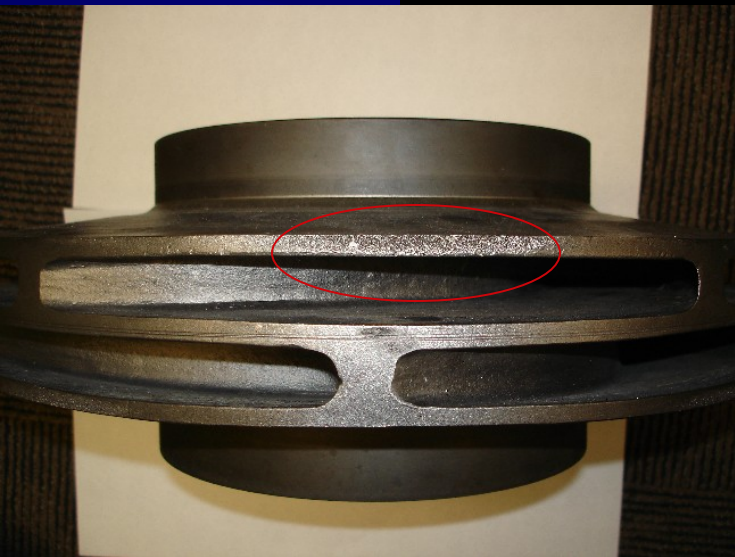
Evidence of Recirculation

- Pump audibly cavitates.
- Pump seems to operate in regions where a lower energy pump would have enough NPSH margin to suppress cavitation.
- At higher rates, pump is prone to violent axial shuttling, destroying the thrust bearings.
- Older impellers show evidence of recirculation cavitation while newer ones do not. 316 ss masks this damage.
- Primary failure modes are bearings and seals.

- Pump has an Nss of 11,810.
- Pump sized and selected to the left of BEP. Pump will experience classic cavitation before approaching BEP.
- Pump experiences recirculation cavitation at lower flows.
- Pump suction energy level is 282×10^6 . This is 57% over the very high threshold level.
- Rate has increased ~40% since commissioning of the unit.

- Rate on Unit Capped.
- Shutdown on axial position being added to pump.
- Never accept a curve that has been truncated.
- Always ensure a low energy vacuum tower bottoms pump by providing the following:
 - Low speed – 1800 RPM rather than 3600 RPM
 - Low Nss
 - Low Suction Energy
- Alternate Selections:
 - Two stage 1800 RPM pump.
 - Primary/Booster Arrangement with the bottoms pump operating at 1800 RPM.

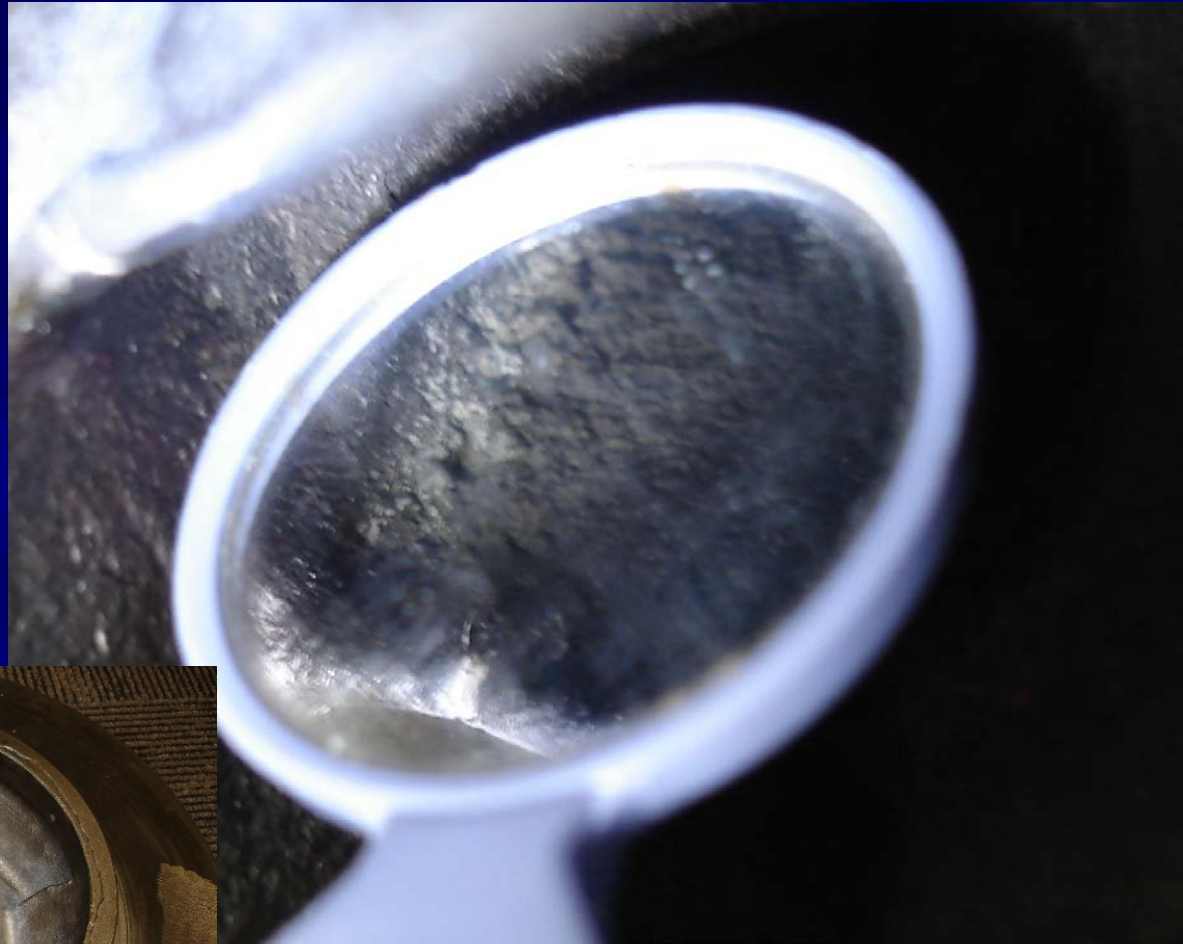
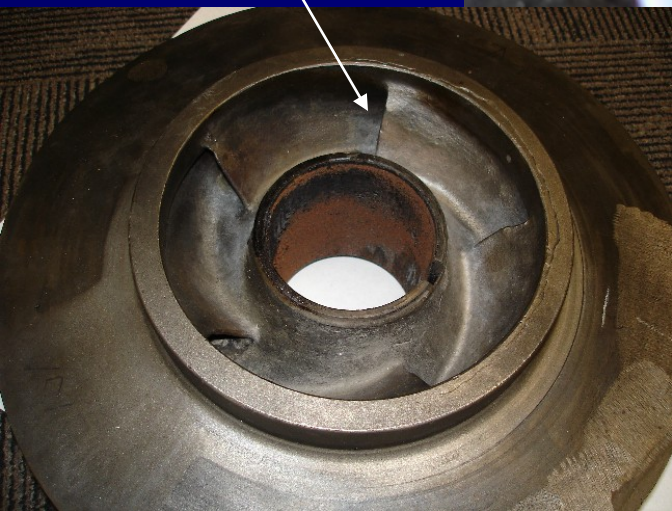
Evidence of Recirculation

View of
Underside of
Impeller
