# HYDRAULICALLY RERATING CENTRIFUGAL PUMPS TO IMPROVE RELIABILITY

## ABSTRACT

RERATE CASE STUDY 1—  
300 HP LEAN AMINE PUMPS

**RERATE CASE STUDY #2—  
700 HP HOT OIL PUMPS**

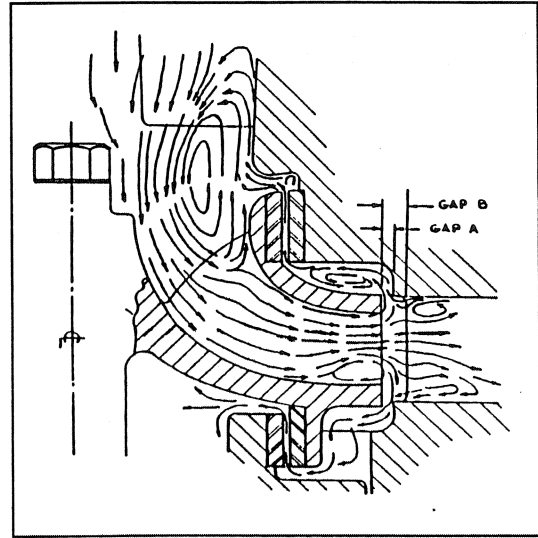
Figure 1. Secondary Flow Pattern in and Around a Pump Impeller at Off-Design Conditions.

Fraser (1981) and others have investigated the nature of internal recirculation that occurs at off-design conditions. These flow reversals, which can occur at the impeller eye or at the impeller discharge tips (Figure 1), can generate damaging pressure pulsations (Florjancic, 1993) that can limit the minimum safe flow of pump operation. Figure 2 shows how pressure pulsations related to internal recirculation are generated at low flows (Fraser, 1981). Incipient internal recirculation is the point where the centrifugal pressure field exceeds the dynamic head gradient. Comparing a high  $N_{ss}$  impeller with a low  $N_{ss}$  impeller, the reader will discover the high  $N_{ss}$  impeller has a larger impeller eye and, therefore, a correspondingly lower inlet fluid velocity than that of a lower  $N_{ss}$  impeller. At lower flows and related lower inlet fluid velocities, the dynamic head falls below the centrifugal pressure, resulting in suction recirculation. This explains why impellers with low inlet velocities and high suction specific speeds are more susceptible to internal recirculation. In high energy pumps (> 250 hp/stage), internal recirculation can impart damaging levels of fluid energy in the impeller, shaft, bearings, and casing.

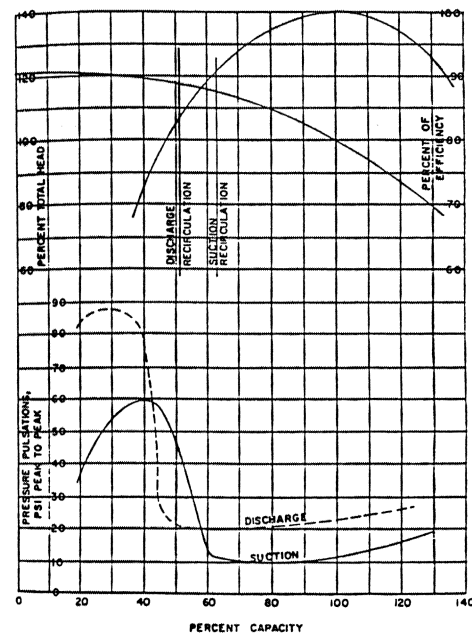
Figure 2. The Effect of Off-Design Flow on Pressure Pulsations Levels.

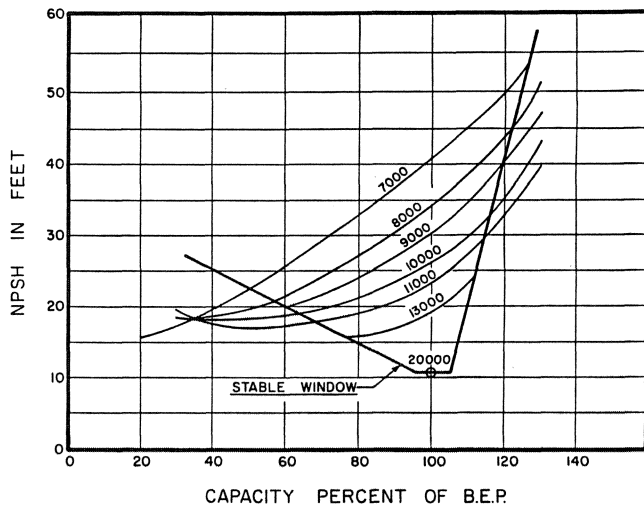
Figure 3. Stable Operating Window Versus Suction Specific Speed.

There are numerous methods available to determine the MCSF, such as those proposed by Heald (1996), Fraser (1981), and others. One common conclusion that can be drawn from these methods is that an impeller's  $N_{ss}$  has a significant impact on the useful flow range of the pump. The higher the impeller's  $N_{ss}$ , the narrower its operating range. Figure 3 (Lobanoff and Ross, 1992) clearly illustrates the effect of  $N_{ss}$  on the width of the operating flow window. For example, a pump with an  $N_{ss}$  of 8,000 can be operated in a stable manner from about 60 percent to 120 percent of its BEP, while a pump with an  $N_{ss}$  of 13,000 can only be operated in a stable manner from about 80 percent to 110 percent of BEP. (Keep in mind, Figure 3 is only presented as a general example and cannot be applied widely.) Hallam (1982) has suggested a practical upper limit of 11,000 for  $N_{ss}$  when selecting new general duty process pumps. Dufour and Nelson (1993) recommend boiler feed and condensate pumps and general hydrocarbon pumps should have  $N_{ss}$  values in the 8,500 to 11,000 range.

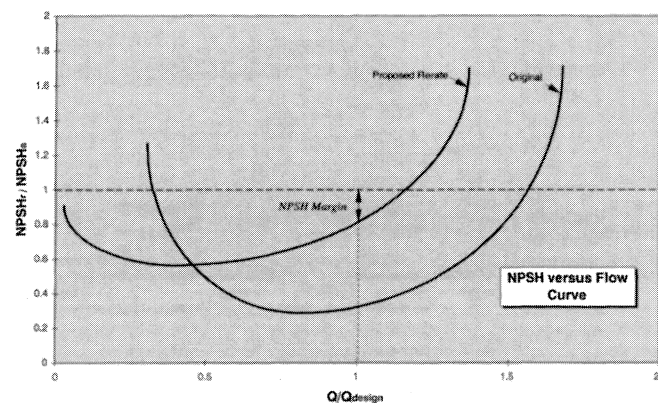
Figure 4. Example of a Viable Hydraulic Rerate.

Of the options mentioned above, the rerate option is usually the most appealing, because it is cheaper than buying a new pump, it does not require an expensive spill-back line, and it does not waste horsepower at flows below the original minimum flow point. Performing a rerate requires that an impeller capable of the desired performance and with an acceptable  $N_{ss}$  be available. In addition, the suction system must have excess  $NPSH_A$  to allow the new, lower-flow impeller to be used. If you remember, it was stated that internal recirculation occurs when the centrifugal pressure field exceeds the dynamic (or velocity) head gradient. Suction recirculation, for example, occurs because the inlet velocity falls to critical levels at lower flows. So, in general, to improve hydraulic stability, inlet and outlet impeller fluid velocities must be increased. At the impeller eye, increasing the average fluid velocity means decreasing the eye area and increasing the  $NPSH_R$ . Figures 4 and 5 show two different plots of normalized  $NPSH_R$  versus flow. Figure 4 shows a proposed impeller with excess  $NPSH$  margin ( $NPSH_A - NPSH_R$ ) and Figure 5 shows a proposed impeller with little or no  $NPSH$  margin. The impeller depicted in Figure 4 could be replaced with a better fitting impeller because of the excess suction head margin available, but the impeller depicted in Figure 5 could not be rerated.

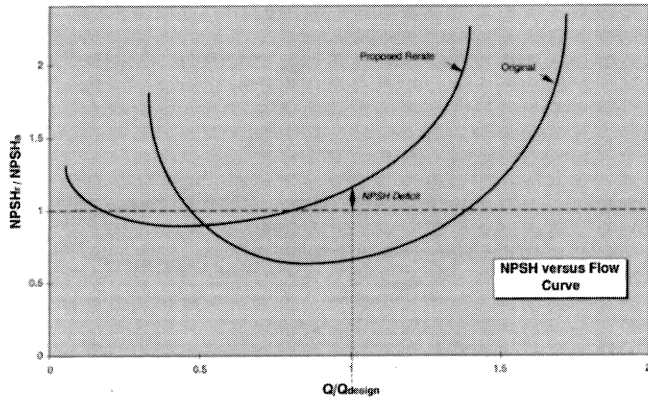
Figure 5. Example of a Nonviable Hydraulic Rerate.

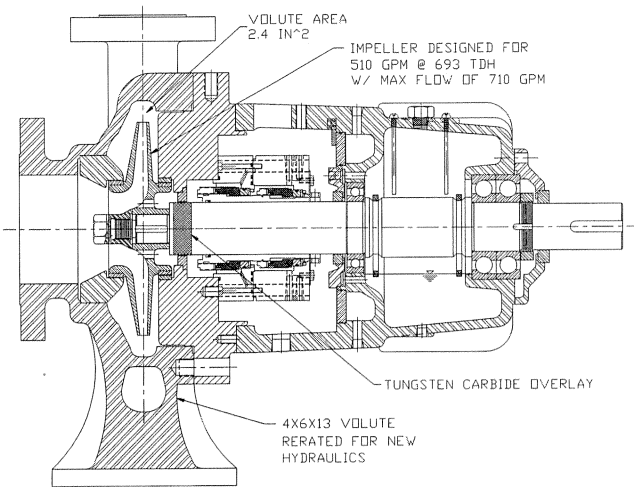
Figure 6. Cross Section of a Typical Hydraulic Rerate with Power End Upgrade.

Figure 6 shows a cross section of a typical pump rerate. It can be seen that the original pump case, impeller shaft, and mechanical seal are unaffected by the rerate. The basic idea is to fit an impeller with a lower flow rating inside an oversized pump casing. To accommodate a smaller impeller, oversized case wear rings are used. In addition to these changes, the volute throat area(s) have to be matched to the new impeller. This is done by cutting out the original volute lips and welding in custom designed volute lips. This simple, straightforward design provides a cost-effective solution for chronic hydraulic instabilities.

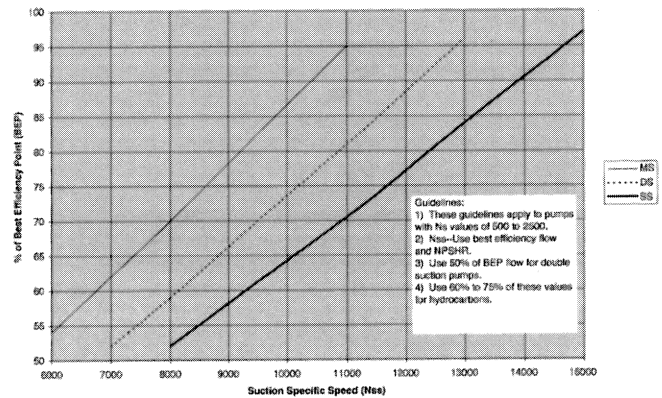
Figure 7. Minimum Flow Guidelines for Centrifugal Pumps ( $N_s = 500$  to  $2500$ ).

The frequent failures of the shafts due to fatigue, noisy operation of the pumps, and broad frequency content in the recorded vibration spectra all seemed to point to a hydraulic instability problem. To confirm this, the  $N_{ss}$  for the pumps was calculated. It was a surprise to discover the  $N_{ss}$  was 16,600, which is well above the recommended limit of 11,000 for general duty process pumps. Referring to Fraser's (1981) guidelines, the reader can see that single suction impellers (corresponds to line "ss" in Figure 7) with  $N_{ss}$  values above 15,000 have no turndown capabilities. This means these pumps must be operated at their BEP to avoid internal recirculation. To make matters worse, it was also discovered the pumps were normally operated at 31 to 36 percent of their BEP. It is obvious these pumps had no chance to operate reliably. (Note: While the original pump curves contained no caveat concerning operation well below the best efficiency point, current sales performance curves from the original equipment manufacturer now recommend a minimum flow of 1000 gpm, or about 71 percent of the BEP.)

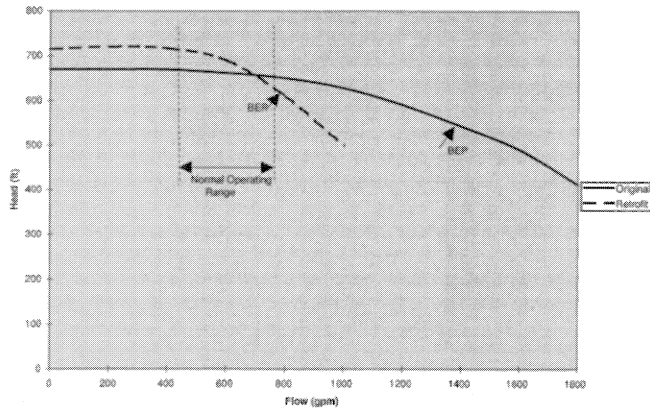
Figure 8 shows the original and proposed performance curves, which illustrate the improvement in hydraulic fit. The BEP of the proposed impeller is closer to the actual flow required by the process. The combination of improved hydraulic fit and lower  $N_{ss}$  value made the proposal attractive. (APPENDIX A describes the thought processes and analytical methods, typically used in a hydraulic rerate, for the selection of a suitable impeller and volute throat area.)

Figure 8. Comparison of the Original and Proposed Performance Curves (Case Study #1).

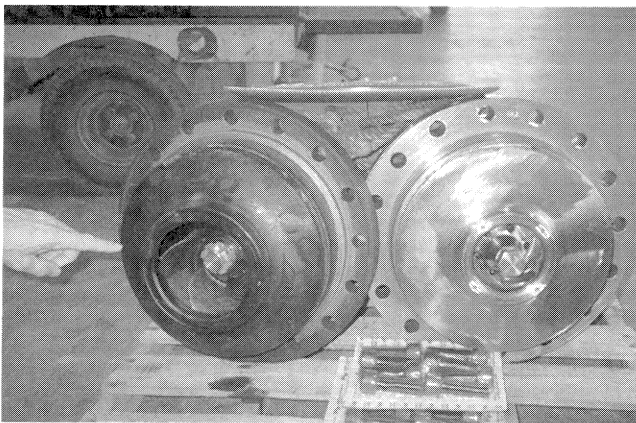
Figure 9. Side by Side Comparison of Original and Rerated Impellers (Case Study #1).

A successful hydraulic rerate begins with the selection of an impeller design that best satisfies the flow, differential pressure, and  $NPSH_A$  requirements for the application. Referring to Figure 9, the reader can easily distinguish the significant differences in the existing and new impeller, noting especially the impeller eyes. Due to the reduction requirement of flow, the impeller eye area decreased from 22 in<sup>2</sup> to 13.2 in<sup>2</sup>, thereby reducing the suction specific speed value and increasing the reliable operating range of the pump. This new and smaller optimal impeller design meant that the impeller's physical geometry no longer fit the existing volute, so changes had to be made. Due to the need to maintain the impeller to volute centerline, the suction and discharge wear ring journals in the original design became sufficiently short of achieving the desired 80 percent wear ring overlap. Therefore, the case and cover wear ring areas were redesigned to move toward the volute centerline, while maintaining their original fits (Figure 6). Additionally, the impeller width and bore lengths were sufficiently shorter than the original impeller. To maintain the centerline arrangement, the shaft locating shoulder had to be modified, along with the impeller journal diameter, in order to fit the smaller impeller bore.

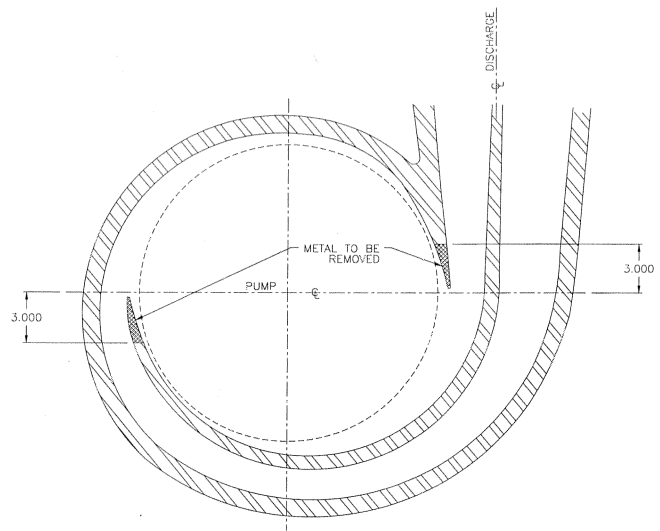
Figure 10. Typical Volute Tongue Removal Detail.

An important aspect of this rerate involved matching the volute area to the new impeller hydraulics, meaning that the volute throat would have to be minimized from its original cast area of 5.0 in<sup>2</sup>, to that of 2.4 in<sup>2</sup>. (Refer to APPENDIX A for additional information on how the volute throat area was determined.) The general idea is to remove as much existing volute cutwater as practical, so that the progression of fluid velocity is consistent from the initial cutwater (Figure 10), to the point of full pressure development prior to exiting the nozzle at full rated capacity. To enhance the more uniform velocity reduction, the manufacturer selected a point at which the least amount of disturbance to velocity would occur and removed the "long" volute up to this point. Correspondingly, the newly engineered volute was inserted and welded into place following ASME Section IX weld procedures, necessitating that specific preheat, interpass, and post heat specifications would be followed (Figure 11). The new volute insert (Figure 12) was manufactured from mill certified material matching the original cast material, and was machined to provide full weld penetration from the front (top) side on all three edges. While the "B" gap is a primary factor in creating optimum efficiencies, the primary goal of the rerate was to maintain the volute area required for the actual pumping conditions. This resulted in a "B" gap of 14 percent, essentially due to the impeller's final trim diameter. The shorter of the two volute cutwater's was also cutback, as previously described, to establish a premier velocity reduction surface for the new volute, and to ensure an integral foundation for the root of the new volute lip. The interfaces between the cast volute wall and the manufactured volute tongue are not in machinable locations, therefore much grinding was required by an experienced mechanic to remove weldments that did not create uniformity, and to alert the welder for additional filler metal when location templates did not match. The final volute lip ends were located exactly 180 degrees apart from each other to further promote radially hydraulic balance (Figure 11).

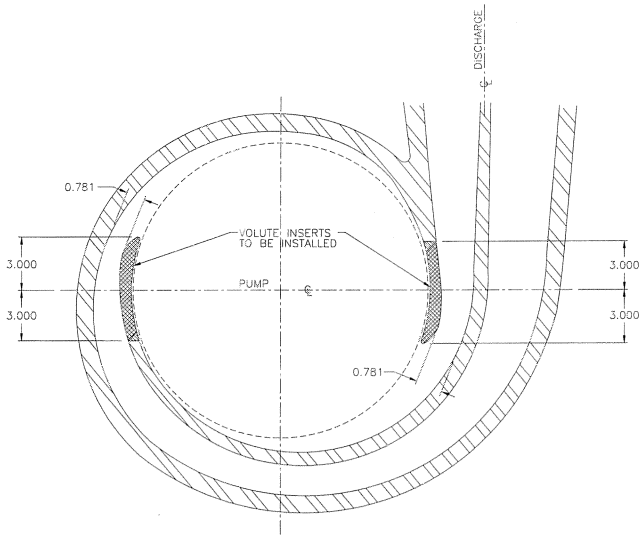
Figure 11. Typical Detail of Modified Volute Tongue Installation.

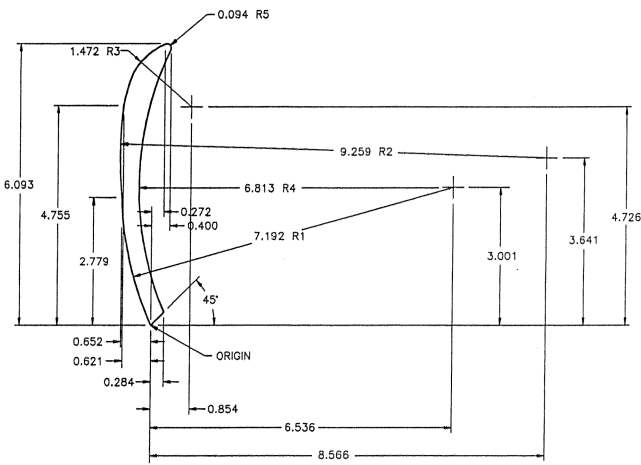
Figure 12. Typical Detail of Manufactured Volute Tongue.

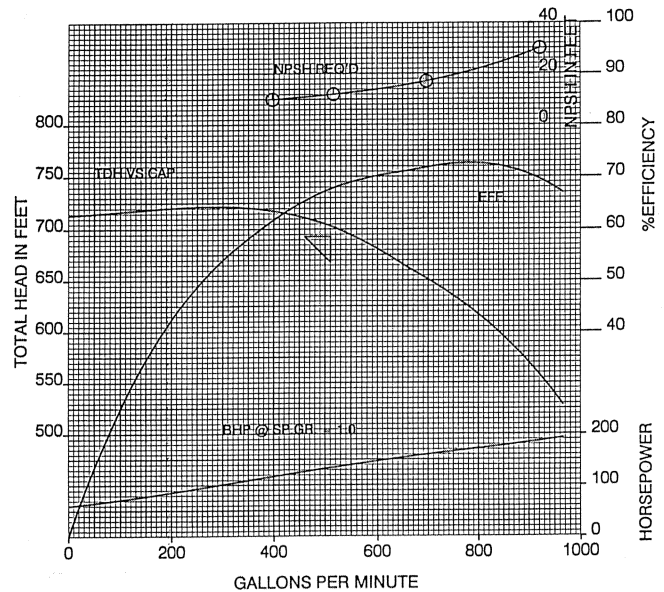
at differential pressure values would be met with calibrated gauging, driver, and instrumentation. By reviewing Figure 13, it can be seen that at 3570 rpm, the rated flowrate and differential pressure were met, with a corresponding vibration level of .13 in/sec.  $NPSH_R$  at full capacity was well within the two feet of  $NPSH$  margin previously established. Subsequent to the factory testing, the pump was then commissioned in the refinery for the real test. Obviously, the pump was now secured to a grouted base while sufficient suction and discharge piping forces were imposed. Reading like a script, the parameters of flow and discharge were achieved. Vibration levels were monitored and proved satisfactorily in the range of .12 IPS. As an added benefit, operators now notice both pumps' flows are much more stable than before the rerate. As expected, the mechanical reliability has improved significantly. These pumps have not experienced a failure since their installation on August 15, 1996.

Figure 13. Actual Performance Curve of One of the Rerated Pumps (Case Study #1).

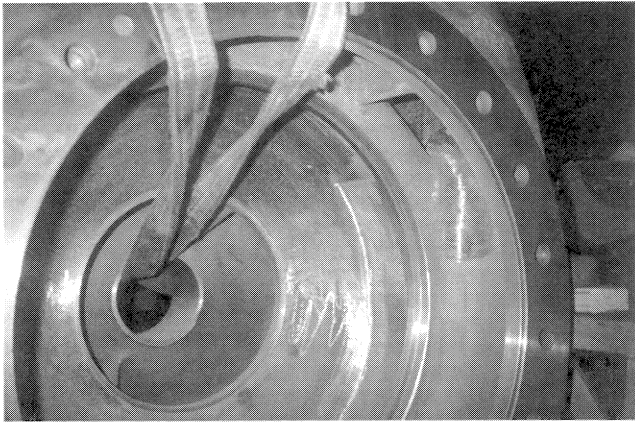
Figure 17. Transition Region of Modified Volute (After).

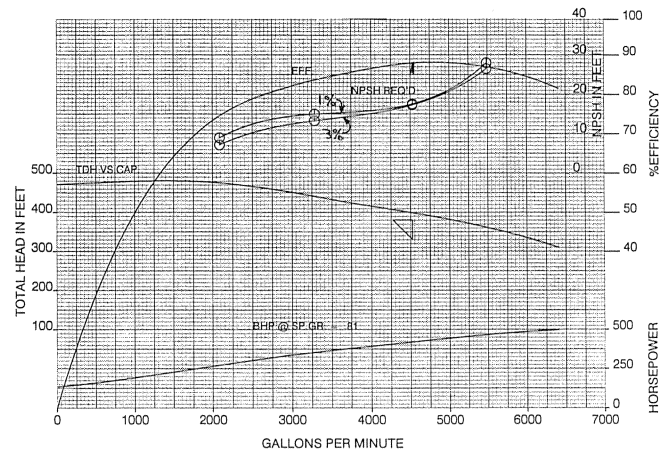
Performance testing at the factory was necessary to prove that the rerate and modifications were satisfactory. By reviewing the actual pump test data, Figure 18, it can be seen that at 1780 rpm, the capacity at differential was met. The efficiency of the pump exceeded the estimated 82 percent efficiency by 4.7 percent, and the corresponding vibration at 4529 gpm was .09 to .11 IPS. The two pumps have not experienced a failure since their installation in September 1995. Operators have noticed the pumps are much quieter than before and that pressure pulsations have been significantly reduced.

Figure 18. Performance Curve from One of the Rerated Double Suction Pumps (Case Study #2).
