TAMU Project

**Energy Consumption Data Quality Assurance/Quality
Control Assessment Report for the
Month of November 2016**

**Utility & Energy Services
Division of Administration
Texas A&M University**

December 2016

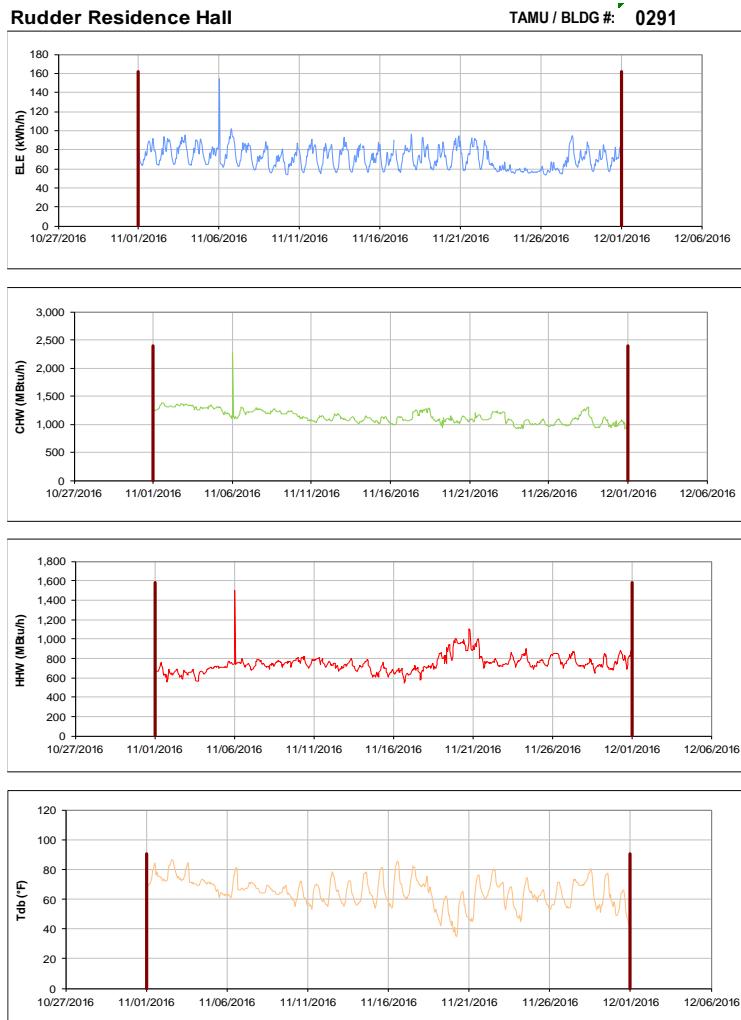
Figure III-4 Hourly Whole Building Electricity, Chilled Water, and Hot Water Consumption for Rudder Residence Hall during the Month of November 2016 and the Corresponding Hourly Outdoor Dry Bulb Temperature for College Station, TX

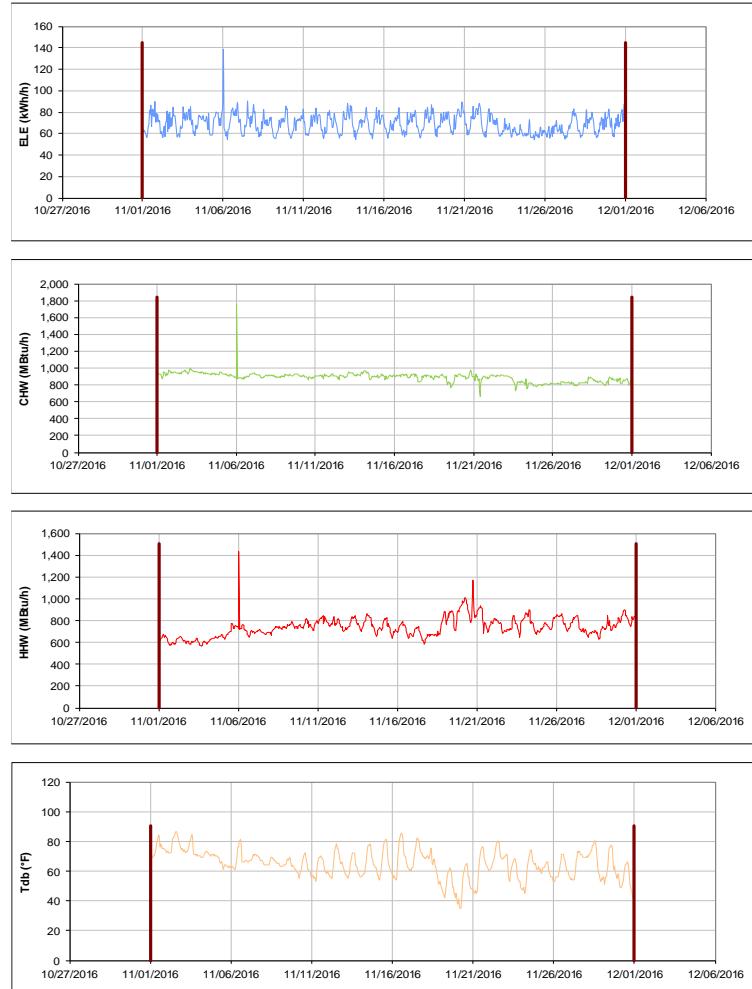
TAMU / BLDG #: 0294

Figure III-7 Hourly Whole Building Electricity, Chilled Water, and Hot Water Consumption for Lechner Residence Hall during the Month of November 2016 and the Corresponding Hourly Outdoor Dry Bulb Temperature for College Station, TX

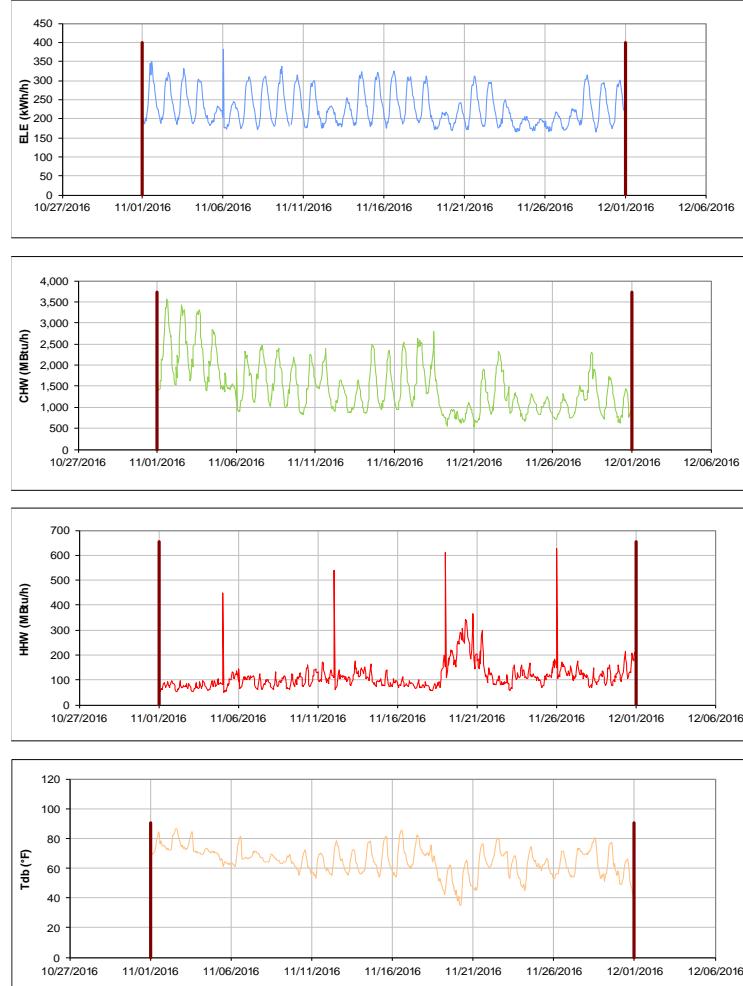
TAMU / BLDG #: 0353

Figure III-10 Hourly Whole Building Electricity, Chilled Water, and Hot Water Consumption for Bright Aerospace Building during the Month of November 2016 and the Corresponding Hourly Outdoor Dry Bulb Temperature for College Station, TX

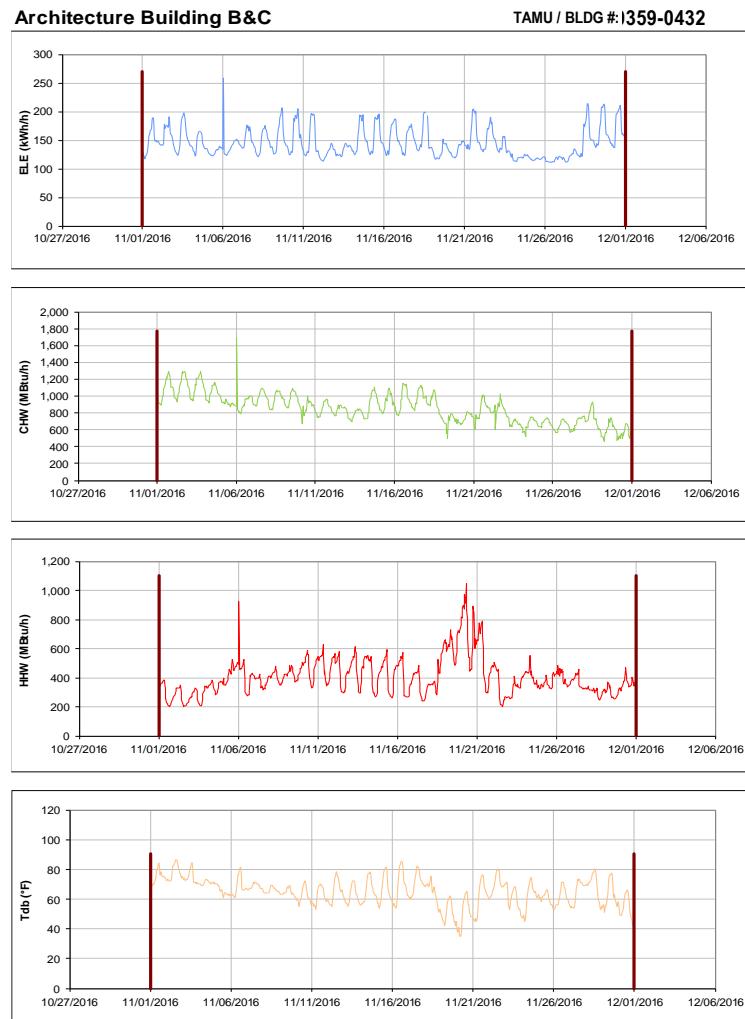
Figure III-12 Hourly Whole Building Electricity, Chilled Water, and Hot Water Consumption for Architecture Building B&C during the Month of November 2016 and the Corresponding Hourly Outdoor Dry Bulb Temperature for College Station, TX

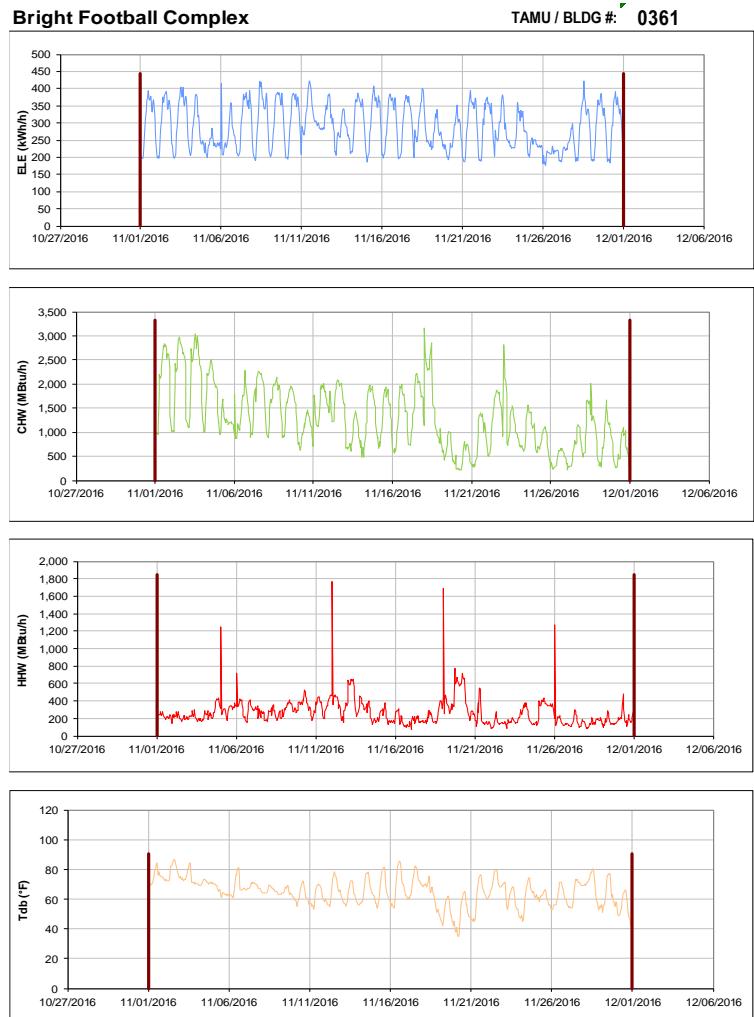
Figure III-15 Hourly Whole Building Electricity, Chilled Water, and Hot Water Consumption for Bright Football Complex during the Month of November 2016 and the Corresponding Hourly Outdoor Dry Bulb Temperature for College Station, TX

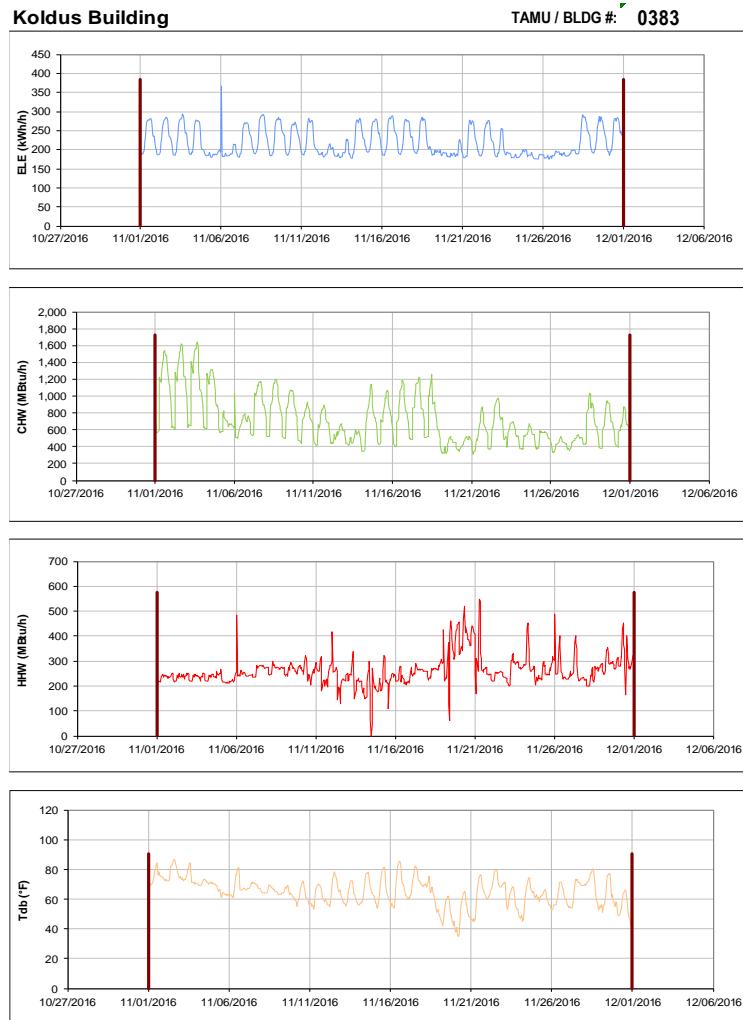
Figure III-18 Hourly Whole Building Electricity, Chilled Water, and Hot Water Consumption for Koldus Building during the Month of November 2016 and the Corresponding Hourly Outdoor Dry Bulb Temperature for College Station, TX

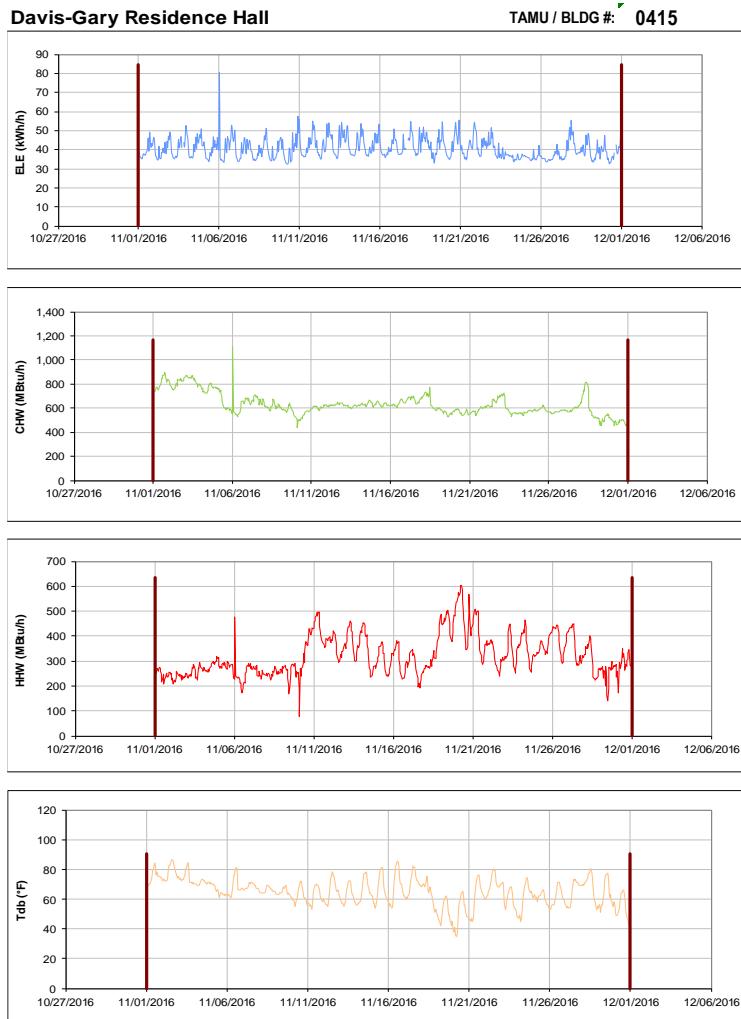
Figure III-42 Hourly Whole Building Electricity, Chilled Water, and Hot Water Consumption for Davis-Gary Residence Hall during the Month of November 2016 and the Corresponding Hourly Outdoor Dry Bulb Temperature for College Station, TX

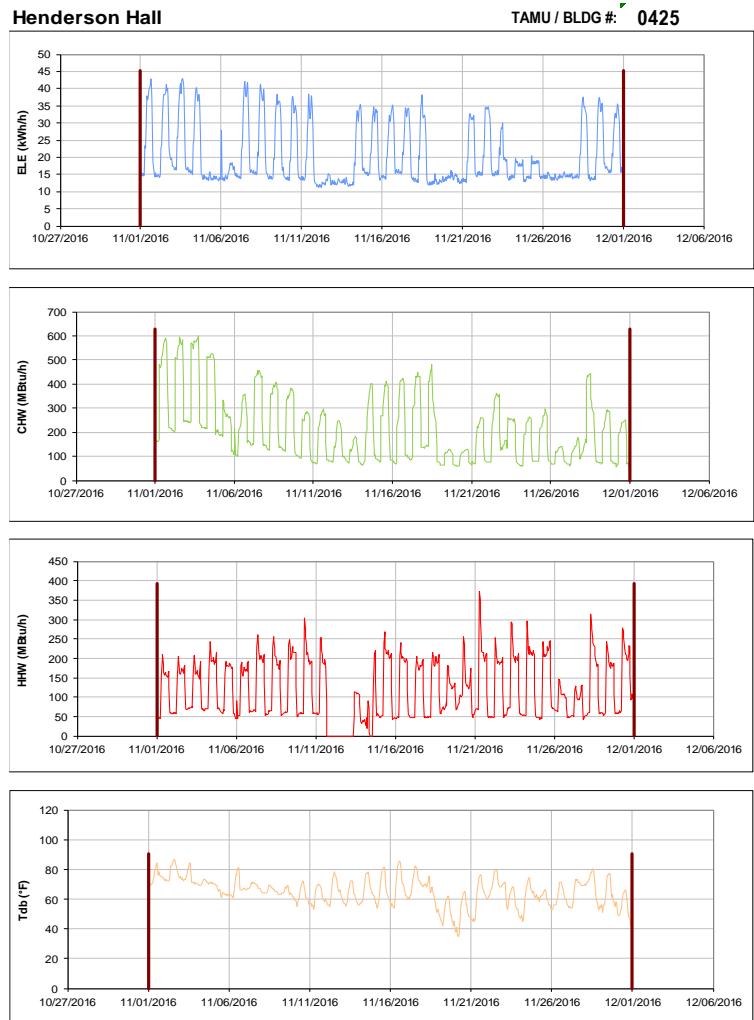
Figure III-47 Hourly Whole Building Electricity, Chilled Water, and Hot Water Consumption for Henderson Hall during the Month of November 2016 and the Corresponding Hourly Outdoor Dry Bulb Temperature for College Station, TX

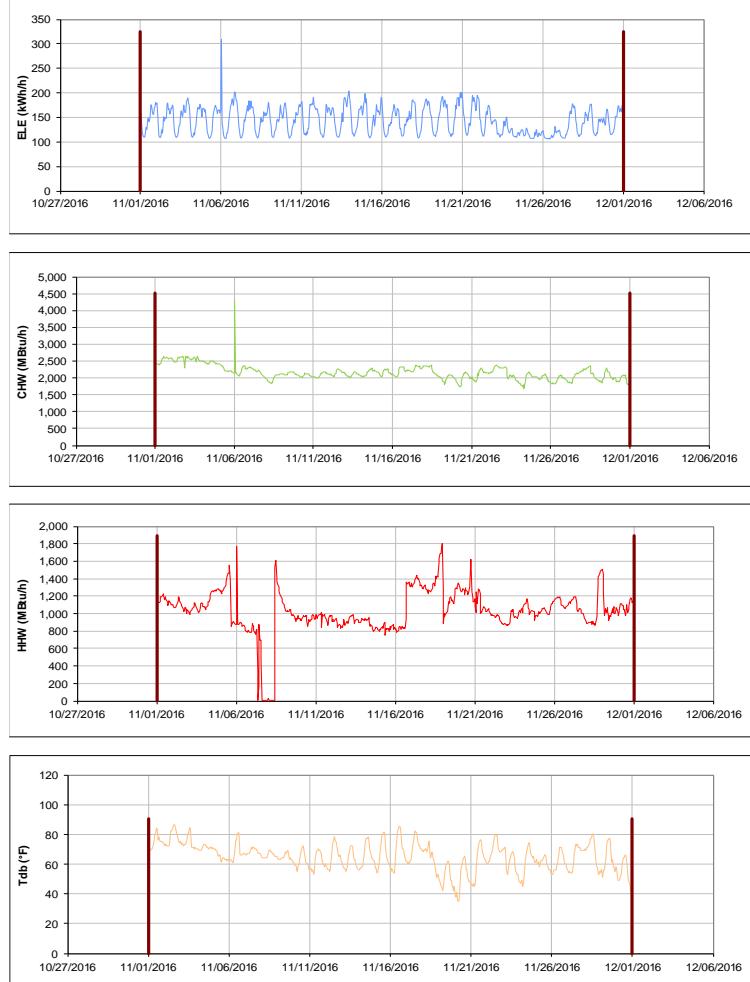
TAMU / BLDG #: 0433

Figure III-51 Hourly Whole Building Electricity, Chilled Water, and Hot Water Consumption for Mosher Residence Hall during the Month of November 2016 and the Corresponding Hourly Outdoor Dry Bulb Temperature for College Station, TX

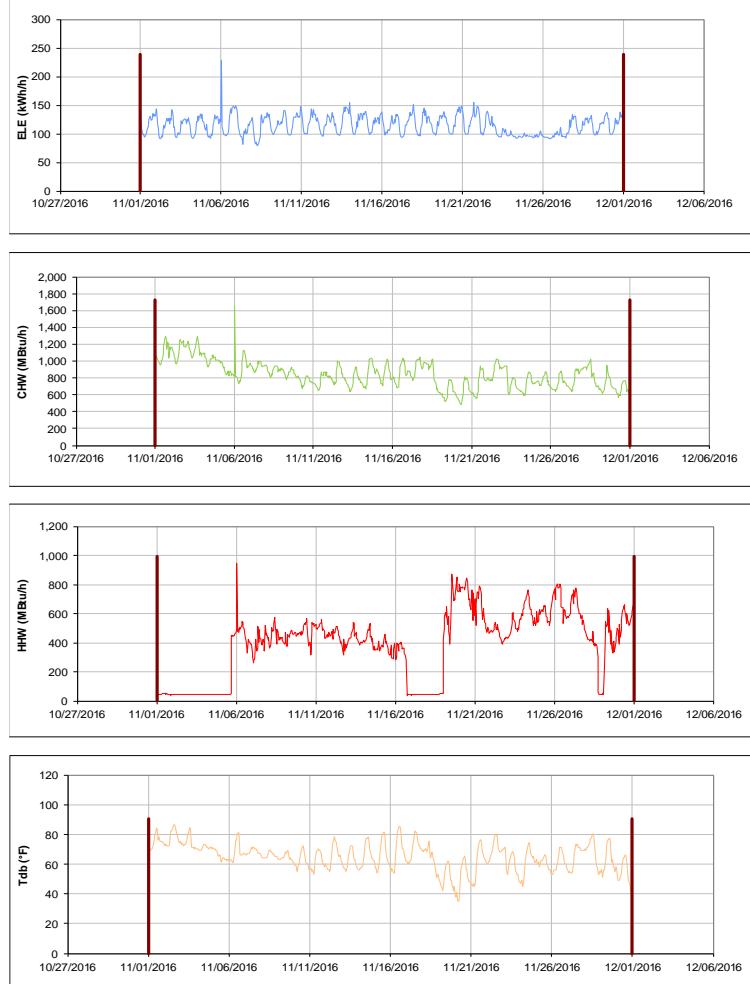
TAMU / BLDG #: 0441

Figure III-53 Hourly Whole Building Electricity, Chilled Water, and Hot Water Consumption for Krueger Residence Hall during the Month of November 2016 and the Corresponding Hourly Outdoor Dry Bulb Temperature for College Station, TX

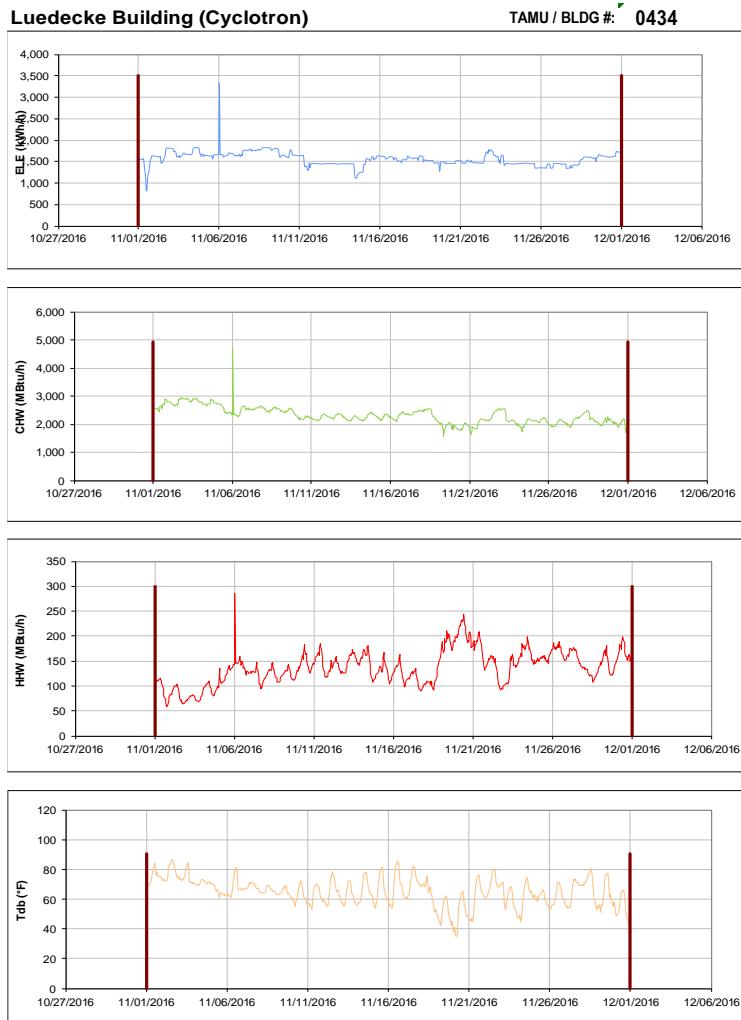
Figure III-56 Hourly Whole Building Electricity, Chilled Water, and Hot Water Consumption for Luedcke Building (Cyclotron) during the Month of November 2016 and the Corresponding Hourly Outdoor Dry Bulb Temperature for College Station, TX

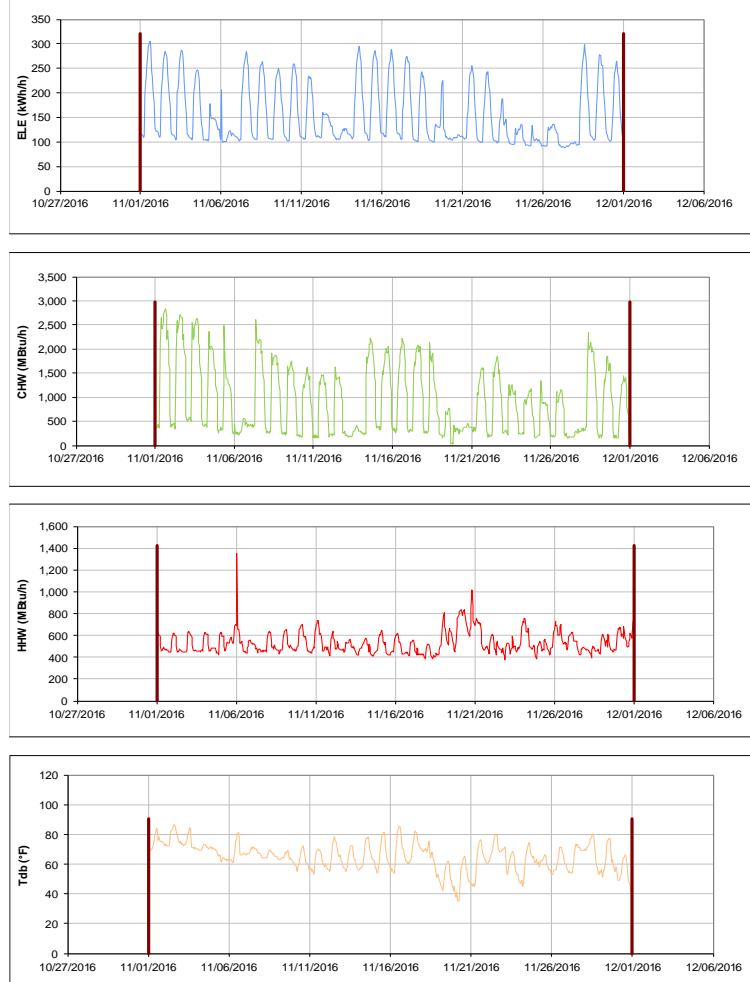
TAMU / BLDG #: 0435

Figure III-57 Hourly Whole Building Electricity, Chilled Water, and Hot Water Consumption for Harrington Education Center Office Tower during the Month of November 2016 and the Corresponding Hourly Outdoor Dry Bulb Temperature for College Station, TX

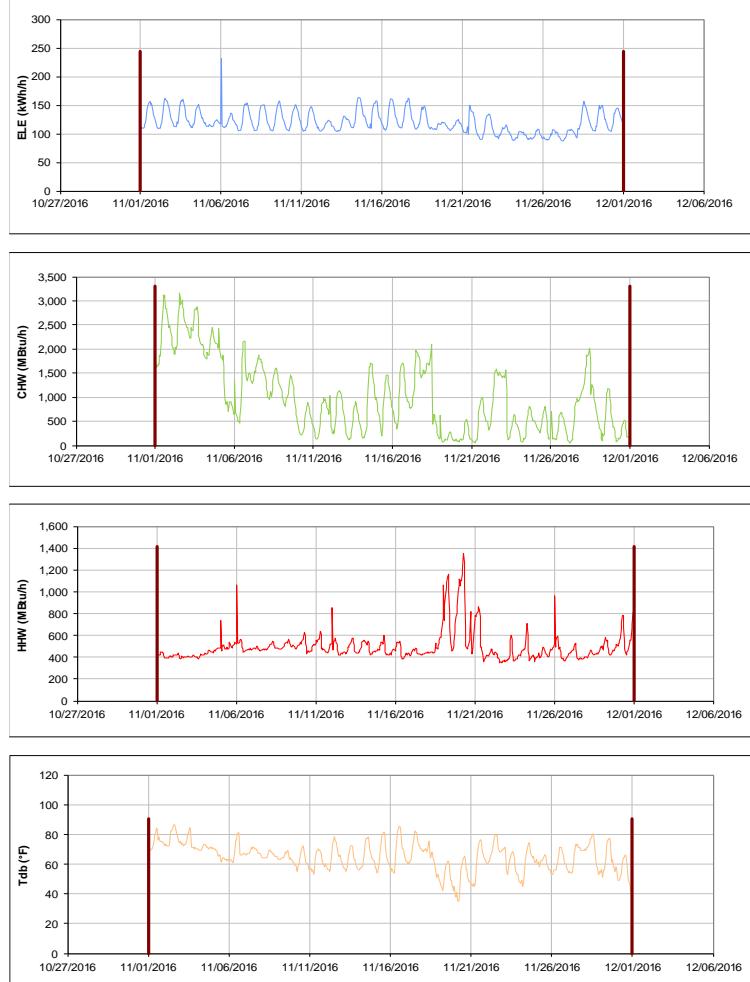
TAMU / BLDG #: 0436

Figure III-59 Hourly Whole Building Electricity, Chilled Water, and Hot Water Consumption for Reed-McDonald Building during the Month of November 2016 and the Corresponding Hourly Outdoor Dry Bulb Temperature for College Station, TX

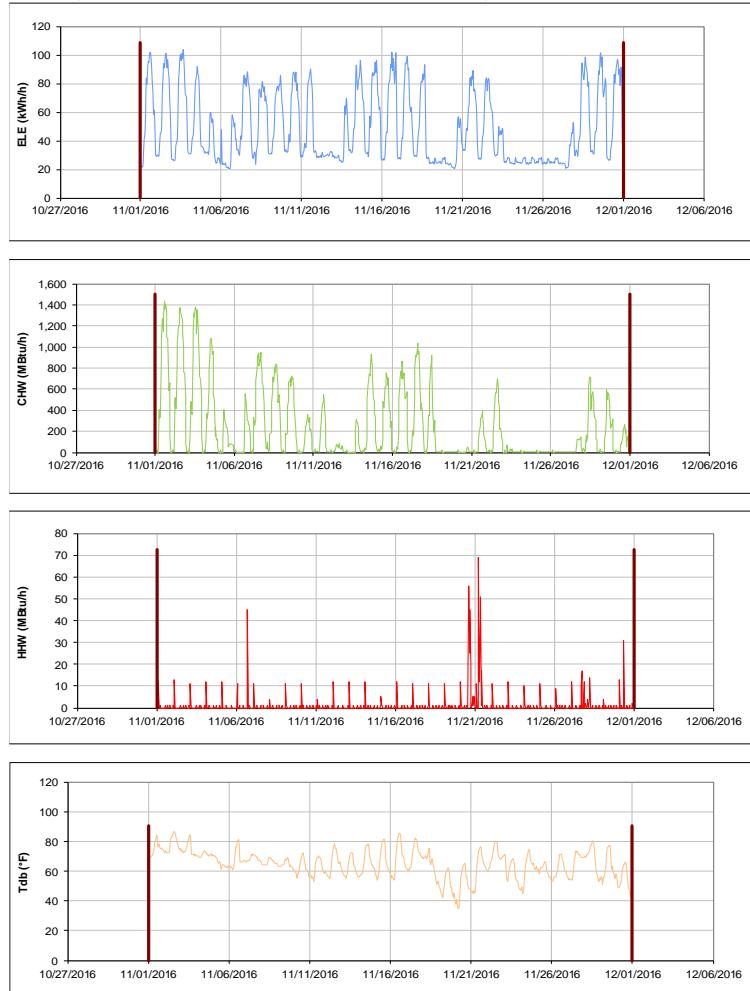
Harrington Education Center Classroom Building TAMU / BLDG #: 0438

Figure III-61 Hourly Whole Building Electricity, Chilled Water, and Hot Water Consumption for Harrington Education Center Classroom Building during the Month of November 2016 and the Corresponding Hourly Outdoor Dry Bulb Temperature for College Station, TX

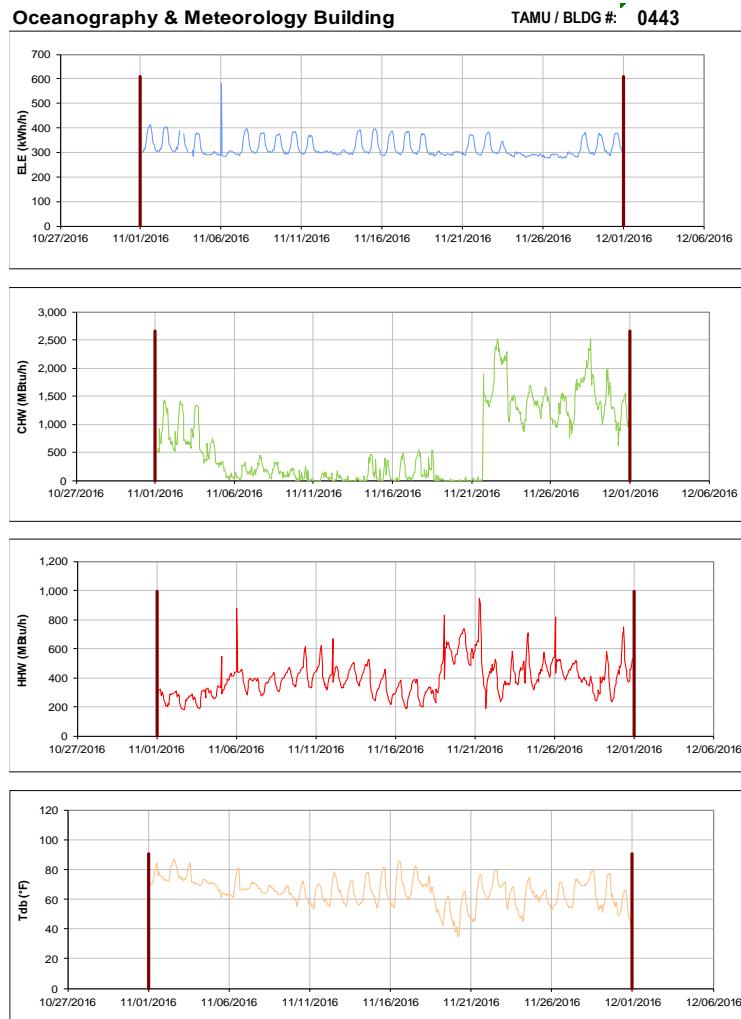
Figure III-62 Hourly Whole Building Electricity, Chilled Water, and Hot Water Consumption for Oceanography & Meteorology Building during the Month of November 2016 and the Corresponding Hourly Outdoor Dry Bulb Temperature for College Station, TX

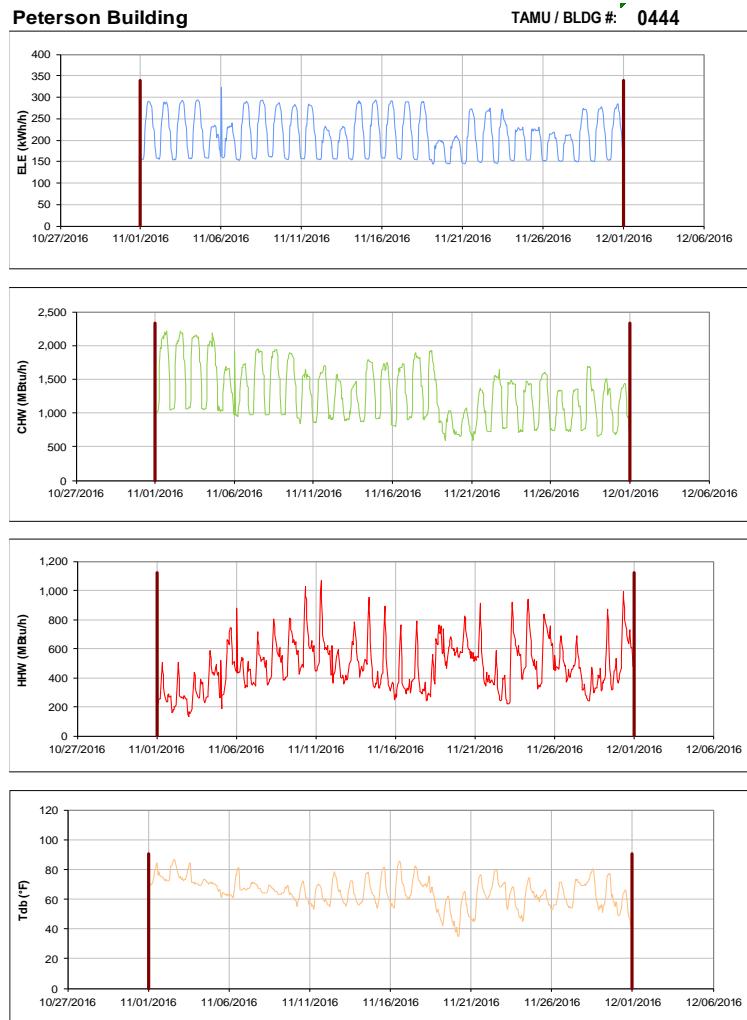
Figure III-63 Hourly Whole Building Electricity, Chilled Water, and Hot Water Consumption for Peterson Building during the Month of November 2016 and the Corresponding Hourly Outdoor Dry Bulb Temperature for College Station, TX

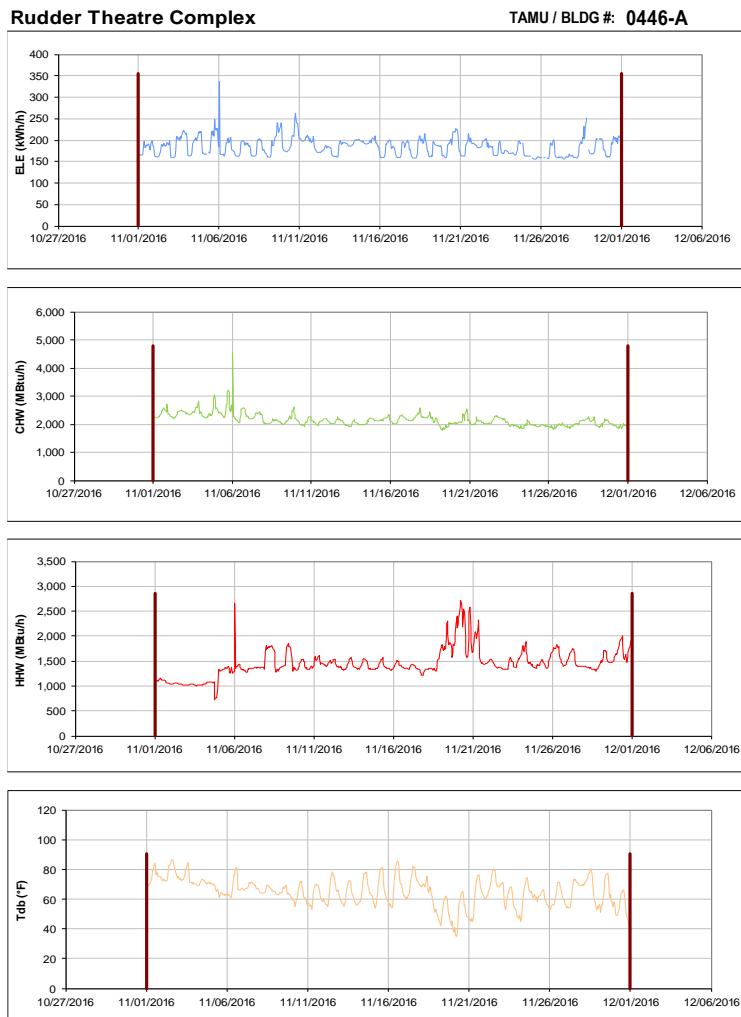
Figure III-68 Hourly Whole Building Electricity, Chilled Water, and Hot Water Consumption for Rudder Theatre Complex during the Month of November 2016 and the Corresponding Hourly Outdoor Dry Bulb Temperature for College Station, TX

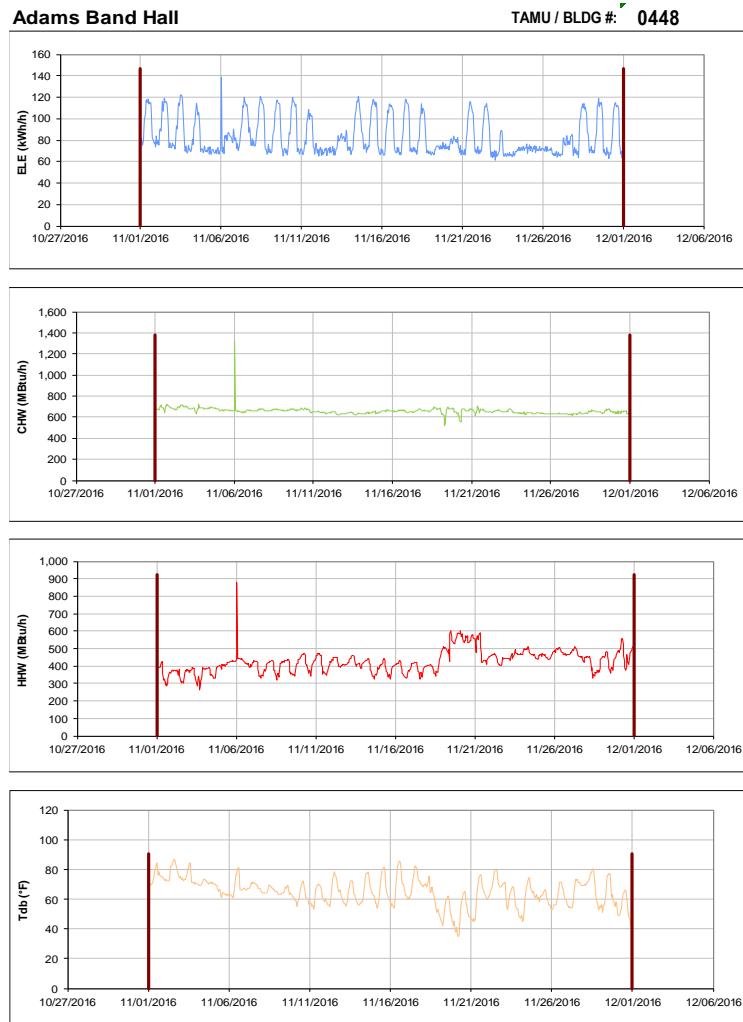
Figure III-70 Hourly Whole Building Electricity, Chilled Water, and Hot Water Consumption for Adams Band Hall during the Month of November 2016 and the Corresponding Hourly Outdoor Dry Bulb Temperature for College Station, TX

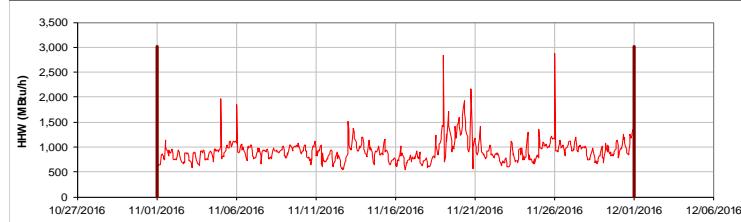
TAMU / BLDG #: 0454

Figure III-73 Hourly Whole Building Electricity, Chilled Water, and Hot Water Consumption for MSC during the Month of November 2016 and the Corresponding Hourly Outdoor Dry Bulb Temperature for College Station, TX

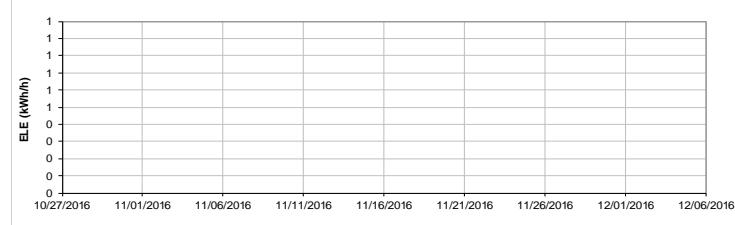
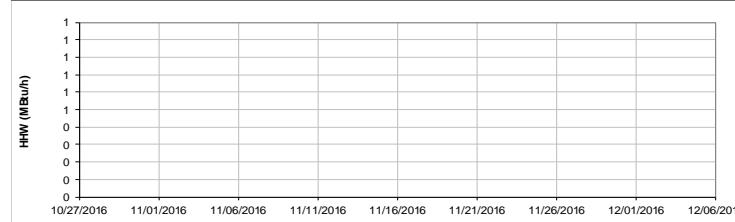
TAMU / BLDG #: 0456

Figure III-74 Hourly Whole Building Electricity, Chilled Water, and Hot Water Consumption for Military Sciences Building during the Month of November 2016 and the Corresponding Hourly Outdoor Dry Bulb Temperature for College Station, TX

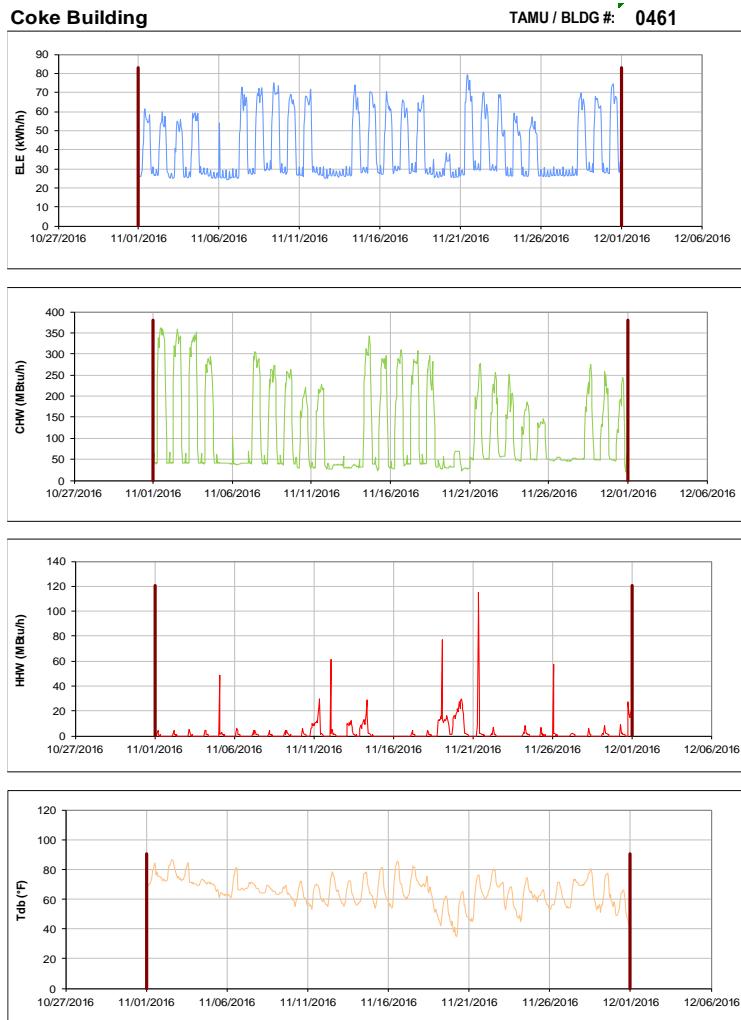
Figure III-76 Hourly Whole Building Electricity, Chilled Water, and Hot Water Consumption for Coke Building during the Month of November 2016 and the Corresponding Hourly Outdoor Dry Bulb Temperature for College Station, TX

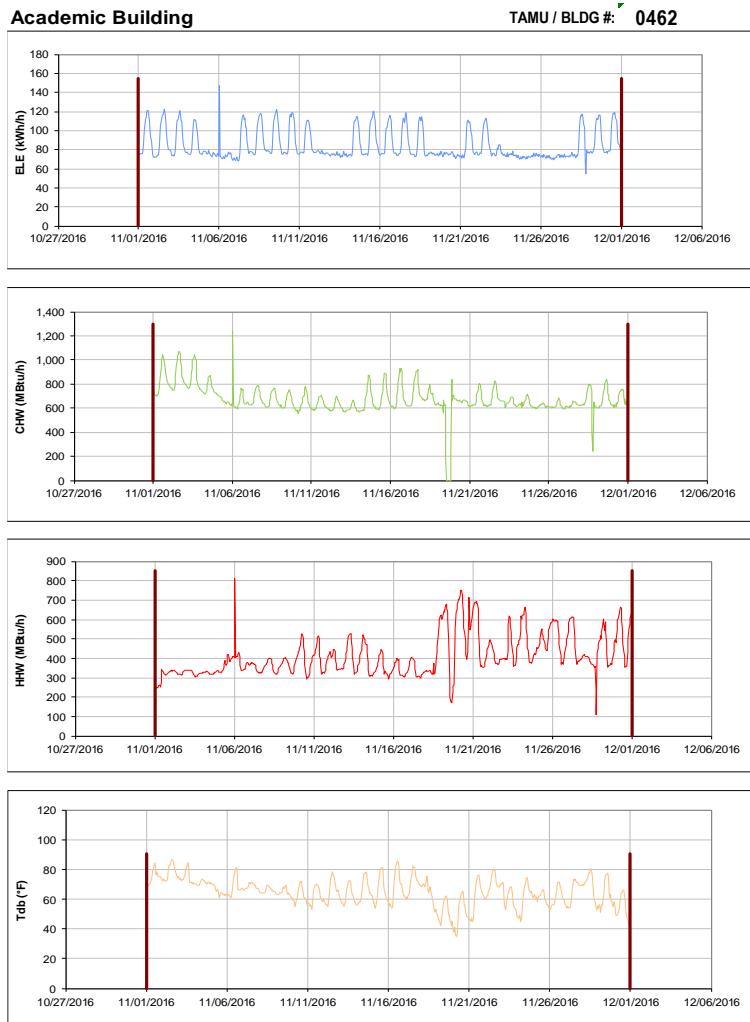
Figure III-77 Hourly Whole Building Electricity, Chilled Water, and Hot Water Consumption for Academic Building during the Month of November 2016 and the Corresponding Hourly Outdoor Dry Bulb Temperature for College Station, TX

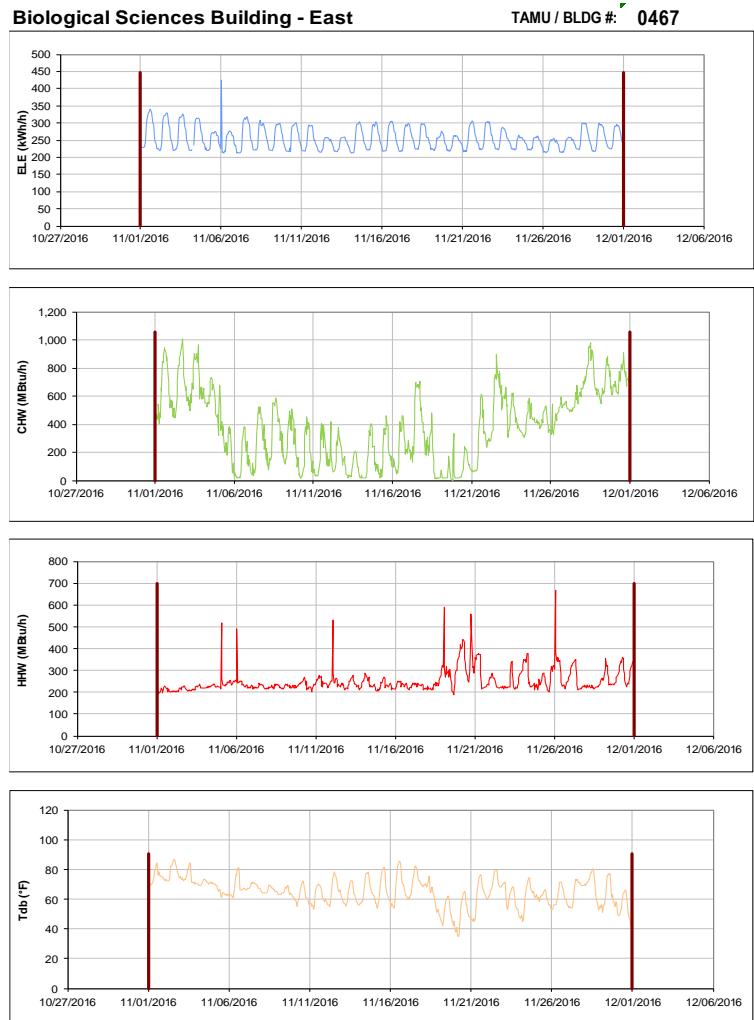
Figure III-81 Hourly Whole Building Electricity, Chilled Water, and Hot Water Consumption for Biological Sciences Building - East during the Month of November 2016 and the Corresponding Hourly Outdoor Dry Bulb Temperature for College Station, TX

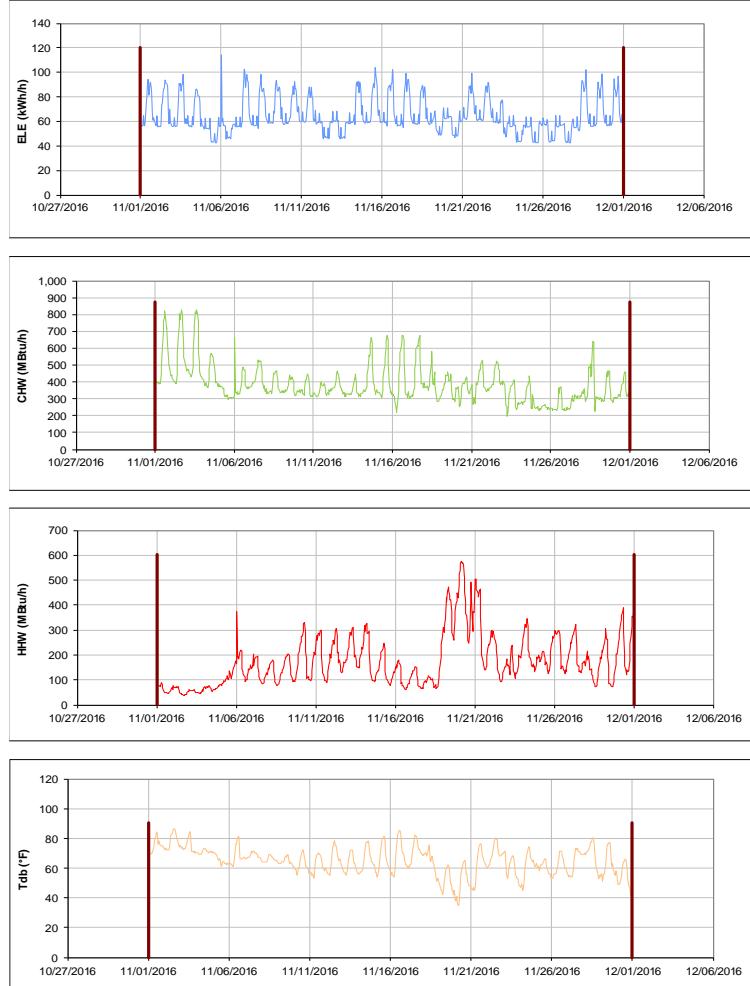
TAMU / BLDG #: 0473

Figure III-87 Hourly Whole Building Electricity, Chilled Water, and Hot Water Consumption for Williams Administration Building during the Month of November 2016 and the Corresponding Hourly Outdoor Dry Bulb Temperature for College Station, TX

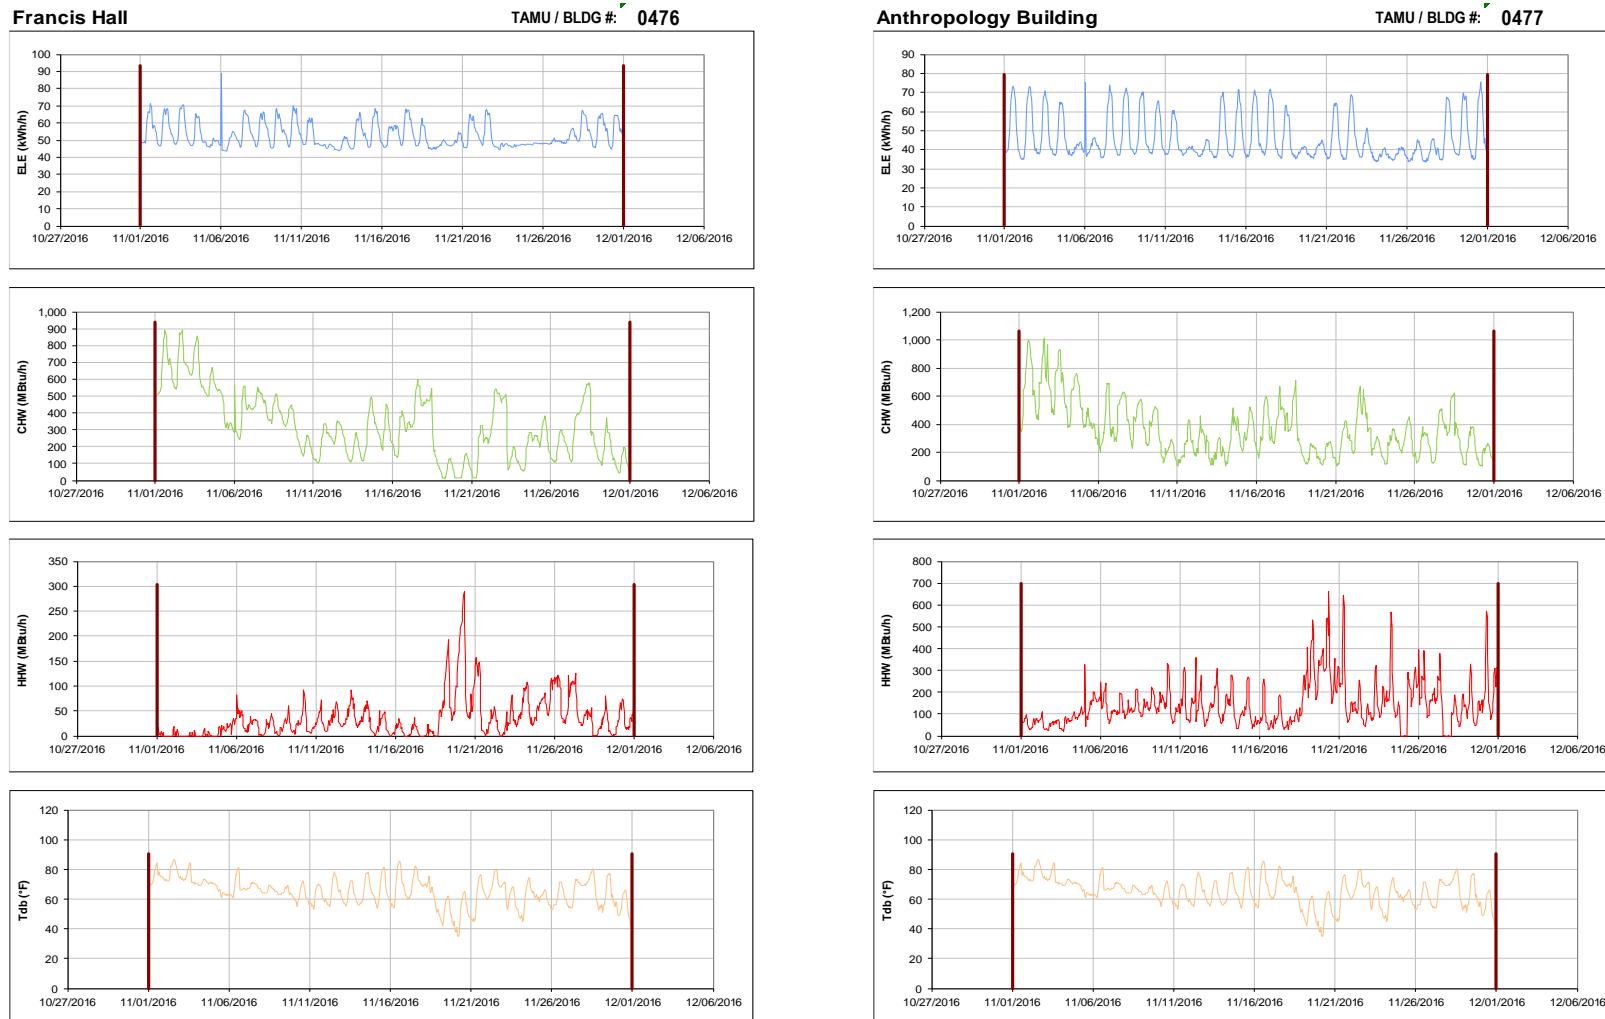
Figure III-89 Hourly Whole Building Electricity, Chilled Water, and Hot Water Consumption for Francis Hall during the Month of November 2016 and the Corresponding Hourly Outdoor Dry Bulb Temperature for College Station, TX

Figure III-90 Hourly Whole Building Electricity, Chilled Water, and Hot Water Consumption for Anthropology Building during the Month of November 2016 and the Corresponding Hourly Outdoor Dry Bulb Temperature for College Station, TX

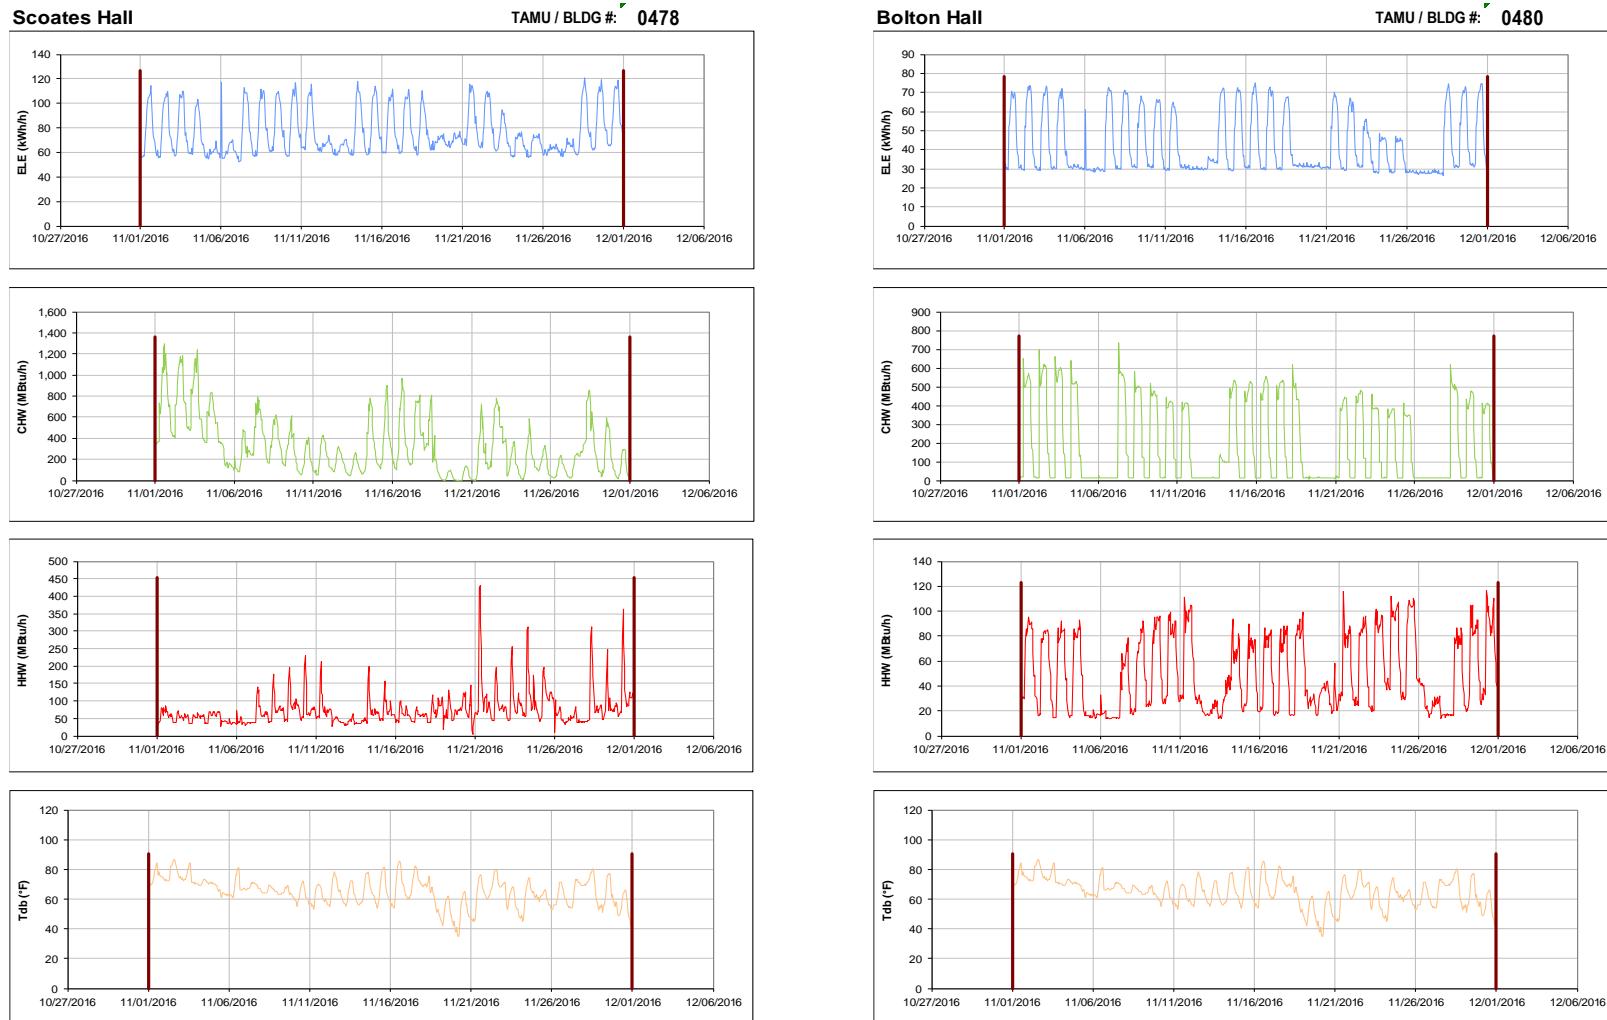
Figure III-91 Hourly Whole Building Electricity, Chilled Water, and Hot Water Consumption for Scoates Hall during the Month of November 2016 and the Corresponding Hourly Outdoor Dry Bulb Temperature for College Station, TX

Figure III-92 Hourly Whole Building Electricity, Chilled Water, and Hot Water Consumption for Bolton Hall during the Month of November 2016 and the Corresponding Hourly Outdoor Dry Bulb Temperature for College Station, TX

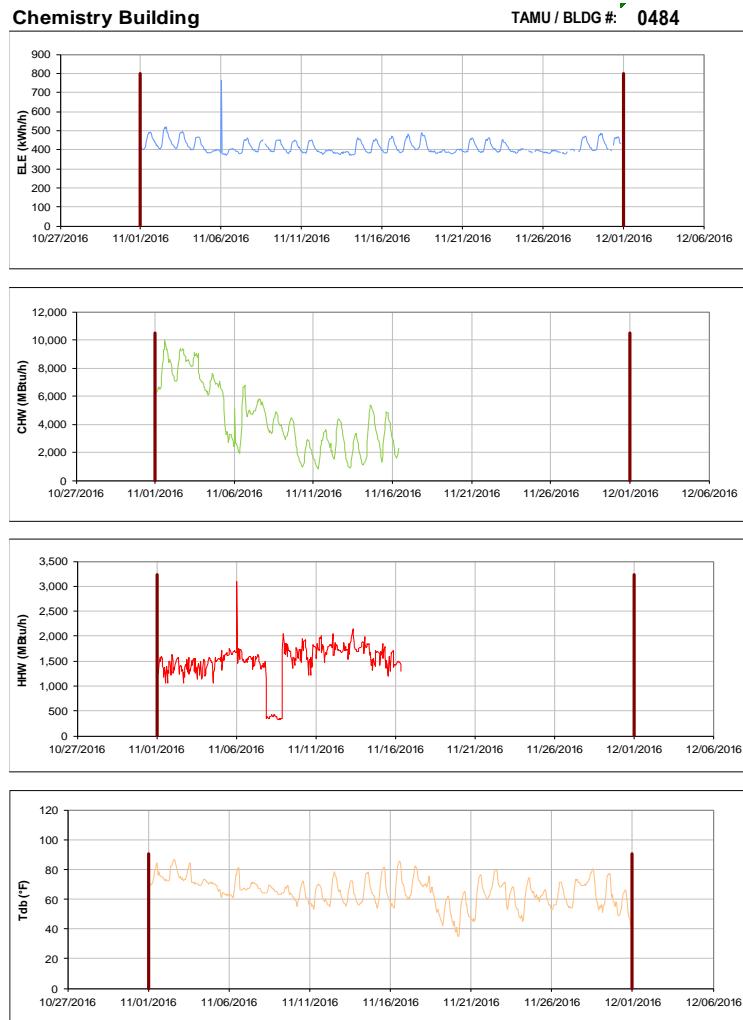
Figure III-96 Hourly Whole Building Electricity, Chilled Water, and Hot Water Consumption for Chemistry Building during the Month of November 2016 and the Corresponding Hourly Outdoor Dry Bulb Temperature for College Station, TX
