TAMU Project

**Energy Consumption Data Quality Assurance/Quality
Control Assessment Report for the
Month of November 2016**

**Utility & Energy Services
Division of Administration
Texas A&M University**

December 2016

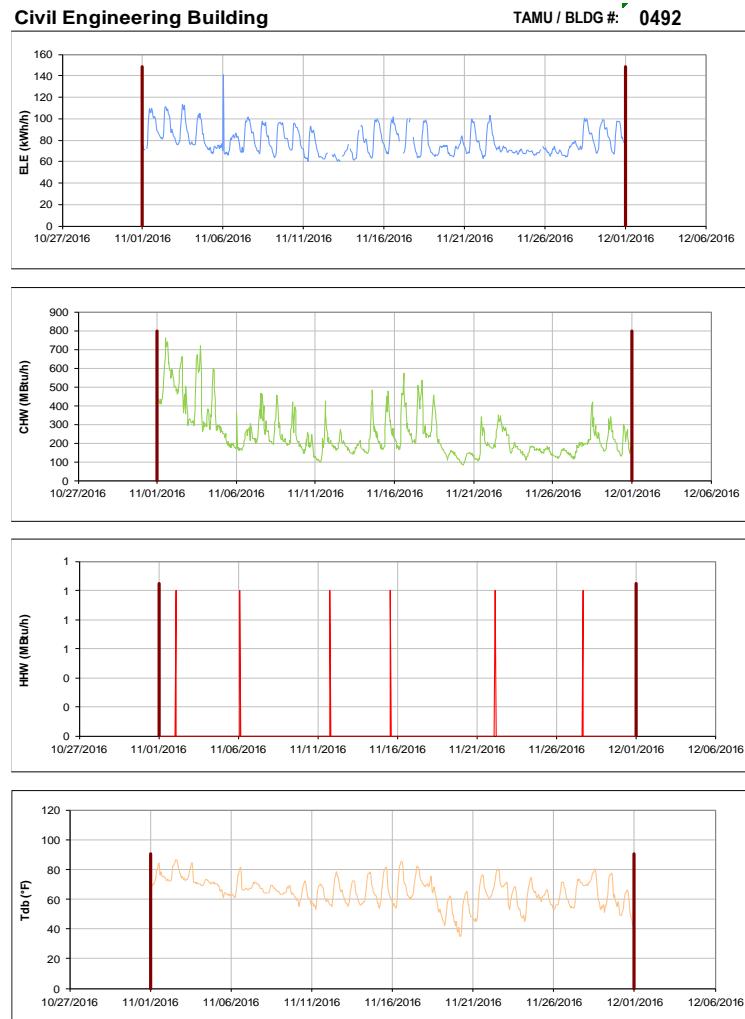
Figure III-98 Hourly Whole Building Electricity, Chilled Water, and Hot Water Consumption for Civil Engineering Building during the Month of November 2016 and the Corresponding Hourly Outdoor Dry Bulb Temperature for College Station, TX

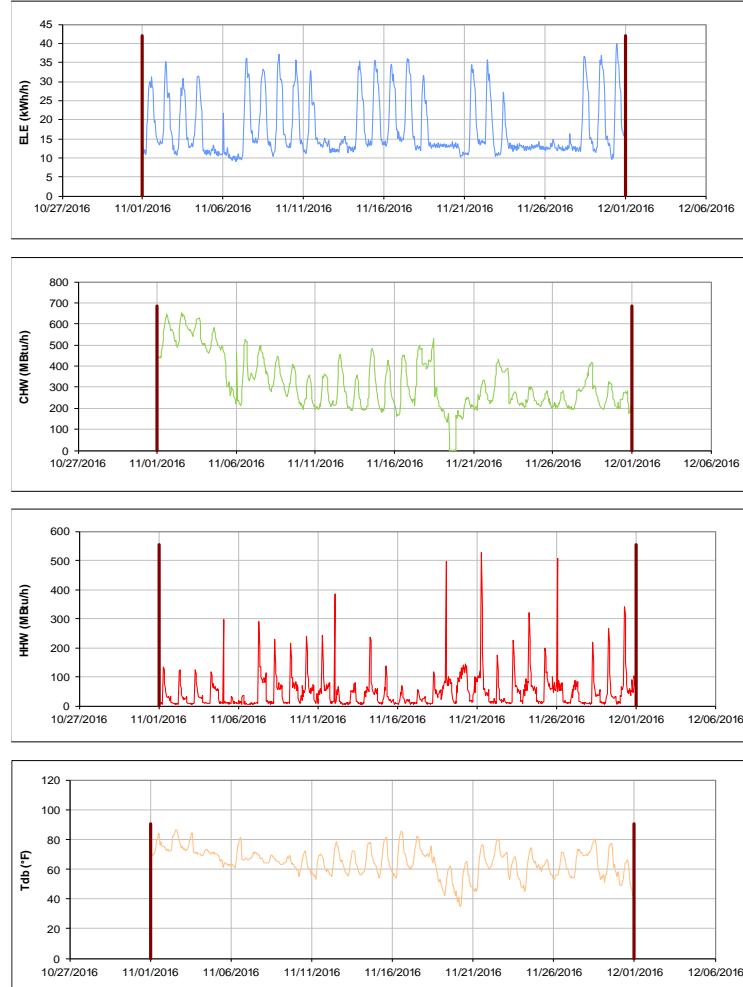
TAMU / BLDG #: 0506

Figure III-102 Hourly Whole Building Electricity, Chilled Water, and Hot Water Consumption for Nagle Hall during the Month of November 2016 and the Corresponding Hourly Outdoor Dry Bulb Temperature for College Station, TX

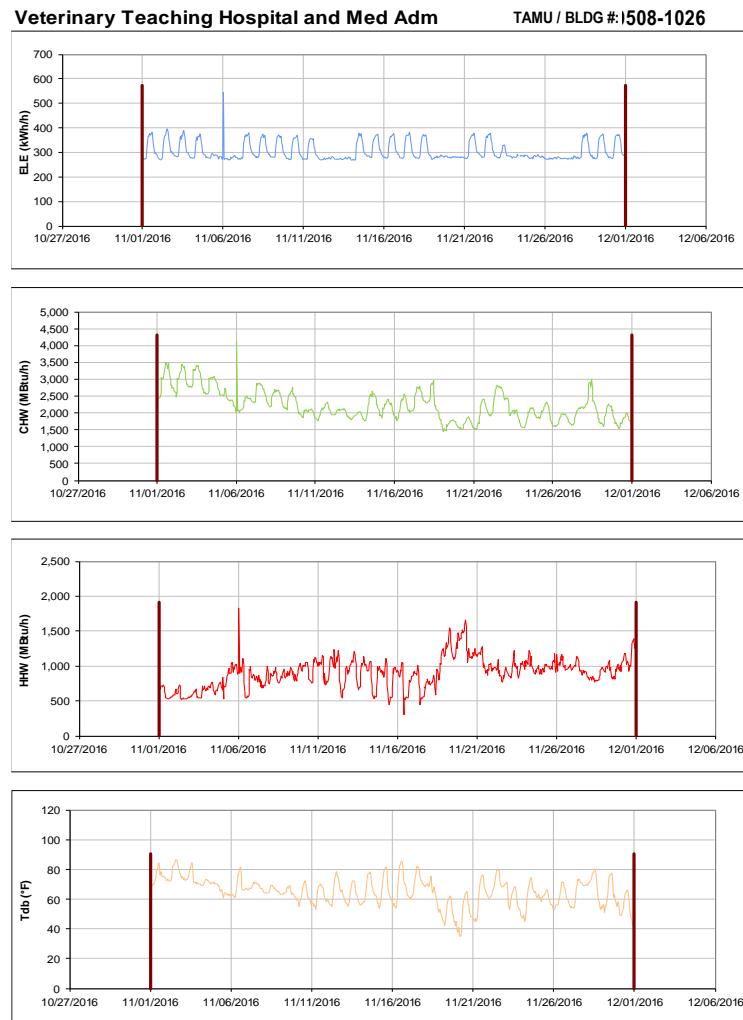
Figure III-104 Hourly Whole Building Electricity, Chilled Water, and Hot Water Consumption for Veterinary Teaching Hospital and Med Adm during the Month of November 2016 and the Corresponding Hourly Outdoor Dry Bulb Temperature for College Station, TX

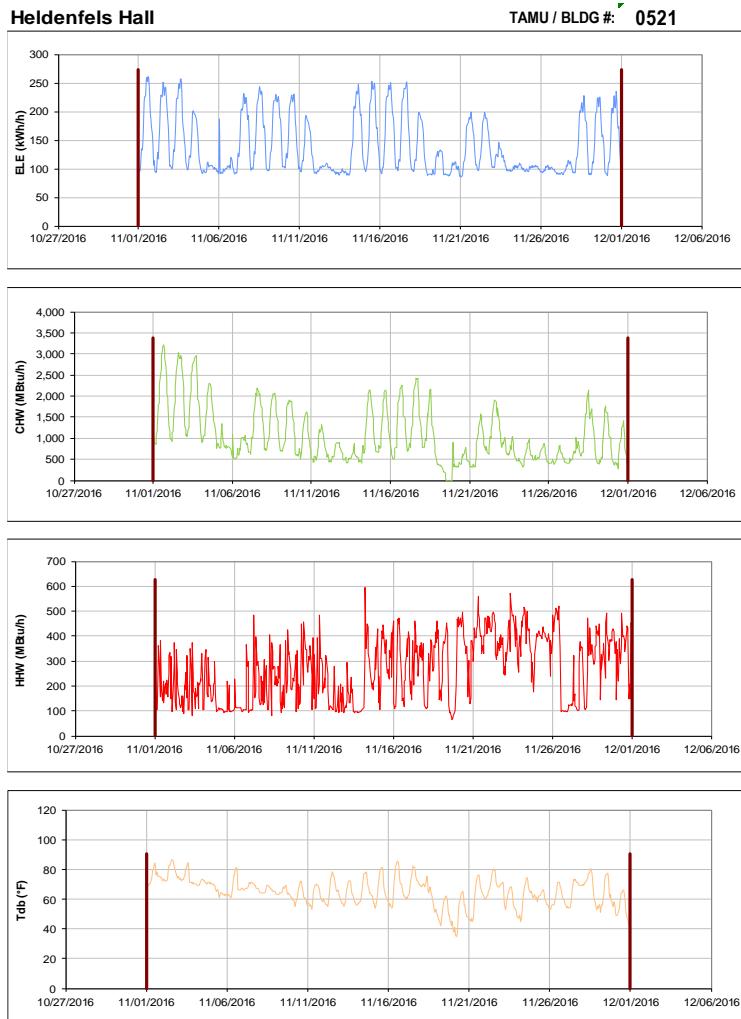
Figure III-112 Hourly Whole Building Electricity, Chilled Water, and Hot Water Consumption for Heldenfels Hall during the Month of November 2016 and the Corresponding Hourly Outdoor Dry Bulb Temperature for College Station, TX
