TAMU Project

**Energy Consumption Data Quality Assurance/Quality
Control Assessment Report for the
Month of March 2017**

**Utility & Energy Services
Division of Administration
Texas A&M University**

April 2017

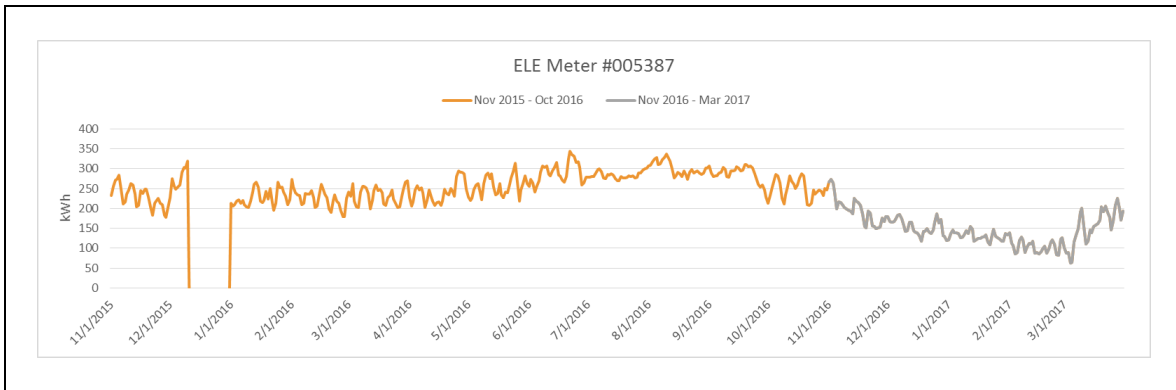
Explanatory Figure: Times series plot of hourly ELE energy consumption for meter #005837. The series in grey represents the recent data from Nov 2016 through Mar 2017.

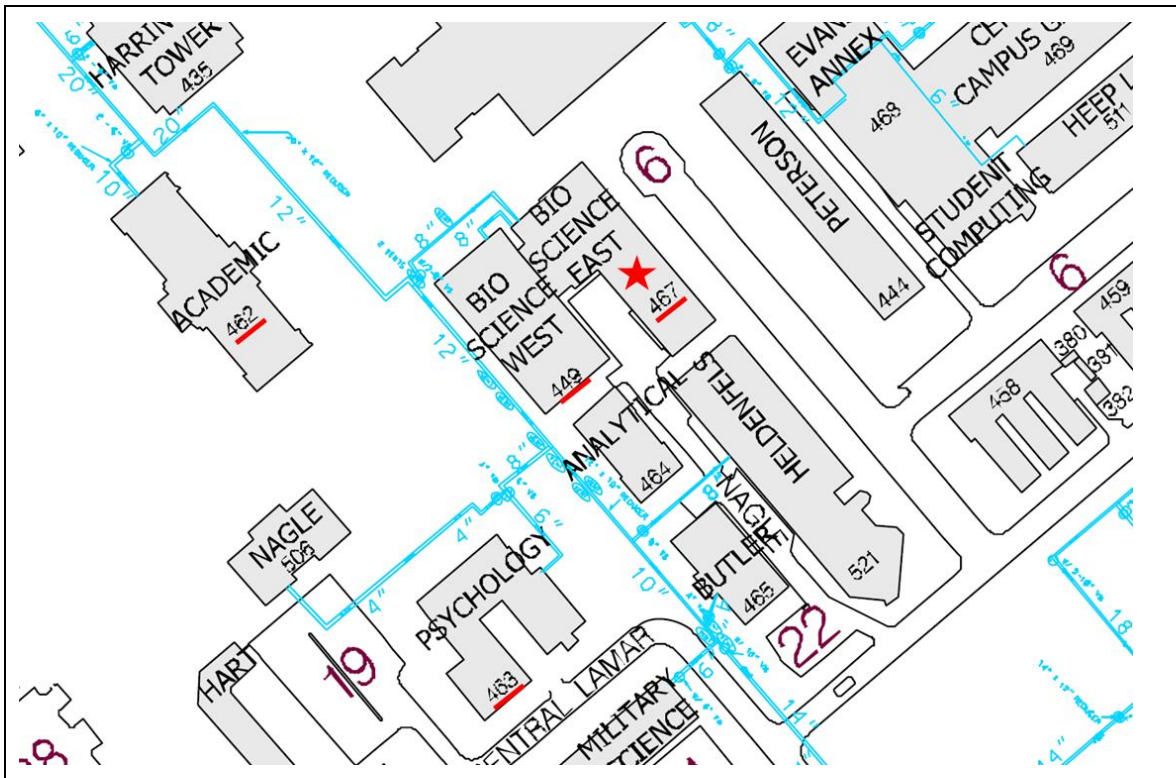
Explanatory Figure: CHW distribution with Bldgs. #467 Biological Sciences East, #462 Academic, #449 Biological Sciences West, and #463 Psychology highlighted.

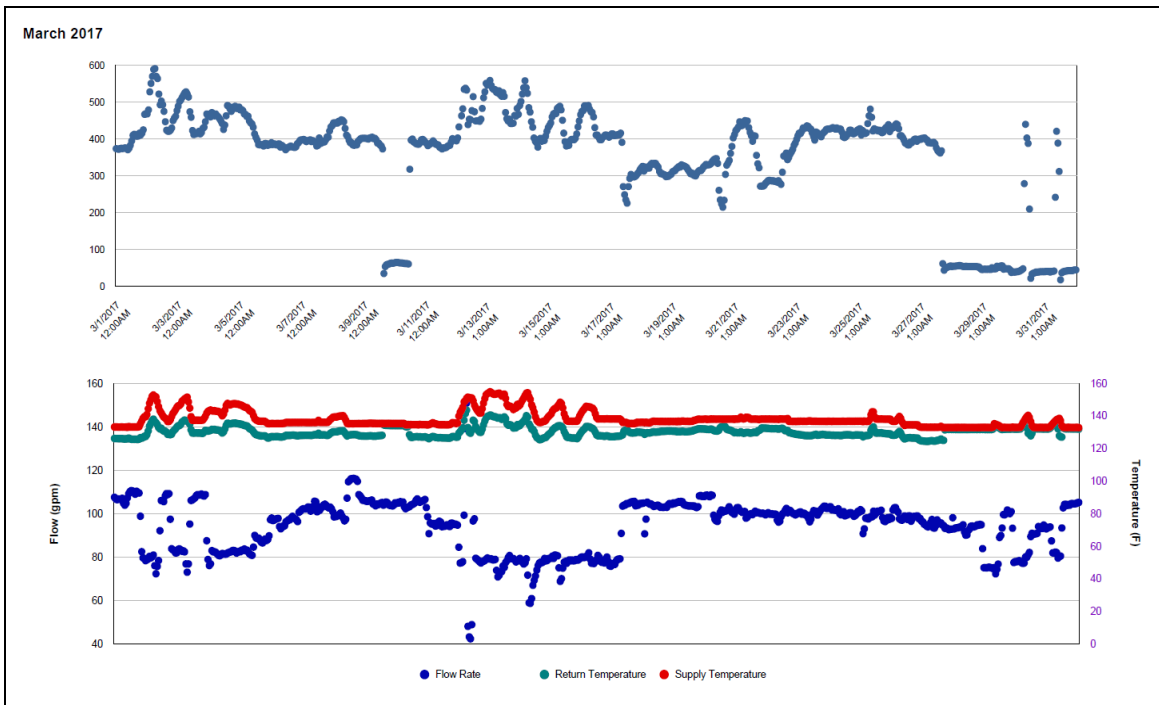
There are two HHW meters (#006900 and #006917) for this building. Starting 12/19/2016, for HHW meter #006900, the consumption suddenly decreased and remained at zero caused by faulty flow rate and constant supply and return temperature values (supply 174°F, return 147°F). The flow rate returned on 1/13/2017, but the temperature sensors still maintain a constant value. The HHW for March was estimated by model for this meter.

Explanatory Figure: Time series plots of MID 006917 hourly HHW energy consumption, flow, and supply/return temperatures from utilities office. (March 2017)

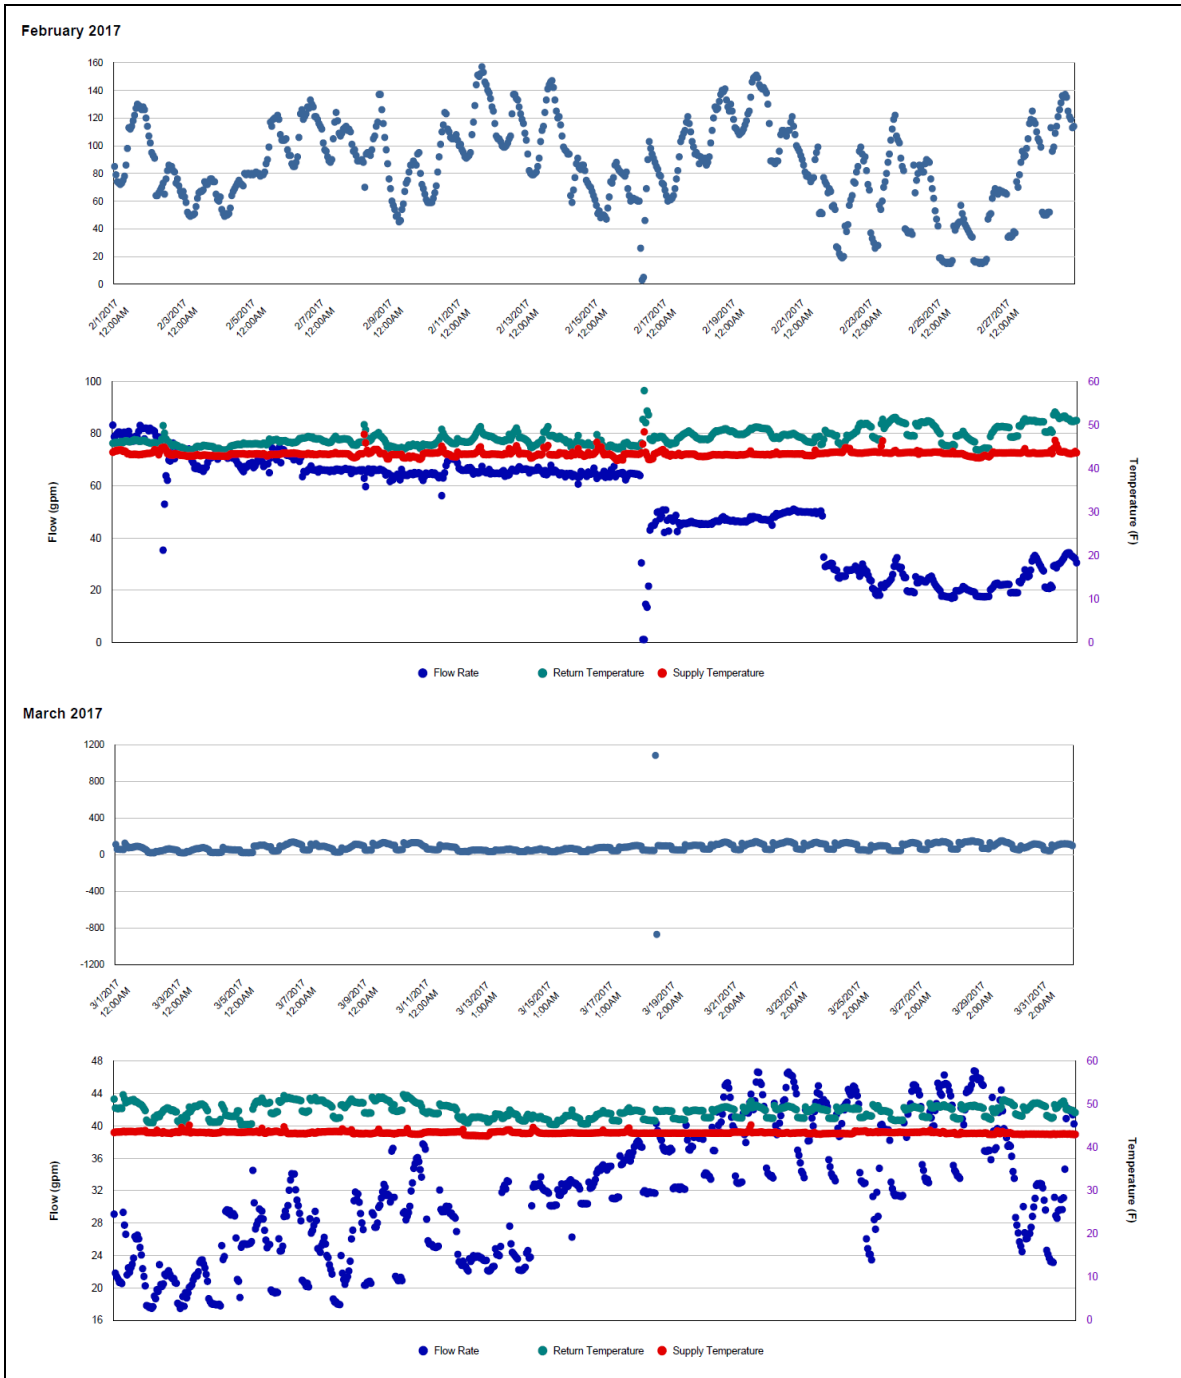
Explanatory Figure: Time series plots of hourly CHW energy consumption, flow, and supply/return temperatures from utilities office. (Top: February 2017, Bottom: March 2017)

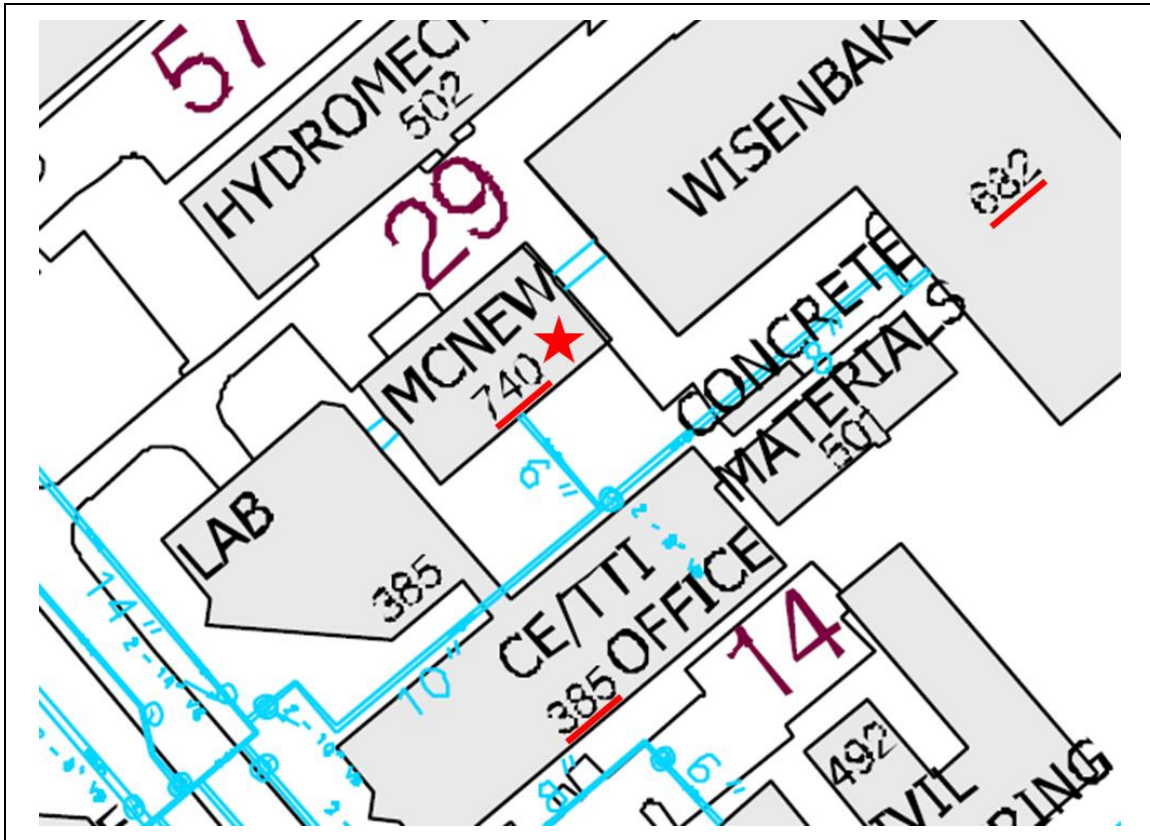
Explanatory Figure: CHW distribution with Bldgs. #740 McNew Laboratory, #682 Wisenbaker, and #385 CE/TTI Office during highlighted.

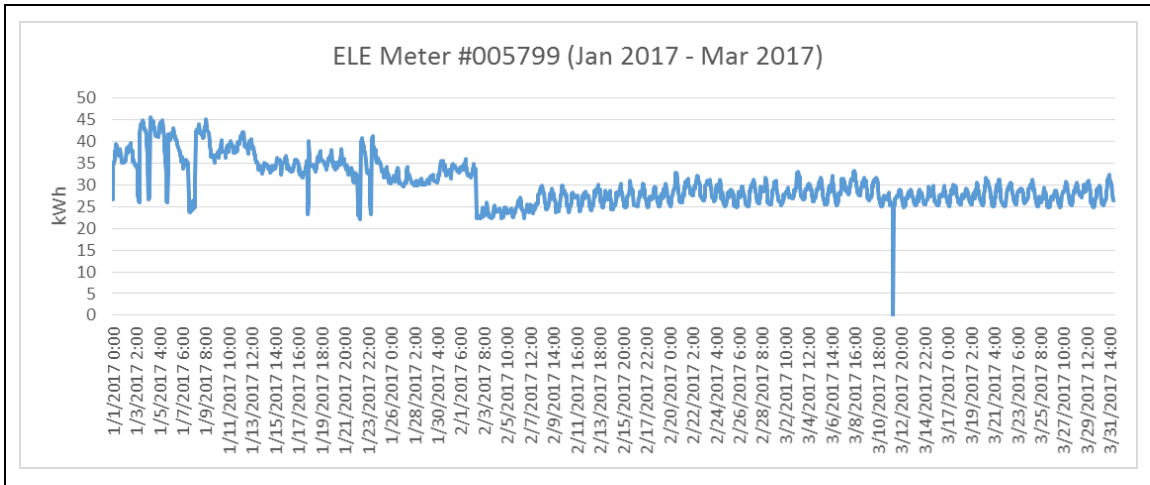
The ELE consumption level suddenly dropped on 2/2/2017 by approximately 10 kWh/h (~30%). After that, no clear temperature dependence was observed.

Explanatory Figure: Time series plot of hourly ELE consumption for meter #005799.

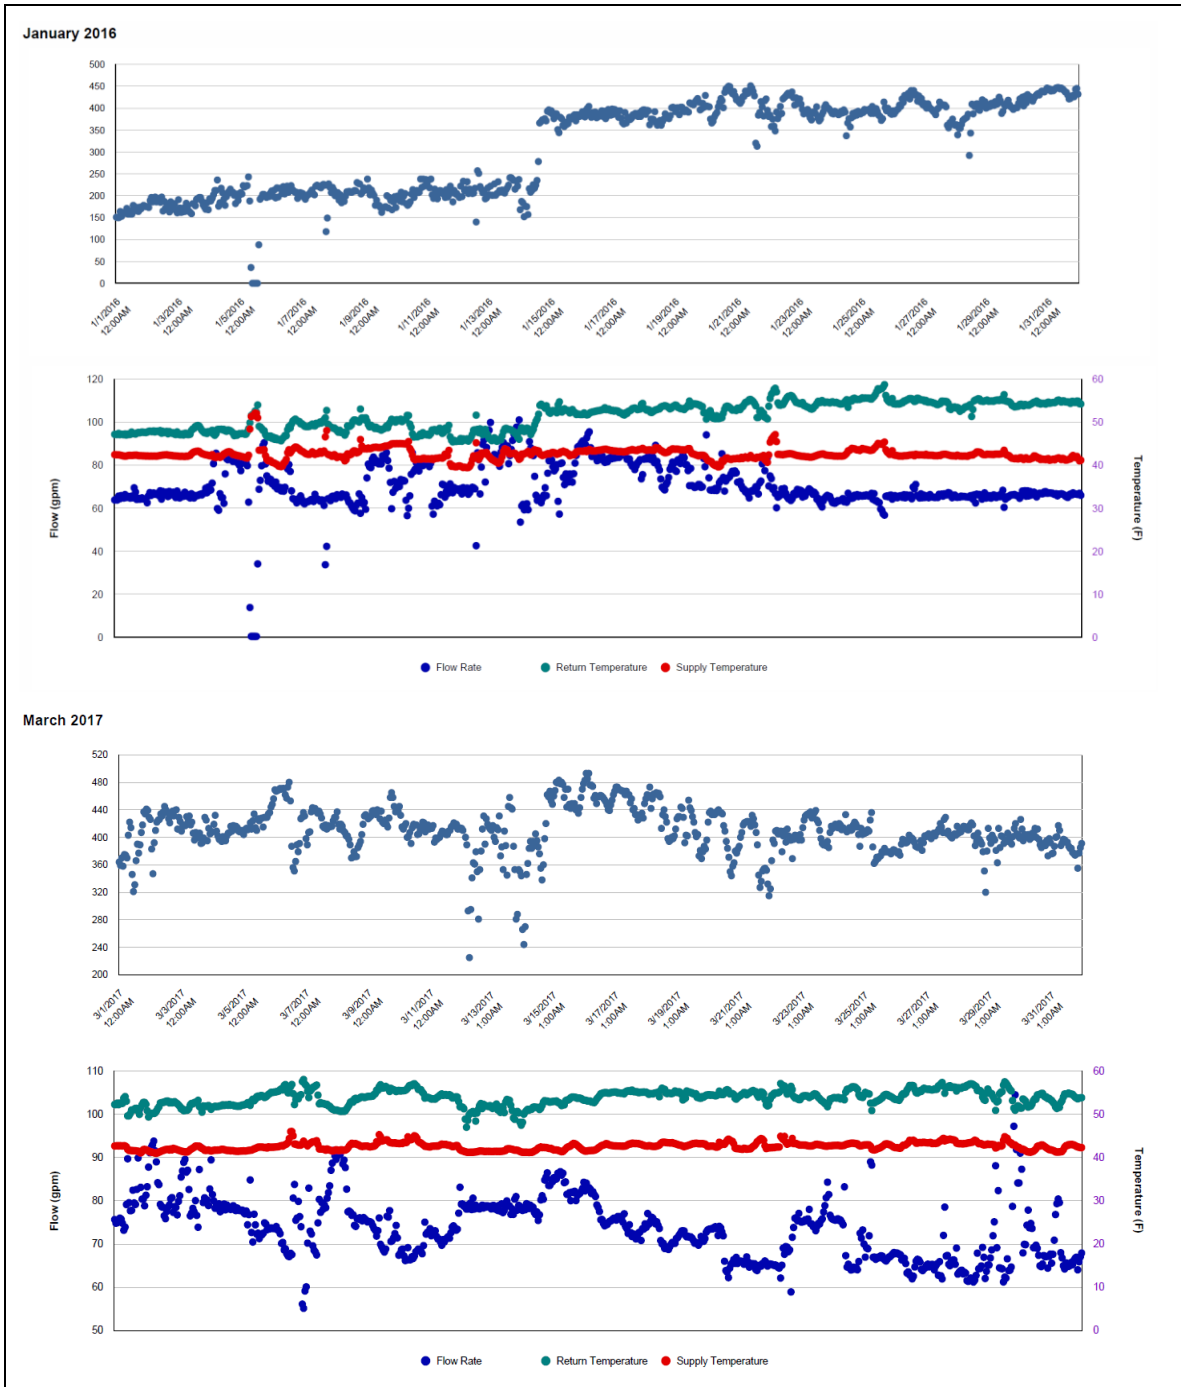
Explanatory Figure: Time series plots of hourly CHW energy consumption, flow rate, and supply and return temperatures from utilities office. (Top: January 2016, Bottom: March 2017)

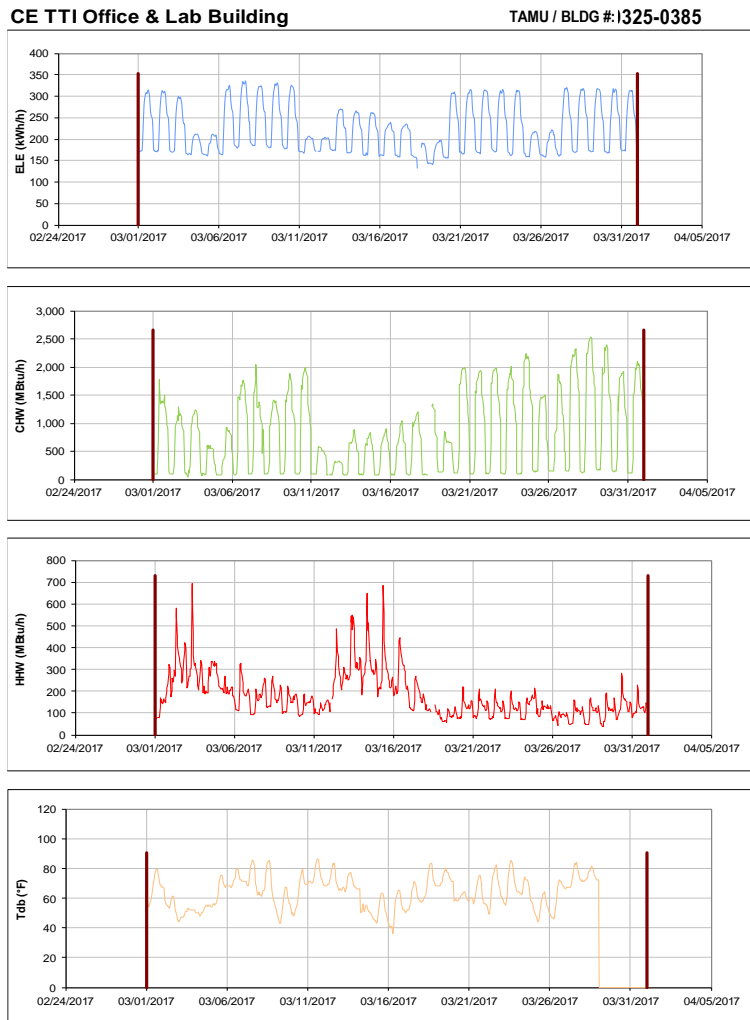
Figure III-9 Hourly Whole Building Electricity, Chilled Water, and Hot Water Consumption for CE TTI Office & Lab Building during the Month of March 2017 and the Corresponding Hourly Outdoor Dry Bulb Temperature for College Station, TX

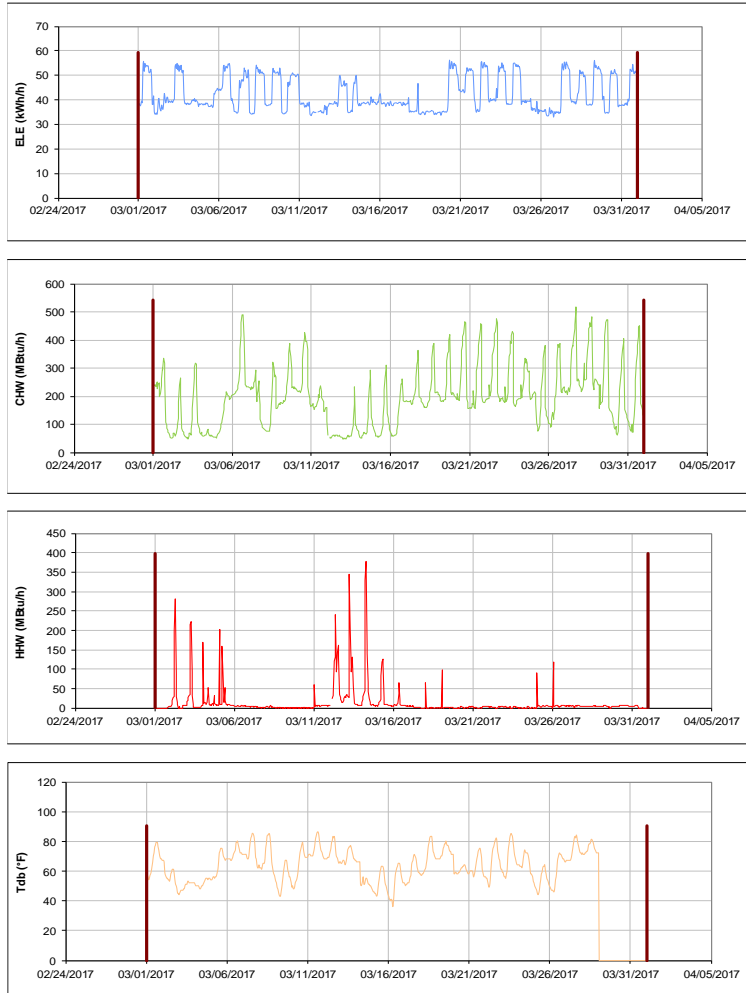
Davis Football Player Development Center TAMU / BLDG #: 0358

Figure III-11 Hourly Whole Building Electricity, Chilled Water, and Hot Water Consumption for Davis Football Player Development Center during the Month of March 2017 and the Corresponding Hourly Outdoor Dry Bulb Temperature for College Station, TX

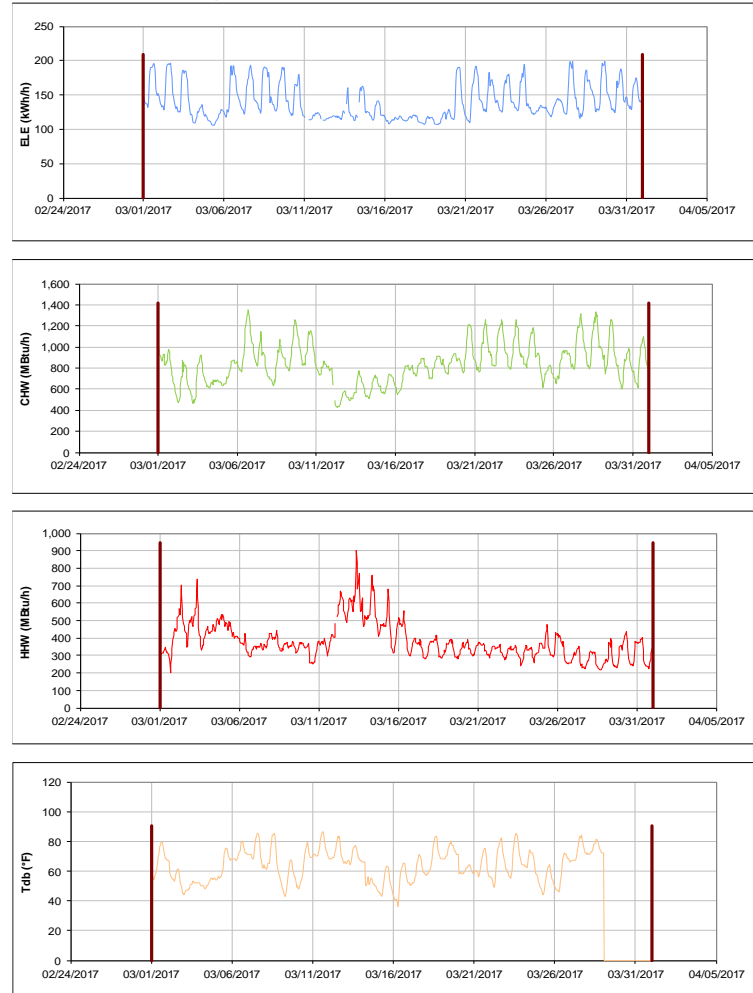
Architecture Building B&C TAMU / BLDG #: 1359-0432

Figure III-12 Hourly Whole Building Electricity, Chilled Water, and Hot Water Consumption for Architecture Building B&C during the Month of March 2017 and the Corresponding Hourly Outdoor Dry Bulb Temperature for College Station, TX

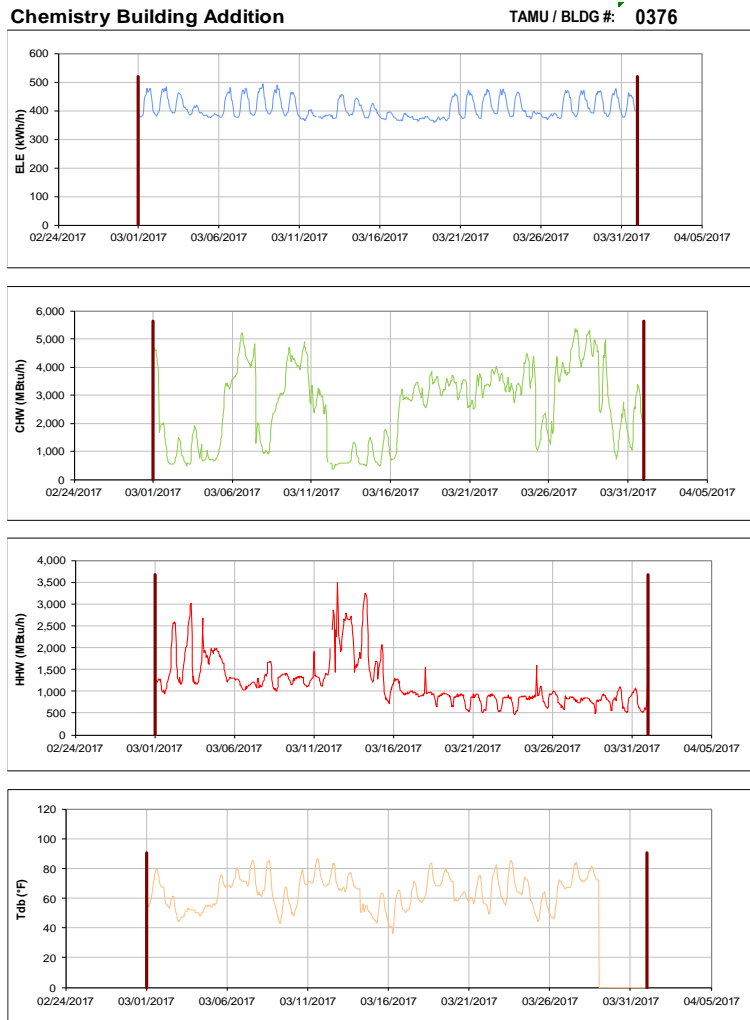
Figure III-17 Hourly Whole Building Electricity, Chilled Water, and Hot Water Consumption for Chemistry Building Addition during the Month of March 2017 and the Corresponding Hourly Outdoor Dry Bulb Temperature for College Station, TX

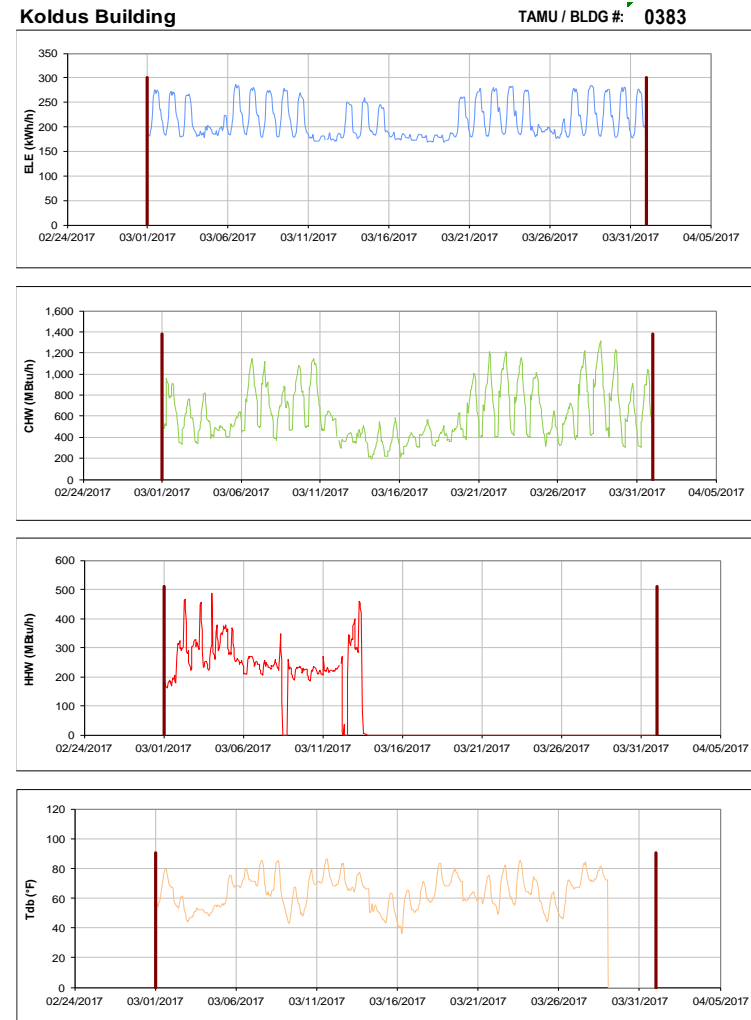
Figure III-18 Hourly Whole Building Electricity, Chilled Water, and Hot Water Consumption for Koldus Building during the Month of March 2017 and the Corresponding Hourly Outdoor Dry Bulb Temperature for College Station, TX

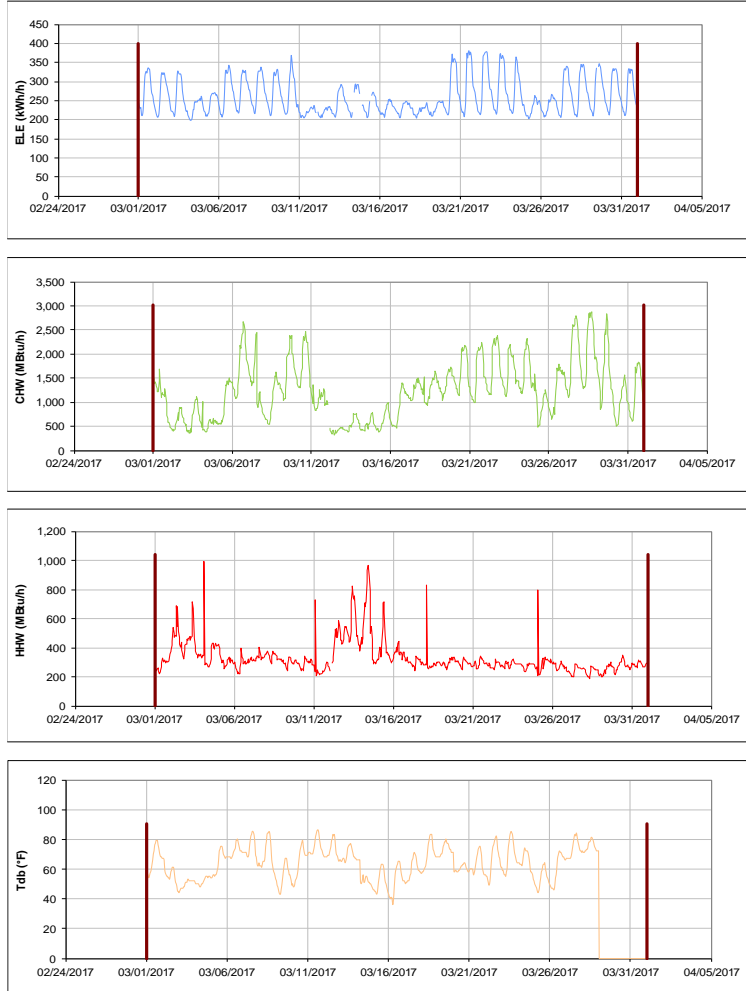
Richardson Petroleum Engineering Building TAMU / BLDG #: 0387

Figure III-21 Hourly Whole Building Electricity, Chilled Water, and Hot Water Consumption for Richardson Petroleum Engineering Building during the Month of March 2017 and the Corresponding Hourly Outdoor Dry Bulb Temperature for College Station, TX

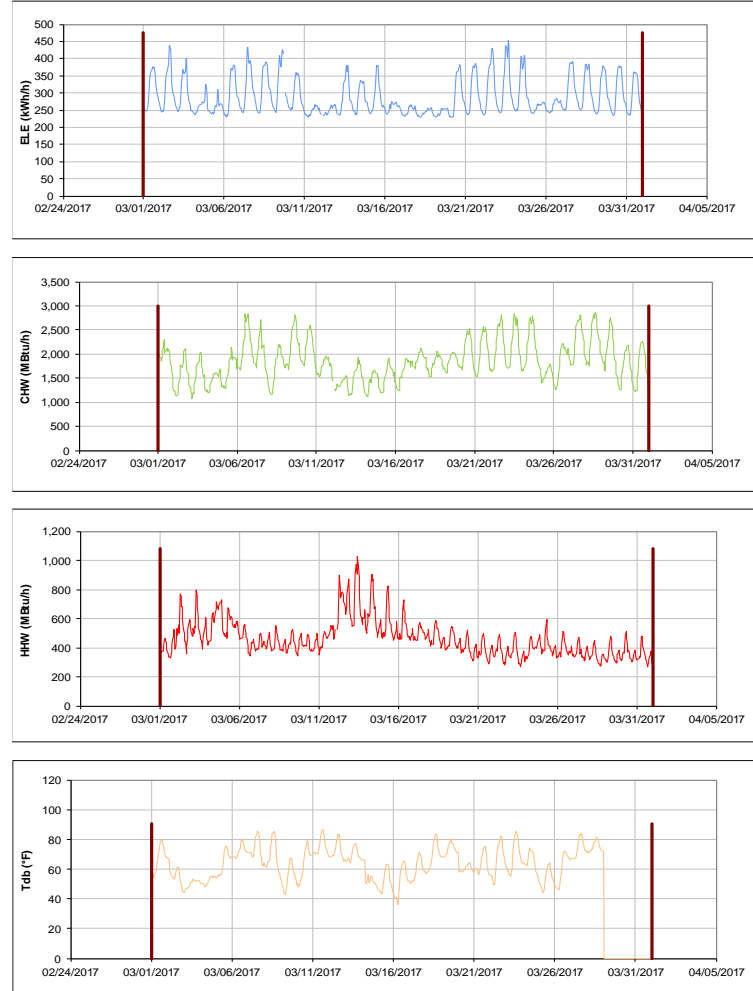
James J. Cain'51 and Mechanical Engineering Office Building TAMU / BLDG #: 1391-0392

Figure III-22 Hourly Whole Building Electricity, Chilled Water, and Hot Water Consumption for James J. Cain'51 and Mechanical Engineering Office Building during the Month of March 2017 and the Corresponding Hourly Outdoor Dry Bulb Temperature for College Station, TX

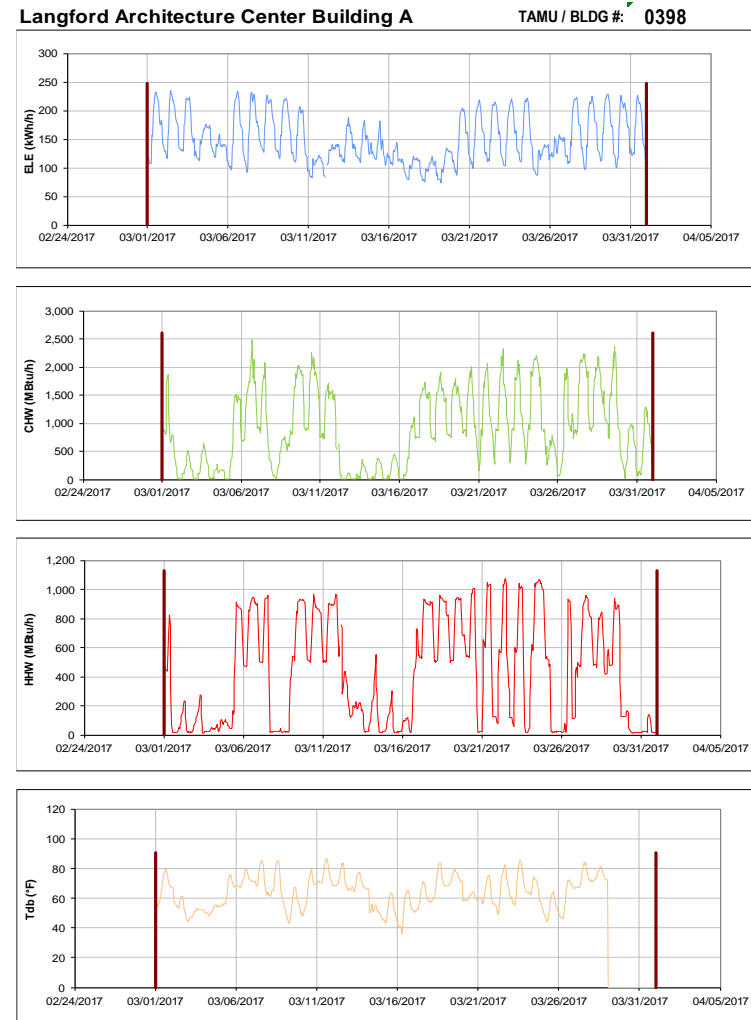
Figure III-24 Hourly Whole Building Electricity, Chilled Water, and Hot Water Consumption for Langford Architecture Center Building A during the Month of March 2017 and the Corresponding Hourly Outdoor Dry Bulb Temperature for College Station, TX

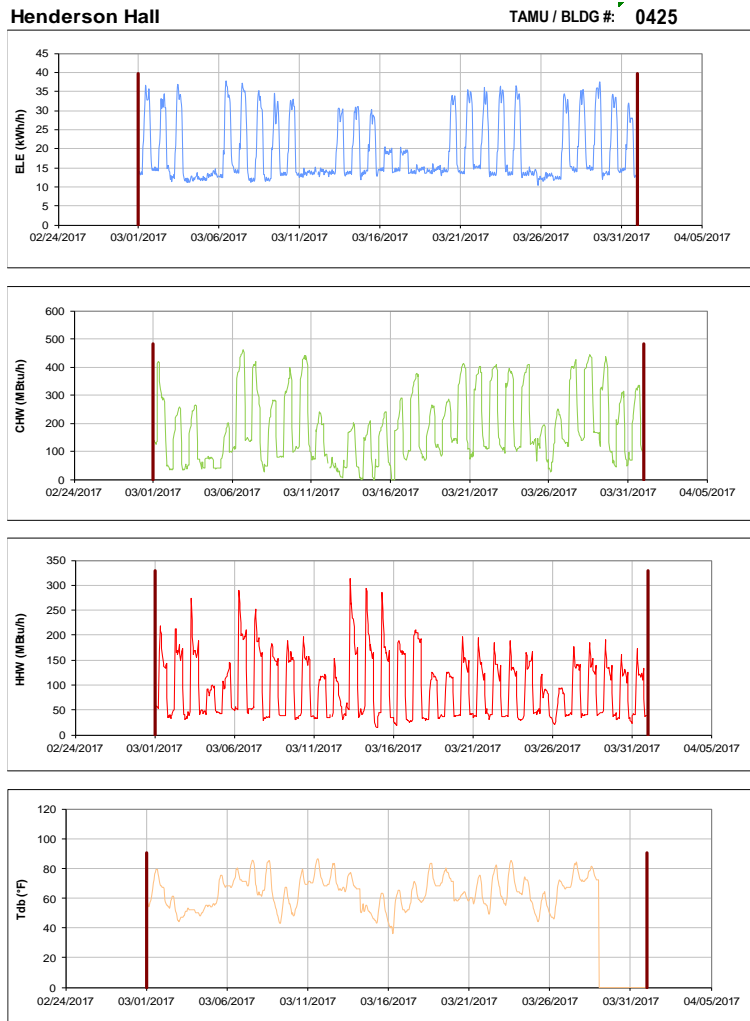
Figure III-47 Hourly Whole Building Electricity, Chilled Water, and Hot Water Consumption for Henderson Hall during the Month of March 2017 and the Corresponding Hourly Outdoor Dry Bulb Temperature for College Station, TX

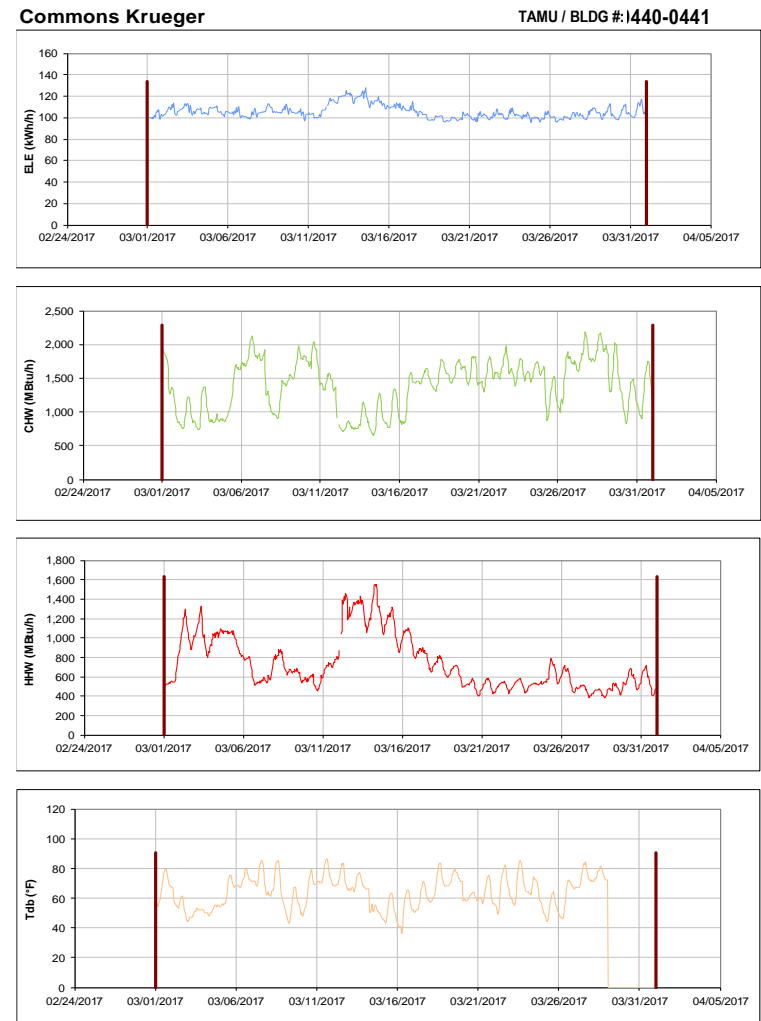
Figure III-52 Hourly Whole Building Electricity, Chilled Water, and Hot Water Consumption for Commons Krueger during the Month of March 2017 and the Corresponding Hourly Outdoor Dry Bulb Temperature for College Station, TX

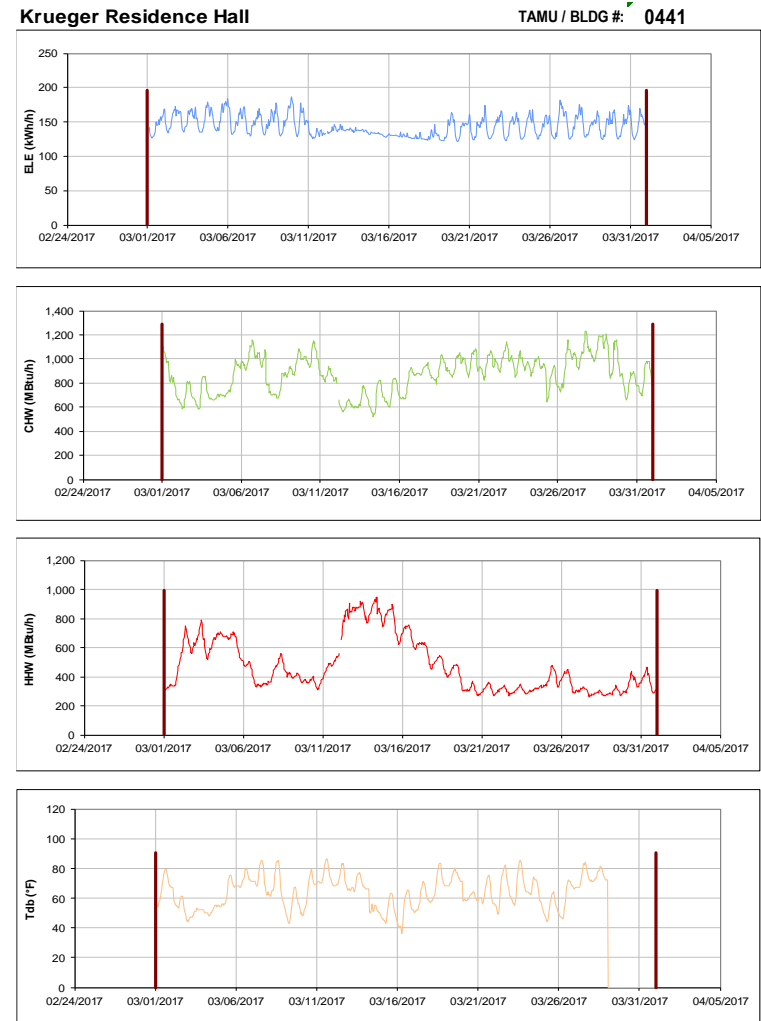
Figure III-54 Hourly Whole Building Electricity, Chilled Water, and Hot Water Consumption for Krueger Residence Hall during the Month of March 2017 and the Corresponding Hourly Outdoor Dry Bulb Temperature for College Station, TX

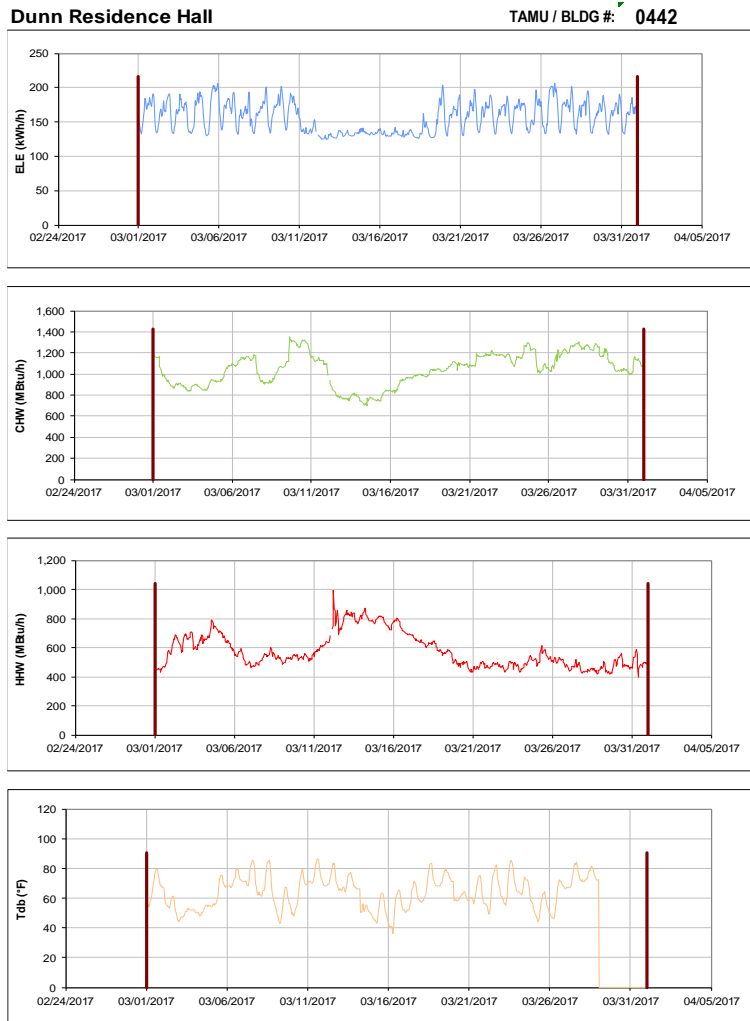
Figure III-55 Hourly Whole Building Electricity, Chilled Water, and Hot Water Consumption for Dunn Residence Hall during the Month of March 2017 and the Corresponding Hourly Outdoor Dry Bulb Temperature for College Station, TX

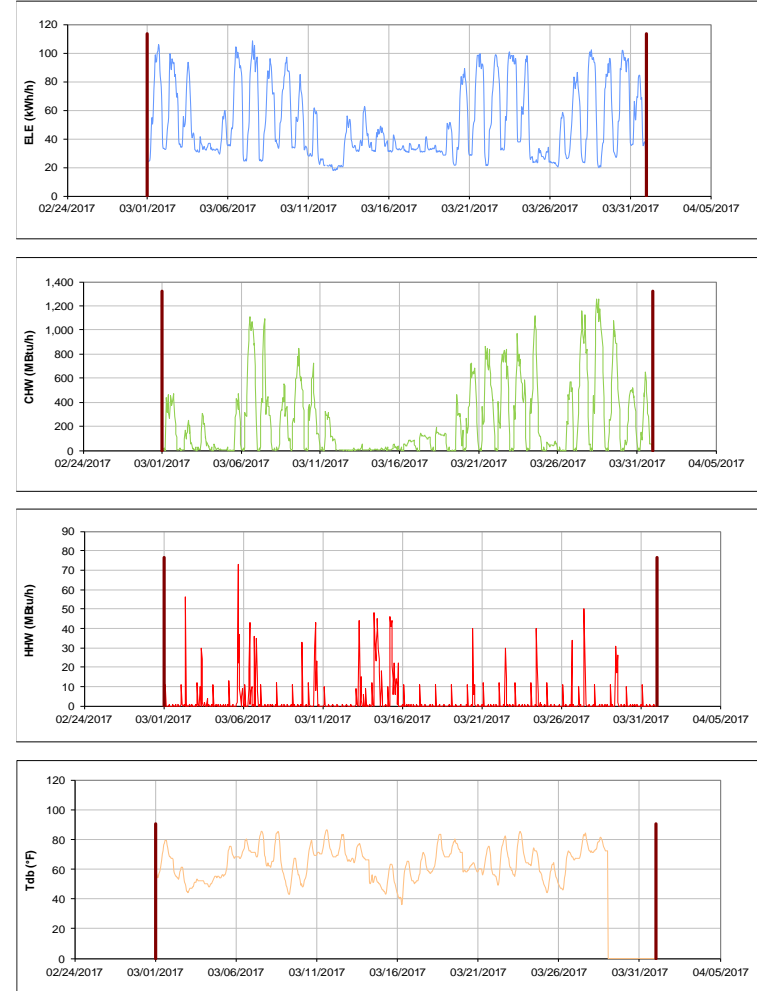
Harrington Education Center Classroom Building TAMU / BLDG #: 0438

Figure III-62 Hourly Whole Building Electricity, Chilled Water, and Hot Water Consumption for Harrington Education Center Classroom Building during the Month of March 2017 and the Corresponding Hourly Outdoor Dry Bulb Temperature for College Station, TX

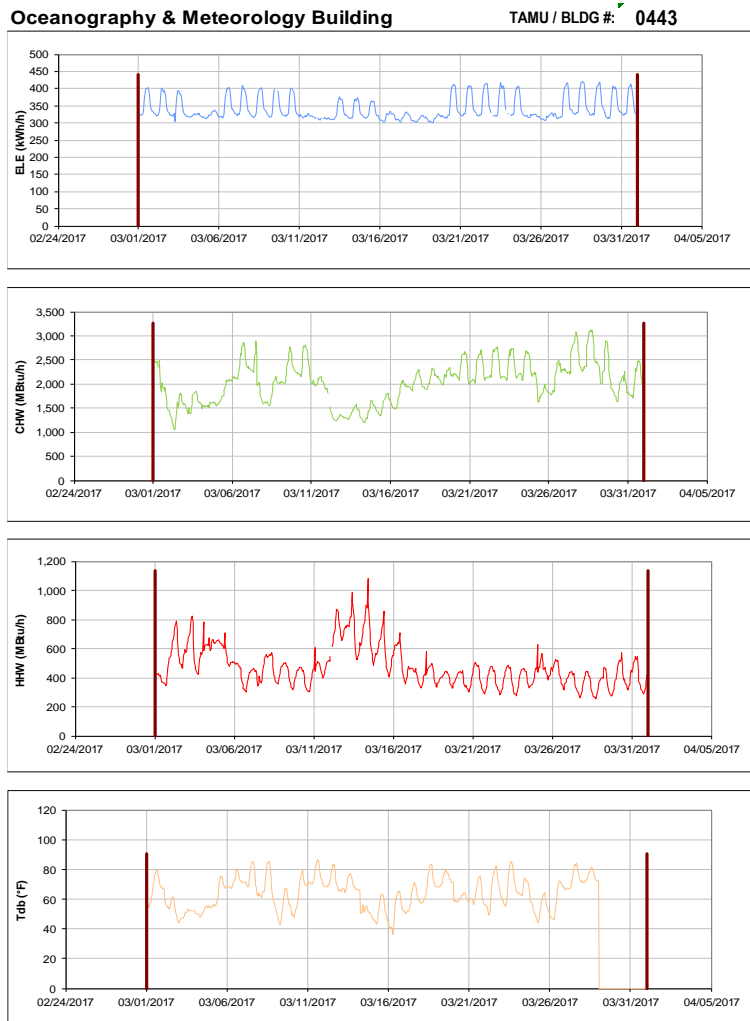
Figure III-63 Hourly Whole Building Electricity, Chilled Water, and Hot Water Consumption for Oceanography & Meteorology Building during the Month of March 2017 and the Corresponding Hourly Outdoor Dry Bulb Temperature for College Station, TX

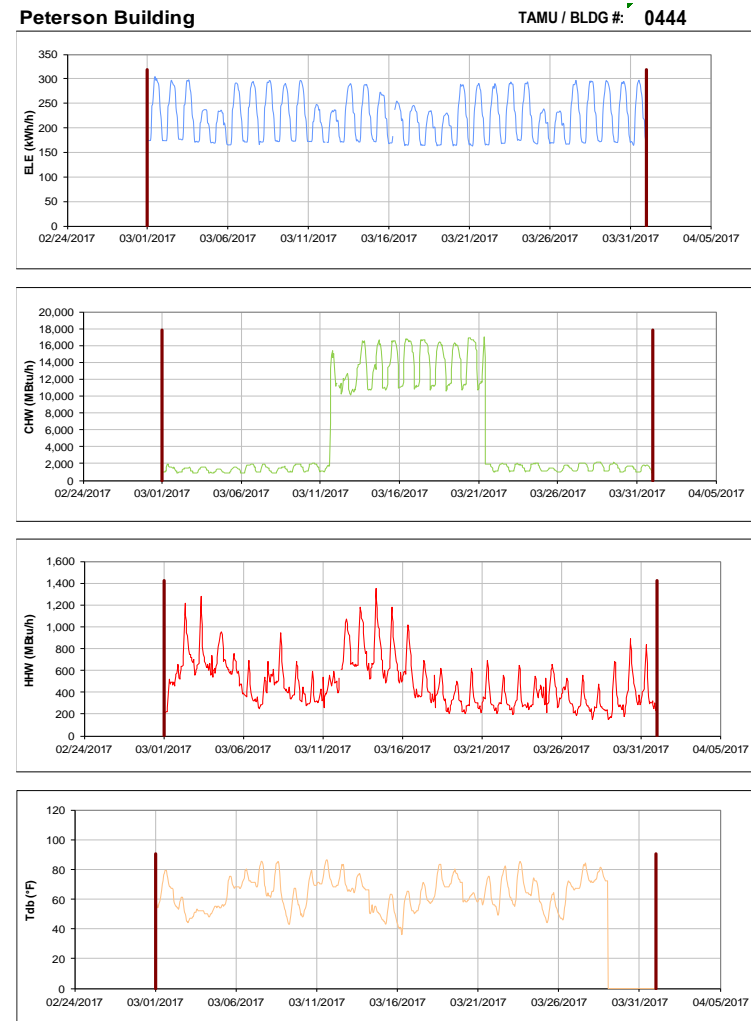
Figure III-64 Hourly Whole Building Electricity, Chilled Water, and Hot Water Consumption for Peterson Building during the Month of March 2017 and the Corresponding Hourly Outdoor Dry Bulb Temperature for College Station, TX

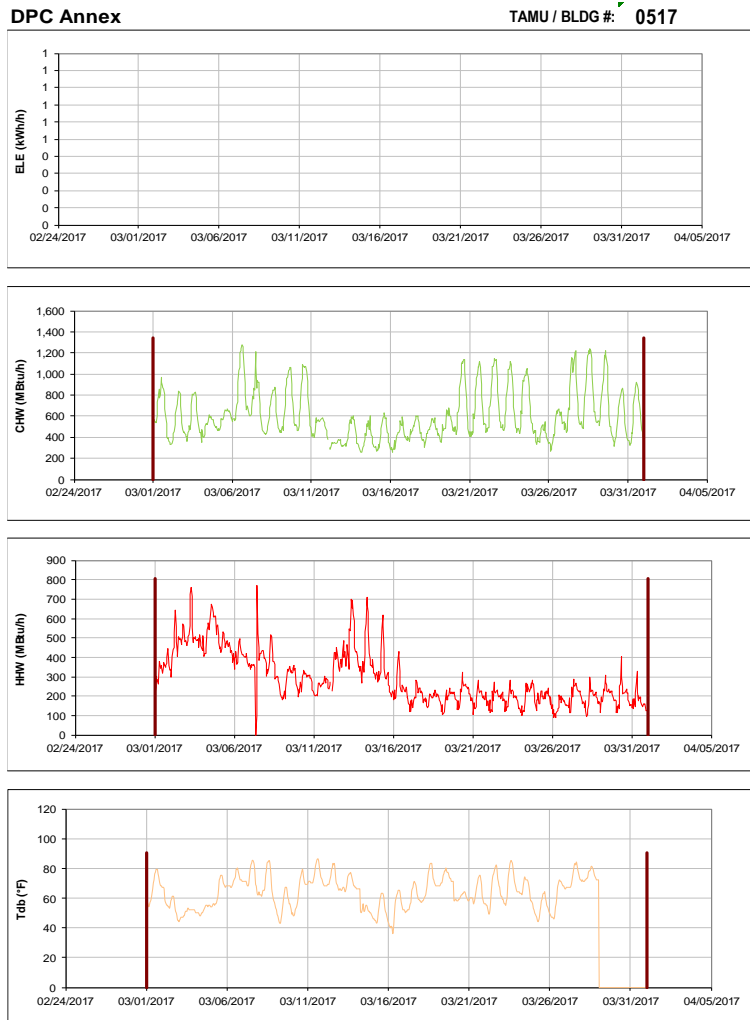
Figure III-67 Hourly Whole Building Electricity, Chilled Water, and Hot Water Consumption for DPC Annex during the Month of March 2017 and the Corresponding Hourly Outdoor Dry Bulb Temperature for College Station, TX

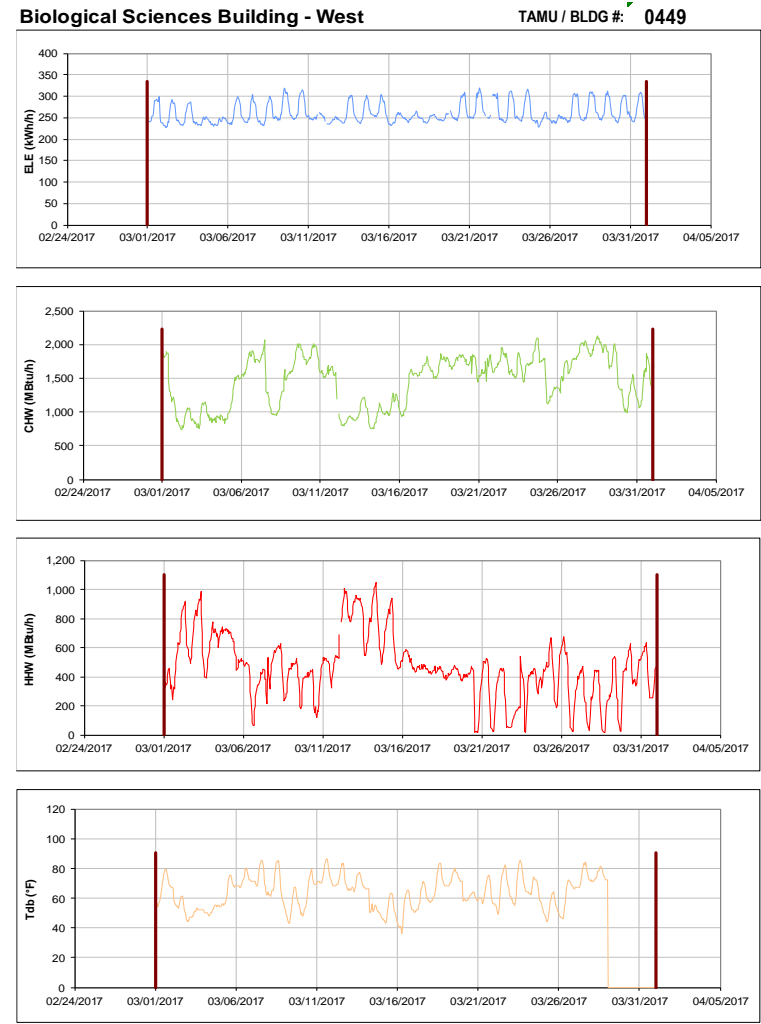
Figure III-72 Hourly Whole Building Electricity, Chilled Water, and Hot Water Consumption for Biological Sciences Building - West during the Month of March 2017 and the Corresponding Hourly Outdoor Dry Bulb Temperature for College Station, TX

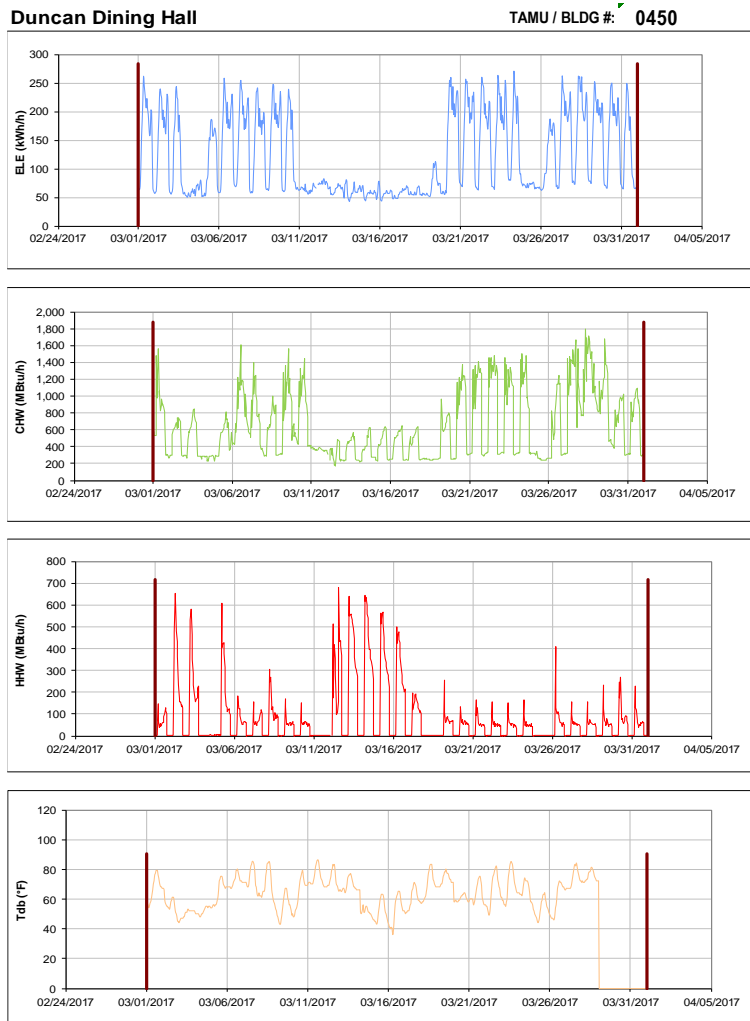
Figure III-73 Hourly Whole Building Electricity, Chilled Water, and Hot Water Consumption for Duncan Dining Hall during the Month of March 2017 and the Corresponding Hourly Outdoor Dry Bulb Temperature for College Station, TX
