TAMU Project

**Energy Consumption Data Quality Assurance/Quality
Control Assessment Report for the
Month of March 2017**

**Utility & Energy Services
Division of Administration
Texas A&M University**

April 2017

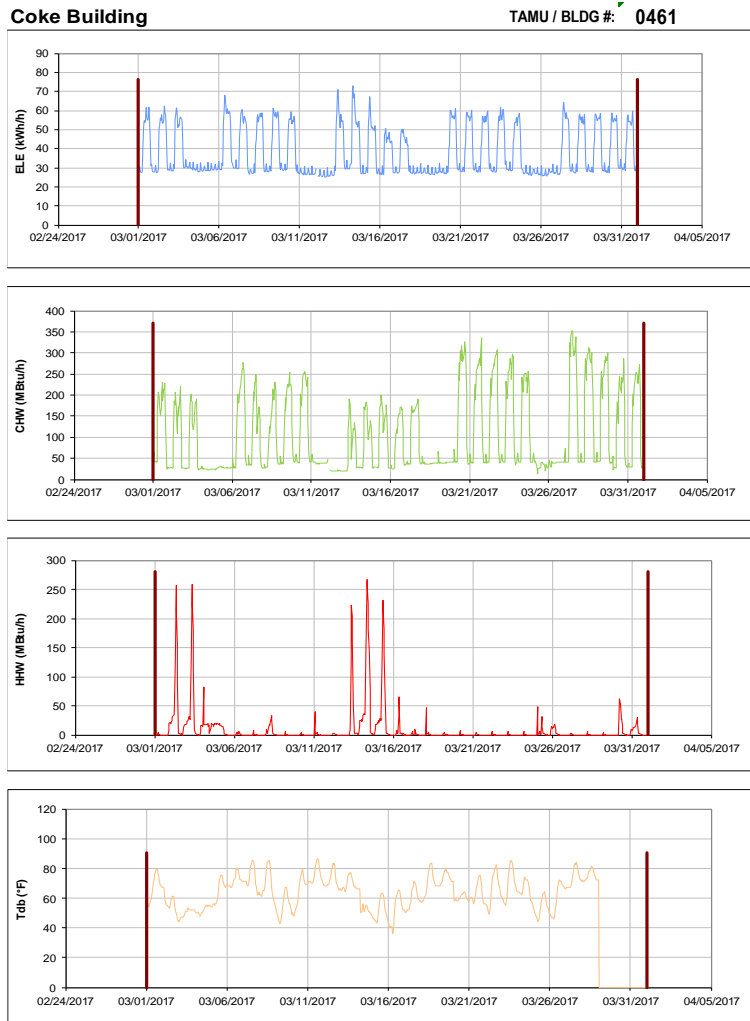
Figure III-77 Hourly Whole Building Electricity, Chilled Water, and Hot Water Consumption for Coke Building during the Month of March 2017 and the Corresponding Hourly Outdoor Dry Bulb Temperature for College Station, TX

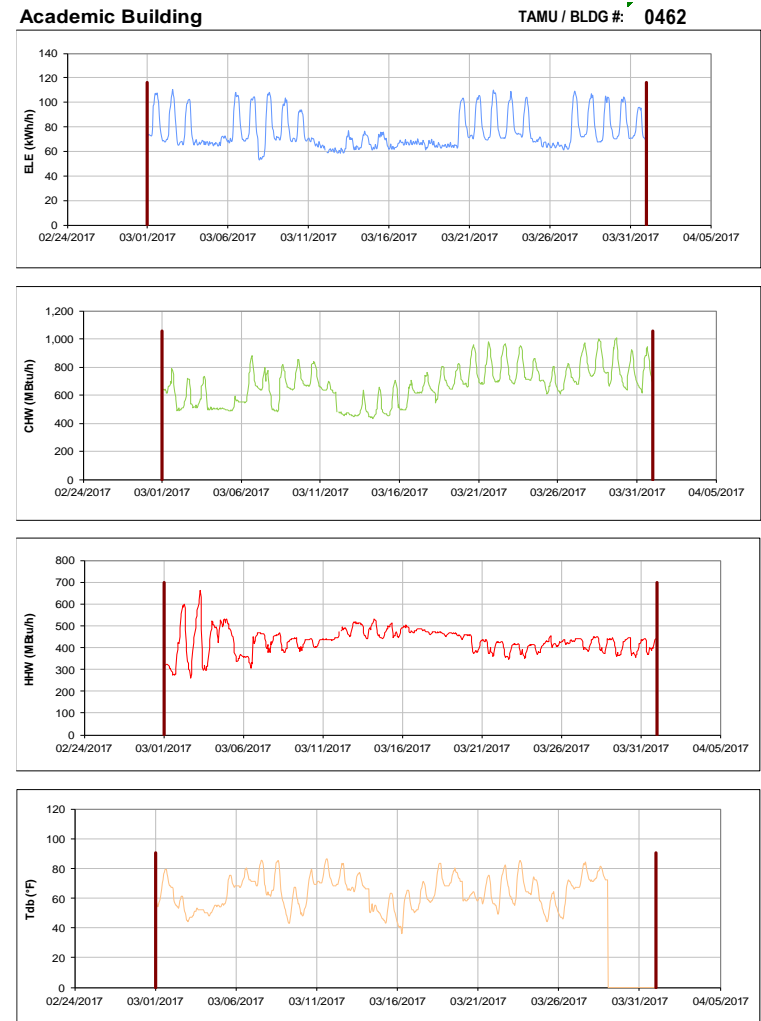
Figure III-78 Hourly Whole Building Electricity, Chilled Water, and Hot Water Consumption for Academic Building during the Month of March 2017 and the Corresponding Hourly Outdoor Dry Bulb Temperature for College Station, TX

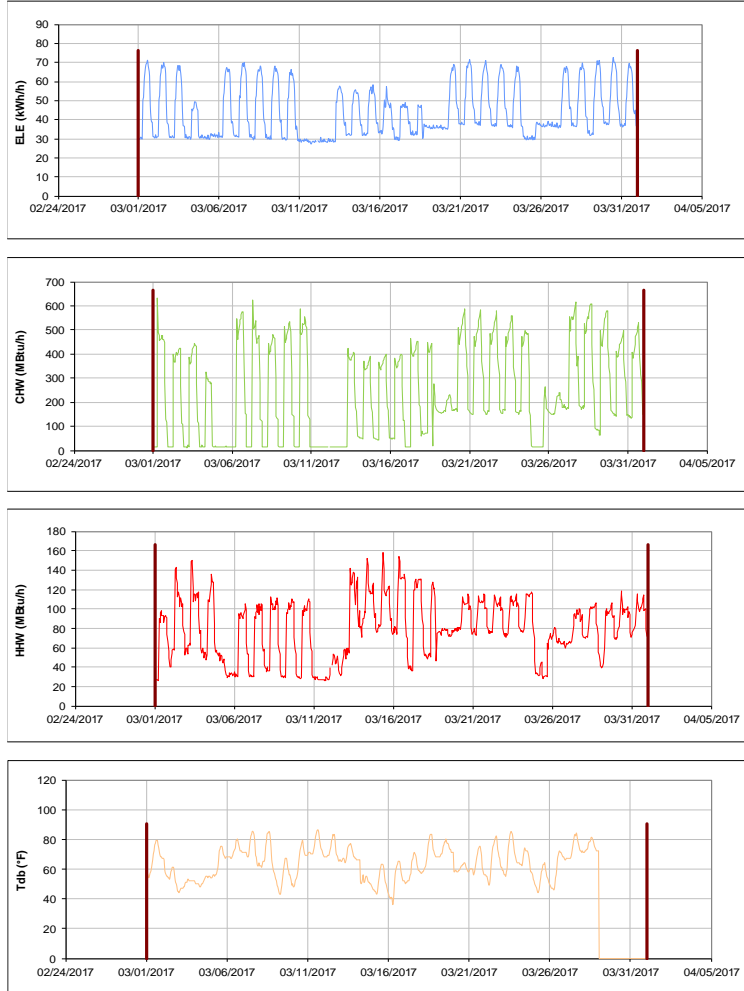
TAMU / BLDG #: 0480

Figure III-93 Hourly Whole Building Electricity, Chilled Water, and Hot Water Consumption for Bolton Hall during the Month of March 2017 and the Corresponding Hourly Outdoor Dry Bulb Temperature for College Station, TX

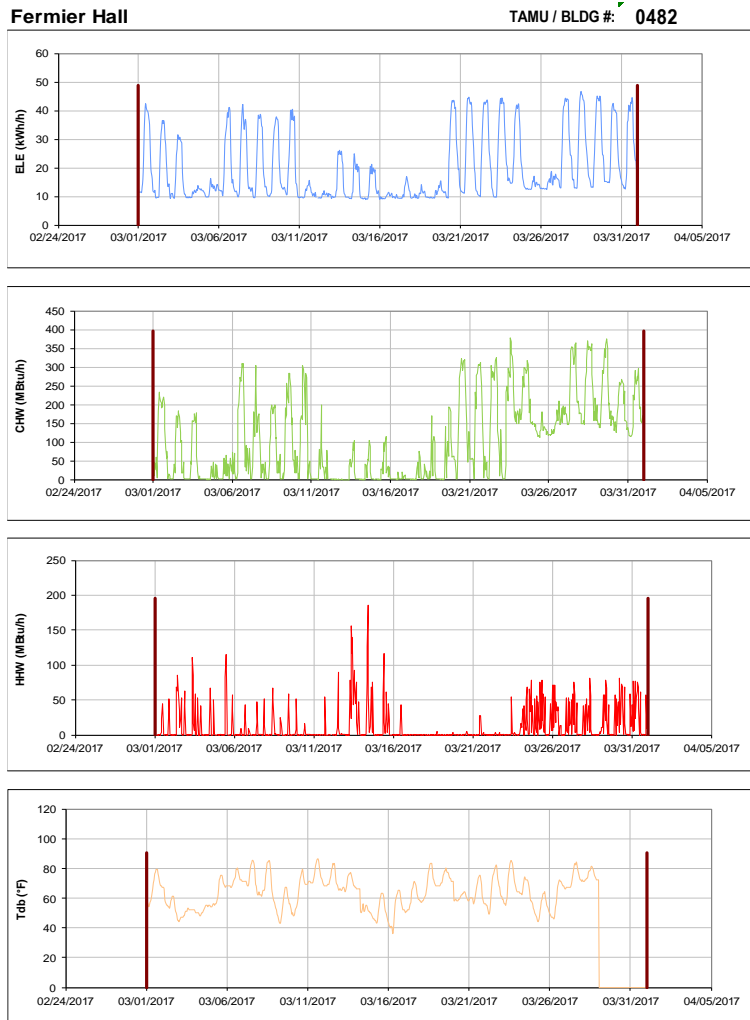
Figure III-95 Hourly Whole Building Electricity, Chilled Water, and Hot Water Consumption for Fermier Hall during the Month of March 2017 and the Corresponding Hourly Outdoor Dry Bulb Temperature for College Station, TX

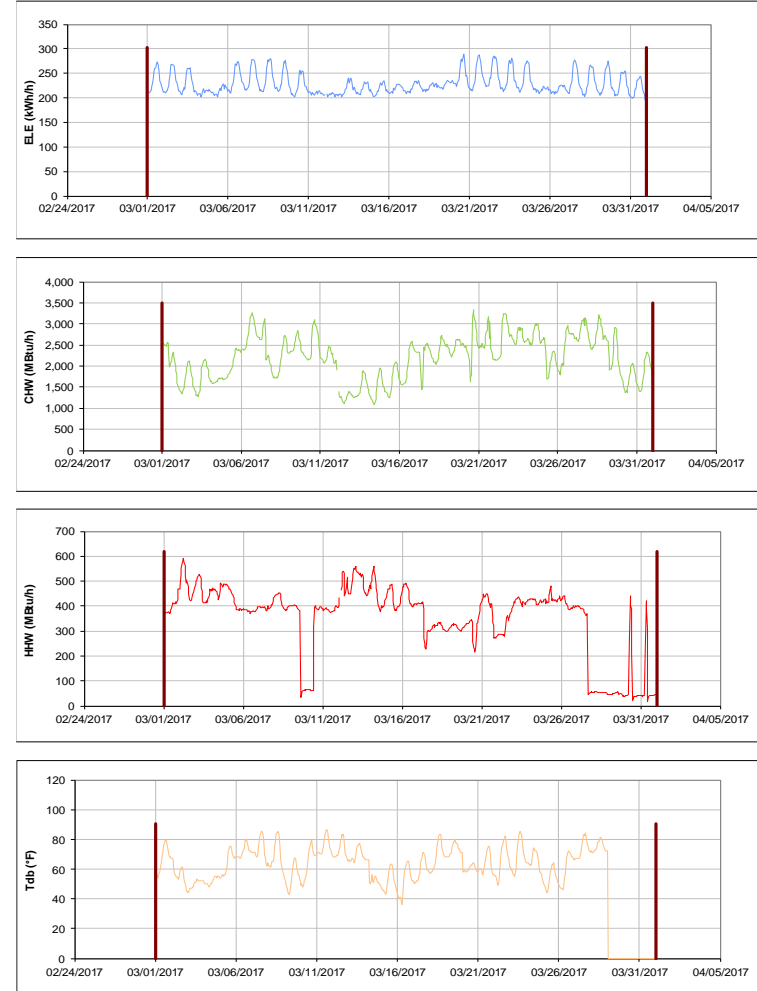
TAMU / BLDG #: 0490

Figure III-98 Hourly Whole Building Electricity, Chilled Water, and Hot Water Consumption for Halbuty Geosciences Building during the Month of March 2017 and the Corresponding Hourly Outdoor Dry Bulb Temperature for College Station, TX

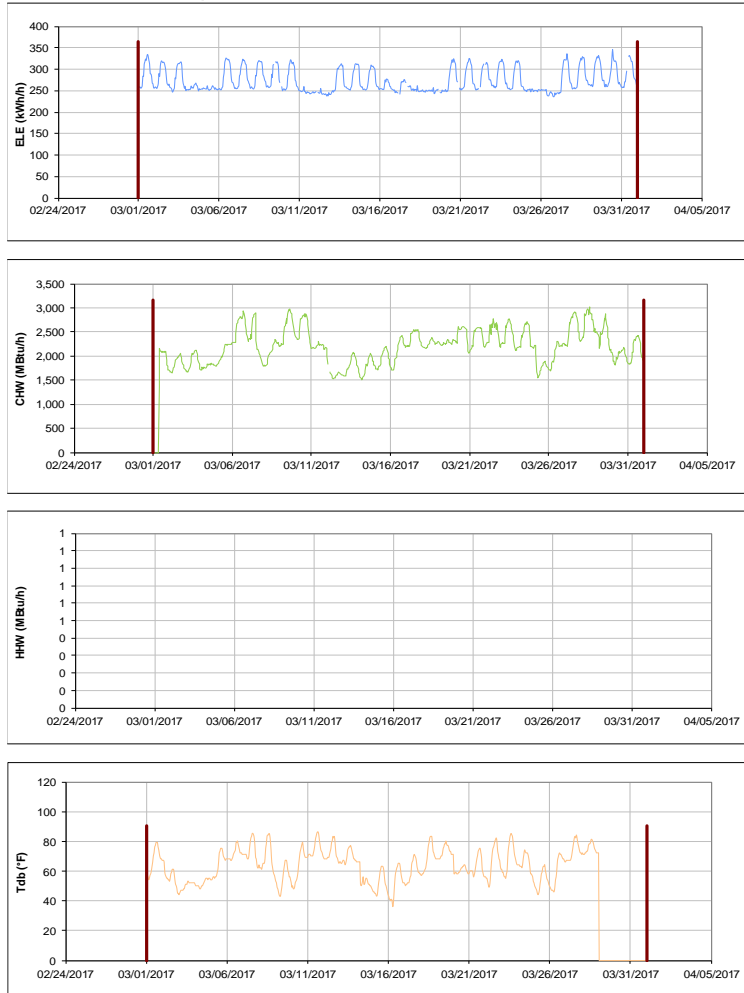
Veterinary Teaching Hospital and Med Adm TAMU / BLDG #: 1508-1026

Figure III-105 Hourly Whole Building Electricity, Chilled Water, and Hot Water Consumption for Veterinary Teaching Hospital and Med Adm during the Month of March 2017 and the Corresponding Hourly Outdoor Dry Bulb Temperature for College Station, TX

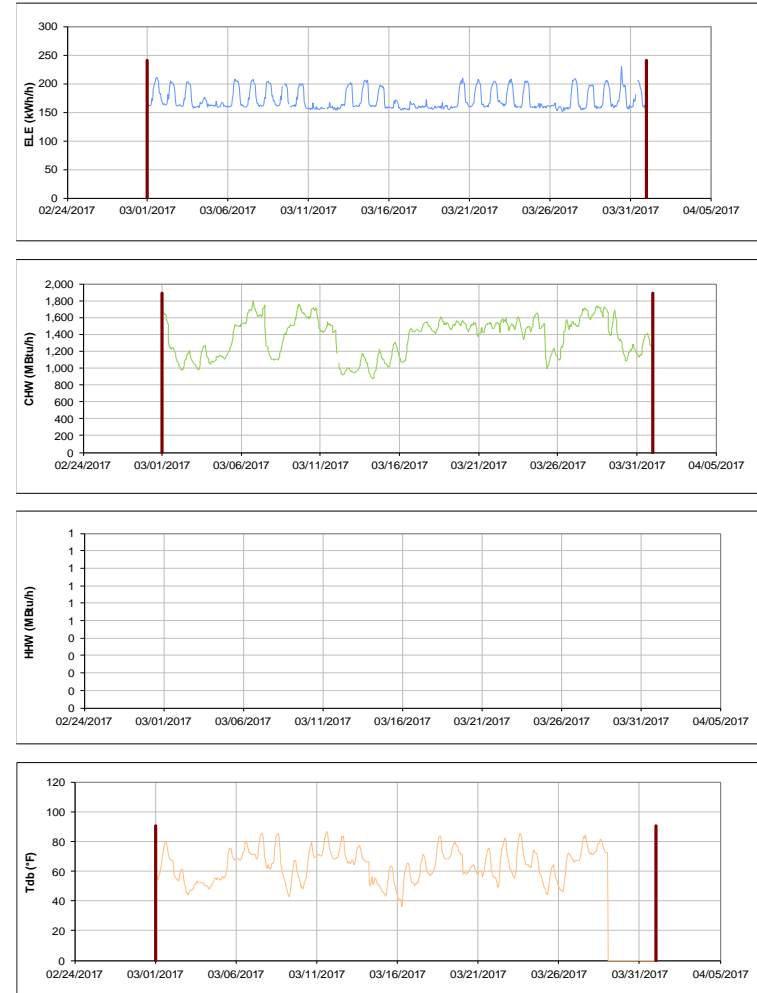
Veterinary Medicine Administration TAMU / BLDG #: 1026

Figure III-106 Hourly Whole Building Electricity, Chilled Water, and Hot Water Consumption for Veterinary Medicine Administration during the Month of March 2017 and the Corresponding Hourly Outdoor Dry Bulb Temperature for College Station, TX

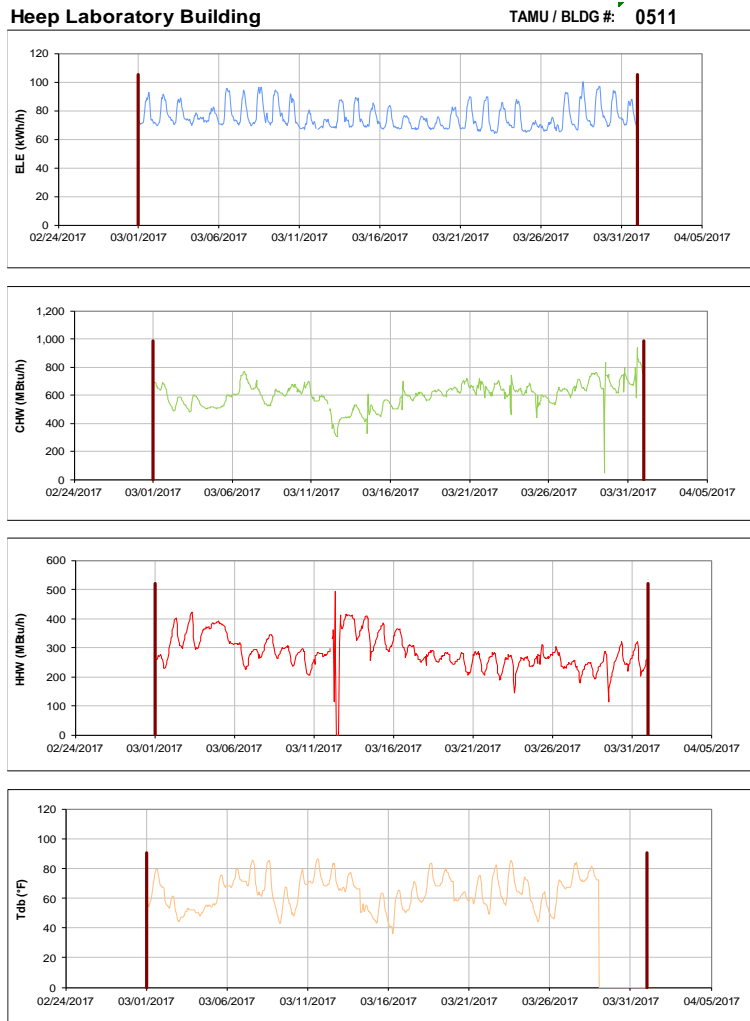
Figure III-107 Hourly Whole Building Electricity, Chilled Water, and Hot Water Consumption for Heep Laboratory Building during the Month of March 2017 and the Corresponding Hourly Outdoor Dry Bulb Temperature for College Station, TX

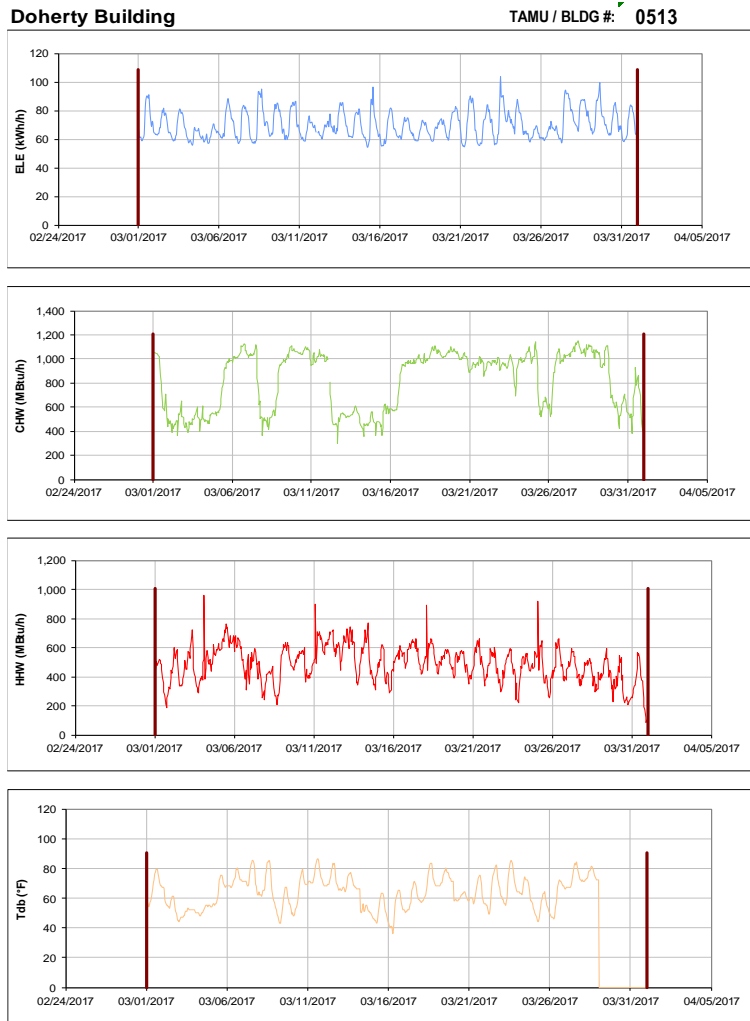
Figure III-109 Hourly Whole Building Electricity, Chilled Water, and Hot Water Consumption for Doherty Building during the Month of March 2017 and the Corresponding Hourly Outdoor Dry Bulb Temperature for College Station, TX

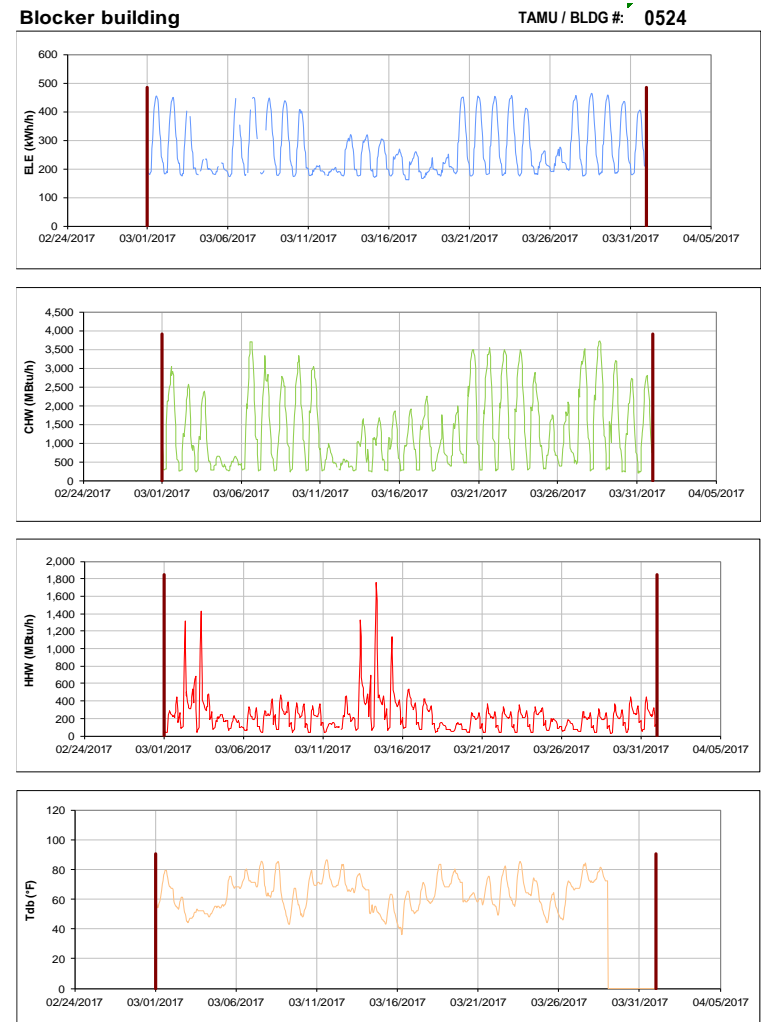
Figure III-114 Hourly Whole Building Electricity, Chilled Water, and Hot Water Consumption for Blocker building during the Month of March 2017 and the Corresponding Hourly Outdoor Dry Bulb Temperature for College Station, TX

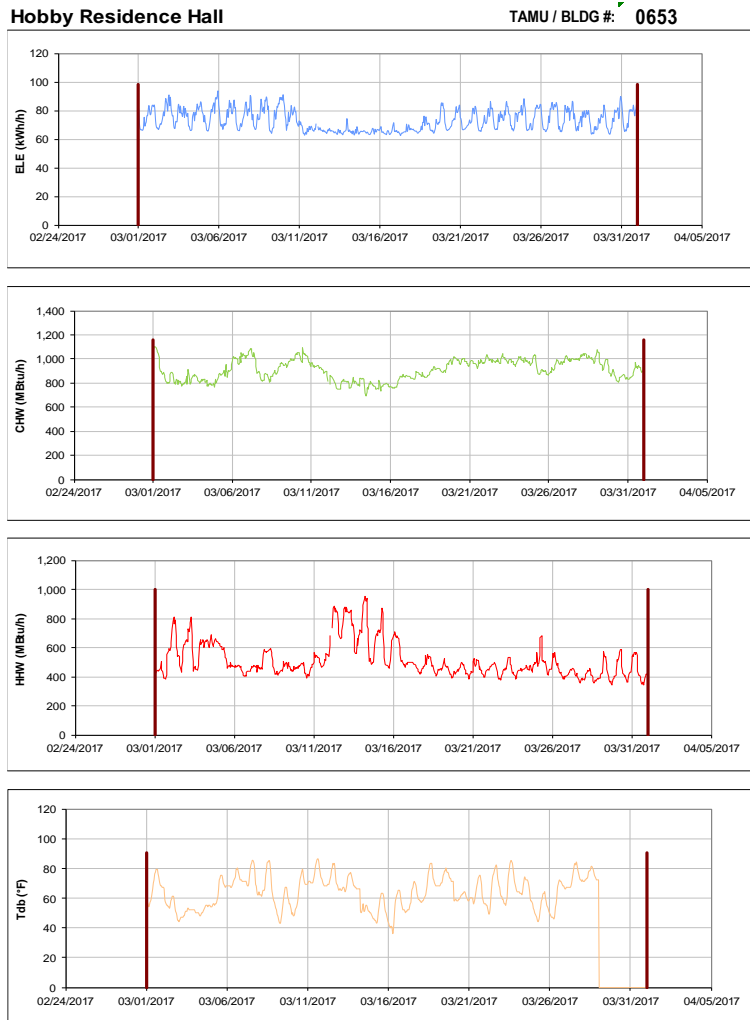
Figure III-119 Hourly Whole Building Electricity, Chilled Water, and Hot Water Consumption for Hobby Residence Hall during the Month of March 2017 and the Corresponding Hourly Outdoor Dry Bulb Temperature for College Station, TX

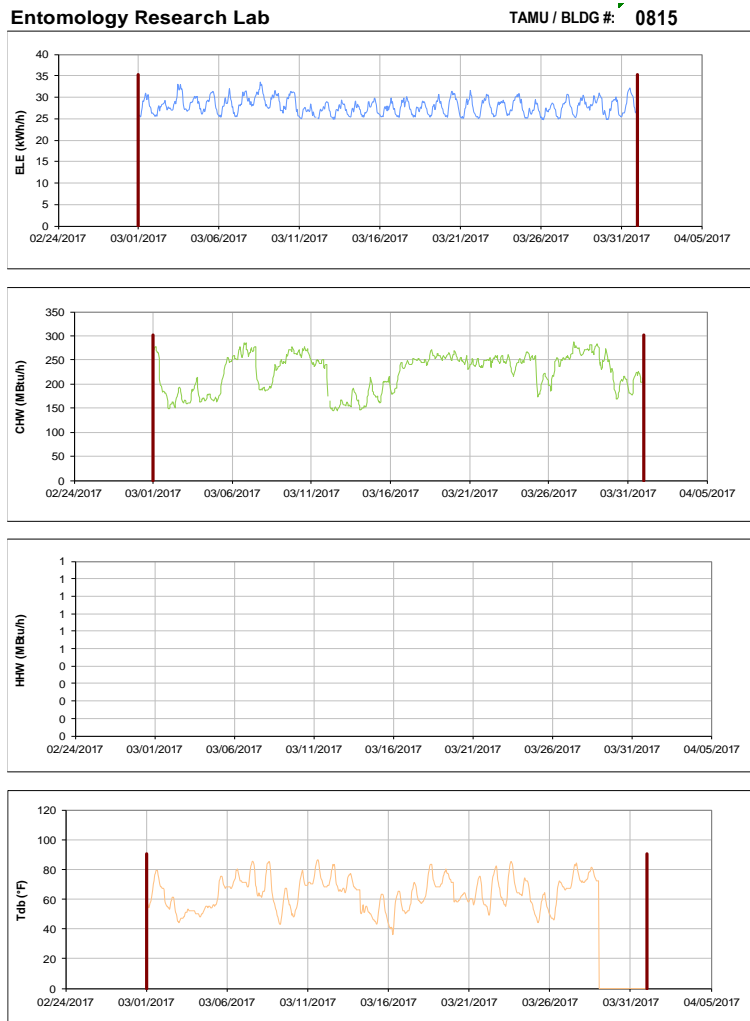
Figure III-123 Hourly Whole Building Electricity, Chilled Water, and Hot Water Consumption for Entomology Research Lab during the Month of March 2017 and the Corresponding Hourly Outdoor Dry Bulb Temperature for College Station, TX

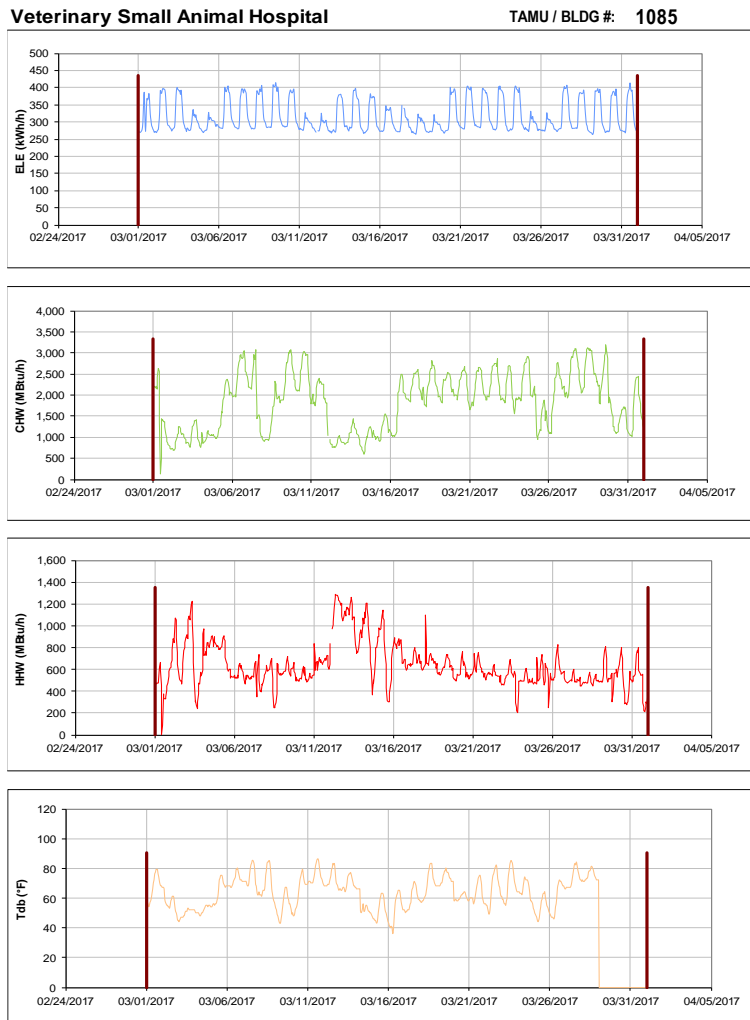
Figure III-129 Hourly Whole Building Electricity, Chilled Water, and Hot Water Consumption for Veterinary Small Animal Hospital during the Month of March 2017 and the Corresponding Hourly Outdoor Dry Bulb Temperature for College Station, TX

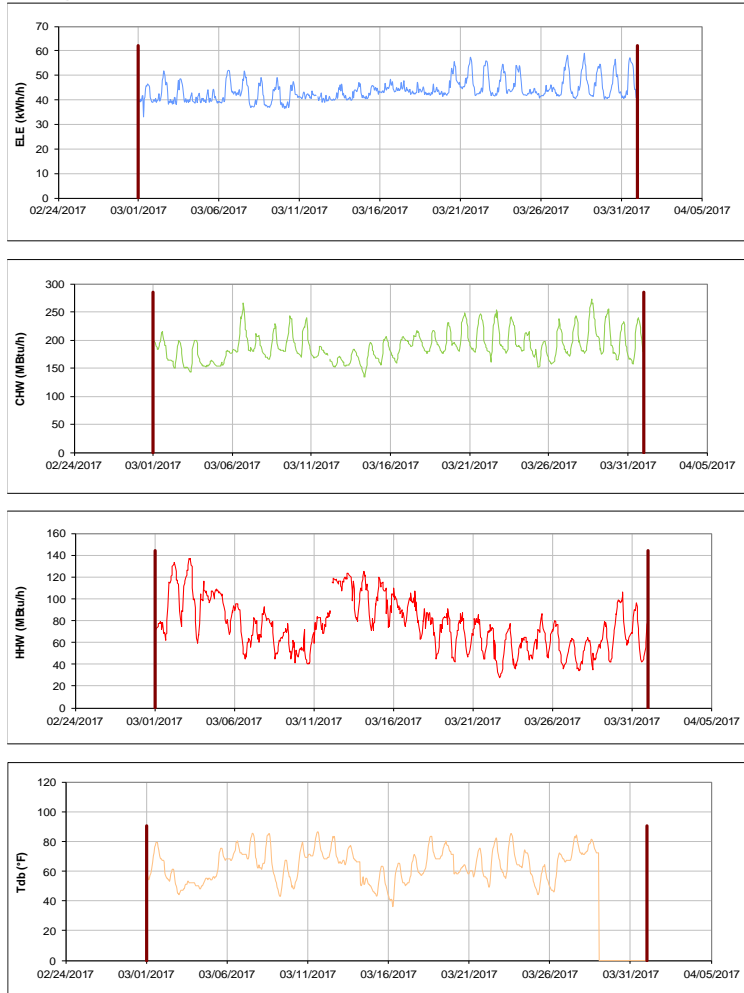
TAMU / BLDG #: 1146

Figure III-131 Hourly Whole Building Electricity, Chilled Water, and Hot Water Consumption for Biological Control Facility during the Month of March 2017 and the Corresponding Hourly Outdoor Dry Bulb Temperature for College Station, TX

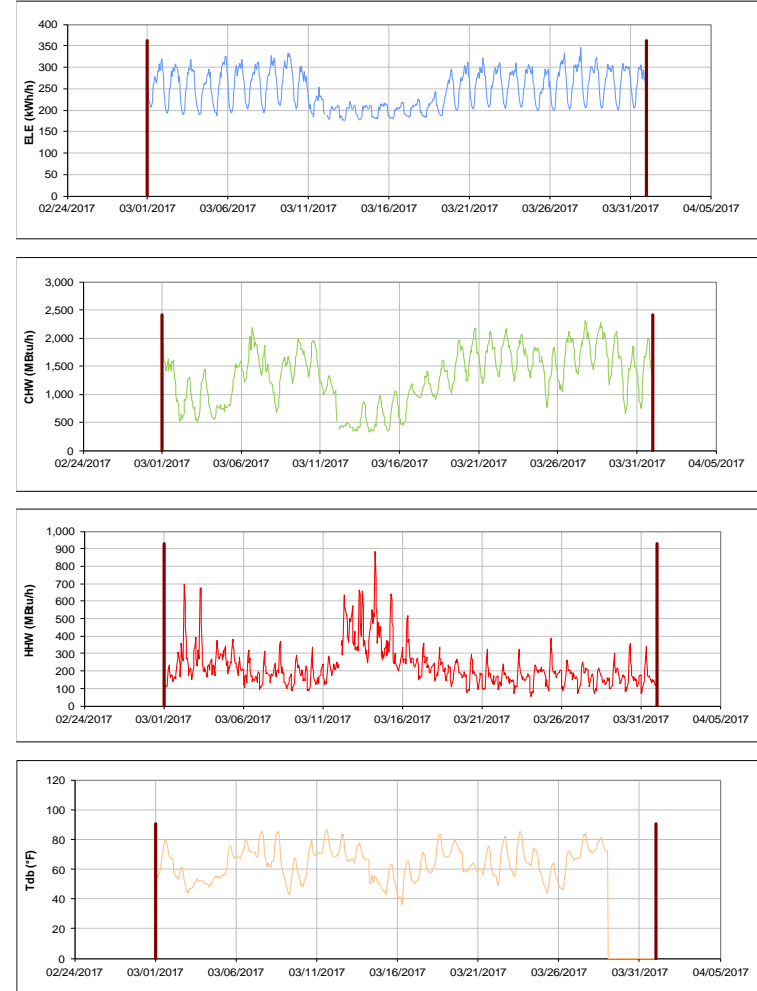
TAMU / BLDG #: 1416

Figure III-136 Hourly Whole Building Electricity, Chilled Water, and Hot Water Consumption for Hullabaloo Residence Hall during the Month of March 2017 and the Corresponding Hourly Outdoor Dry Bulb Temperature for College Station, TX

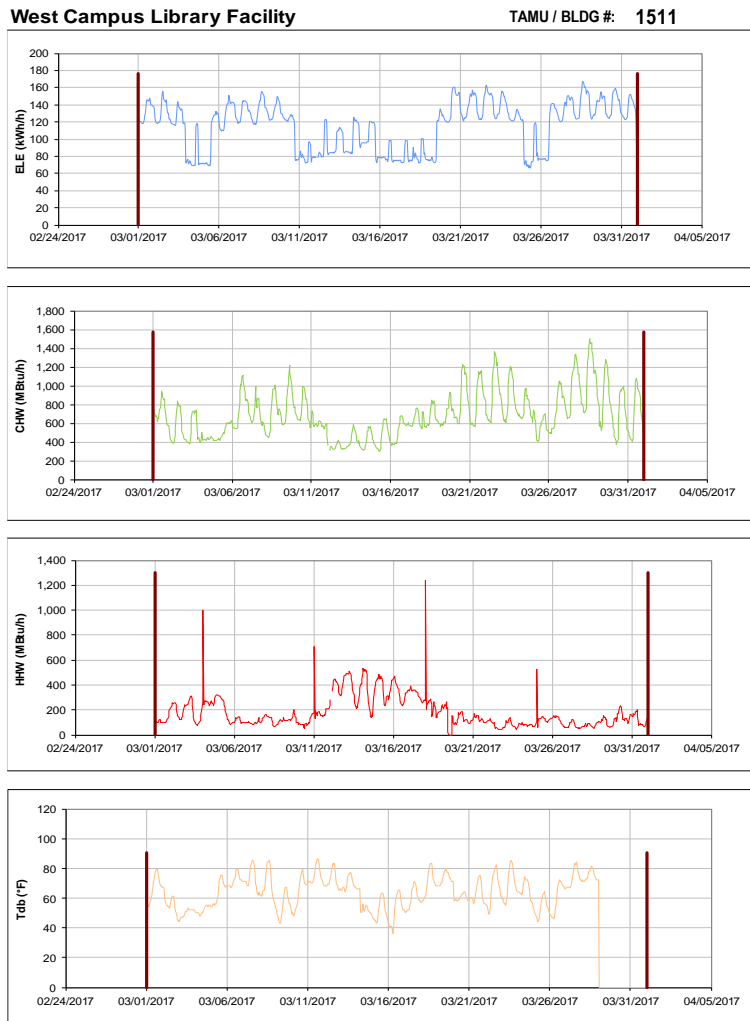
Figure III-159 Hourly Whole Building Electricity, Chilled Water, and Hot Water Consumption for West Campus Library Facility during the Month of March 2017 and the Corresponding Hourly Outdoor Dry Bulb Temperature for College Station, TX

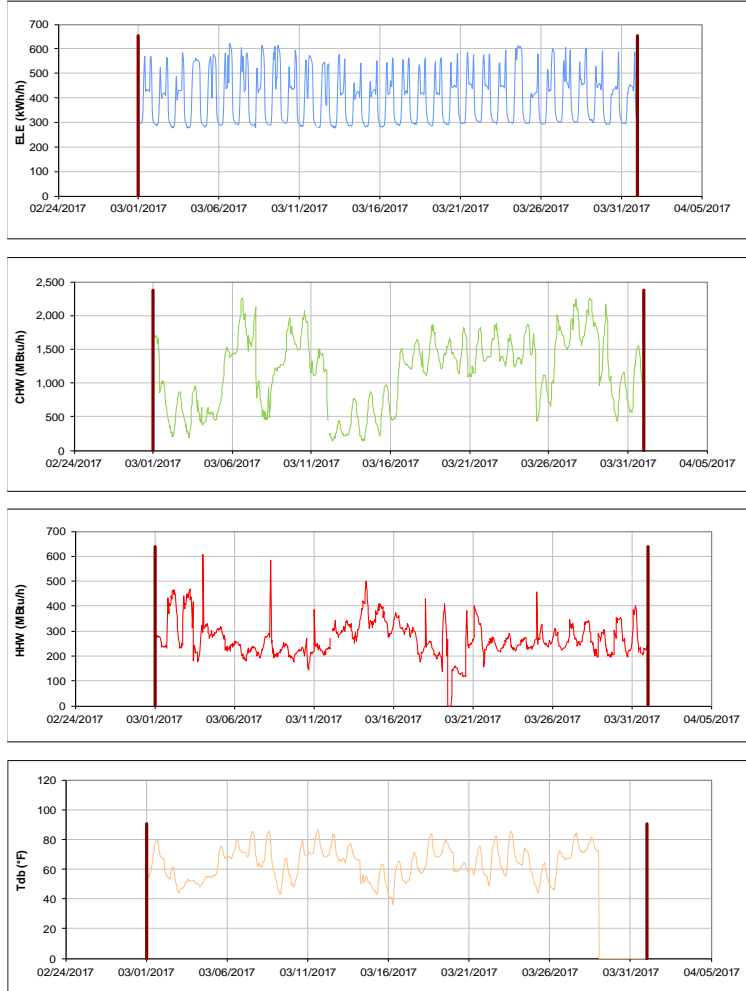
Borlaug Center for Southern Crop Improvement TAMU / BLDG #: 1513

Figure III-161 Hourly Whole Building Electricity, Chilled Water, and Hot Water Consumption for Borlaug Center for Southern Crop Improvement during the Month of March 2017 and the Corresponding Hourly Outdoor Dry Bulb Temperature for College Station, TX

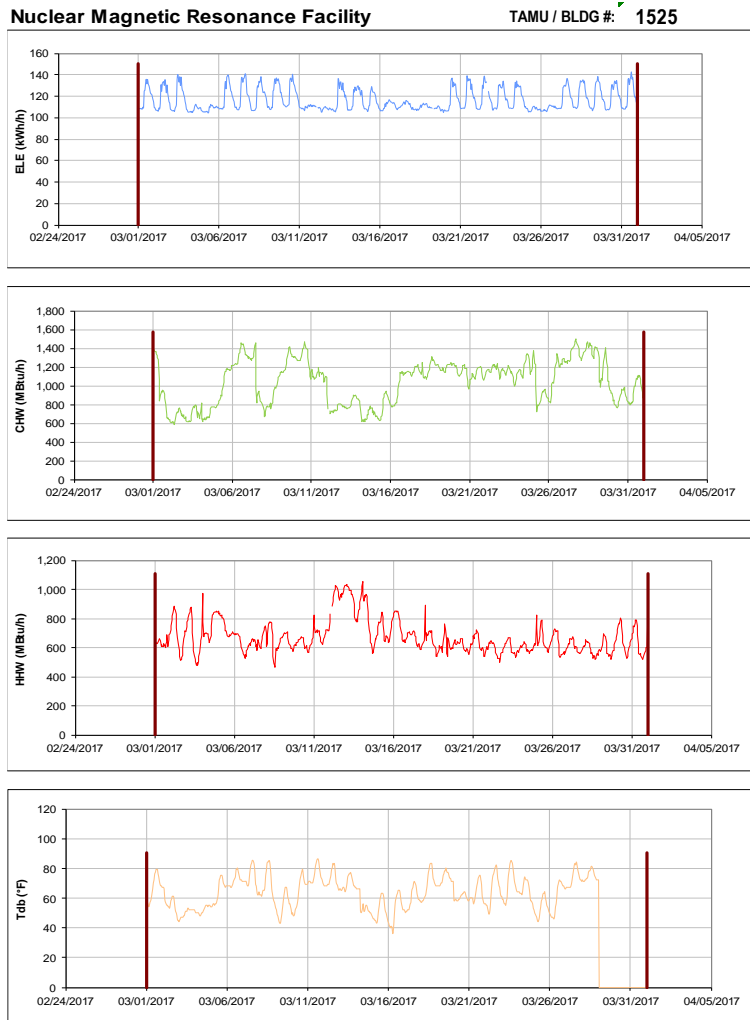
Figure III-163 Hourly Whole Building Electricity, Chilled Water, and Hot Water Consumption for Nuclear Magnetic Resonance Facility during the Month of March 2017 and the Corresponding Hourly Outdoor Dry Bulb Temperature for College Station, TX

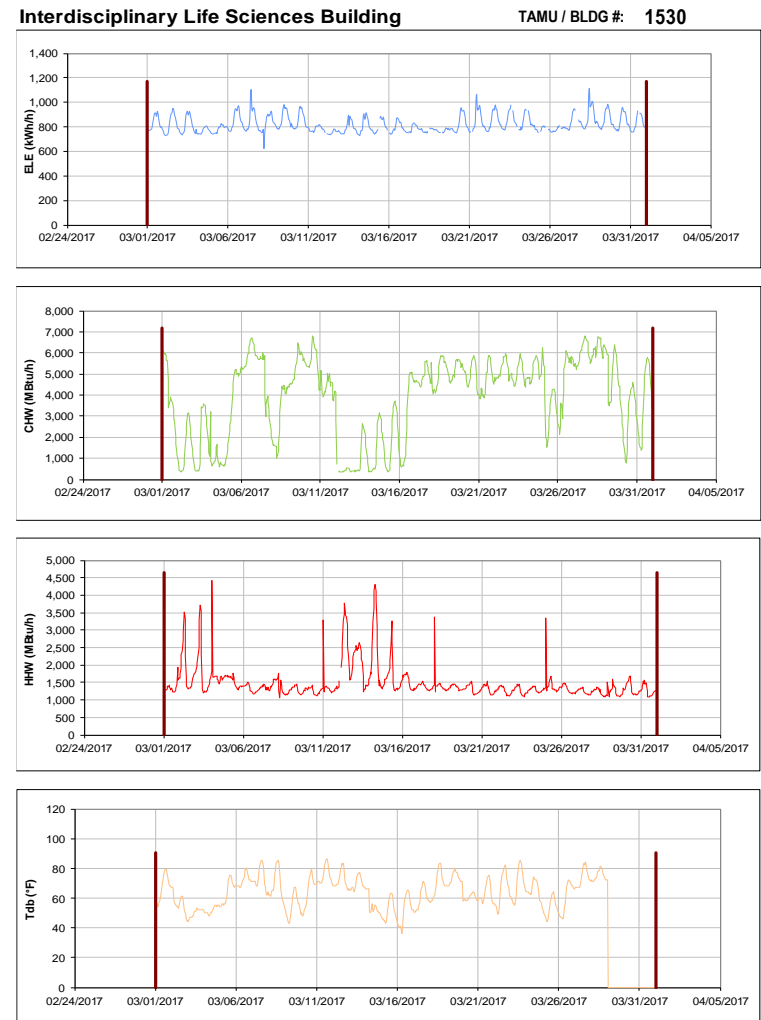
Figure III-164 Hourly Whole Building Electricity, Chilled Water, and Hot Water Consumption for Interdisciplinary Life Sciences Building during the Month of March 2017 and the Corresponding Hourly Outdoor Dry Bulb Temperature for College Station, TX

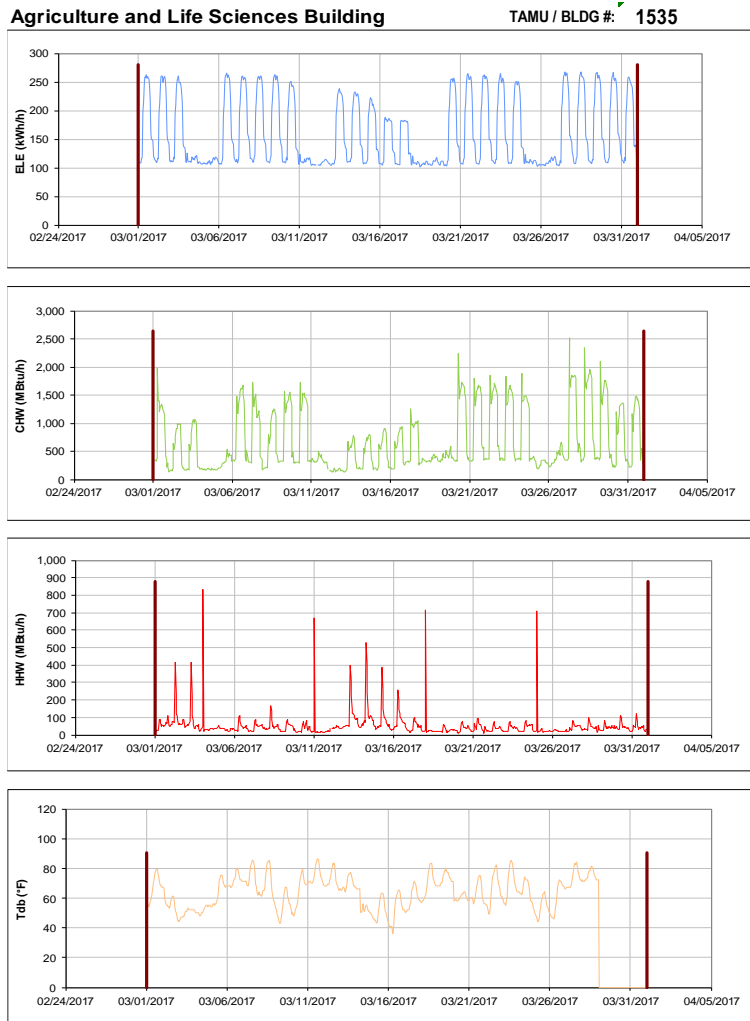
Figure III-165 Hourly Whole Building Electricity, Chilled Water, and Hot Water Consumption for Agriculture and Life Sciences Building during the Month of March 2017 and the Corresponding Hourly Outdoor Dry Bulb Temperature for College Station, TX

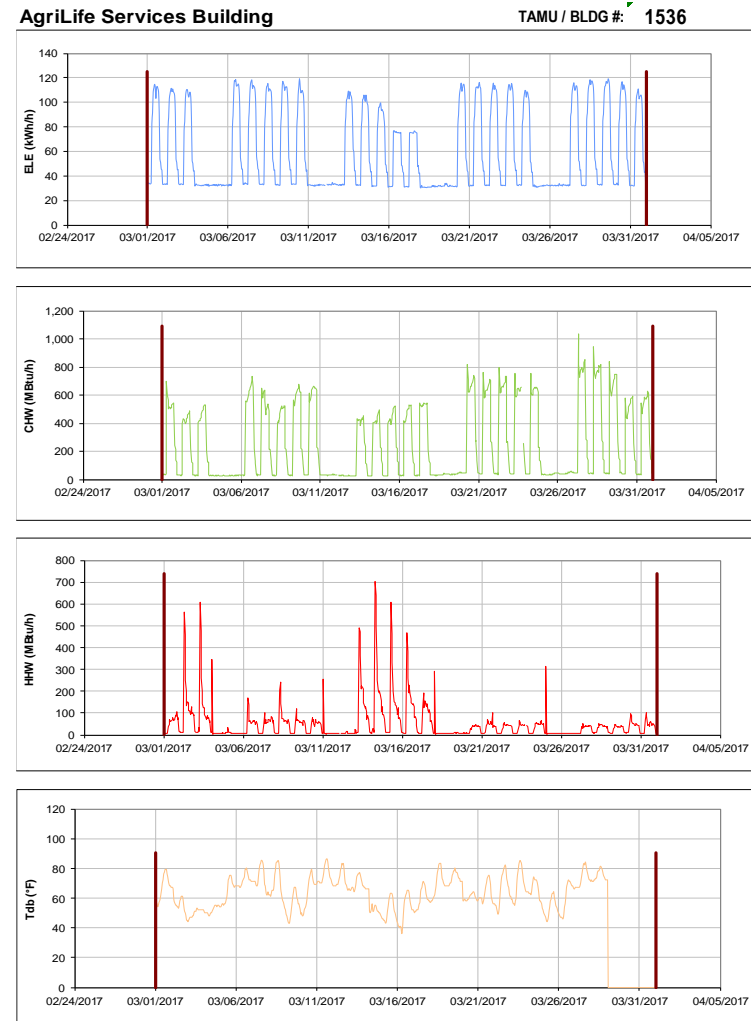
Figure III-166 Hourly Whole Building Electricity, Chilled Water, and Hot Water Consumption for AgriLife Services Building during the Month of March 2017 and the Corresponding Hourly Outdoor Dry Bulb Temperature for College Station, TX

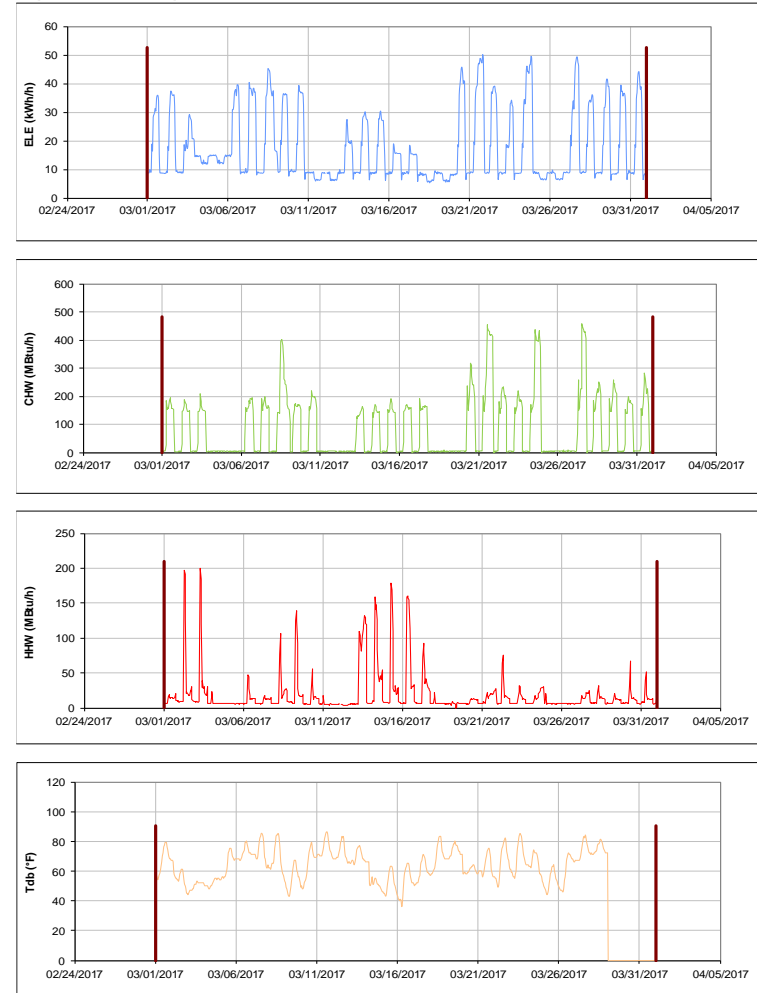
TAMU / BLDG #: 1538

Figure III-168 Hourly Whole Building Electricity, Chilled Water, and Hot Water Consumption for Agriculture Program Visitors Center during the Month of March 2017 and the Corresponding Hourly Outdoor Dry Bulb Temperature for College Station, TX

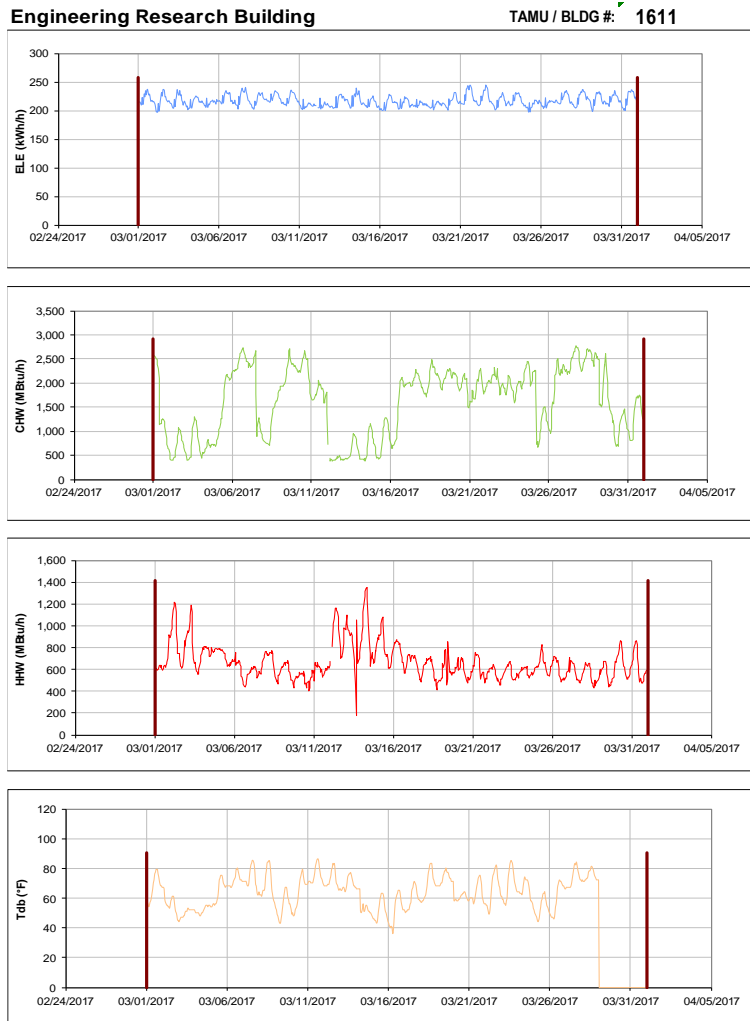
Figure III-187 Hourly Whole Building Electricity, Chilled Water, and Hot Water Consumption for Engineering Research Building during the Month of March 2017 and the Corresponding Hourly Outdoor Dry Bulb Temperature for College Station, TX

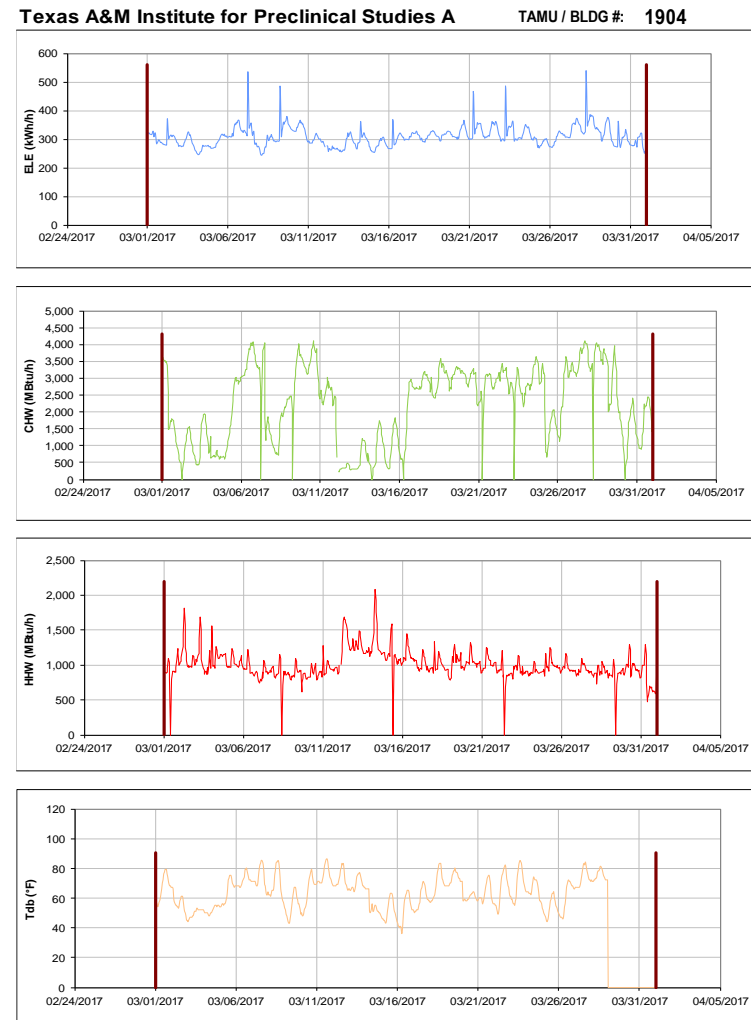
Figure III-194 Hourly Whole Building Electricity, Chilled Water, and Hot Water Consumption for Texas A&M Institute for Preclinical Studies A during the Month of March 2017 and the Corresponding Hourly Outdoor Dry Bulb Temperature for College Station, TX

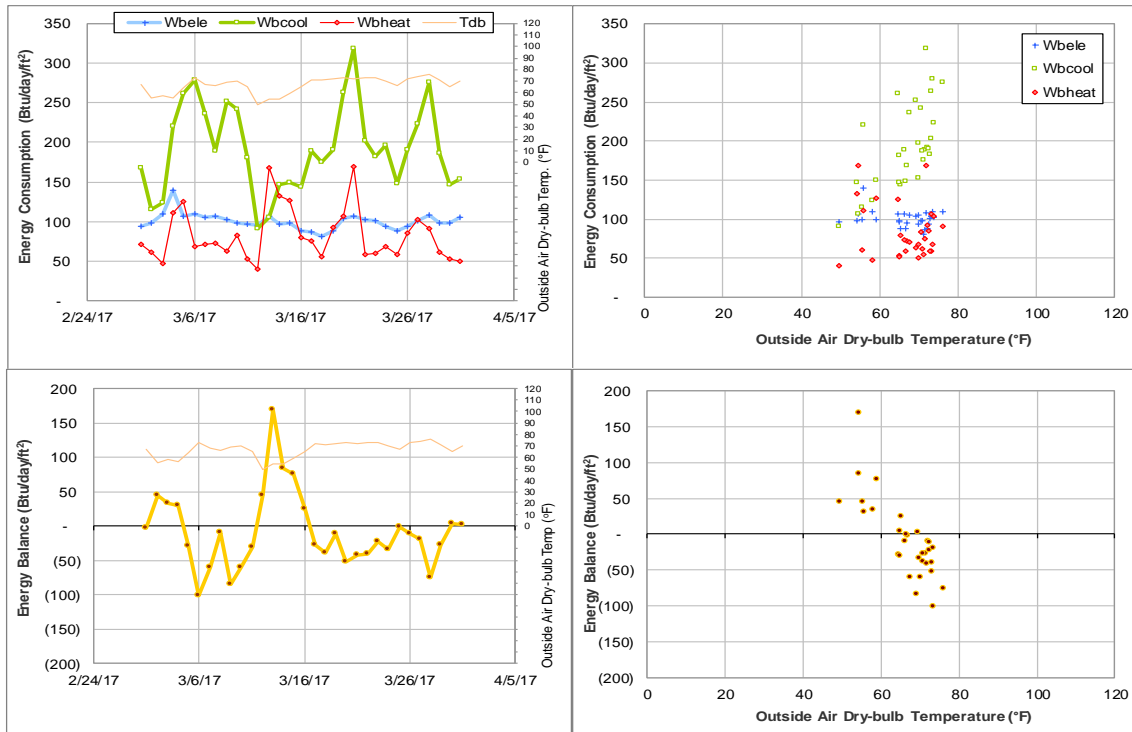
Figure V-18 Reed Arena and Cox-McFerrin Center TAMU BLDG # 1544 Energy Balance Plot during March 2017
