ASIA TURBOMACHINERY & PUMP SYMPOSIUM  
12 - 15 MARCH 2018  
SUNTEC SINGAPORE

## Subsynchronous Shaft Vibration in an Integrally Geared Expander-Compressor due to Vortex Flow in an Expander

Subsynchronous shaft vibration was observed in an integrally geared expander-compressor when the machine was operated with a partial load in the course of plant start up. The root cause of the synchronous shaft vibration was identified, by means of CFD analysis, as the vortex flow which was generated in the downstream piping of the gas expander wheel.

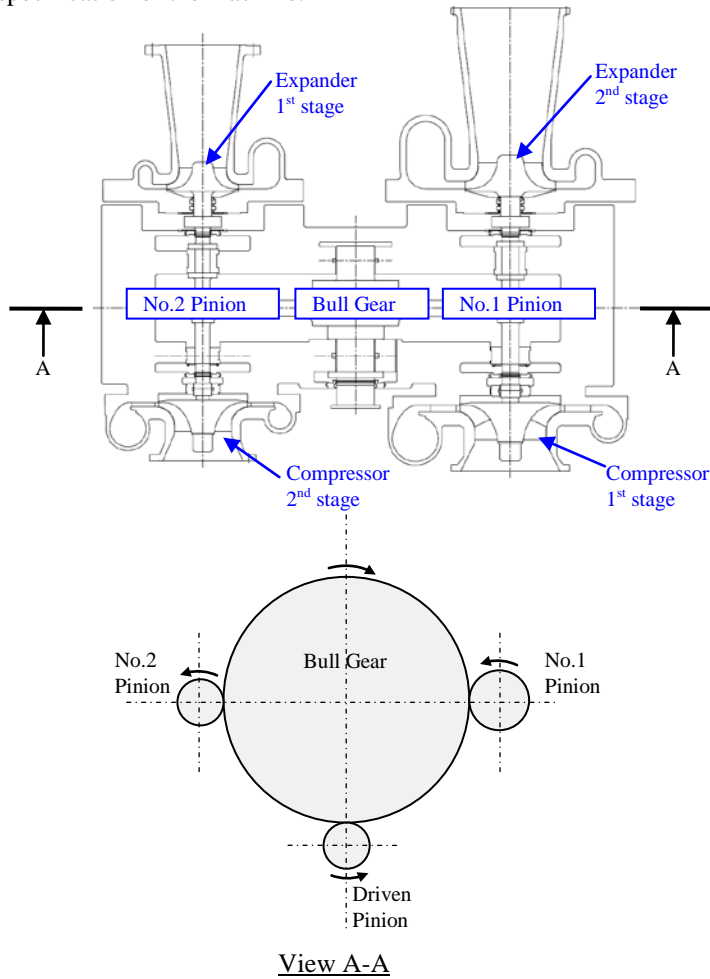
The compressor 1<sup>st</sup> stage and expander 2<sup>nd</sup> stage are equipped in no.1 pinion rotor, and the compressor 2<sup>nd</sup> stage and expander 1<sup>st</sup> stage are equipped in no.2 pinion rotor [Fig.1]. This construction, that is one pinion has a compressor impeller and an expander wheel, provides the lower power transmission on gears and lower mechanical losses. Table 1 shows the specification of the machine.

Fig.1 Integally Geared Compressor-Expander

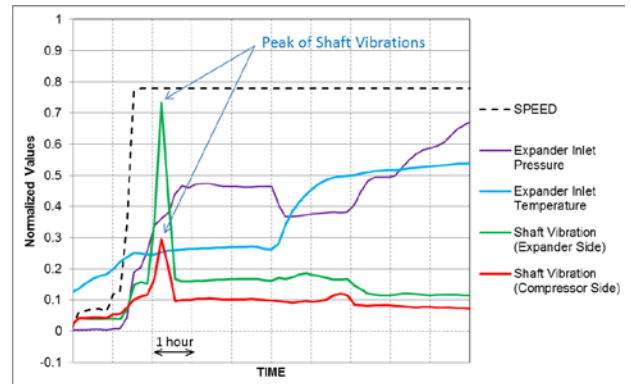
In the course of plant start up, the no.1 pinion rotor faced a steep increase of shaft vibration when the operating parameters reached a particular condition, and immediately after such a condition was passed, the shaft vibration decreased [Fig.2]. The shaft vibration amplitude at the expander side of approx. 70  $\mu\text{m}$  was much higher than that at the compressor side of 30  $\mu\text{m}$ , and the dominant vibration frequency was subsynchronous component of 45~50 Hz (0.3 times operating speed) [Fig.3], which almost matched with one of natural frequencies of no.1 pinion rotor.

Fig.2 Time Trend Data of Operating Speed, Inlet Pressure/Temperature of Expander 2<sup>nd</sup> Stage and Shaft Vibration

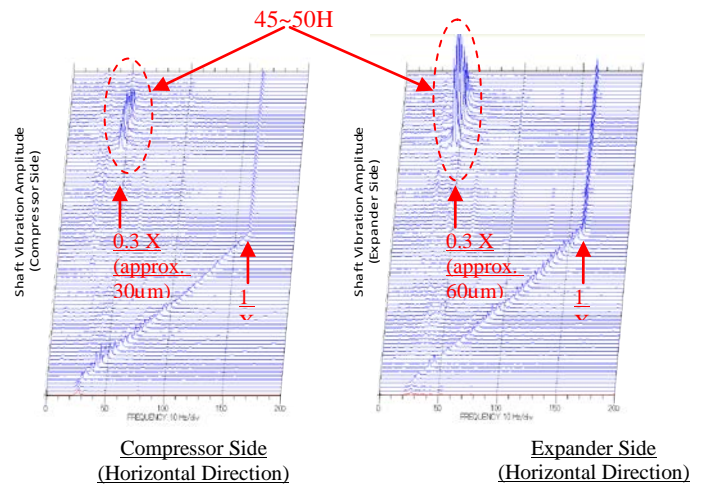
Fig.3 Waterfall Plot during Plant Start Up of No.1 Pinion Rotor

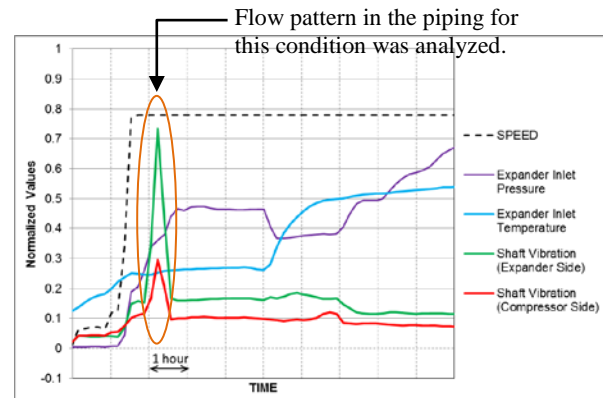
Finally the flow induced excitation force from downstream piping was pointed out as one of the possible cause with reference to past experience of a hydraulic turbine <sup>[3]</sup>. In order to simulate the flow pattern in the piping downstream of the 2<sup>nd</sup> stage expander wheel, time transient CFD analysis was conducted. Boundary conditions for the CFD analysis were defined based on the recorded operating parameters, such as pressure/temperature of inlet/outlet and so on, at the timing when the steep increment in shaft vibrations was observed **[Fig.4]**.

**Fig.4 Condition and Objects for CFD Analysis for 2<sup>nd</sup> Stage Expander Wheel**

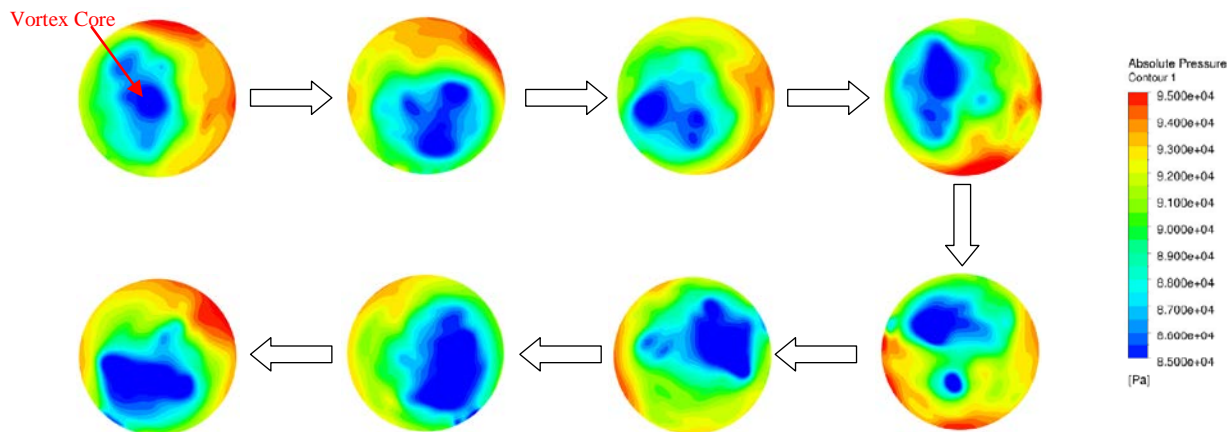
**Fig.5** shows velocity contour and equipollent plane of static pressure in the piping downstream of 2<sup>nd</sup> stage expander wheel, these figures provide a shape of vortex. **Fig.6** shows a transition of pressure contour with time at reference plane shown in **Fig.5** viewed from downstream of the expander wheel. The pressure contour clearly shows a core of the vortex which is revolving with time. **Fig.7** shows the pressure distributions in the 2<sup>nd</sup> stage expander wheel at a certain moment. The contours for each section (right side figures in **Fig.7**) show the circumferential uneven pressure distributions in the 2<sup>nd</sup> stage expander wheel which can be generated by the vortex in the piping. This uneven pressure distribution causes excitation force on the expander wheel in a direction from higher pressure side to lower pressure side. For example in section A-A, B-B and C-C in the **Fig.7**, the pressure on left side is relatively higher than that on right side, consequently the excitation force, which can be estimated as the integration of the pressure over the surface area of the wheel, from left side to right side on the expander wheel can be induced.

Fig.6 Time Transition of Pressure Contour at Reference Plane in the Piping of Fig.5 viewed from downstream of 2<sup>nd</sup> Stage Expander Wheel

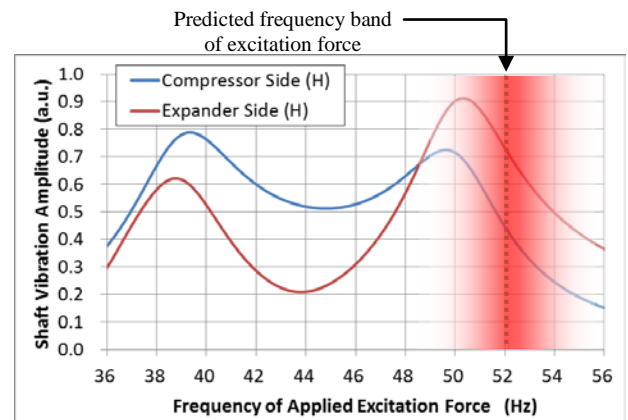
Fig.10 Shaft Vibration Response against Excitation Force on Expander Wheel of no.1 Pinion Rotor

Furthermore, rotordynamics for no.1 pinion rotor was studied with a consideration of the excitation force on 2<sup>nd</sup> stage expander wheel. That is ; the non-synchronous rotor vibration responses at rated speed were calculated by applying a unit external force with changing its frequency onto 2<sup>nd</sup> stage expander wheel in the rotordynamic model [Fig.9]. Fig.10 shows rotor vibration responses verses frequency of the unit excitation force, and it is confirmed that there are some peaks which are corresponding to the natural frequencies or the rotor at around 38 Hz and 50 Hz. As the predicted frequency of the excitation force from a vortex is 52 Hz, the second peak must be amplified by an interaction with the excitation force.

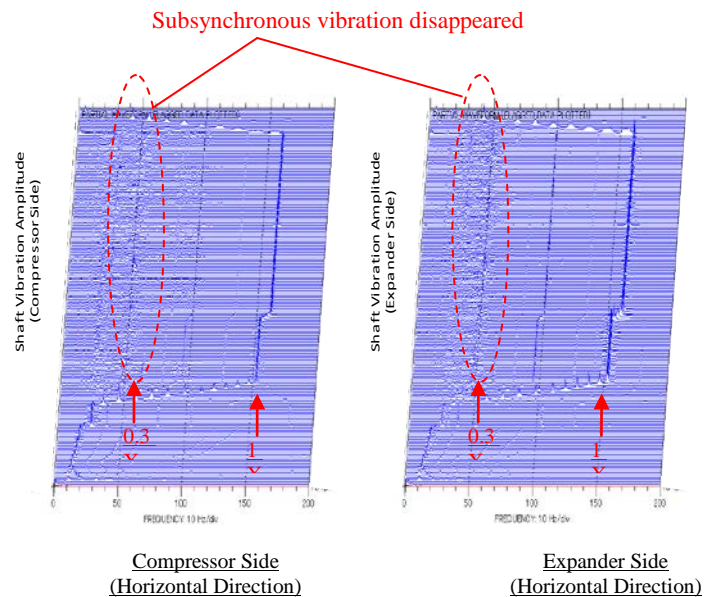
Fig.16 Waterfall Plot of No.1 Pinion Rotor after Countermeasure

Fig.15 shows the time trend data of operating parameters of a verification run after countermeasure was implemented. In this run, the process conditions (pressure and temperature of process gas) were repeatedly (three times) controlled to get the particular condition, in which the high shaft vibration had been observed since initial start up, in order to prove the effectiveness of the vortex breaker. During this operation, the shaft vibration in no.1 pinion on both compressor side and expander side did not show the steep increase and the subsynchronous vibrations at 45~50 Hz also disappeared as predicted by the analyses [Fig. 16]
