THE INFLUENCE OF STEP-POOLS ON WATER CHEMISTRY: SAN JUAN MOUNTAINS,
COLORADO

A Thesis

STEPHANIE NICOLE RUFF

August 2018

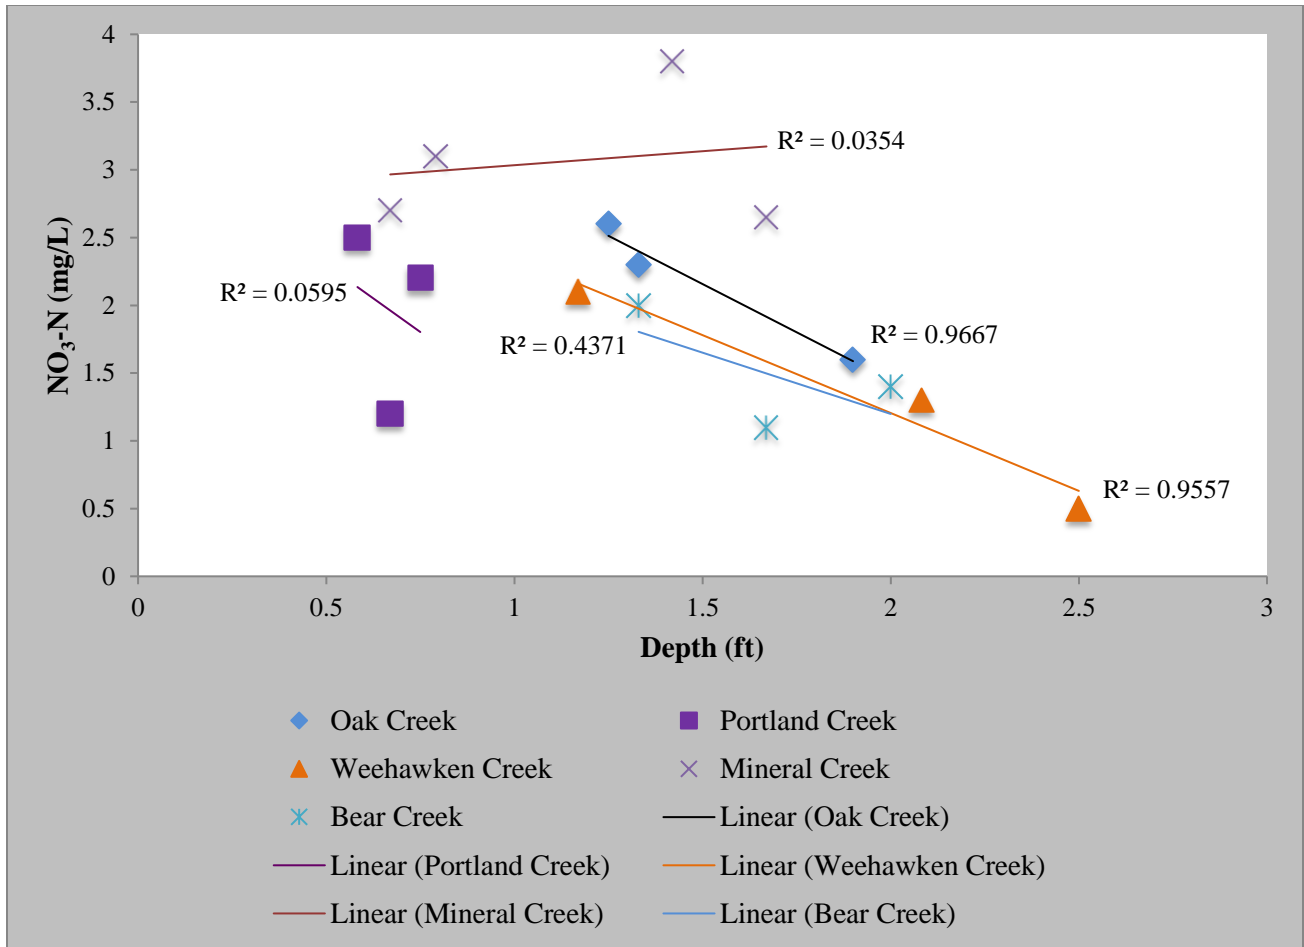
Figure 11. Step-pool nitrate-nitrogen concentrations compared to step-pool depth

The comparison of NO₃-N concentration and step-pool depth demonstrated a visual pattern in which as the depth of the step-pools increase the NO₃-N concentrations are decreasing (Figure 11). There were two creeks (Oak Creek and Weehawken Creek) that show a strong relationship (negative) between NO₃-N concentration and depth. However, the Red Mountain Creek data (Figure 12) shows a strong positive relationship.

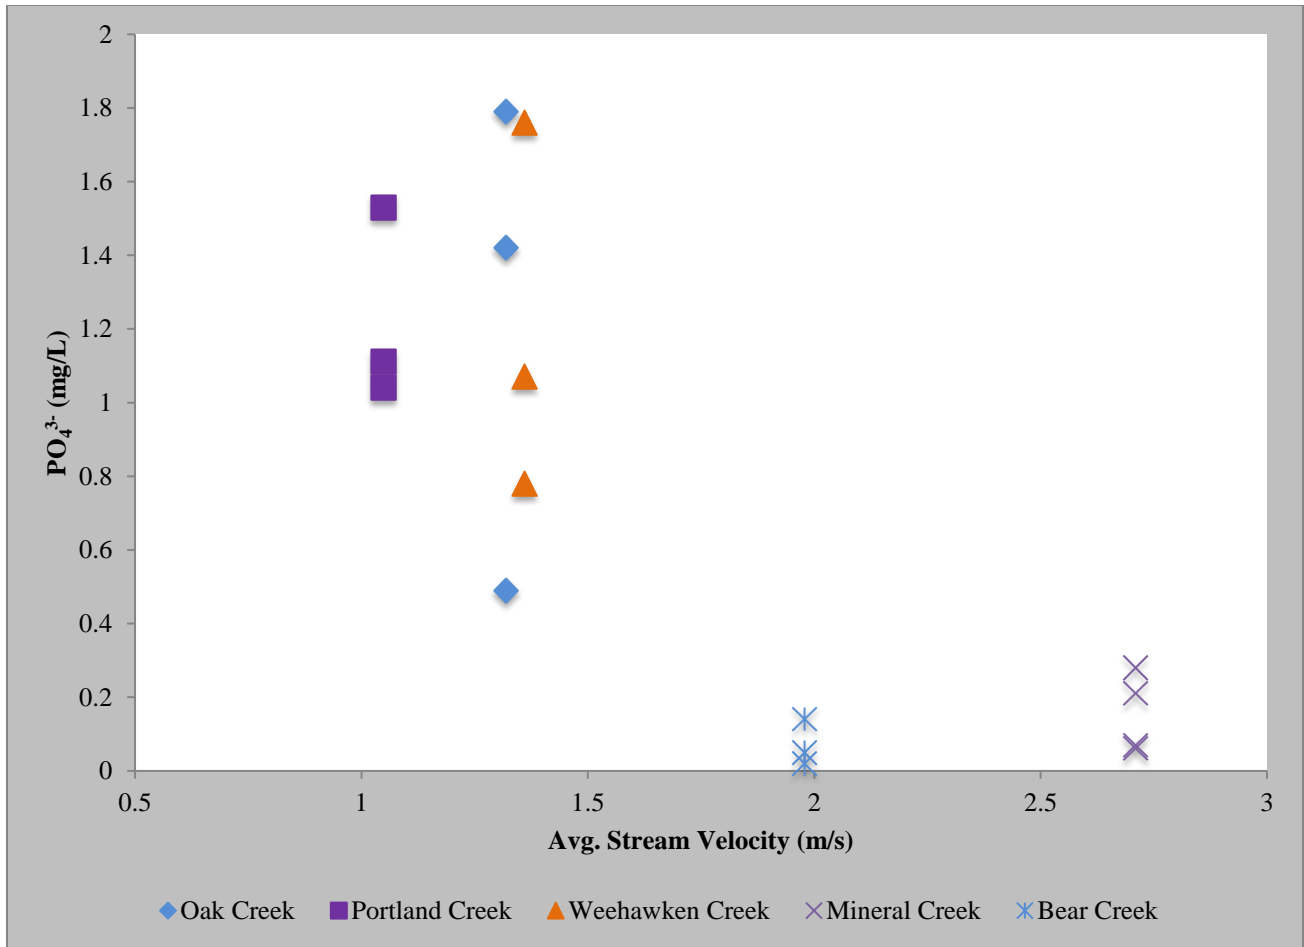
Figure 13. Step-pool phosphate concentrations compared to average stream velocity

There was only one PO₄³⁻ and physical comparison that showed a clear visual pattern, which was the comparison of PO₄³⁻ and average stream velocity. In Figure 13, as PO₄³⁻ concentrations are decreasing, average stream velocity values are typically increasing. Only Oak Creek showed a strong relationship (positive) between the two characteristics. Another observation that can be made is that the creeks with larger differences in the PO₄³⁻ concentrations also had higher overall PO₄³⁻ concentration values. There were no strong positive or negative relationships because the stream velocity is the same for all the step-pools. The following figure (Figure 14) depicts the Red Mountain Creek data.

Another average stream flow comparison that depicted a strong visual pattern was the comparison with PO_4^{3-} (Figure 13). The overall trend of the graph is negative, with average stream flow increasing as PO_4^{3-} concentration decreases. Previous research has found that phosphorus levels increased as water velocity increased, which is the opposite of the relationship seen in the creeks with step-pool sequences (House et. al, 1995). One explanation as to why PO_4^{3-} is decreasing as average stream velocity increases in step-pools could be that when the stream water is moving more quickly, it is more difficult for the PO_4^{3-} to settle at the bottom of the pools where the sample was collected. This could cause the concentrations at the bottom of

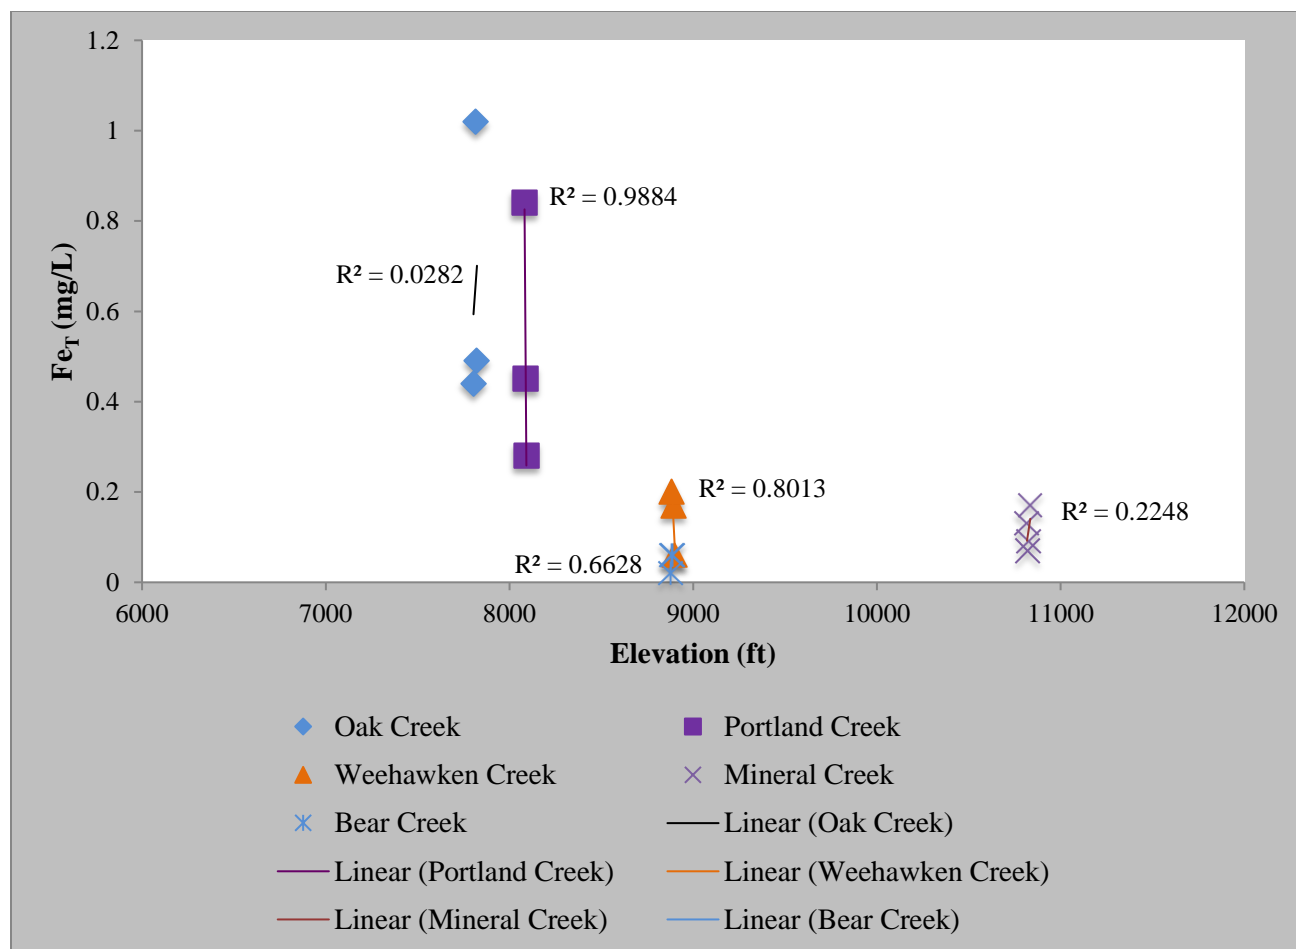
Figure 15. Step-pool total iron concentrations compared to step-pool elevation

For Fe_T concentration versus elevation, the general trend appears to be as the elevation increases the Fe_T concentrations are decreasing (Figure 12). Only Portland Creek data points showed a strong relationship (negative) during the regression analysis. There is no Red Mountain Creek data for Fe_T because the Fe_T concentrations were too high for the HACH DR 900 Colorimeter® to record. The HACH DR 900 Colorimeter® has can only record up to a maximum of 3.0 mg/L for Fe_T.

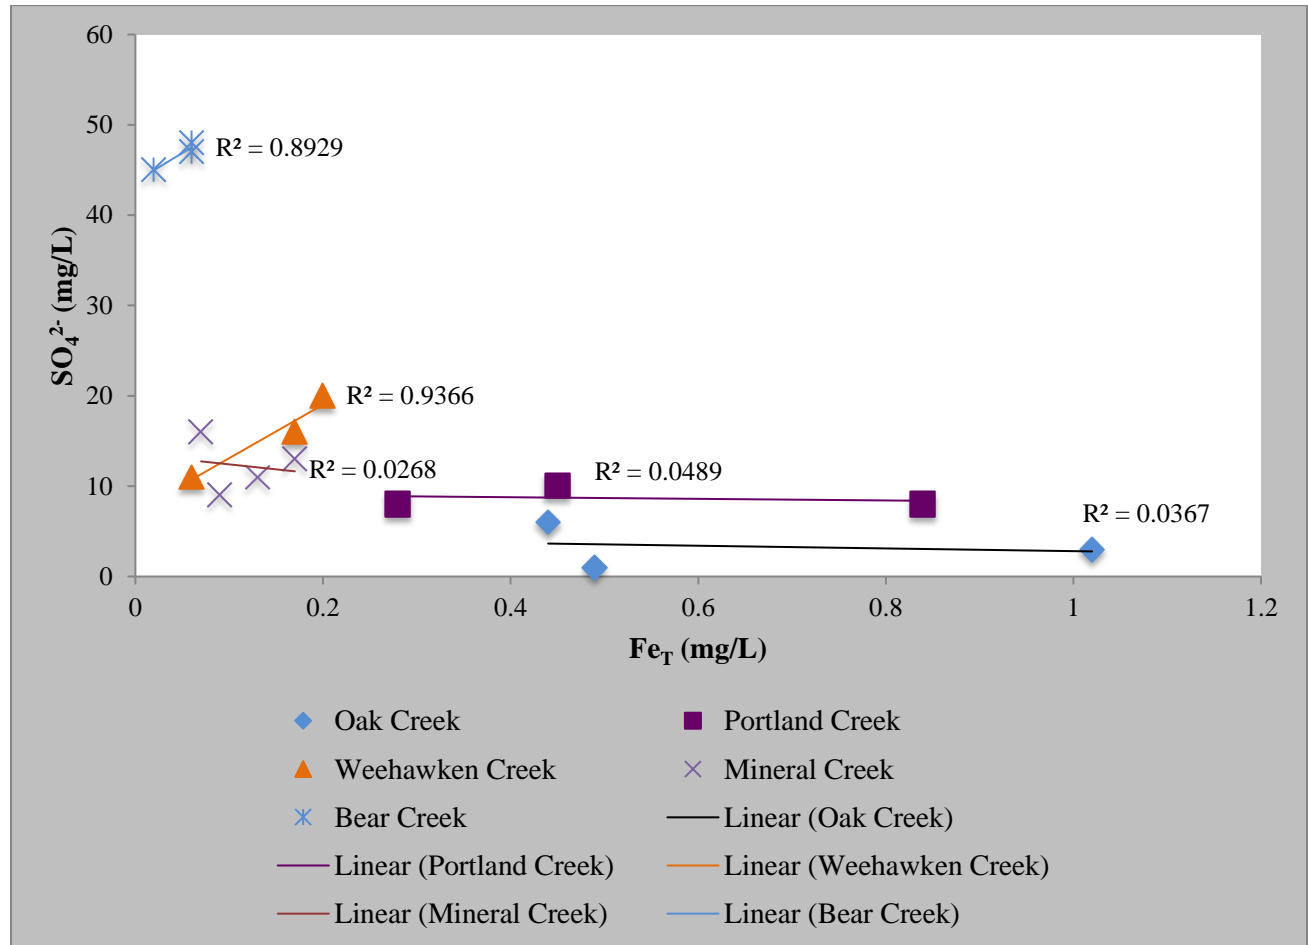
Figure 16. Step-pool sulfate concentrations compared to step-pool total iron concentrations

This comparison of SO₄²⁻ and Fe_T has an overall negative relationship between SO₄²⁻ and Fe_T. Both Portland Creek and Oak Creek show a similar pattern of having the highest Fe_T concentrations while also having most of the lowest SO₄²⁻ concentrations (Figure 16). Red Mountain Creek was not included because both the SO₄²⁻ values and the Fe_T values were too high

for HACH DR 900 Colorimeter® to record. The maximum value that the HACH DR 900 Colorimeter® can record for sulfate is 70 mg/L.

The second part of the regression analysis was the chemical versus chemical characteristic analysis. The first relationship to discuss is the comparison between Fe_T and SO_4^{2-} . Weehawken Creek is the only creek to have a strong relationship, which is positive, but the remaining creeks show an overall negative trend between the characteristics (Figure 16). Usually the two characteristics are most commonly linked in literature when AMD is occurring because both can come from the oxidation of iron pyrite. Location of the step-pools may be the cause of this negative relationship. Portland Creek and Oakland Creek are the closest creeks to town both have the lowest sulfate concentrations compared to Fe_T . This could be because the soils near the town contain clay and iron has a common relationship with clay. Iron can be an essential ion in clay mineral structure or adhered to the outside of the mineral as an oxide (Carroll, 1958).

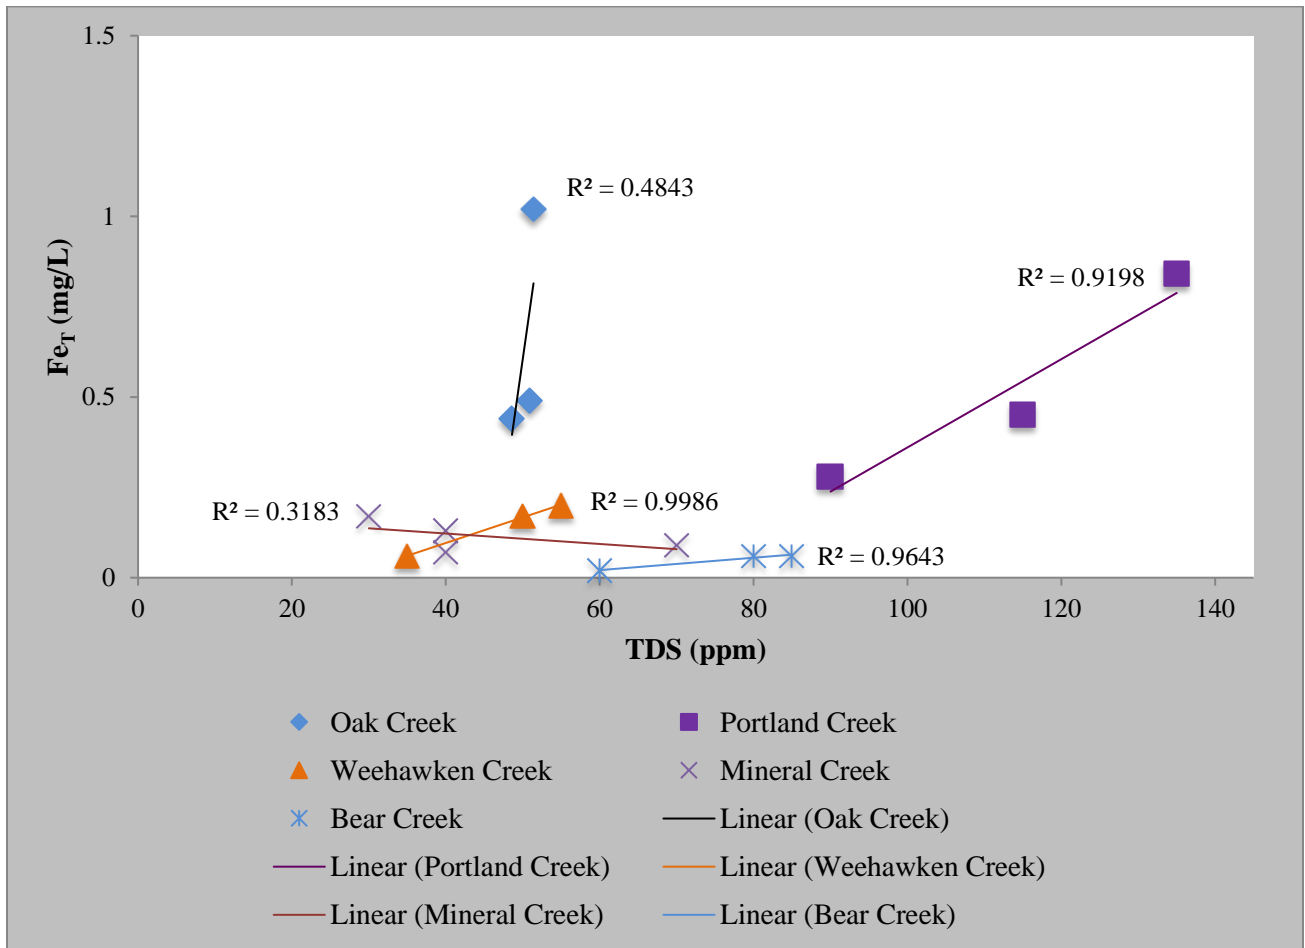
Figure 17. Step-pool total iron concentrations compared to step-pool total dissolved solids concentrations

Figure 17 is one of the few graphs that had more than two creeks showing strong relationships during a comparison. The graph comparing Fe_T with TDS depicts a strong positive relationship in which Fe_T and TDS are both increasing with one another. The three creeks that show strong relationships are Portland Creek, Weehawken Creek, and Bear Creek. Red

Mountain Creek data points were not included because the instrument could not record the high Fe_T values.

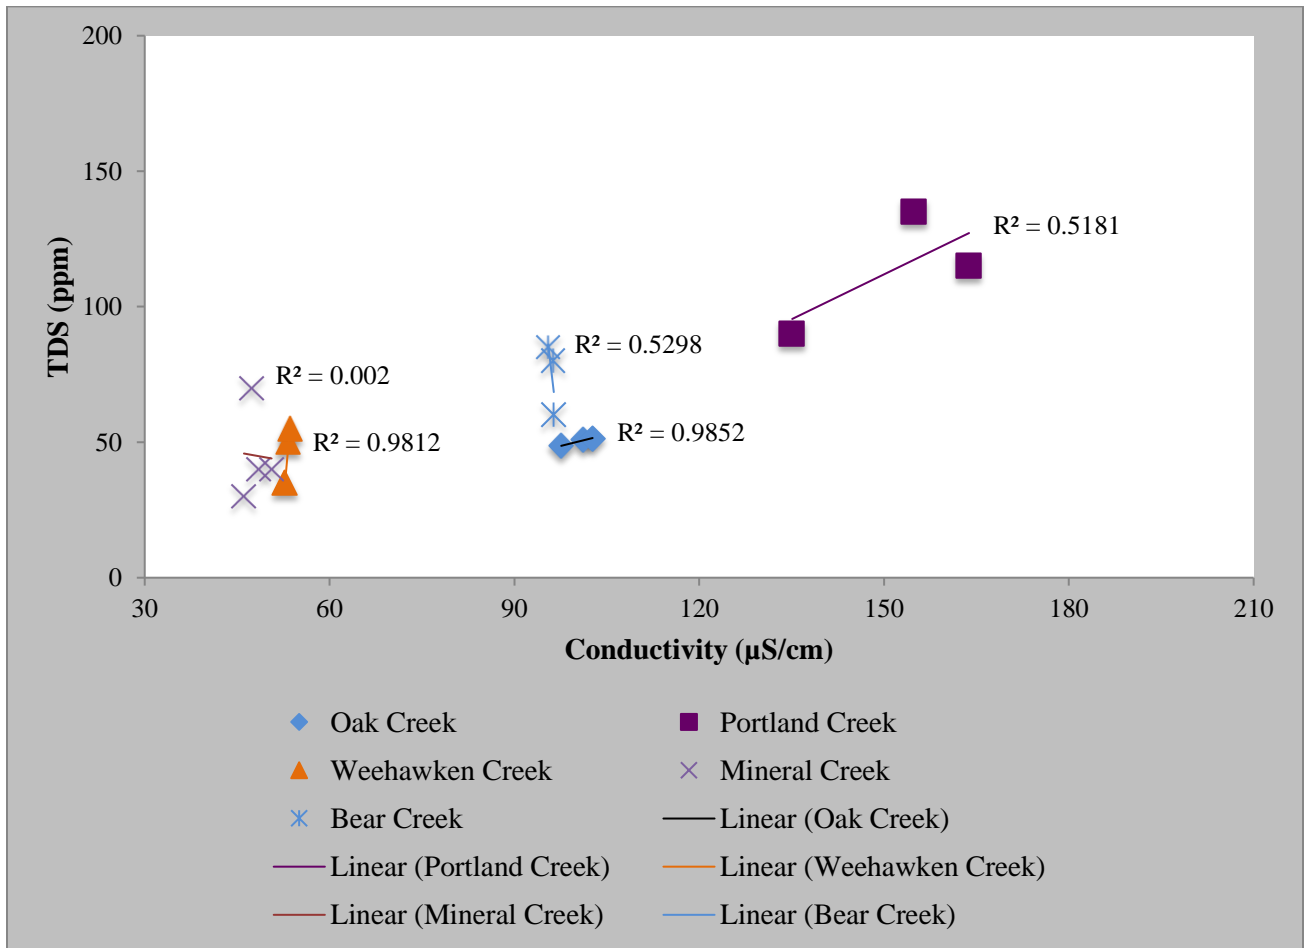
Figure 18. Step-pool total dissolved solids concentrations compared to step-pool conductivity

Figure 18 depicts a clear positive relationship between TDS and conductivity. In this figure, TDS is increasing as conductivity is increasing. There were also two creeks (Weehawken Creek and Oak Creek) that had strong positive relationships, which helps support this assumption. The Red Mountain Creek data (Figure 19) shows a positive relationship.
