NEW IN-SITU EROSION TEST AND MAXIMUM ALLOWABLE SCOUR DEPTH
AT BRIDGE ABUTMENTS

A Dissertation

Major Subject: Civil Engineering

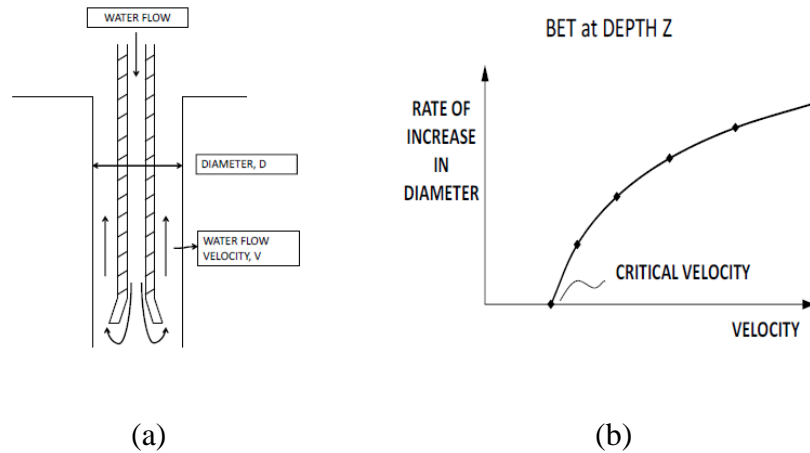
Figure 1- Borehole erosion test concept (reprinted from Briaud et al. 2017, with permission from ASCE): (a) sketch of the BET; (b) erosion function obtained at one depth

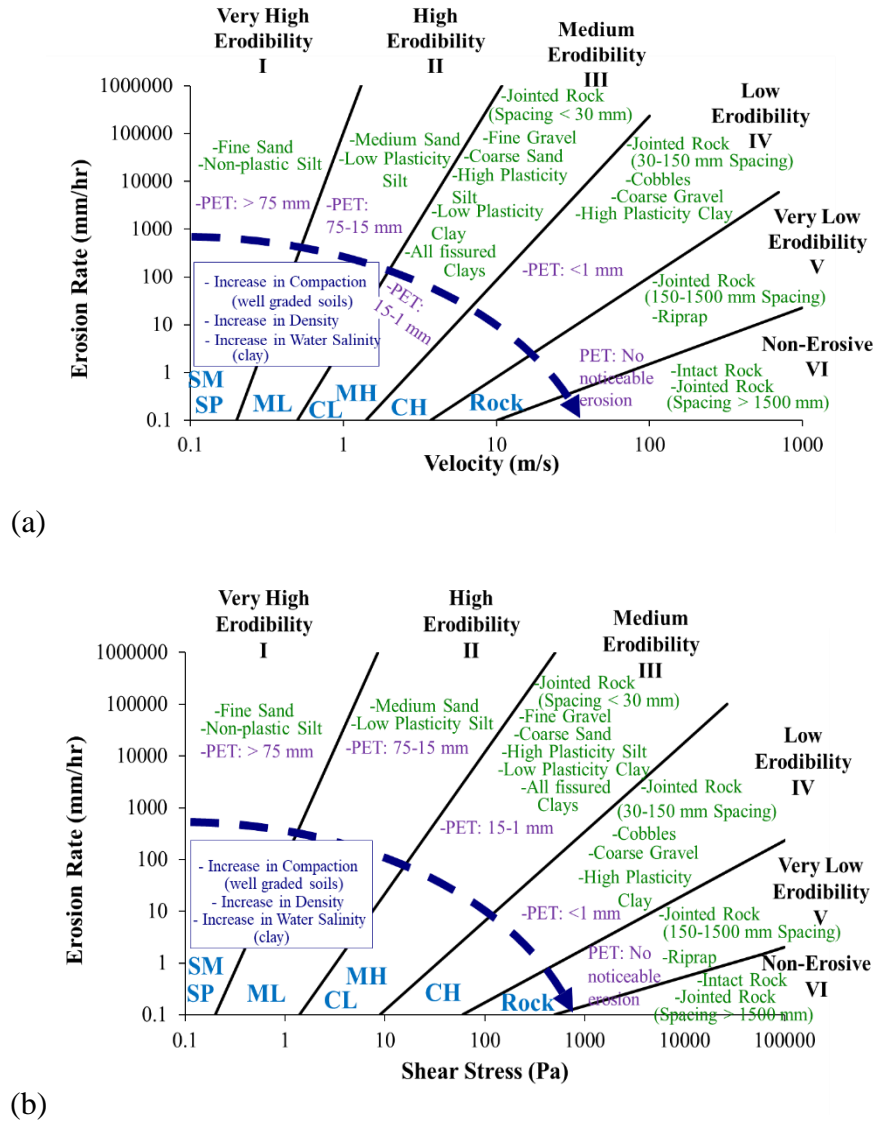
Figure 3- Erosion classification and soil types (reprinted from Briaud et. al 2017, with permission from ASCE): (a) velocity; (b) shear stress

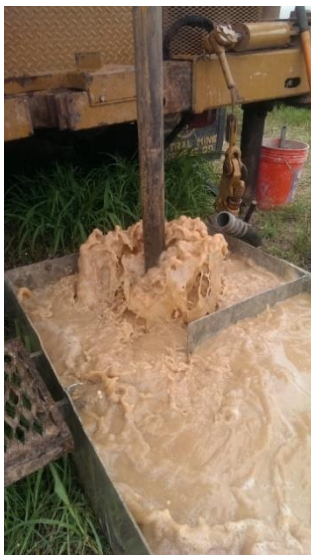
Figure 16- Flow during BET

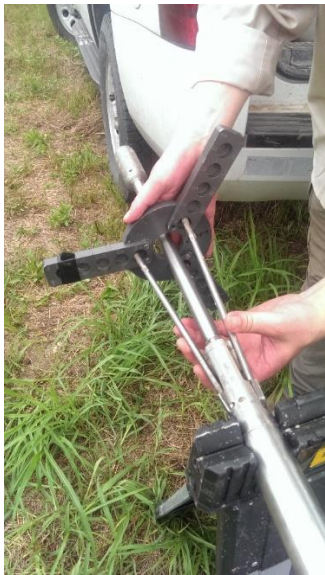
Figure 18- Borehole mechanical caliper

gives a complete scan of the diameter by rapid rotation scanning of the wave propagation beam. An acoustic caliper was used in the tests reported here but it was found that the precision with which the diameter was measured was much worse than that of the mechanical calipers. The reason was that the signal of the return wave was fuzzy and difficult to interpret because the interface at the wall of the soil borehole did not provide a sharp enough stiffness discontinuity. Acoustic calipers work well for rock borehole profiling because of the sharp stiffness discontinuity at the borehole wall but in the case of soils, the tests carried out here showed that mechanical calipers are to be favored.

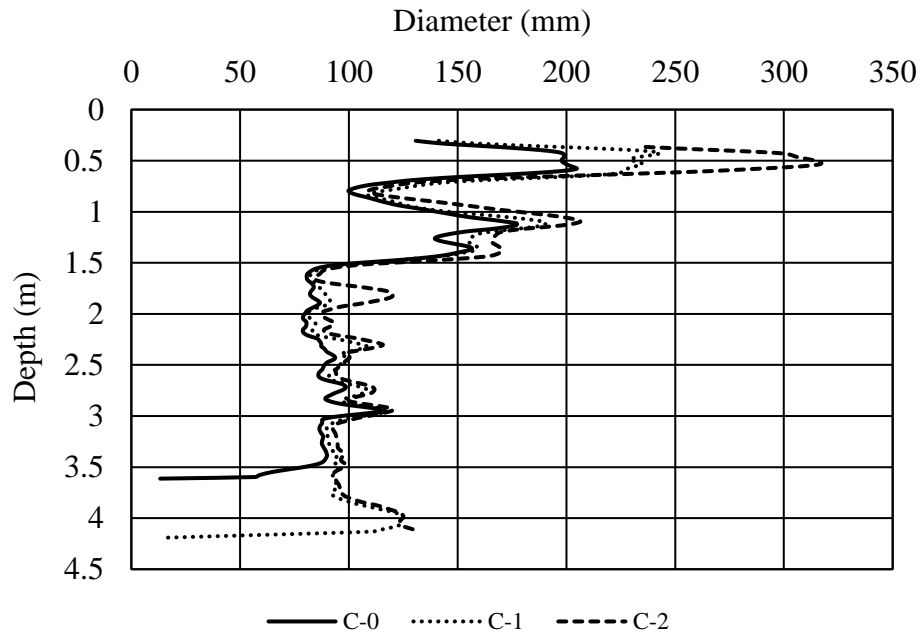
Figure 29- BET diameter profiles for SBH9 at the sand site

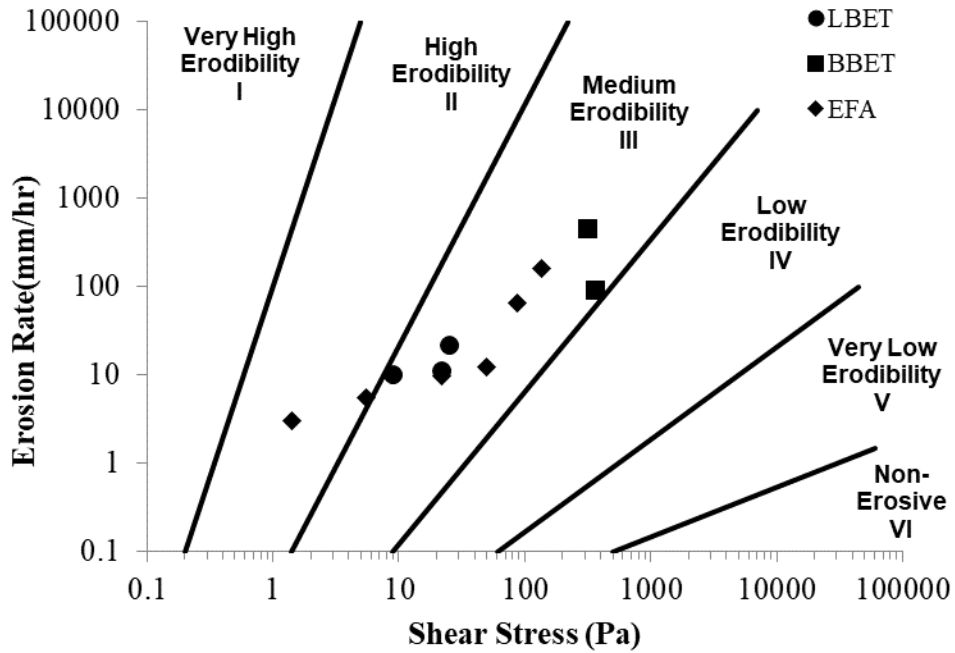
Figure 34- EFA, LBET and BBET results for clay borehole CBH3

types of erosion tests is reasonable and the trend is similar. The scatter in the results gives an indication of the precision which can be expected. It is also noted that the LBET and the BBET are reasonably consistent since they approximately line up on the same erosion function curve. The BBET does generate much larger shear stresses than the LBET thus the erosion rate associated with the BBET are much higher. Also, the shear stresses calculated assumed that the fluid was water. This is not exactly correct as, at the clay site, the water mixed with the natural clay to form a drilling mud while at the sand site it was purposely mixed with bentonite clay to form the drilling fluid. Drilling mud has a higher viscosity than water; if the viscosity of water is 10^{-6} kPa.s, the drilling mud viscosity is typically anywhere from 1.3 to 2.5 times higher than that. No correction factor was applied for this difference as the mud viscosity was unknown. In the future the mud viscosity should be measured for example with the Marsh Funnel test to improve on the precision with which the shear stresses are calculated. Overall, the comparison of BET with EFA tests proves the new BET concept and validates its results.

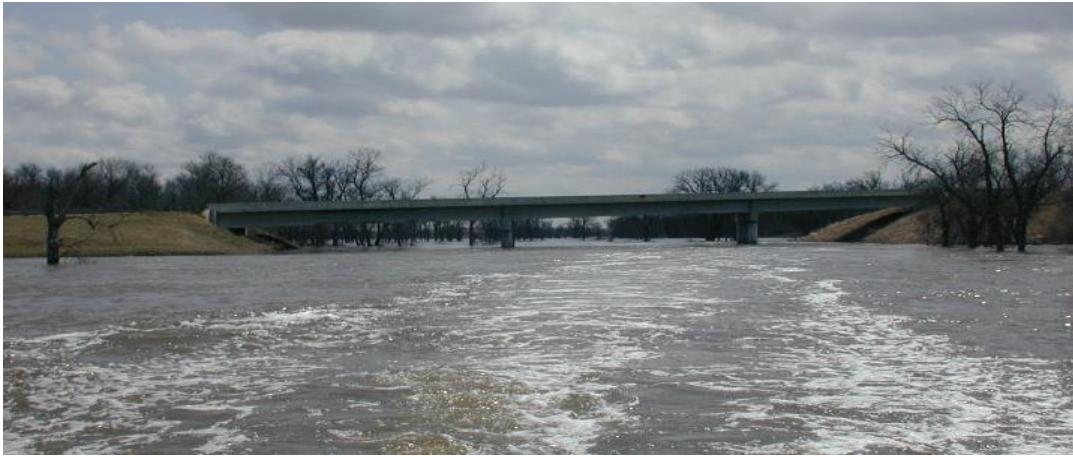
Figure 42- SR 37 over James River during the flood—looking downstream

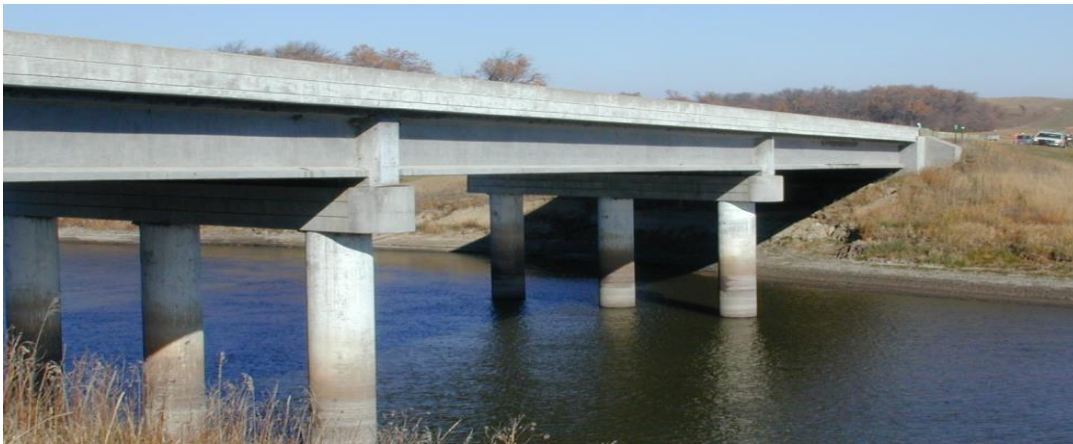
Figure 43- SR 37 over James River after the flood—looking at the left abutment from the downstream

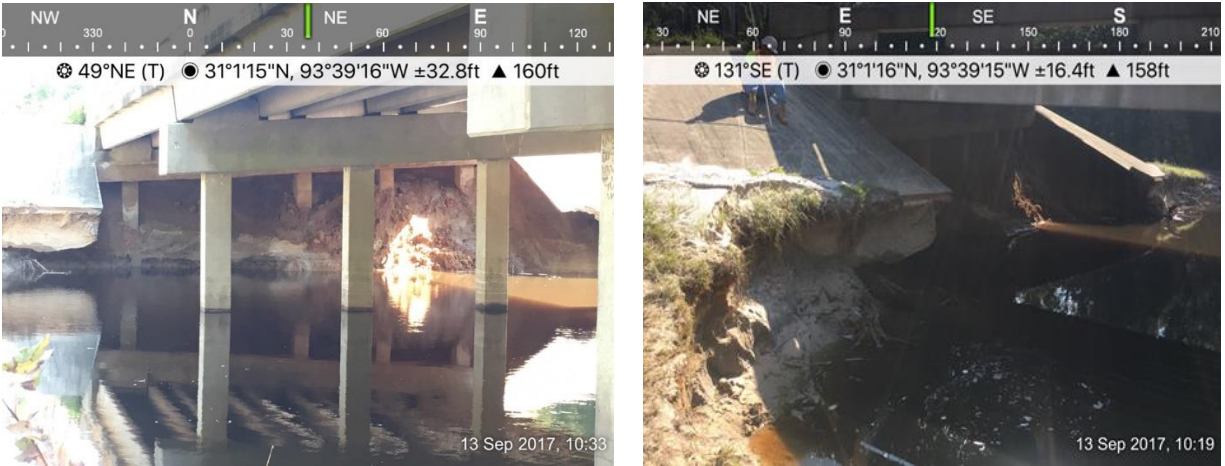
Figure 46- Left abutment failure at FM 692 over McGraw Creek

caused significant scour in the bridge channel and caused the failure of the left abutment (Figure 46- Left abutment failure at FM 692 over McGraw Creek).

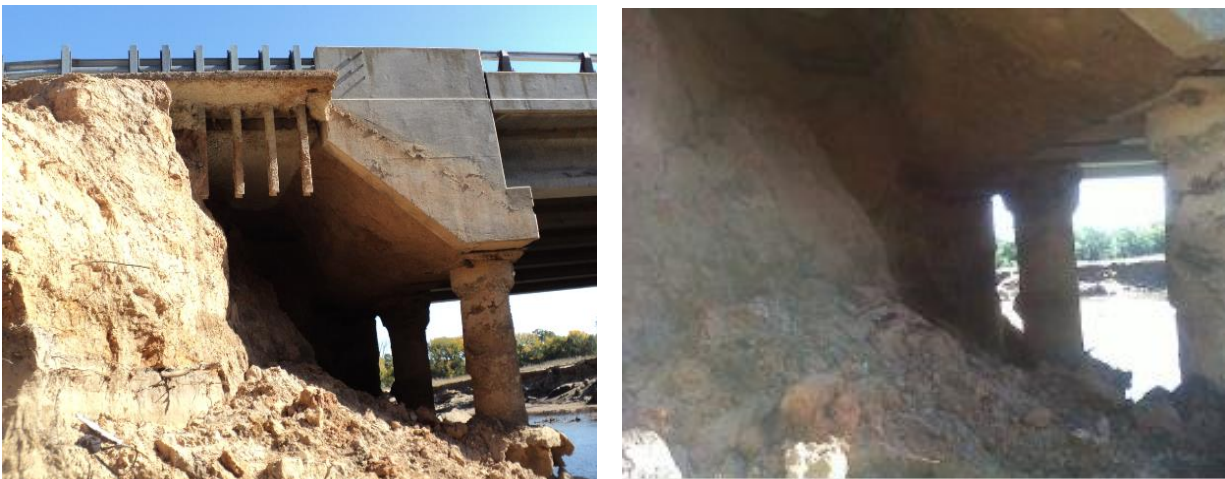
Figure 48- Left abutment failure at FM 937 over Montgomery Creek

FM 937 over Montgomery Creek is a single span bridge located in Limestone County, Texas. The bridge was closed to traffic in October 2013 due to the Halloween flash flood event. Figure 48 shows the slope stability failure of the left abutment embankment.

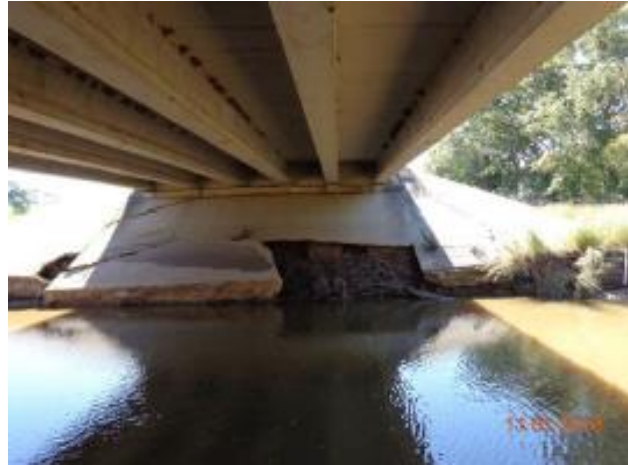
Figure 49- Damaged concrete riprap at the right abutment of FM 937 over Montgomery Creek

The slope of the right embankment did not fail, but the concrete riprap was damaged (Figure 49).

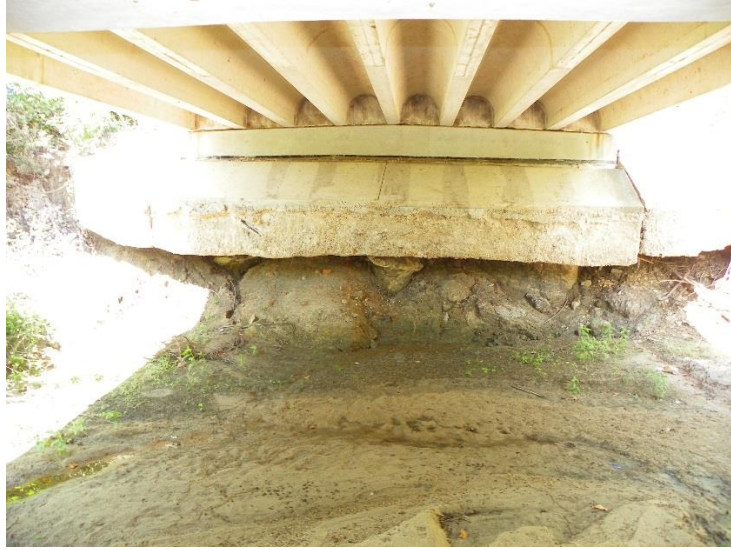
Figure 50- Scour at the left abutment of CR 309 over Rocky Creek

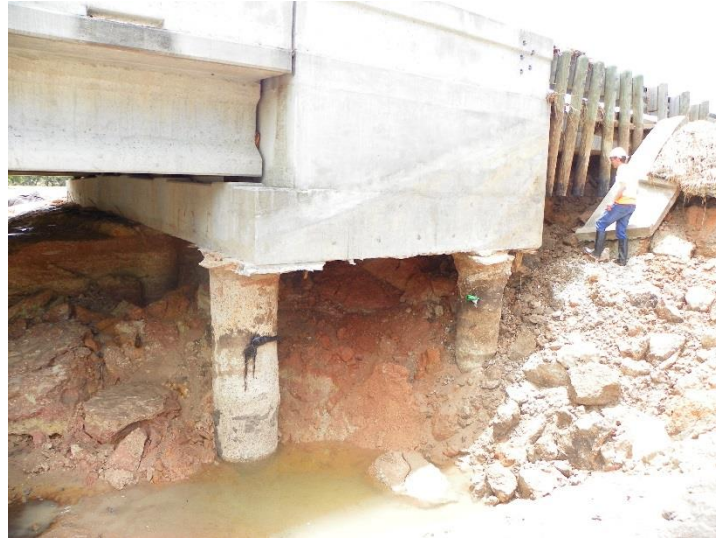
Figure 53- Right abutment failure at SH 105 over Rock Creek

The channel cross-section was not surveyed during the post-flood inspection. However, the inspector was contacted and asked about the scour that happened in front of the right abutment. It is estimated that the deepest point of the scour near that location was approximately 0.9–1.2 m deep.

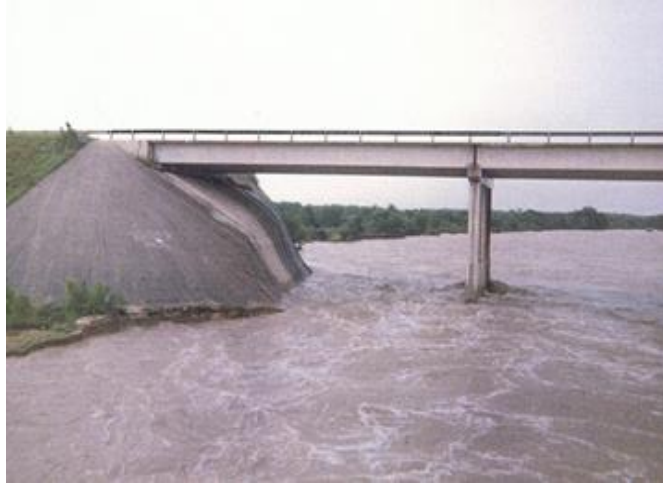
Figure 54- Right abutment failure at US 90 over Nueces River

This bridge is in Uvalde County, Texas. In 1998, a major flooding scoured the right abutment of the bridge and nearly took out the abutment embankment (Figure 54). The embankment was promptly repaired, and stone riprap was placed at the end of the embankment to prevent future failure due to scour (Figure 55).

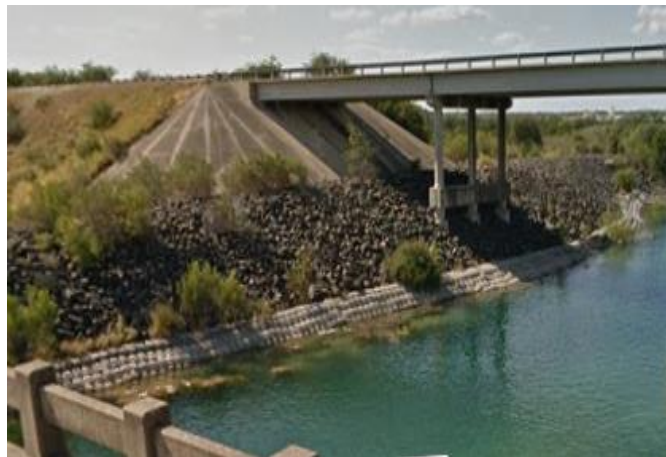
Figure 55- Right abutment repair at US 90 over Nueces River

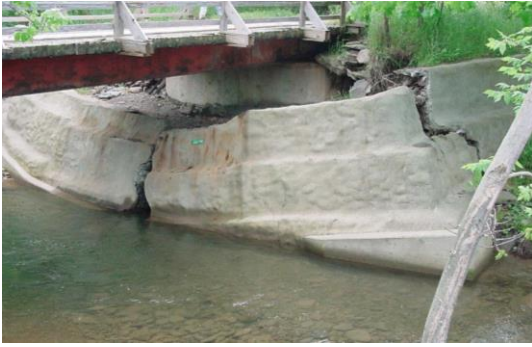
Figure 57- Abutment foundation failure by vertical loading

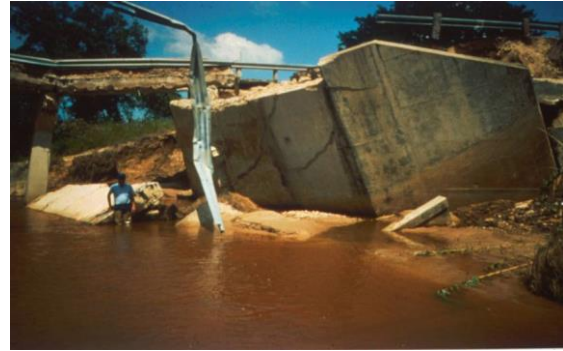
Figure 58- Abutment foundation failure by horizontal loading

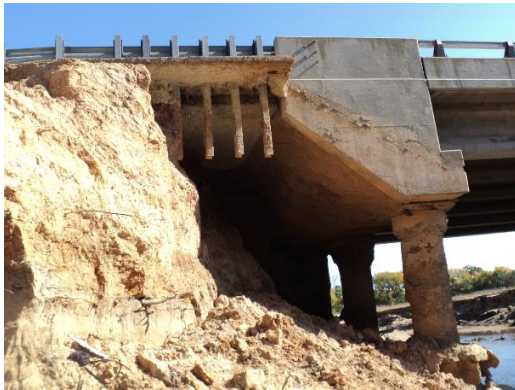
Figure 59- Slope stability failure of the abutment embankment

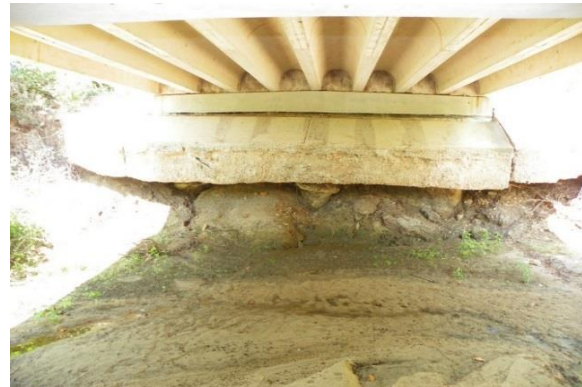
Figure 60- Erosion of the embankment soil

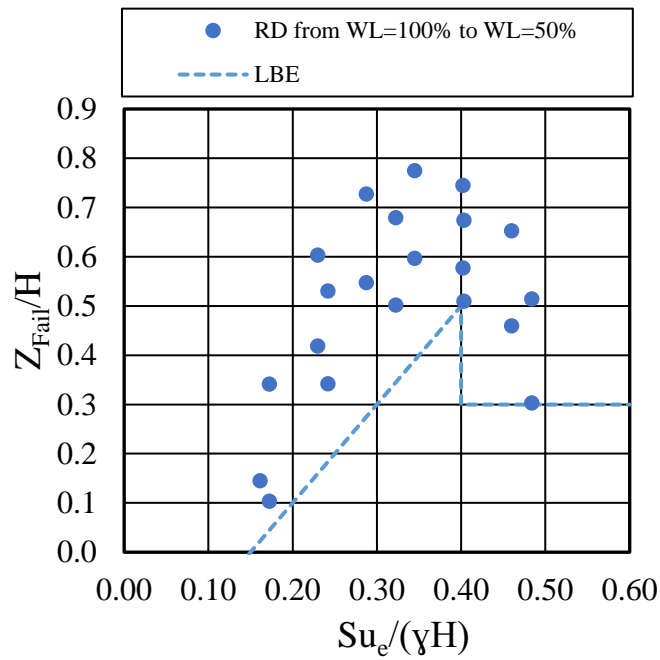
Figure 83- Z_{Fail}/H versus $S_{u_e}/\gamma H$ for rapid drawdown to half slope height
