47TH TURBOMACHINERY & 34TH PUMP SYMPOSIA
HOUSTON, TEXAS | SEPTEMBER 17-20, 2018
GEORGE R. BROWN CONVENTION CENTER

Stray Currents and their Damaging Effects on Rotating Machinery

Dian J. Hanekom

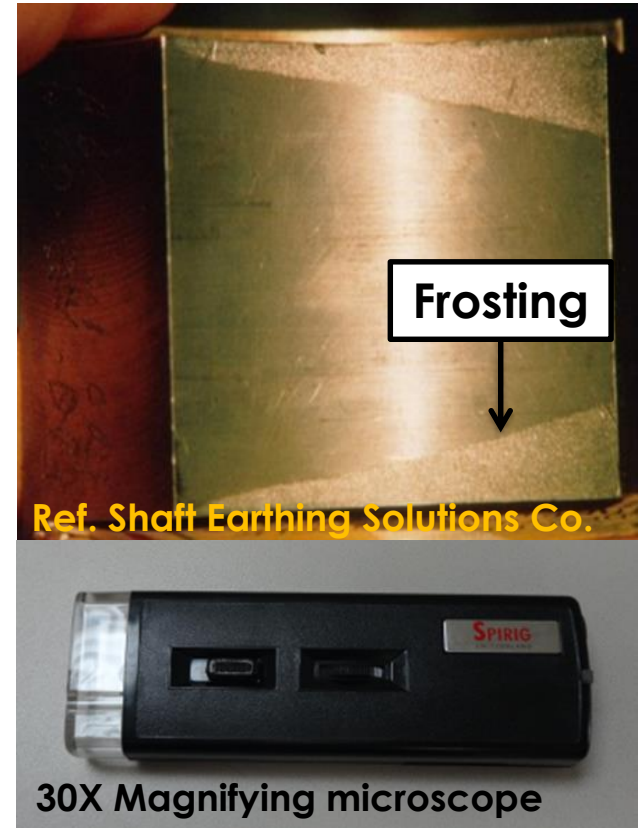
- **Frosting** forms a uniform, continuous, satin-like surface, similar to sand blasting or shot-peened surface. It looks very much like a piece of frosted or etched glass, hence the term “frosting” or “spark etching”.
- This kind of damage can be found on radial and thrust pads.

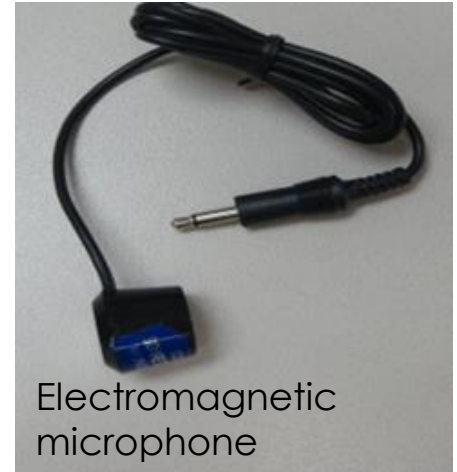
- **Electromagnetic Activity Testing (EMA).**
EMA testing is conducted by recording the magnetic flux circulating in the machine using an electromagnetic microphone held at the split-line of casings and bearings. When the flux circulates within the housing the tiny gap in the split offers reluctance to the magnetic field and distorts the field. This forces the magnetic field to exit the metal path and rejoins after the split. An audible humming sound is recorded.

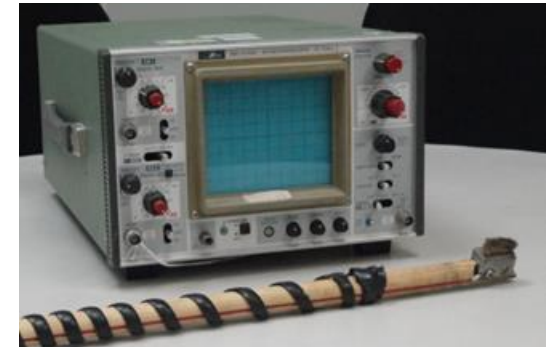
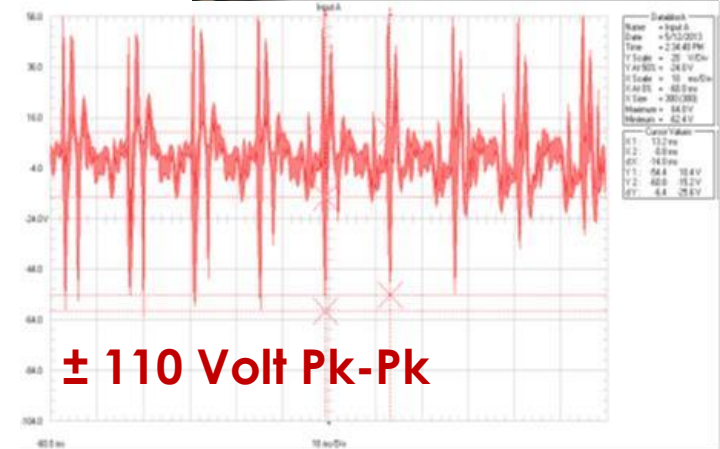
- **Shaft Voltage** measurements works on the principal that a hand held earth brush is put on the shaft with a wooden stick while the machine is running. The voltage is then recorded using an oscilloscope, while the voltage is pulled from the shaft via lead wires;
- An accurate assessment of shaft end-to-end voltage .

± 110 Volt Pk-Pk

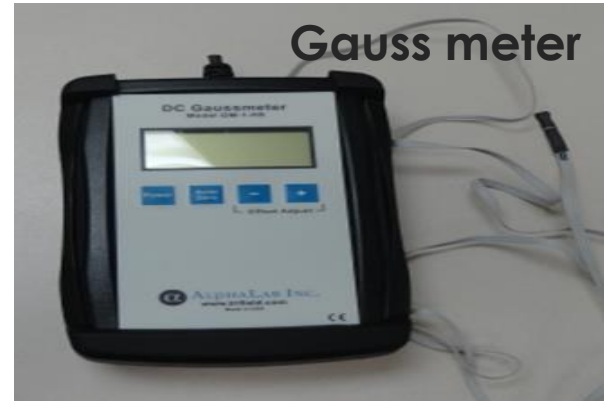
- **Gauss levels of components** can be measured and evaluated in accordance with established industry best practices.

This method is quantitative, but you need to disassemble the complete machine (driver and driven) and measure the gauss levels of each component individually to be successful.

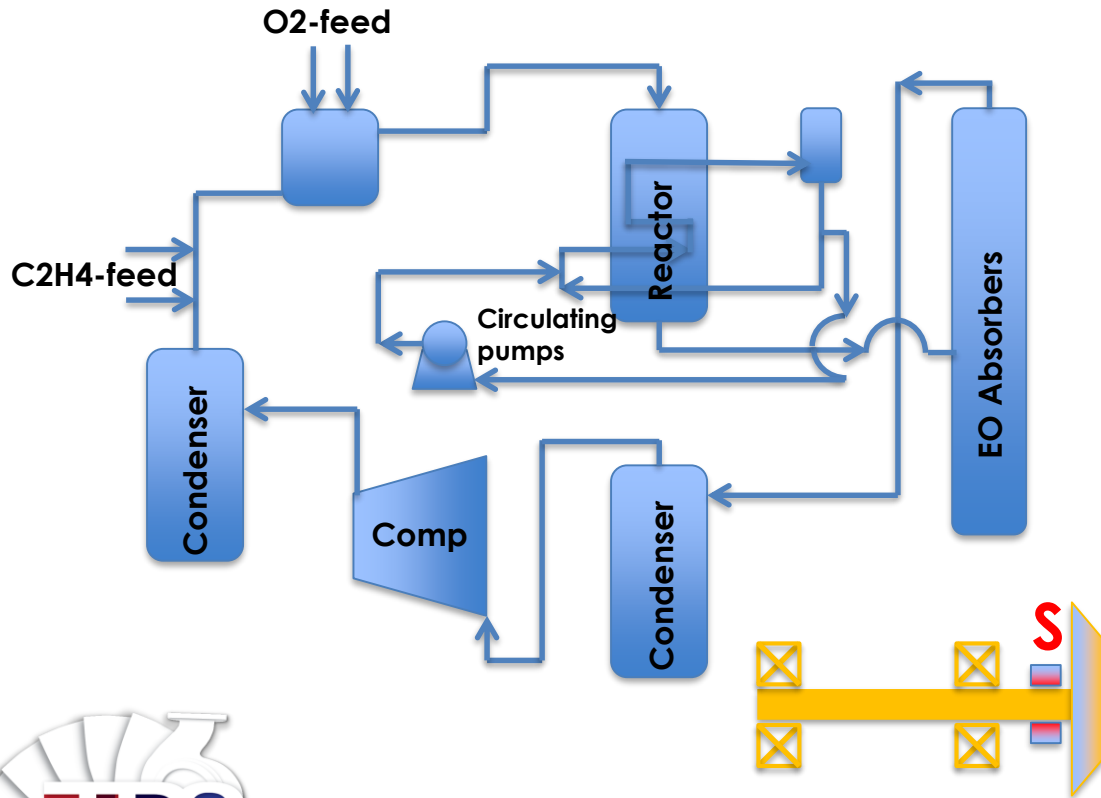
Case Study 1 – Recycle Gas Compressor Seal Failure

- Shaft failure;
- Temperature buildup;
- Welding marks noticed;
- Rotor/seal replacement;
- 120 V shaft voltage;
- 2 yr later demag.;
- EDM on seal carrier ring;
- Demagnification, brush installation & monitoring.

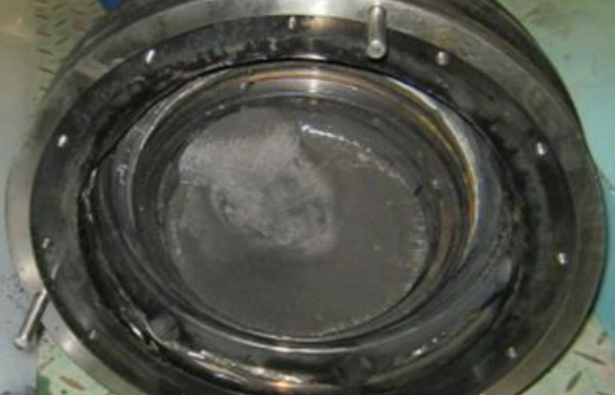
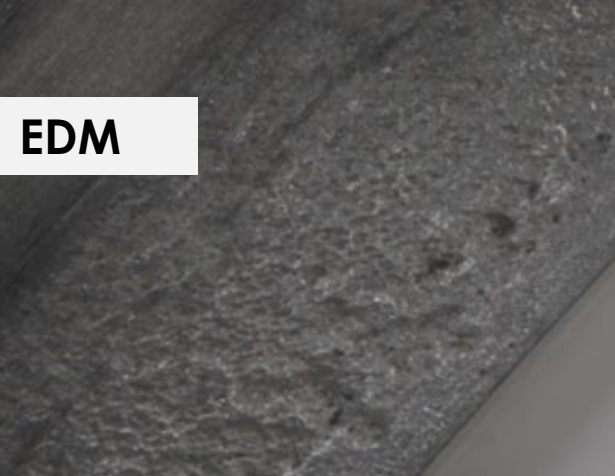
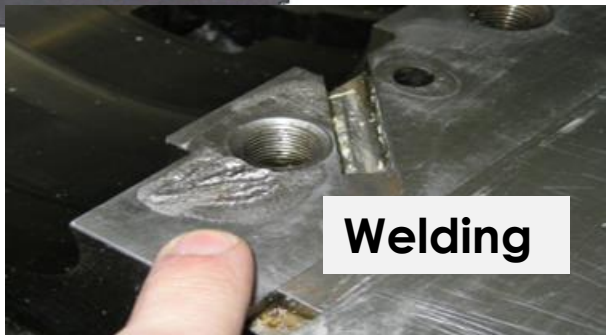
Shaft failure in seal area

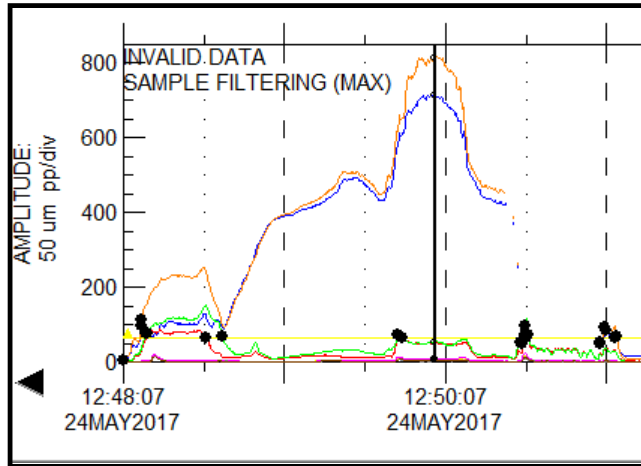
Case Study 2 – Product Compressor Coupling Failure

- Coupling failed between HP & LP1
- Vibration reached 800 µm LP1-DE, & 500 µm HP-DE
- Heavy rub in process seal area Cl. 0.63 to 0.84
- DGS rotates 270-degrees.
