TURBOMACHINERY
& PUMP SYMPOSIA

High Reliability Pistons for Reciprocating Compressors in High Wear Situations.

Andreas Brandl, John Ladd
HOERBIGER Service Inc.
Houston, TX

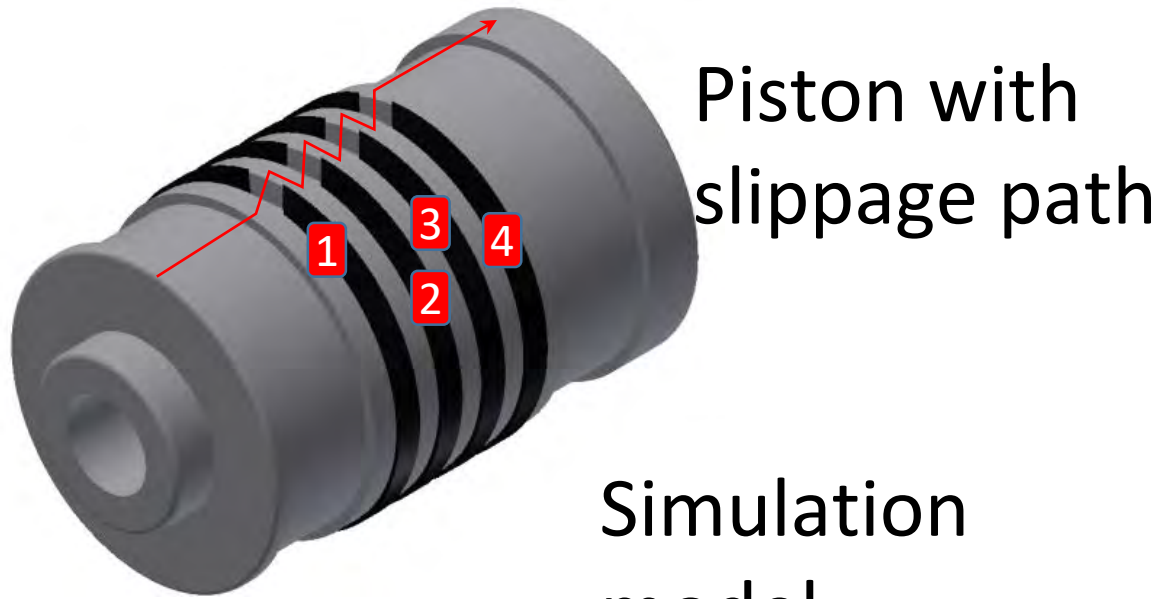
Piston ring leakage model

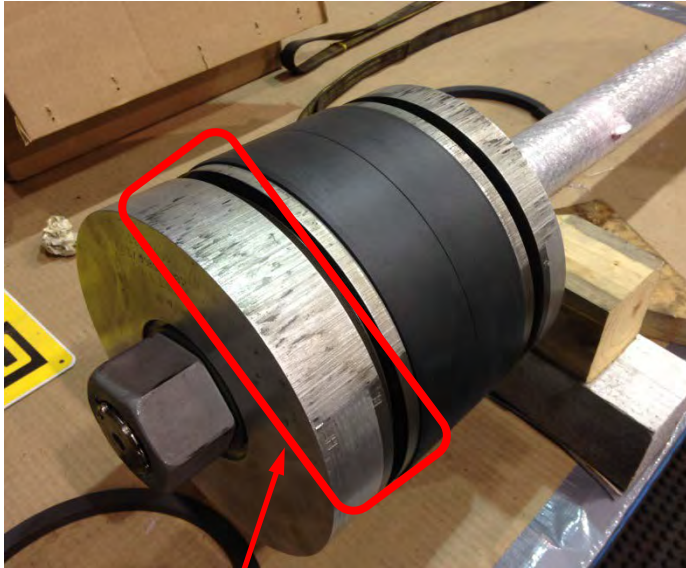
Shut down due to rider band wear every 6 months.

Piston wear marks indicate that rider band wear is a re-occurring problem

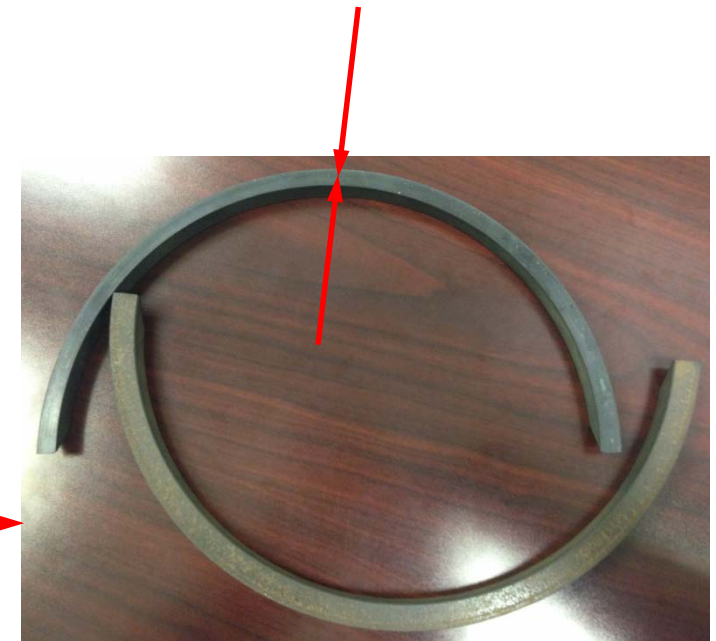
Max run time: 6 months

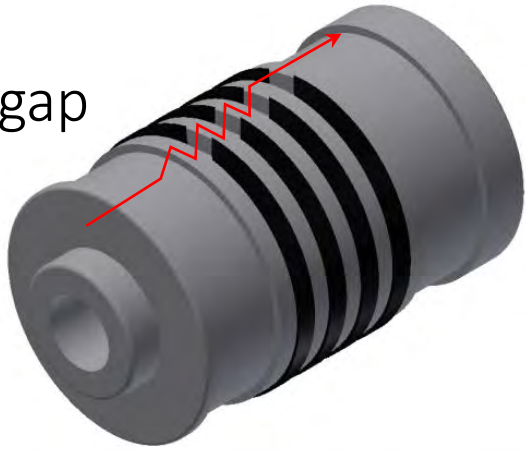
2nd stage blow-by

Blow-by in end gap of piston ring

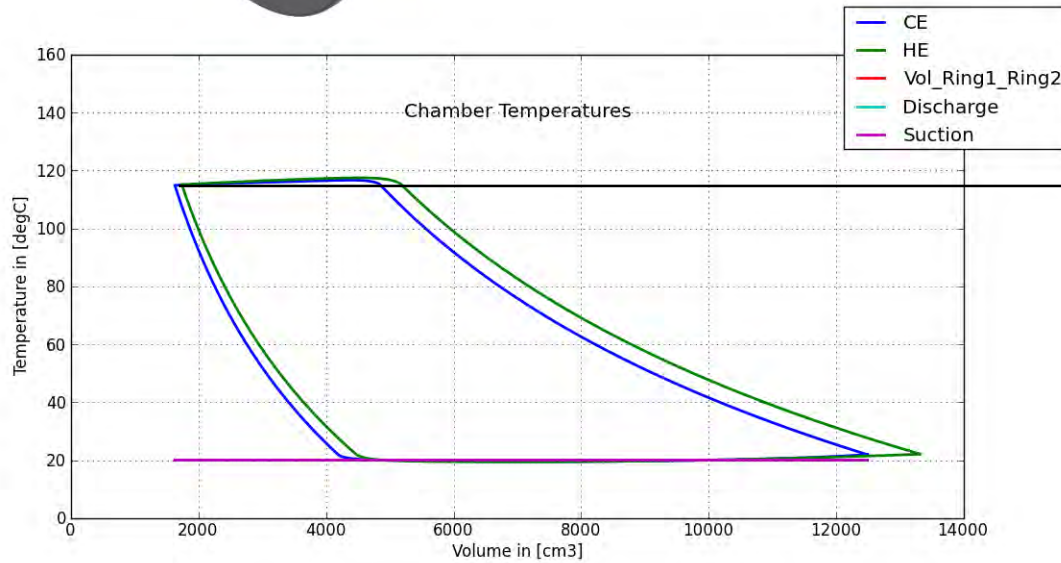
54°F Temp increase; 20% capacity losses

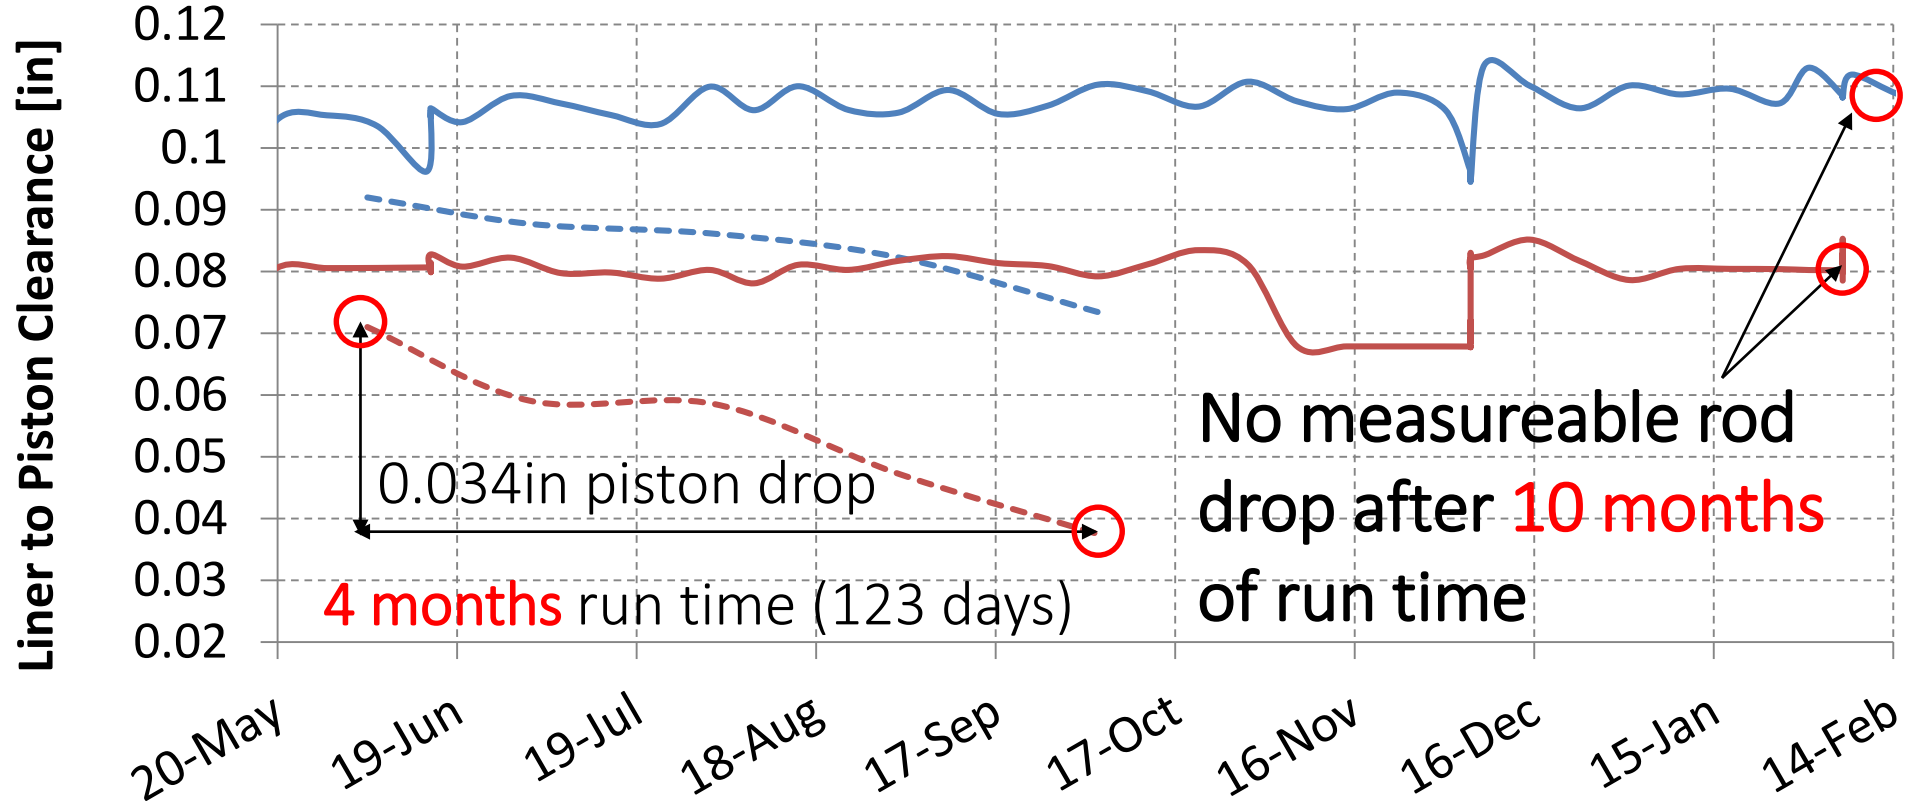
Performance of new design

--- 2nd Stg A Original --- 2nd Stg B Original — 2nd Stg A Upgrade — 2nd Stg B Upgrade
