Influence of Bearing Selection on MTBF (Mean Time Between Failure) of a Screw Expander in Geothermal Power Generation Service

Michael Macek, P.E. - Macek Power & Turbomachinery Engineering

Monte Morrison, P.E. - Cyrq Energy

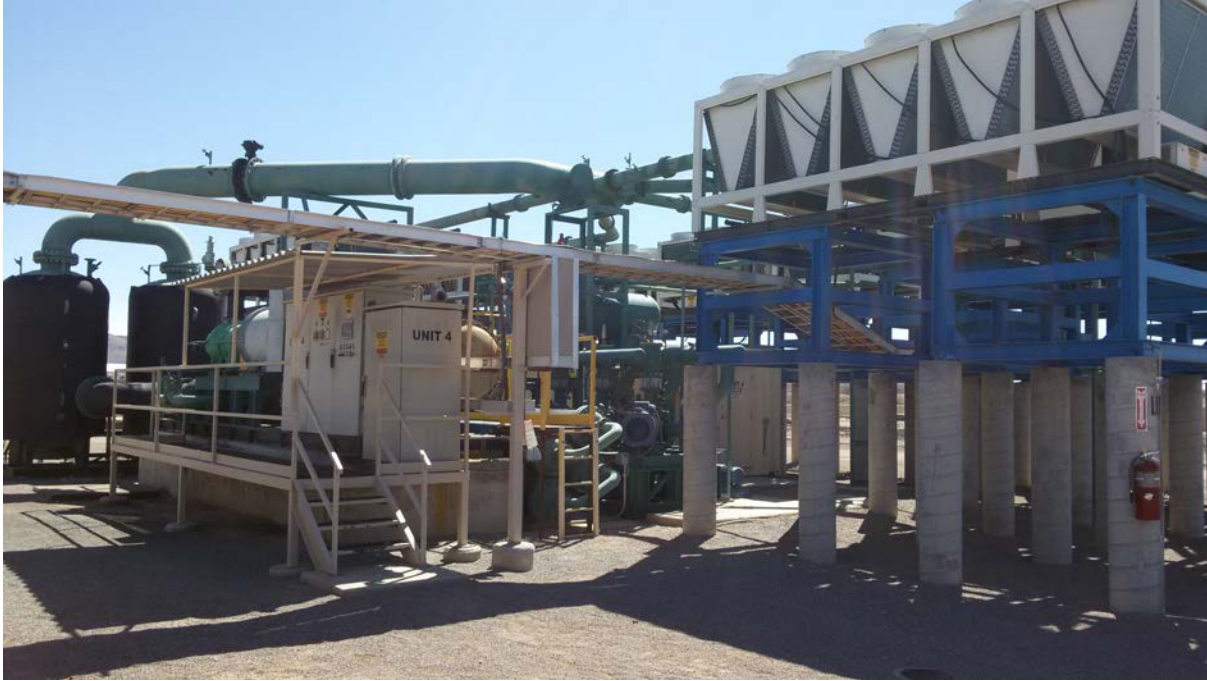
Background

Lightning Dock Geothermal, one of several facilities owned by Cyrq Energy, is a power producer located near Animas, New Mexico, USA. Installed as part of Phase I are four (4) “power blocks”. The prime mover of each power block is a screw expander unit, rated at 1,000 kW. The driven machine is a synchronous AC generator. The working fluid is R245fa refrigerant, which is transformed to a slightly superheated state by means of a heat exchanger and hot geothermal water extracted from the well field.

The plant was commissioned in 2013 December and unfortunately, since that time, has suffered from numerous equipment failures related primarily to equipment design. Chronic, extremely short expander life manifested through catastrophic bearing failure has been the most notable and by far, the most costly of the equipment problems. This case study describes a change in bearing selection that significantly increased MTBF (mean time between failure).

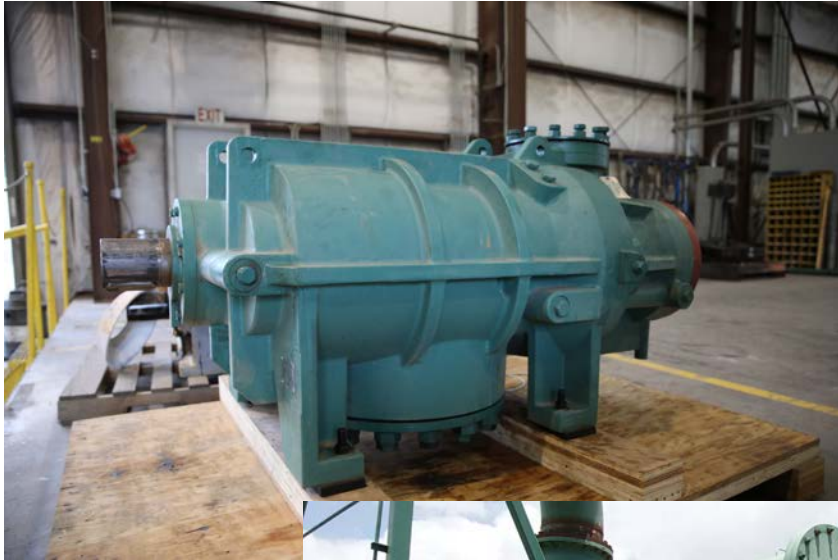
Problematic Machine – Screw Expander

Application: Power generation

Rated Output: 4 x 1,000 kW (4 identical units installed)

Working fluid: R245fa (refrigerant)

Male rotor: 5 lobes (1800 RPM)

Female Rotor: 6 lobes (1500 RPM)

Bearings: Rolling element (cylindrical and tapered)

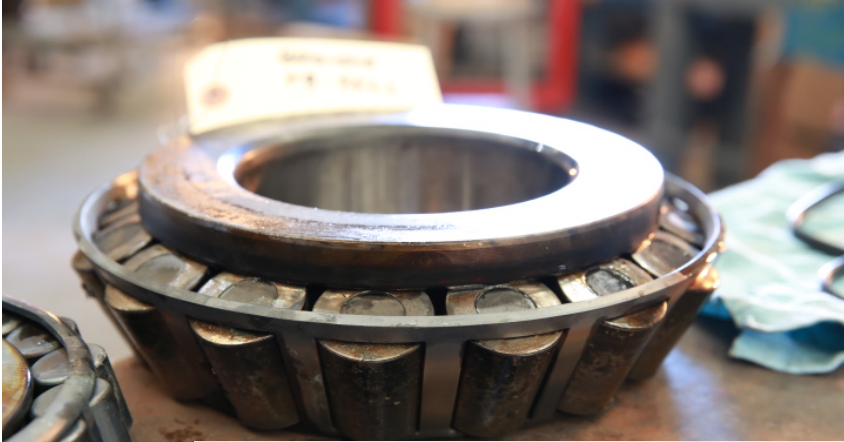
Determine cause or causes of highly premature bearing failure

Failure	Unit	Run time at Failure [hrs]
1	3	2,769
2	4	2,065
3	2	3,891
4	1	3,460
5	4	1,338
6	3	2,808

Pending failure indicated by casing vibration (velocity) sensors.

Failed Component

Bearing '2' (Male rotor active thrust bearing) – All six (6) failures
