THE EFFECTS OF URBANIZATION ON CHANNEL MORPHOLOGY OF  
RIVERS IN TEXAS

A Dissertation

REBECCA ANNE OWENS

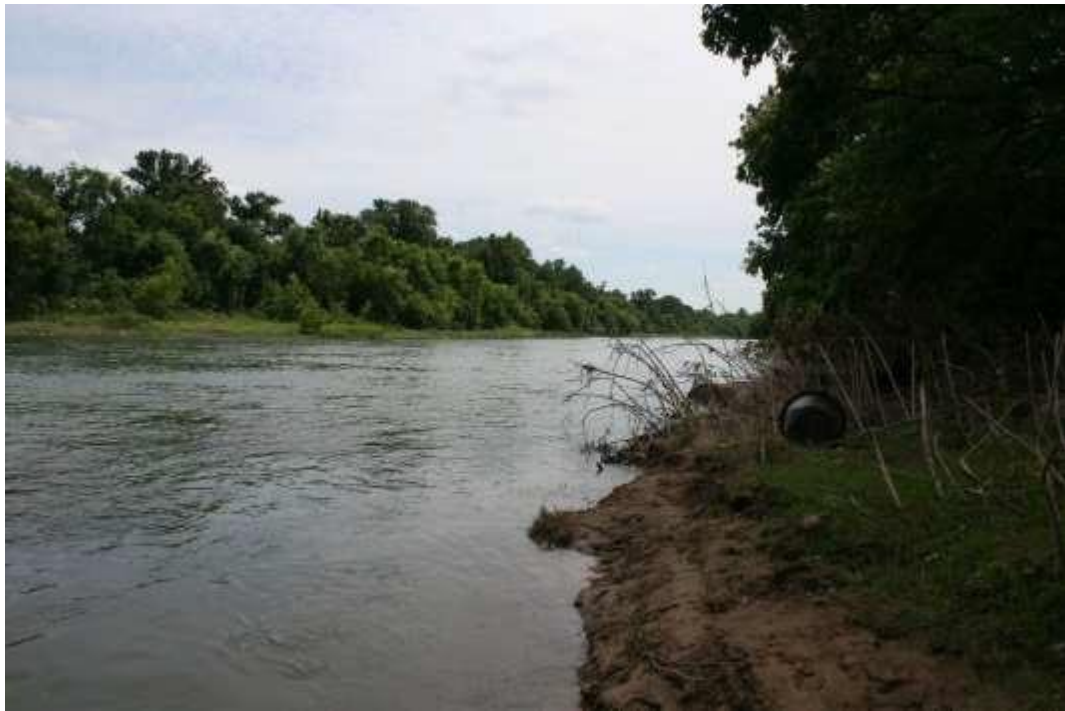
**Figure 13: Colorado River channel downstream of Austin, Texas.**

Downstream of Austin, the Colorado River flows through a natural channel with undeveloped banks (Figure 13).

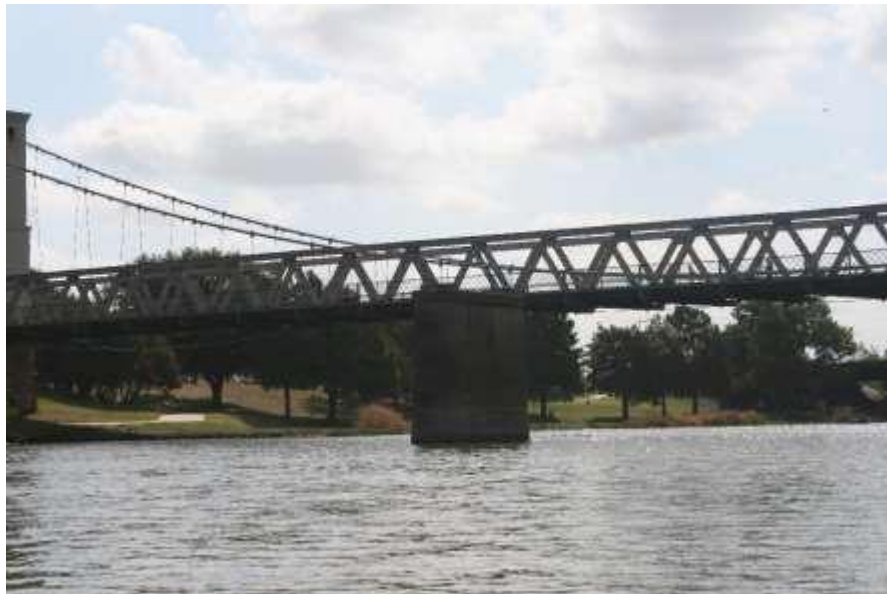
**Figure 23: Modified river banks in Waco, Texas**

This reach of the Brazos River flows through a modified stretch in Waco where the channel has been often reinforced with stone or wood and vegetation cleared (Figure 23).

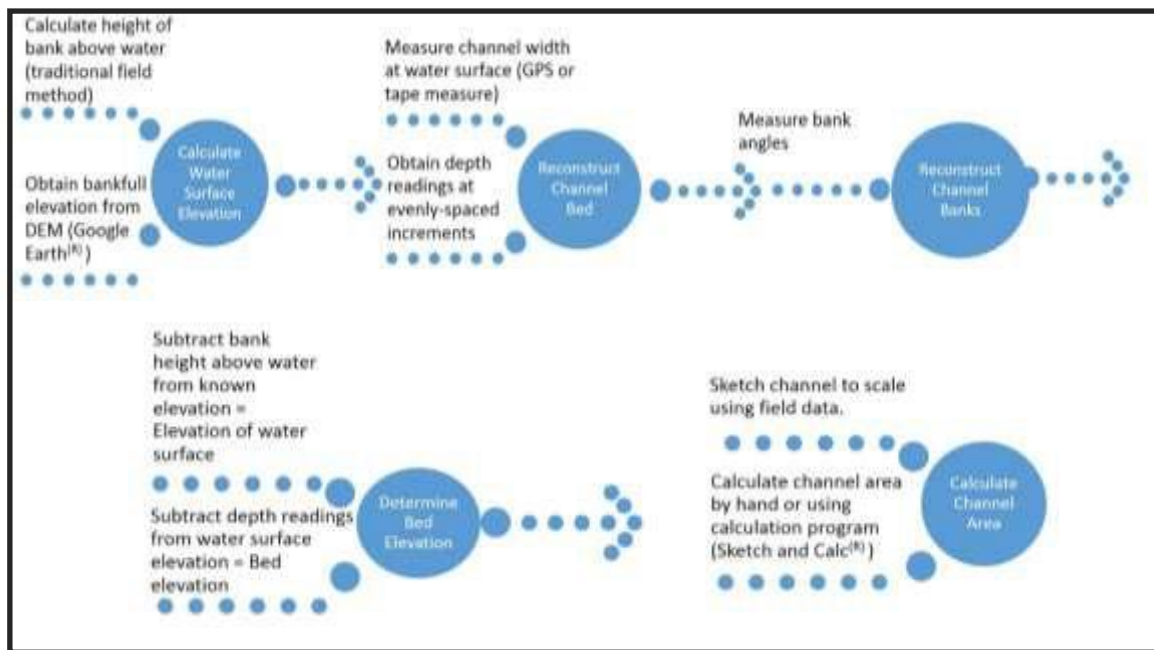
**Figure 59: Process for determination of bed elevation and bankfull channel area using a combination of field and simple remote sensing techniques.**

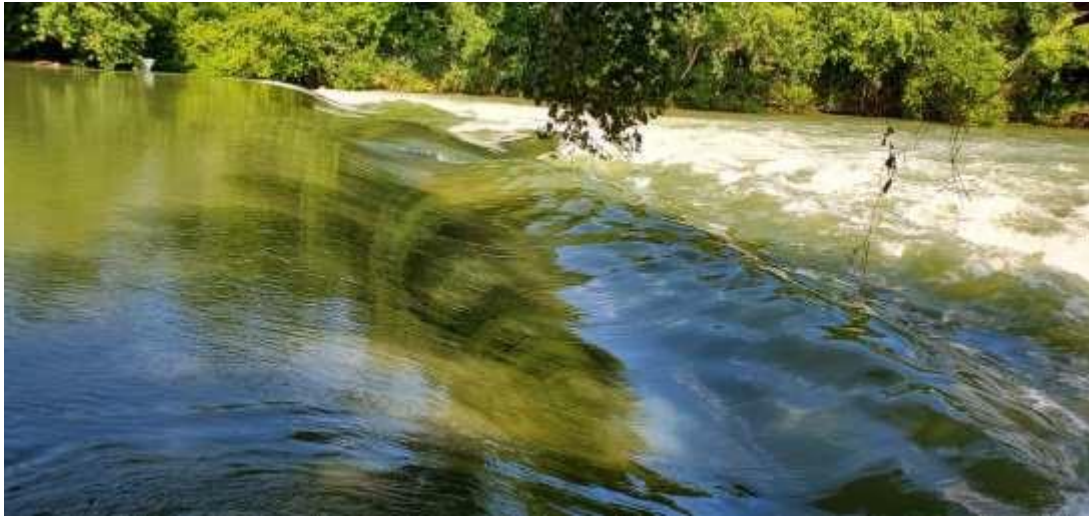
**Figure 83: Artificial standing wave on the Colorado River downstream of Austin, Texas. The location of the wave on a sharp bend causes it to be out of sight until one is directly upon it.**

Landcover is pasture, shrub/scrub, or low-medium intensity development. Two locations in the study area create flow disruptions: a weir precariously placed beneath the US-183 overpass such that it does not appear on aerial photographs and surprises unsuspecting canoeists, and a recreational standing wave at a southward bend of the channel 10 km downstream of Longhorn Dam (Figure 83). Future researchers are advised to consult aerial photographs before canoeing this reach, because the placement of the standing wave on a bend causes it to be out of sight until one is directly upon it.

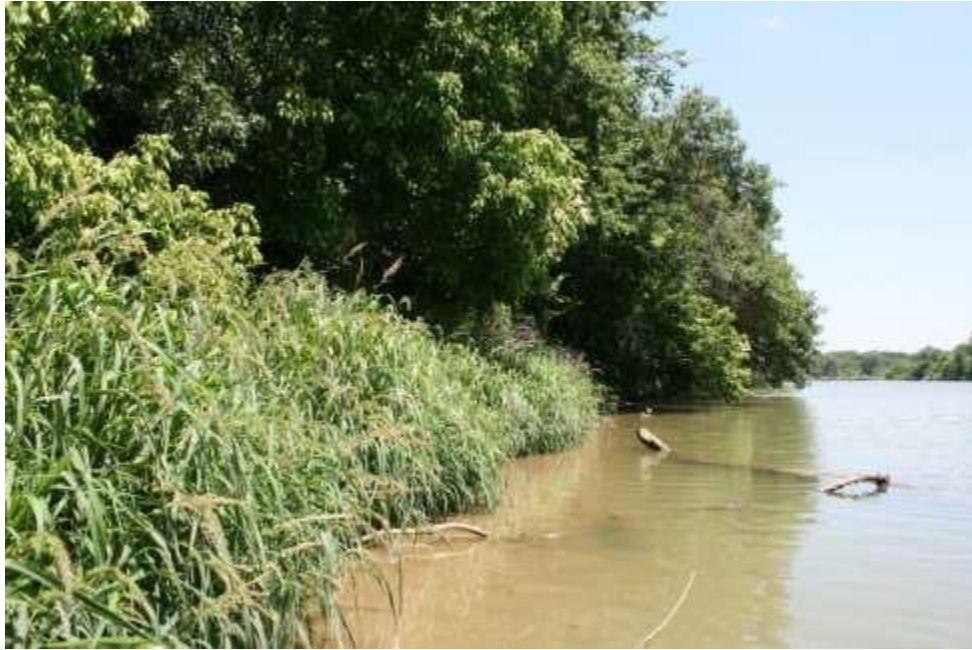
**Figure 95: Eastern bank at BR01. Notice minimal debris and vegetation reaching waterline.**

$$\text{Total: } 4(.6) + 4(.6) + 2(.4) + 3(.8) + 3(.8) + 4(.6) + 1(.2) + 1(.2) + 4(.8) = 16.4$$

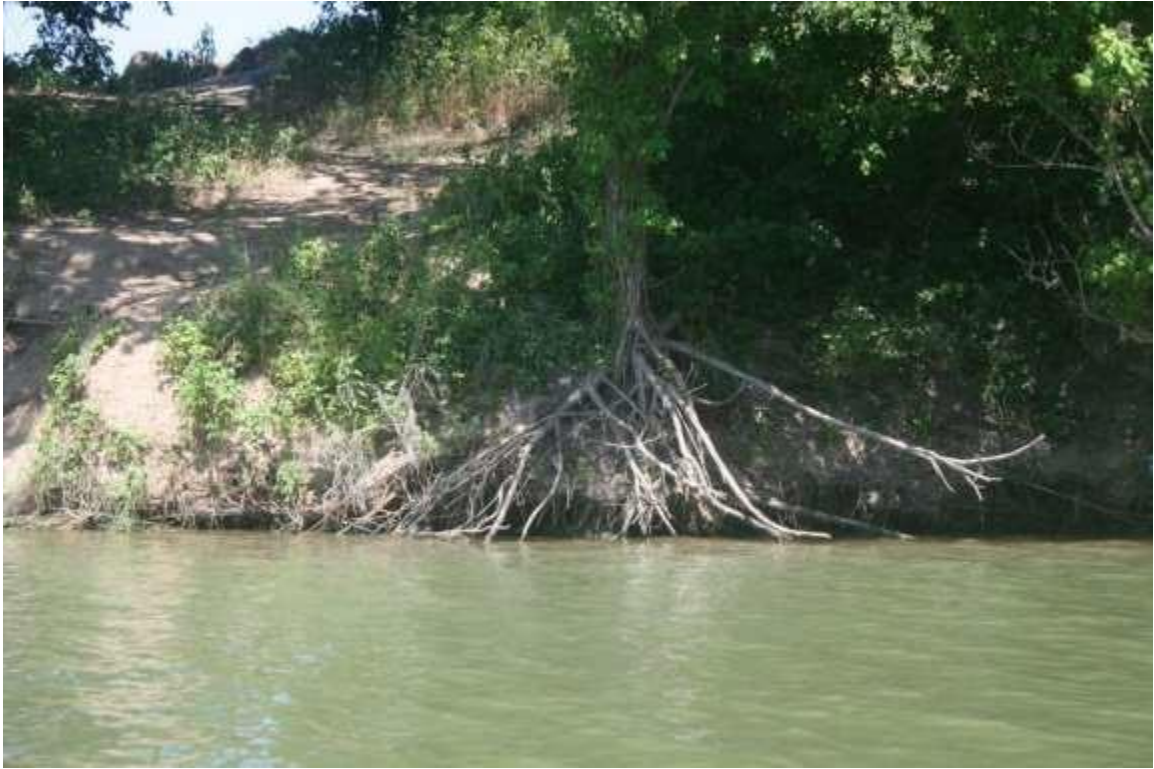
**Figure 119: Increased erosion observed near the FM 3051 overpass**

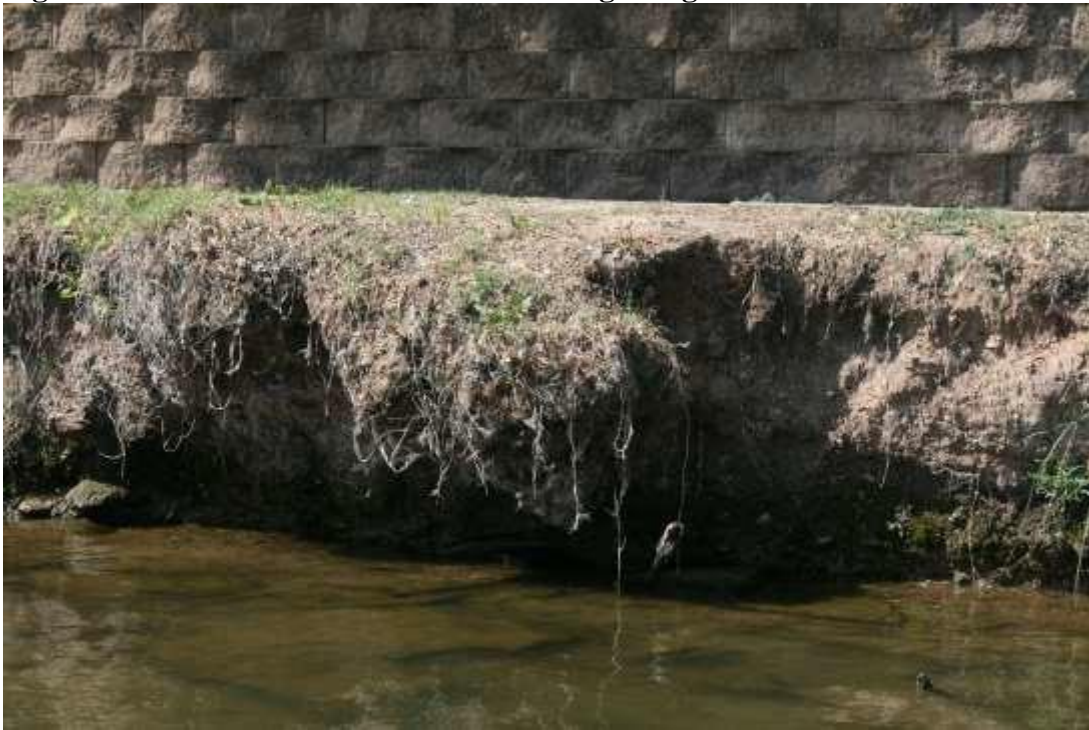
**Figure 141: Close-up of undercutting**

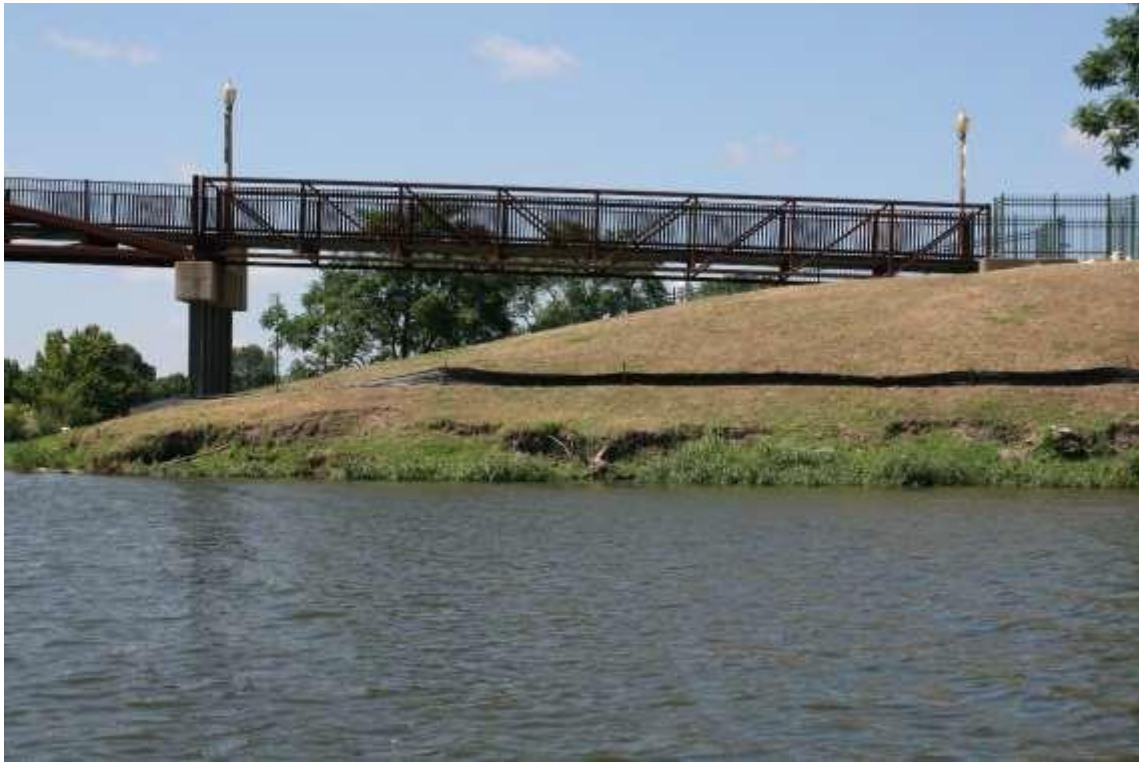
**Figure 142: On southern bank, bank erosion is extensive.**

Total:  $3(.6) + 6(.6) + 3(.4) + 3(.8) + 1(.8) + 4(.6) + 1(.2) + 1(.2) + 2(.8) = 14.2$

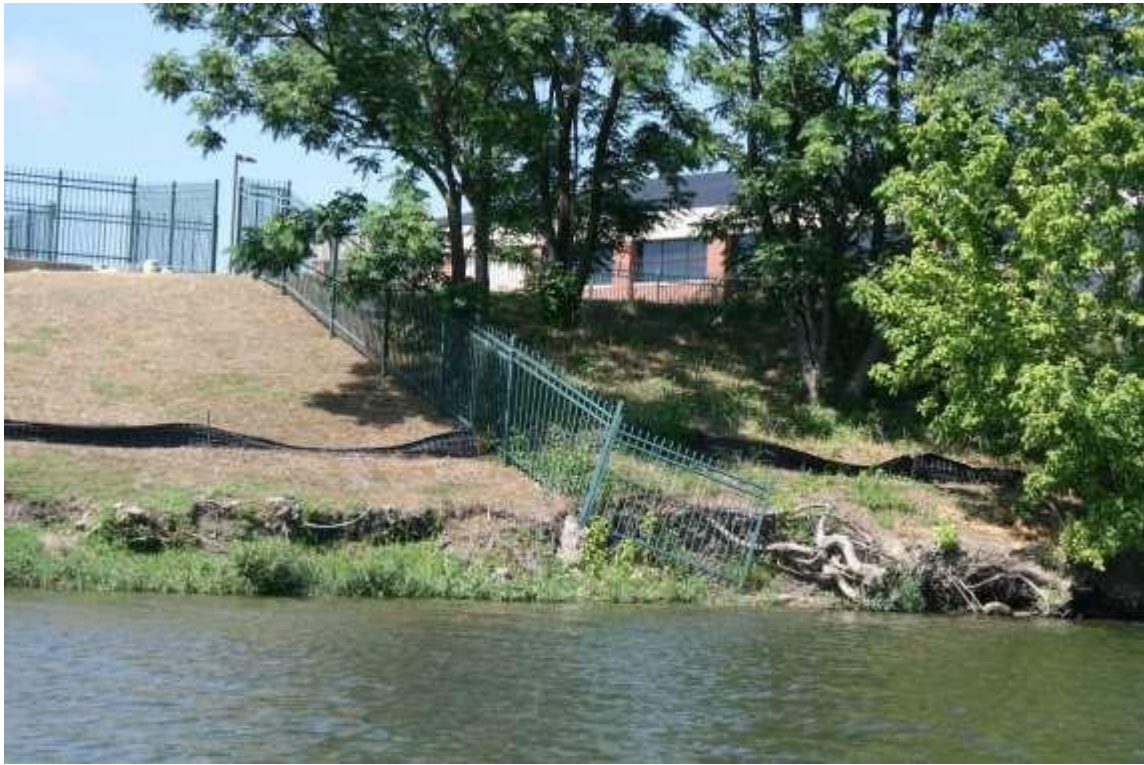
**Figure 143: Fence failure resulting from bank slump**

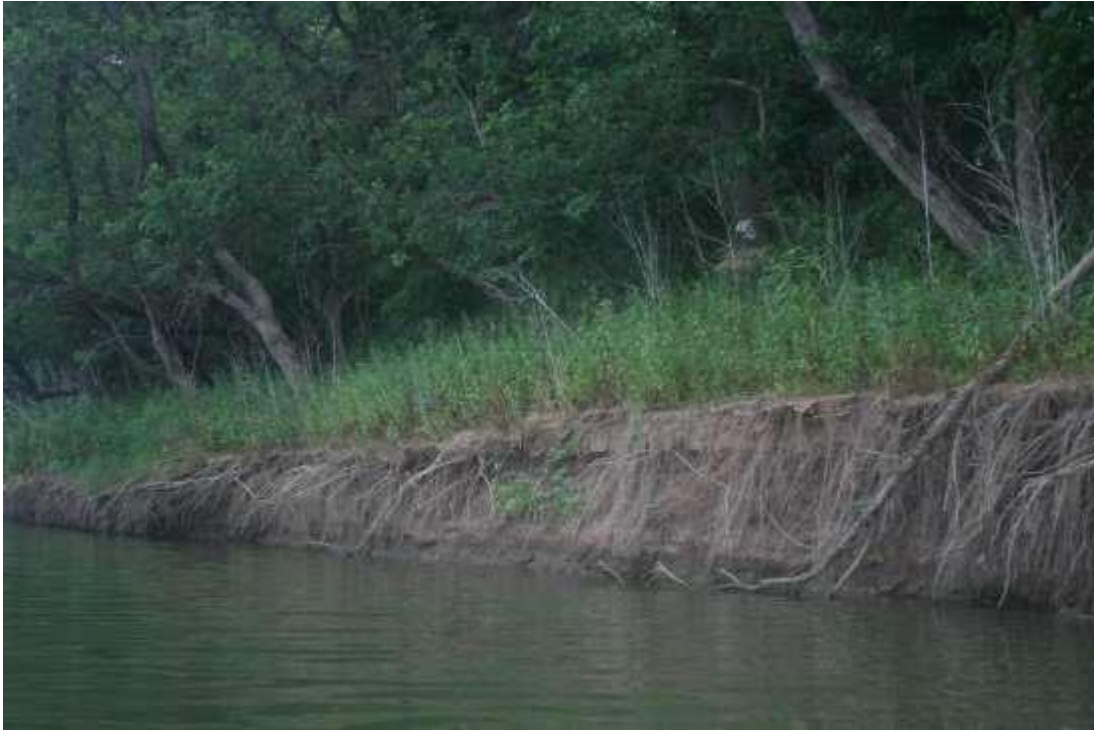
**Figure 152: Continuous bank cutting and exposed roots at BR18**

Total:  $4(.6) + 6(.6) + 7(.4) + 6(.8) + 4(.8) + 10(.6) + 6(.2) + 6(.2) + 3(.8) = 27.6$

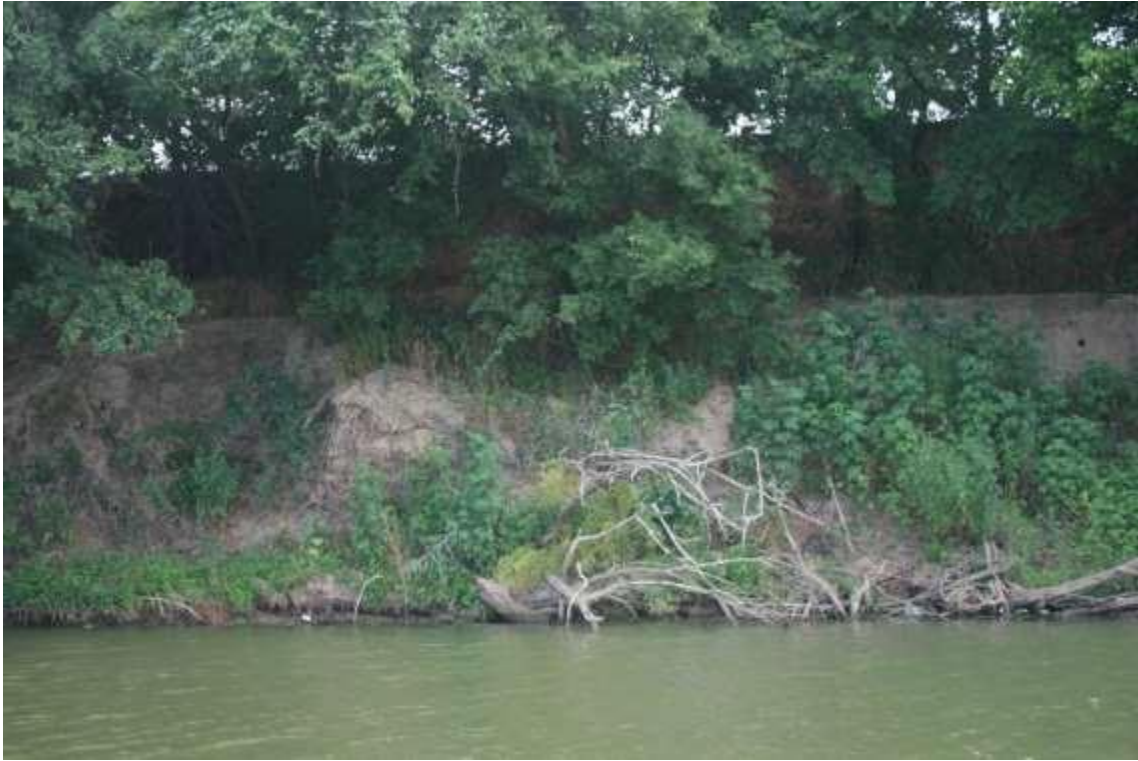
**Figure 159: Bank cutting and erosion was extensive at BR20.**

Total:  $3(.6) + 8(.6) + 9(.4) + 8(.8) + 8(.8) + 6(.6) + 5(.2) + 5(.2) + 3(.8) = 31$

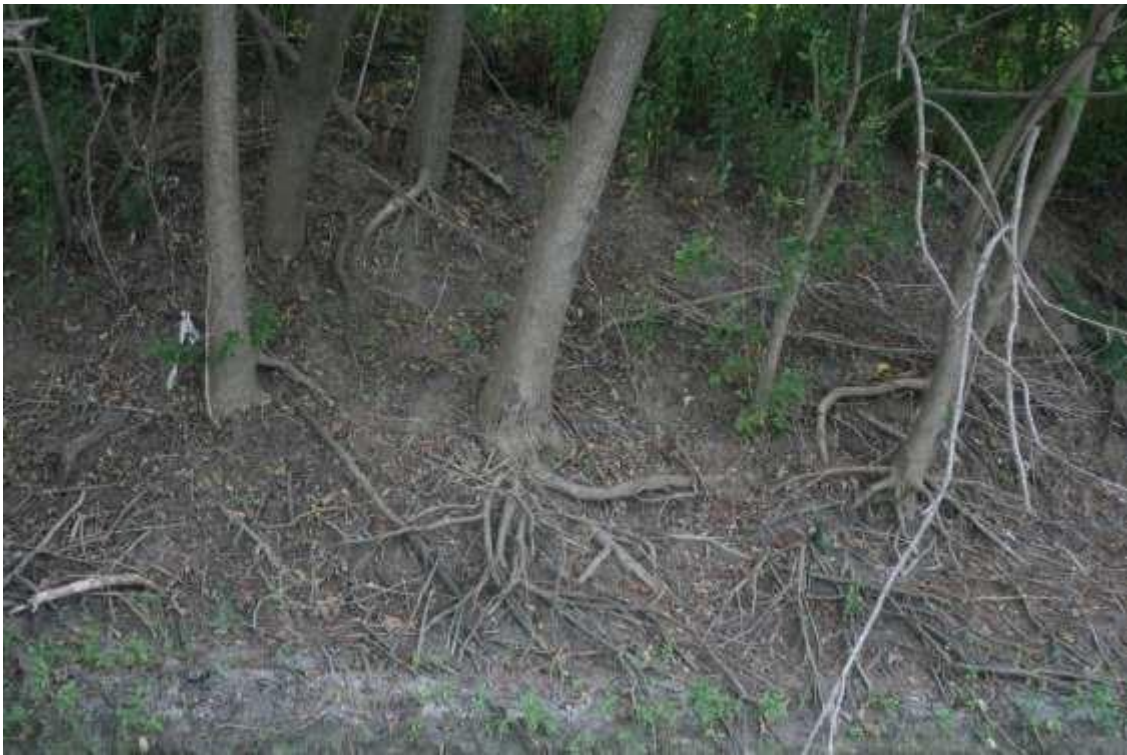
**Figure 162: Exposed roots at BR21**

Total:  $3(.6) + 7(.6) + 8(.4) + 7(.8) + 6(.8) + 6(.6) + 5(.2) + 4(.2) + 3(.8) = 27.4$

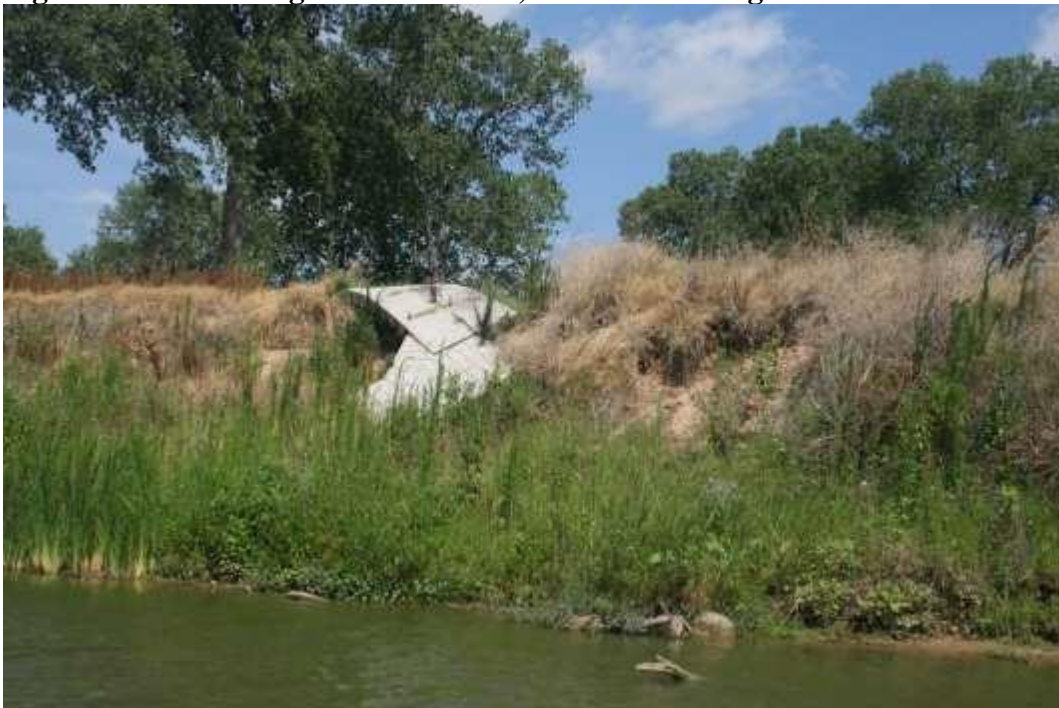
**Figure 167: One of occasional bank failures at BR23**

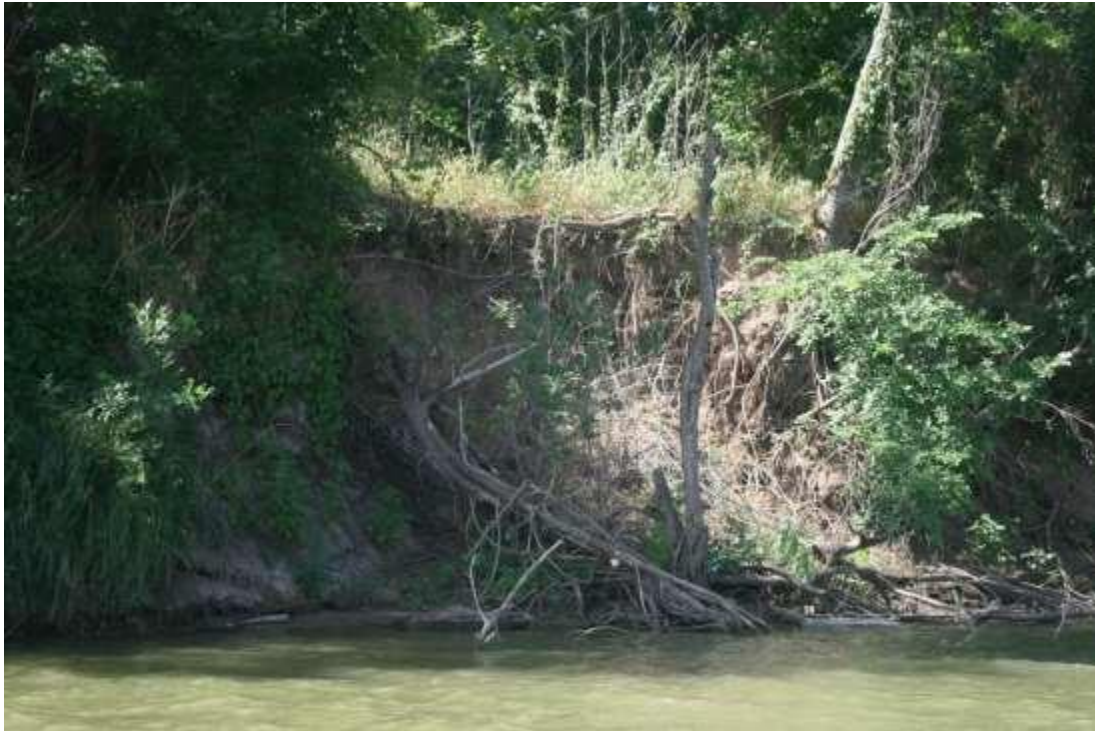
**Figure 170: Even where natural vegetation remained, bank failure was extensive at BR24.**

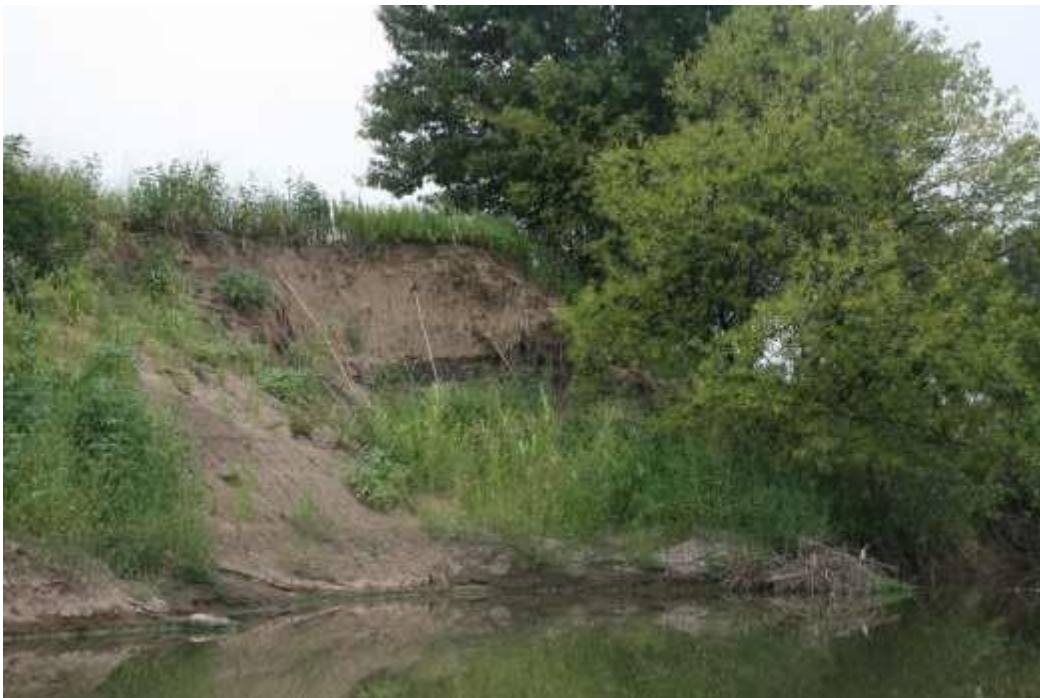
**Figure 180: Cutting and bank failure at TR01. Cutting was not continuous, but serious where present.**

1. **Bank Soil Texture and Coherence (.6): 4-Good.**
2. **Average Bank Angle (.6): 6-Good.** Southern bank angle 26°, northern bank 26°.
3. **Bank Cutting (.4): 7-Fair.**
4. **Vegetative Bank Protection (.8): 6-Good.**
5. **Mass Wasting or Bank Failure (.8): 4-Good.**
6. **Bar Development (.6): 6-Good.**
7. **Debris-jam Potential (.2): 6-Good.** Debris accumulations occasional.
8. **Obstructions, Flow Deflectors, Sediment Traps (.2): 5-Good.** None observed.
9. **Channel-Bed Material Consolidation and Armoring (.8): 7-Fair.**
10. Channel Stability Score:  
 $(.6)(4)+(.6)(6)+(.4)(7)+(.8)(6)+(.8)(4)+(.6)(6)+(.2)(6)+(.2)(5)+(.8)(7)= 28.2$

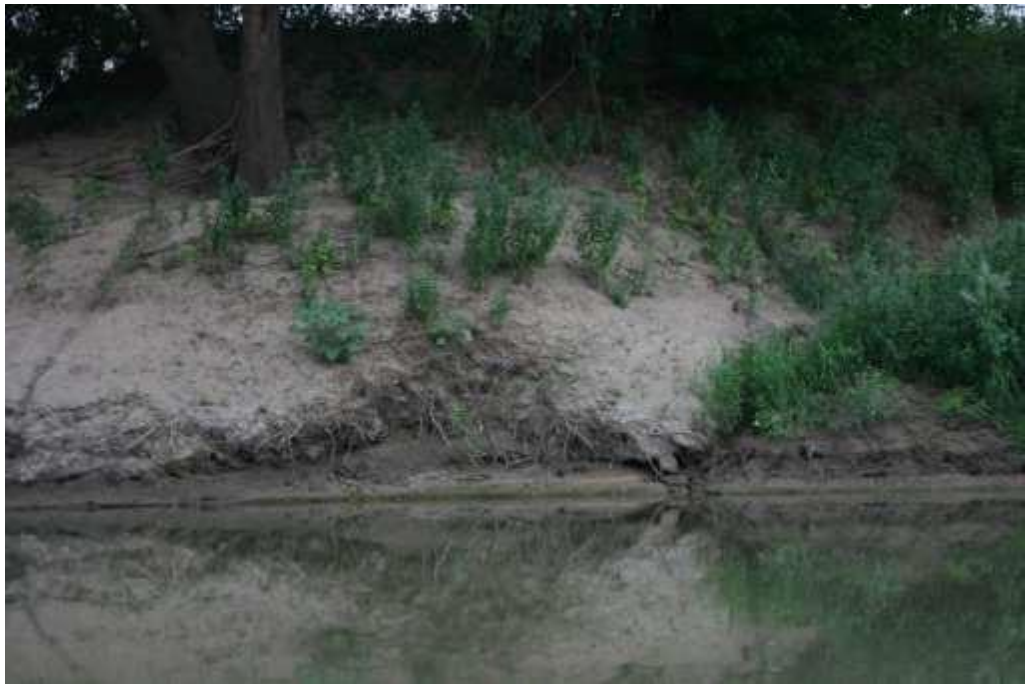
**Figure 186: Bank cutting and failure at TR04.**

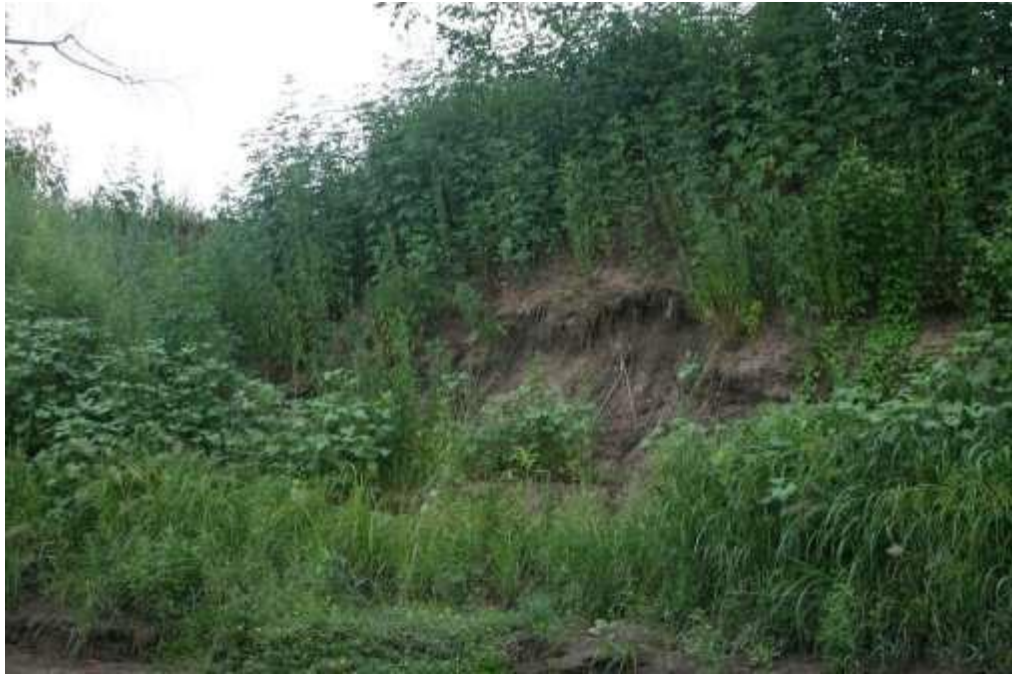
**Figure 187: Bank at TR04. Notice abundant, grassy vegetation and slight mass wasting.**
