DEVELOPMENT OF THE PRELIMINARY GUIDELINES FOR THE EVALUATION
AND REPAIR OF PORTABLE CONCRETE BARRIERS

A Thesis

Graduate study was supported by the funding provided to Texas A&M Transportation Institute by the Texas Department of Transportation [TxDOT] for the Project 0-7059 Develop Guidelines for the Inspection, Use and Repair of Portable Concrete Barriers.

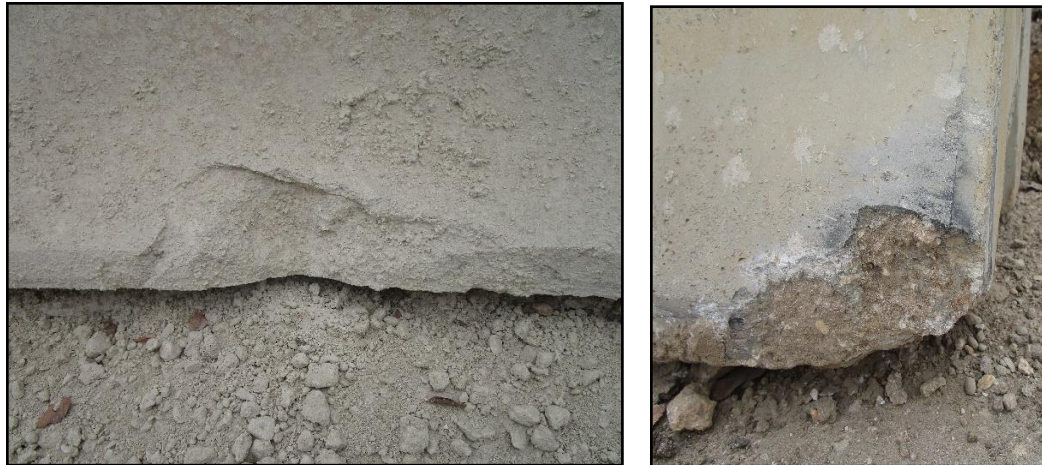
**Figure 2. Real-Life Spalling Observed in Crash Barriers from a Stockyard:
(a) Spall on the Middle Base of the Barrier; (b) Spall on the Toe of the
Barrier.**

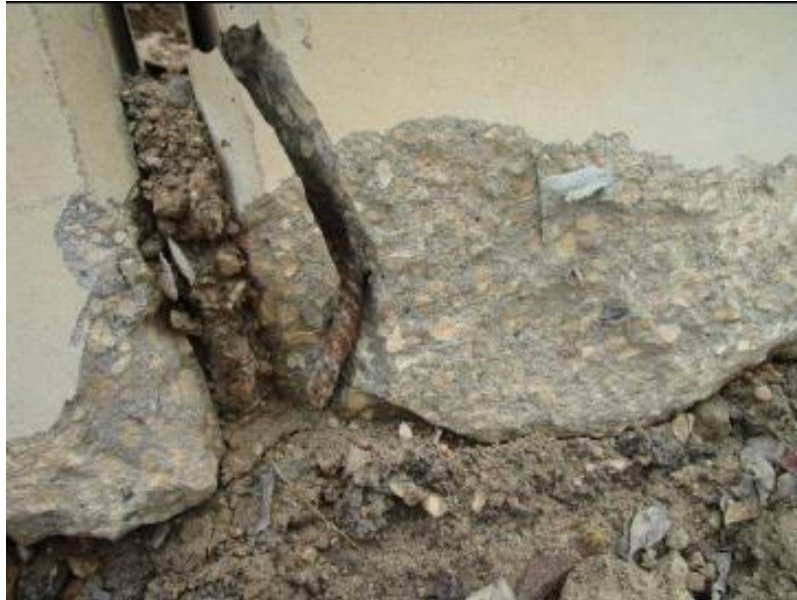
Figure 3. Corrosion of Reinforcing Bar Embedded in the Toe of the Concrete Barrier.

When the rebar is exposed to moisture and water, possibly because of inadequate cover or surface irregularity, a chemical reaction takes place, resulting in the formation of iron oxide (rust) on the rebar surface. Due to the production of iron oxide, the rebar volumetrically expands by up to six times its original volume. This increase in volume imposes significant expansive forces on the surrounding concrete, which can cause a chunk of the concrete to spall and break off. Spalling increases access of air and water to the rebar embedded within the barrier and creates a cycle of corrosion, exacerbating the process with each subsequent cycle (2). Figure 3 shows an example of a barrier with a corroded rebar and spalled concrete.

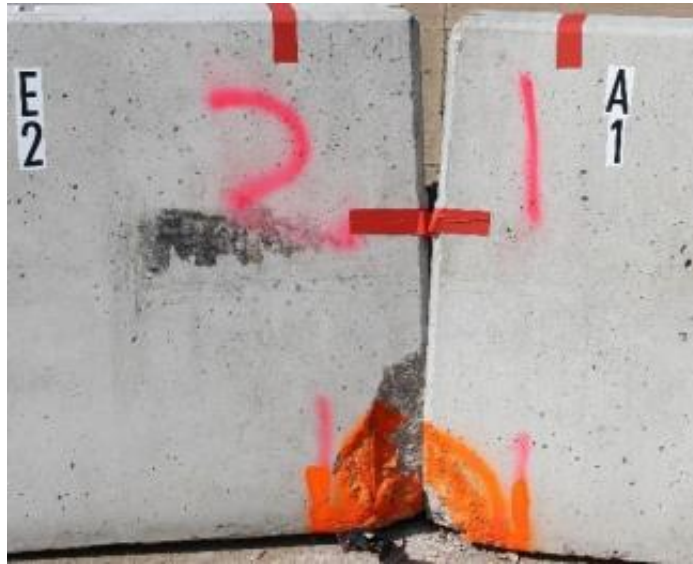
Figure 4. Spalling at the Toe of Barrier E due to a Vehicle Crashing into the Joint between Barriers A and E.

Vehicles crashing against the barrier during road accidents result in portions of the concrete breaking away (Figure 4). Depending on the vehicle type, impact speed, and angle, the extent of spalling may vary.

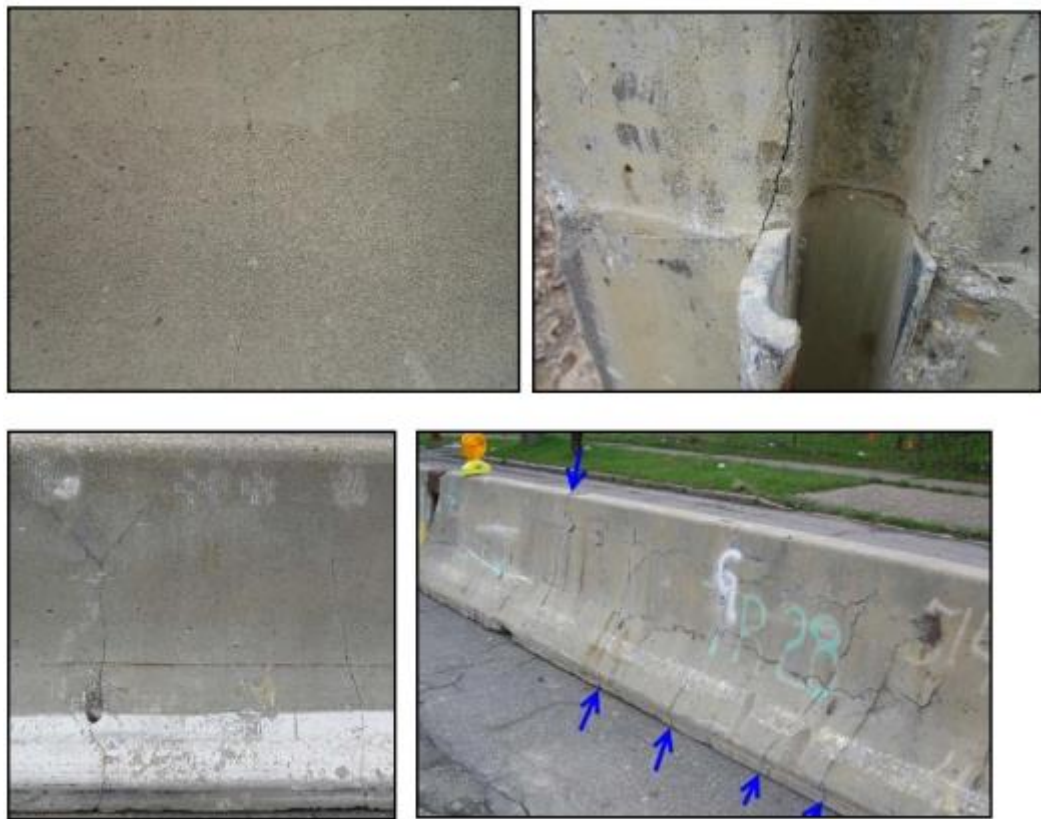
Figure 5. Cracking in Portable Concrete Barriers (8). Reprinted from Temporary Barrier Guidelines-Cracked Sections, NYSDOT.

Cracks in concrete are complete or incomplete separation of the material into two or more parts through breaking or fracturing. Figure 5 shows cracks of varying extent at different locations of PCBs.

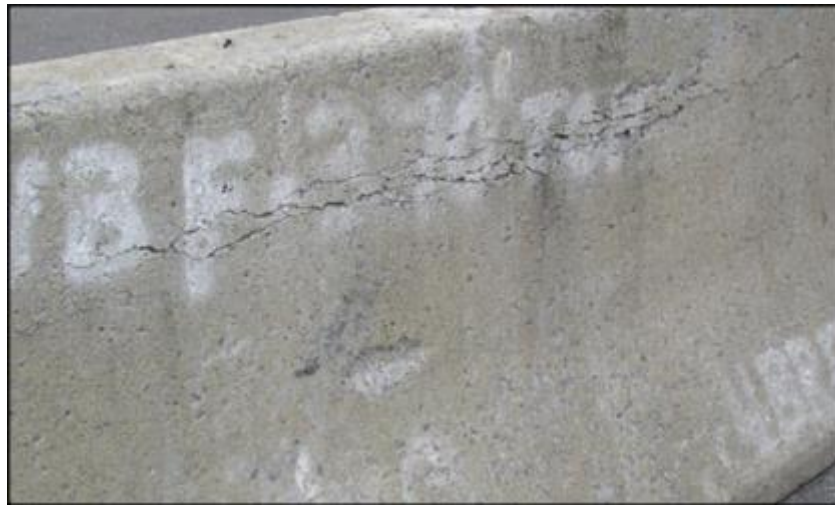
Figure 6. Clustered Horizontal Cracks due to the Tight Clamping of Lifting Devices (10). Reprinted from Temporary Barrier Guidelines-Longitudinal Cracks, NYSDOT.

The excessively tightened grip of lifting devices may lead to clustered horizontal cracks in the upper portion of the barrier stem. Figure 6 shows an example of clustered horizontal cracks.

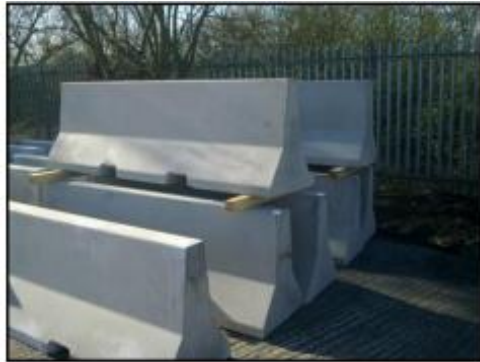
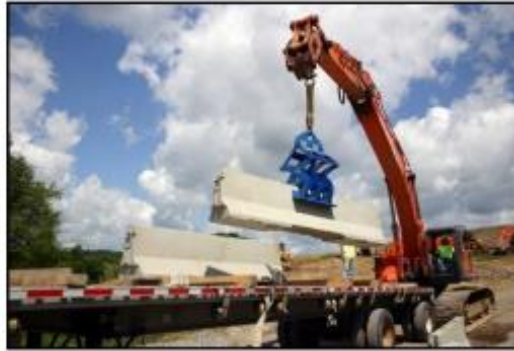
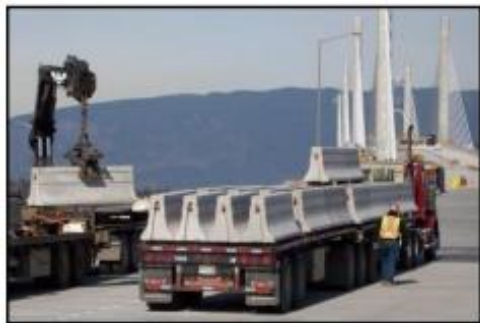
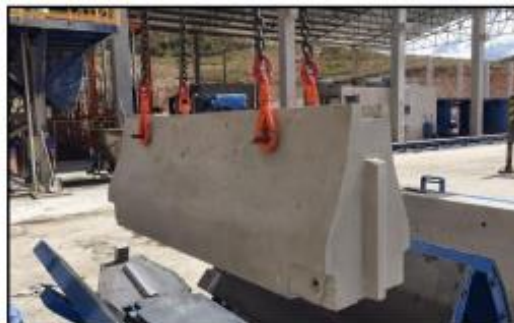
Figure 7. Various Stages in the Transportation of PCBs: (a) Stacking (12). Reprinted from externalworksindex.co.uk (b) Single-Point Lifting (13). Reprinted from kenco.com (c) Loading (14). Reprinted from eaglewestcranes.com (d) Two-Point Lifting (15). Reprinted from moldtechsl.es

Figure 7 shows the various stages of the transportation of PCBs: stacking, lifting, and loading. At any of these stages, pre-cast reinforced concrete barriers may be subject to stresses that overload them. If these stresses are encountered in the concrete's early life, the stresses may lead to permanent cracks in the barrier (11). Precast concrete barrier units should be lifted after the concrete has gained the required strength. Lifting

One important aspect of design is ensuring sufficient and properly detailed reinforcement to withstand the bending stresses during lifting. Depending on the way the barrier is lifted, it could behave either as a cantilever beam (Figure 7b) or as a continuous beam (Figure 7d). The design engineer must have the correct sense of these support conditions to design the reinforcement area. Otherwise, the barrier is bound to crack on the tension side.

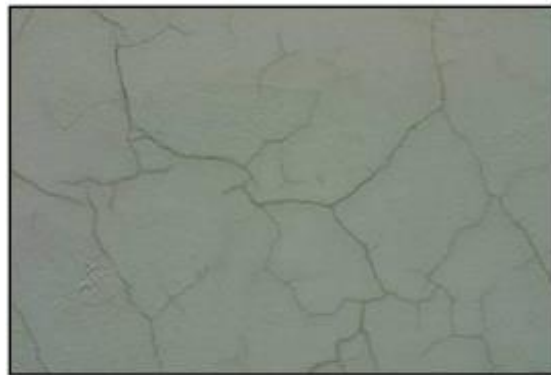
Figure 8. Shrinkage Cracks (18,19,20) Note. Figure 8(a) Reprinted from “What are shrinkage cracks in concrete” by Gopal Mishra. Figure 8(b) Reprinted from “Structural vs Non-Structural foundation cracks” by Rachel Wood. Figure 8(c) Reprinted from “Types and Remedies of Cracks in Concrete” by Hasan Shirazi.

this leads to little or no shrinkage, whereas in the finer water-filled capillary pores (2.5 to 50 nm), due to the loss of moisture, menisci (the curved upper surface of a liquid in a tube) are formed, and the surface tension of water pulls the walls of the pores. Internal negative pressure developed due to the formation of menisci in the capillary pores results in a compressive force that leads to concrete shrinkage. The thickness of the adsorbed water layer is reported to increase with increasing humidity. Therefore, a higher water content leads to a thicker layer of adsorbed water and more drying shrinkage. When the shrinkage movement is opposed by external or internal restraint, stresses develop. When these stresses exceed the tensile capacity of the concrete, cracks develop. Therefore, shrinkage should be considered at the design stage with appropriate detailing of reinforcement to minimize cracking. Usually, it takes several months to four years after casting for these cracks to form, depending on the rate of drying. Concrete near the corners and edges is vulnerable to cracking because loss of moisture takes place from the adjacent surfaces. There is no typical pattern that drying shrinkage cracking follows because the cracks form at any location where there is a restraint to shrinkage movement. Shrinkage cracks usually develop approximately at right angles to the direction of restraint (16, 17). Figure 8 shows examples of shrinkage cracks.

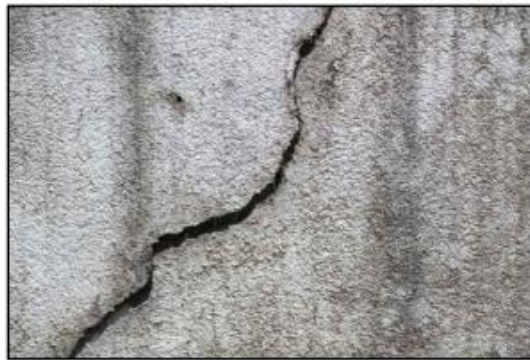
Figure 10. Crack due to the Formation of More Voluminous Products (22). Reprinted from gharpedia.com

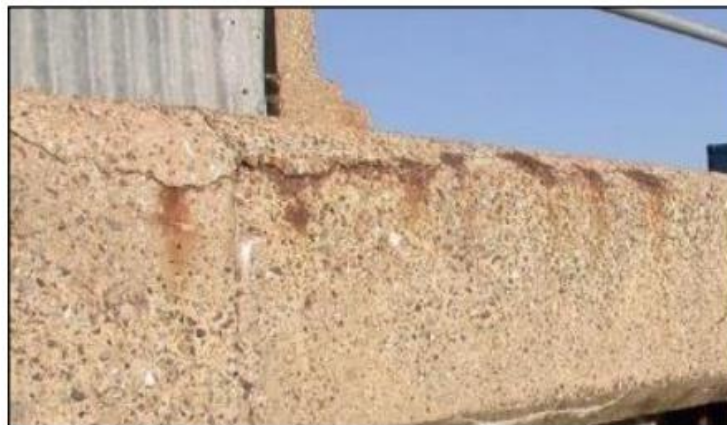
Figure 11. Crack due to the Corrosion of Reinforcement (24). Reprinted from concrete.org.uk

Three conditions that must be present to initiate corrosion are oxygen, moisture, and electron flow within steel. Elimination or limitation of any of these conditions reduces the corrosion of the steel reinforcement embedded in the concrete member, reducing the risk of cracking. Concrete provides a passive protection to the steel by forming a protective oxide coating around it in an alkaline environment. But as carbonation alters the concrete's levels of alkalinity, corrosion may take place. Iron oxides and hydroxides are formed as byproducts during the corrosive reaction. As these byproducts form on the surface of the steel reinforcement, volume of the rebar increases. This increase in volume increases the pressure on the concrete and causes radial cracking in the member because the tensile stresses developed in the concrete exceed the tensile strength (Figure 11). Repairing these cracks at the initial stage is important because as they become larger, oxygen and water have a greater chance to penetrate the concrete and accelerate the corrosion of the reinforcement (23).

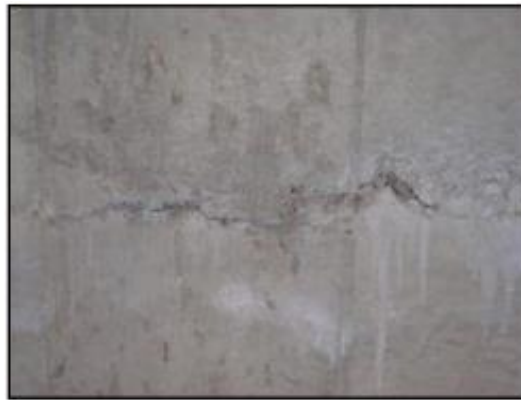
Figure 12. Crack-Like Formation due to the Lack of Mixing of Two Batches of Concrete during the Pour (21). Reprinted from waterstopsolutions.com

Numerous poor construction practices, such as increasing the cement content to offset a decrease in strength from the addition of water, inadequate curing, etc. can lead to cracking in concrete (12) (Figure 12).

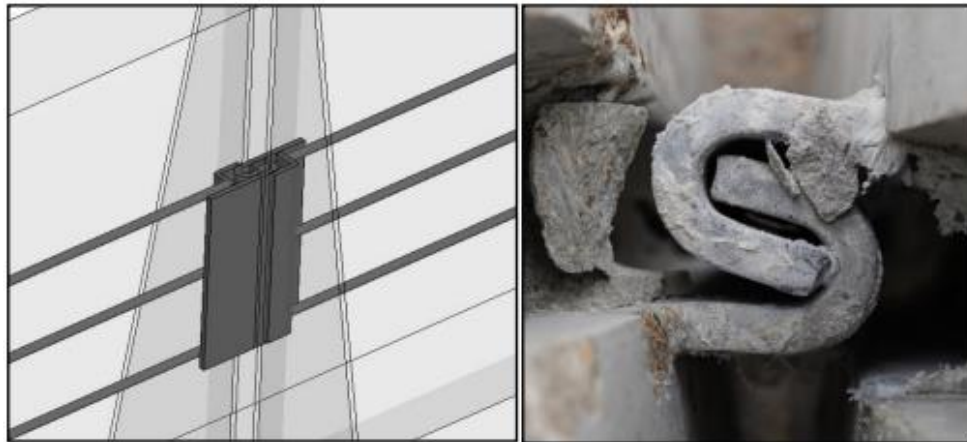
Figure 13. JJ Hook Connections: (a) Isometric View of the JJ Hook Connection between Barrier Units; (b) Top View of a JJ Hook Connection between Barrier Units.

F-shape and single-slope PCBs are connected via JJ hook connections, which consist of two identical J-shaped steel hooks, each of which is welded to an angle plate and multiple steel rebars (Figure 13a). This assembly provides a self-aligning continuous steel connection throughout the barrier installation. The connection automatically hooks into place without requiring workers to place their hands between the barrier units to make the connection. The major advantage of using JJ hooks to connect the barrier segments is that they are easy to install since the hooks are identical on both ends of the barrier. Since barriers can be vertically lifted, a single barrier unit can be removed without having to disturb the adjacent barrier units. There is no concern of lost or stolen hardware (bolts and pins) since this system is integrated in nature (27).

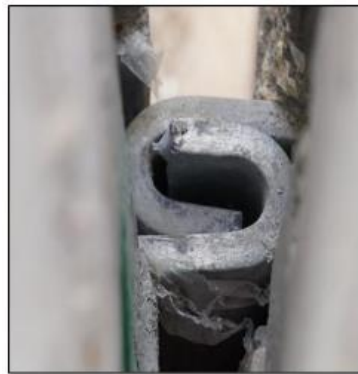
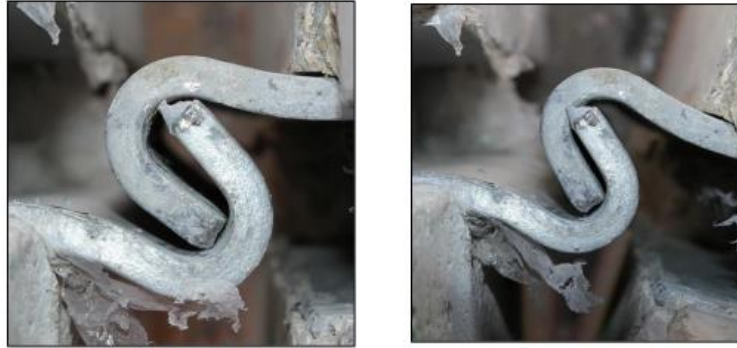
Figure 15. Stages of deformation of the joint between the single slope barriers E and A.

Rotation of the connection between the JJ hooks of the barriers E2 and A1 increased as the speed of the bogie increased from 18 mph (Test B2) to 26 mph (Test B10). Also, the JJ hooks successively opened more as the impact speed increased from 18 mph to 26 mph.

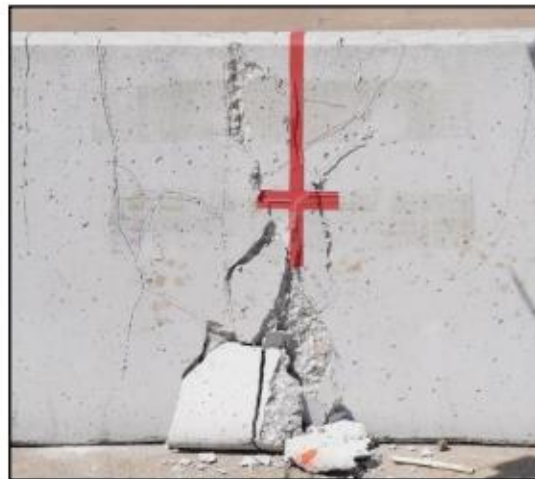
Figure 16. Damage observed on the impact side the single slope barrier after the component testing performed to evaluate the barrier strength.

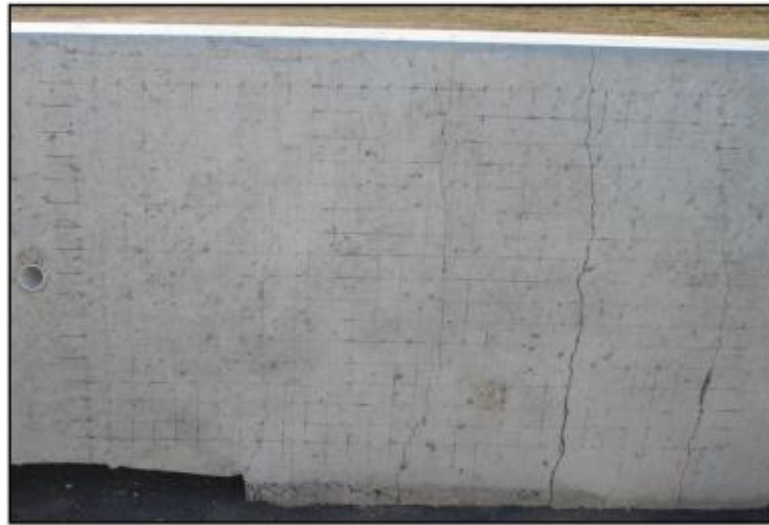
Region 1 was chosen somewhere in the middle of Barrier E, above and near the scupper. This region had multiple transverse cracks gradually increasing in width as one moved from left to right along the longitudinal direction of the barrier. These cracks resulted from the series of destructive tests (B2, B9, B7, B10).

Figure 19. Region 1 with transverse cracks gradually increasing in width (left to right), Barrier E.

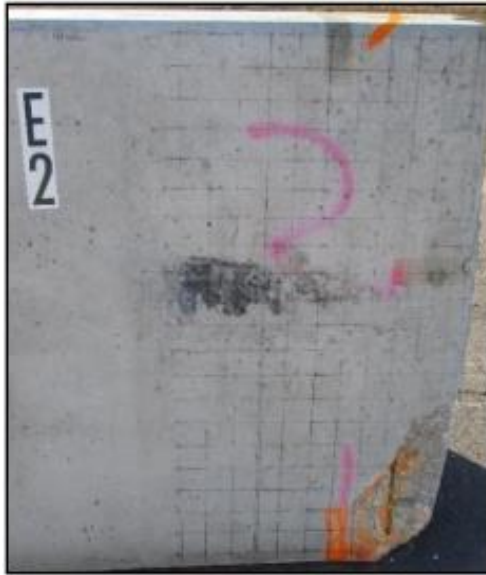
Region 2 was located towards the barrier end, near the joint which was previously impacted four times during the series of destructive tests-B2, B9, B7, B10. The region had a spall on the right corner with exposed reinforcement.

Figure 20. Region 2 at the extreme end of Barrier E. Right corner has a spall with exposed reinforcement.

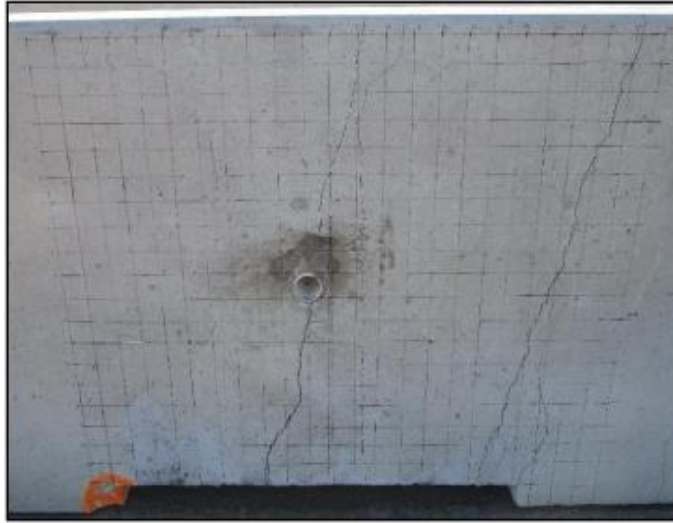
Figure 21. Region 3 on Barrier A, encompassing cracks gradually increasing in their width.

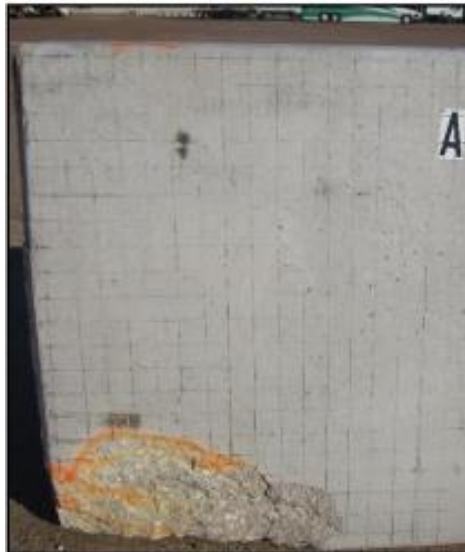
Figure 22. Region 4 towards the end of Barrier A. Part of the base at the left end has a spall with no exposed reinforcement.

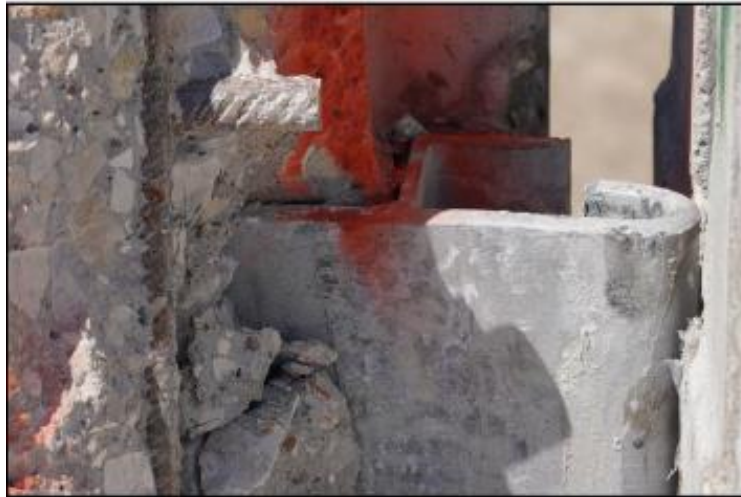
Figure 53. Unacceptable Barrier—Spalling beyond the Outer Layer of Rebar Embedded within the Barrier, Exposing It and Making It Protrude.

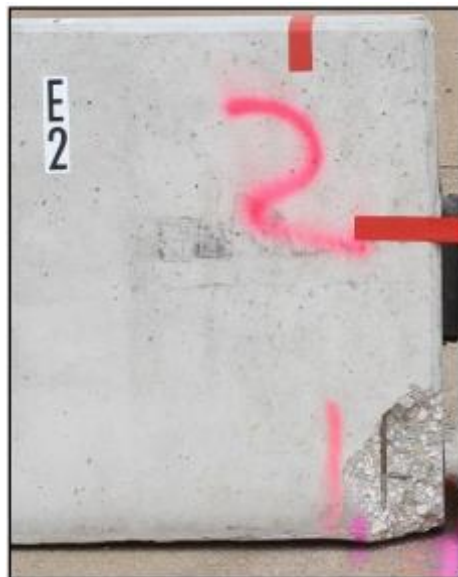
Figure 54. Barrier which is Acceptable with Repair—Spalled Region Where Reinforcement May Have Some Exposure but Does Not Protrude

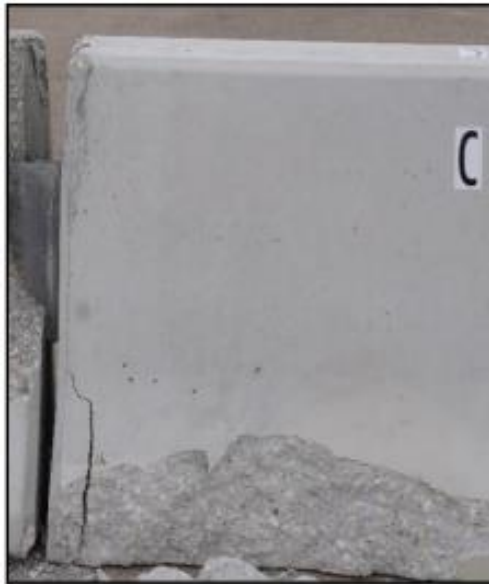
Figure 55. Unacceptable Barrier—Large Chunk of Partially Broken Concrete Piece from the Toe Susceptible to Break Off When Further Impacted.

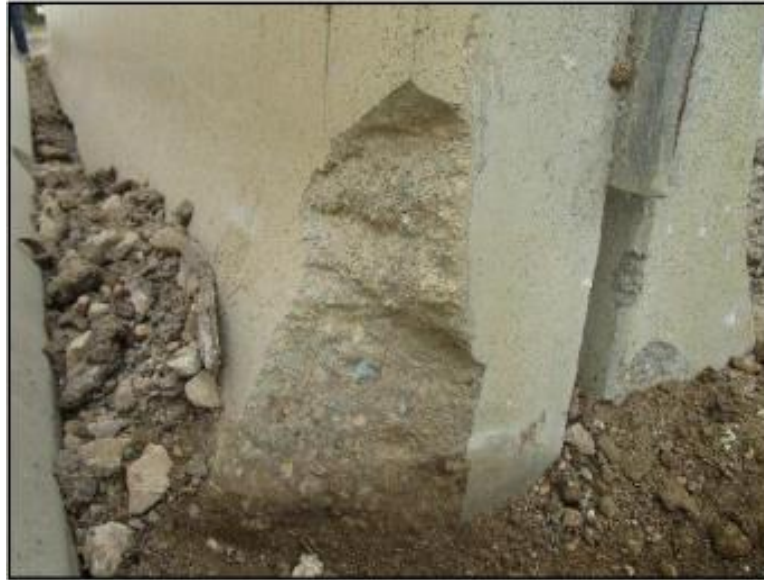
Figure 57. Unacceptable Barrier—Spalled Dimension Equal to 12 Inches and Spall Depth Less than the Cover; Reinforcement Is Not Exposed.

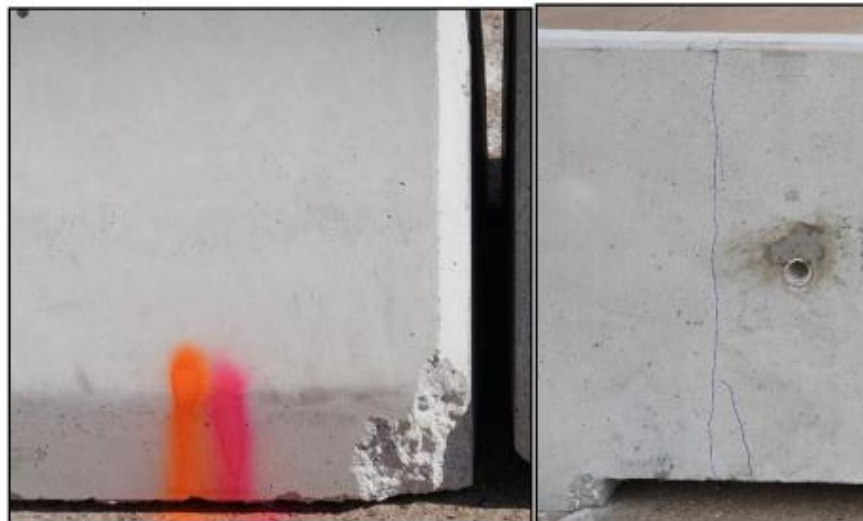
Figure 58. Acceptable Barrier— Spalled Dimension Less than 12 Inches and Spall Depth Less than the Cover; Reinforcement Is Not Exposed.

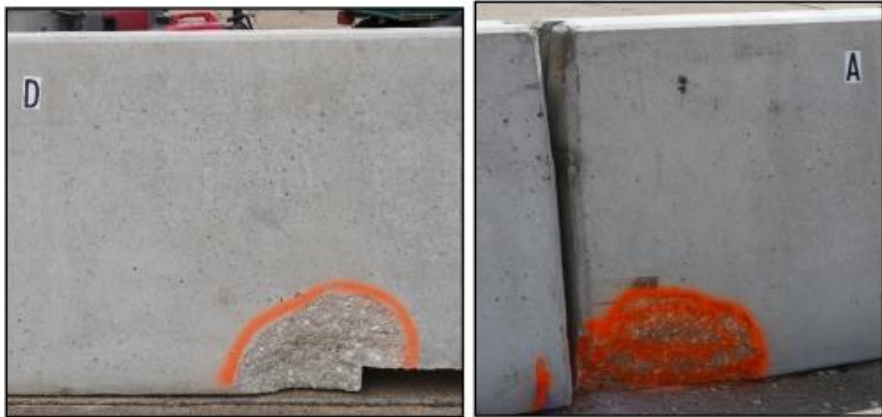
Figure 60. Unacceptable Barrier—Spall Projects towards Traffic by More than 30 Degrees.

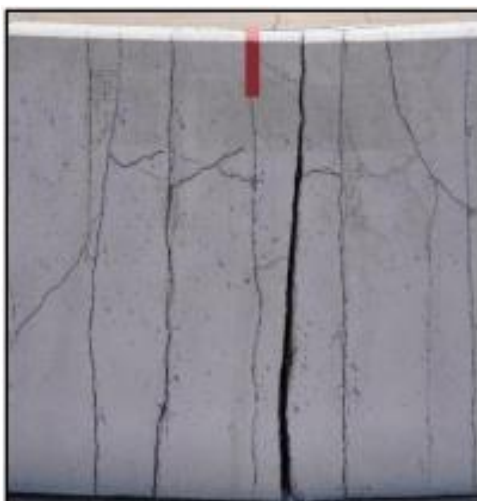
Figure 62. Unacceptable Barrier—Multiple Open Transverse Cracks.

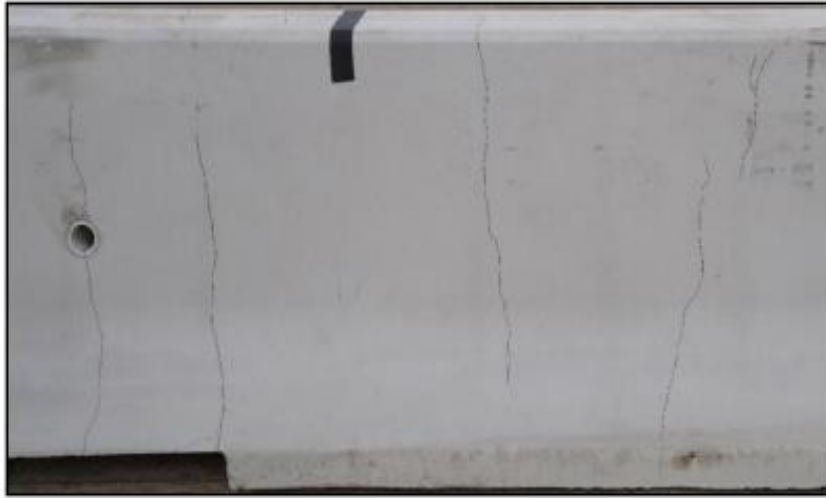
Figure 64. Compressed Transverse Cracks: A Decision May Not Be Made Immediately.

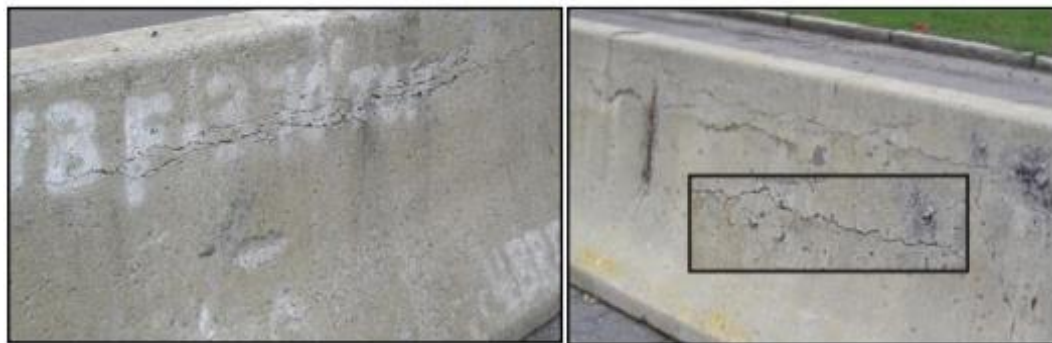
Figure 66. Unacceptable Barrier—(a) Clustered Longitudinal Cracks in the Upper Half of the Barrier Stem; (b) Open Longitudinal Crack More than 4 ft in Length (2). Reprinted from Temporary Barrier Guidelines-Longitudinal Cracks, NYSDOT.

A PCB is unacceptable if it has a longitudinal open crack (measurable width) in the upper half of the barrier stem (50 percent of the total height, starting from the top edge) with or without the evidence of rusting (Figure 66). However, a PCB with a compressed longitudinal crack in the lower portion of the stem that does not show any evidence of rusting maybe deemed acceptable (2) (Figure 67). To decide if a repair is necessary on a later date, this barrier may be observed for two years while keeping it in service to see if the longitudinal crack (temporarily closed with a surface sealant) propagates further.

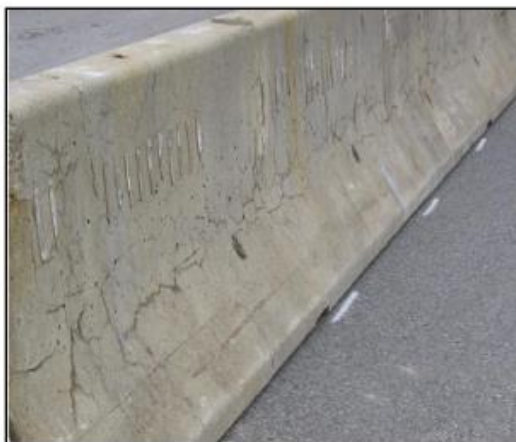
Figure 67. Acceptable Barrier—Compressed Longitudinal Crack in the Lower Half of the Barrier Stem (Bottom 50 Percent of the Total Height) (2). Reprinted from Temporary Barrier Guidelines-Longitudinal Cracks, NYSDOT.

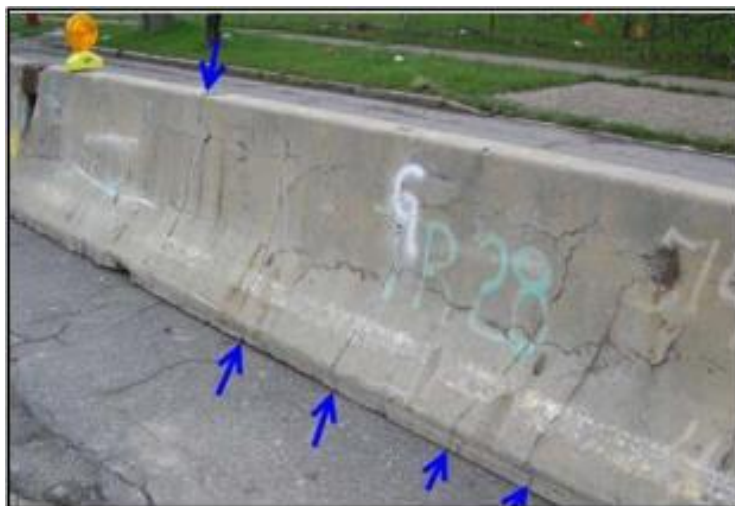
Figure 68. Unacceptable Barrier—Longitudinal Cracks Intersected by Transverse Cracks at Intermediate Locations (2). Reprinted from Temporary Barrier Guidelines-Longitudinal Cracks, NYSDOT.

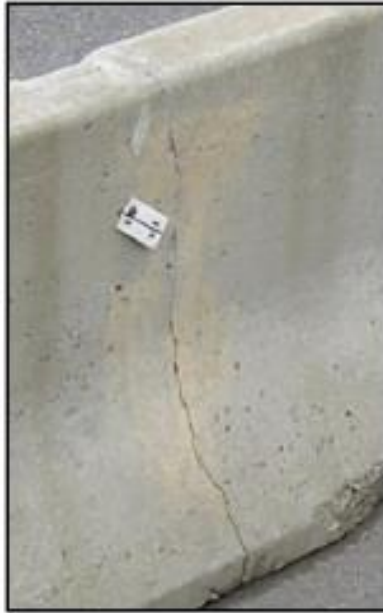
Figure 69. Barrier which is Acceptable with Repair—Single Transverse Crack with No Evidence of Corrosion (3). Reprinted from Temporary Barrier Guidelines-Cracked Sections, NYSDOT.

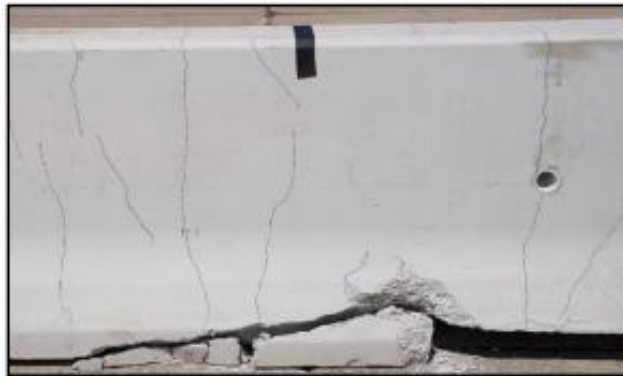
Figure 70. Unacceptable Barrier—Missing Section near the Edge of the Scupper.

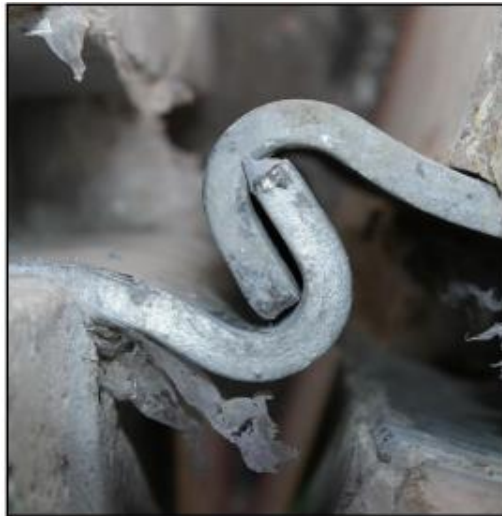
Figure 71. Unacceptable Barrier—Rotated JJ Hooks Coming from Different Ends; The Ability of This Connection to Redirect an Errant Vehicle Will Be Reduced.

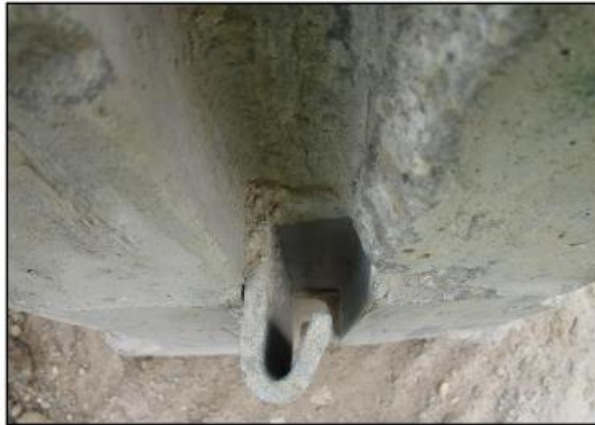
Figure 72. Unacceptable Barrier—Rotated JJ Hook at the End; a Connection Will Be Difficult to Form.

A PCB is unacceptable if it has a bent, rotated, deformed, or broken JJ hook at either or both ends (Figure 71 through Figure 73). Segments with hooks rotated by different angles (or one segment with a straight hook along with another segment with a bent hook) do not properly align to make a continuous and sound connection when brought together. Even if connectors are rotated by the same degrees and if the connection is further rotated during an accident, the ability of redirecting the errant vehicle should be reduced. Effect of bent/rotated/deformed JJ hooks on the crashworthiness of the barrier system has been further investigated through predictive FEA simulations in Chapter 7.

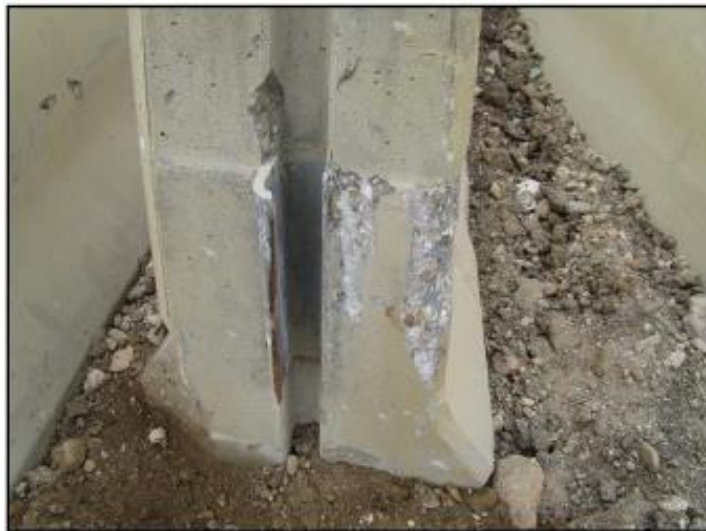
Figure 73. Unacceptable Barrier—JJ Hook Failure by Brittle Fracture.

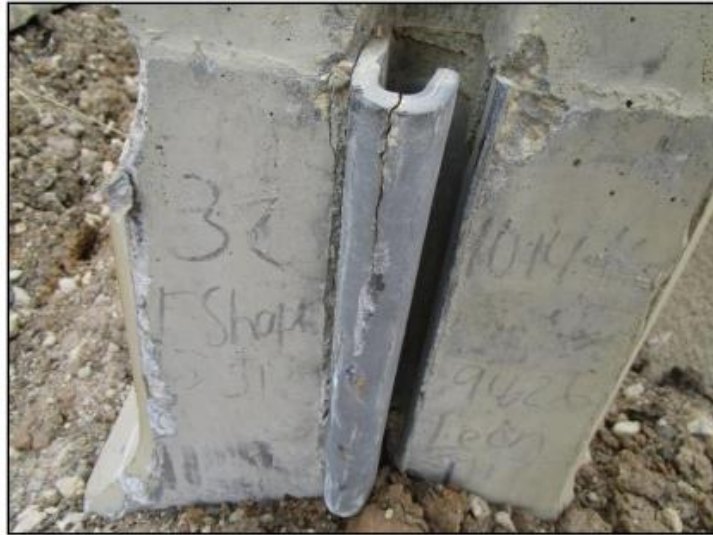
Figure 75. Unacceptable Barrier—Cracked JJ Hook.

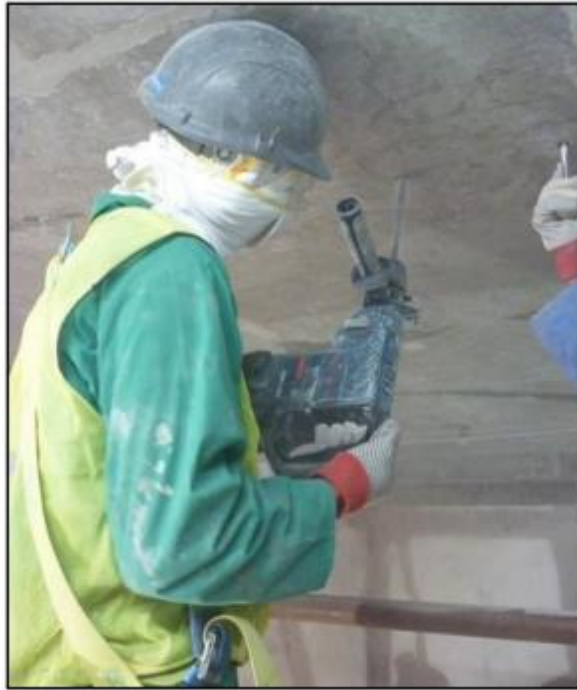
Figure 76. Drilling Holes in the Concrete Member (6). Reprinted from “Concrete Repairing by Epoxy Injection”, Design Consulting Services.

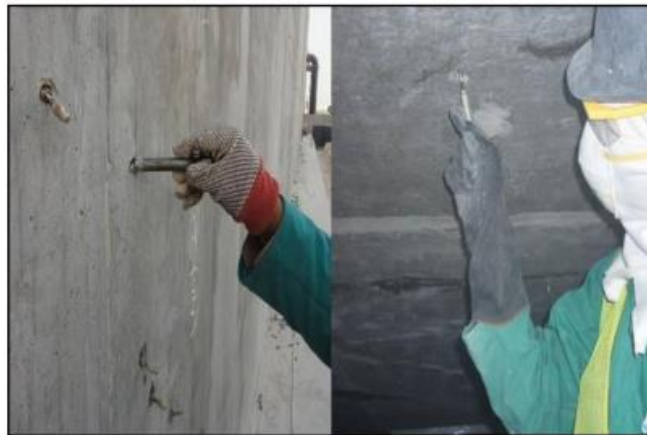
Figure 78. Installing Injection Ports (6). Reprinted from “Concrete Repairing by Epoxy Injection”, Design Consulting Services.

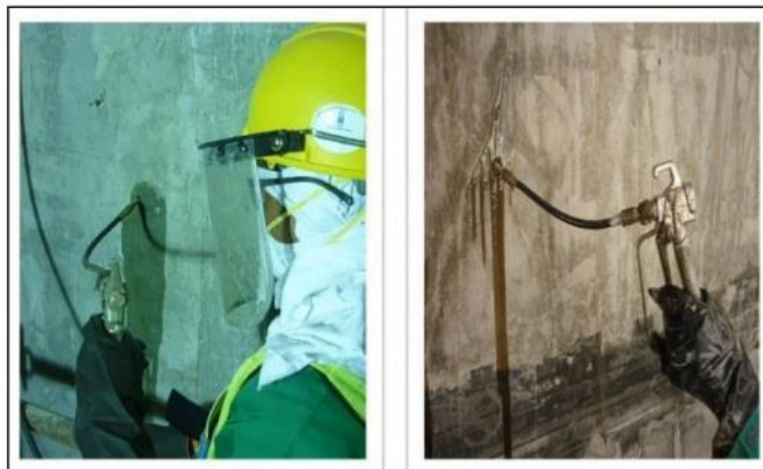
Figure 79. Injection of Epoxy Resin into the Holes (6). Reprinted from “Concrete Repairing by Epoxy Injection”, Design Consulting Services.

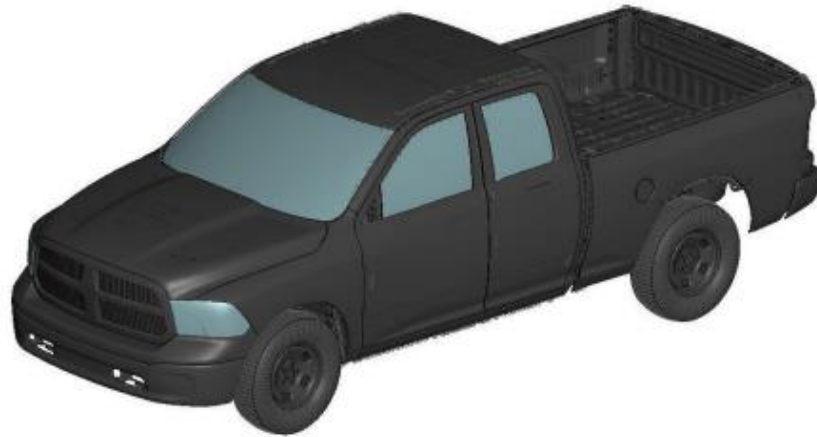
Figure 91. Isometric View of 2018 Dodge RAM Quad Cab, 4 door, 0.5-Ton.

The model of 2018 Dodge RAM Quad Cab was directly included in the combined assembly file at an angle of 25 degrees and CIP (Critical Impact Point) distance of 4.3 foot from the location which was targeted to be impacted. Initial linear velocity of 62.2 mph and angular velocity of 71 rad/s were provided to the pickup truck. Once the vehicle was rotated at an angle of 25 degrees in the combined assembly file, the initial velocity was resolved into two components, $V_x = 56.4$ mph and $V_y = 26.3$ mph. Radius of the wheel was measured as 15.4 in. thus giving an angular velocity of 71

rad/s. Figure 91 shows the isometric view of the vehicle model, Figure 92 shows the location of the vehicle with respect to the barrier assembly.

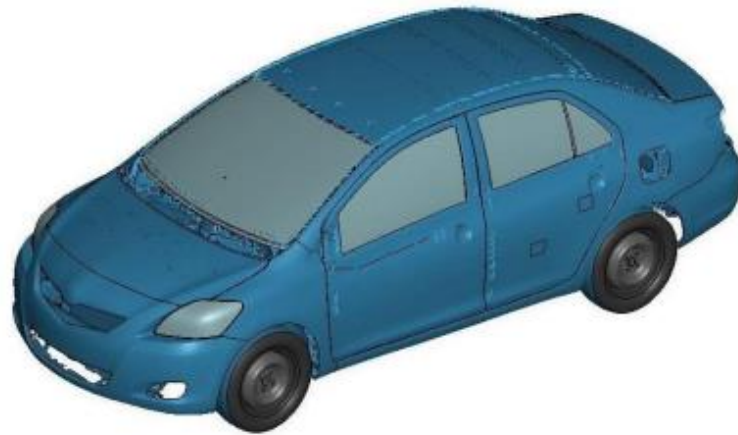
Figure 93. Isometric View of Toyota Yaris Passenger Car

Toyota Yaris model representing a 2420 lb. (1100 C) MASH small car test vehicle was directly included in the combined assembly file at an angle of 25 degrees and CIP (Critical Impact Point) distance of 3.6 foot from the location which was targeted to be impacted. Initial linear velocity of 62.2 mph and angular velocity of 71 rad/s were provided to the car. Once the vehicle was rotated at an angle of 25 degrees in the combined assembly file, the initial velocity was resolved into two components, $V_x = 56.4$ mph and $V_y = 26.3$ mph. Radius of the wheel was measured as 11.9 in. thus giving an angular velocity of 92 rad/s. Figure 93 shows the isometric view of the vehicle model, Figure 94 shows the location of the vehicle with respect to the barrier assembly.

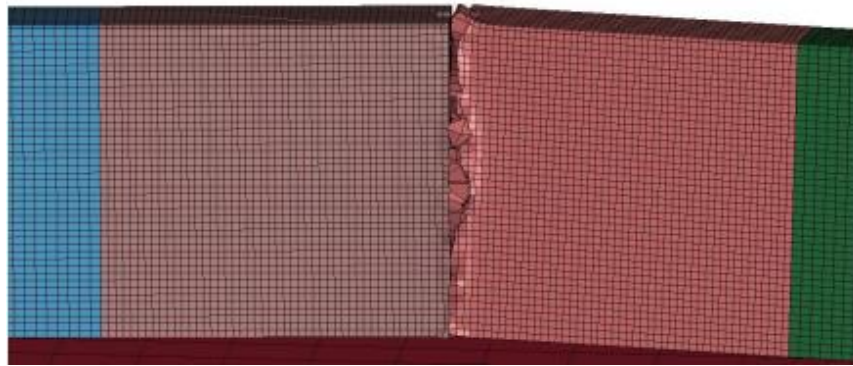
Figure 101. Single slope barrier simulation without hourglass card

Non-physical, zero-energy modes of deformation that produce zero strain and zero stress are known as hourglass modes. These modes occur in under-integrated solid, shell, and thick shell elements (2). They can be completely eliminated by adopting fully-integrated or selectively reduced integration element formulation. For example, type 2 solids can be used in place of the default option of type 1 constant stress solid element, but this selection can be very computationally expensive. Also type 2 solids are much more unstable in large deformation applications such as vehicle impact, thus type 1 solid

was used to formulate the concrete elements in the barrier. LS-DYNA has many algorithms to inhibit hourglass modes, hourglass control type (IHQ) 5 was used for the type 1 solid elements in the single slope barrier model developed for this research study. Hourglass coefficient of 0.08 was used for IHQ=5. Using a too high value for the hourglass coefficient may overly stiffen the response, while using a too low value for the coefficient may result in visible hourglass modes of deformation. Figures 101 and 102 illustrate the difference between the barrier without hourglass and with hourglass card used, respectively.

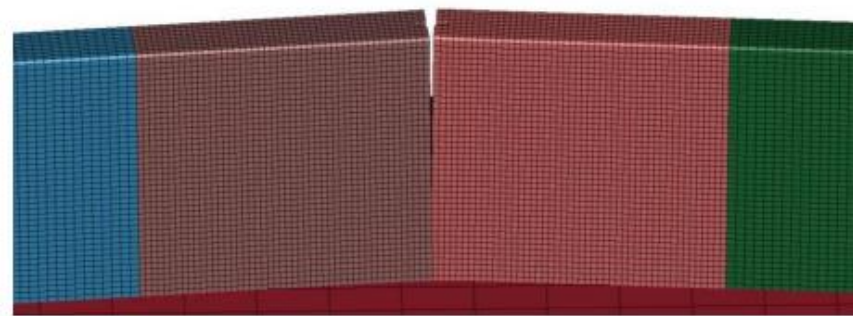
Figure 102. Single slope barrier simulation with hourglass card

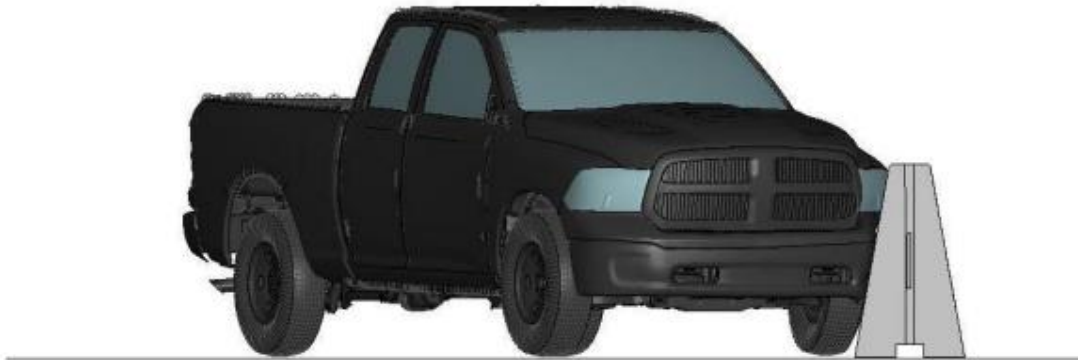
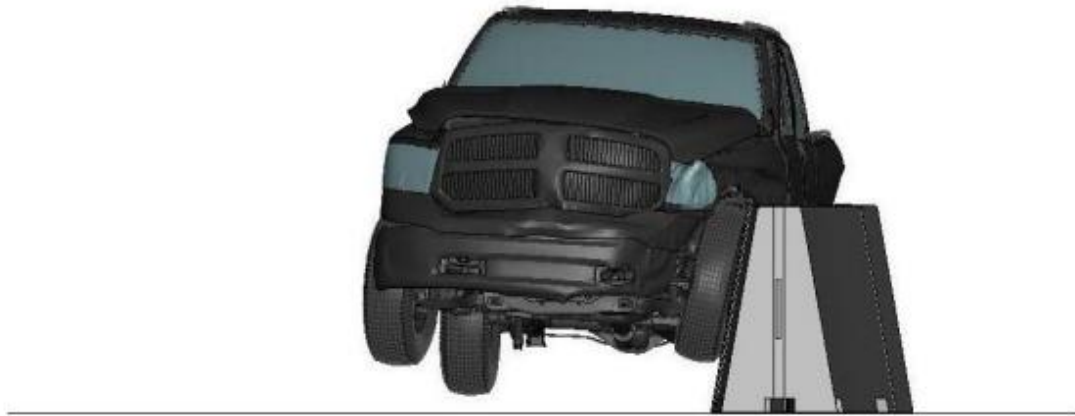
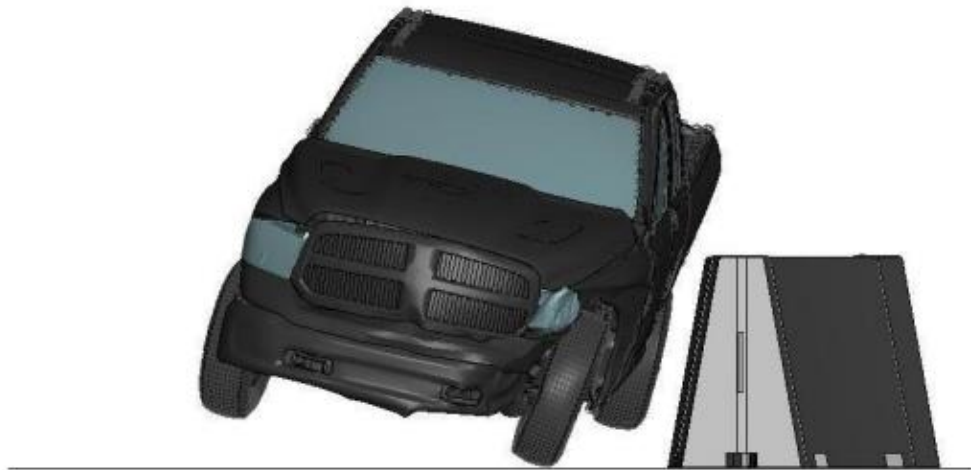
t = 0.10 s, event = front right tire contacts the barrier

$t = 0.31$ s, event = rear right tire contacts the barrier

$t = 0.54$ s, event = front right tire touches ground

Figure 107. Post impact trajectory of the RAM pickup truck

Figure 107 illustrates the behavior of RAM pickup truck at various time instants

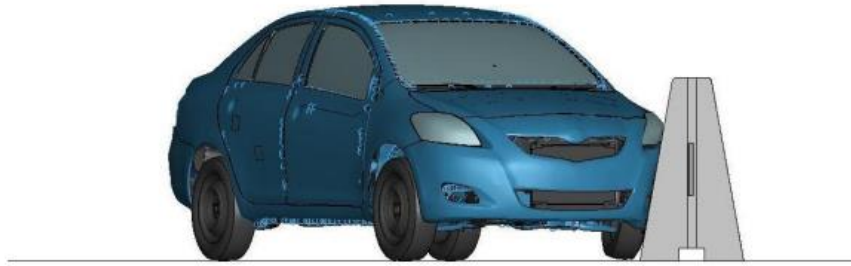
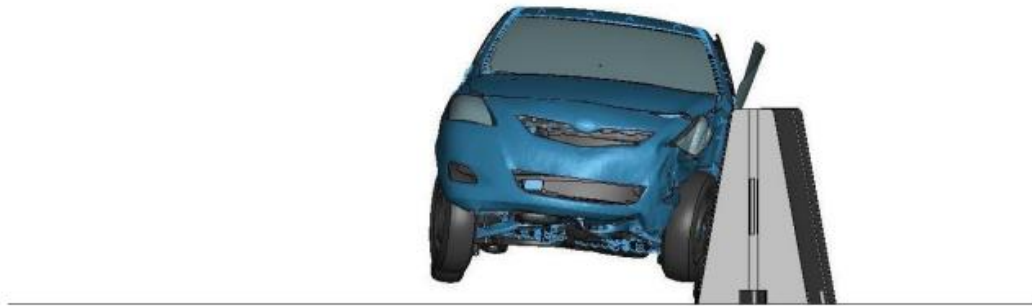
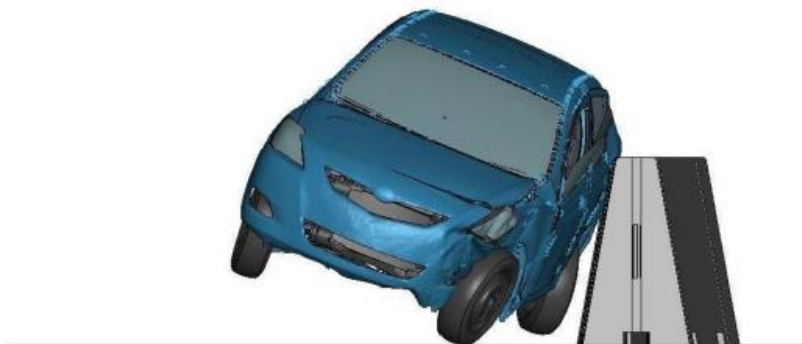
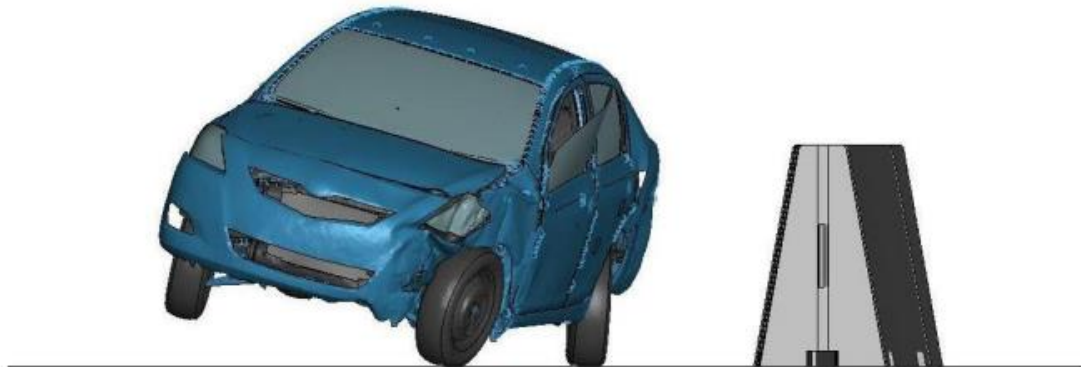
$t = 0.10$ s, event = front right tire contacts the barrier

$t = 0.23$ s, event = rear right tire contacts the barrier, windowpane snags against the barrier

$t = 0.45$ s, event = front right tire touches ground

t = 0.91 s, event = rear right tire stabilizes on ground

Figure 110. Post impact trajectory of the Toyota Yaris passenger car.

Figure 110 illustrates the post impact trajectory of the car.
