TURBOMACHINERY & PUMP SYMPOSIA

Accidental Excitation of Acoustic Resonances from Balance Holes on Rotating Disk: Noise Troubleshooting and Mitigation

*Southwest Research Institute
San Antonio, TX*

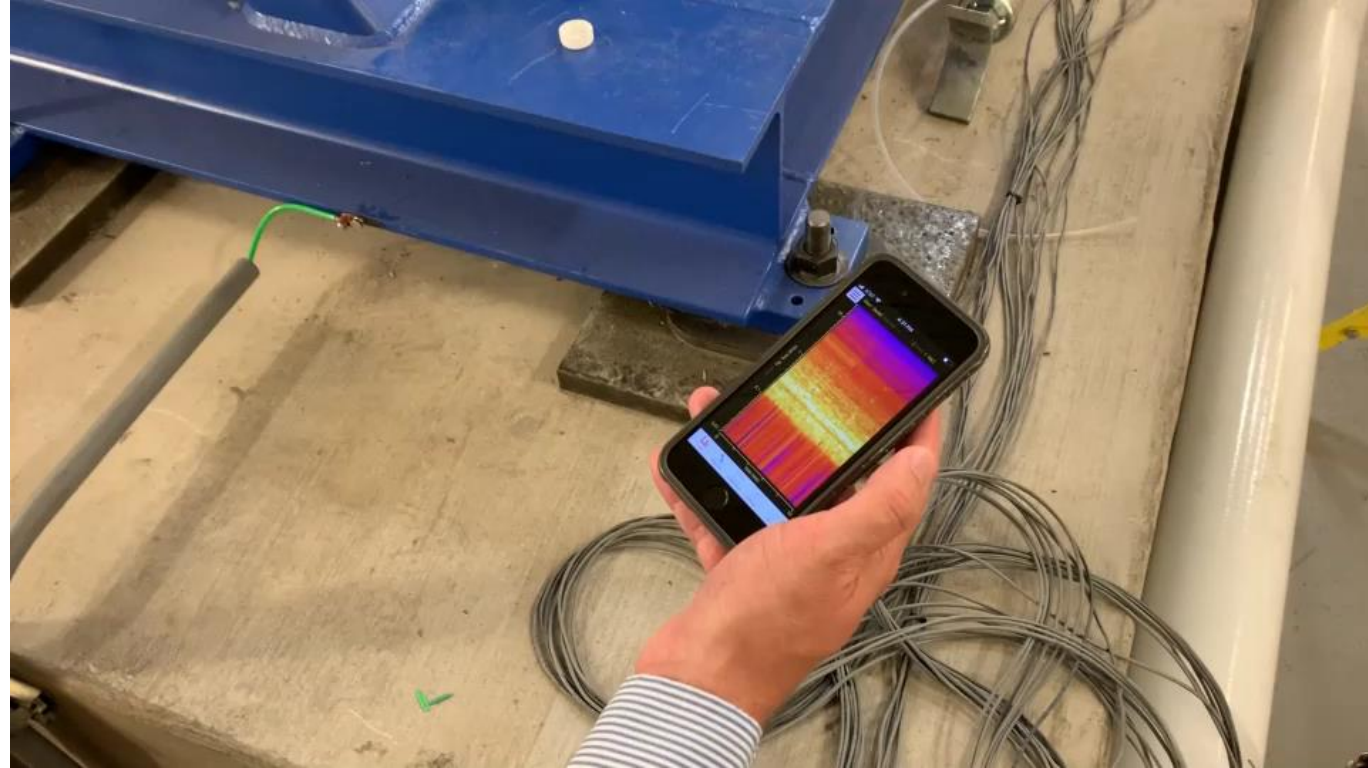
During commissioning of test rig - observed loud “squealing” noise at speeds above 3,000 rpm

- Greater than 105 dB
- High-pitch, range ~3 kHz

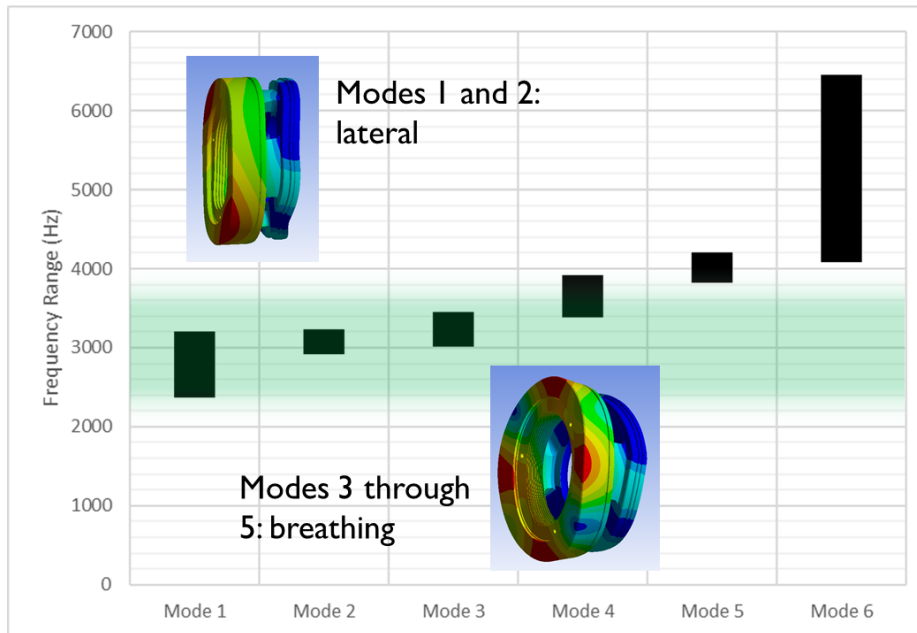
Ranges of predicted natural frequencies

Laby seals

Lip seals

Modal
analysis
showed that
seal holder
has
frequencies in
range of
audible noise

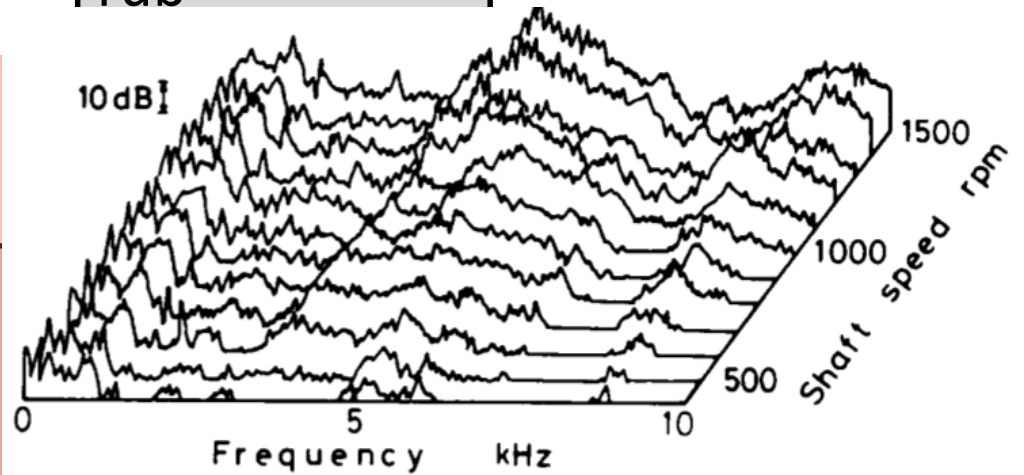
Noise Amplitude for “Squealing bearing” where spin speed excited natural frequency of a single roller. [1]

Race noise
(Matching characteristics: frequency doesn't change with speed, louder with speed)

Squealing
(Matching characteristics: metallic sound, usually with grease vs. oil lube)

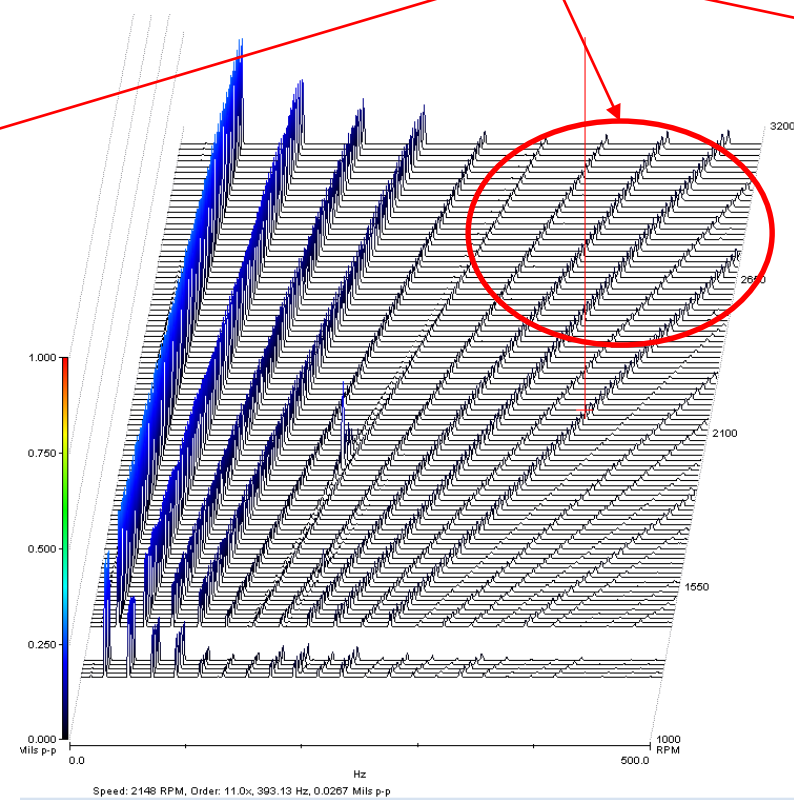
No vibration occurs in frequency range where sound is occurring

Vertical Displacement

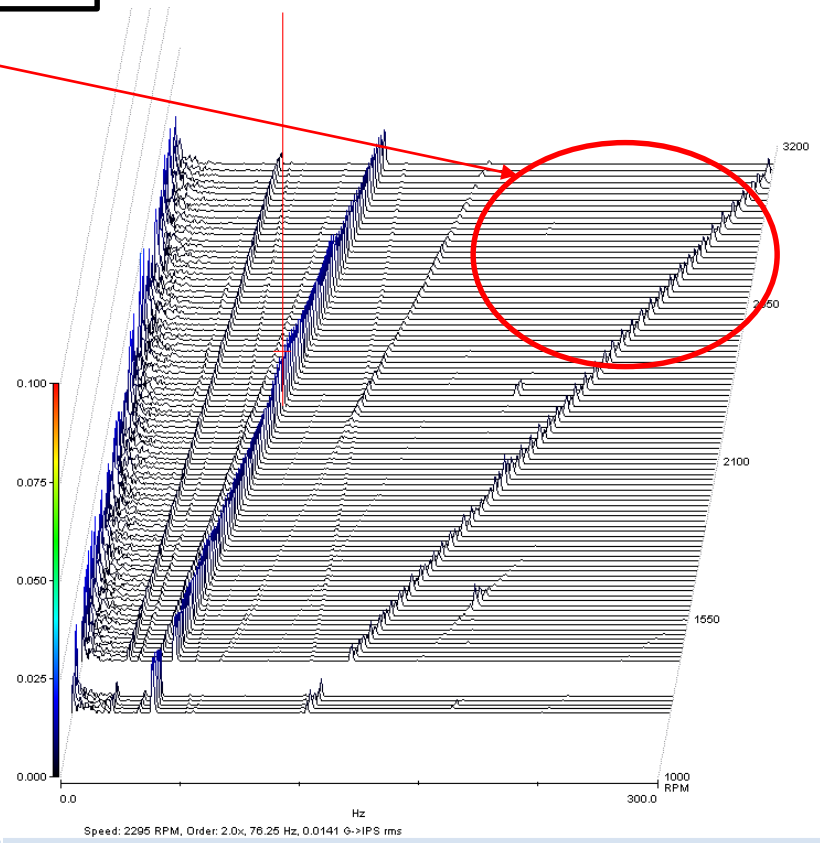
Housing Acceleration

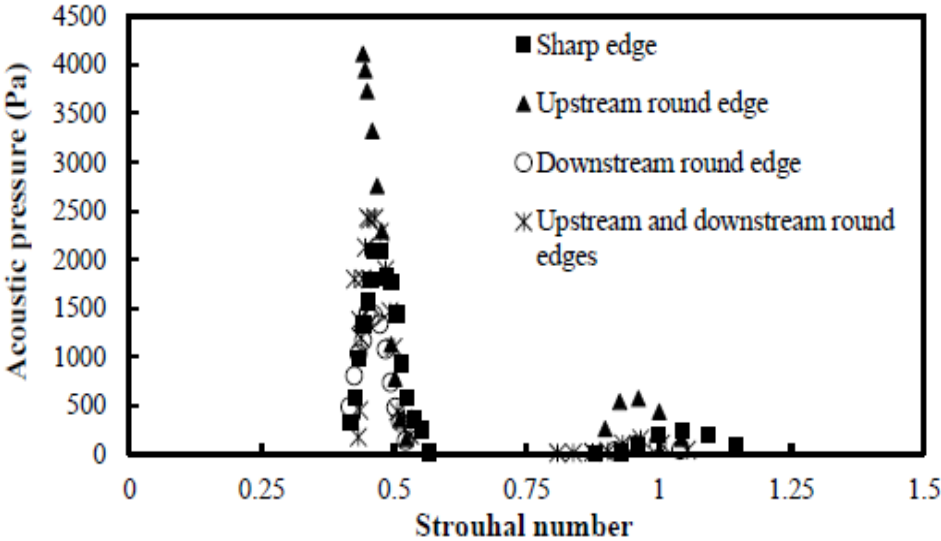
Strouhal Numbers Associated with Excitation of a Shallow Cavity as a Function of Different Edge Geometries [5]

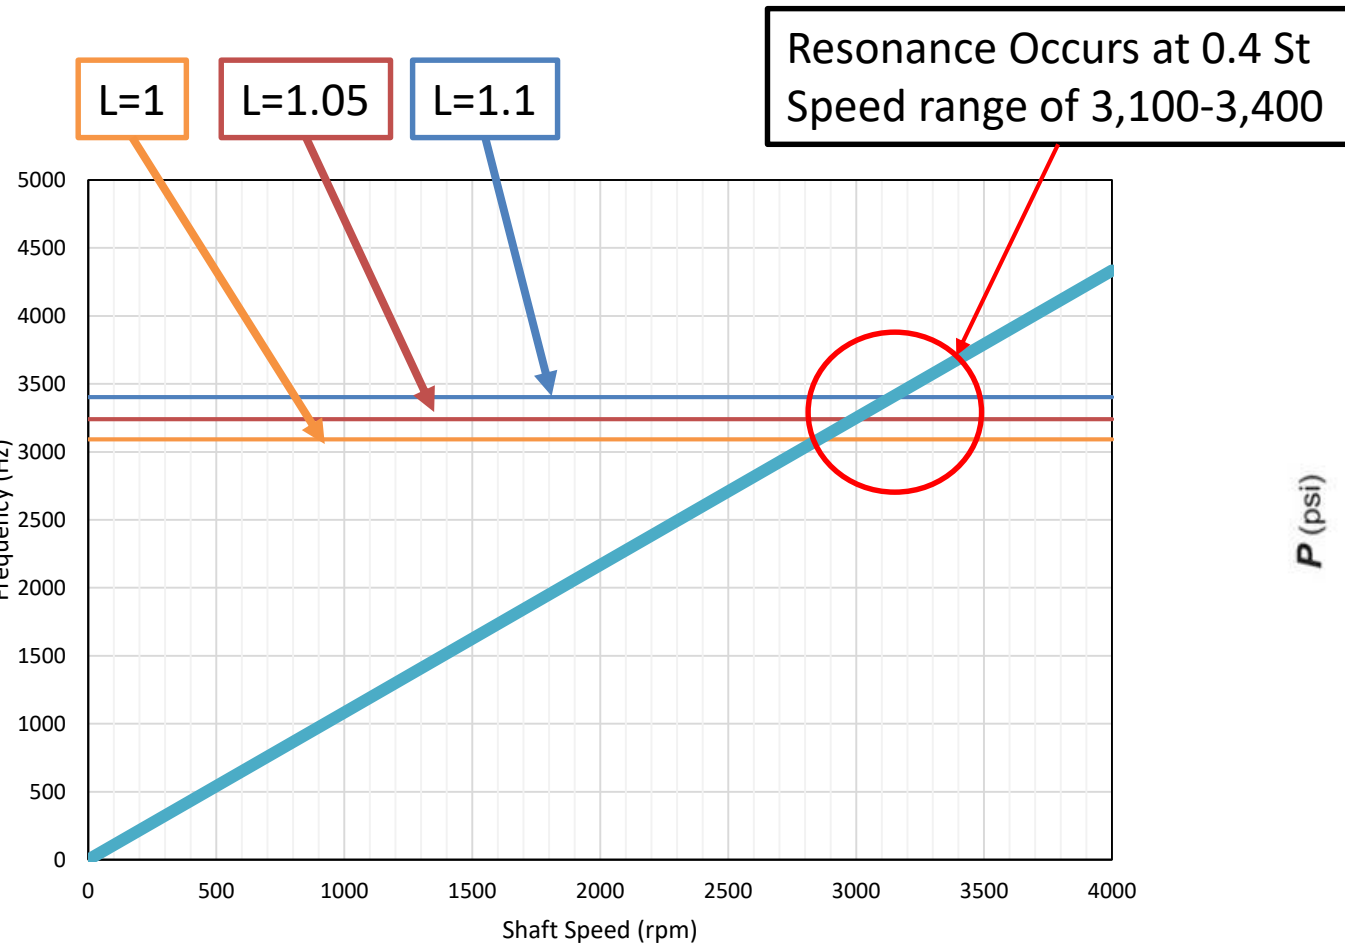
Resonance Occurs when Excitation Locks onto Acoustic Natural Frequency

Example of Pressure Peak Associated with Vortex-Shedding Resonance when Operating Over a Range of Flow Velocities [5]
