49TH TURBOMACHINERY & 36TH PUMP SYMPOSIA

Vibration and NPSHr (NPSH₃), improvement of BB1 two stage pump reliability.

This case study discusses the impeller redesign of 10 **8x15 BB1 two stages** Amine pump in a Gas Sweetening Plant in Malaysia. The original pump was supplied in 1996 and after some design changes it had an history of recurring high vibration and impeller damages such as a cavitation erosion on inlet suction side and disk break at impeller outlet.

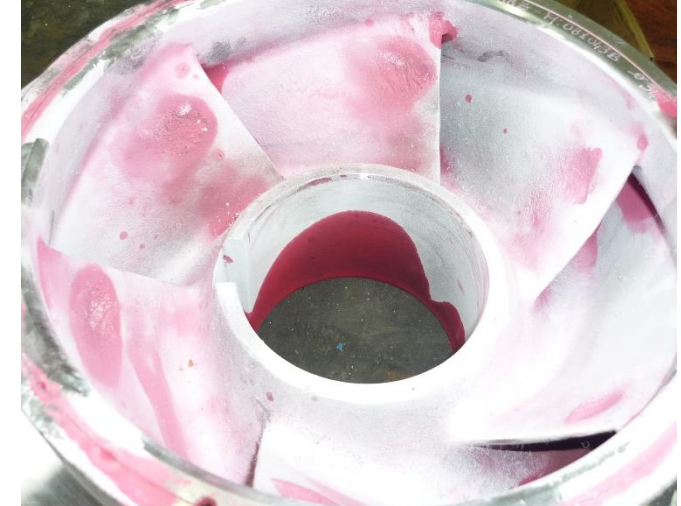
Figure 1 - Impeller Erosion at Suction Indication of Suction Recirculation

- High Vibration & Noise
- Cavitation Erosion on First Stage Impeller
- Impeller Material Detachment

- Pump service point range between 0.7-0.8 Q_{BEP} close to Minimum Continuous Stable Flow (MCSF)
- Erosion patterns on inlet blade can be related to recirculation flows due to partial load service
- Recirculation flows induce high vibration at Vane Passing Frequency (VPF) highlighted in spectrum analysis
- A new tailored impeller seized to service point leads to efficiency improvement and a drastic reduction of secondary flows

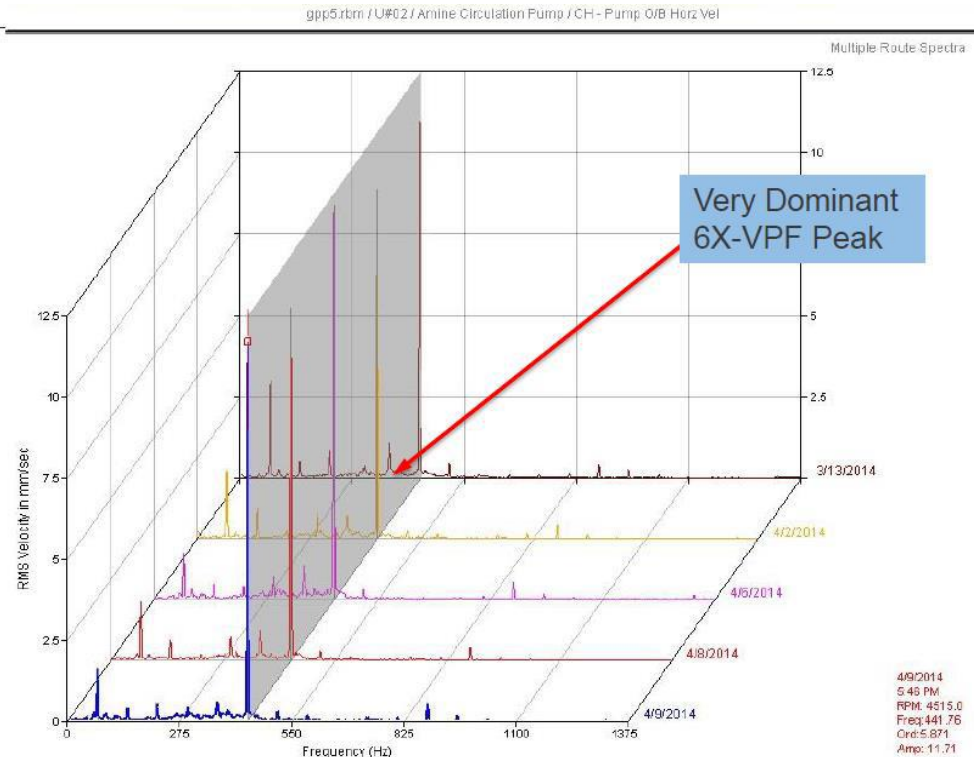
Figure 3 – Waterfall Pump NDE Shaft

- More than 50% of the pump trip and shutdown between 2011-2014 are associated to vibration issue with 6 stop
- 1X - 6X dominant frequency

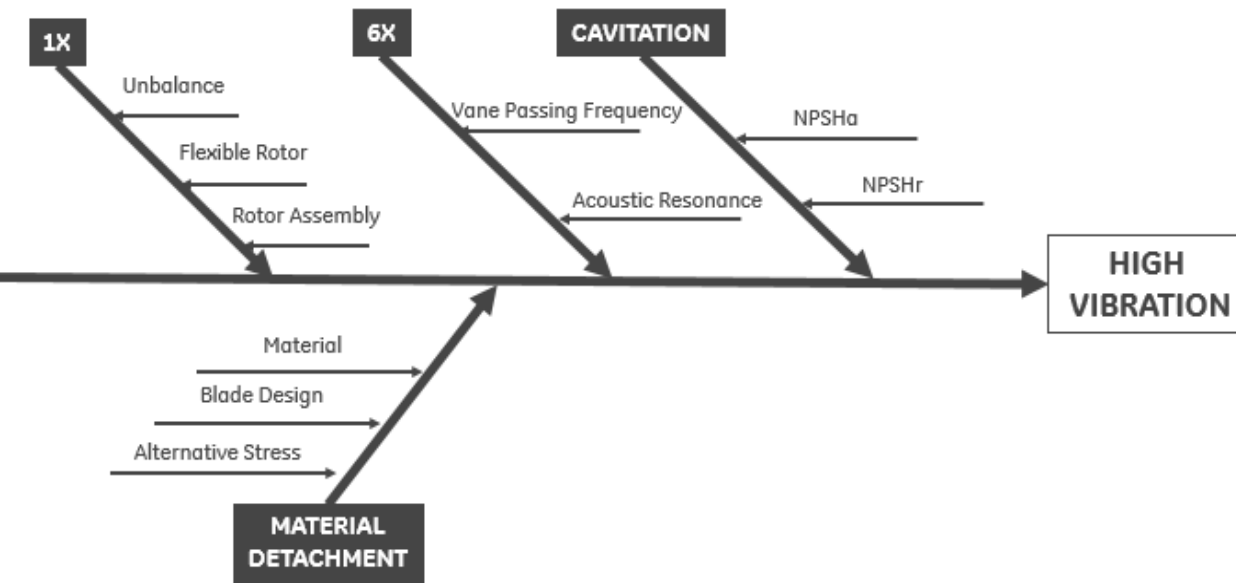
Fishbone Analysis – Potential Causes and Actions

CAUSES		Synchronous Vibration	Vane Passing Freq.	NPSHr	NPSHa	Material Detachment	Rotor Assembly
ACTIONS	VIBRATION ANALYSIS	X	X				
	RUN OUT REPORT	X					
	MODAL ANALYSIS	X	X			X	
	BLADE DESIGN		X	X		X	
	B-GAP DESIGN		X				
	ACOUSTIC RESONANCE	X	X				
	CFX ANALYSIS			X		X	
	PLANT DATA				X		
	STRESS ANALYSIS					X	
	ASSEMBLY REPORT						X

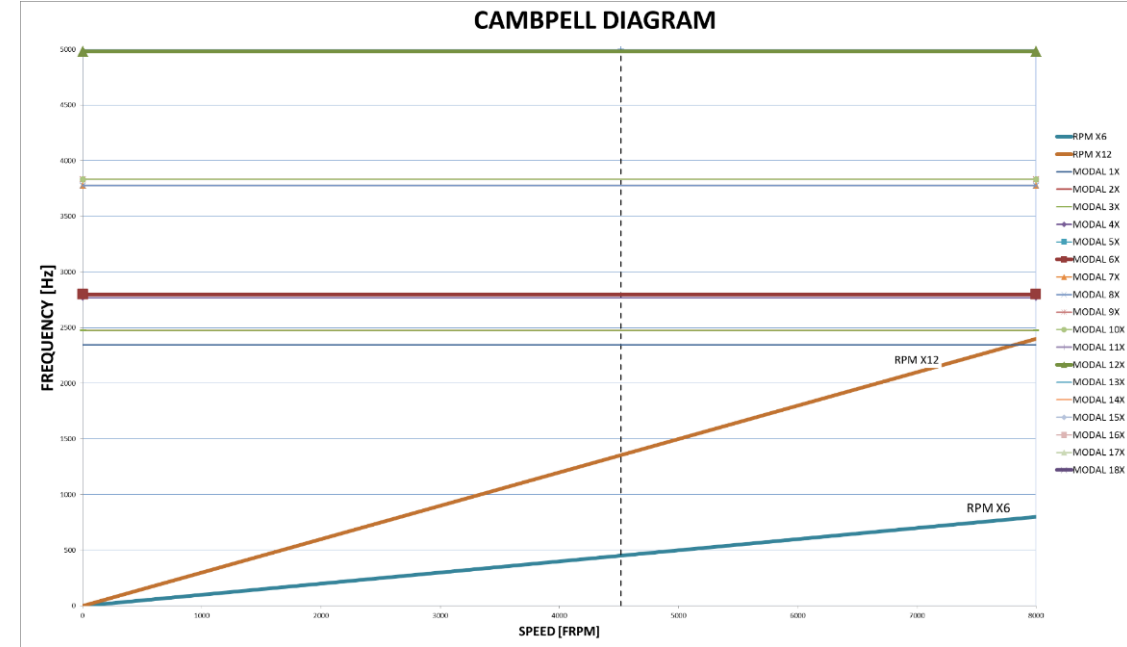
Curves intersect at high speed.

Campbell diagram shows : rotating speed line, harmonic frequencies depending on number of vanes (6X and 12X) and impeller natural frequencies. Intersection point indicates a possible resonance phenomena but a speed far from operating speed.

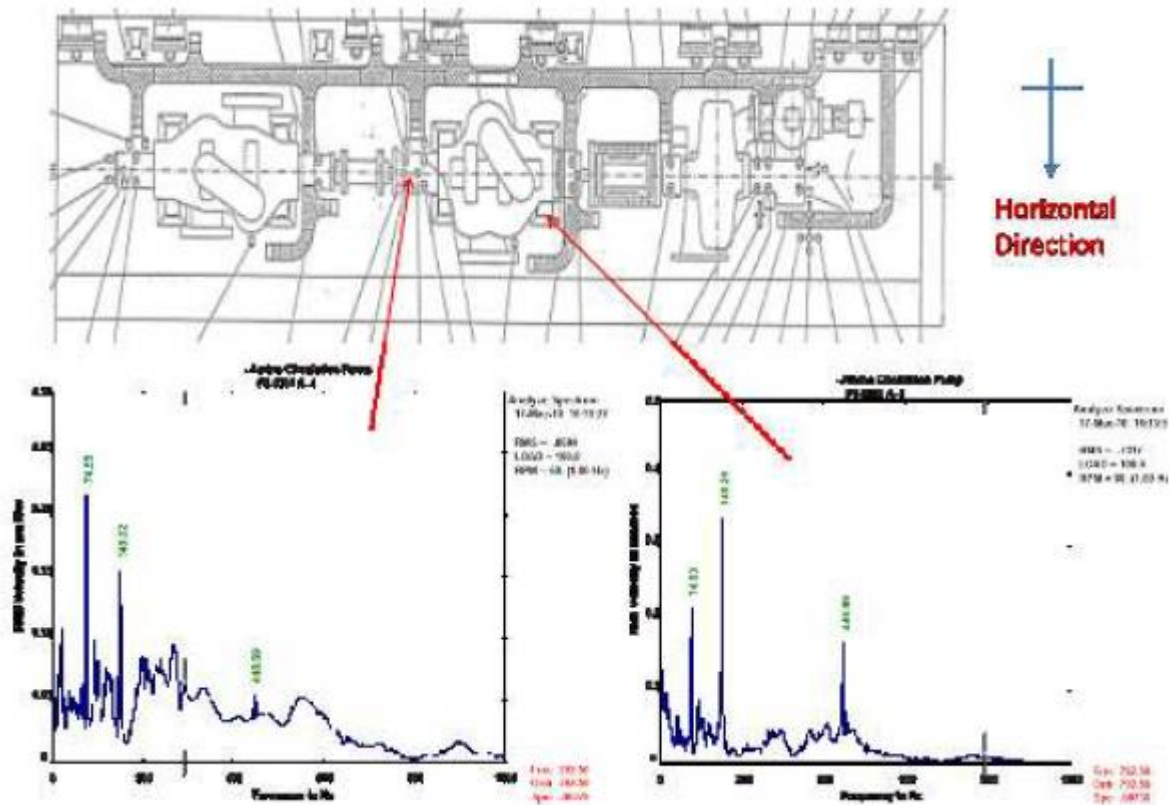
Figure 10 – Bump Test on Site

- The bump test indicates a natural frequency of about 446 [Hz].
- VPF (Vane Passing Frequency) is close to 451.5 [Hz]. Vibration on site are excited also by the natural frequency of the bearing support.
- Using a #7 blade impeller design the VPF arises to 527 [Hz]. Lower excitation of bearing support at VPF

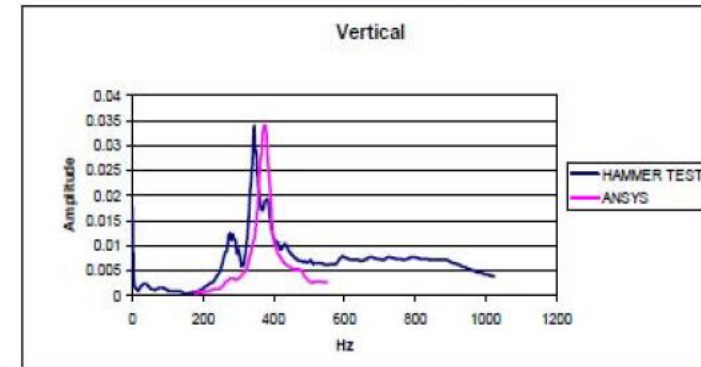
Figure 11 – Ansys and Hammer Test on DE Support

Due to the absence of 3D model a dummy bearing support + bearing housing has been simulated

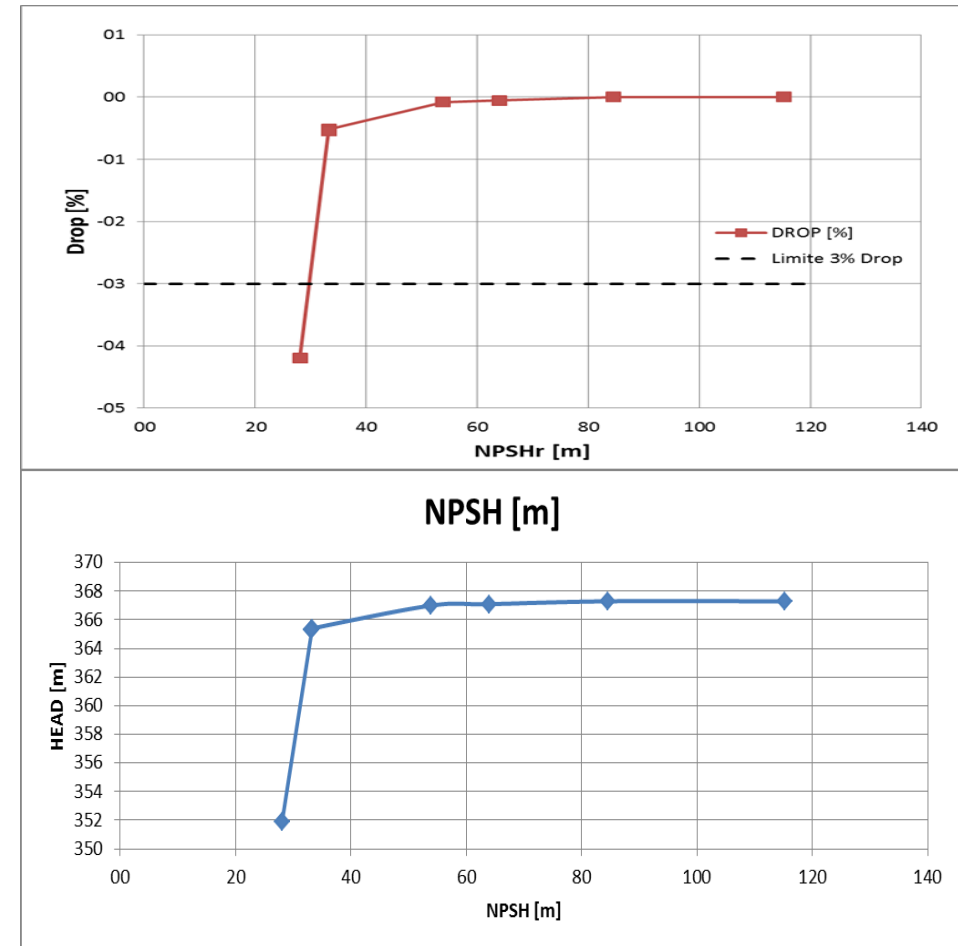
Figure 13 – Drop Cruves

NPSH a = 52 m (as per TDS)

NPSH r \cong 36 m

NPSH margin of about 40%
