TURBOMACHINERY & PUMP SYMPOSIA | HOUSTON, TX
SEPTEMBER 15-17, 2020
SHORT COURSES: SEPTEMBER 14, 2020

WHY MACHINES FAIL TO FOLLOW TEXTBOOK STATED RULES, AS ILLUSTRATED BY SHAFT CRACK AND ROTOR SELF EXCITED VIBRATION CASES IN CRITICAL MACHINERY

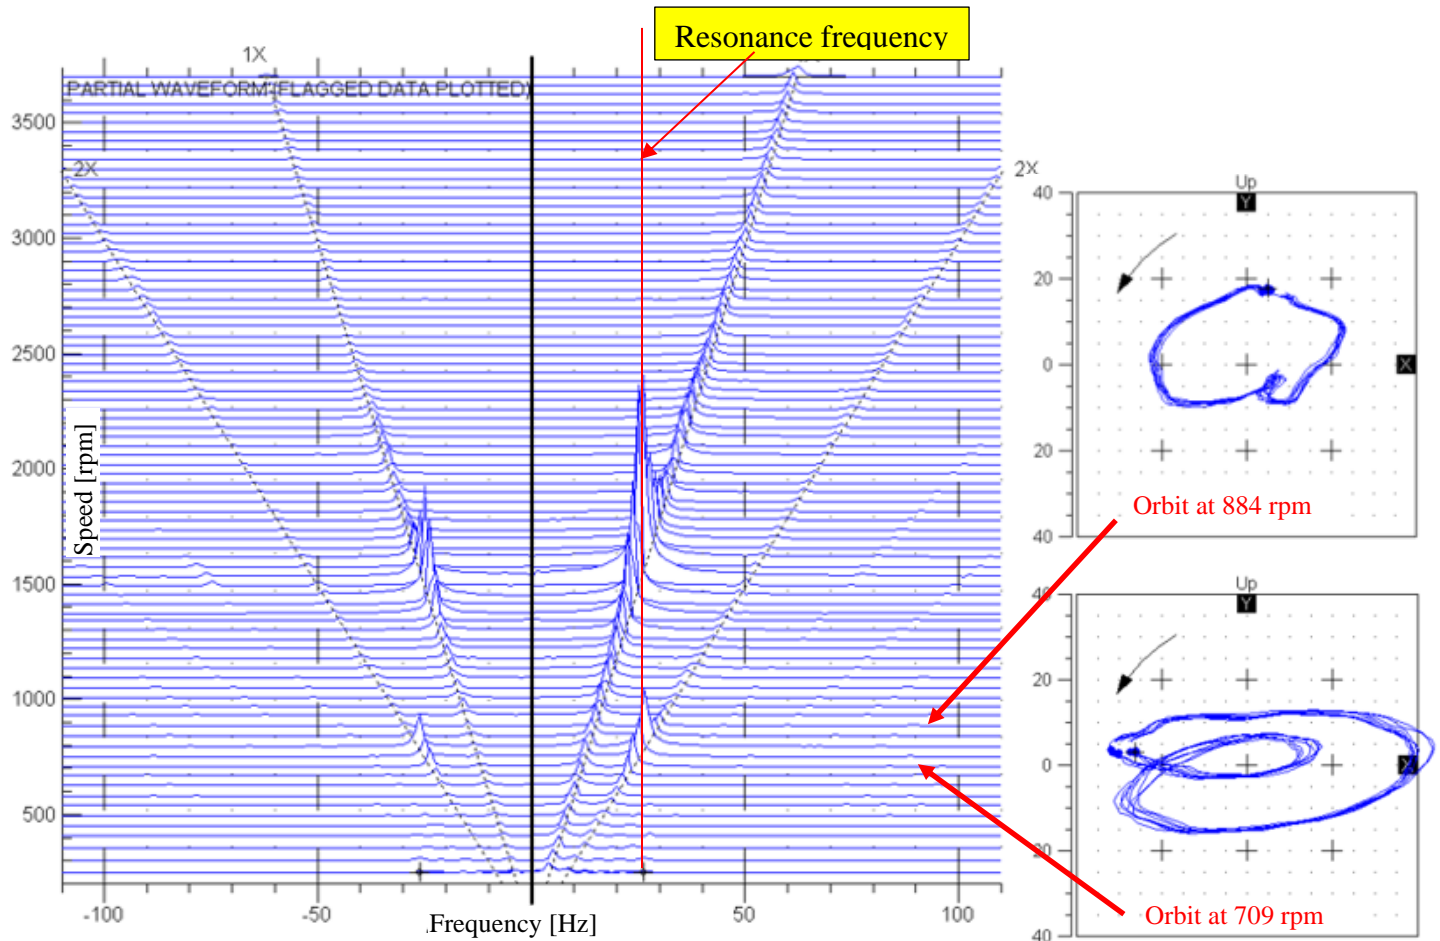
Fig. 3. Cascade plot of shaft relative vibration response for rotor kit with anisotropy of rotor stiffness. Vertical relation i.e. the same frequency of 1X and 2X excited resonances. The 2X is forward in precession.

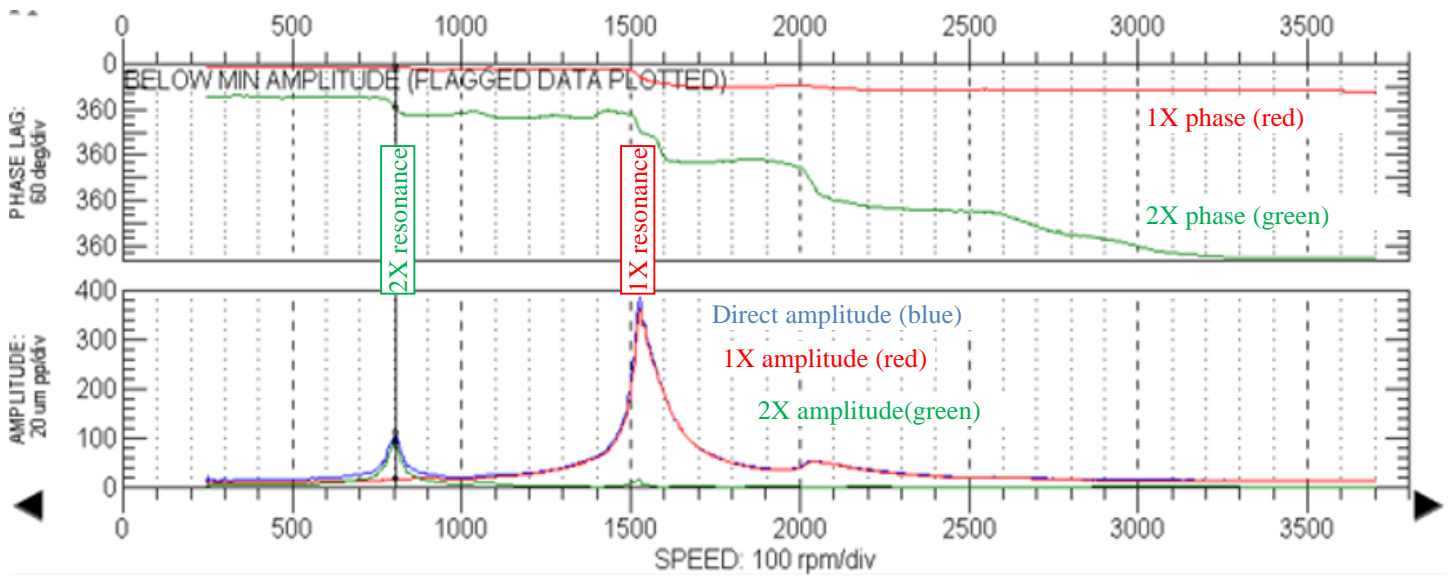
Fig.4. Bode plot for the vibration response with the 2X resonance at half of 1X resonance speed.

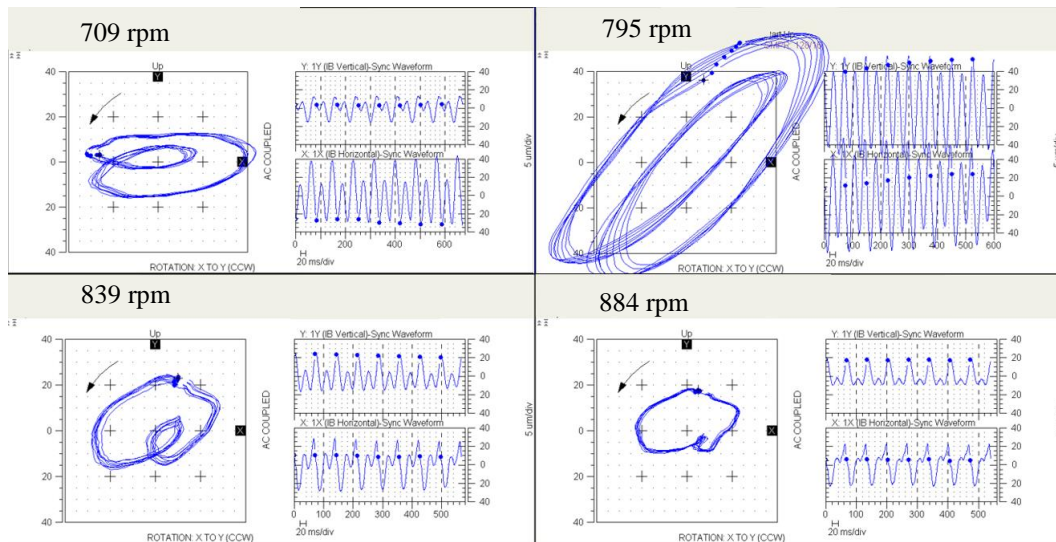
Fig.5. Sample orbits in 2X resonance region: internal loop changes position in forward direction as the rotor speed increases.

Direct orbits (Fig.5) for the 2X resonance area, with characteristic internal loop changes the position, forward precession 2X component adds to normally present 1X forward orbit, due to unbalance.

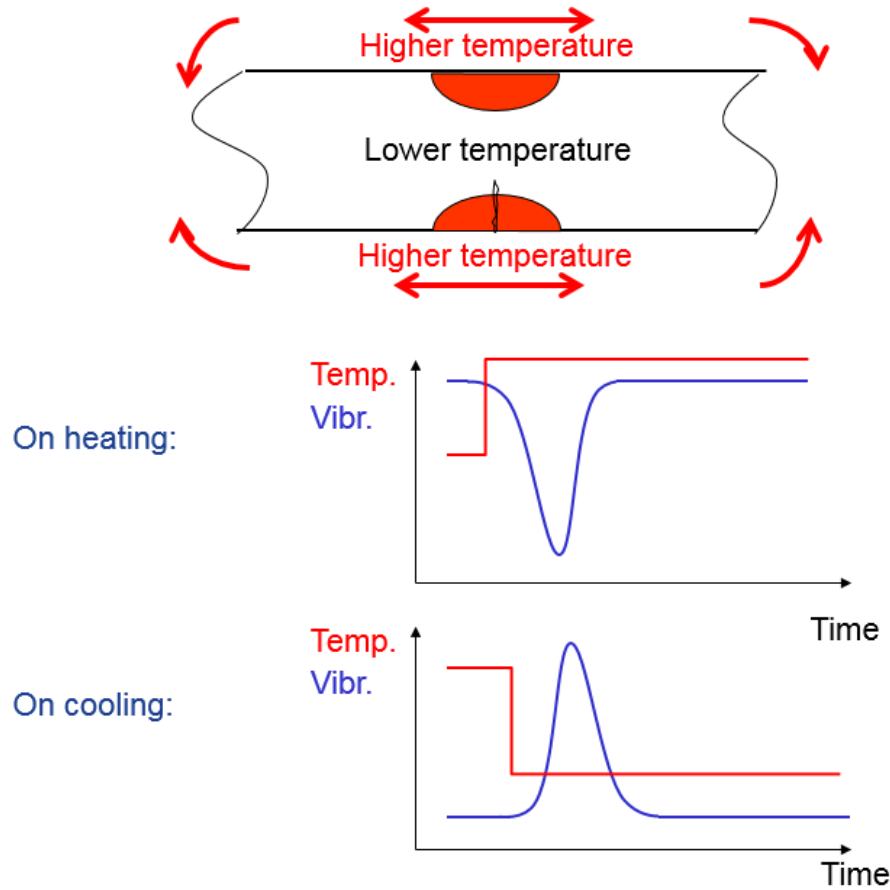
Fig.7. Cracked rotor can demonstrate transient thermal sensitivity due to fast change in surrounding media temperature.

One other rule that can be stated is Rule #3, thermal sensitivity of a cracked rotor. Additionally, to the long term 1X vector changes as described in rule #1, the cracked rotors may show transient change of 1X vibration i.e. change in the dynamic bow when the temperature of the surrounding medium is changed fast enough. Consider the crack development from rotor surface, no matter if it is transverse from one side, symmetric or for example circumferential one (Fig. 7). When the temperature of the medium around the rotor is increased then, with some inertia, the rotor temperature starts to rise. But the temperature will change faster at the surface than at the core of the rotor. In consequence the thermal expansion of the metal closer to surface is higher than at the core, so for some time the crack will “close” and the stiffness of the rotor will be partially restored. When the temperature equalizes along the rotor section diameter, the crack “opens” again. Reverse process (temporary opening of the crack and reduction of the stiffness for time of thermal transient) can be expected when rotor cools down. See for instance the case of the cracked generator rotor in [2] describing the reaction of rotor vibration on the change of the coolant (hydrogen) temperature.

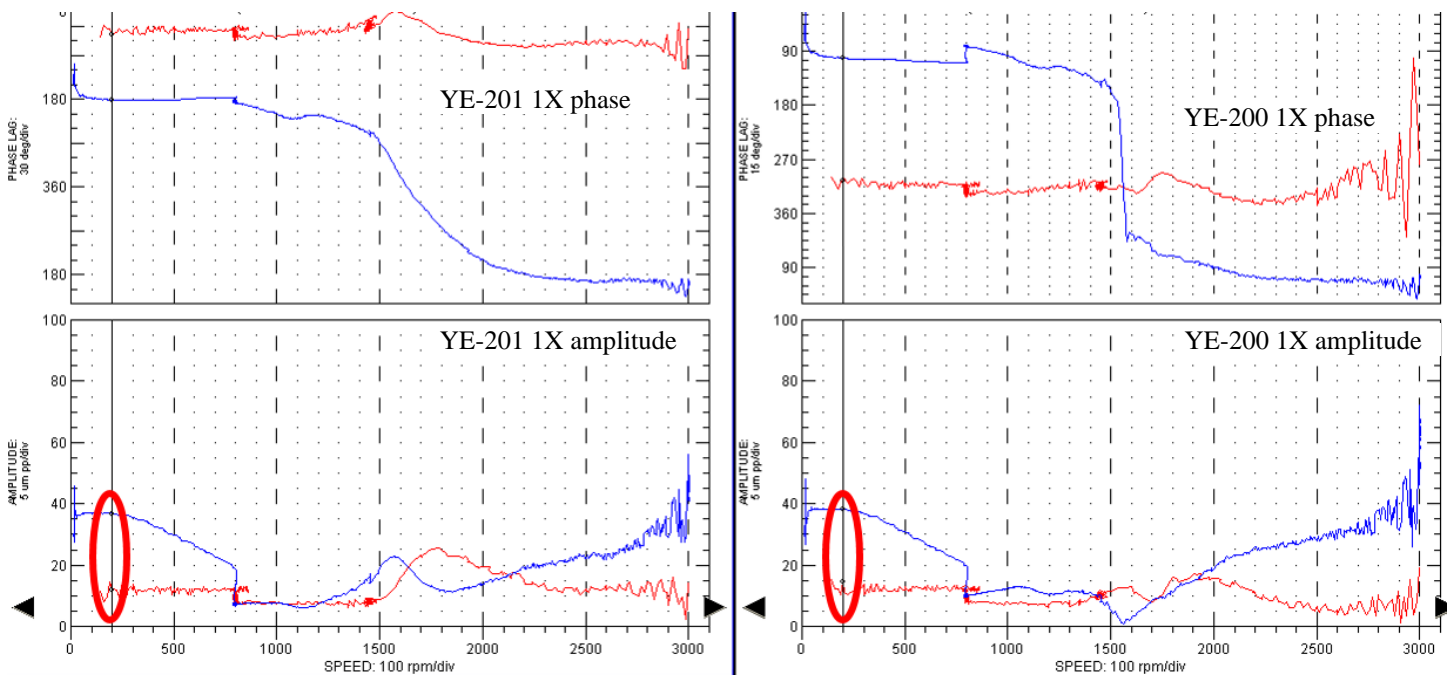
Fig.9. Uncompensated 1X Bode Plots, (Red-June 20, 2008; Blue-July 29, 2009)

Fig. 9 contains the uncompensated 1X Bode plots of shaft relative vibration for the steam turbine bearings. The Bode plots show a difference in the slow-roll vectors, mainly on DE bearing 1 (YE-201). The slow roll vectors from a startup in 2009 are significantly (3 times) higher than from a startup in 2008. Increased 1X slow roll vectors indicate increased rotor bow due to a crack propagation, with the assumption that the rotor runout had not changed.

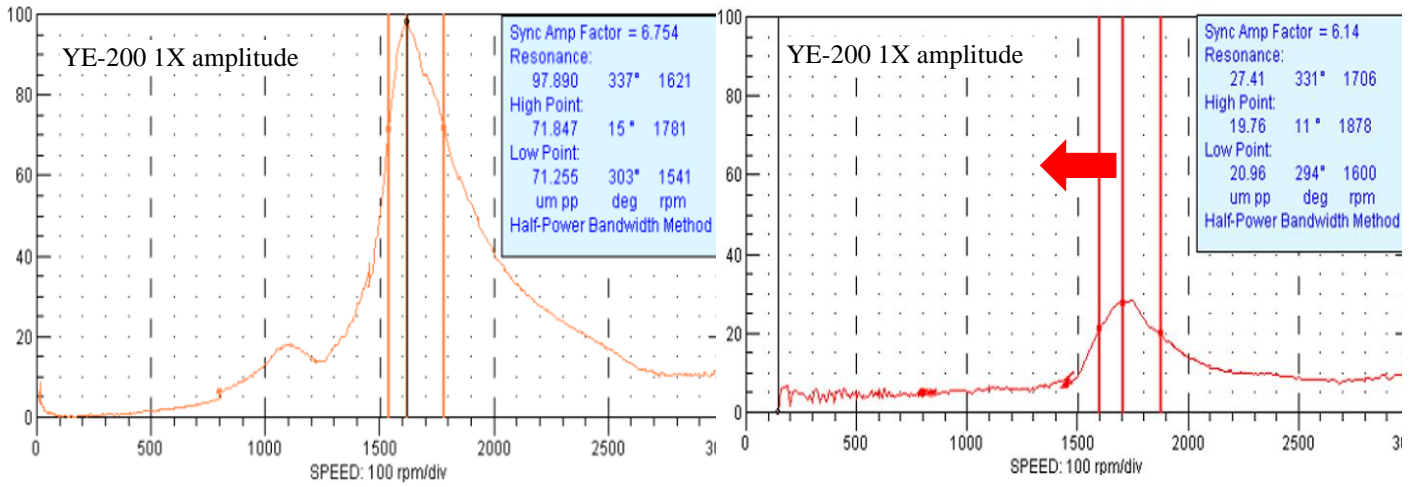
The 1X compensated Bode plots (Fig. 10) show the rotor 1st balance resonance frequency shifted to a lower speed (red arrow) during the startup in 2009 (left) when compared to the startup in 2008(right). For the compared startups, the first resonance frequency changed from approximately 1750–1800 rpm to 1550–1620 rpm. A lower resonance speed implies a decrease in the rotor modal stiffness with the normally acceptable assumption that the rotor mass remained unchanged. A decrease in modal stiffness is one of the expected (and primary) symptoms of a rotor crack.

The Synchronous Amplification Factor (SAF) calculations derived from the Half-Power Bandwidth method are shown in the blue square insets in Fig. 10. From the shape of resonances, we can see increase in the SAF. The half-power bandwidth method in this case gives similar results for both runs, because the resonance curve is far from the ideal characteristic (due to split resonance). It should be also noticed that the compensation of year 2008 data (right plot) is not correct. Using the peak ratio method, we can estimate a four times increase in amplification of the response at the resonance. A similar change was visible on bearing1 too, not presented here. A decrease in effective damping, as shown in that case, is an indicative symptom of a rotor crack. The red arrow highlights the shift of the critical speed to the left, to a lower speed, due to propagating rotor crack and lowered modal stiffness.

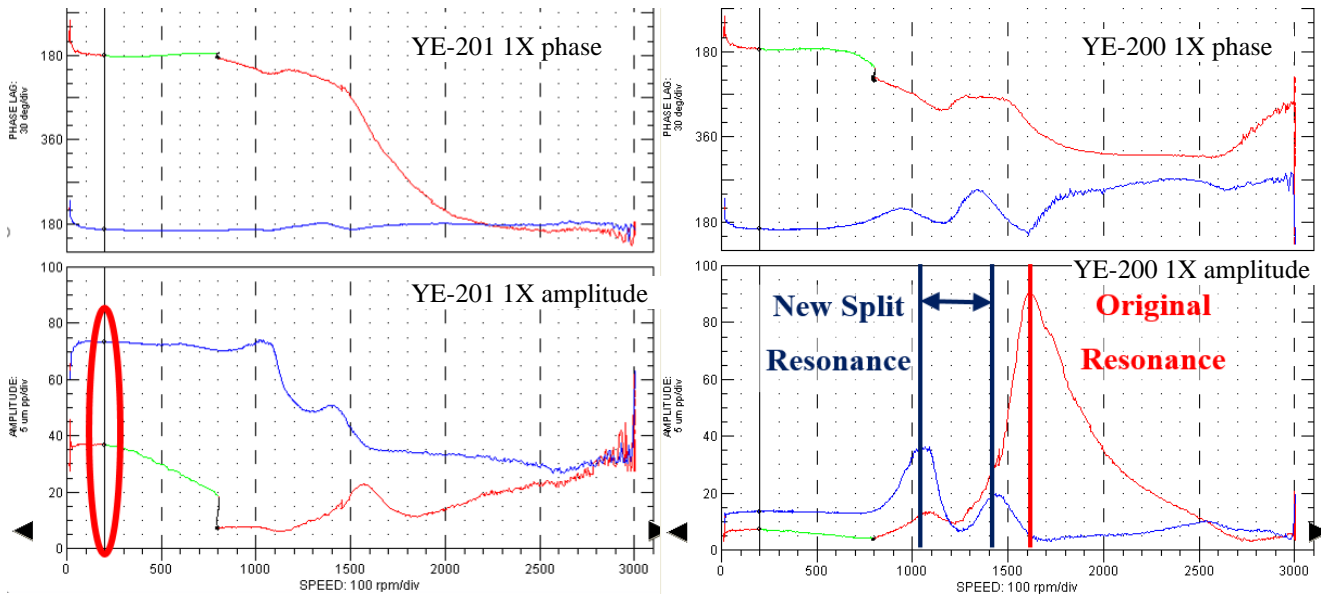
Fig.11. Uncompensated 1X Bode Plots, (Red-start up July 29, 2009; Blue-shut down July 29, 2009)

The plots in Fig. 11 below compare the startup and shutdown rotor responses recorded on the same day, July 29, 2009. The Bode plots show a significant rise in the slow roll vectors amplitudes during shutdown (blue curves) versus startup (red curves). The amplitude rise from 36 $\mu\text{m pp}$ (1.42 mil pp) to 73 $\mu\text{m pp}$ (2.87 mil pp) represents a two-fold increase. The increased in amplitude for the 1X slow roll vectors indicates pronounced rotor bow due to crack opening. The phase of the slow roll vectors for startup and shutdown is the same (180° - 190°), confirming unidirectional rotor bow in the direction of the deepest crack. The phase (180°) during the shutdown on bearing 1 is almost constant. This is suggesting that rotor crack is fully opened in the 180° direction during the shutdown. Slow roll vector amplitude for the DE bearing 1 is almost six times higher at shut down than in the NDE bearing 2, indicating that crack location is closer to the bearing 1.

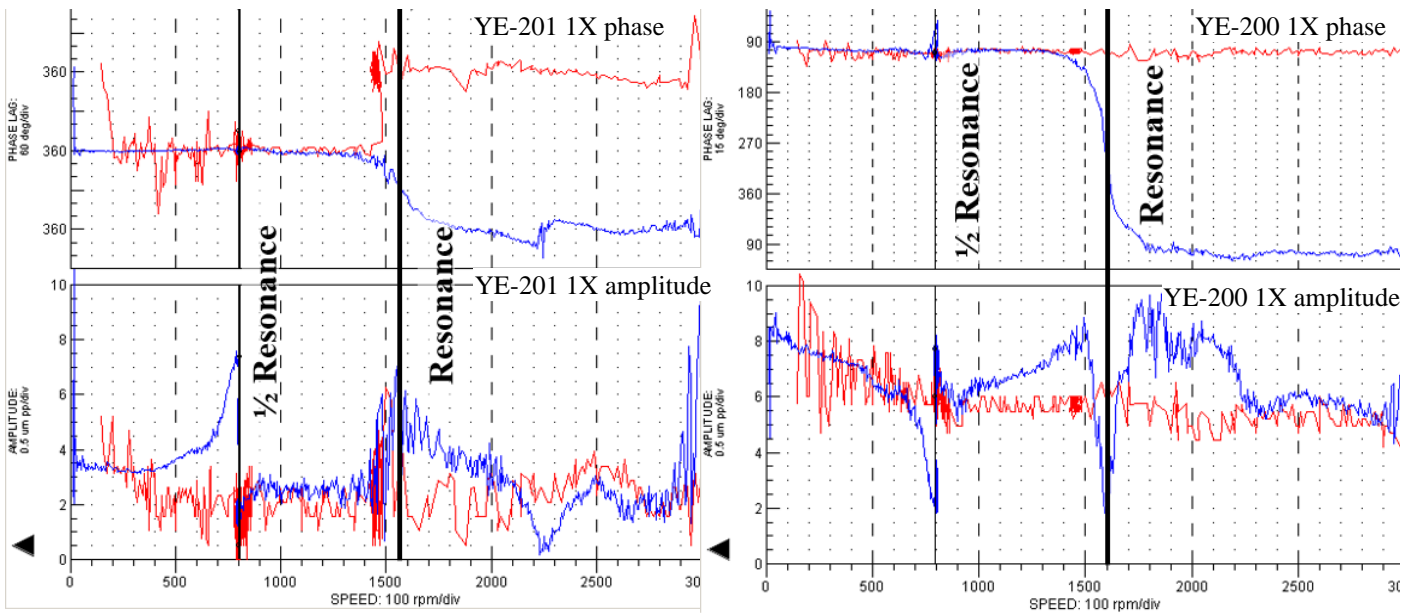
Fig.12. 2X Bode Plots, (Red-June20, 2008; -July29, 2009)

As per Rule #2, in general, the symptoms of the propagating transverse crack can increase rotor stiffness asymmetry—which likely produces the 2X frequency component—if the rotor is subjected to a steady unidirectional radial load. The 2X component can be greatly amplified when the rotor turns at half (of any) resonance speed because of the excitation of the resonance mode. The above-mentioned symptoms are not visible in our case (see Fig. 12). This can be interpreted as that either there is no crack, or there is not enough radial preload, or that the existing crack does not cause stiffness asymmetry.

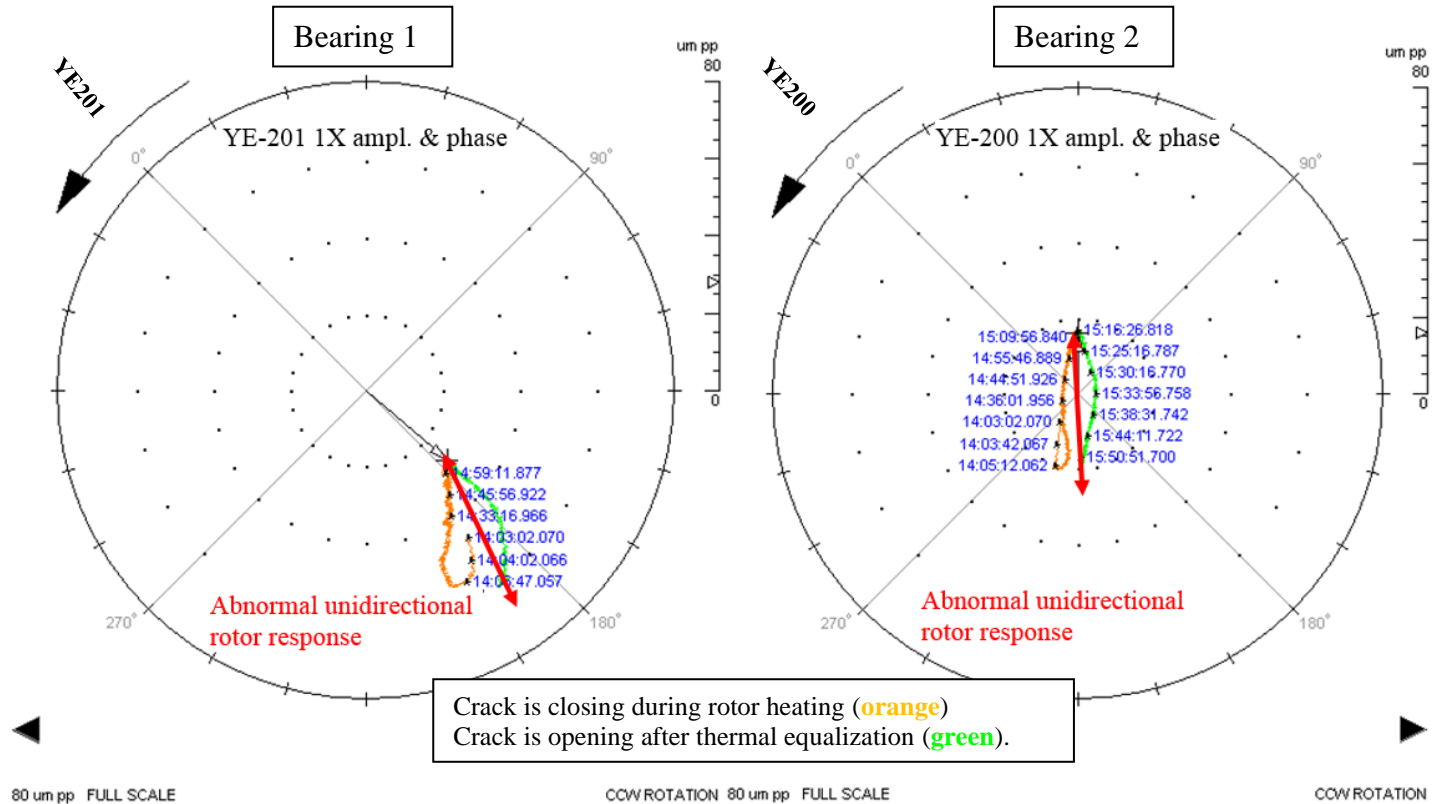
Fig.13. 1X polar plot showing abnormal unidirectional rotor response changes with temperature.

Each time the rotor heats, there is an apparent temporal change in vibration amplitude, as shown on the Polar plots in Fig.13 . The vibration amplitude is decreasing (orange color) due to initial rotor surface heating and rotor crack closing. Later, as the rotor heats up equally all the way from the rotor surface to the center, the vibration amplitude is increasing (green color) to the previous level and the rotor crack is opening again. This behavior is repeatable as shown on the trend plot in Fig. 14.

Abnormal unidirectional rotor response change with the temperature change (Fig.13) is another symptom supporting the possible presence of a turbine rotor crack. The change of the shaft relative vibration, always in the same direction, suggest sudden changes in the rotor bow, possibly caused by “closing” and “opening” of the shaft crack.

Polar plots (Fig. 13) for steam turbine DE bearings 1 (left) and NDE bearing 2 (right) show the unidirectional change of the shaft relative vibration during the rotor heating (orange). The change of the shaft relative vibration and eccentricity (pk-pk) measurement, together with phase step changes (in 1–2 minutes), always in the same direction, suggest sudden changes in the rotor bow, possibly caused by „closing” and „opening” of the shaft crack. The Polar plots for bearings 1 and 2 show the unidirectional change of the shaft relative vibration during the rotor heating. As the rotor thermally equalizes, in our case, in one hour after the synchronization (and three hours from startup), the direction of the vibration suddenly changes to the opposite direction (green). The possible explanation of thermal sensitivity for the axially heated rotor is that the transverse crack acts as the insulation. The heat transfer is faster on the opposite side of the crack and the rotor starts to bow in this direction, causing the crack to close (accompanied with a decrease of 1X response) until the temperature equalizes (Fig.7). There are also some models described in the literature for radial heat transfer, concluding that for a transverse crack the heating of the rotor should cause the temporary closing of the crack (the surface of the shaft expands more and faster than the center of the shaft) until the temperature equalizes. The same can be seen on Amplitude and Phase Trend Plot (Fig. 14), where the phase is nearly constant, confirming unidirectional behavior.

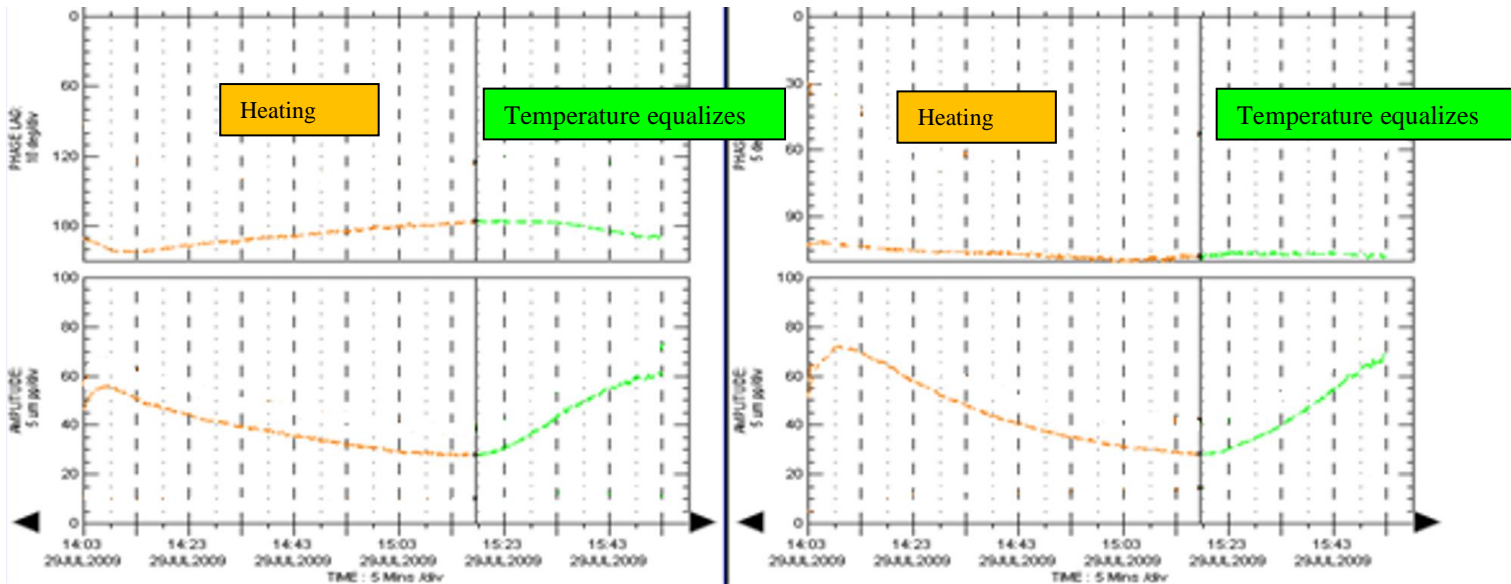
Fig.14. Bearing #1 (DE) Amplitude and Phase Trend Plot

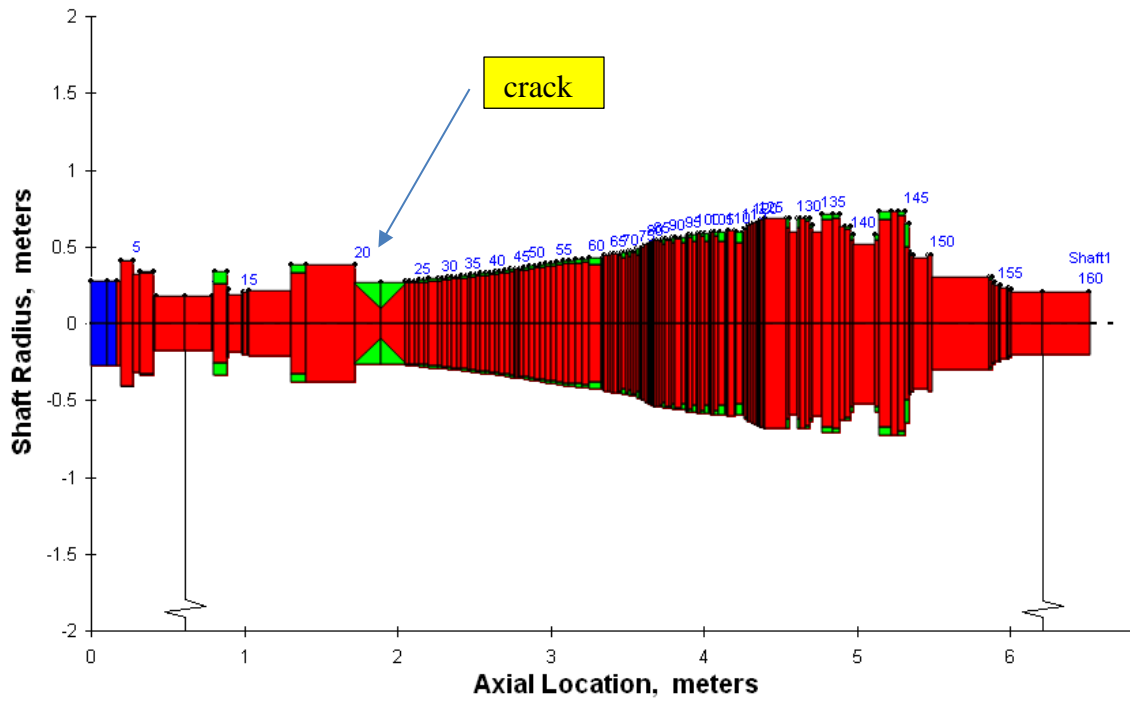
Fig.15. Shaft Model of rotor with a crack.

The shaft FEM model of actual steam turbine rotor was designed (Fig. 15) based on the steam turbine manufacturer rotordynamics report containing necessary shaft design information. The shaft model located a circumferential crack at the dovetail groove in the first-stage buckets. The model (or crack) was designed with double-sided conical beam Finite Elements. The smaller diameter beam of the crack section represents the actual shaft material left after the circumferential crack propagation. The crack location section was defined in the dovetail groove, under the first-stage buckets, as found in the actual rotor [9].

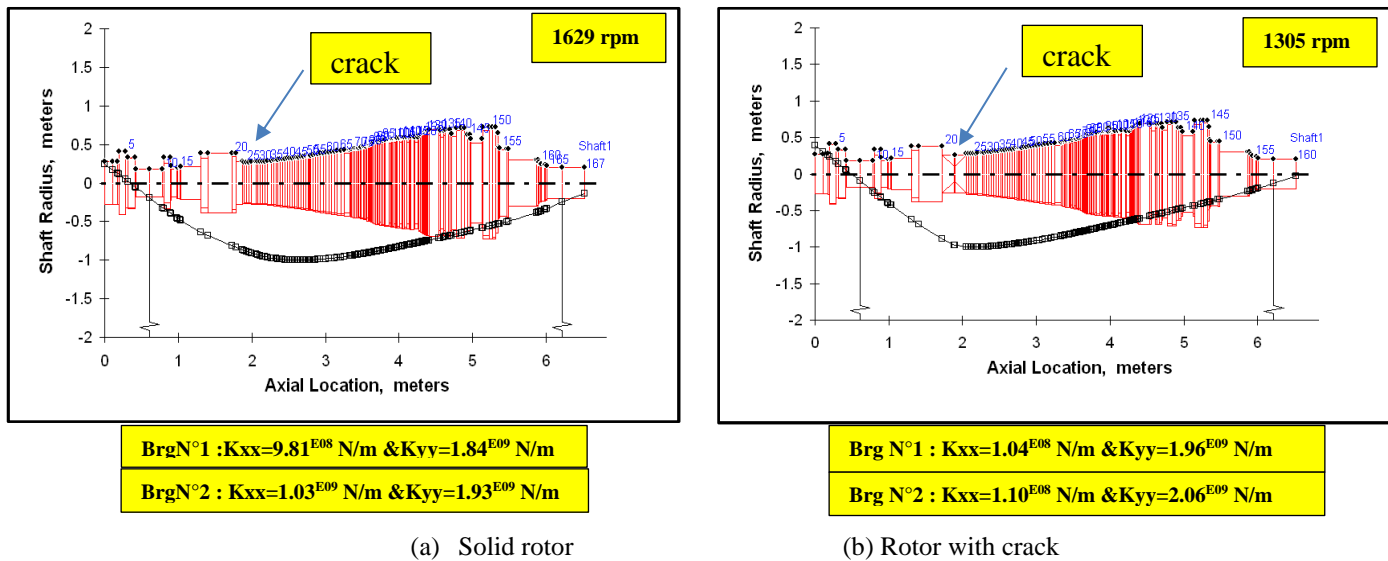
Fig. 17. Deflected Shape Plots for solid turbine rotor (left) and cracked turbine rotor (right).

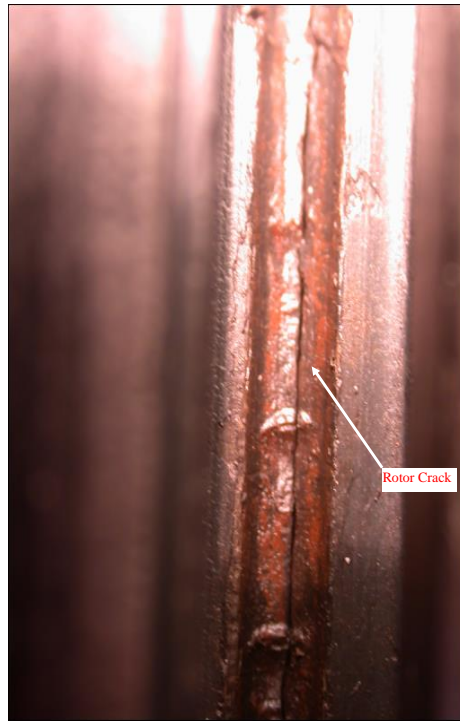
Fig. 18. The steam turbine rotor dovetail groove with circumferential crack

The rotor transverse crack was confirmed under the first-stage buckets in the dovetail groove, see Fig. 18. The crack was symmetric and 360° in circumferential extent, thus explaining the absence of the 2X frequency component increase.

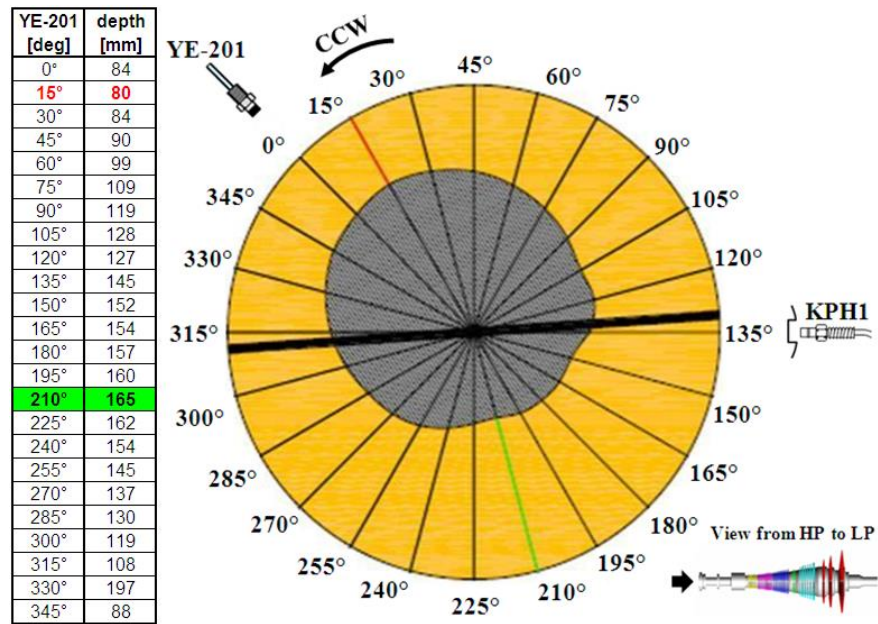
Fig. 20. The steam turbine rotor crack section

The steam turbine rotor crack section was thoroughly investigated, and the crack depth measured every 15° circumferentially. The measurement results are documented in the table and the sectional drawing shown in Fig. 20. The angles are set with respect to the

The biggest crack depth was measured at 210° angular direction (green line), exactly as predicted by the vibration measurement results. The estimated angular direction of the rotor crack was estimated at 190°-210° from YE-201 reference transducer, measured against the rotation.

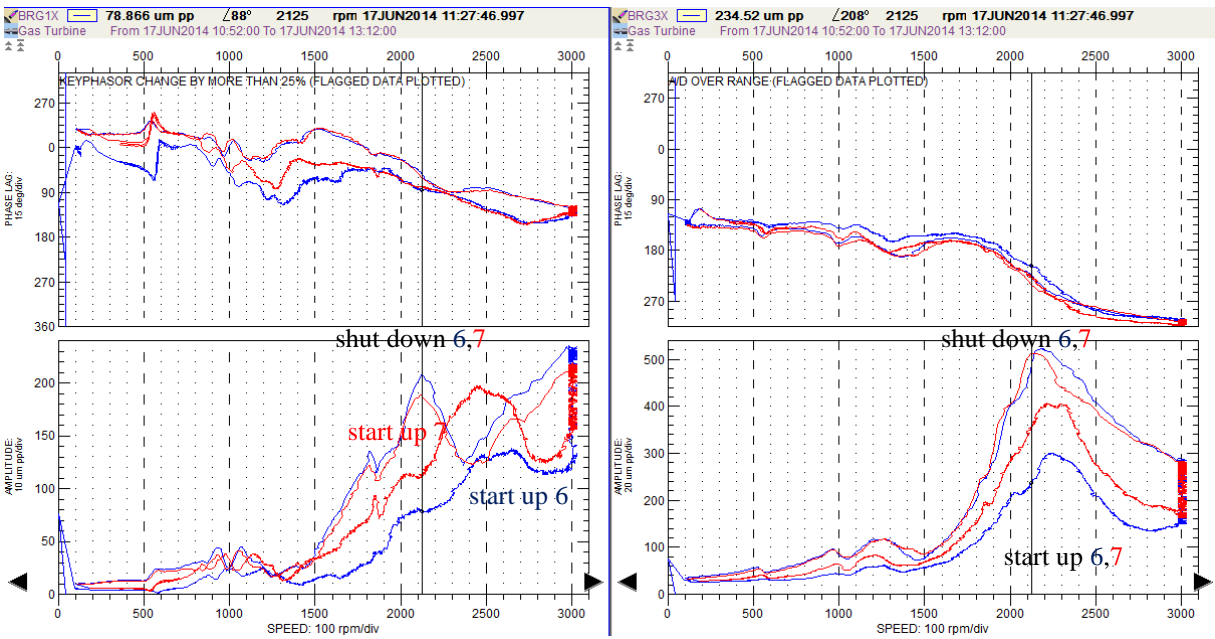
Fig. 22. Uncompensated 1X Bode plot of rotor vibrations for GT brg.1, 3 for SU6 (blue) and SU7 (red).

The uncompensated 1X Bode plots (Fig 22) show small increase in slow-roll vectors when comparing start-up/shut down 6 and start-up/shut down 7, indicating an increase of rotor bow. There is visible change in the balance resonance frequency between start-up and shut down, decreasing from 2500rpm to 2133rpm, suggesting a decrease in modal stiffness. This abnormal change is repeatable for start-up 6 (SU6) and start-up 7 (SU7). A decrease in modal stiffness is one of the expected and primary symptoms of a rotor crack. Thus, the observed increase of rotor bow demonstrated by changes in slow roll vectors, the decrease in modal stiffness demonstrated by a downward shift in the balance resonance, and the decrease in effective damping demonstrated by the higher amplitude peak at resonance are all indicative of a rotor crack. In addition, repeatability of abnormal rotor behavior is a typical symptom of a cracked rotor.

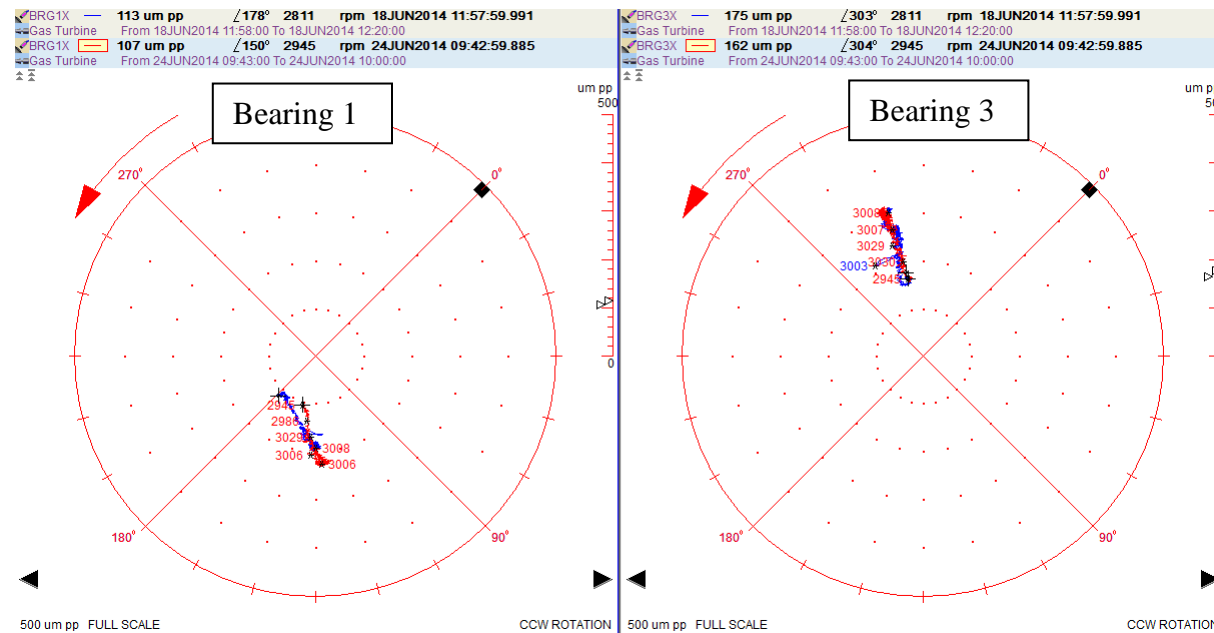
Fig. 25. 1X Polar plot for GT bearing 1 and 3 at steady state SU10 (blue) and SU11 (red).

Polar plots (Fig. 25) show abnormal unidirectional rotor response change during the steady state conditions. The shaft-relative vibrations increased in one direction, suggesting the rotor bow increased. This suggests that rotor bow was increased due to crack opening and the 1X vibration component was increased due to the modified bow and unbalance. This abnormal rotor behavior is exactly repeatable for start-up 10 (blue) and start-up 11 (red). Repeatability of abnormal-unidirectional rotor response is typical sign of rotor crack.

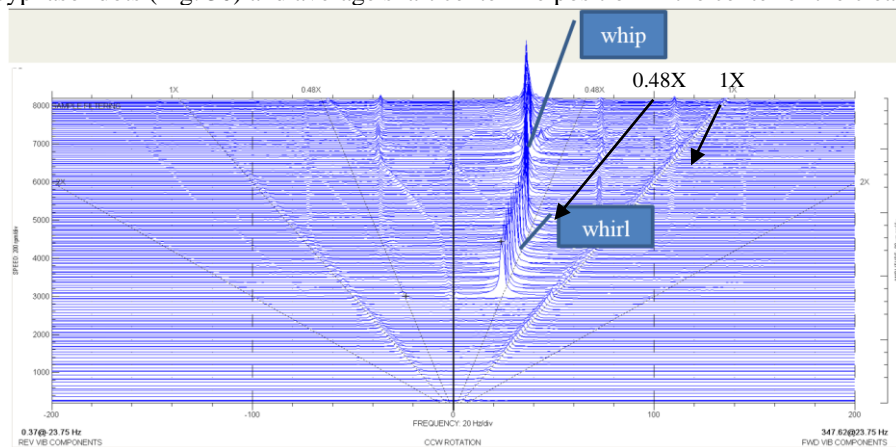
Fig. 29. Demonstration result: forward precession, subsynchronous component vibration for whirl and whip mode.

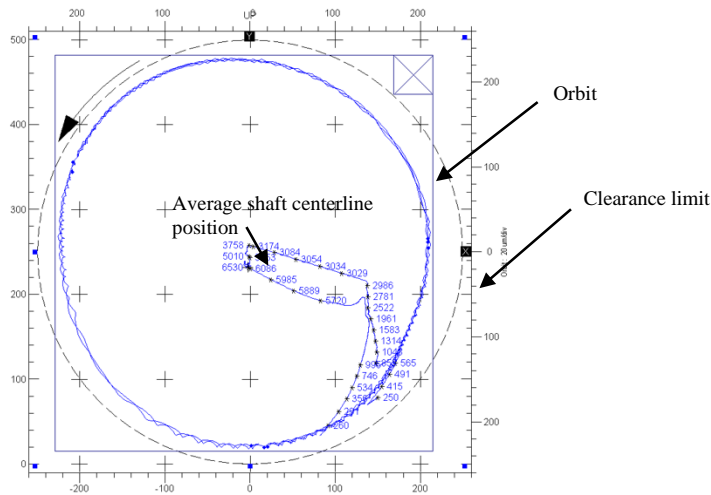
Fig. 31. Shaft centerline plot with an overlay of the orbit in instability condition – orbit follows the clearance, so the average position of journal is at the center of the clearance.

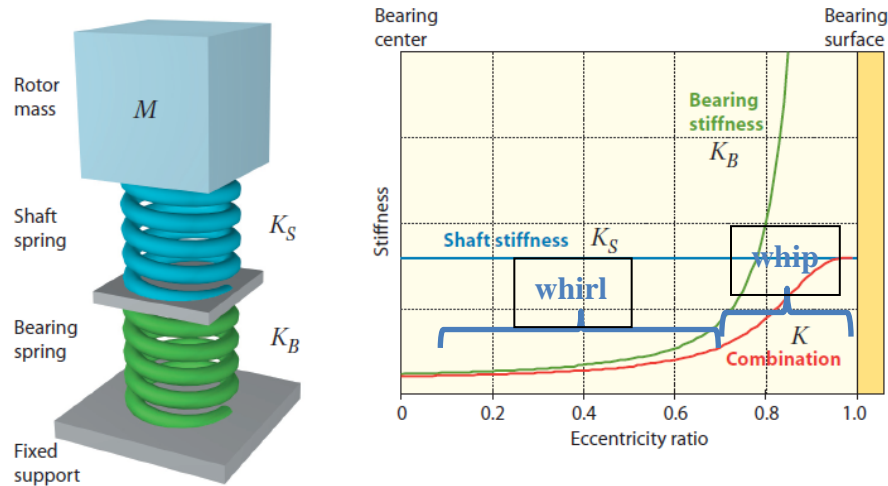
Fig. 33. The whip and whirl areas are depending on the direct stiffness which is combination of shaft stiffness (constant) and bearing stiffness (function of eccentricity ratio).

For the whip condition, the mechanical resonance condition is easy to see, as the frequency is locked at the rotor natural frequency but to keep the system in fluid resonance the average velocity of the fluid must decrease proportionally to rotor speed increase. The reduction of λ is caused by an increase in vibration and dynamically loading the bearing, thereby reducing the average gap the rotating fluid flows through. The rotor is operating in the bending mode, with all the consequences of increased amplitude at the midspan and the bending stress. The type instability mode (whirl or whip) of the rotor at given condition is governed by the relation of the bearing stiffness K_B and rotor stiffness K_S , acting in a row to constitute spring stiffness K (Fig. 33).

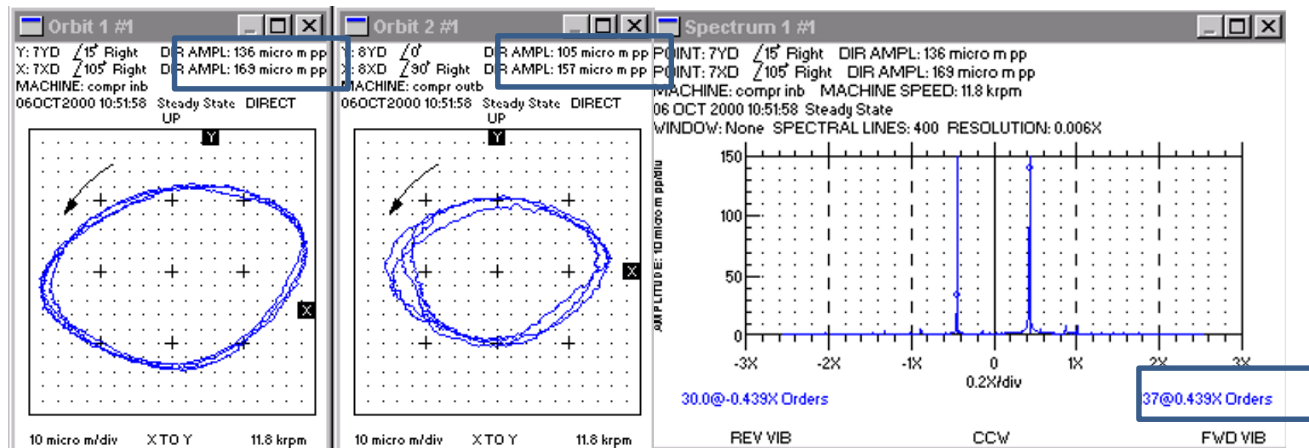
Fig. 34. Fluid induced instability in hydrogen compressor: orbits in both bearings and the full spectrum for bearing 7(DE).

The first case we review is a barrel type hydrogen compressor, running 10.8 krpm, with elliptical bearings. The Unit developed unstable vibration conditions following an overhaul. When the diagnostic services were called for intervention the unit was already in operation for 5 months and during the entirety of this time it was in a condition of instability. Vibrations were characterized by elliptical orbits with amplitudes at the level of the bearing clearance, forward in precession and with the subsynchronous frequency $\sim 0.44X$ (Fig. 34). The unit was not equipped with a keyphasor, so there is no multiple dot pattern visible in the orbits.

Reason for instability was excessive clearance in brg 7, which can be spotted in the data once the nominal clearances (identical for both bearings) are known – the orbit in brg 7 is bigger than the maximum bearing clearance. During the overhaul the rotor was machined to remove scratches on the measurement path, but the bearing was not changed. The End User was aware about instability as well as the root-cause of it but tried to stabilize the machine when in operation. Furthermore, the operations manager had a constraint on production – a stop of the machine for more than 6 hours would cause long term break of production due to subsequent damages in other machines in the process. The question was which instability: whip or whirl type. The diagnostic engineer claimed it to be whirl, based on the low absolute vibration measured on the bearing covers. Still, the continuation of operation was considered unsafe, in the longer perspective. A new bearing with the bore reduced to match the machined journal was manufactured and the mechanical team was given time to practice the replacement operation on a similar unit in the overhaul. After this training practice, the mechanical team replaced bearing during a short outage window (<5 h). During the shutdown the resonance frequency was confirmed to be higher than 5000 rpm, so the condition was whirl.

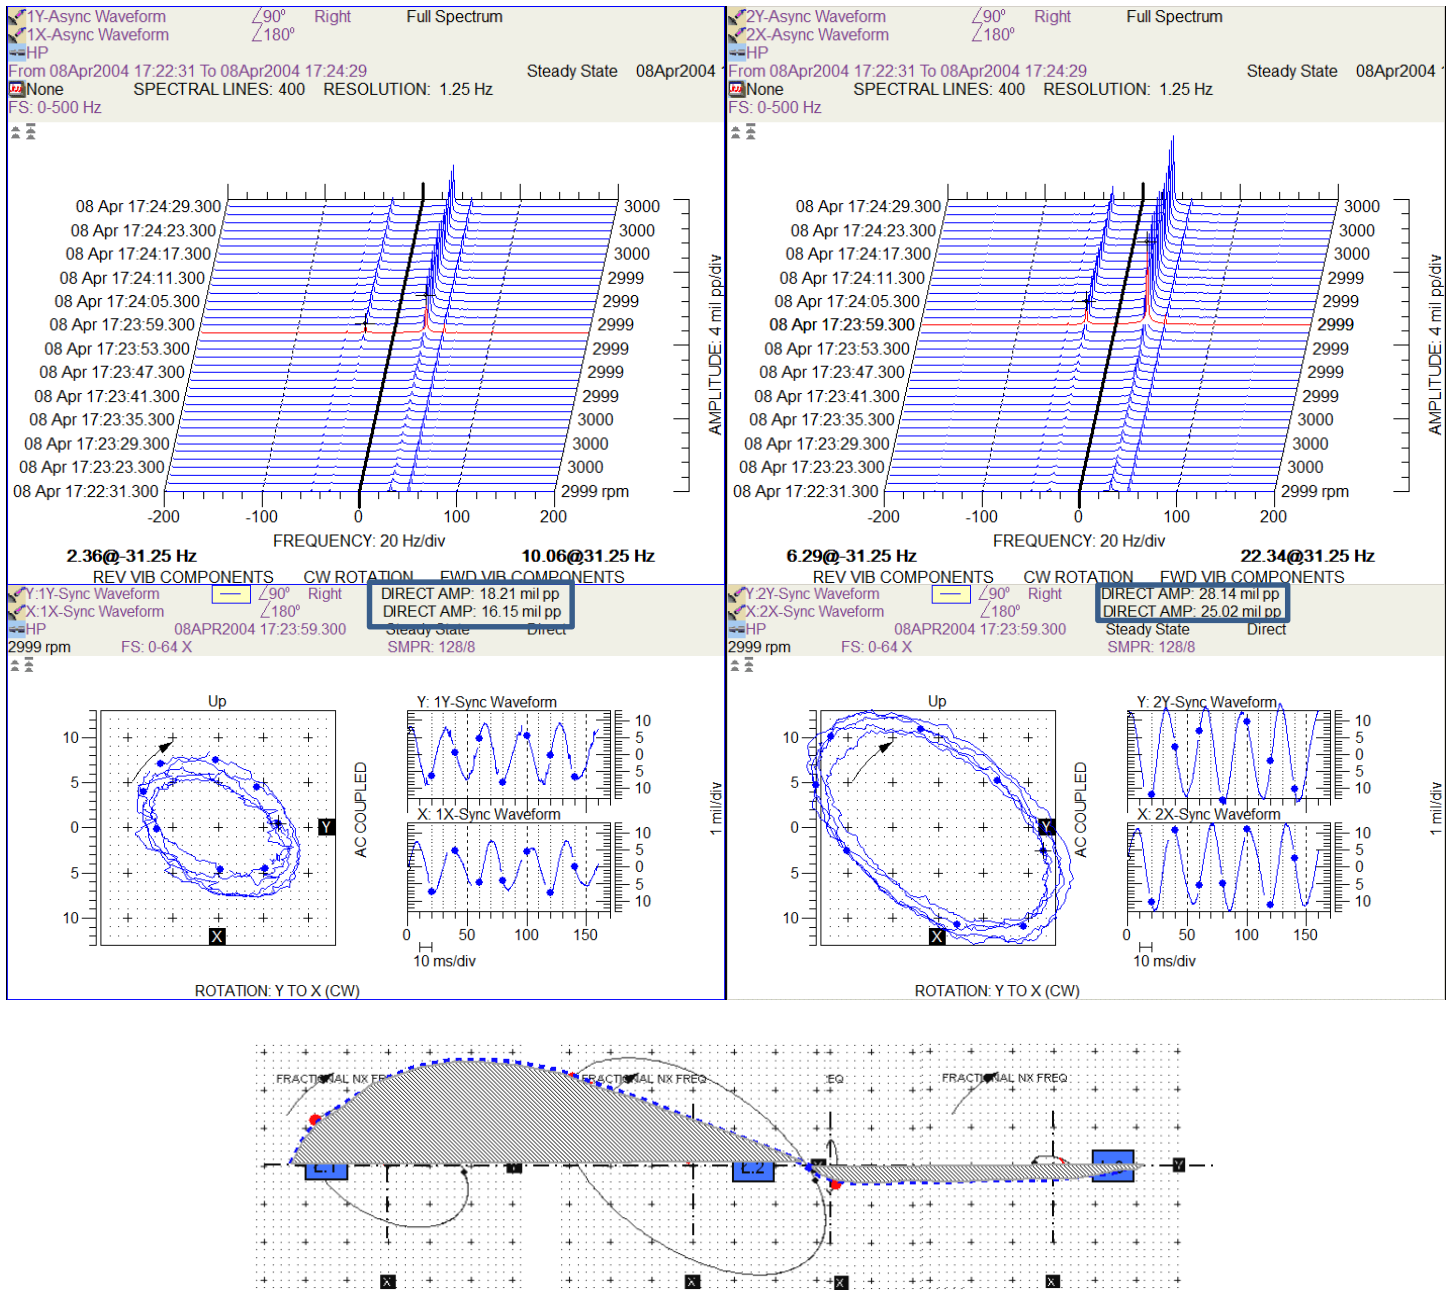
Fig. 35. Unstable operation in HP turbine bearings on inlet steam flow increase: full spectrum waterfall and orbits for bearings 1 and 2, estimated shape of the vibration mode based on orbits measured in bearings 1-3.

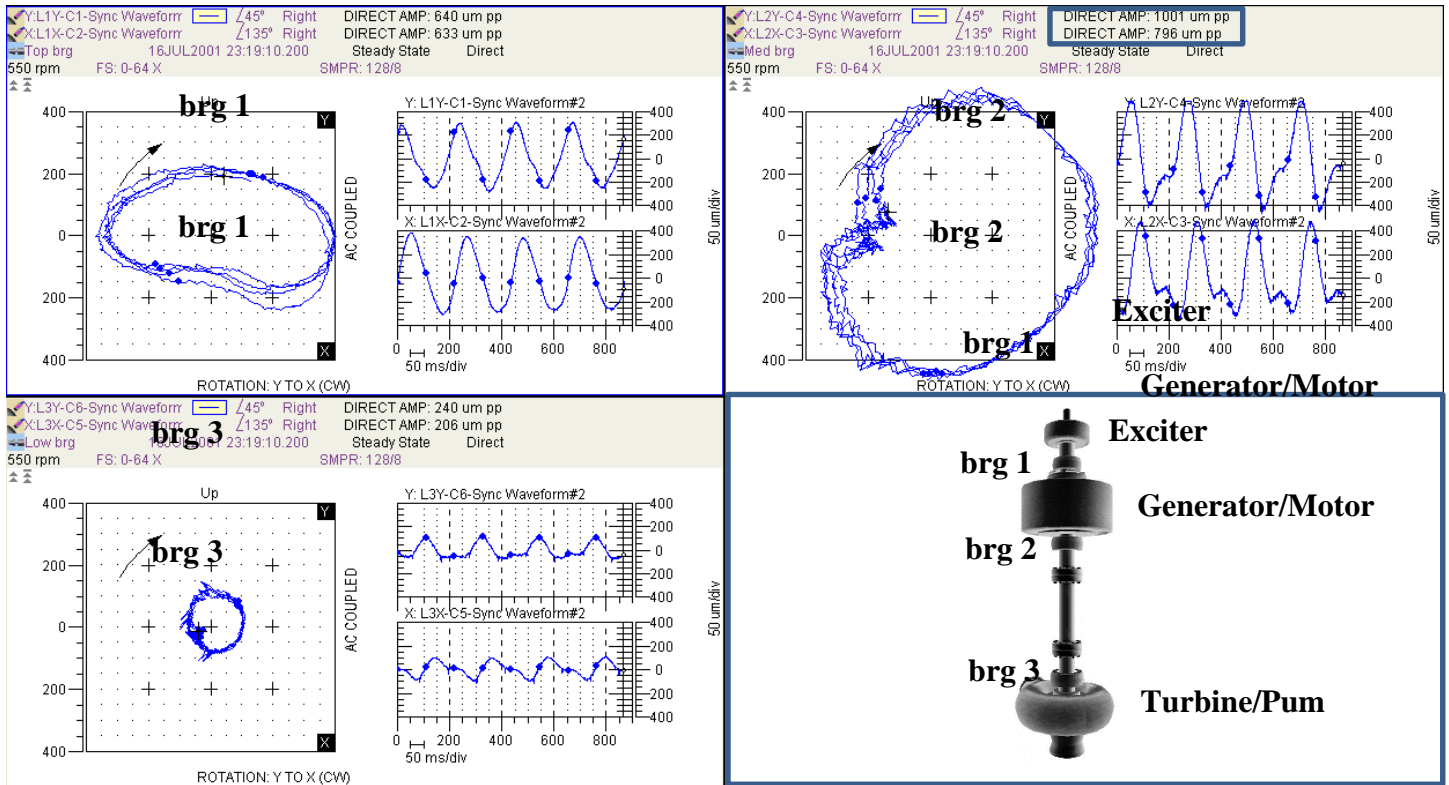
Fig. 38. Instable orbits (1/2X vibration) in bearings of hydraulic turbine/pump 125 MW train.

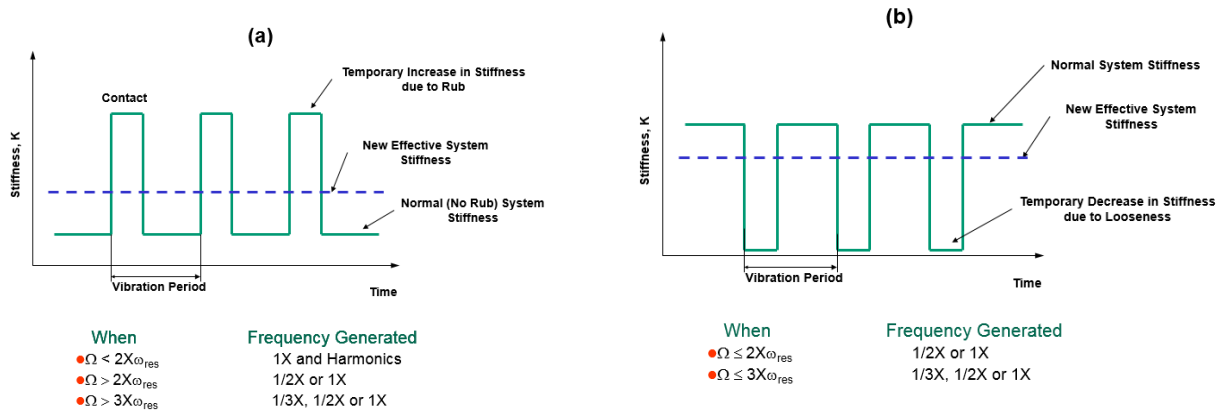
Fig. 42. Periodic change of stiffness in the Mathieu normal-tight (a) and normal-loose (b) condition with typically generated vibration components.
