TURBOMACHINERY & PUMP SYMPOSIA | HOUSTON, TX
SEPTEMBER 15-17, 2020
SHORT COURSES: SEPTEMBER 14, 2020

WHY MACHINES FAIL TO FOLLOW TEXTBOOK STATED RULES, AS ILLUSTRATED BY SHAFT CRACK AND ROTOR SELF EXCITED VIBRATION CASES IN CRITICAL MACHINERY

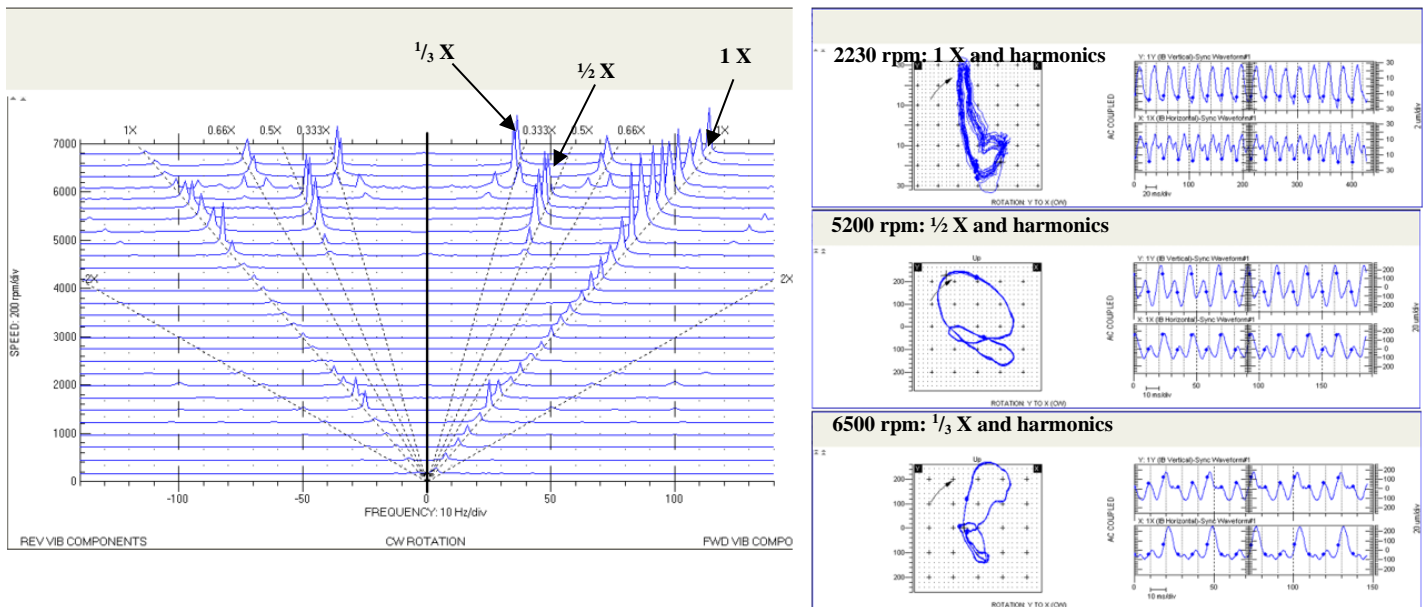
Fig. 43. Full spectrum cascade from rub test on rotor kit, orbit-timebase plots with 1X and harmonics, 1/2X and harmonics and 1/3X and harmonics, depending on actual speed vs. resonance speed.
