3 Featherbed Alley St. George's, Bermuda

Photogrammetric Report

Benjamin E. Baaske

12 January 2018

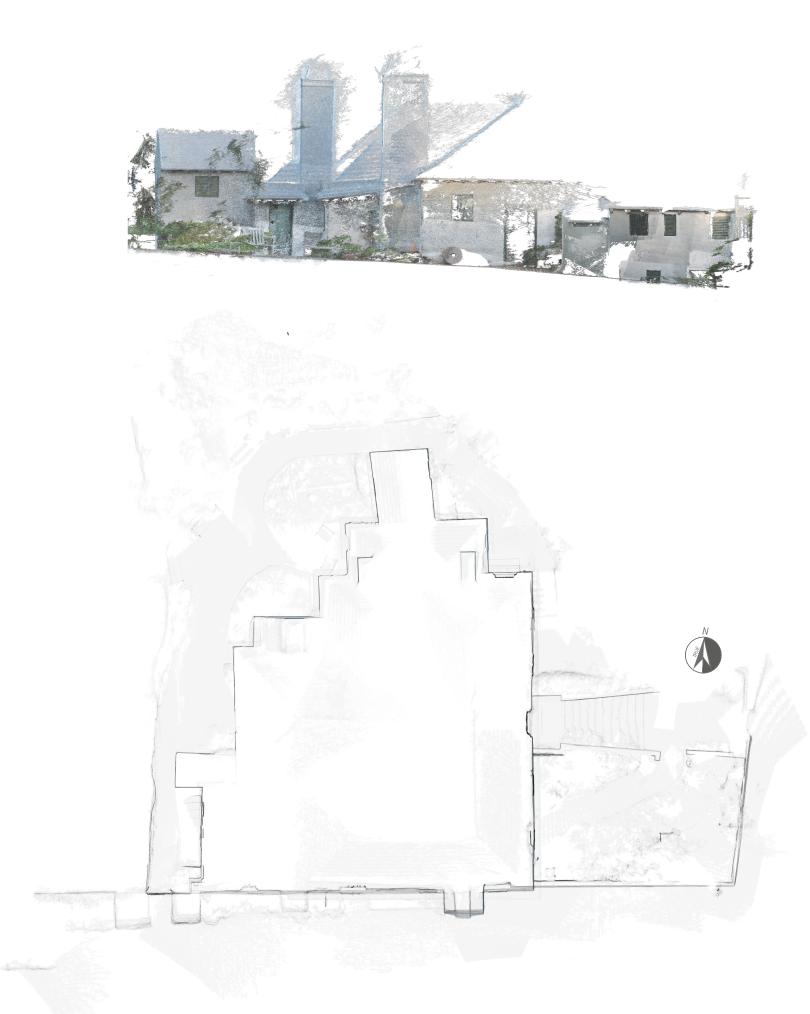
Figure 1. West Elevation, Model 02_ West&North (top; page 2).

Figure 2. Site Plan, Model 02_ West&North + Model 03_East&South (bottom; page 2).

This brightness and contrast issue was addressed using a combination of piecemeal photogrammetry i.e. breaking the model into fragments, and monitoring and utilizing preferential weather (cloud cover with little or no precipitation) conditions. The first round of photogrammetric reconnaissance consisted of what might be consider "loose" photogrammetry, meaning, camera settings were allowed to act in full automation; this method is quicker, but more often results in less accurate models or registration failures [Figures 1-6].

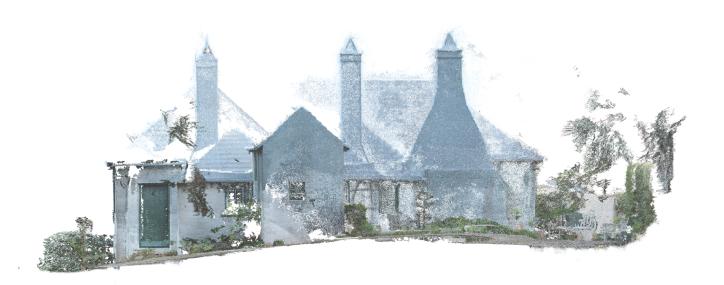
Figure 3. North Elevation, Model 02_ West&North (below).

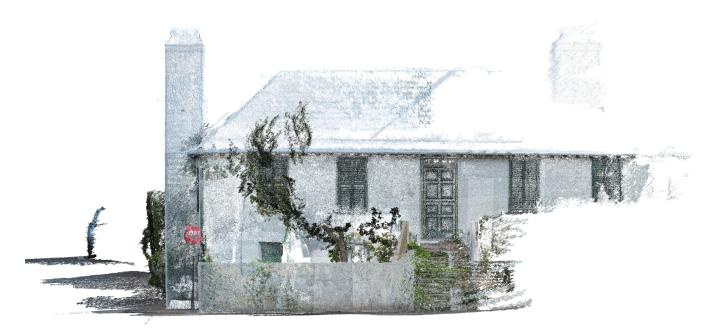
Figure 5. East Elevation, Model 03_East&South

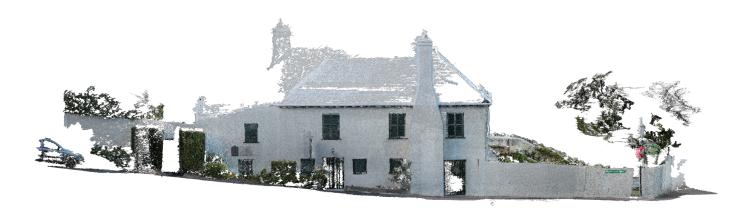
Figure 6. South Elevation, Model 03_East&South

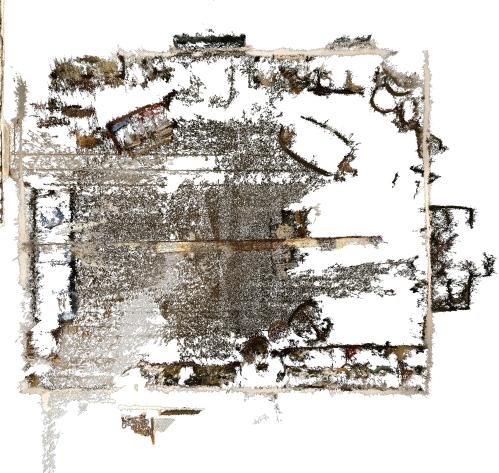
Figure 8. Southeast Isometric View, Model 13_InteriorKitchen&Closet

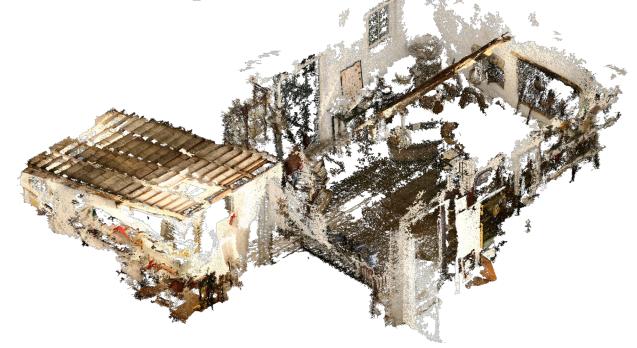
Figure 9. Southeast Section-Isometric View, Model 13_InteriorKitchen&Closet

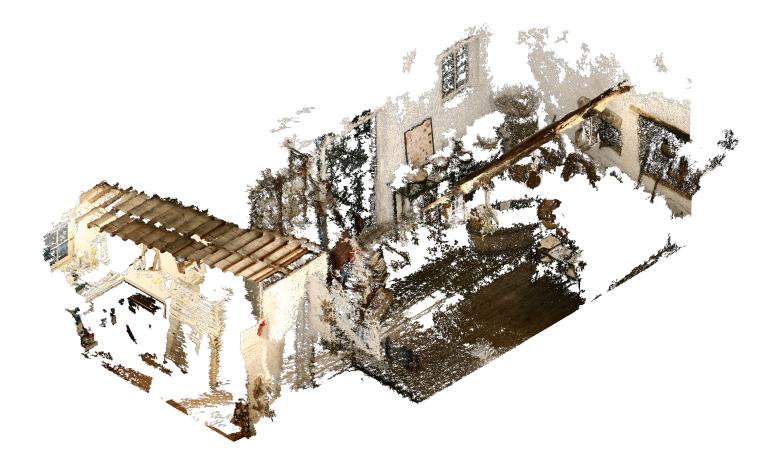
Figure 10. Southeast Plan-Isometric View, Model 13_InteriorKitchen&Closet
