METALLIC COATINGS AS PERIPHERAL BARRIERS TO DIMINISH THE ADVERSE  
EFFECTS OF CATHODIC PROTECTION ON PRESTRESSING MEMBERS

A Dissertation

ARASH ROCKEY

Submitted to the Graduate and Professional School of  
Texas A&M University  
in partial fulfillment of the requirements for the degree of  
DOCTOR OF PHILOSOPHY

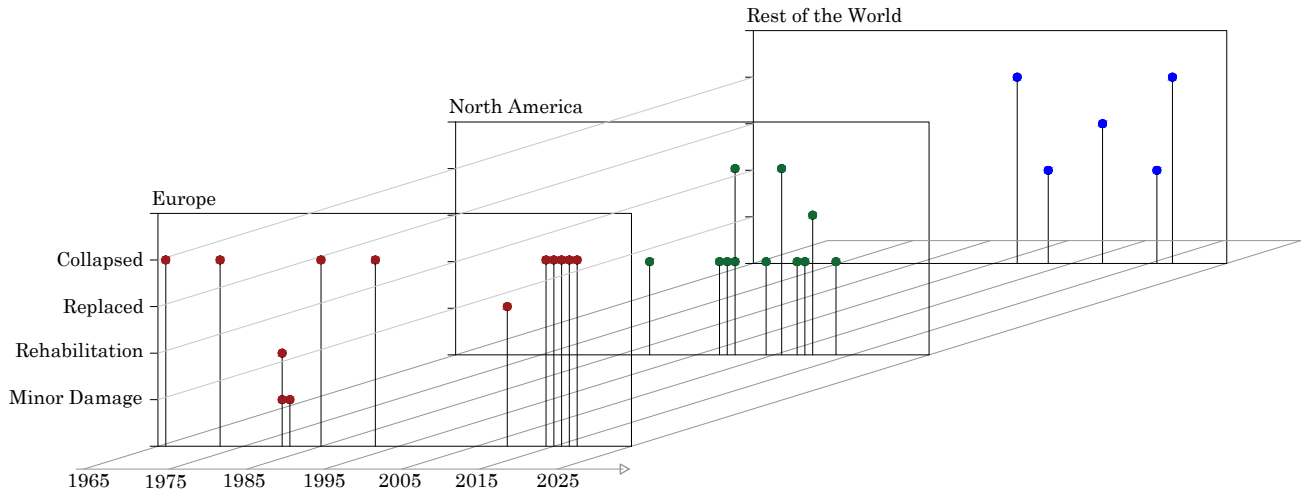
Figure 2.2: Previous failures of non-building prestressed structures, see Appendix A for detail.

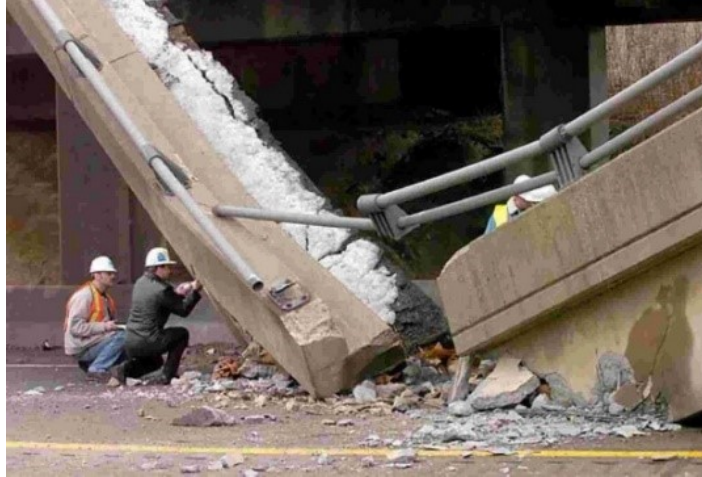
Figure 2.4: Failure of the Lake View Drive Bridge, reprinted from (Donaldson, 2005) with permission.

The shoulder of a 55-year-old post-tensioned box-beam on the Lake View Drive Bridge collapsed under its own load in 2005 (Figure 2.4). After conducting a comprehensive investigation, Naito et al. (2010) concluded that the quality of concrete was acceptable

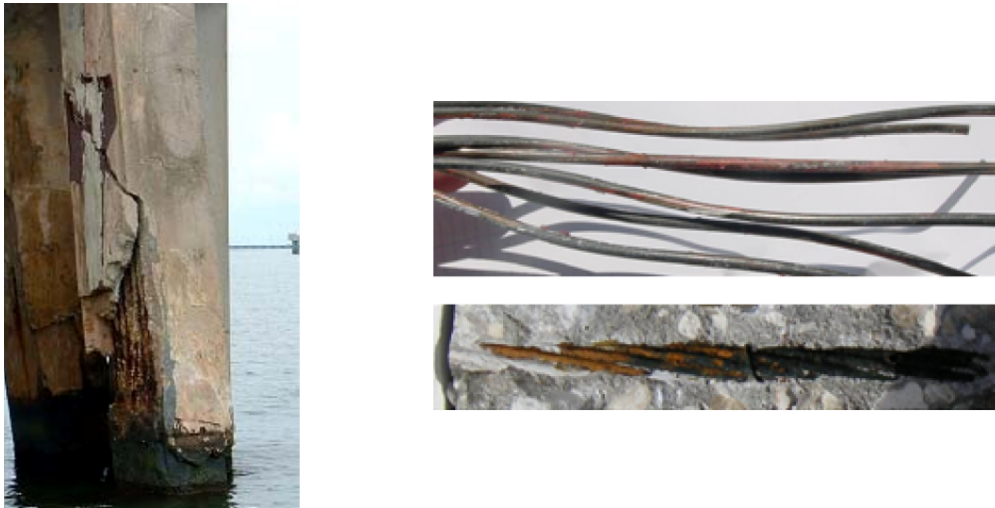
Figure 2.5: Corroded high-strength steel from the pile of the St. George Island Bridge, reprinted from (Cannon et al., 2006) with permission.

In 2004, the Florida Department of Transportation decided to replace the 40-year prestressed St. George Island concrete bridge crossing Apalachicola Bay with the new Bryant Patton Bridge because some piers of the old viaduct had lost up to 70% of their flexural capacity, as depicted in (Figure 2.5). After examining corrosion damage in 12 piers, two of which had been protected with a cathodic protection since 1994, Cannon et al. (2006) concluded that cathodically protected steel wires had been embrittled by hydrogen in 10 years, but the loss of flexural capacity in piers protected with ICCP was generally less than

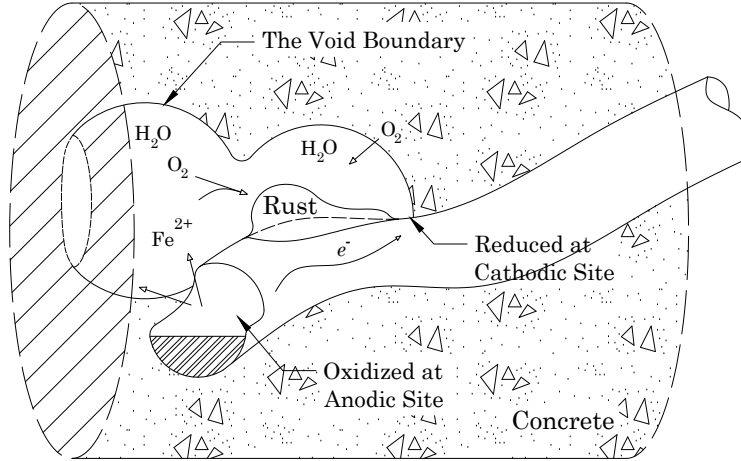
Figure 2.7: Electrochemical process leading to corrosion in concrete.

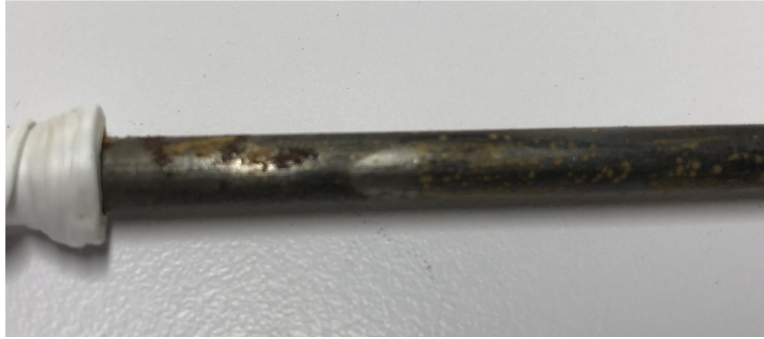
Figure 2.11: Pitting corrosion. Corrosive agents attacked ASTM A 416 steel coated with nickel-cobalt alloy and caused the formation of corrosion pits.

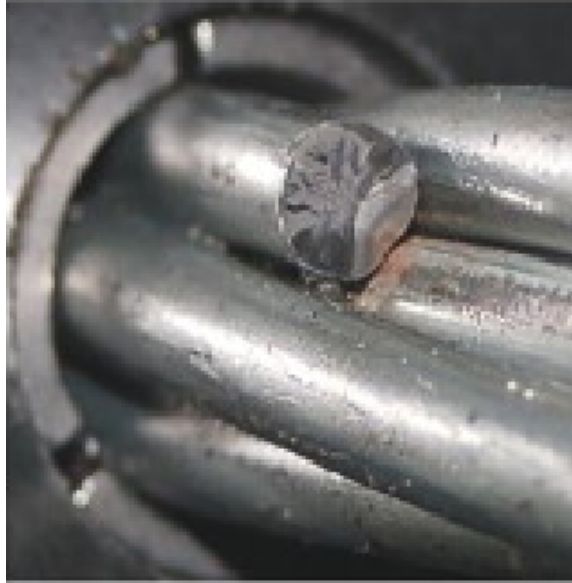
Figure 2.13: Rupture of steel wire due to fretting fatigue, reprinted from (Winkler et al., 2015) with permission.

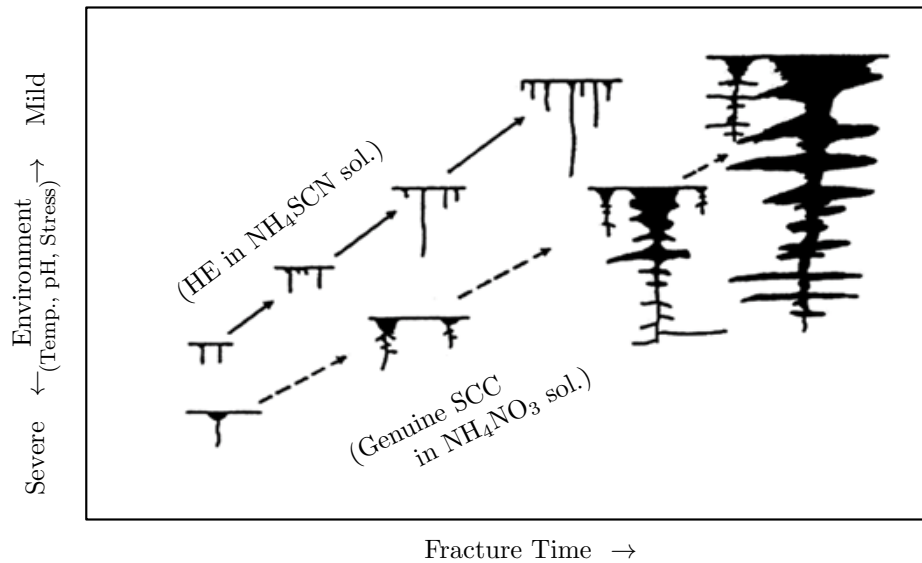
Figure 2.16: Comparison between stress corrosion cracking and hydrogen embrittlement in high-strength steel strand, reprinted from ACI 222.2R-01 (2014) with permission.

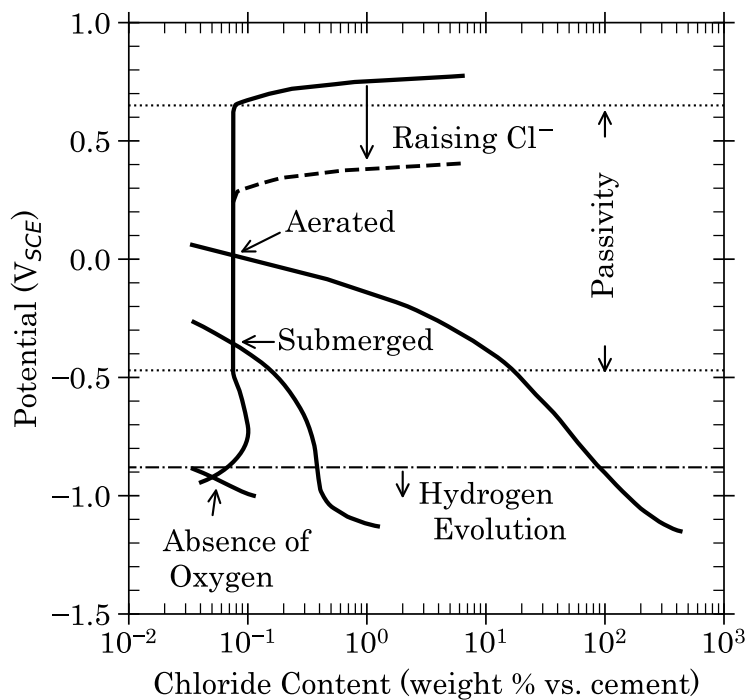
Figure 2.18: Polarization curves, reprinted from (Bertolini et al., 2004) with permission. Herein are anodic and cathodic reactions in reinforced concrete placed in aerated environment in addition to submerged in water and in absence of oxygen.

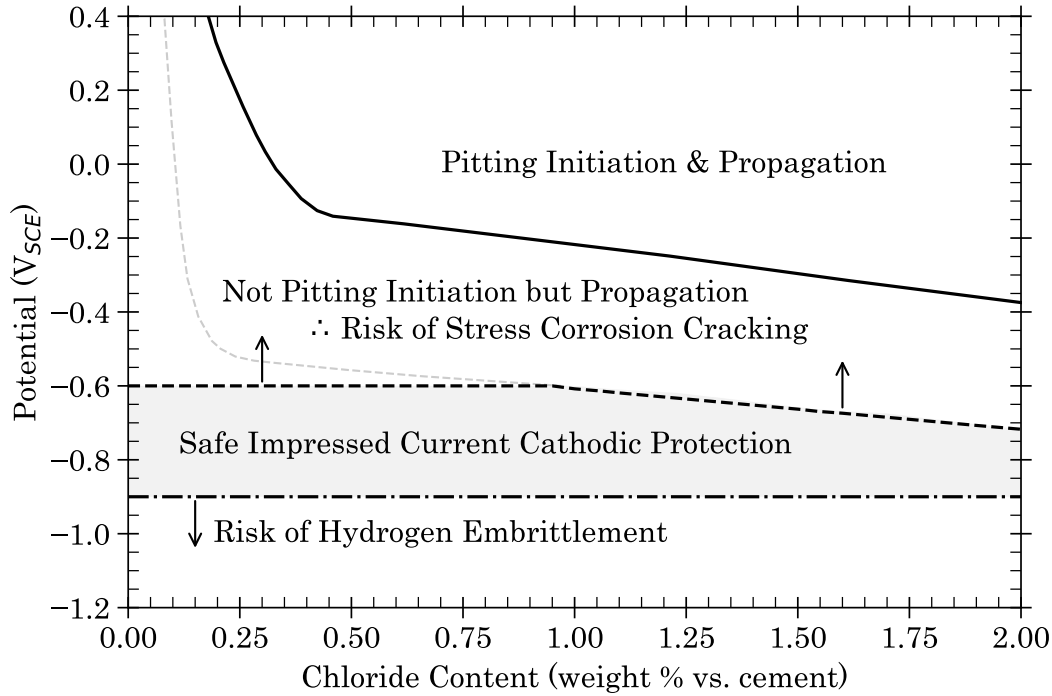
Figure 2.19: Pedferri diagram. Corrosion behavior of steel embedded in concrete based on electric potential and chloride content, modified for ASTM A 416 steel from (Pedferri, 1996) with permission.

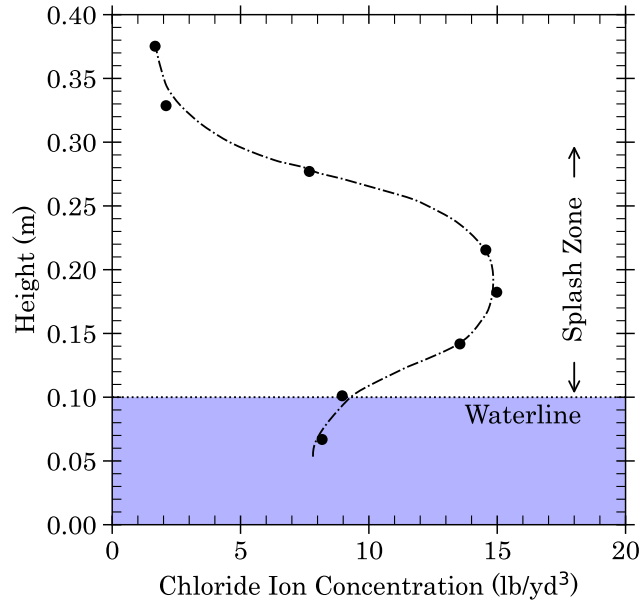
Figure 2.20: A comparison between the distribution of chloride content in a prestressed piling at splash zone and submerged region based on a laboratory study, modified from (Chaix et al., 1995) with permission.

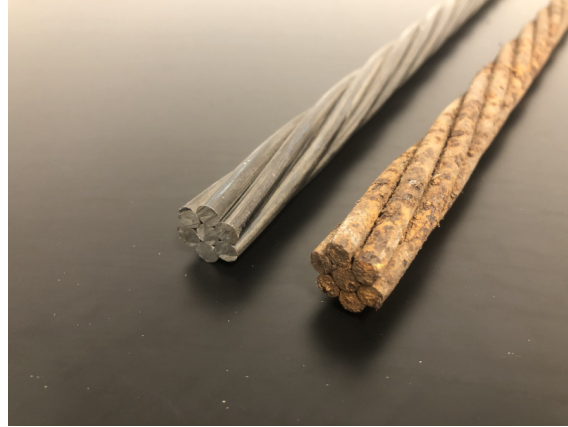
Figure 3.1: Comparison between intact and corroded ASTM A 416 strands. The corroded steel strand was left outside for more than 3 years and were exposed to air and moisture.

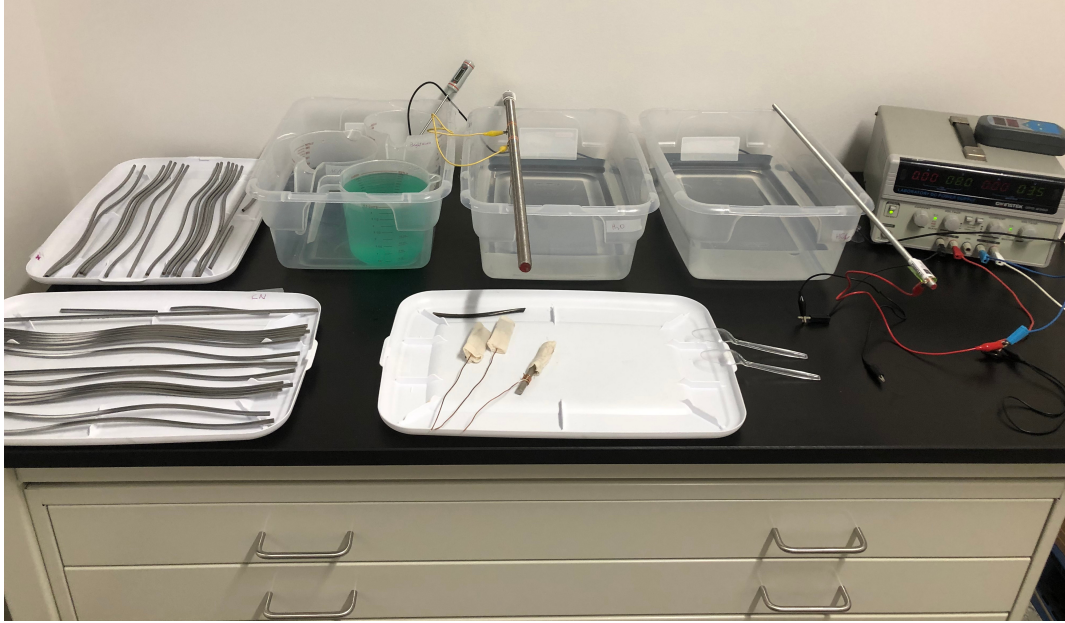
Figure 3.3: Apparatus and materials used for metallic coating on steel wires.

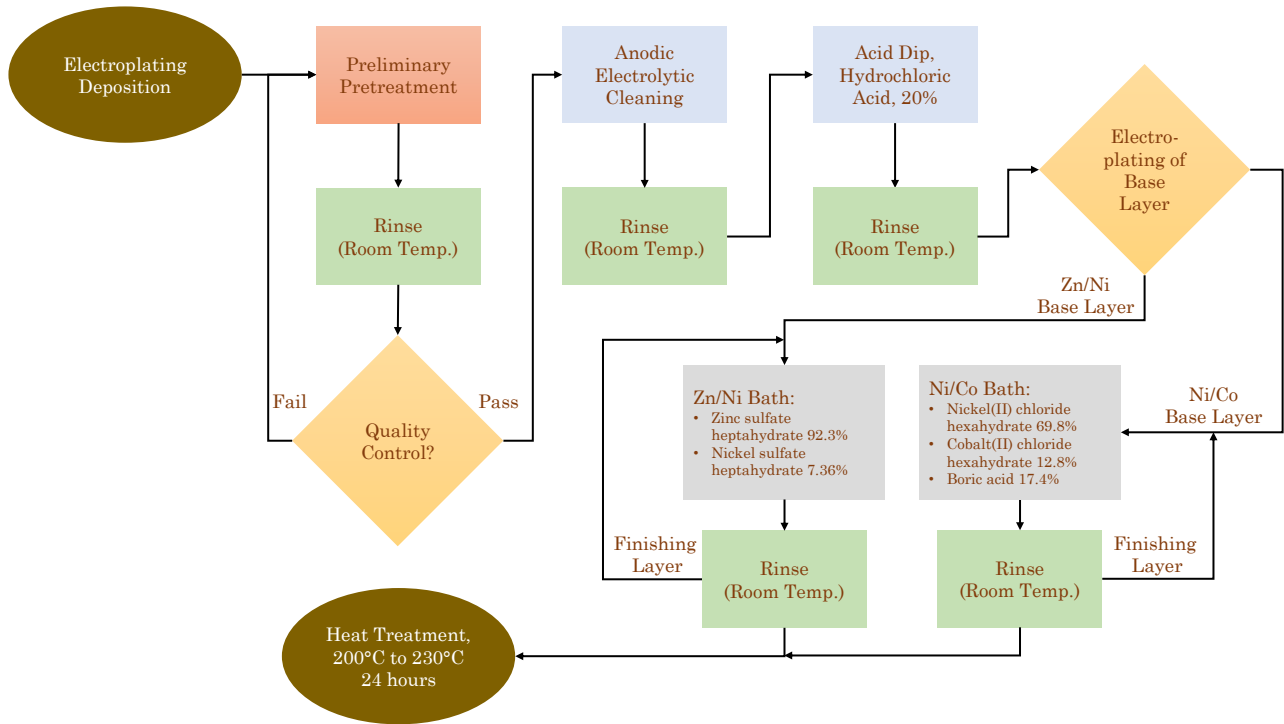
Figure 3.4: Process required for electroplating on high-carbon and low-alloy steel.

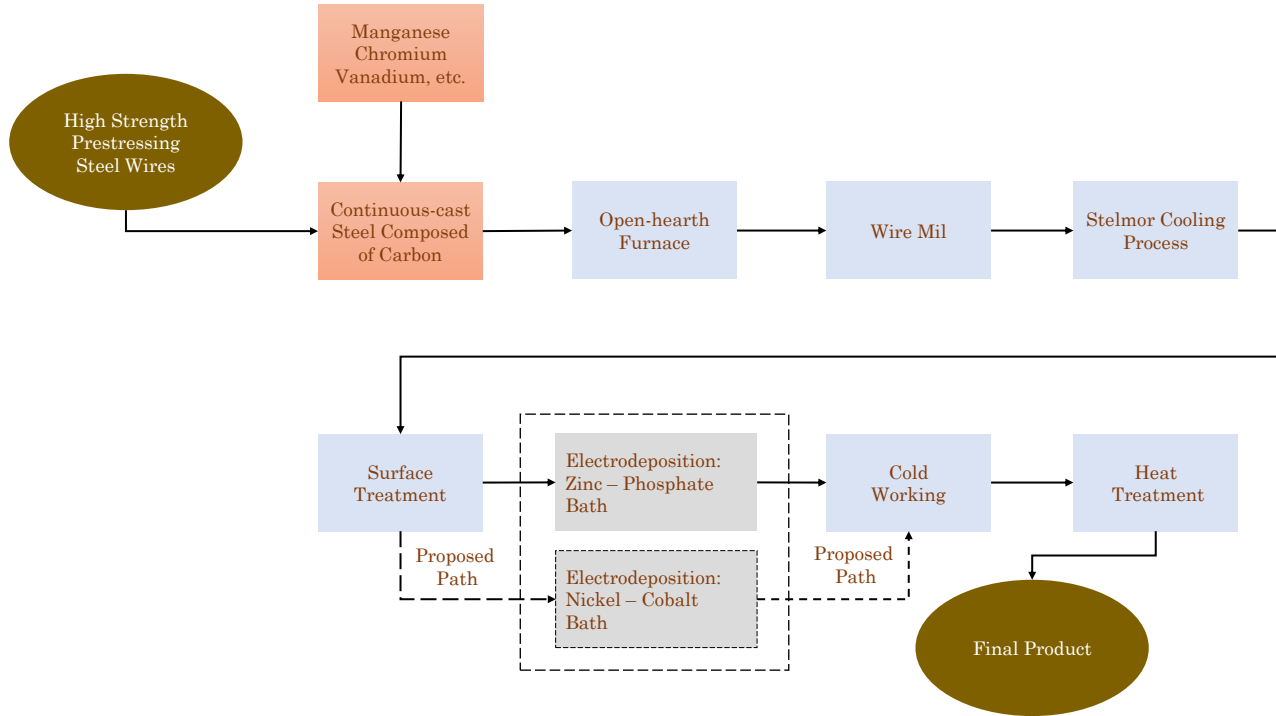
Figure 3.5: Process required in making high-strength steel wires, ASTM A 416, adapted from (ACI cmte. 222, 2014).

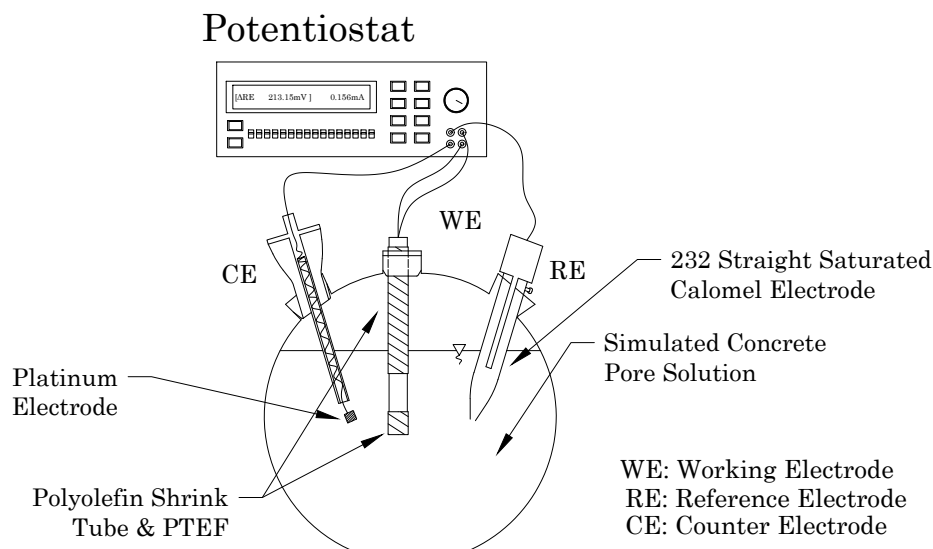
Figure 4.1: Schematic view of corrosion cell during CPP operation.

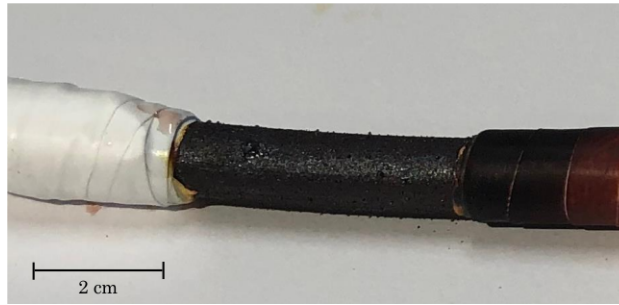
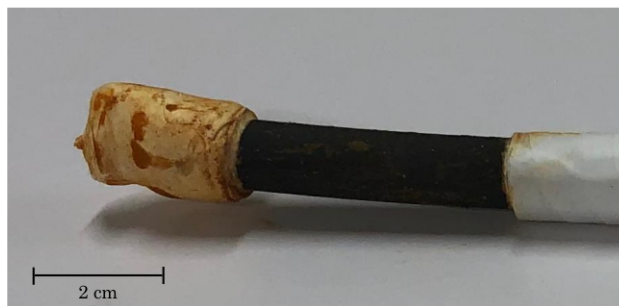
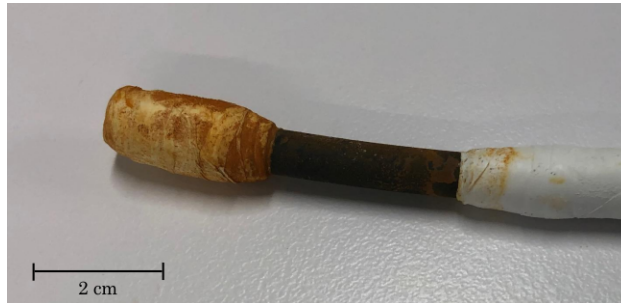
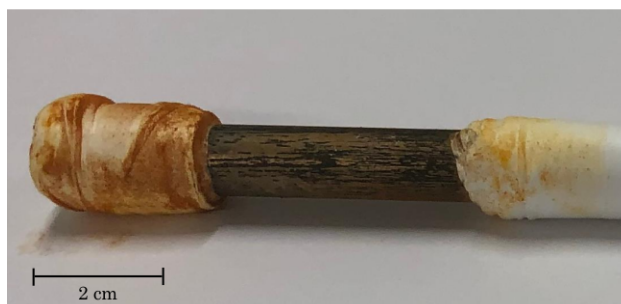
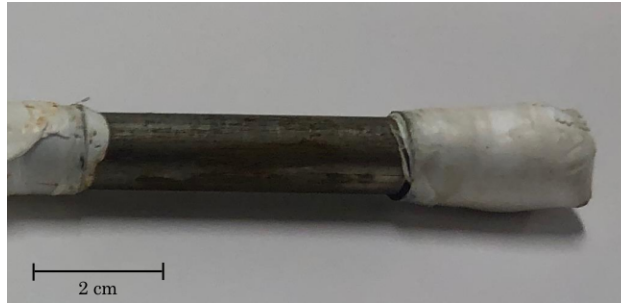
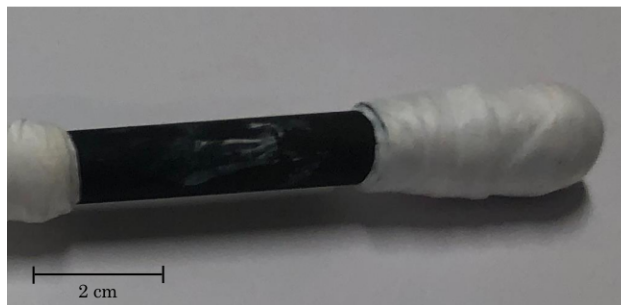
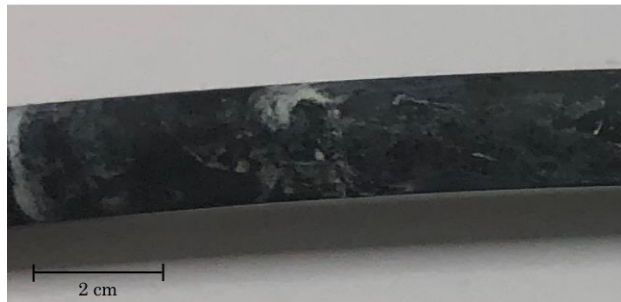
Figure 4.7: Samples after completion of CPP.

(a) As-Received ASTM A 416 wire tested in an acidic environment (pH=3.8).

(d) As-Received ASTM A 416 wire tested in a corrosive environment (pH=7).

(e) Uncoated ASTM A 416 wire tested in a corrosive environment (pH=7).

(h) Ni/Co coated wire tested in a corrosive environment (pH=7).

(i) Ni/Co coated wire tested in a simulated pore environment (pH=12).

(j) Zn/Ni coated wire tested in a corrosive environment (pH=7).

(k) Zn/Ni coated wire tested in a simulated pore environment (pH=12).

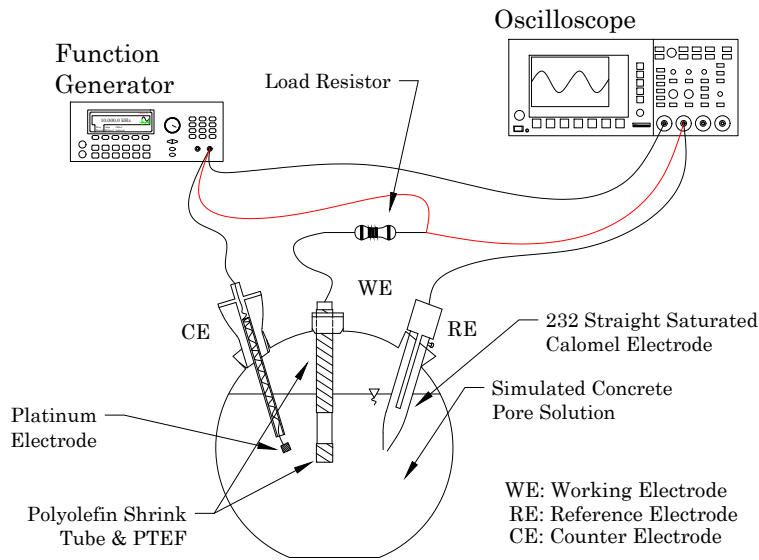
Figure 5.2: Schematic view of corrosion cell during EIS operation.

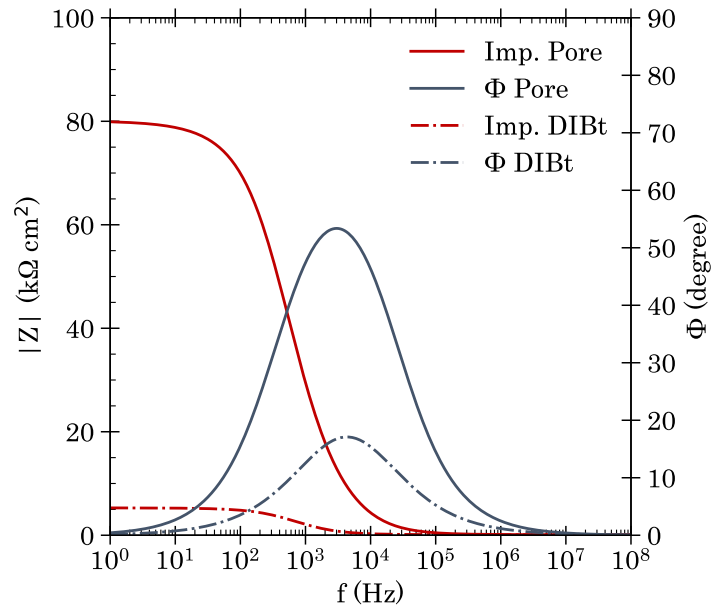
(a) As-received specimen tested in simulated pore and corrosive environments.

(b) Nickel-cobalt wire tested in simulated pore and corrosive environments.

(c) Zinc-nickel wire tested in simulated pore and corrosive environments.

(d) As-received and uncoated samples tested in simulated pore environment.

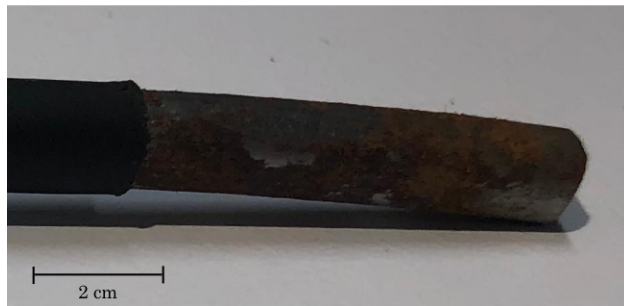
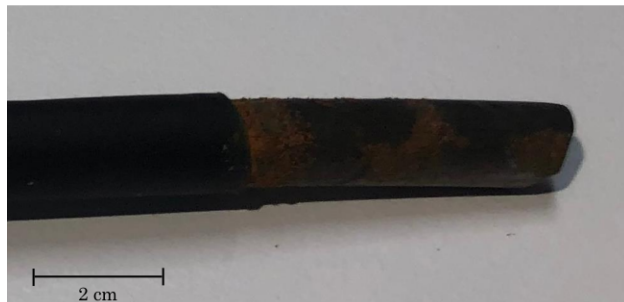
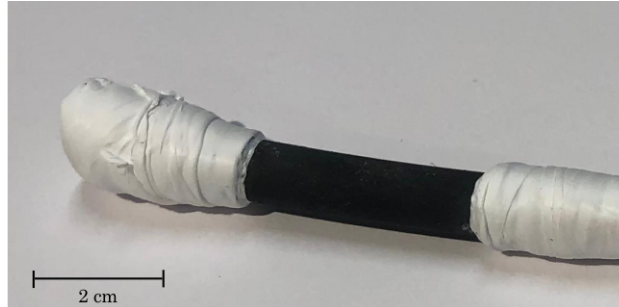
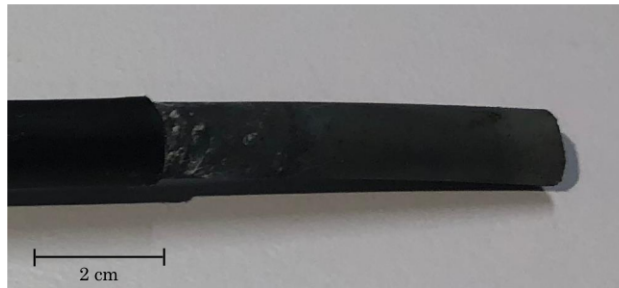
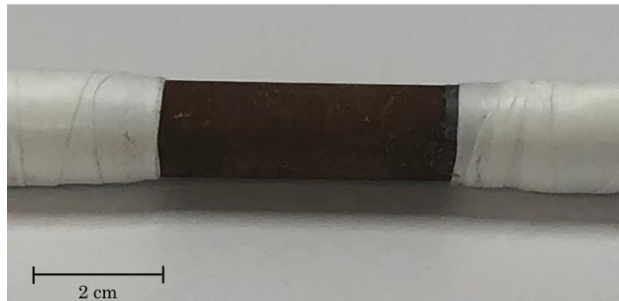
(b) Uncoated steel wire exposed to corrosive environment (pH=7).

(d) Ni/Co coated wire exposed to corrosive environment (pH=7).

(e) Zn/Ni coated wire protected in corrosive environment (pH=7).

(f) Zn/Ni coated wire exposed to corrosive environment (pH=7).

(g) Zn/Ni coated wire protected with impressed current. The potential limit to protect the sample was not achieved, causing the zinc coated layer to break off and develop uniform pits on the surface of the substrate. Pits were small and it was difficult to see with an unaided eye. After the sample was left at room temperature for a day, the uniform pits propagated throughout the surface and caused uniform corrosion.

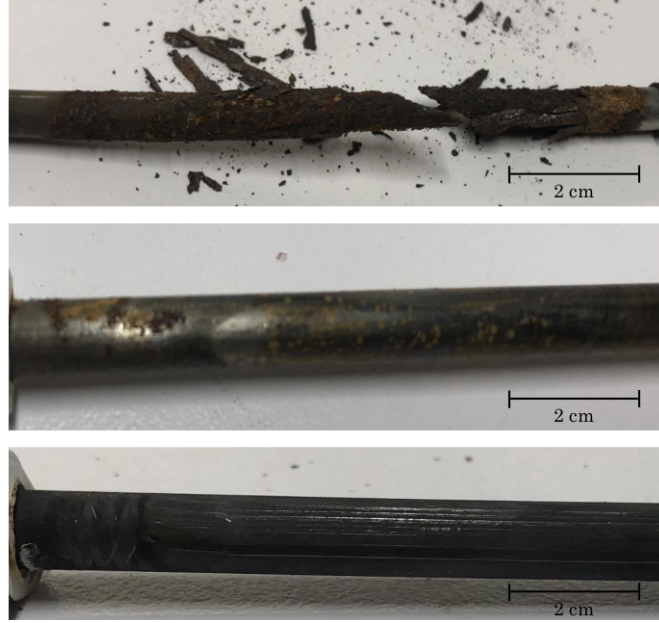
Figure 7.5: As-received specimen as well as nickel-cobalt and zinc-nickel coated wires a month after the embrittlement test, from top to bottom respectively.

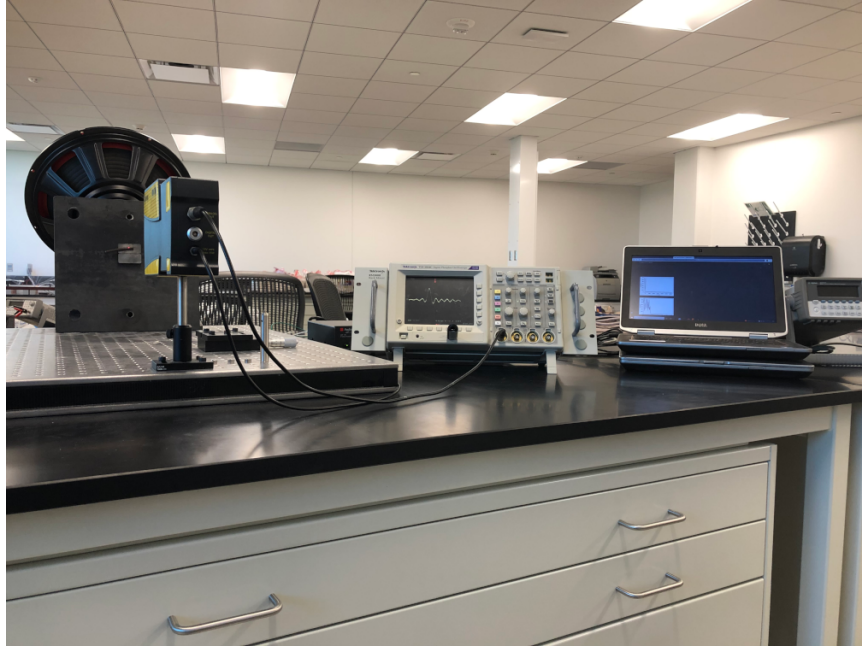
Figure 8.2: Oscilloscope visualization of the signals from the optical laser where a python script saved time domain signals in CSV files, simultaneously.
