# Air Cooled Condenser Fan Blade Failure

Cindy Li, Air Products and Chemicals

Patrick Smith, Air Products and Chemicals

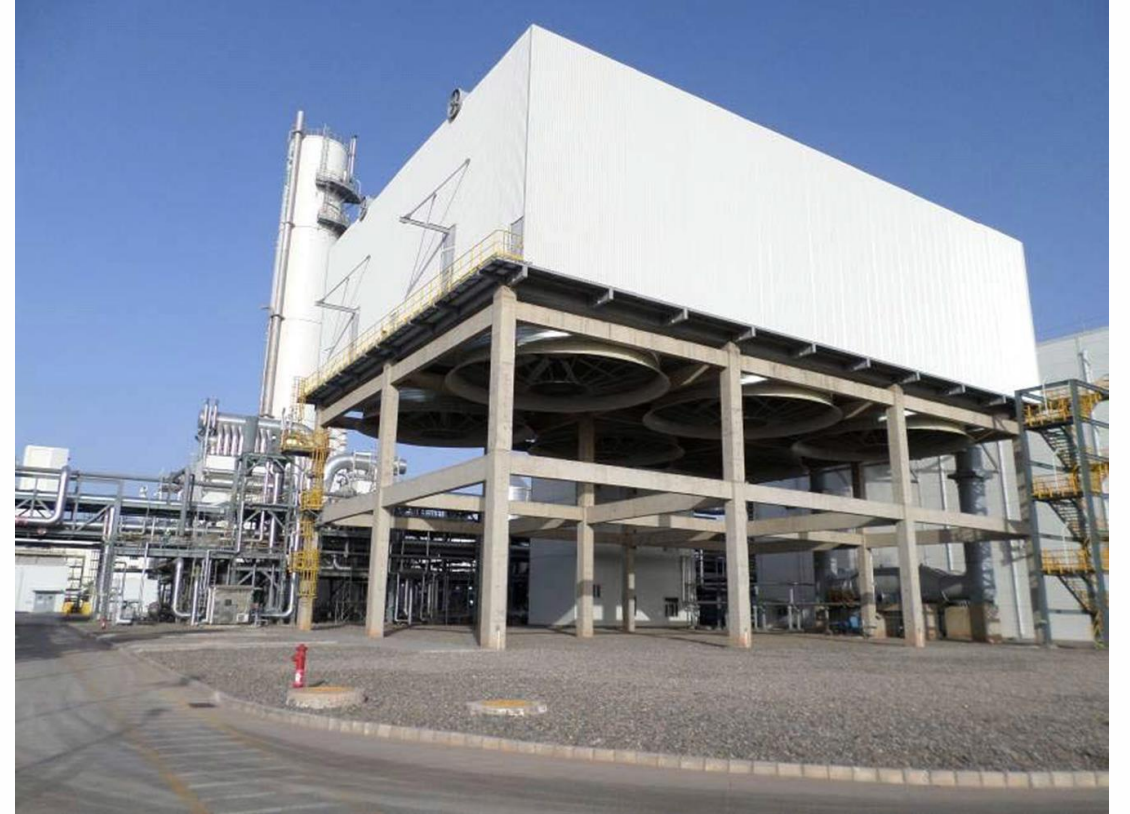
- A surface condenser is a commonly used term for a water-cooled shell and tube heat exchanger installed to condense exhaust steam from a steam turbine. These condensers convert steam from its gaseous state to its liquid state at a pressure below atmospheric pressure.
- Where cooling water is in short supply, an air-cooled condenser (ACC) is often used. An air-cooled condenser is however, significantly more expensive and cannot achieve as low a steam turbine exhaust pressure (and temperature) as a water-cooled surface condenser.
- The picture on the right shows a typical 3 cell ACC

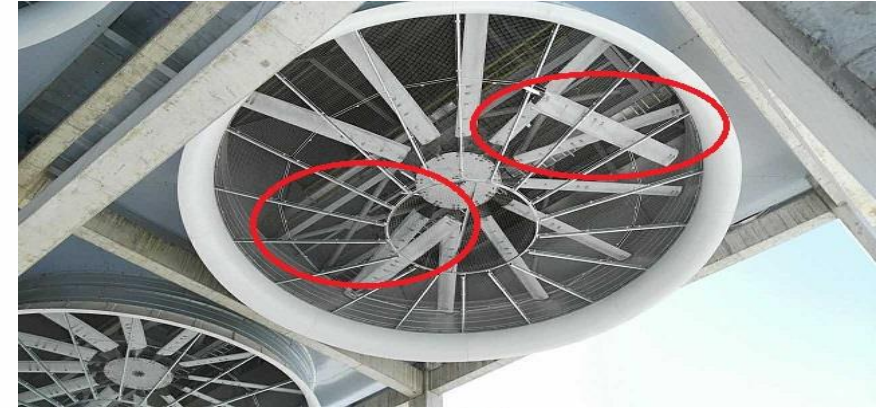
Broken Location

- ACC fan blade failures occurred on several fans at two Air Product facilities. There are multiple trains at each facility.
- The fan design and construction in all the trains was similar and all the blade failures had similar characteristics.
- Failures included broken blades, cracked blades and loose bolts.
- The failures only occurred on the variable speed fans.

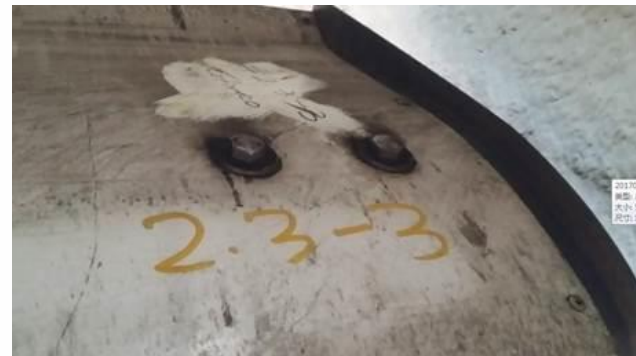
## ➤ Measurement after the modification showed a significant reduction in stress at the root of blade

*The following modifications were made at one plant to shift the blade natural frequency out of the operating speed range.*

- *Upgrade airfoil to shaft attachment bolts.*
- *Remove the ballast (weight installed at the tip of blade) on the blades driven by VFD to increase the blade natural frequency above 80 cpm.*
- *Limit the maximum fan speed to 80 rpm.*
- *Re-pitch of the blades to compensate for the design speed reduction.*
