ASIA **TURBOMACHINERY** & **PUMP** SYMPOSIUM
APRIL 2020 | KUALA LUMPUR CONVENTION CENTRE

Dry Screw Compressor Trip on Axial Displacement during Cold Start

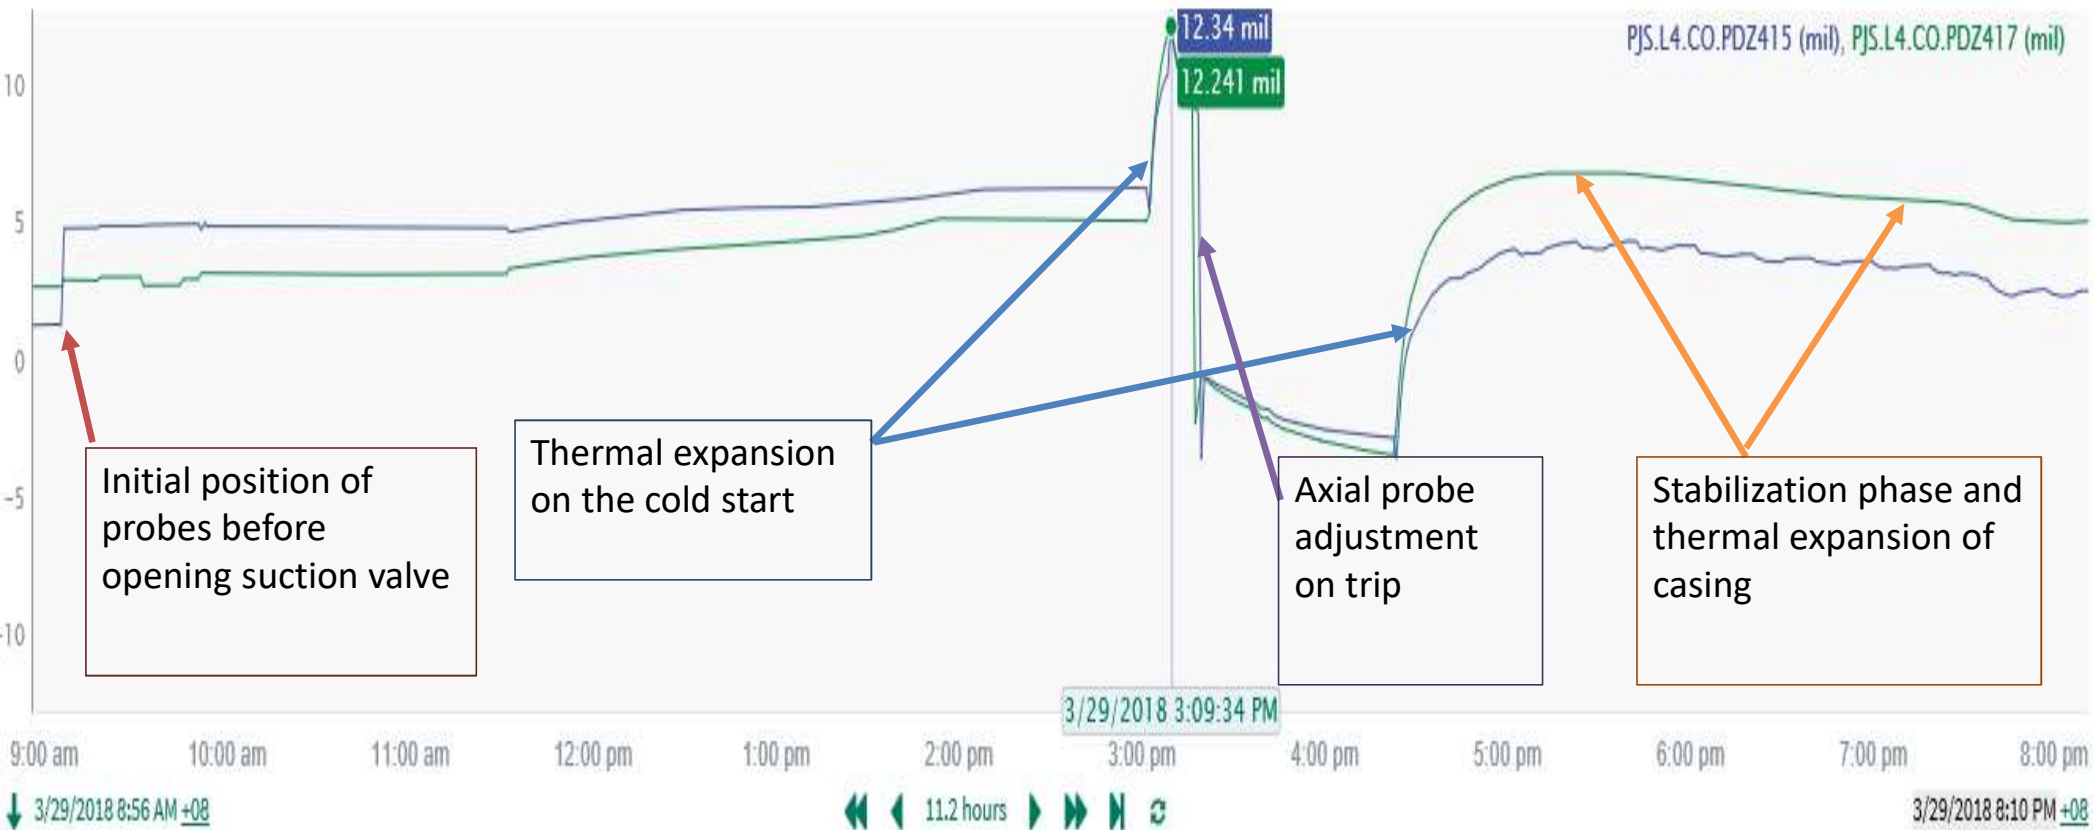
Trends

- Similar trend observed on every cold start and similar increase is observed on the stage 1 & stage 2 compressor axial position.
- During the increase of thrust position value, the thrust bearing temperatures for both stage 1 & 2 are steady and well within acceptable limits.
- Compressor radial and vibration parameters are also normal during this period.
- Above data shows that the thrust position increase during start up is not indicative of any damage to the thrust bearings or the rotors.

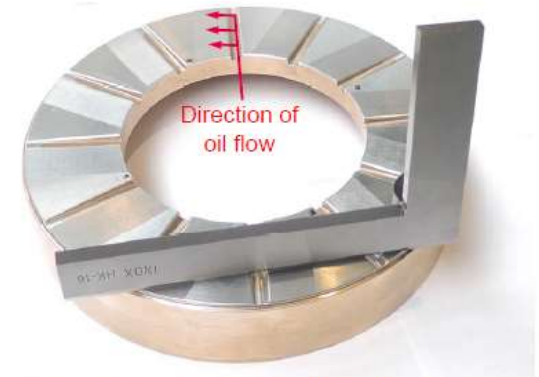
Picture 1: thrust bearing male rotor overview

- Increase in trip limits (not implemented):
 - Current trip limit is more than the thrust bearing clearance and thrust pad allowable wear.
 - Tapered land type fixed pad thrust bearing with allowable wear of 1.18 mils only. Screw clearance 4 mils.
 - Current alarm/ trip values already much more than allowable wear, hence increase of trip not logical.
