### Fast and Ultimate Vibration Field Solution: From Problem Detection to Field Performance Validation

Giancarlo Cikatelli, Bruno Schiavello

*26th International Pump Users Symposium*

During commissioning, customer reported unacceptable vibration levels on pumps tested with water.

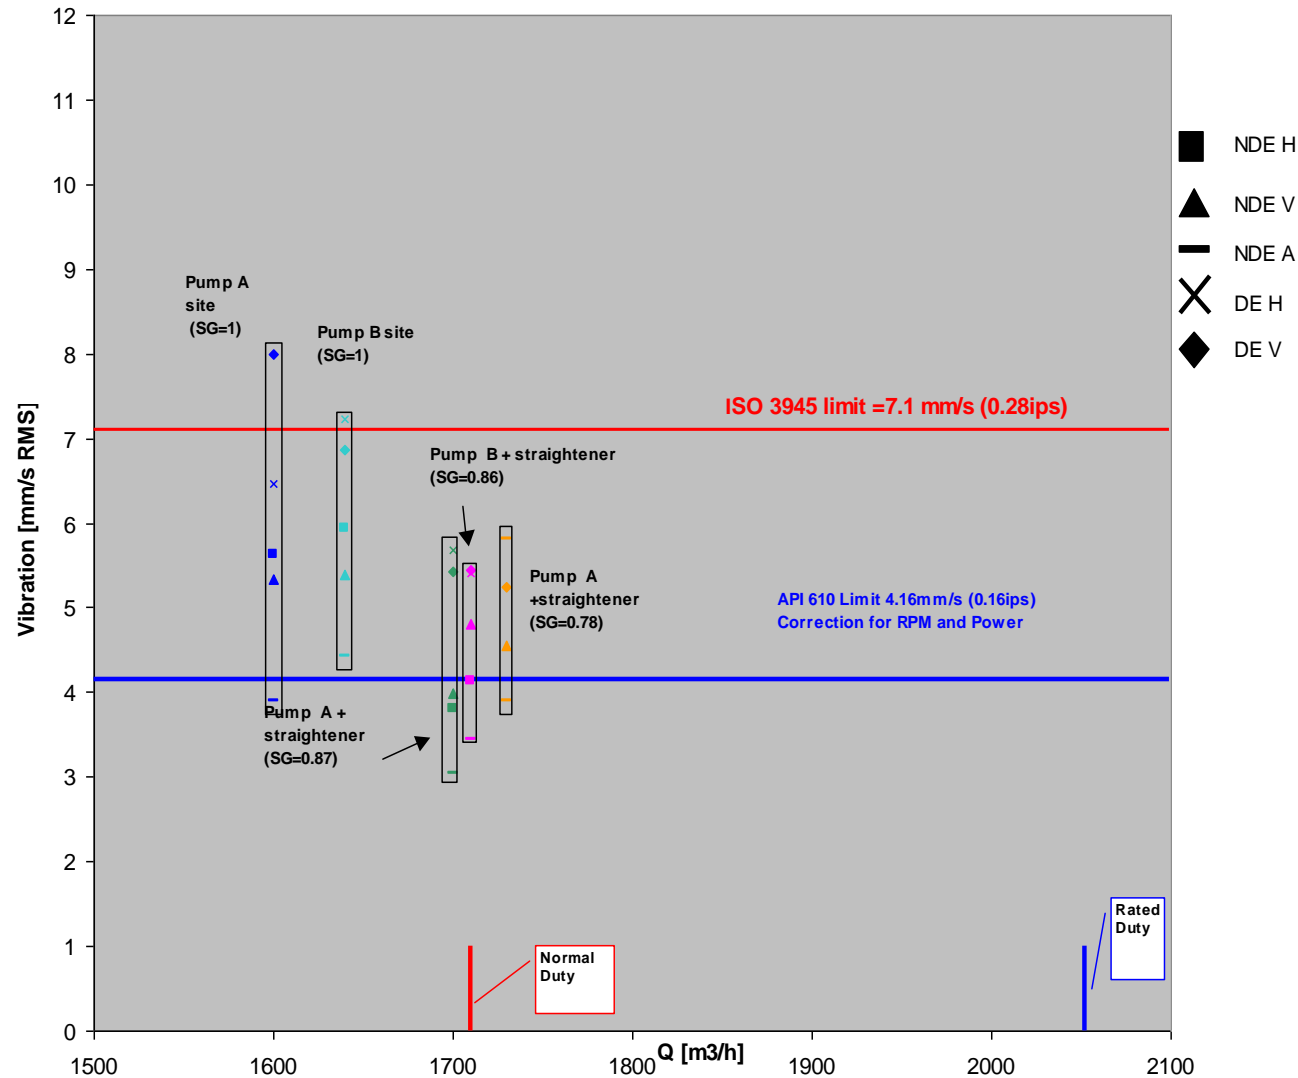
## Suction piping with flow straightener (February-March 2009)

The results of the modification showed visible reduction in vibration level, though not within the required acceptance limits.

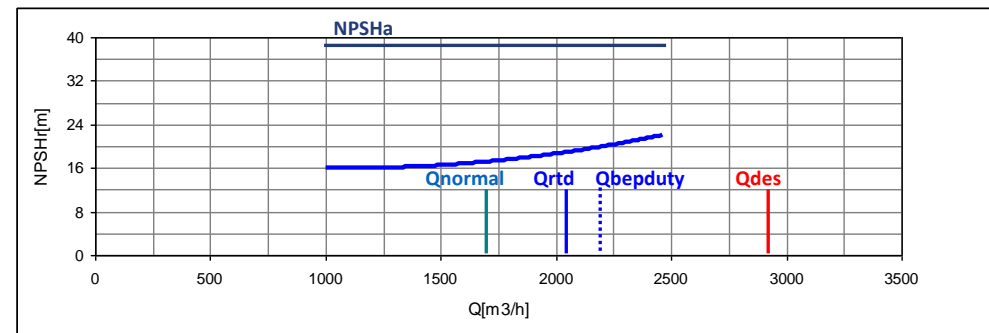
## Test Curves

Q<sub>normal</sub>/Q<sub>bepdes</sub> = 0.59 ( Too low )

Q<sub>normal</sub>/Q<sub>sl</sub> = 0.54 ( Too low )

Q<sub>n</sub> = 59% of Q<sub>des</sub> – RED FLAG

Suction recirculation is root cause  
of vibrations

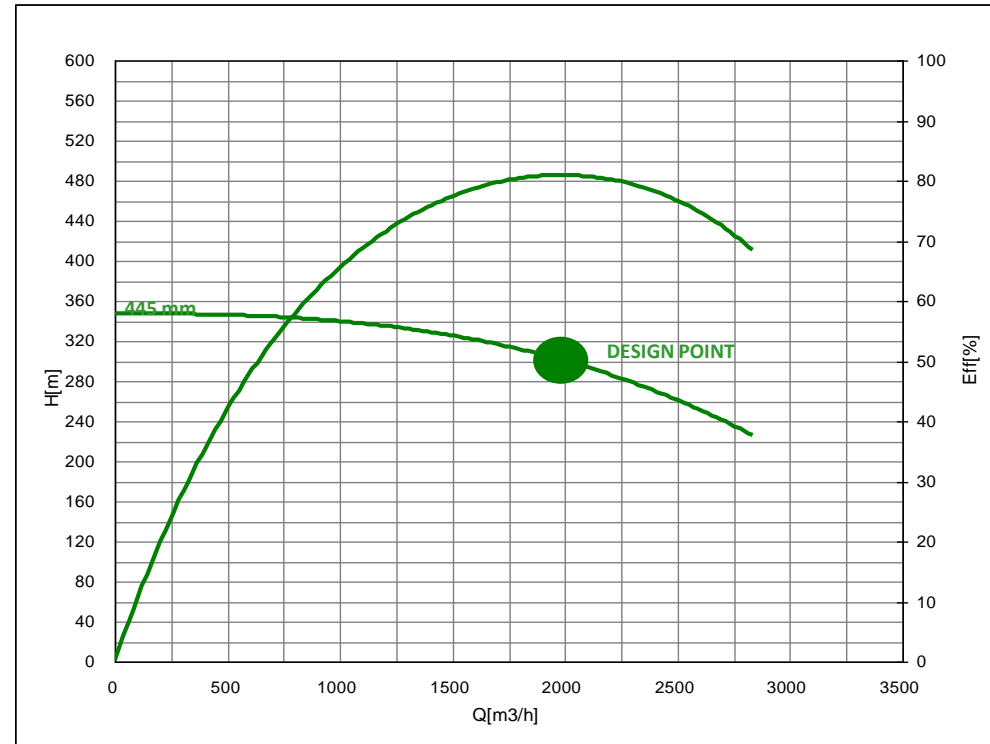
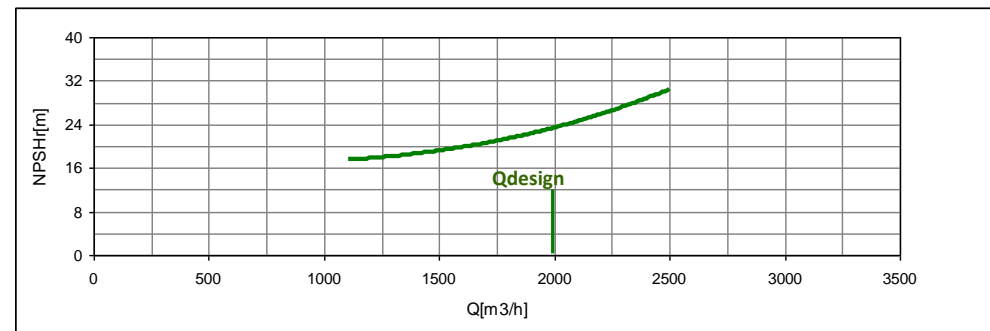
## Expected Curves

$Q = 2000$  m<sup>3</sup>/h (8810 gpm) close to rated

$Z=7$  vanes, rake - no stagger

$U_{eye} = 47.8$  m/s (157 ft/s ) (reduced)

$Q_{sr}/Q_{rated} = 0.68$  ( $\ll 1$ )

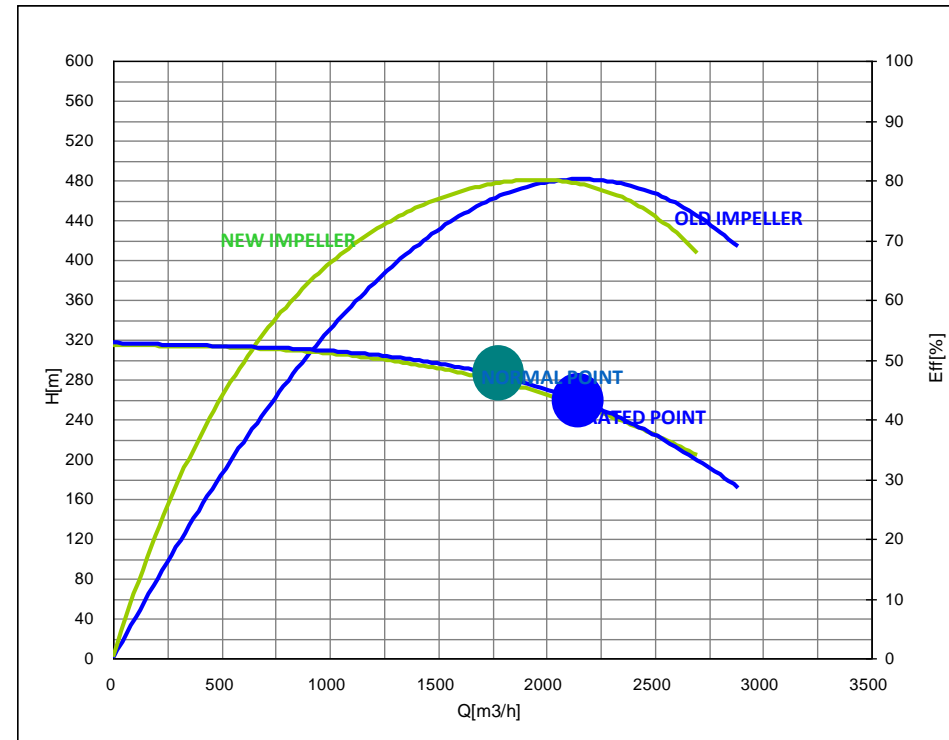
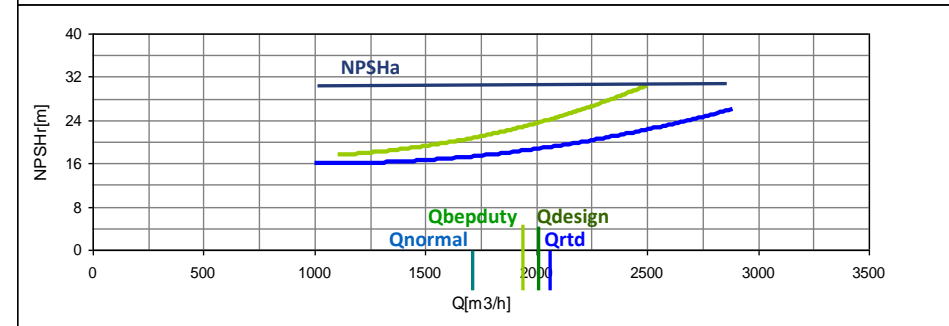
## Expected versus Test Curves

$Q_{\text{rated}}/Q_{\text{bepduty}} = 1.08 \text{ ( Good )}$

$Q_{\text{rated}}/Q_{\text{rs}} = 1.46 \text{ ( Well above suction recirculation onset )}$

No suction recirculation

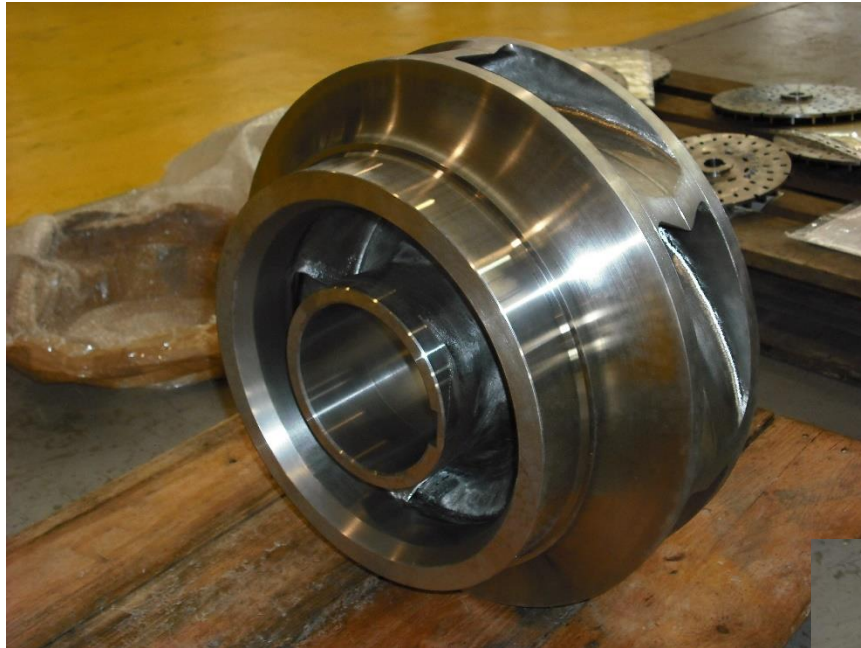
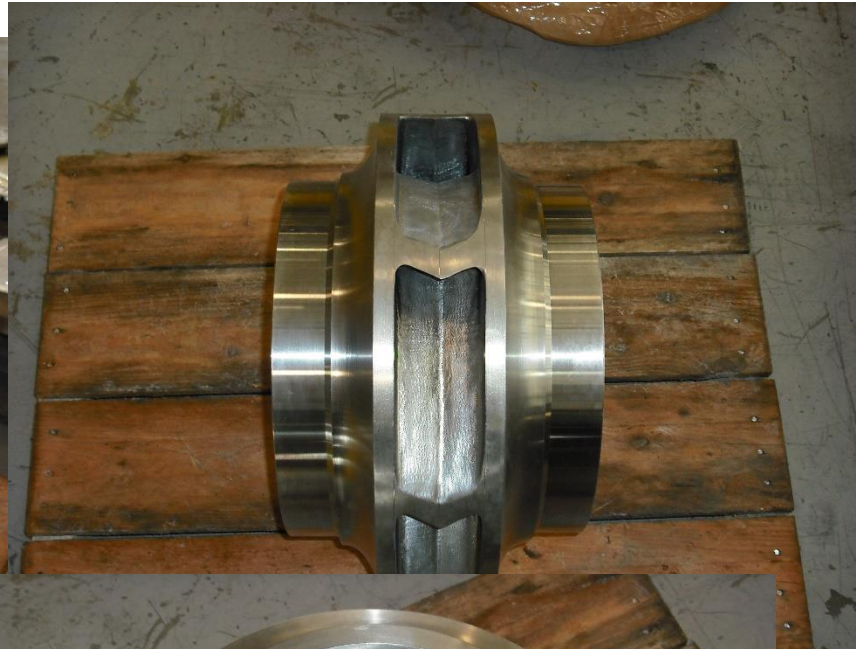
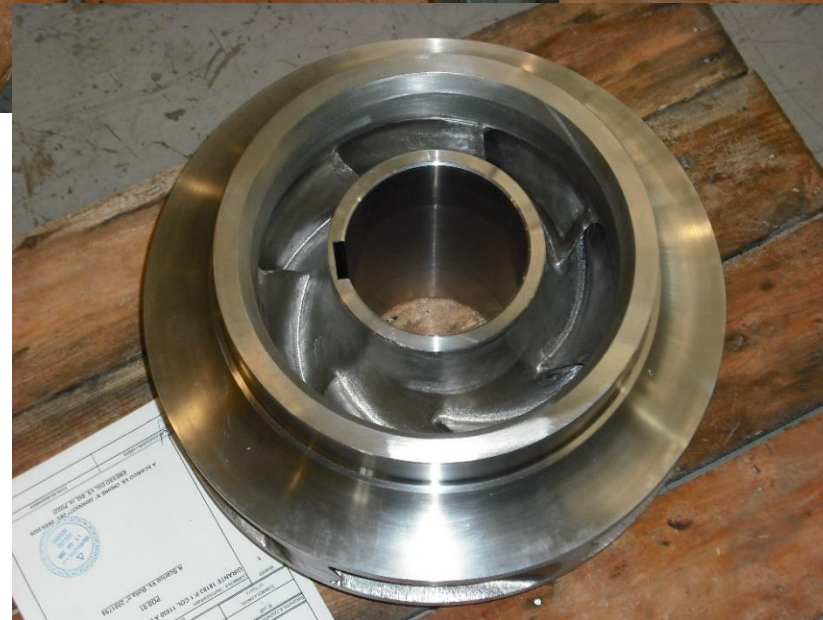
# Machined impeller as shipped (June 2009)

Remark: No shop test

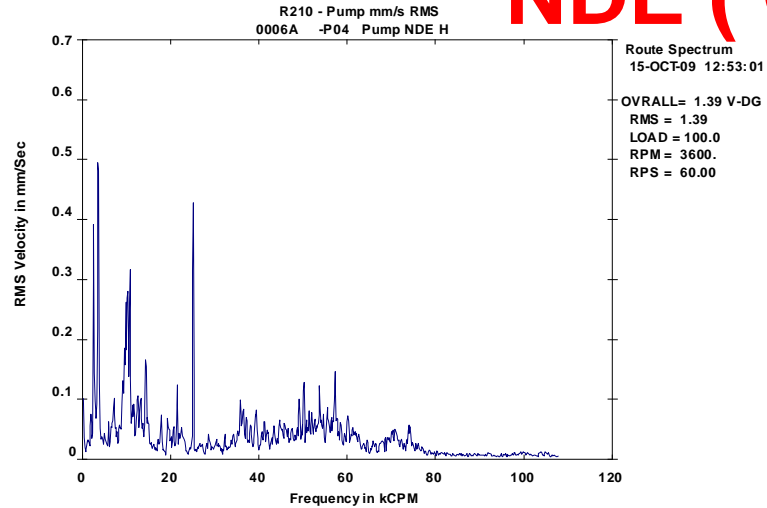
## NDE ( October 2009 )

Initial field data with old impeller

Old	New
H mm/s(ips)	5.93 (0.23)	1.39 (0.05)
V mm/s(ips)	5.39 (0.21)	3.11 (0.12)

Final field data with new impeller

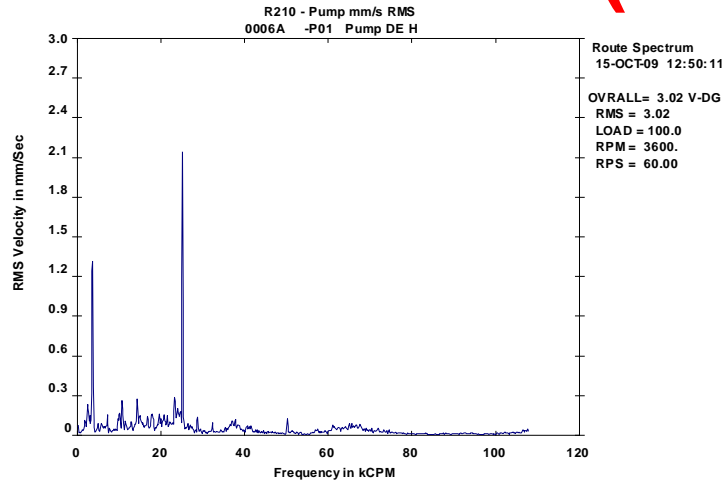
Final field data with new impeller

Initial field data with old impeller

Old	New
H mm/s(ips)	7.23 (0.28)	3.02 (0.12)
V mm/s(ips)	6.86 (0.27)	2.25 (0.09)

The new impellers have been installed in the pumps and field data show a drastic reduction of all vibration components below API acceptance level with full satisfaction of Contractor and End User for ultimate solution of pump vibrations with fast field implementation allowing the start of plant production according schedule.
