51ST TURBOMACHINERY & 38TH PUMP SYMPOSIA

Installation of a Stall Ring to Mitigate Boiler Feed Water Pump NPSH3 Requirements at Low Flow

An ubiquitous multistage boiler feed water pump for a SMR Hydrogen Plant in a refinery was specified to meet feed water requirements at plant design hydrogen capacity and at a turndown rate. During testing, it was discovered that the pump could not meet the proposed NPSH3 values at rated or low flow conditions.

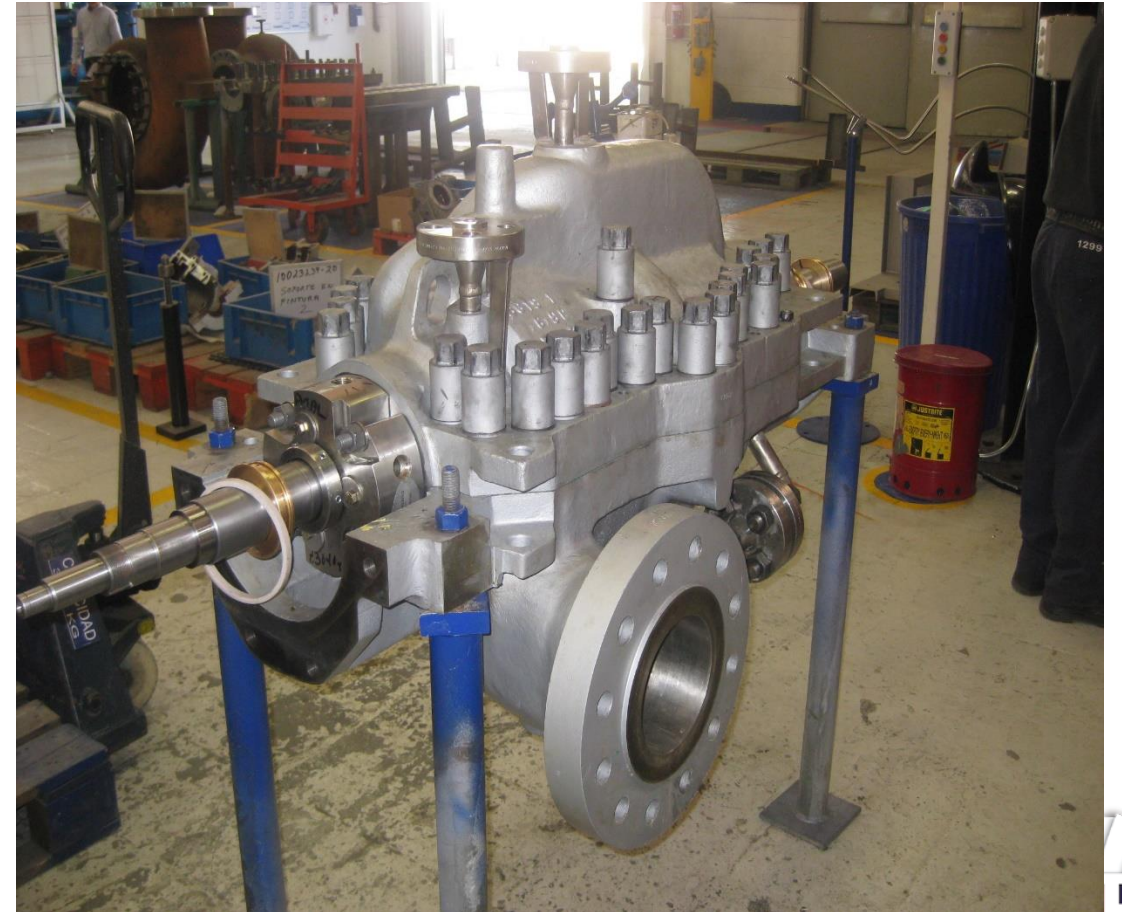
H2 Unit HPBFW Pump Proposal Conditions

- 5 Stage Horizontal Split
- Rated- 620 GPM @ 1462 TDH
- 3563 RPM, Impeller Trim 8.89”
- 1st Stage Impeller Single Suction w/ Impeller Eye Diameter- 5.5” and Shaft Diameter- 2.25”
- NPSH3- 15.2 feet at Rated Condition
- NPSH3- 11.8 feet at 240 GPM MCSF
- NPSHA- 20.8 feet
- Pumps should have adequate NPSH3 margin based on proposal data

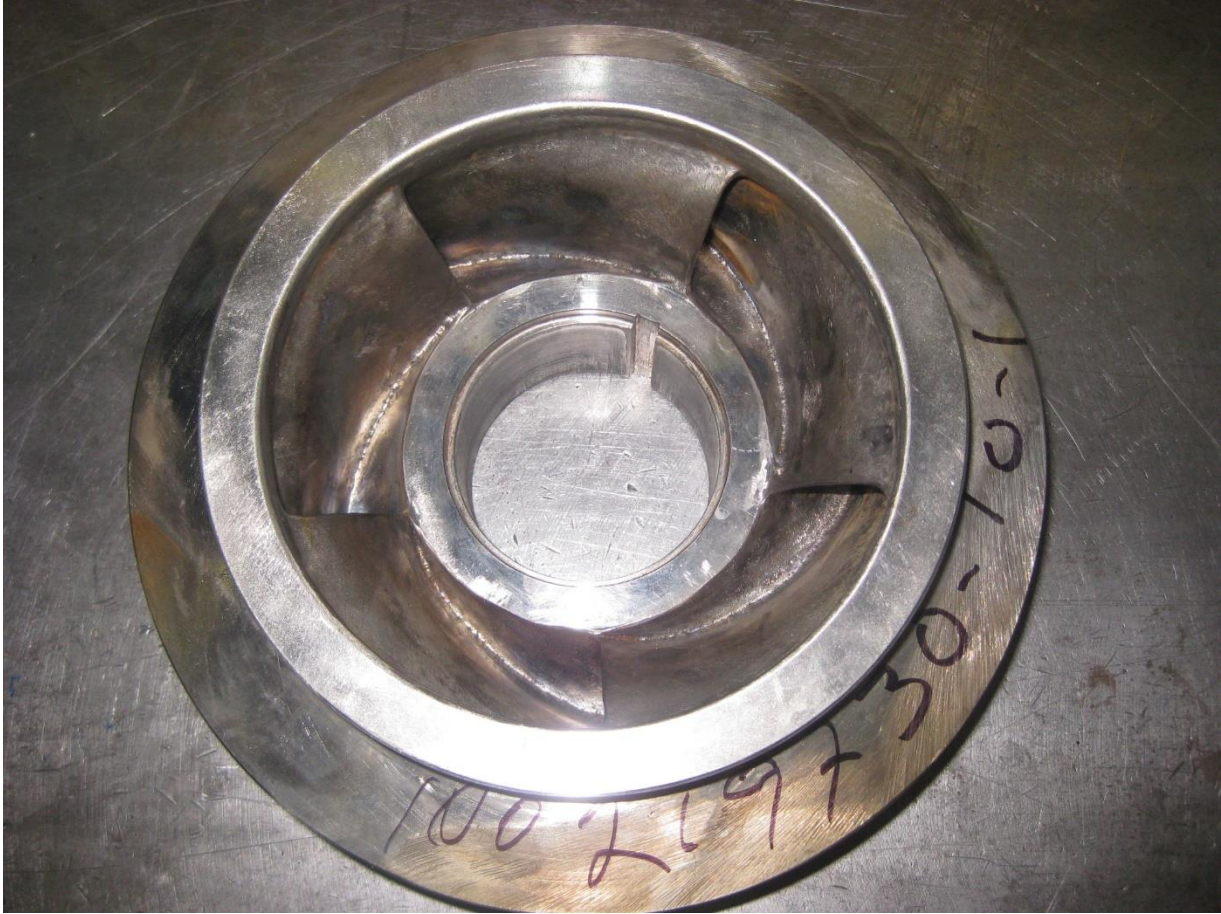
Investment Cast Impeller

- The original impellers were sand cast and there was a concern with dimensional non-conformances, vane profile, and surface finish. The first option was to provide a new investment cast 1st stage impeller and retest for NPSH3.
- The second option was to install a choke/stall ring into the eye of the 1st stage impeller. The stall ring inside diameter would be determined by iterative testing to optimize the NPSH3 from the rated point down to the MCSF.
- The new investment cast impeller was to use the same pattern dimensions as the sand cast with no changes in blade angle or profile.
- Third option would be a new impeller design with CFD modeling.

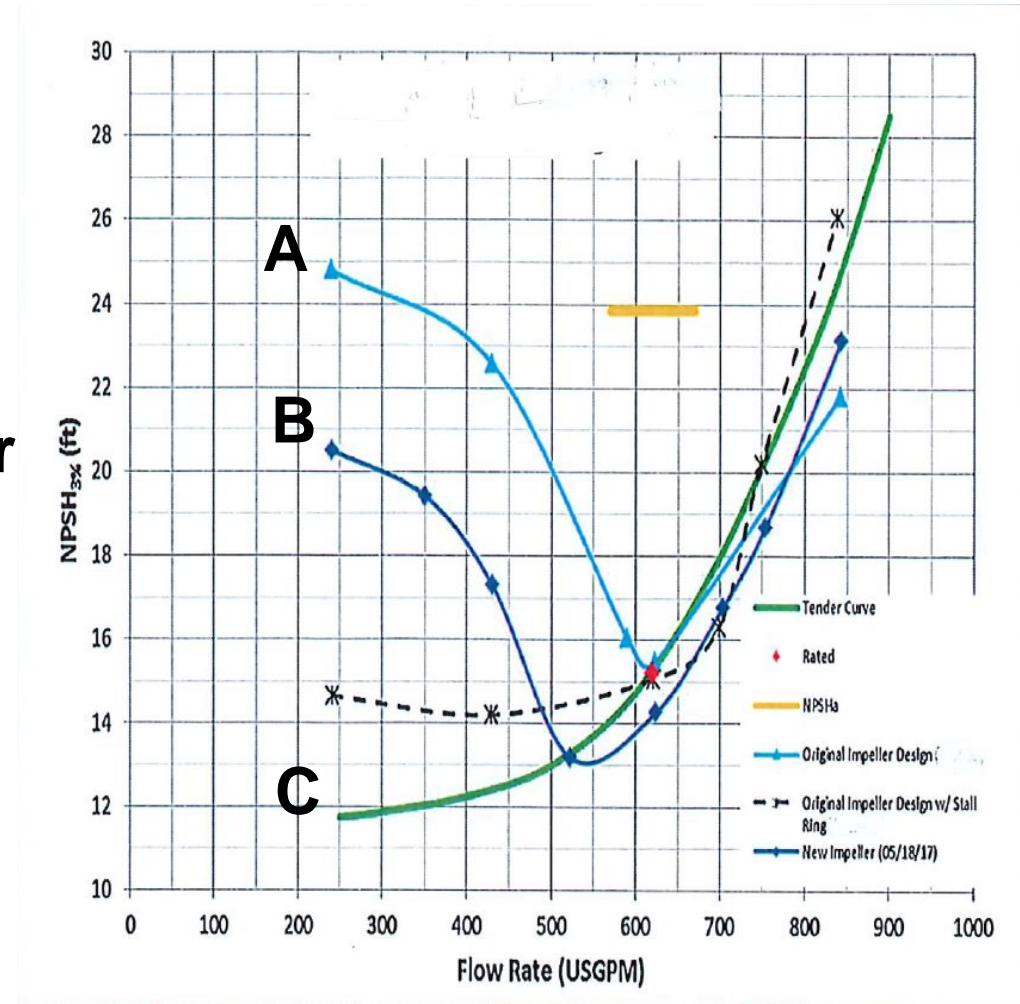
New Impeller NPSH Testing Results

- **A- Original Sand Cast Impeller NPSH₃ Curve**
 - Does not meet NPSH₃ at MCSF/Turndown Spec
- **B- New Investment Cast Impeller NPSH₃ Curve**
 - Meets NPSH₃ requirements at rated point with 6 feet margin
 - Better at Turndown, but still does not meet NPSH₃ margin.
- **C-Proposal NPSH Curve**

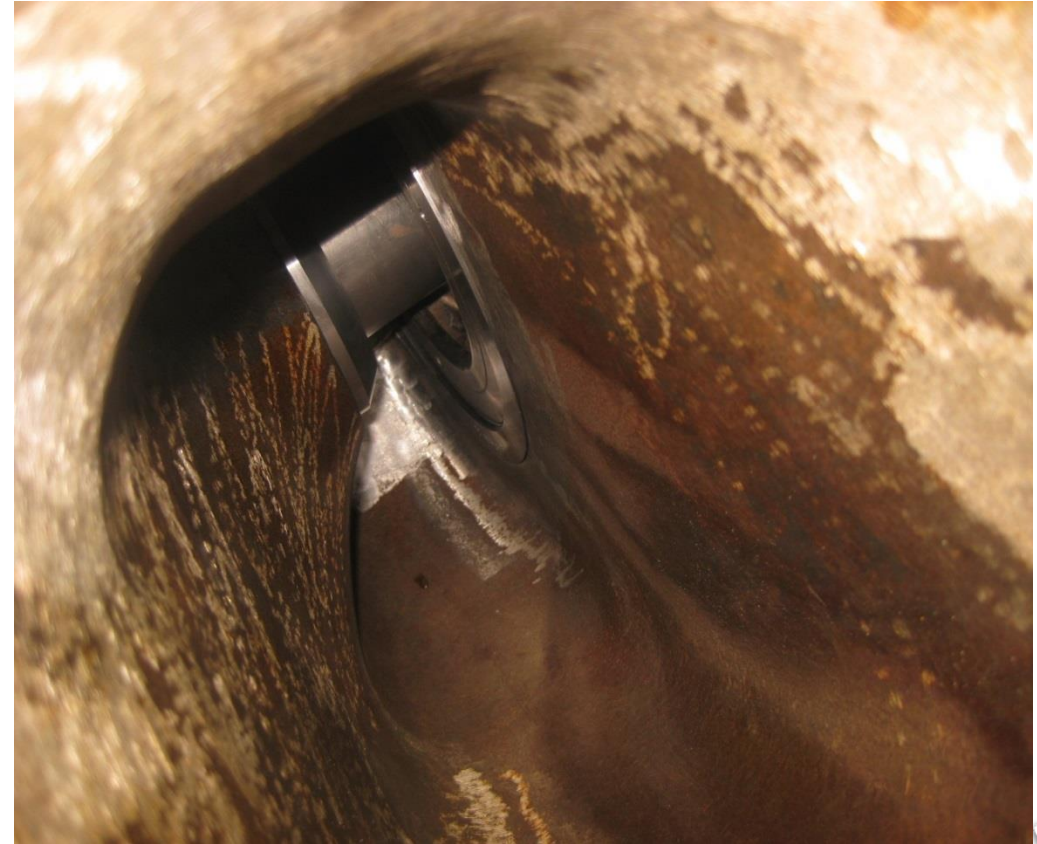
View of Stall Ring Installed in Impeller and Pump

- Pump Suction Chamber with rotor installed

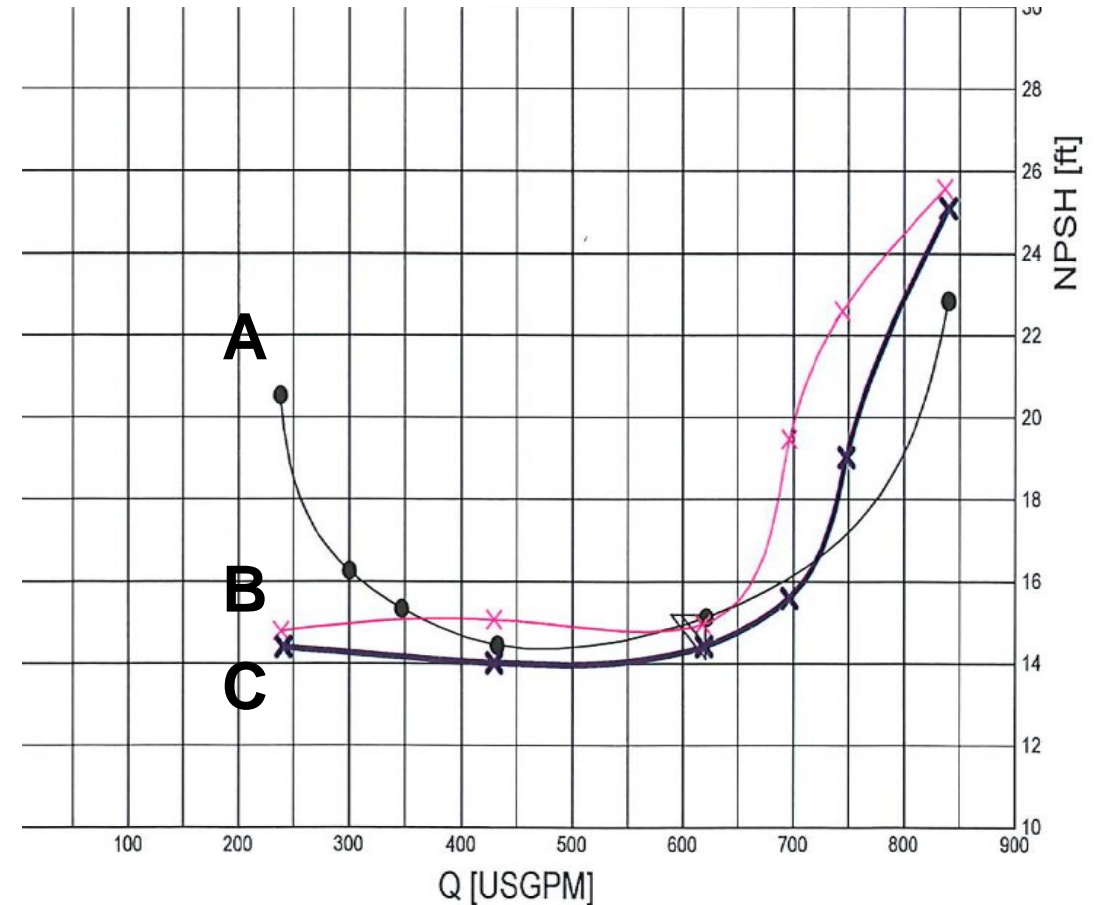
Stall Ring Test Data

- “A” Line is 5” Stall Ring
 - Margin not acceptable at Low Flow
- “B” Line is 4 ¾”
 - Acceptable at Low Flow
- “C” Line is 4 7/8”
 - Acceptable and best results
 - NPSH3 14.2’ at Rated and MCSF/Turndown
 - The process is limited above 700 GPM, but turndown to 240 GPM is required.

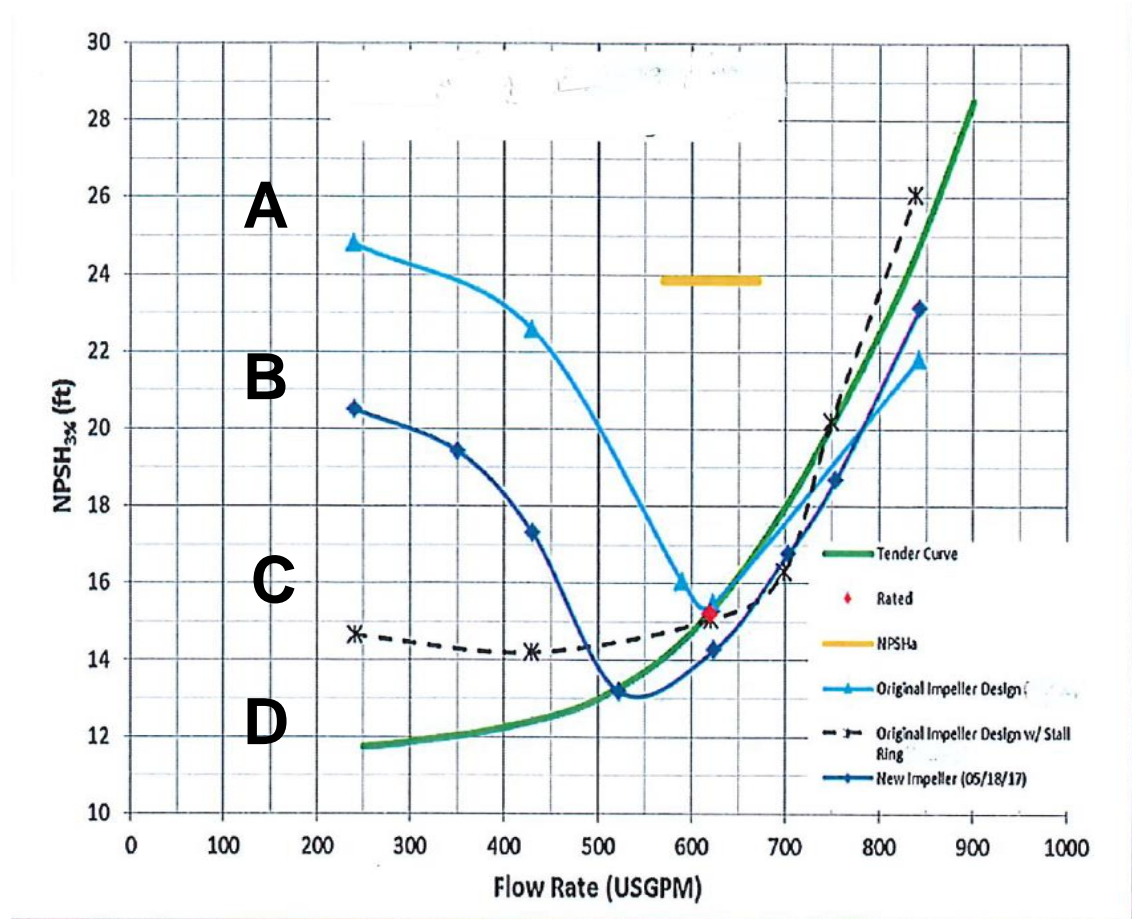
- The Installation of a stall ring proved to be a viable solution to meeting the required NPSH3 at reduced flow
- NPSH3 test results require rigorous evaluation to ensure compliance
- Purchaser should require all test data and individual test point Knee Curves
- Witness inspection of NPSH testing is invaluable for pumps in critical service
- NPSH3 testing acceptance criteria must be clearly defined on the Data Sheet and purchase documents
- Legend: **A**-Sand Cast Impeller, **B**-Investment Cast Impeller, **C**- Impeller with 4 7/8" Stall Ring, **D**- Proposal NPSH3 Curve
