CHARACTERIZATION OF WEAR AND DYNAMIC PERFORMANCE OF INTERSTAGE
SEALS FOR ELECTRIC SUBMERSIBLE PUMPS

A Thesis

Major Subject: Mechanical Engineering

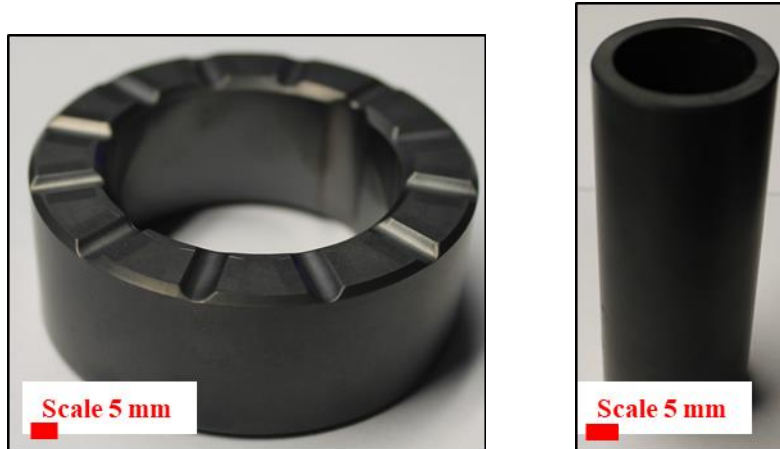
Figure 4- 1 Silicon carbide seal and shaft sleeve

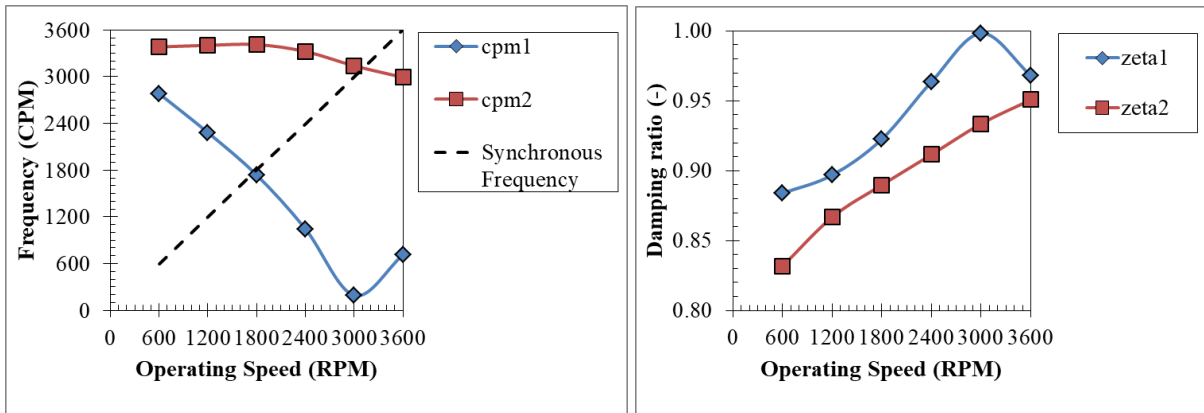
Figure 5- 1 Predicted damped natural frequencies and damping ratios for the reinforced thermoplastic seal with 127 μm radial clearance

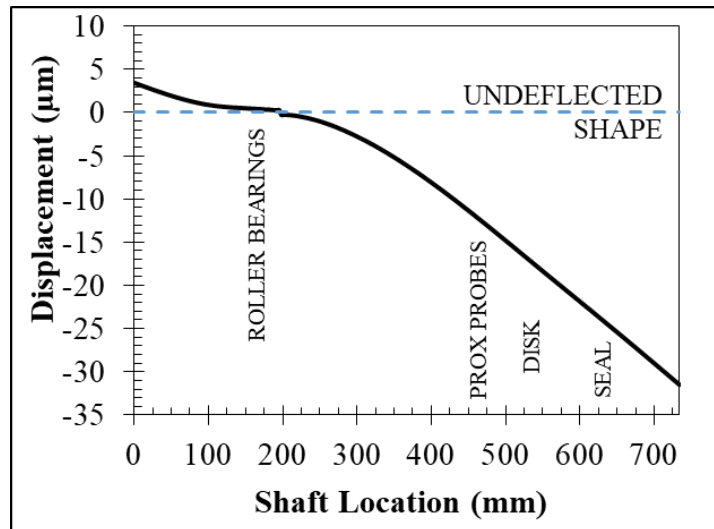
Figure 5- 2 Typical shaft vibrational mode. Roller bearings located around shaft location of 150 mm, and seal located near shaft location of 650 mm. Shown: reinforced thermoplastic seal, 76 μm radial clearance

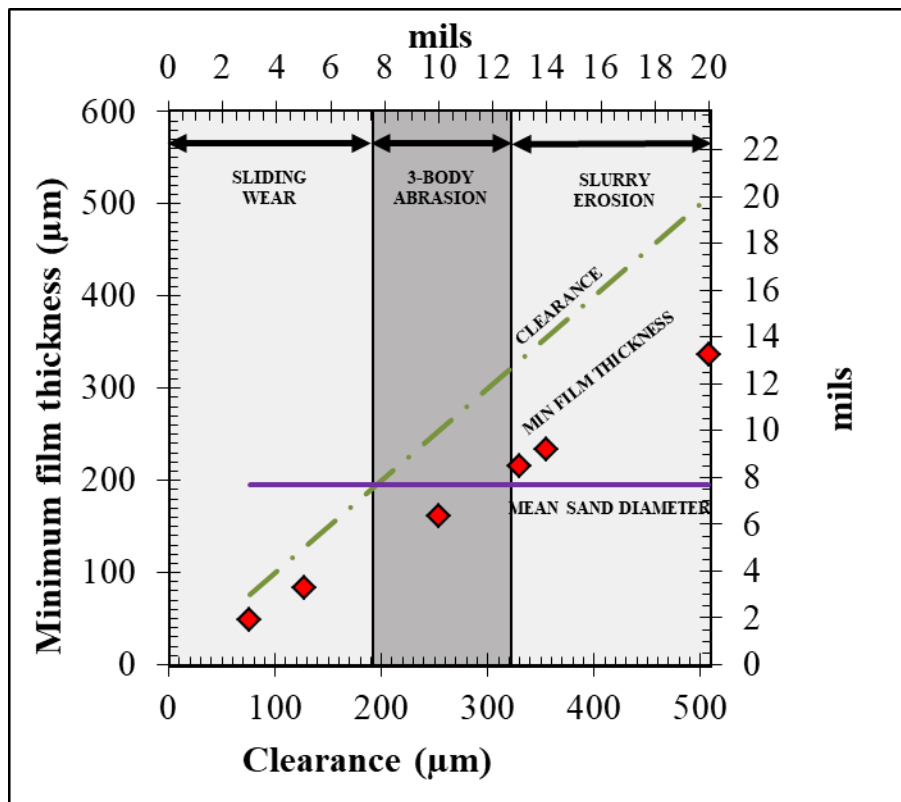
Figure 5- 5 Minimum film thickness for the reinforced thermoplastic seal using a zero eccentricity approximation at 0% GVF

making sliding wear the predicted dominant mechanism. For minimum film thicknesses greater than sand diameters, the shaft does not deflect enough to crush the sand and create three-body abrasion, making slurry erosion the predicted dominant mechanism. For clearances greater than sand diameters and minimum film thicknesses less than sand diameters, sand is crushed between the shaft and seal to produce three-body abrasion. Greater shaft displacement is predicted for higher GVFs, extending the range of clearances that produce three-body abrasion. Figure 5-7 illustrates sliding wear, three-body abrasion, and slurry erosion. Simulations indicate changes in clearances will result in changes in wear mechanisms.

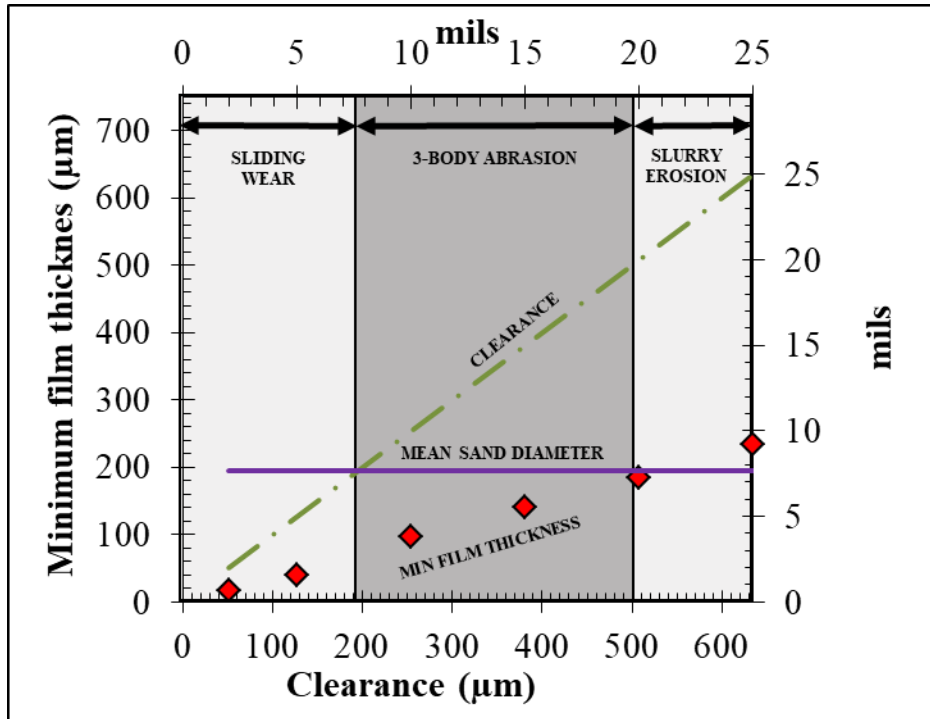
Figure 5- 6 Minimum film thickness comparison for the carbide seal using a zero eccentricity approximation at 0% GVF

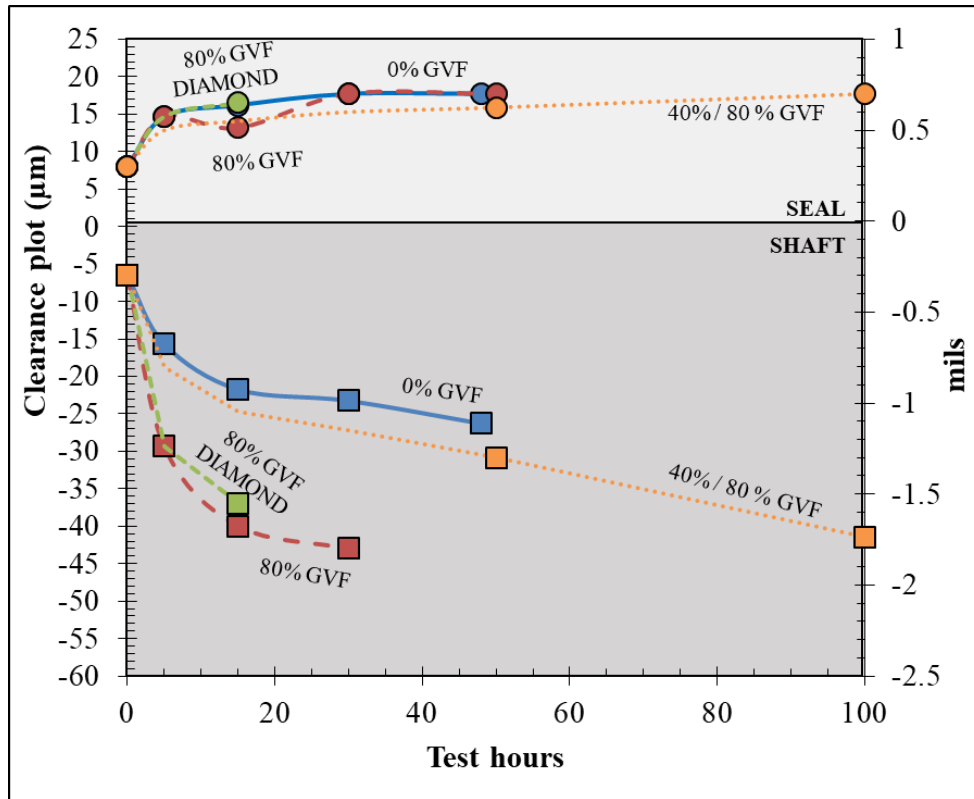
Figure 6-2 Radial clearance as a function of seal and sleeve wear for SiC seals and shaft sleeves with an initial radial clearance of 15 μm

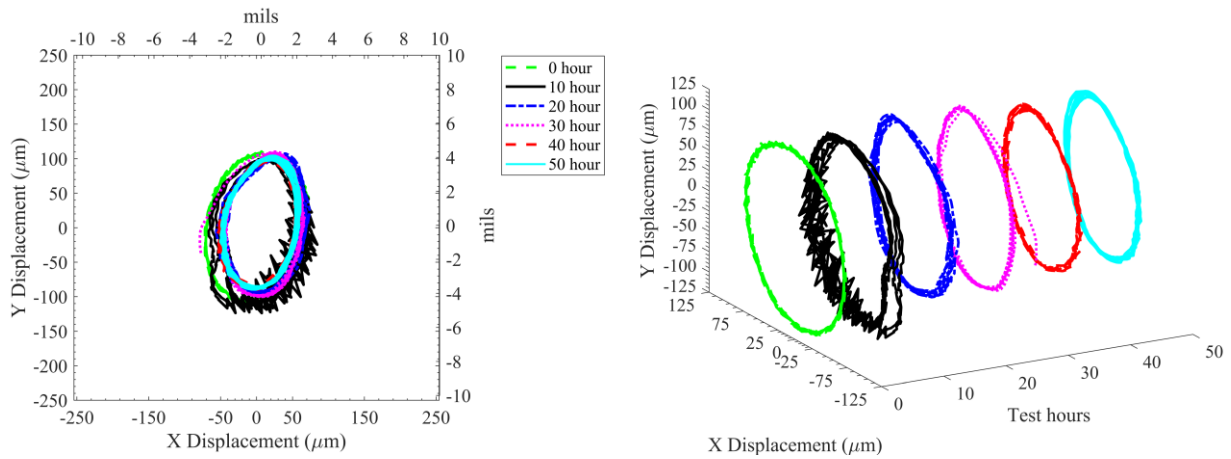
Figure 6- 3 Unbalanced disk vibrational orbit response over the duration of SiC test 1 (0 % GVF) with an initial radial clearance of 15 μm

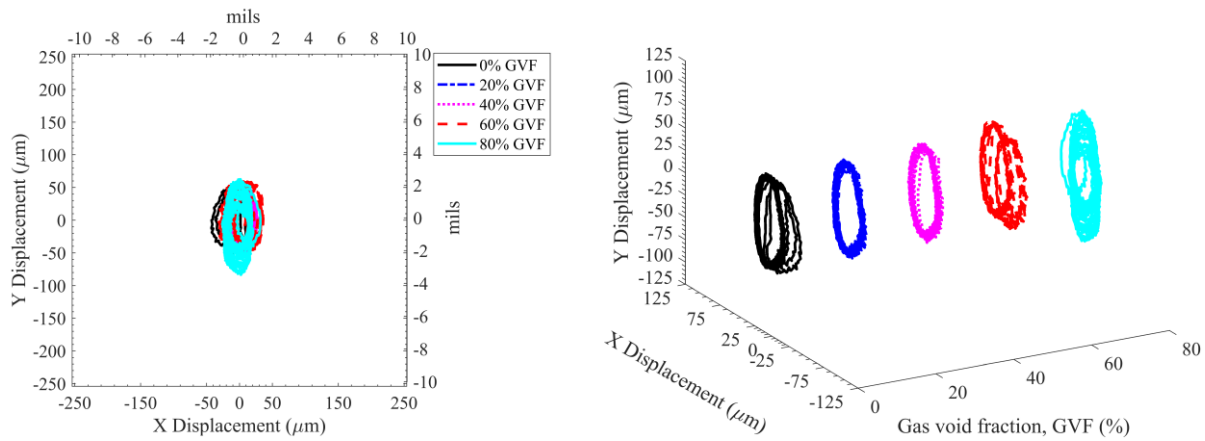
Figure 6- 7 Unbalanced disk vibration orbit at different GVFs during test 4 after 30 hours of operation with an initial radial clearance of 15 μm

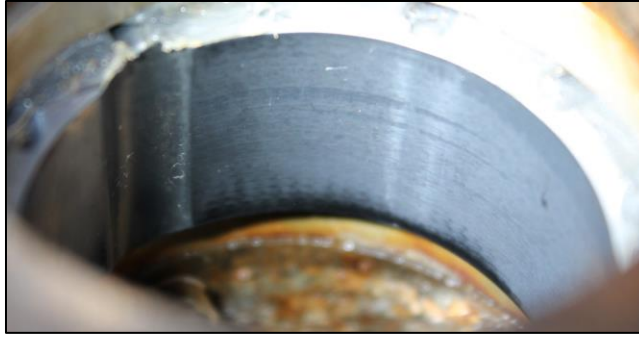
Figure 6- 10 Seal polishing after 50 hours of operation from SiC test no. 4 with an initial radial clearance of 15 μm

Polishing decreases the coefficient of friction and the film thickness required to prevent sliding wear. Polishing on a 120° portion of the shaft sleeve indicates non-stationary contact occurred, where the point of contact between the shaft and seal rotate around the seal with the rotor unbalance. Unlike tungsten carbide seals tested by Morrison et al. [4], SiC materials exhibited no signs of heat checking.

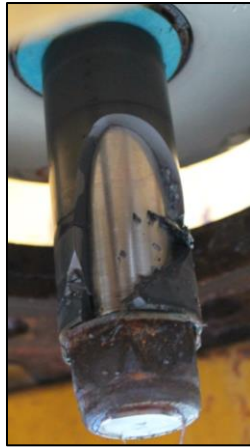
a) Test 2 fracture

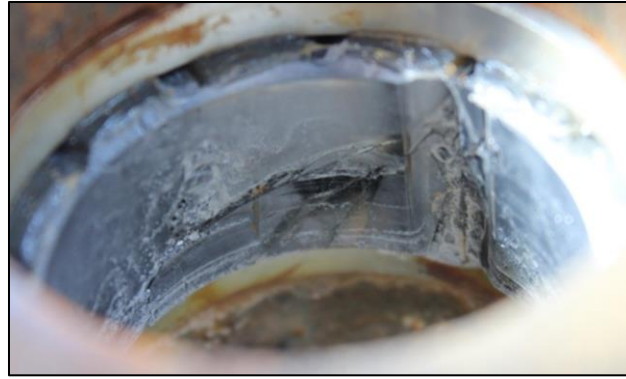
b) Test 4 fracture

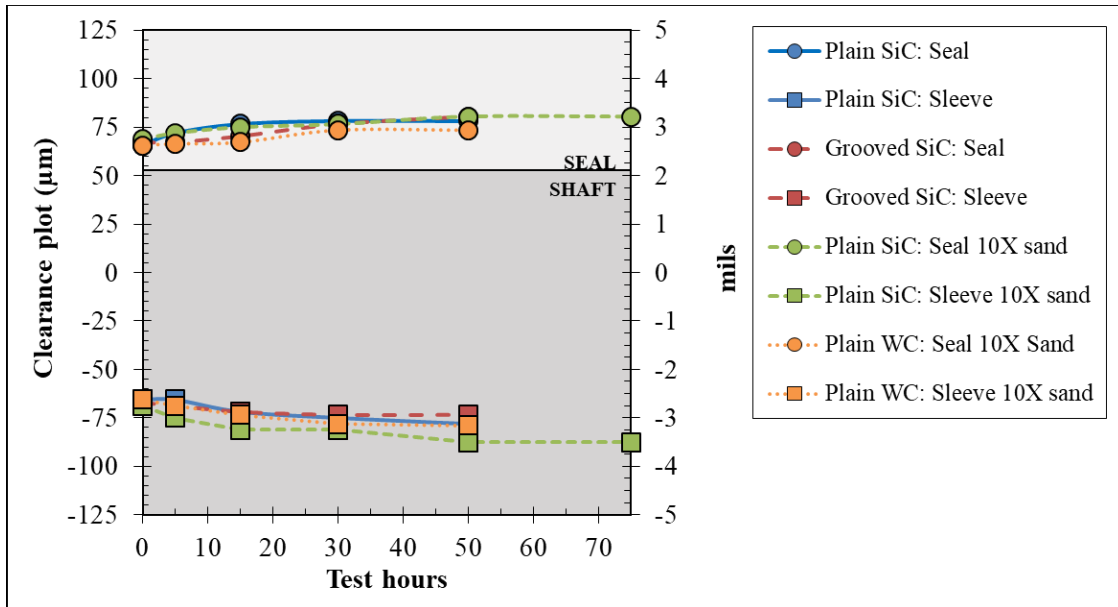
Figure 6- 13 Radial clearance as a function of seal and shaft sleeve wear for carbide tests with an initial radial clearance of 127 µm

Figure 6-12 shows the radial clearance as a function of test hours. Axial grooves negligibly impact wear rate. Higher sand concentrations slightly increase wear rate, but not by an appreciable amount. This suggests the majority of wear results from sliding wear rather than three-body abrasion. WC performs slightly better than SiC, but by a negligible amount of roughly 20 μm over 50 hours. Figure 6-13 shows wear is distributed between the seal and shaft sleeve.

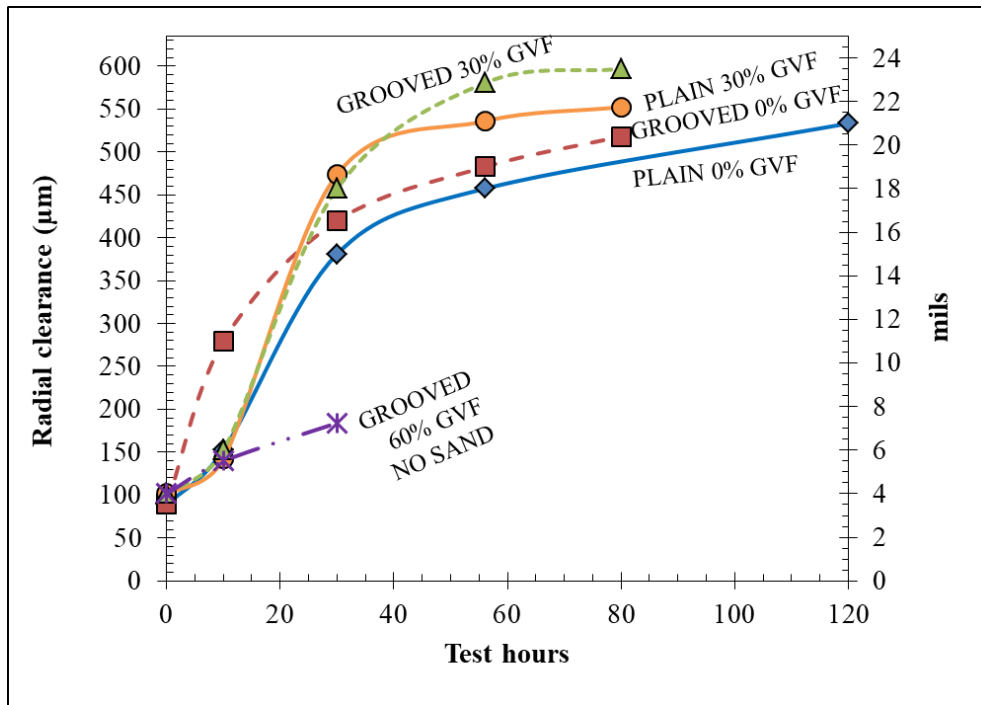
Figure 6- 17 Wet radial clearance as a function of test hours for reinforced thermoplastic I tests

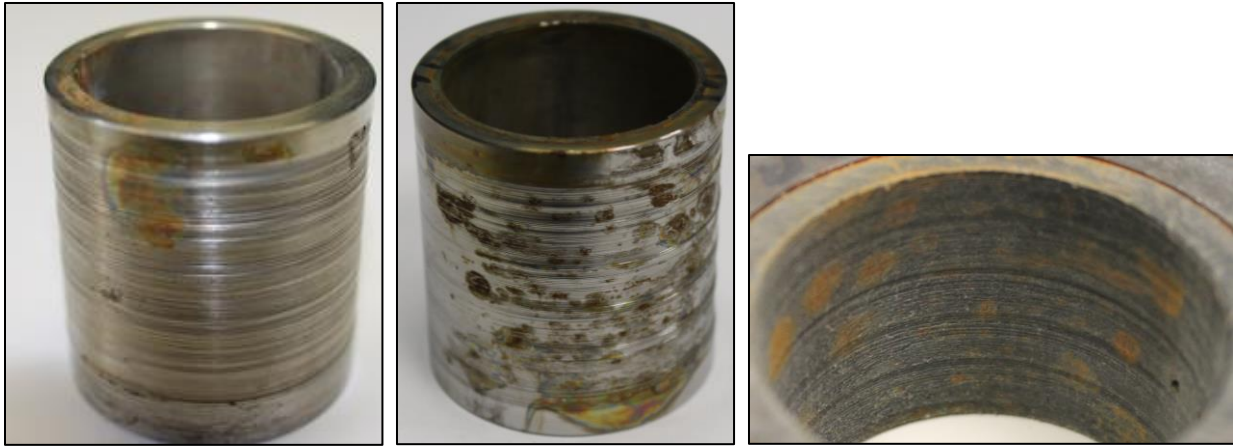
a) 30% GVF sleeve (test 3) b) 60% GVF sleeve (test 5) c) 60% GVF seal (test 5)

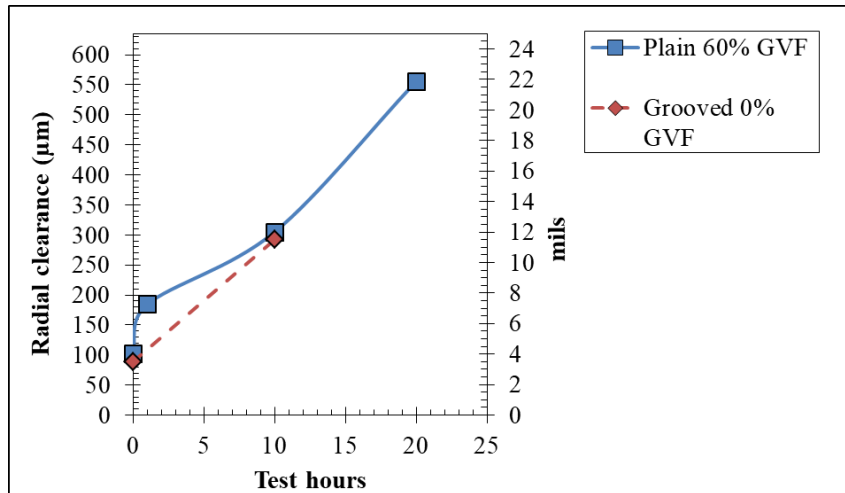
Figure 6- 28 Wet radial clearance as a function of test hours for aborted reinforced thermoplastic I tests
