DEVELOPMENT OF A HIGH LOAD CAPACITY TEST RIG TO EVALUATE THE STATIC
PERFORMANCE OF PROCESS FLUID LUBRICATED THRUST BEARINGS

A Thesis

ZHENG BIAN

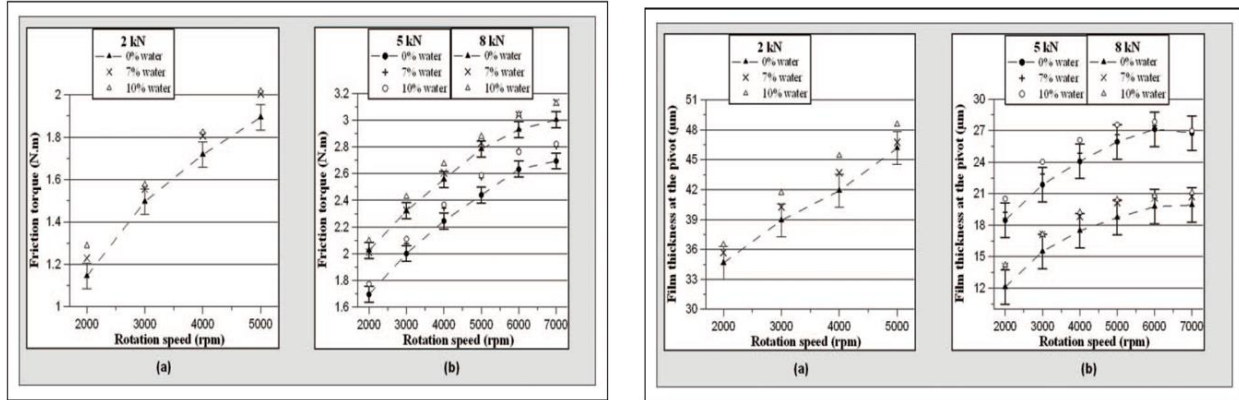
Figure 1 Friction torque and film thickness for 0%, 7%, and 10% water emulsion by weight [5]

The concept of water-in-oil lubricant contamination is often viewed as a negative issue in any rotating machinery that lubricates with one but processes the other; however, Harika [5] et al. examined the impact of water contamination in oil lubricants and found positive effects on load capacity when the emulsion is properly handled. Proper design and modeling of the hydrodynamic film can prevent cavitation of the fluid mixture while inhibitors can be added to prevent chemical reactions such as oxidation. Figure 1 shows experimental results demonstrating that an oil mixture with 10% water emulsion by mass exhibits higher film thickness, friction torque, and lower temperatures than the pure oil.

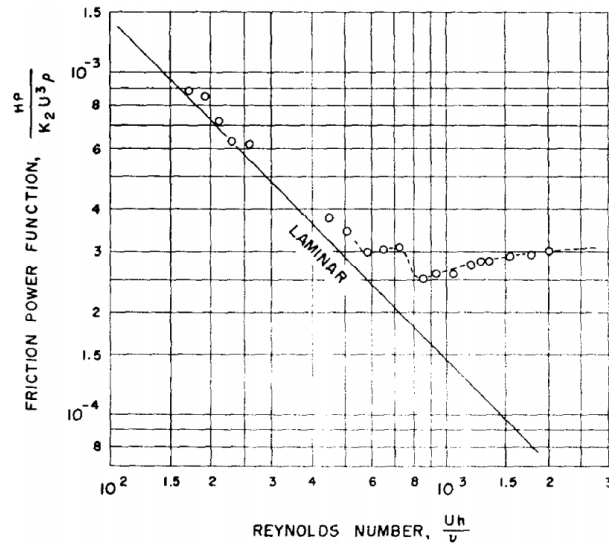
Figure 2 Friction torque vs Reynolds number for water lubrication showing the torque effects when transitioning from laminar to turbulent flow [11]

When lubricating with water instead of oil, the lower viscosity will generate high Reynolds numbers and lead to turbulent flow; however, while turbulence is negative for oil lubrication, it can be potentially beneficial in water lubrication [10]. Deng et al. conducted a numerical study and found the minimum film thickness increased with turbulence and decreased with stronger inertial effects. Abramovitz [11] experimentally found an increase in friction torque once the Reynolds number passed a certain value deemed to be the boundary between laminar and turbulent flow.

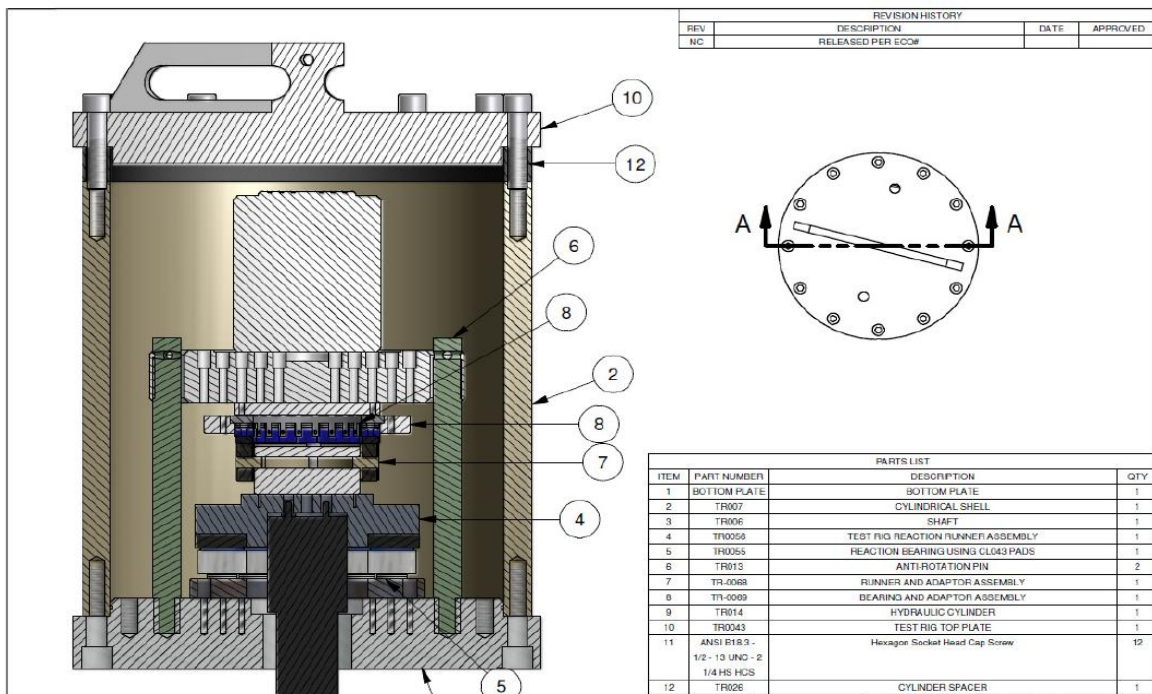
Figure 3 Russell's thrust bearing test rig cross section with labeled components [20]

A review of the existing literature on test rig construction for thrust bearings follows. Russell [20] created a robust yet simple test rig that allowed the testing of ball bearings, mixed lubrication PCD bearings, and hydrodynamic bearings at a variety of loads and speeds. The test rig is a vertical chamber flooded with lubricant and uses hydraulic cylinders to supply the load. The motor is mounted beneath the rig and slave bearing tilting pads handle the reaction load. The test rig, pictured in Figure 3, can provide thrust loads of up to 7000 lbs (31.1 kN) and speeds of up to 1000 RPM.

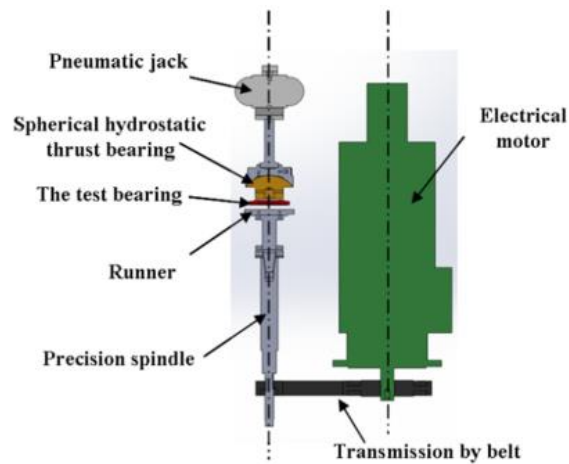
Figure 4 Harika's test rig schematic for water oil contamination with notable features captioned [6]

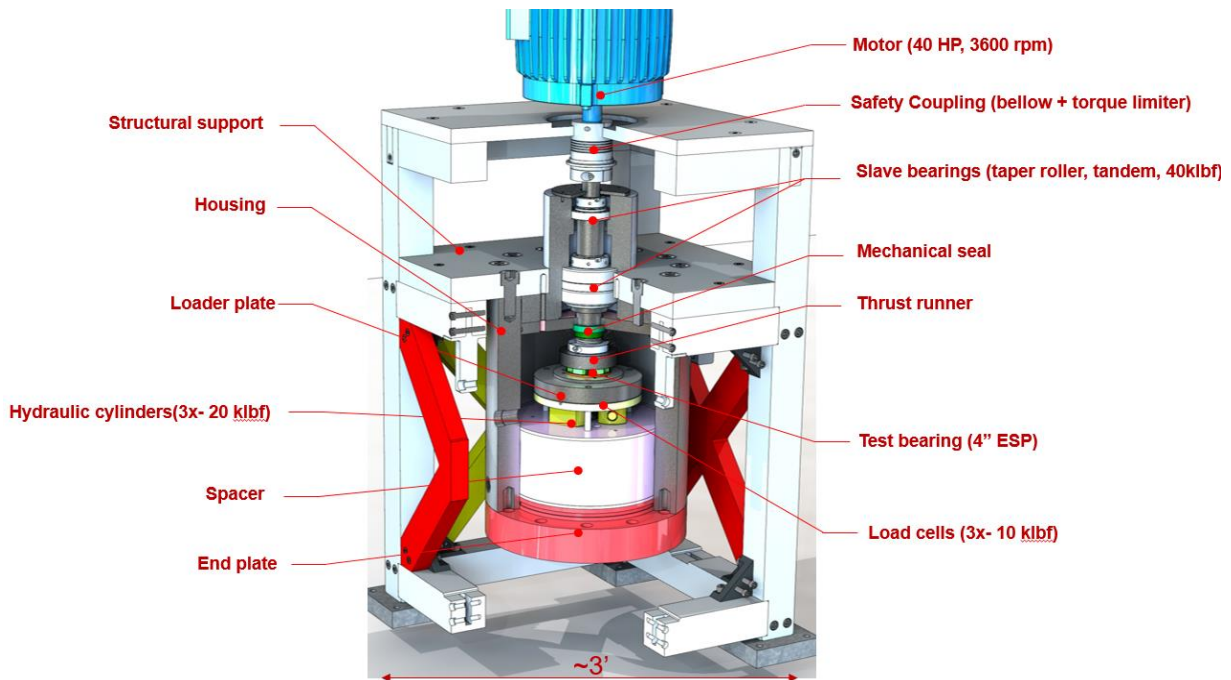
Figure 5 Proposed test rig schematic detailing main components

Figure 5 shows a partial cut view of the test rig design. The design borrows from the Russell [20] test rig by featuring a flooded lubrication chamber. However, a mechanical shaft seal isolates the slave bearings from the test bearing and the test fluid. The slave bearings are tapered roller bearings, grease lubricated. The rig design includes an oil mist injection hole in the spindle to implement active lubrication and enable high-speed operation (up to 3600 RPM) if needed for future testing. Three hydraulic cylinders, capable of 10 metric tons of force each, uniformly push the test bearing through thick plates against the thrust runner. The end plate easily detaches from the bottom for quick access to the bearing chamber following a similar set up as Kingsbury's rig [24]. A large removable spacer offers the option to test bearings in tandem. Slip-fit dowel pins keep the bottom assembly of end plate, spacer, cylinders, and loader plates stationary while the runner rotates freely with the rest of the spindle.

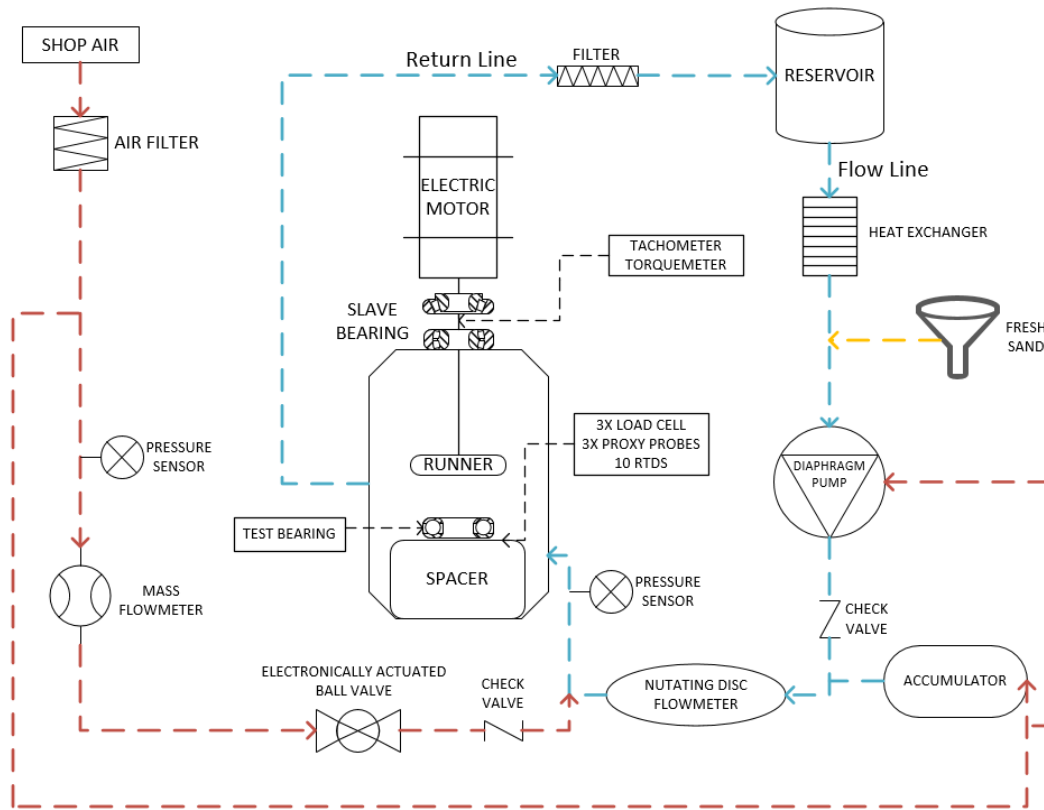
Figure 6 Proposed test rig diagram and floor plan

The air flow starts by passing through a filter before diverting into two directions. One directs the air to the pump and accumulator. The other flow path directs the air across a mass flowmeter and an electronically controlled valve before mixing with the liquid lubricant. Pressure sensors and check valves monitor the inlet pressure and prevent backflow, respectively. The test rig instrumentation includes 3 load cells, 3 displacement probes, and 10 RTDs in the test chamber as well as a contactless torque transducer/tachometer dual sensor at the shaft driven end.

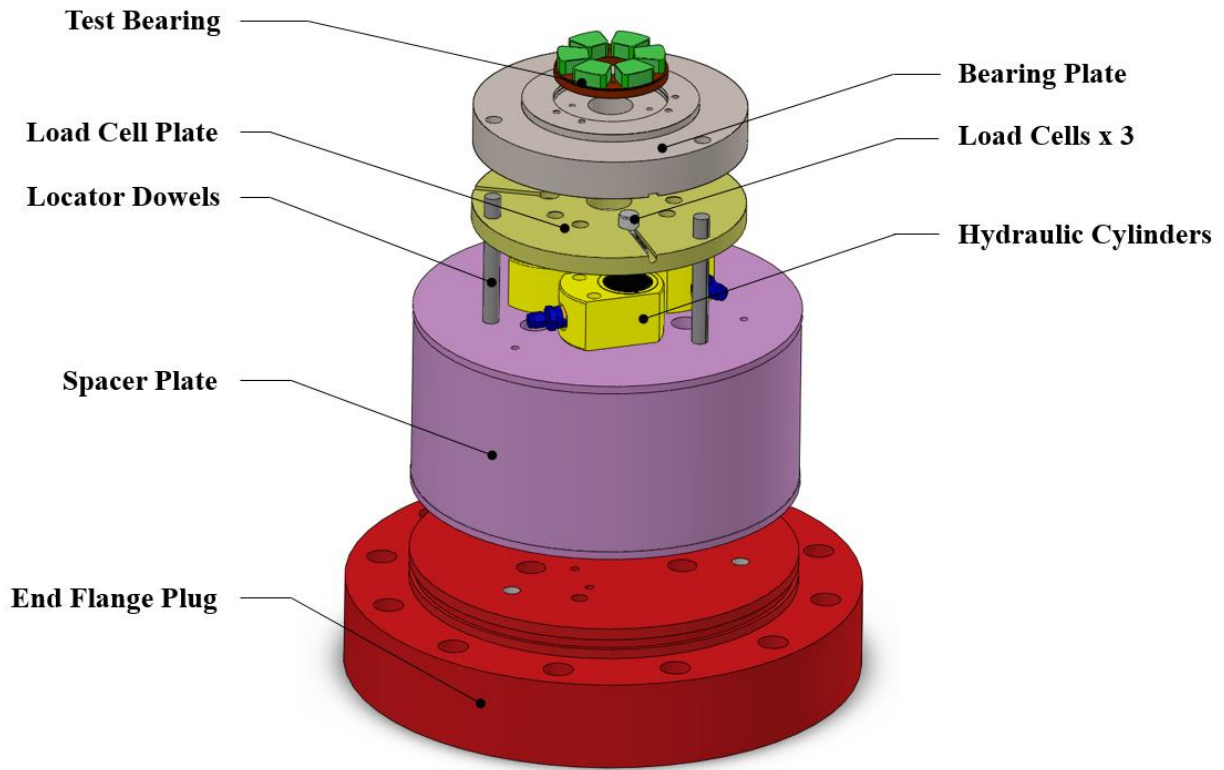
Figure 7 Load driving assembly model and notable components

The load driving assembly, located at the bottom of the test rig, comprises of an end flange (red) attached to the housing, a spacer plate (pink), three hydraulic cylinders (yellow), a load cell plate (yellow), three load cells, and a bearing plate (grey). Figure 7 details the location of these items in the load driving assembly. A critical design feature of this assembly is to provide a uniform axial force driving the bearing into the runner. An external hand pump powers the low profile submersible hydraulic cylinders and an external pressure manifold distributes the pressure uniformly among the three cylinders. The load cell plate (yellow), mounted above the hydraulic cylinders, houses the load cells measuring the force applied to the bearing. The grey bearing plate distributes the point loads from the cylinders into a uniform axial load pushing the bearing onto the thrust runner.

The hydraulic cylinders(yellow), each capable of 11.2 US tons of load, sit on top of the spacer (or plug if testing two bearings) following a symmetric orientation (120° apart) in a slightly slanted fashion allowing them to fit inside the test chamber. The high-pressure tubing that replaces the OEM hose connections provide a smaller form factor, better fit inside of the test chamber, and better leakage sealing on the outside of the rig. An external hydraulic hand press connected to a pressure gauge distributes hydraulic fluid to the three cylinders through a pressure manifold. All equipment is rated for an operating pressure of 10,000 psi (68.94 MPa).

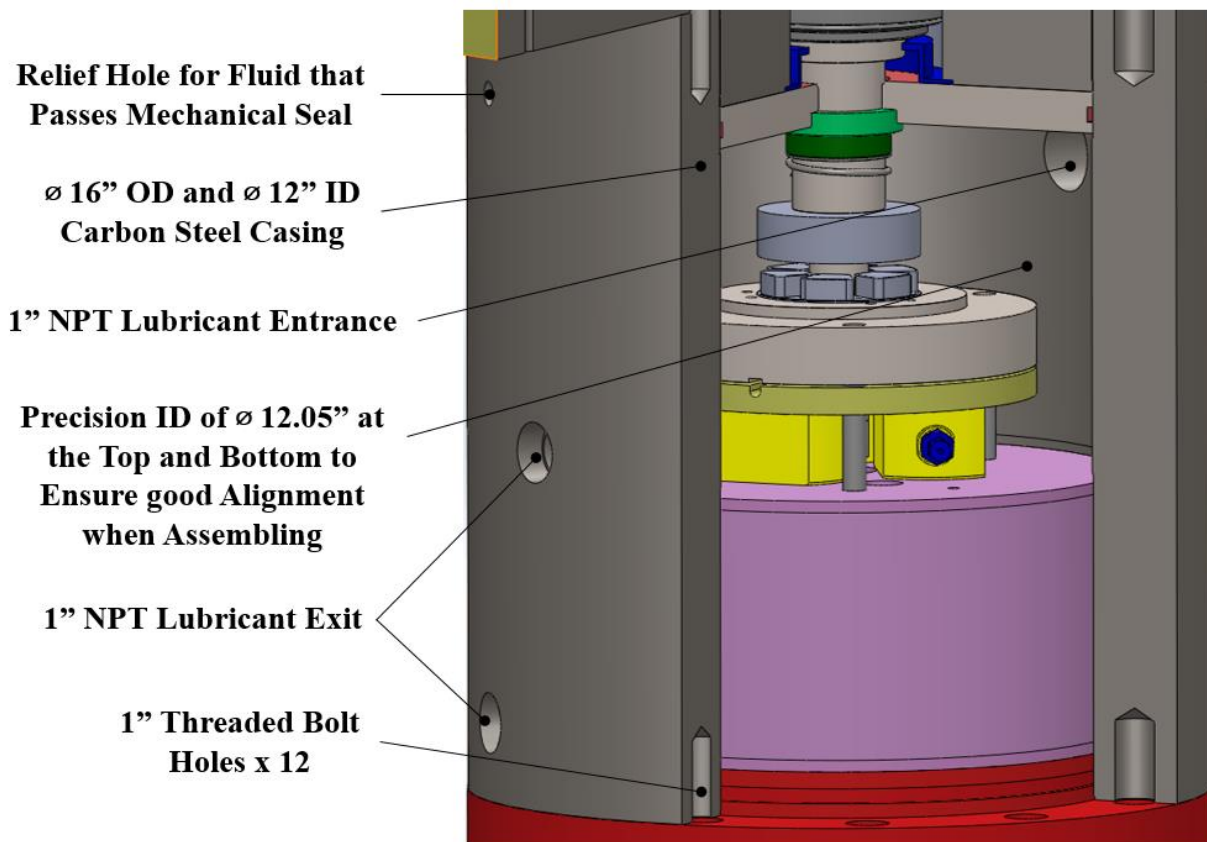
Figure 8 Test chamber casing model and notable features

Figure 8 depicts the vertical test chamber housing load driving assembly. The test chamber casing is a coated carbon steel casing selected for its availability, lead time, and economic advantage over boring a solid stainless-steel round stock. The chamber includes threaded (UNF) bolt holes at the axial ends for assembly and radial holes (NPT) along its length for lubricant in/out ports. The inner diameters of the casing interfacing with other components (locational features) feature a dimensional tolerance of $\sim 0.001''$ to ensure alignment of the multiple components upon assembly. In addition to the inlet and outlet holes for the lubricant bath, a relief channel machined on the top side of the top flange collects fluid that leaks through the seal.

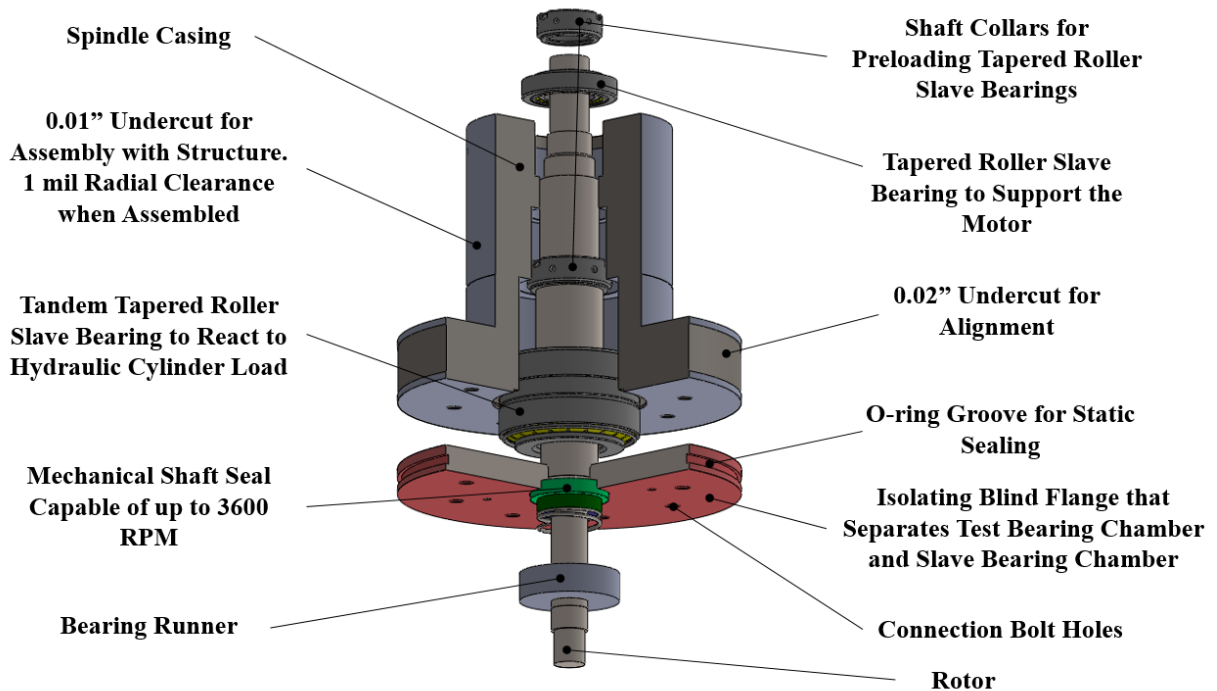
Figure 9 Slave bearing spindle assembly model and component descriptions

Figure 9 depicts the slave bearing assembly featuring an isolation blind flange (red), slave bearing housing (grey), water protection sleeve (blue), mechanical shaft seal (green), two tapered roller slave bearings, shaft (shaft), and the thrust runner (grey). The purpose of the spindle assembly is to create a low maintenance system that can take the load generated by the hydraulic cylinders and maintain alignment between the shaft, motor, and casing. It also serves to isolate the test chamber from the slave bearing chamber. This is a critical feature for testing bearings lubricated with a of water, sand and gas mix.

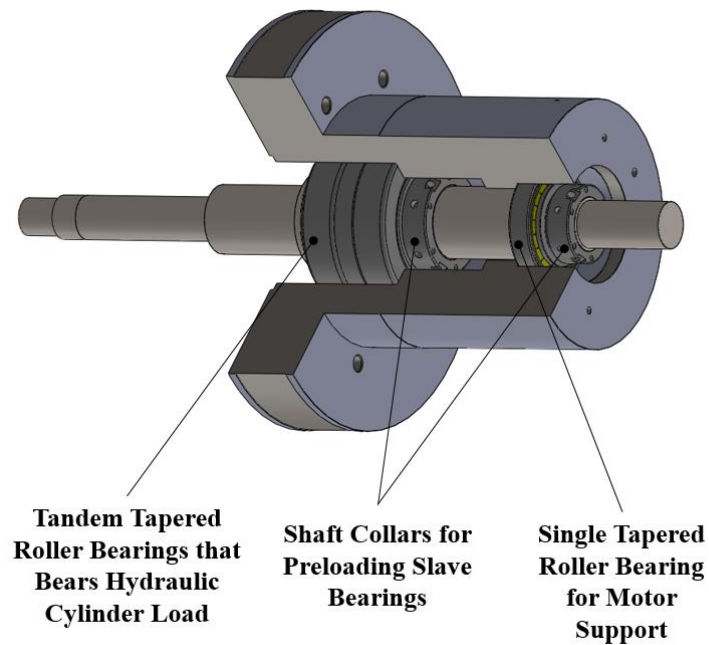
Figure 10 Spindle casing with bearings assembled model and notable features

support both radial loads and axial loads from the hydraulic cylinders. Two threaded collars preload the slave bearings and an undercut on the OD provides two shoulders to align the spindle assembly respect to the test chamber. Figure 10 shows a partial cut-view of the spindle housing with the bearings installed. The end flange includes bolt holes that connect to both the isolating blind flange and the structure.

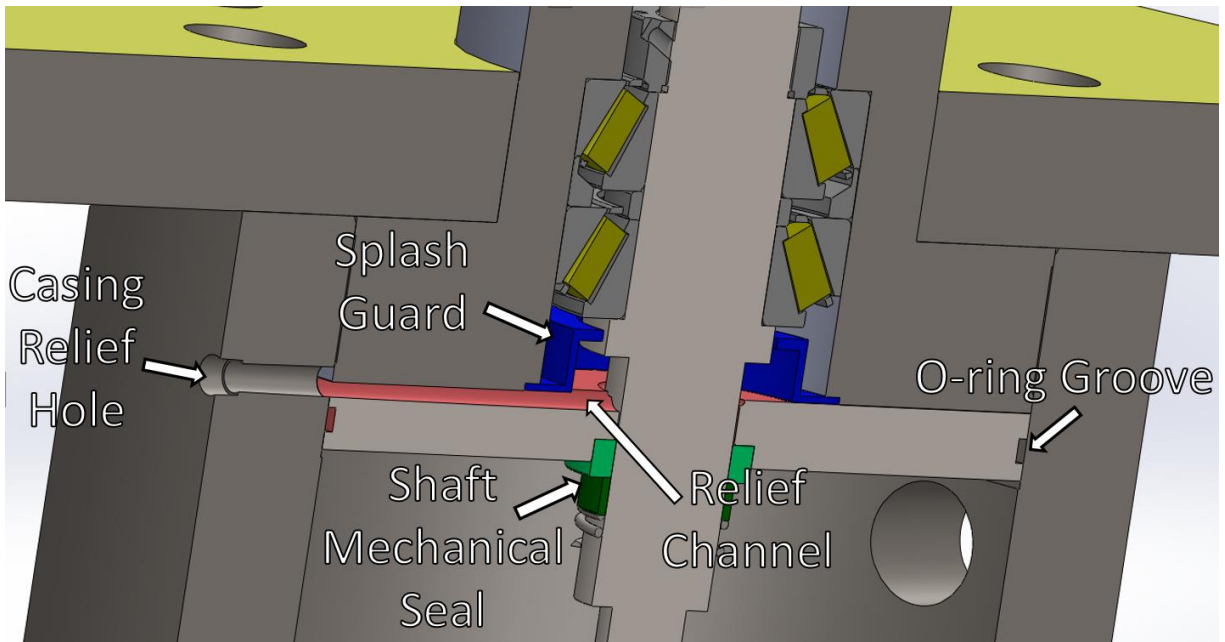
Figure 11 Test bearing and slave bearing chamber leakage isolation configuration

The isolation flange acts as a barrier between the two chambers and prevents water contamination of the grease-lubricated slave bearings. The rotating shaft incorporates a mechanical shaft seal on the test bearing chamber side, which is capable of operating at 3600 RPM. Due to the non-zero leakage nature of the mechanical shaft seal, a 3D printed splash guard is installed on the slave bearing chamber side as a secondary seal. A small counterbore on the NDE of the slave bearing casing secures and aligns the splash guard.

A leakage relief channel machined into the isolating flange and test chamber casing provide a pathway out of the test rig for fluid leaking through the mechanical seal. An O-ring (#381) seals the OD of the isolating flange. Figure 11 shows a close-up view of the sealing configuration identifying critical components.

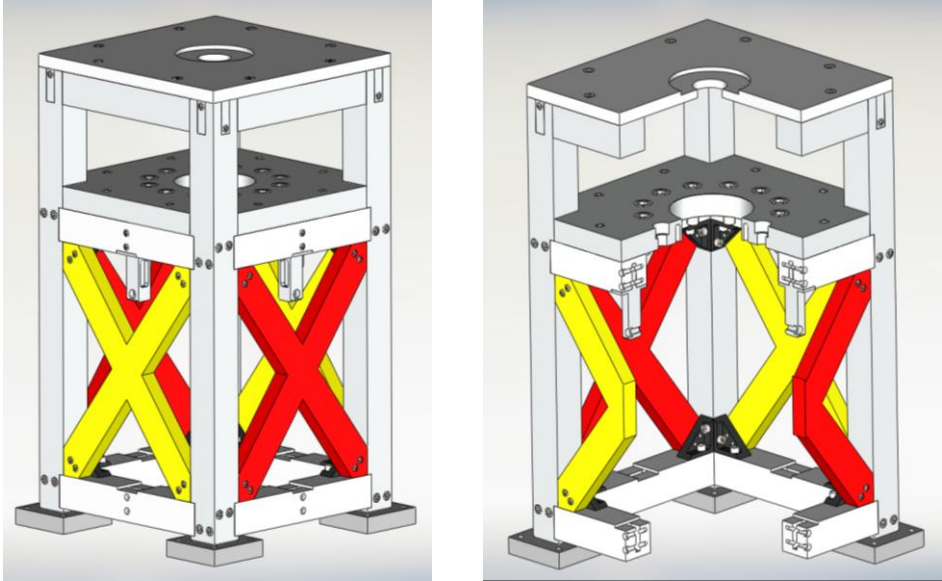
Figure 12 Test rig structure isometric view (left) and section cut view (right)

shaped bars increase system stiffness and help elevate system natural frequency above operating conditions. Furthermore, removing one of the X members allows the use of a hydraulic hand lift that can grab the bottom portion of the test rig for convenient disassembly of the test chamber. This represents a critical feature of the design as there is the need to quickly and frequently access the test bearing without disassembling the entire rig. Figure 13 illustrates the assembly process.

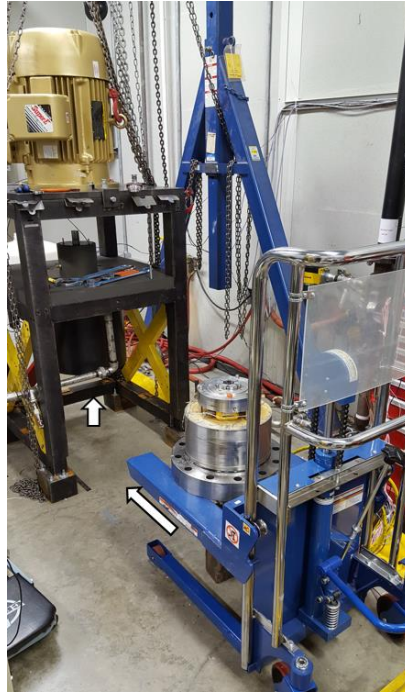
Figure 13 Test bearing assembly. The bottom assembly is lowered on the lift and pushed under the structure where it is raised into the test rig

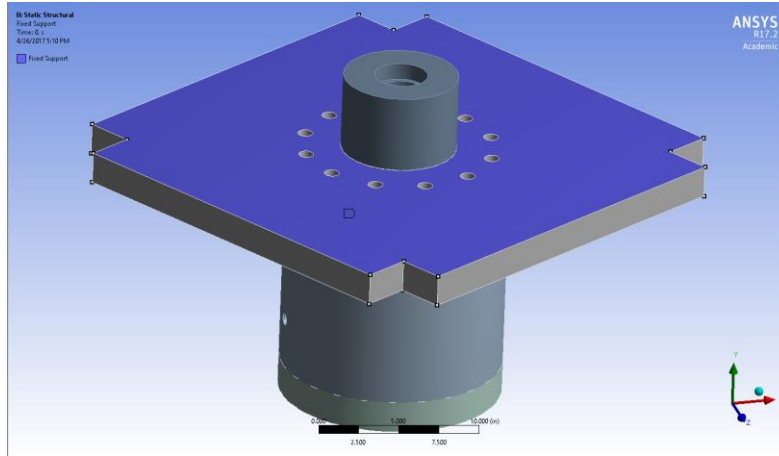
Figure 14 Fixed surface on the support plate in ANSYS deformation analysis

Figure 14 shows the fixed surface corresponding to the structure holding the rig in place, Figure 15 shows the 20,000 lbs force applied on the slave bearing chamber at the surface interfacing with the tapered bearings, as well as the reactive load of the same magnitude applied onto the plug inner face.

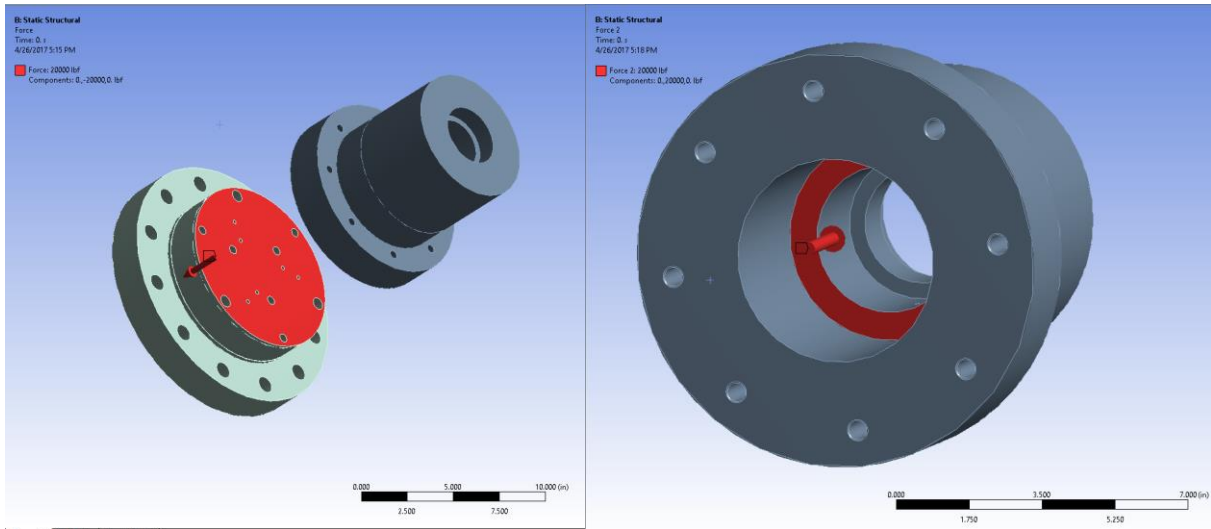
Figure 15 Applied forces on end plug (Left) and slave bearing housing (Right)

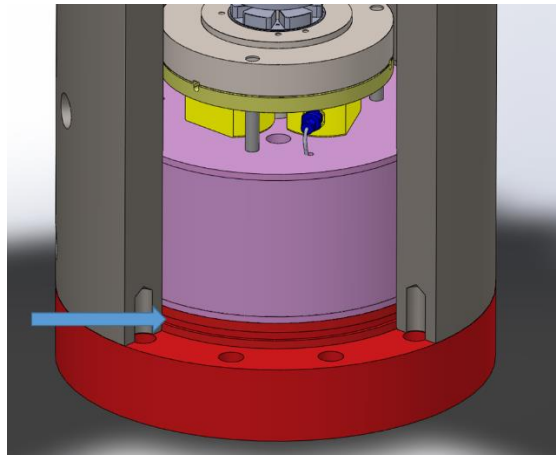
Figure 16 Bottom plug static leakage path. Arrow indicates O-ring placement

There are 3 primary leakage paths in the test rig setup. First possible path, shown in Figure 16, is the connection between the bottom plug and the steel casing, which is static and sealed with an O-ring. The O-ring fits snugly inside a machined groove in the bottom plug and is pressed against the test bearing casing when the rig is fully assembled.

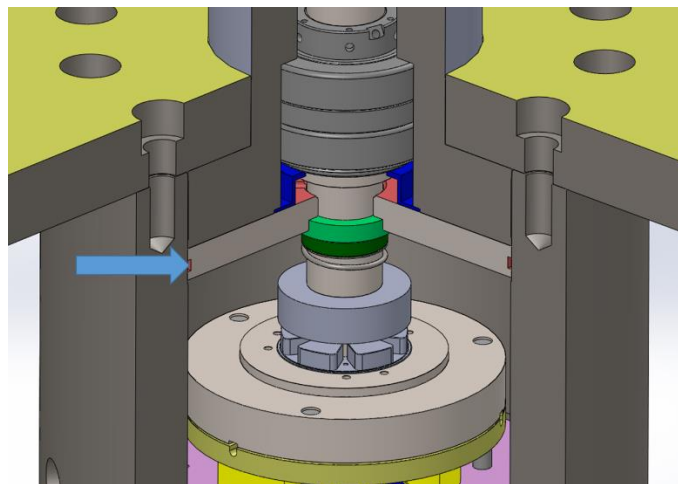
Figure 17 Test bearing chamber and slave bearing chamber seal. Arrow indicates O-ring placement

The second leakage path, illustrated in Figure 17, is the outer diameter of the interface between the test casing and the slave bearing casing and it is also sealed with an O-ring.

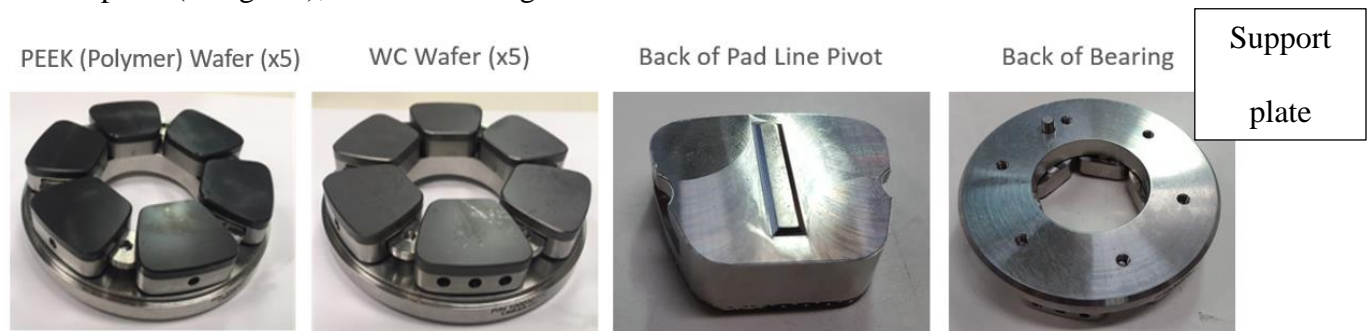
Figure 18 Picture of PEEK and WC wafer test bearings

Figure 18 displays the test bearings and Table 1 lists their dimensions. The Polymer and WC coated tilting pads bearings feature a steel pad support structure with an effective pad OD of 3.5" (8.89 cm). The pivot style is radial line contact and a small flat land region on the pivot allows the offset to be effectively 50% to allow bidirectional operation¹. The tilting pad bearings includes a steel WC or PEEK coated flat face runner. Retainer screws maintain the relative position of the pads respect to each other and the back plate, while allowing tilting motion about the line pivot (2 degrees), as shown in Figure 19.

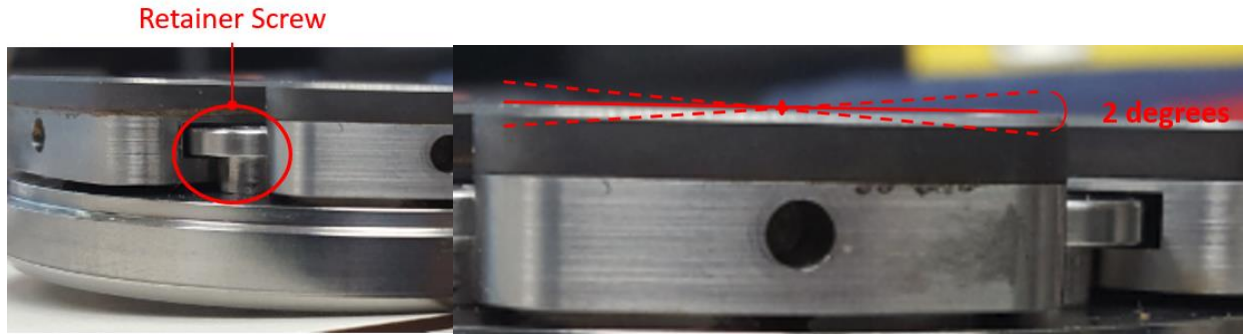
Figure 19 Retainer screw location and tilt angle of bearing pad

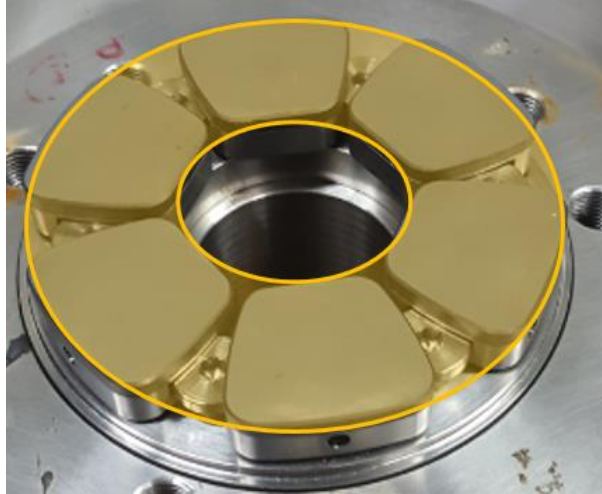
Figure 20 Surface area of a WC tilting pad test bearing

The unit load of a bearing is calculated by dividing the applied load over the surface area of the bearing. The surface area of the bearing is defined as the continuous highlighted region shown in Figure 20.

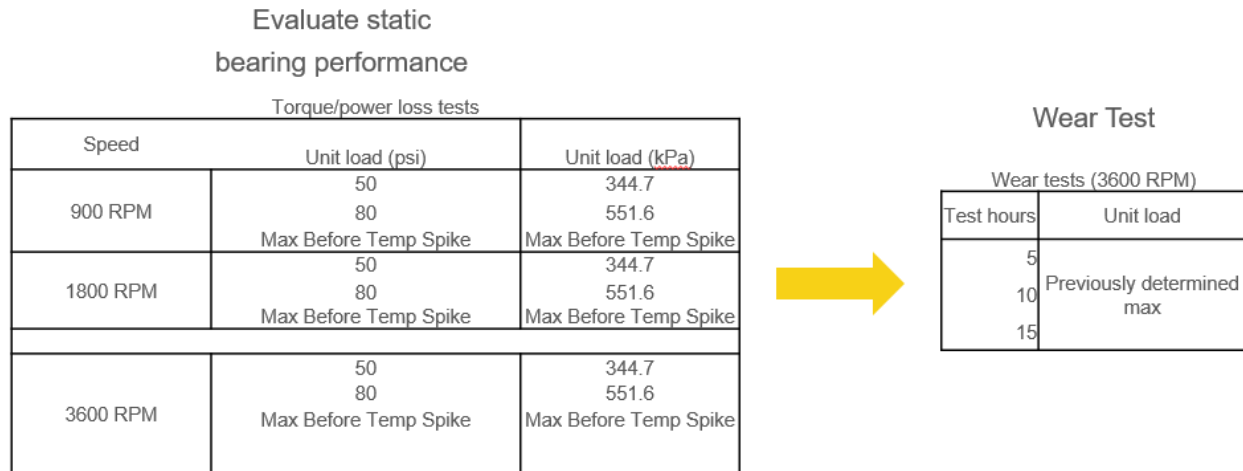
Figure 21 Test matrix for WC and PEEK tilting pad bearings

Figure 21 shows the test matrix and outlines test procedures. The first experiments are forward drag torque and power loss static performance tests. The tests start by spinning the motor to the desired speed and increasing the applied load (at an approximate hand controlled rate of 6 lbs/s) until a temperature spike is recorded in the pads (i.e. a sign of hard contact). The tests serve to determine the bearing load capacity just before the hydrodynamic fluid film collapses. Upon finding the maximum unit load, a wear test follows by subjecting the bearing to 105% of the previously determined load. This is done to determine if the bearing can feasibly operate beyond the hydrodynamic limit. Inspections are performed after every 5 hours to examine the amount of wear on the pad and runner. The purpose of this test is to determine if the wear rate is low enough to allow continuous operation at the set unit load.

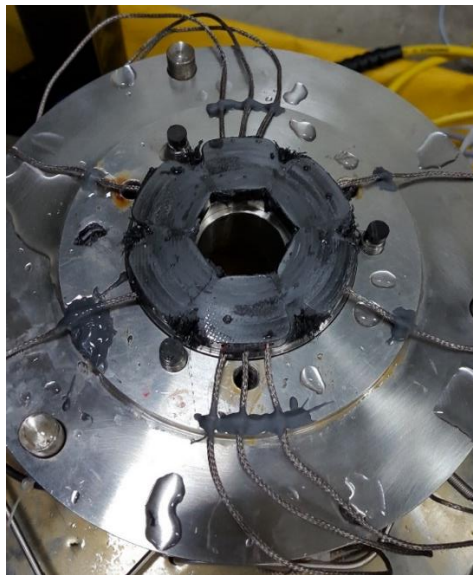
Figure 22 PEEK bearing damaged during testing. Only 100 psi of unit load was applied.

Two 6-pad (PEEK and WC) bearings experienced rubbing almost immediately the moment any load was applied. The PEEK coating was destroyed while the WC coating experienced heavy wear. Figure 22 and Figure 23 show pictures of the bearings after testing with the six pad configuration. Note that in Figure 23, the heavily worn side of the bearing pad is actually on the leading edge of the fluid film as indicated by the runner rotation direction. This also suggests that the pad was not properly lubricated (fluid starvation).

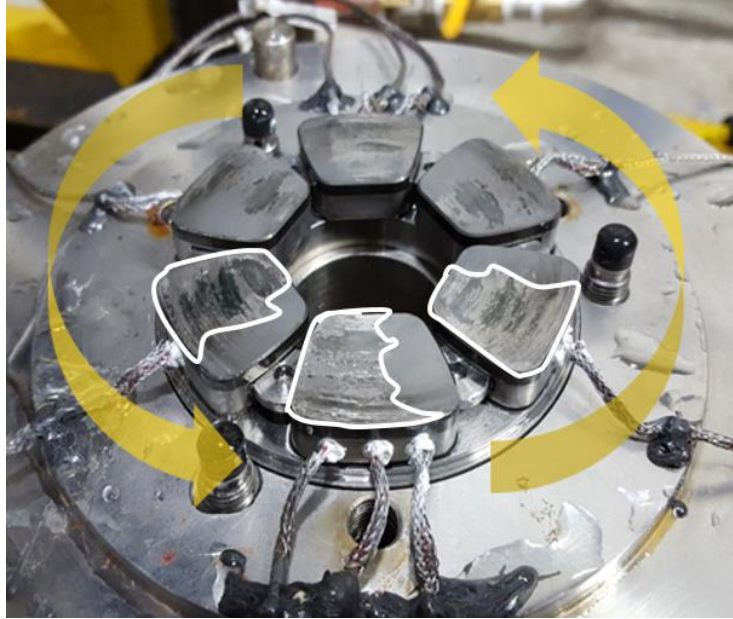
Figure 23 Heavily damaged WC bearing. Arrows indicate rotation of the runner. Leading edge of the pads are outlined in white

as pictured in Figure 23. The wear is more significant on the leading edge of the bearing pad, which suggests that when contact occurred, the fluid film broke and the pads contacted the runner.

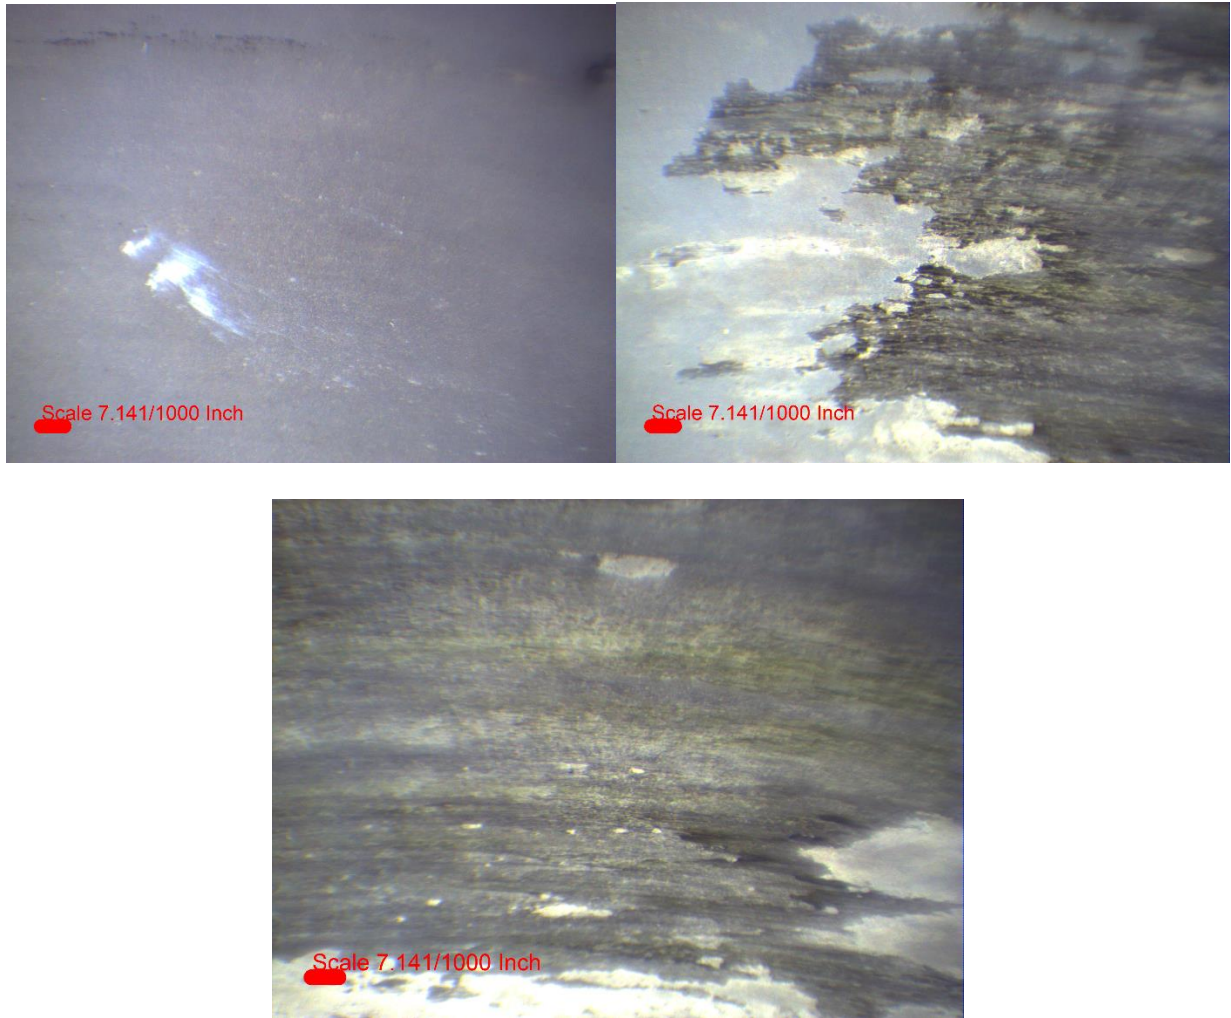
Figure 24 Magnified wear pattern for a lubrication starved WC bearing (pad 2). Top left: trailing edge of pad. Top right: middle of pad. Bottom: leading edge of pad.

A light microscope allowed inspection of the wear intensity on the starved WC bearing as shown in Figure 24. The wear is not uniform as the leading edge experienced much more intense rubbing than the exit region, which appears to be relatively untouched. The pattern of erosion and the absence of particles indicate this wear type resulted from two body abrasion.

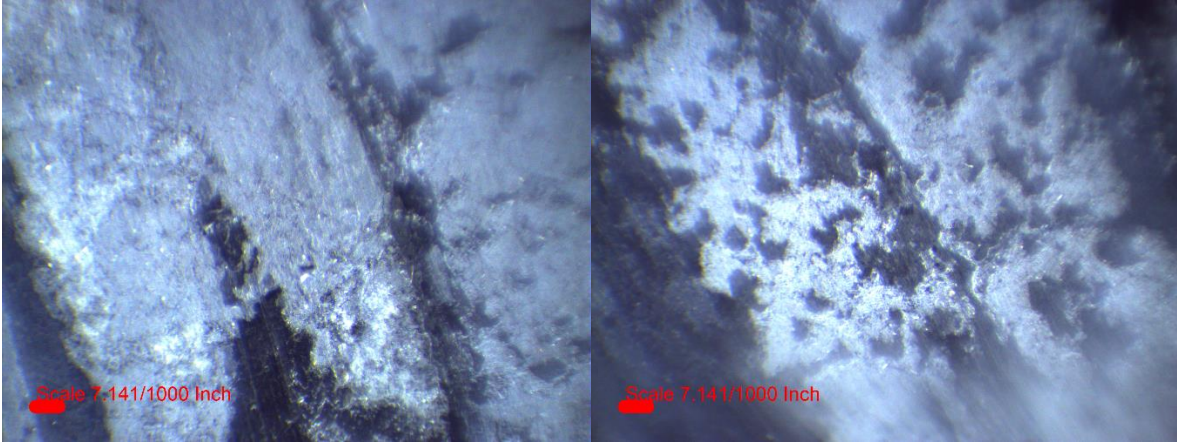
Figure 25 Magnified wear pattern in the middle of the pad for a lubrication starved PEEK pad. Much of the PEEK material has been worn away, leaving the steel substrate exposed

Figure 25 shows the magnified wear on PEEK pad surface. The PEEK material wore out much faster than WC since it is a softer material and was rubbing against a WC coated runner. As a result, most of the PEEK liner was sheared off leaving only the steel substrate below it.

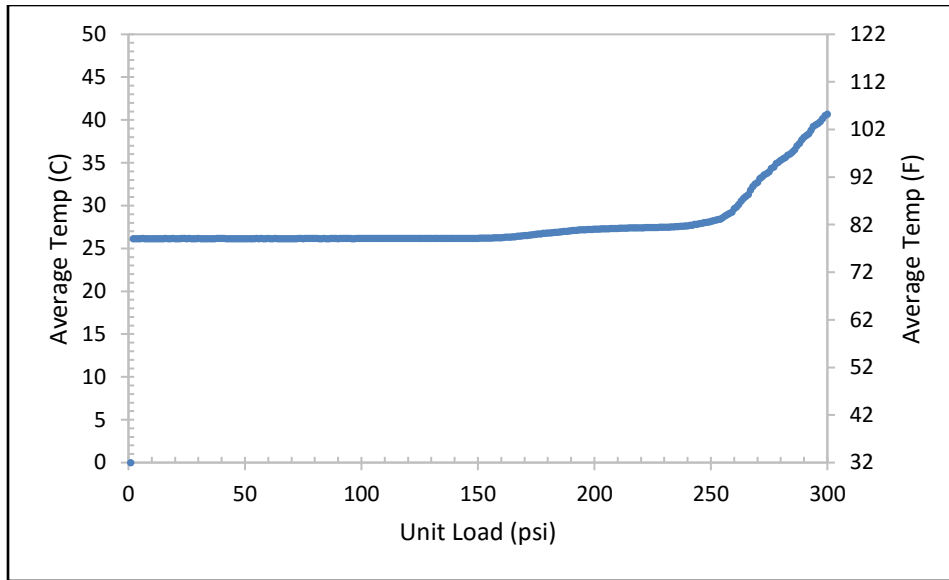
Figure 26 Average temperature in the pads vs unit load for WC wafer at 900 RPM

At 900 RPM (4 m/s surface speed) with proper lubrication, both torque and temperature show marginal increases until contact occurs. The results are shown in Figure 26 and Figure 27. The torque and power loss associated with a zero-load condition in Figure 27 correspond to the torque generated by the slave tapered roller bearings. This baseline case is subtracted from subsequent measurements with load to obtain the torque generated by the test bearing.

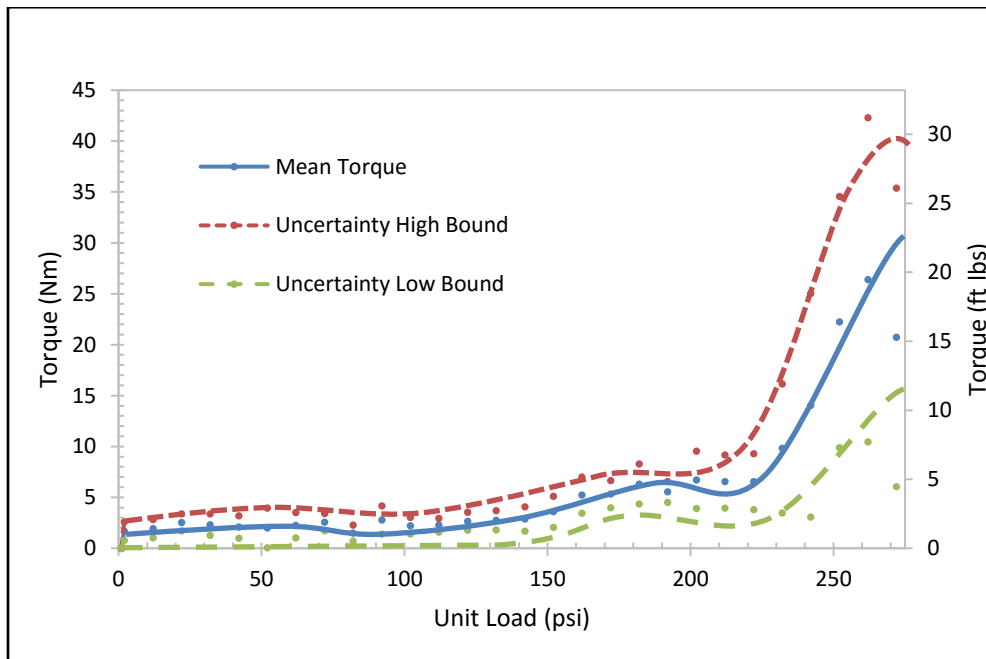
Figure 27 Torque vs unit load for WC wafer at 900 RPM

The torque graph shown in Figure 27 shows less variation in the hydrodynamic regime than the torque graph for the 3600 RPM case (Figure 36). This is likely due to the lower operating speed which causes less rubbing. As expected, the uncertainty increases once rubbing does occur. The maximum unit load before a film begins collapsing is approximately 210 psi (1.24 MPa) and is marked on Figure 27.

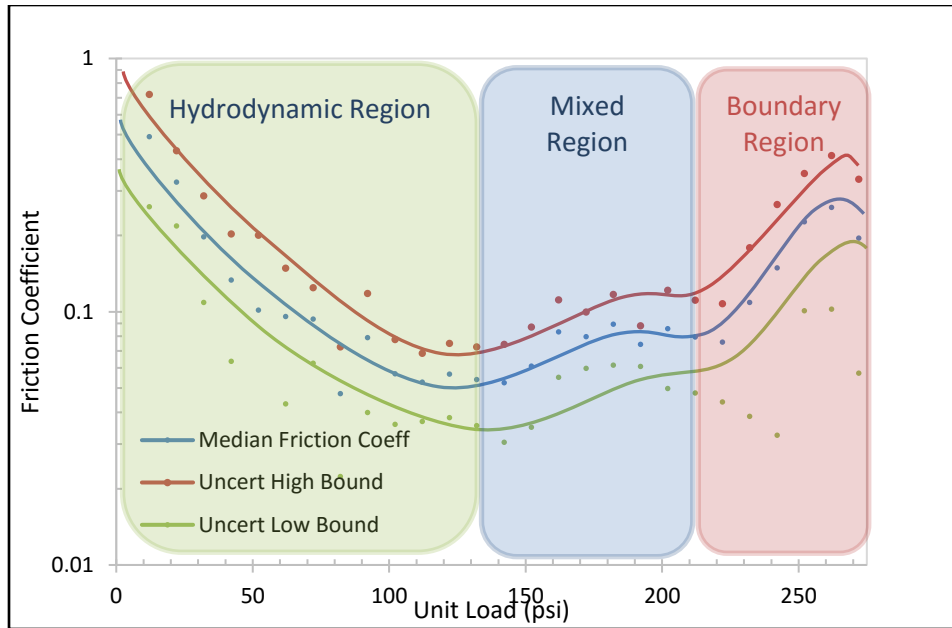
Figure 28 Friction coefficient vs unit load for WC at 900 RPM. The hydrodynamic and mixed lubrication region are marked as green and blue regions respectively.

Figure 28 shows the friction coefficient versus the unit load at 900 RPM. The friction coefficient is calculated by dividing the torque over applied load and mean radius of the bearing. The graph shows three distinctive trends of the viscosity that are qualitatively identified as a hydrodynamic, mixed and boundary lubrication regions. In the hydrodynamic region the friction coefficient decreases as the load increases, which indicates torque is relatively constant and the bearing is operating without contact between runner and pads. The mixed lubrication region displays a modest increase in friction coefficient as the unit load increases, which is associated with a torque increase due to initial asperity contact between the stationary and rotating surfaces. The final region is characterized by an increase of the friction coefficient rate of change respect to unit load, coinciding with a sudden increase of the input torque and pad surface temperature (i.e. film rupture).

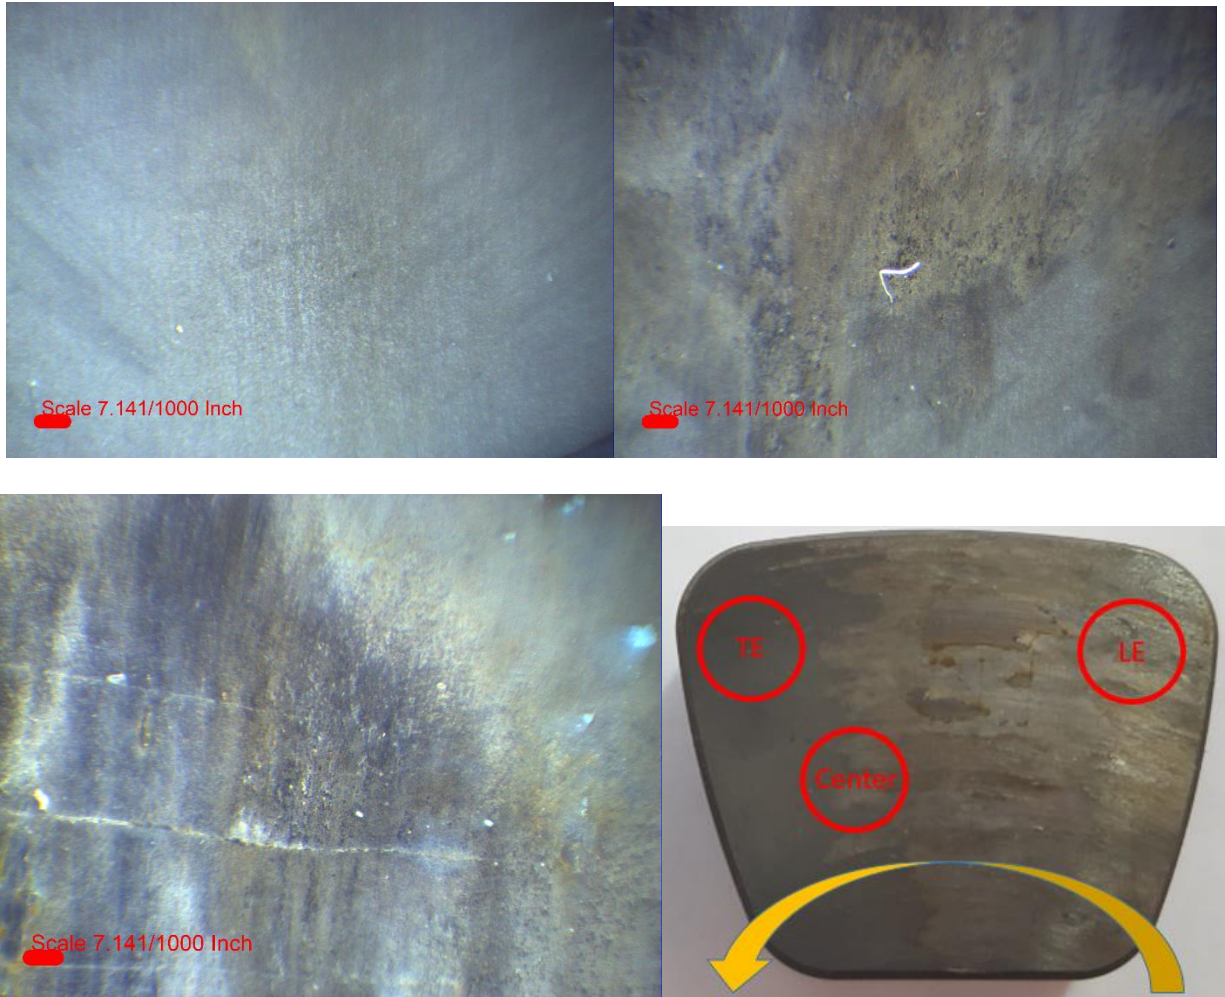
Figure 29 Microscopic views of wear on WC bearing pad 1. Top left: trailing edge. Top right: pad center. Bottom left: leading edge. Bottom right: pad locations with direction of rotation

Figure 29 depict observations under a light microscope showing that the damage incurred on the bearing is indicative of sliding wear and that the pads are not uniformly worn but rather damaged more heavily on one side than the other. In fact, the undamaged side (the trailing edge) barely shows any wear at all; however, the damage when using three pads is notably less severe than the damage incurred when using all six pads, as shown in Figure 24. This further corroborates the lubrication starvation hypothesis.

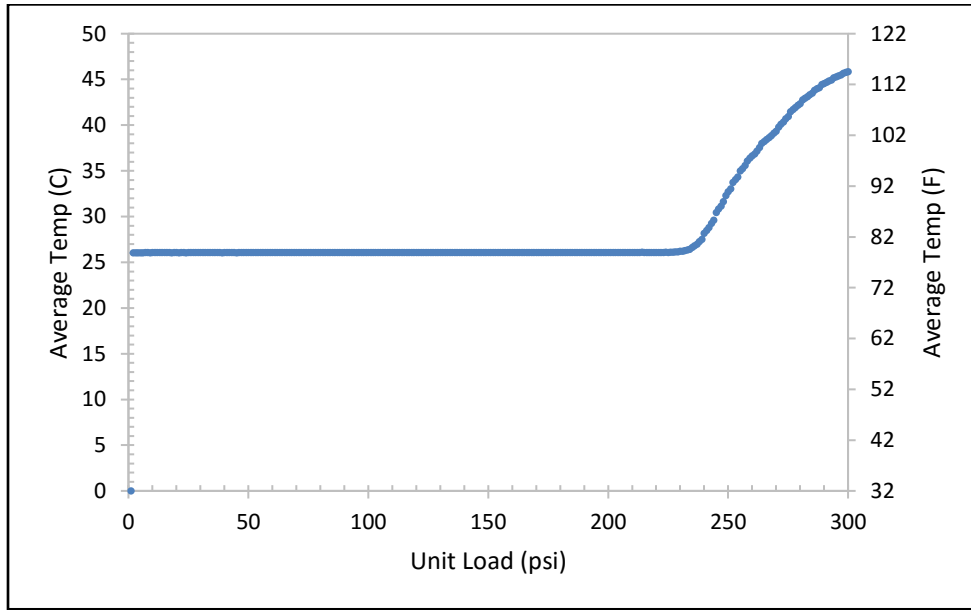
Figure 30 Average temperature vs unit load for WC wafer at 1800 RPM
