DEVELOPMENT OF A HIGH LOAD CAPACITY TEST RIG TO EVALUATE THE STATIC
PERFORMANCE OF PROCESS FLUID LUBRICATED THRUST BEARINGS

A Thesis

ZHENG BIAN

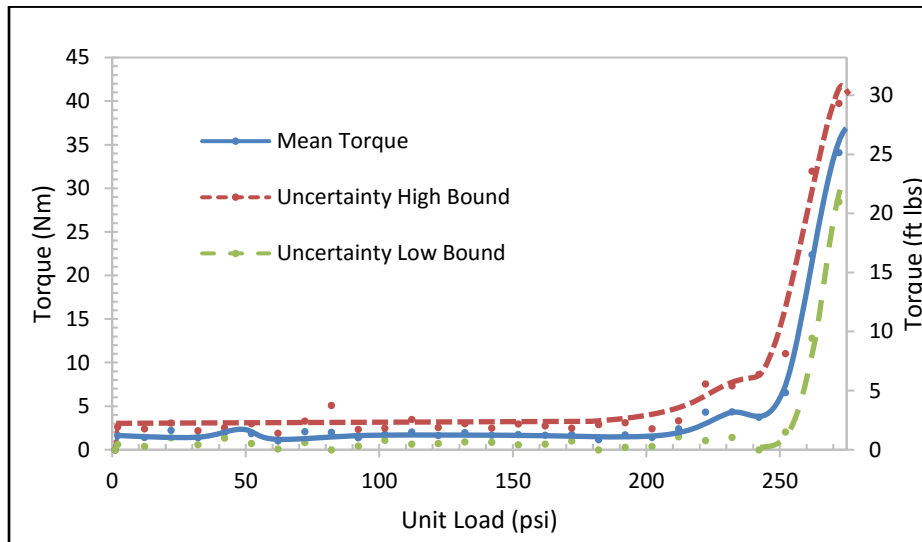
Figure 31 Torque vs unit load for WC wafer at 1800 RPM

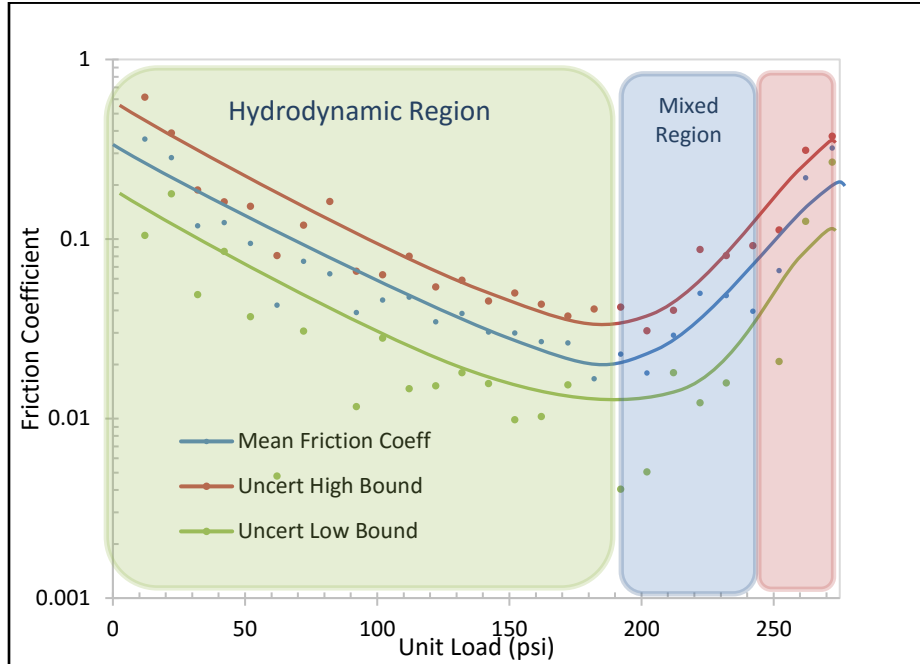
Figure 32 Friction coefficient vs unit load for WC wafer at 1800 RPM. Hydrodynamic and boundary regions are marked green and blue respectively.

The friction coefficient, pictured in Figure 32, follows a similar trend defining three characteristic lubrication regions as that described for the 900 RPM case.

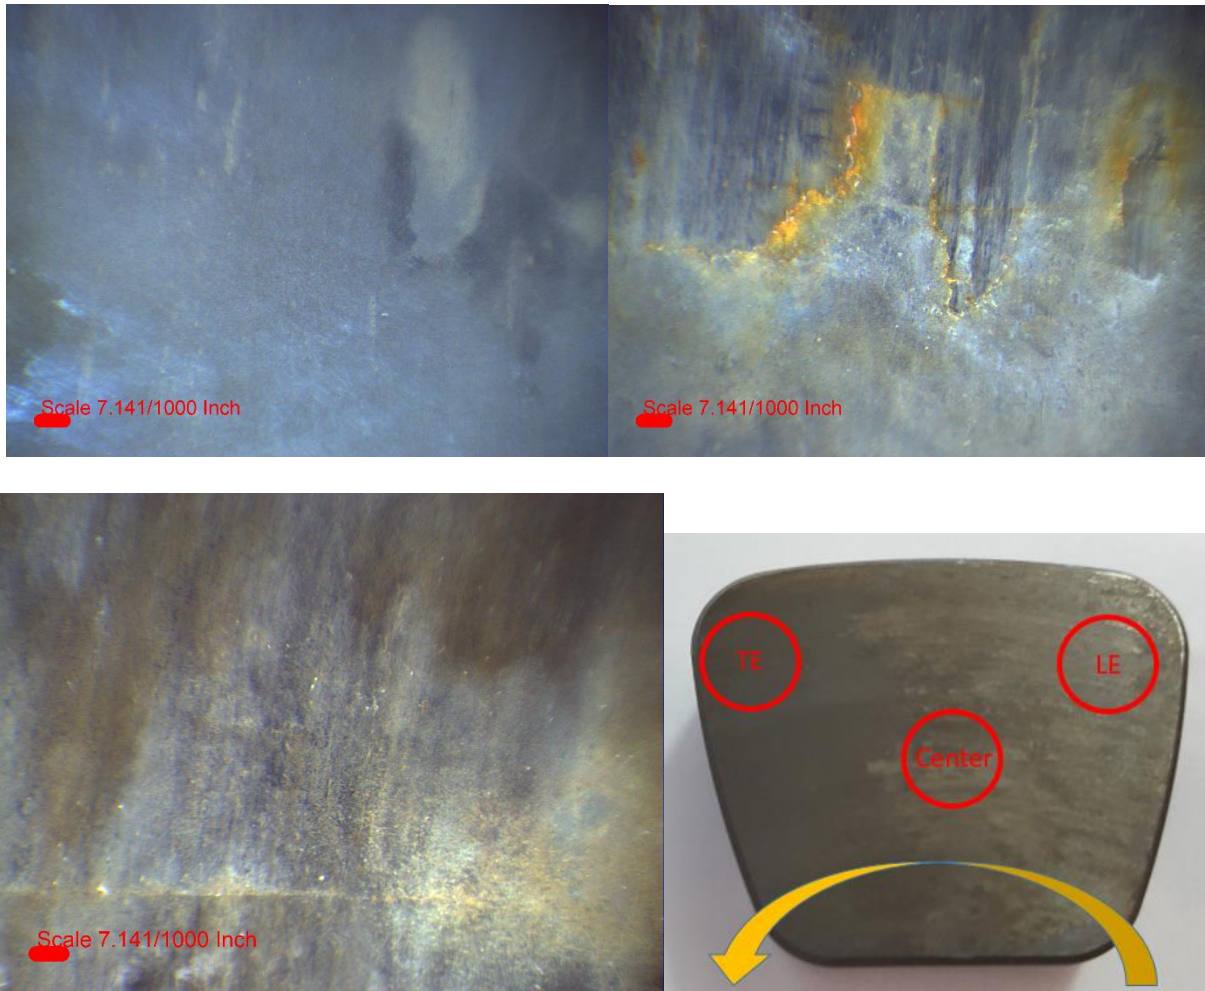
Figure 33 Microscopic views of wear on WC bearing pad 3 for 1800 RPM. Top left: trailing edge. Top right: pad center. Bottom left: leading edge. Bottom right: pad locations with direction of rotation

Upon inspection, wear follows the same pattern (higher at the leading edge, lower or untouched at the trailing edge) as in the 900 RPM case. Microscope inspection of the pads, seen in Figure 33, show the same type of two body sliding wear as seen in the 900 RPM case. The heavily worn leading edge region experienced much more wear than the lubricant exit region which barely experienced any wear at all. Once again, the wear intensity is less severe than as in the lubricant starved case.

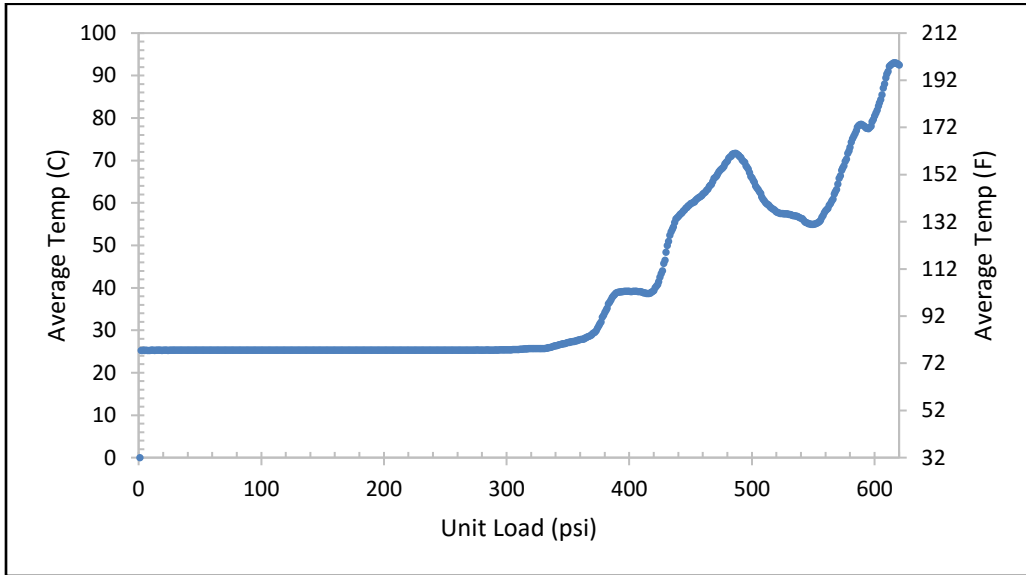
Figure 34 Average temperature vs unit load for WC wafer at 3600 RPM

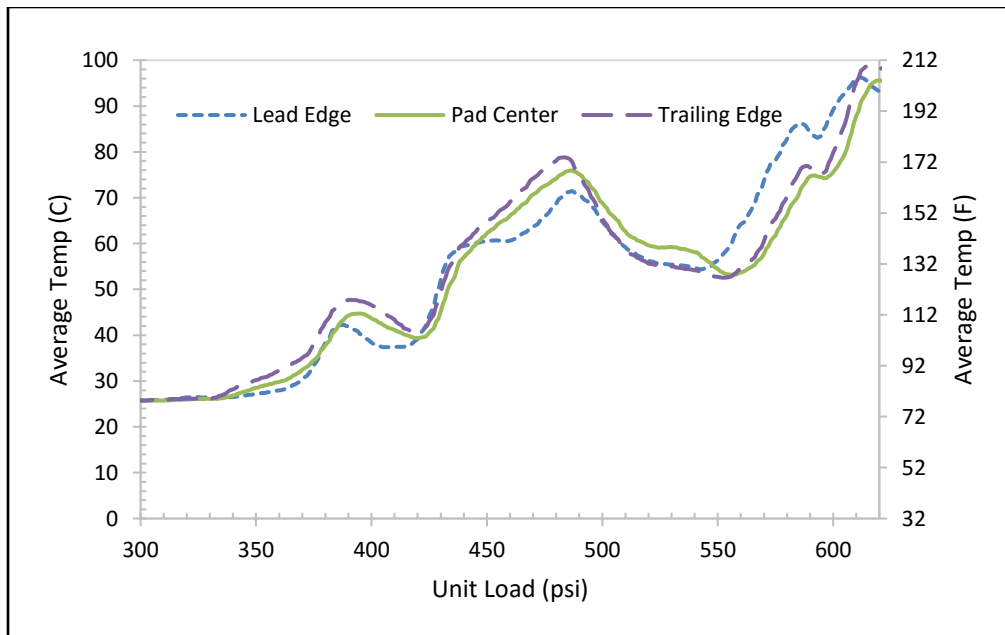
Figure 35 Pad position temperature vs unit load for WC wafer at 3600 RPM

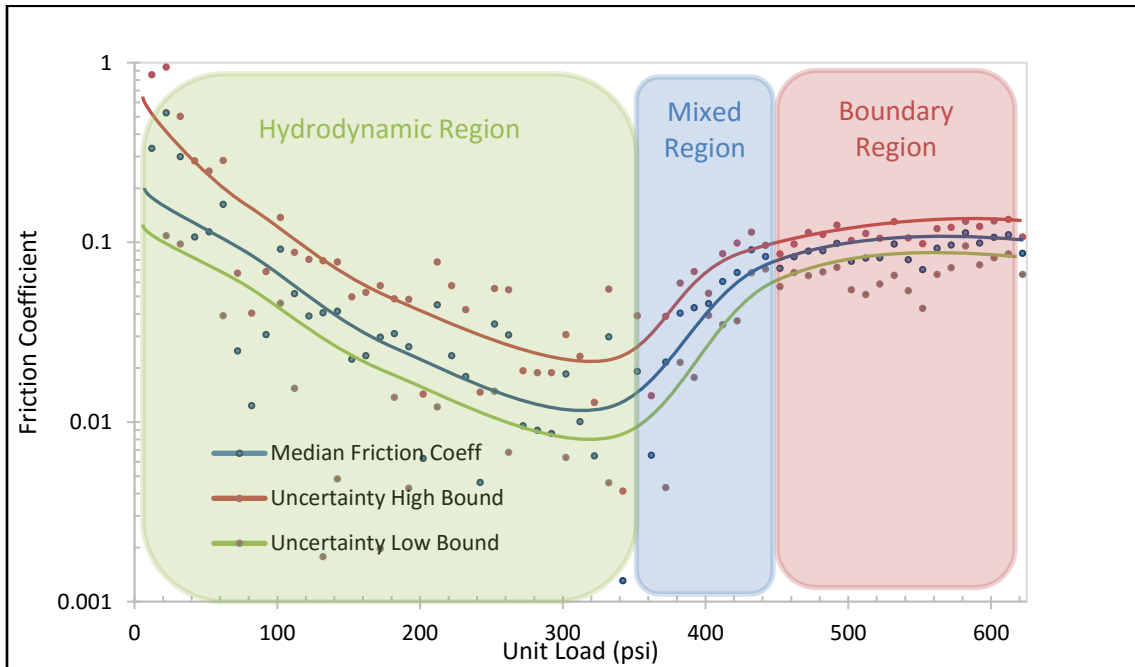
Figure 37 Friction coefficient vs unit load for WC wafer at 3600 RPM. The hydrodynamic, mixed, and boundary lubrication regions are marked green, blue, and red respectively.

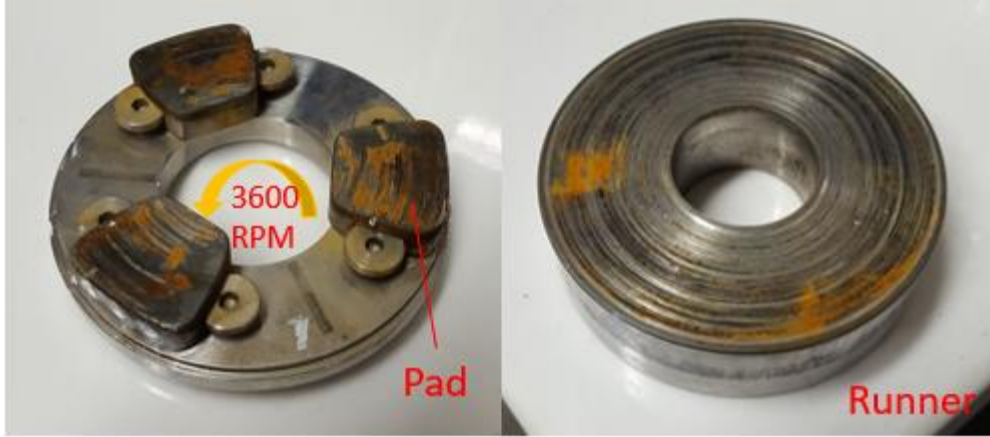
Figure 38 Left: WC bearing post 3600 RPM static test. Right: steel runner after testing. Source of rust is the 17-4 PH stainless steel runner.

Figure 38 shows the thrust bearing and collar after disassembly. The bearing pads display significant wear but mostly concentrated at their leading edges. The source of rust is the 17-4 PH stainless steel runner. This type of martensitic steel is not truly stainless as it does not contain chromium and can rust when exposed to atmospheric conditions. Initially, a coating of WC on the surface of the runner prevents it from rusting; however, the coating wore off during testing which exposed the bare 17-4 PH steel to water. Some of the 17-4 PH steel deposited on the bearing pads and none of the rust originated from the WC wafer. Figure 39, which shows the cleaned up bearing from Figure 38, displays the shaft rotation and the wear patterns. It is important to note that the wear mostly concentrates on the leading edge of a bearing pad. This is a symptom of pad starvation and fluid film breaking, which corroborates the torque readings.

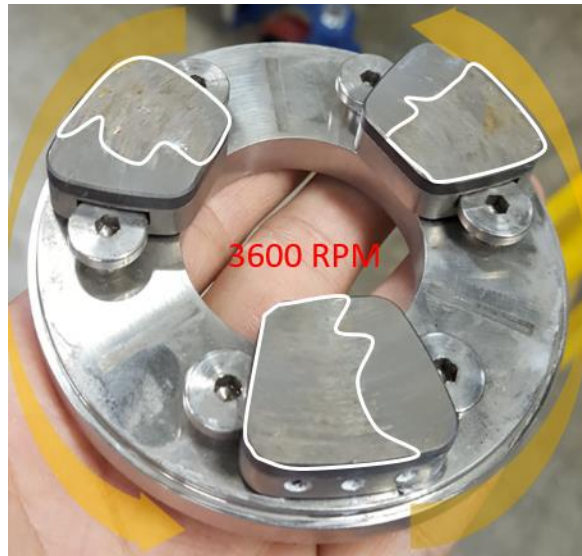
Figure 39 Direction of rotation shown in yellow vs wear pattern for WC bearing. White region denotes leading edge.

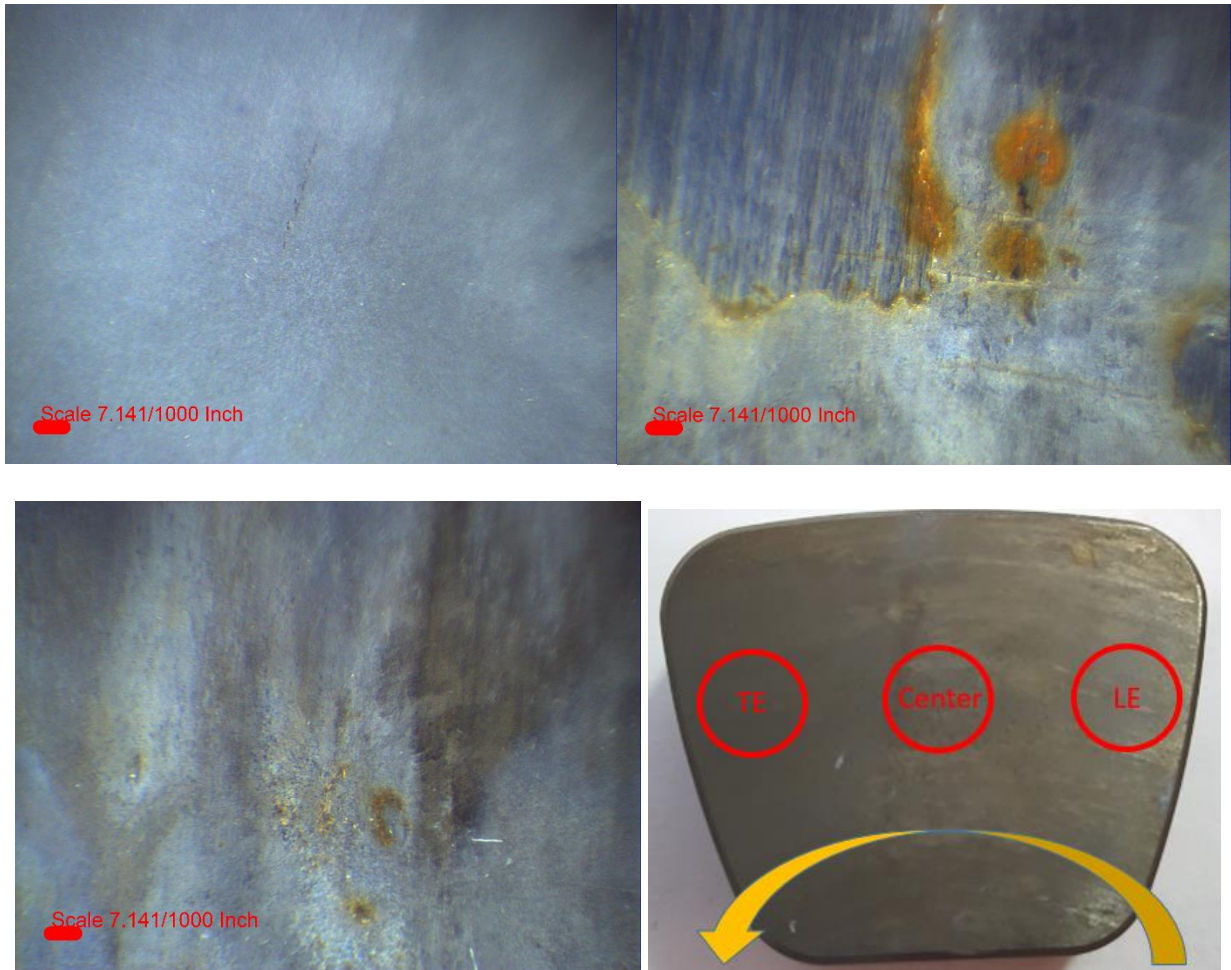
Figure 40 Microscopic views of wear on WC bearing pad 2 for 3600 RPM. Top left: trailing edge region. Top right: middle of pad. Bottom left: leading edge. Bottom right: pad locations with direction of rotation

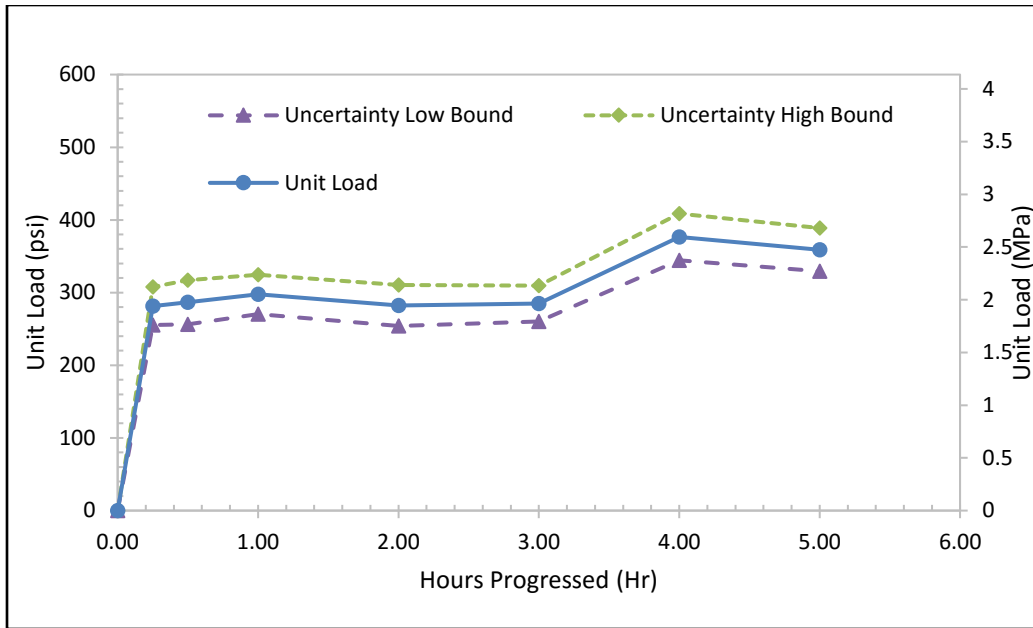
Figure 41 Unit load applied vs time for the WC wafer hydrodynamic test at 3600 RPM

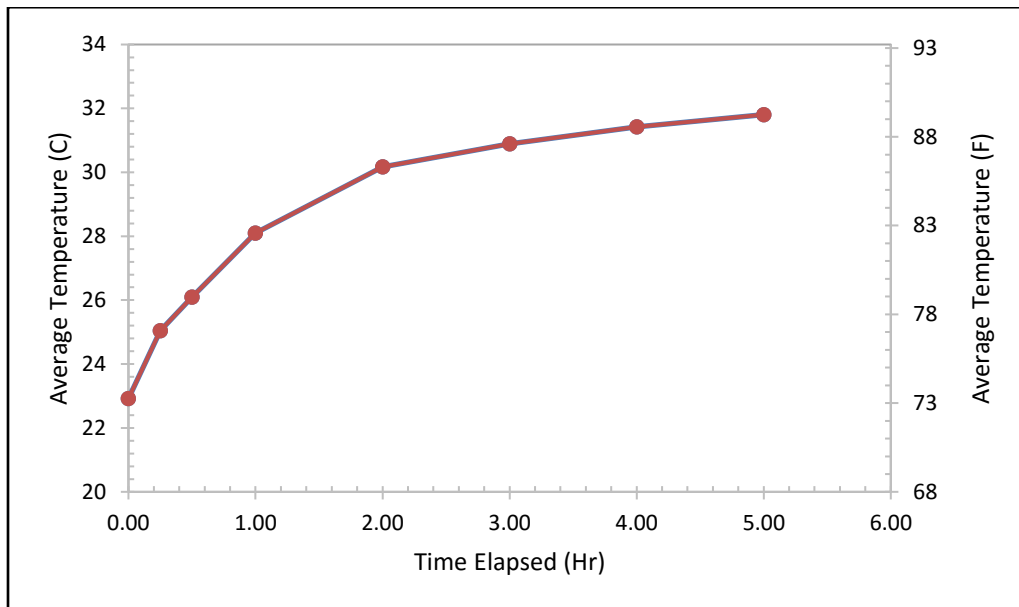
Figure 42 Average temperature in the pads vs time passed for the WC hydrodynamic test at 3600 RPM.

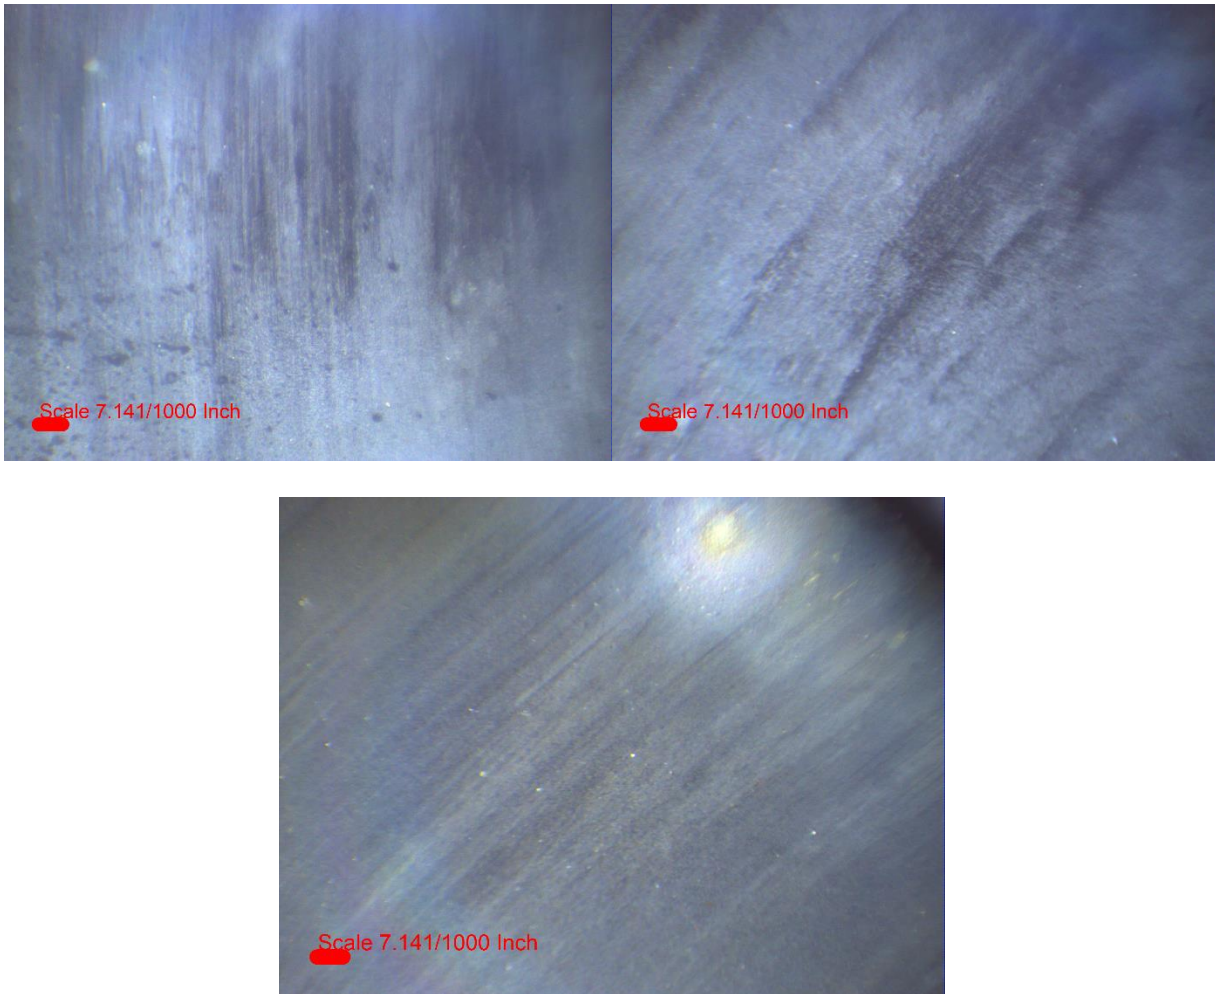
Figure 43 Microscopic view of wear on WC bearing pad for 3600 RPM. Top left: pad 1. Top right: pad 2. Bottom: pad 3. No appreciable wear can be seen

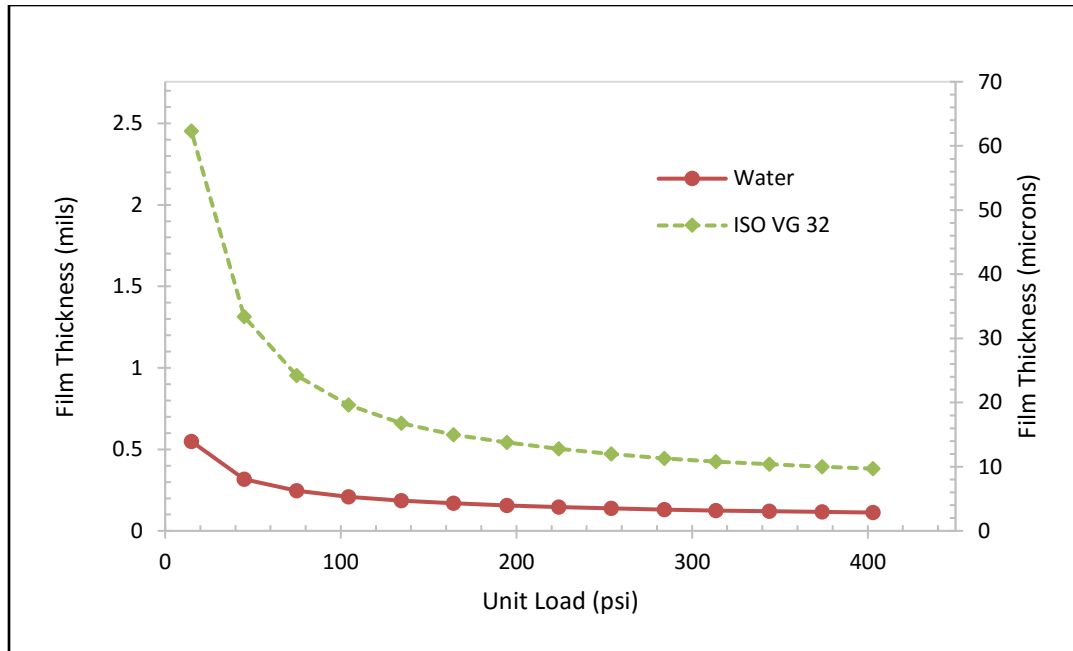
Figure 44 Film thickness vs specific load for water and ISO VG 32

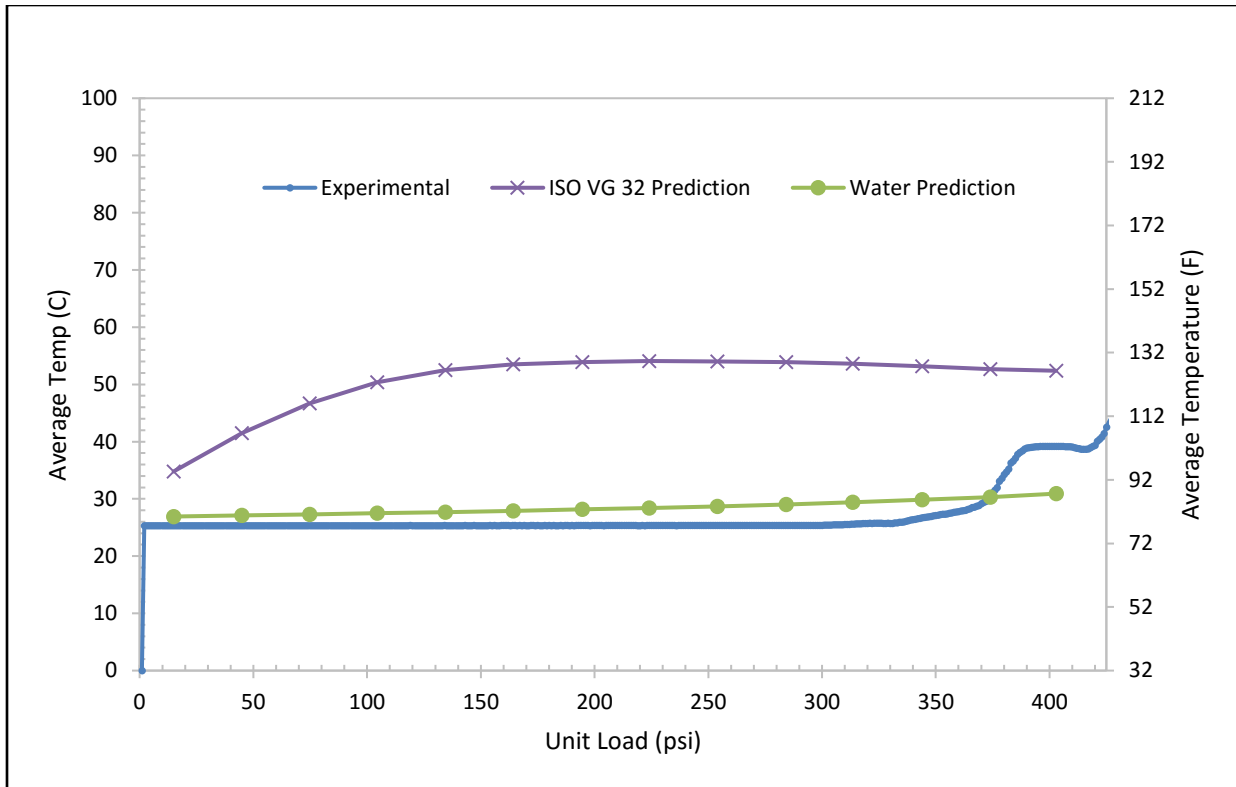
Figure 45 Average temperature increase; predictions vs experiments for water and ISO VG 32 lubricated bearing

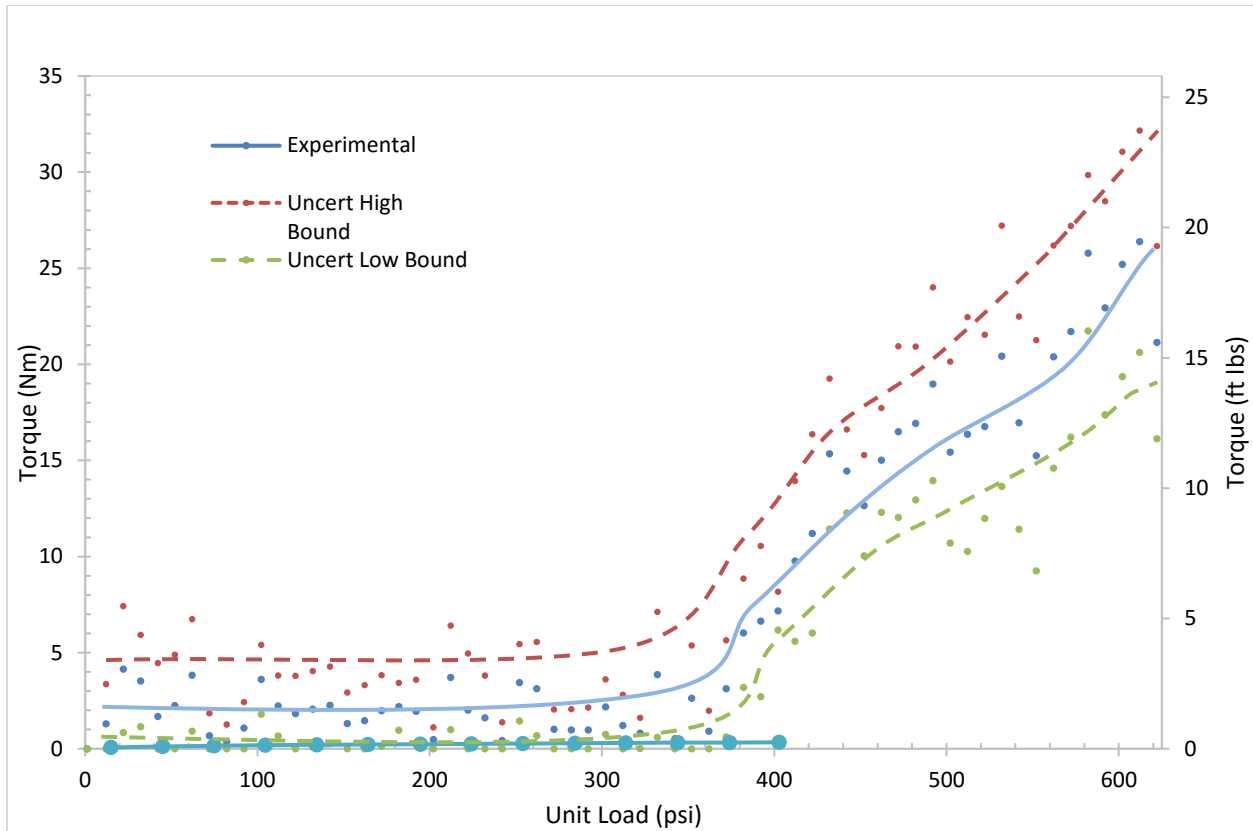
Figure 46 Torque vs unit load predictions vs experimental comparison

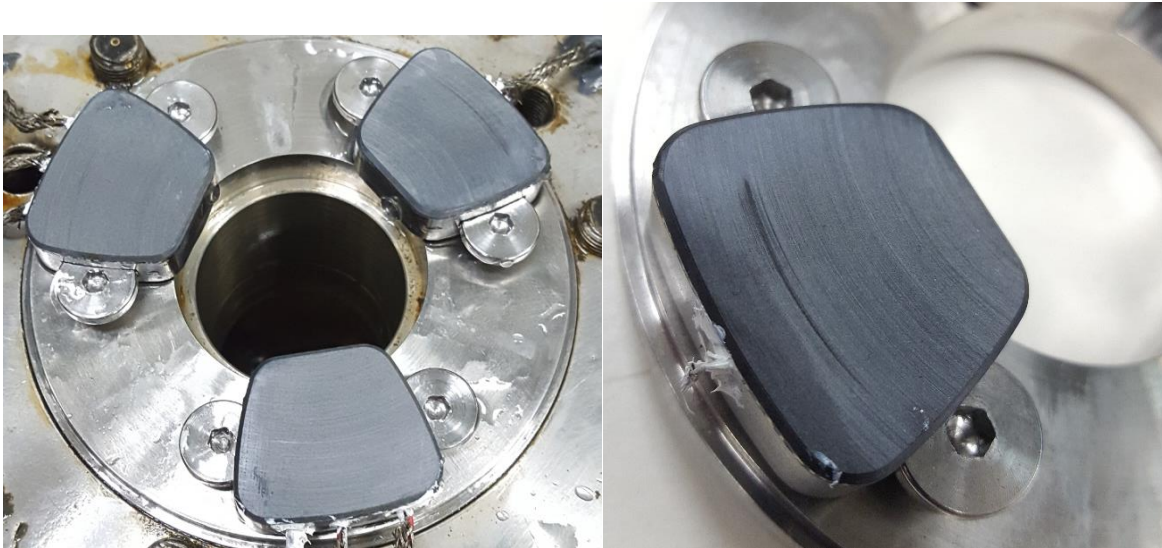
Figure 47 PEEK bearing after operating at 350 psi (2.41 MPa) at 3600 RPM. Close up view on the right

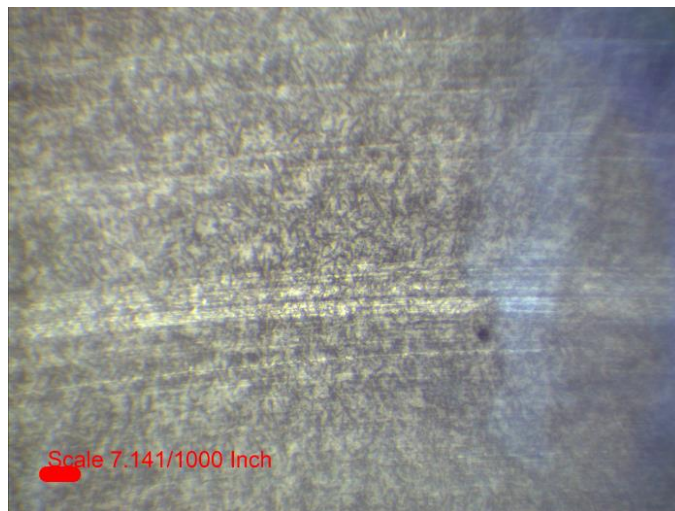
Figure 48 Microscope view of PEEK bearing after operating at 350 psi (2.41 MPa) at 3600 RPM

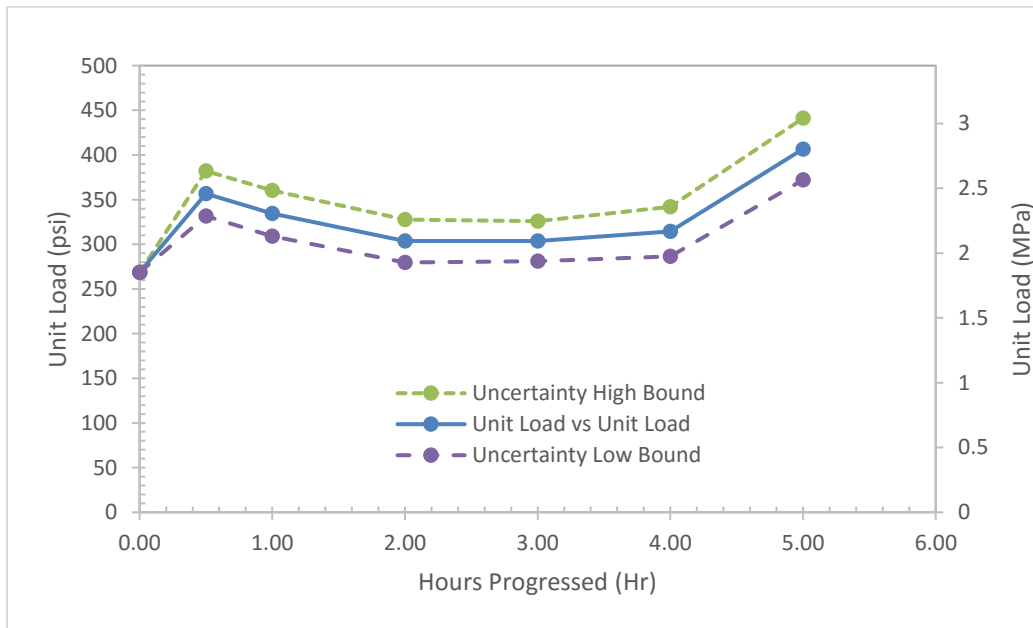
Figure 49 WC bearing unit load vs time for the 5 hr wear test

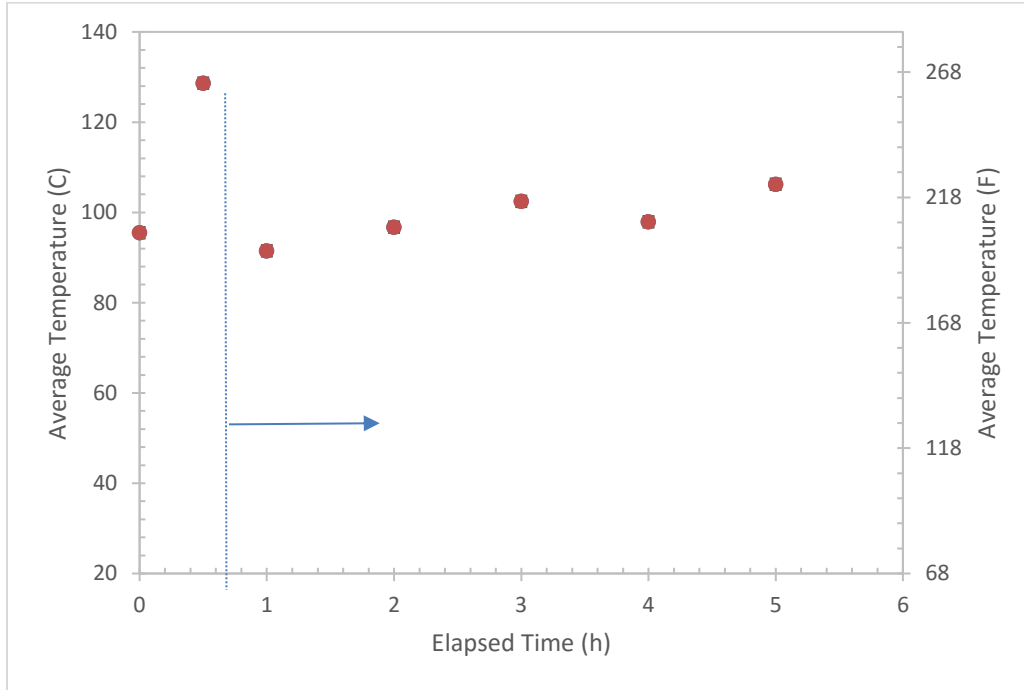
Figure 50 WC bearing average pad temperature vs time for the 5 hr wear test. The line and arrow indicate when the RTDs were likely flung out of the bearing

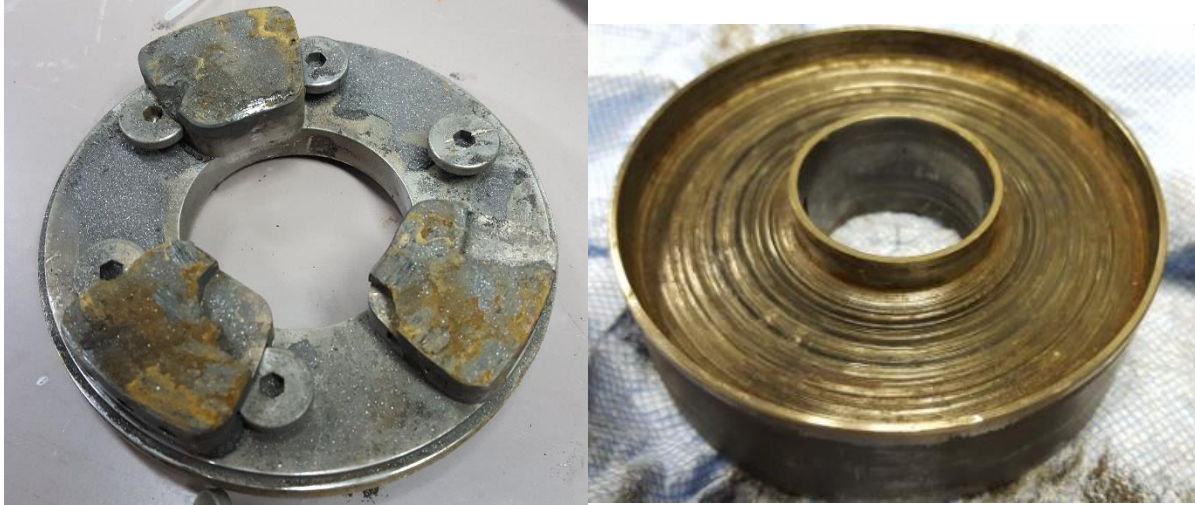
Figure 51 WC bearing (left) and runner (right) after the wear test

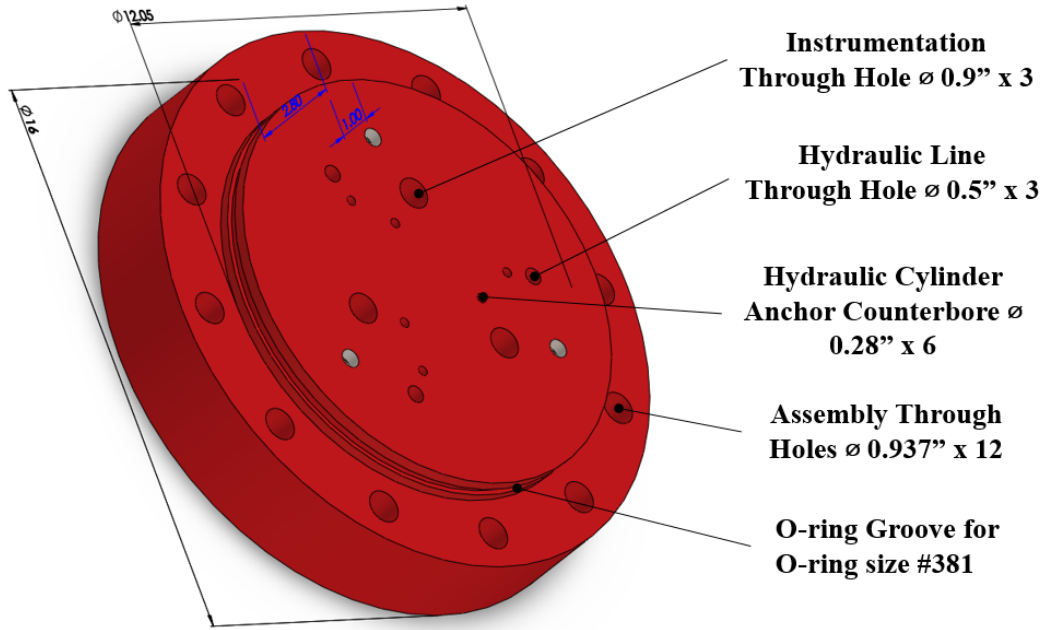
Figure 52 End flange model and notable features

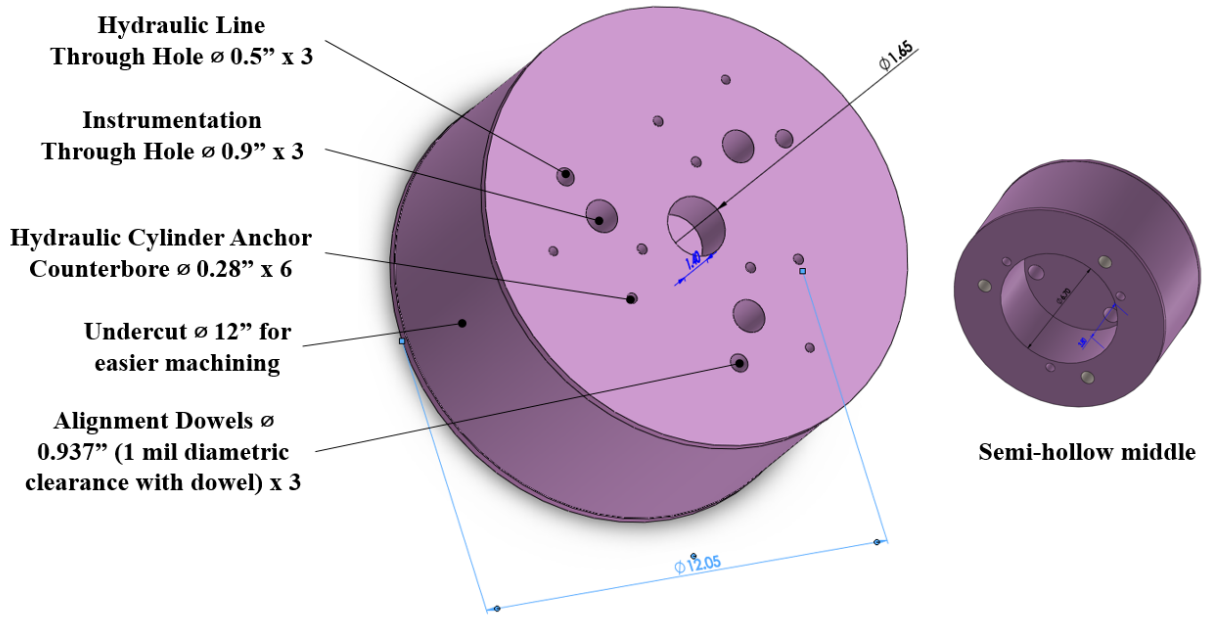
Figure 53 Spacer model and notable features

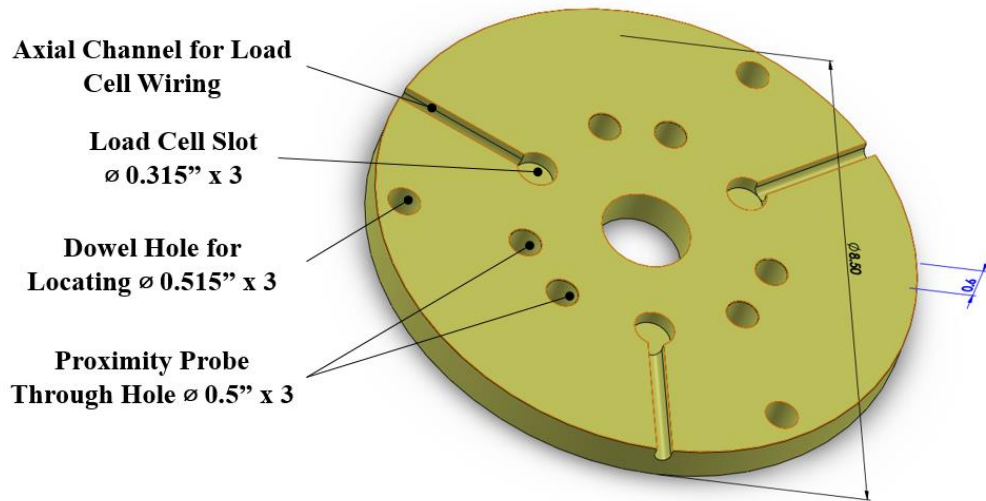
Figure 54 Load cell plate model and notable features

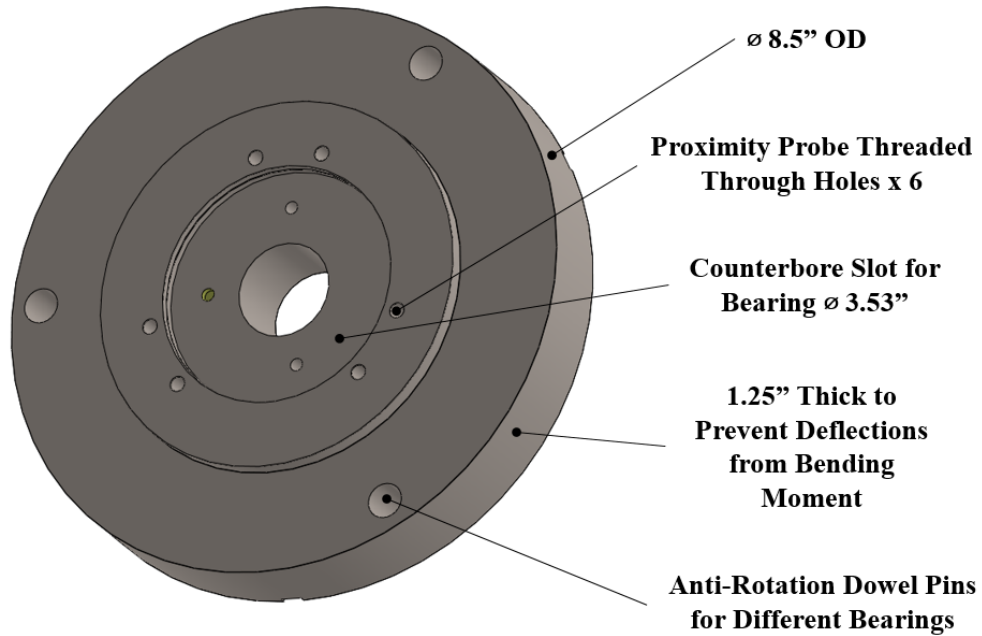
Figure 55 Bearing plate model and notable features

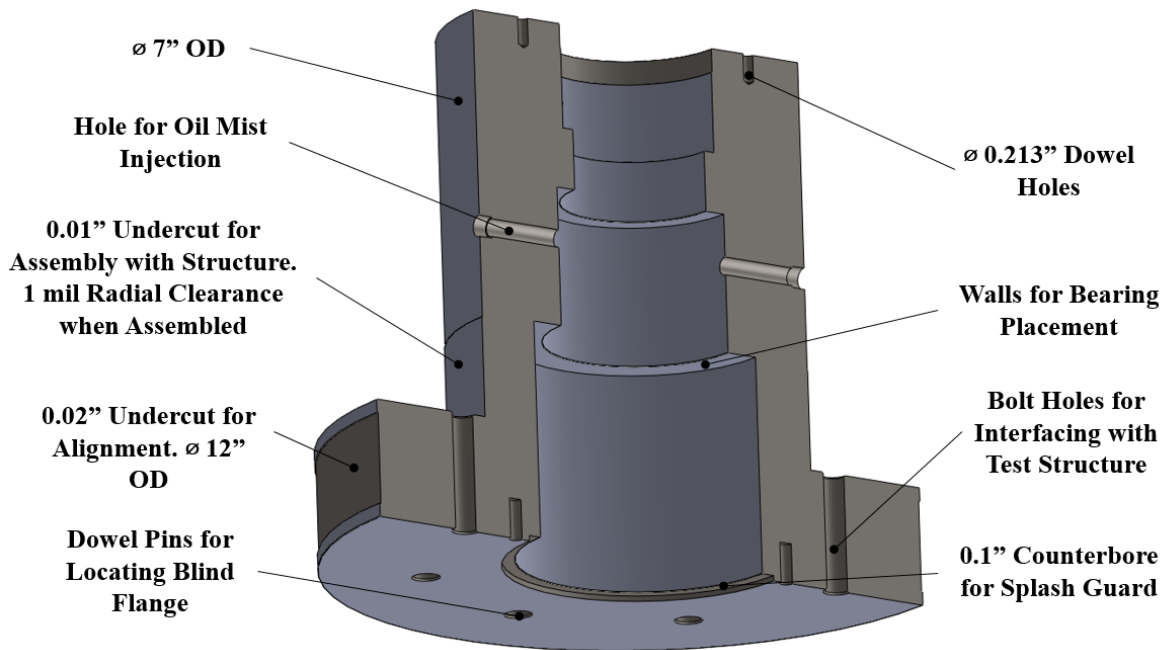
Figure 56 Slave bearing casing model and notable features

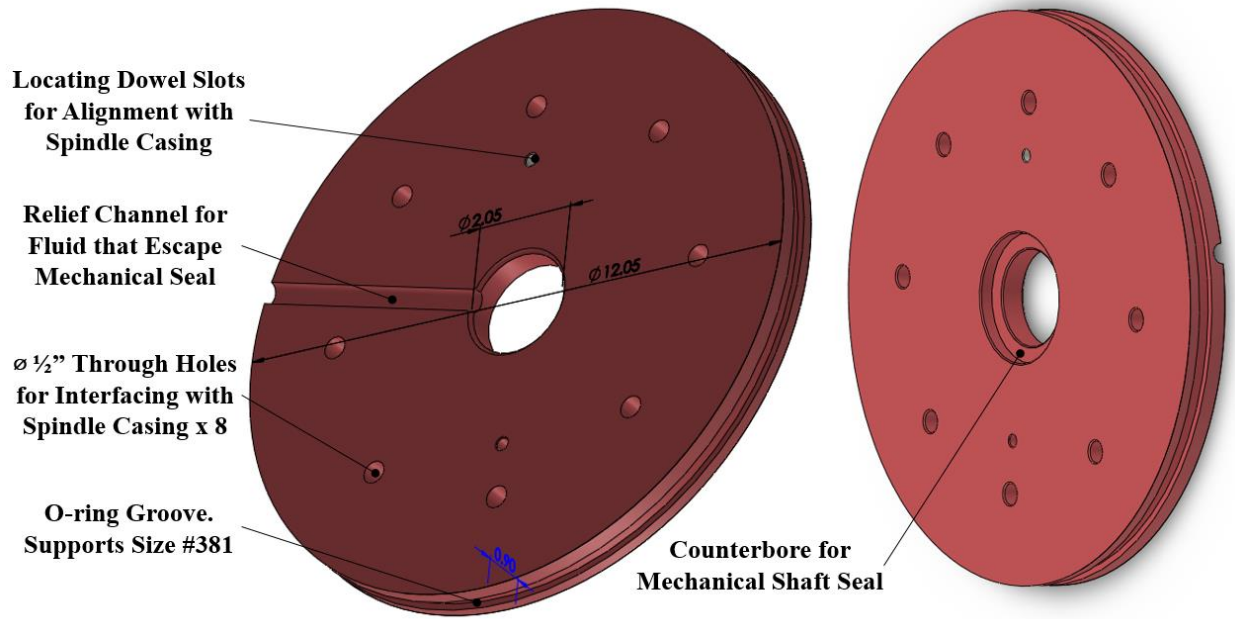
Figure 57 Isolating blind flange model and notable features

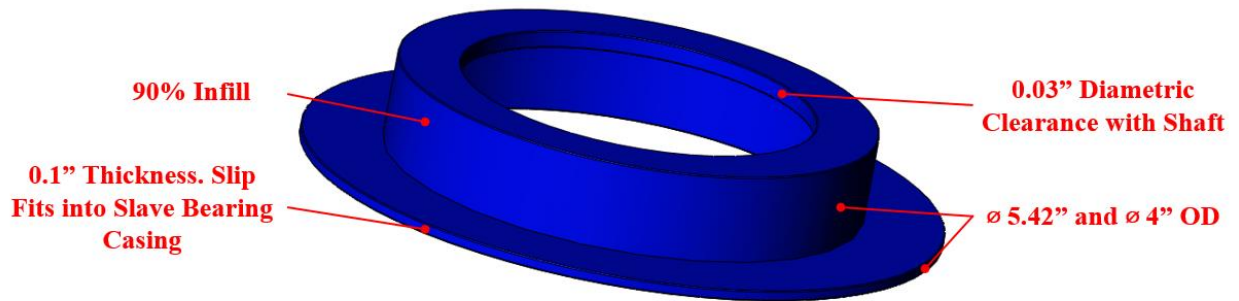
Figure 58 Plastic splash guard model and notable features
