**A CASE STUDY OF COST OVERRUNS IN A THAI CONDOMINIUM
PROJECT**

A Dissertation

Major Subject: Architecture

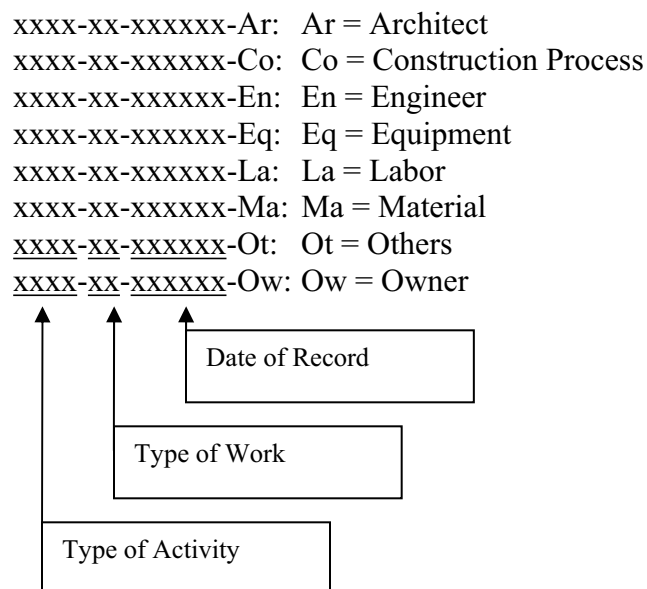
Figure 4: Coding System.

The coding system used in the study was categorized into 16 divisions according to the CSI master format (See Figure 16, Appendix A). Figure 4 shows the system of digits used in the coding system. The events related to the structural work may be categorized into more than one subcategory because structural work involved many activities. A major concern of categorizing events is determining the type of activity as applied in the CSI master format. For example, concrete work may be found in structural work such as beam or column concrete pouring, and may also be listed in architectural work as concrete lintels used to strengthen doors and window frames.

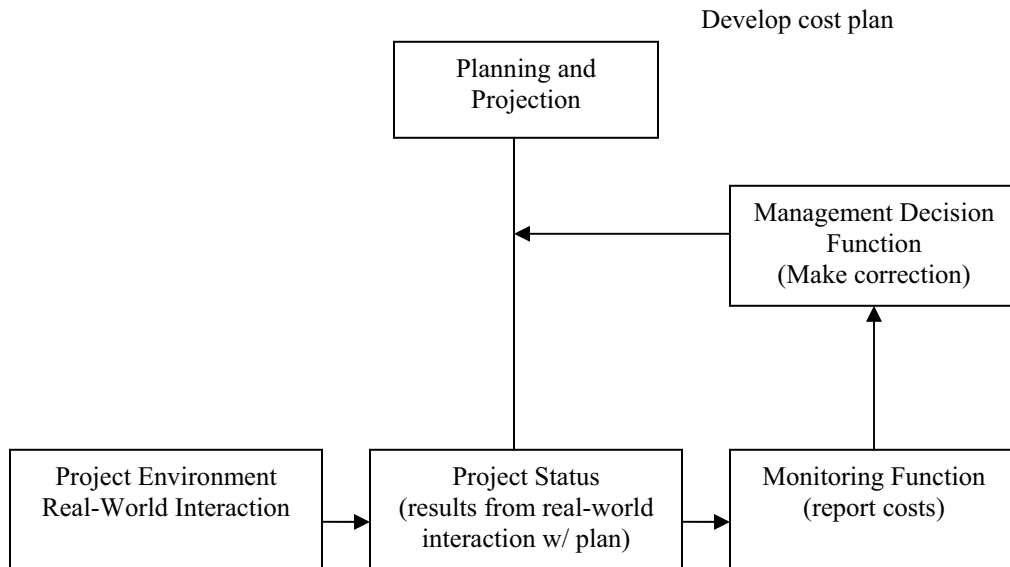
Figure 7: Cost-Control Management Cycle by Halpin (1985).

The first model that is used for comparison is the Cost-Control Management Cycle recommended by Halpin (1985), see Figure 7 which shows the preparation of the cost plan, the first step in the cost control cycle. After construction of the project begins, certain factors can cause deviations in the original plan. The project status, which can reflect the deviations from the conceptual plan, must be verified and reported to the cost engineer. In

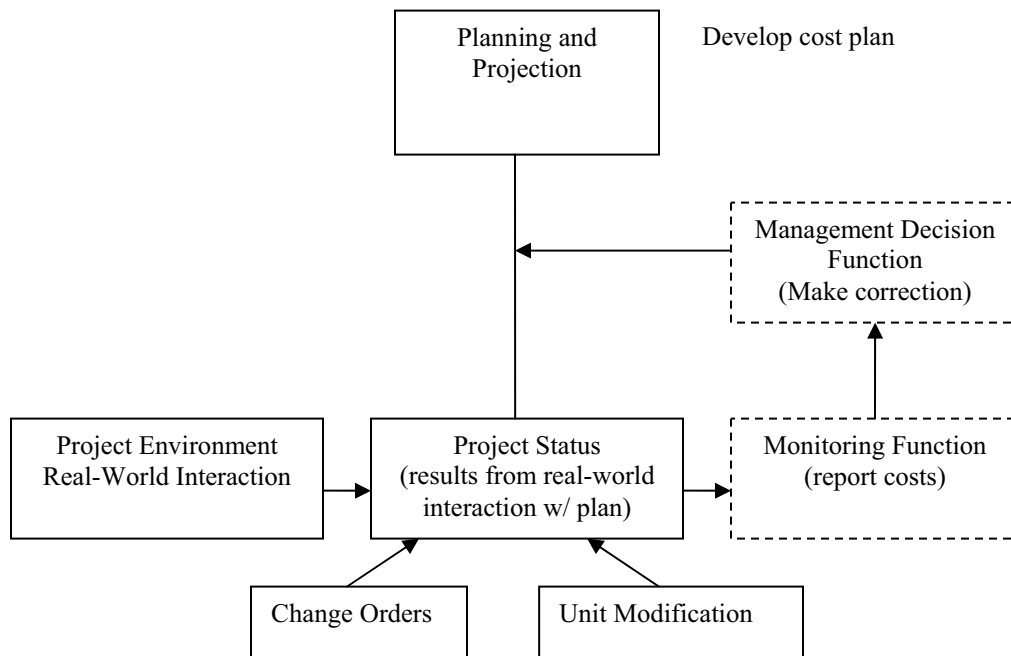
Figure 8: Cost-Control Management Cycle from Case Study.

established. However, the cost center recommended by Halpin (1985) was not established in this project by either the general contractor or construction management.

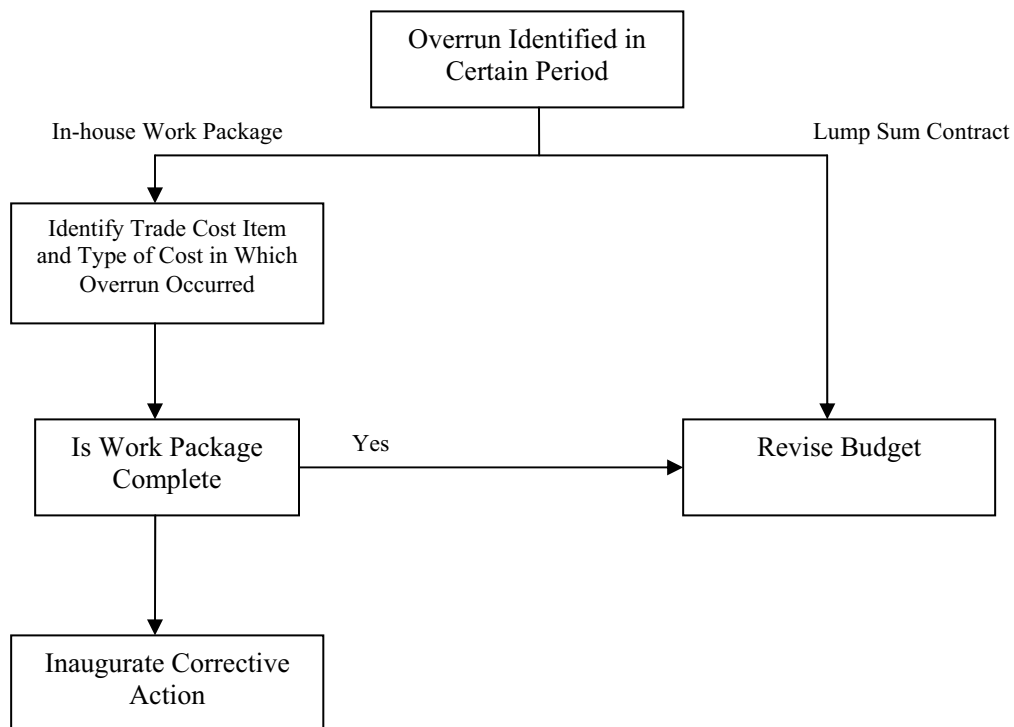
Figure 9: Process of Evaluating Overrun by Ahuja (1976).

The second model is used for evaluating project overruns. Ahuja (1976) suggests the model of “Process for Evaluating Overrun” as seen in Figure 9. It shows the decision process which is needed to be conducted from the identification of a cost overrun to the required action. Ahuja (1976) mentions that overruns found in lump sum contracts will have no alternative – the project owner will have to revise the budget. In some cases, faster or cheaper alternative methods can be applied to solve the problem with delays or overruns,

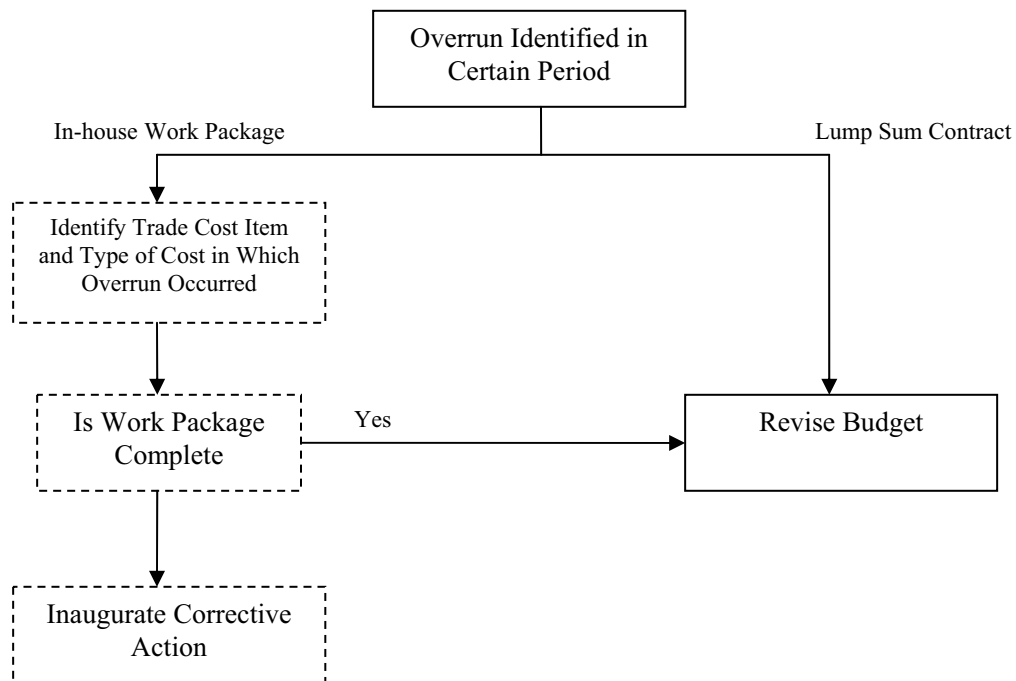
Figure 10: Process of Evaluating Overrun from Case Study.

In this case study, several overruns were found after they had already occurred and the solutions could not be implemented on time. Figure 10 shows the procedure that was implemented in the case study. The components shown in the boxes with dashed lines were the ones that were used but were not effective. Certain events that caused overruns were found by both the construction management company and the general contractor.

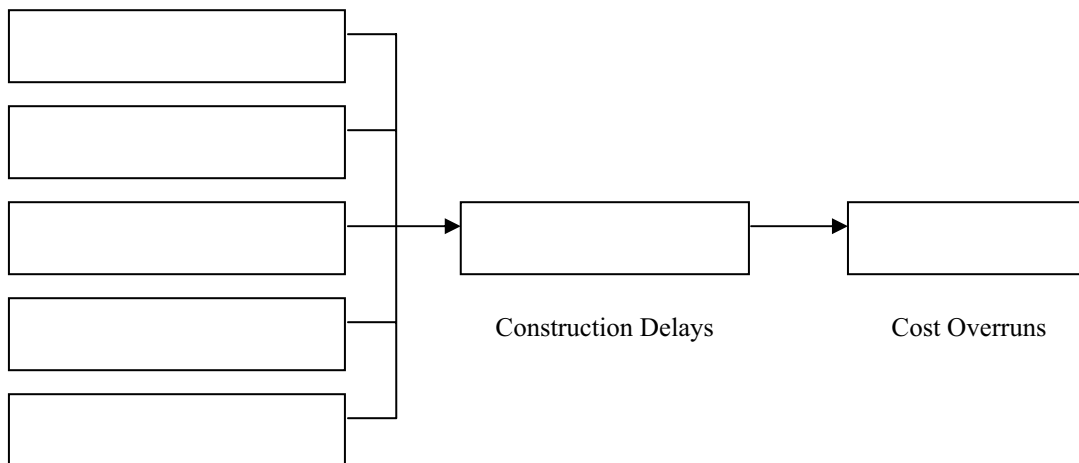
Figure 13: Cause of Construction Delays Indicated in Construction Reports.

As discussed previously in this chapter, there are many factors that caused cost overruns in the project. Certain factors led to a chain reaction of problems. The major causes of overruns were construction delays which resulted when the owner wanted to change the building design or specifications and general contractor and construction management had to wait for approval before implementing those changes. Another factor was incomplete drawings which caused the majority of delays in construction. Figure 13 summarizes the causes of delays.
