## EFFECT OF PHOTOCATALYTIC COATINGS ON THE WEATHERING OF ELASTOMERIC ROOFING MEMBRANE

Dr. Clovis A. Linkous  
Senior Research Scientist  
Florida Solar Energy Center  
University of Central Florida  
Cocoa, FL

Ross H. Robertson  
Senior Engineer, Systems  
Firestone Building Products Company  
Indianapolis, IN

### abstract

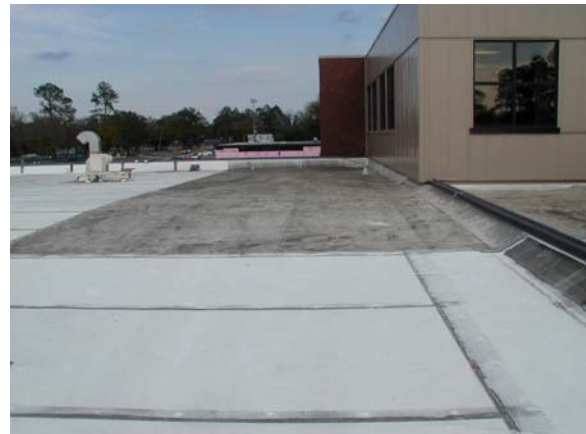
Figure 1. New and Aged Samples of Installed Roofing Membrane.

In Figure 1, newly installed roofing membrane in the foreground contrasts greatly with the same material further back that had been installed a couple years earlier. A typical initial reflectance value for a new installation would be on order of 78-79%. However, once exposed to the elements, most membrane formulations rapidly decay into the 50% range.

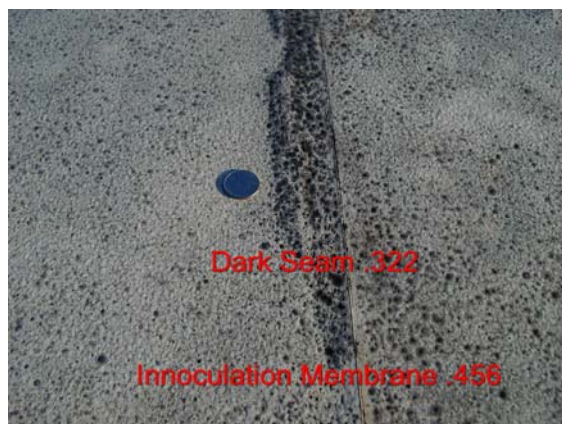
Figure 2. Close-up of Roofing Membrane Affected by Heavy Algae Growth.

Figure 2 shows a close-up of how an initially bright white material rapidly succumbs to a discontinuous overlayer of black spots on order of several mm in diameter. An as yet not fully understood effect is the extra heavy infestation occurring along a seam.

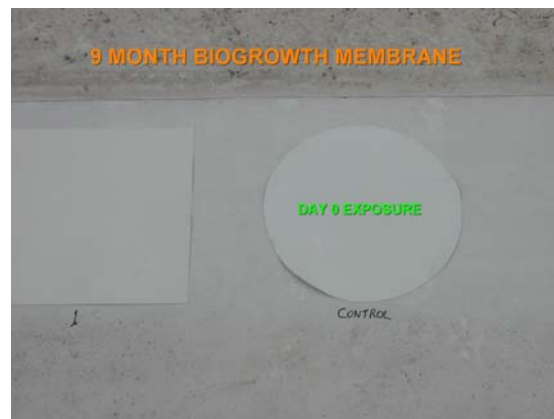
Figure 3. Experimental Installation in Homestead, FL. left: sample with photocatalytic coating; right: control; above: 9 months-aged inoculation membrane.

A variety of photocatalyst formulations were affixed to 929  $\text{cm}^2$  (1.0 square foot) membrane surfaces at a loading of approximately 1  $\text{mg}/\text{cm}^2$ , or 10  $\text{g}/\text{m}^2$ . These samples were taken to Environmental Testing Laboratories in Homestead, Florida, where they were mounted on one of several rooftop test stands. The mountings were done using normal thermoplastic welding, but welded weakly to a dissimilar base membrane. A photograph of test and control samples is shown in Figure 3.

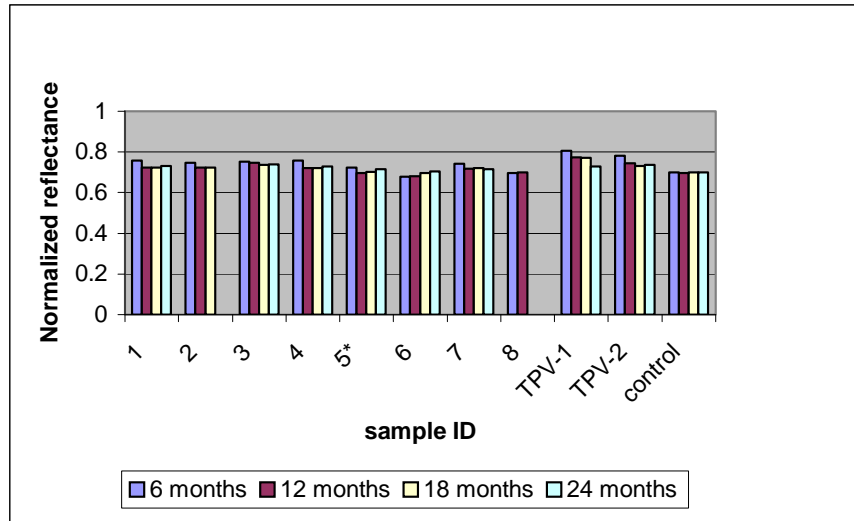
Figure 4. Reflectance Data for TPO Roofing Membrane Samples Modified by Photocatalyst.

Reflectance values for modified and unmodified TPO roofing membranes are shown in Figure 4. Not all samples were studied over the full 24-month period. The test period starting February 2004 included two full summer seasons of thunderstorms, not to mention the edges of several hurricanes in 2004 (Charley, Frances, and Jeanne) and a direct hit by Wilma in 2005. Consequently, some samples were blown off the test stand. Those which were subsequently recovered were remounted (Sample 5); thus the last data bar for #5 Other samples were lost altogether (Samples 2 and 8); even so, the data collected up to that point are still valid.

Nearly all the samples showed some measure of reflectance decay. Samples 6 and 8, and to some extent 5, actually showed an increase over time, but that trend probably had more to do with the fact that they were colored samples, so that the reflectance rise was most likely due to loss of photocatalyst pigment, exposing the reflective white underside.

Samples 1,3,4, and 7 were white photocatalyst application that maintained higher reflectance than the control throughout the test period. Even though the control sample appears to have held steady at 70%, numerous control sample measurements at other field tests put the initial reflectance at 79%. Two of the samples were TPV's, special formulations whose exact composition was proprietary. While their rate of reflectance decay was highest, they nevertheless held onto higher reflectance at the end of the 2-year period, because their initial reflectance values were highest.
