# Investigation of Cooling and Dehumidification Energy Use and Indoor Thermal Conditions in Polk County Schools Permanent Replacement Classroom Buildings

Florida Solar Energy Center  
1679 Clearlake Road  
Cocoa, FL 32922

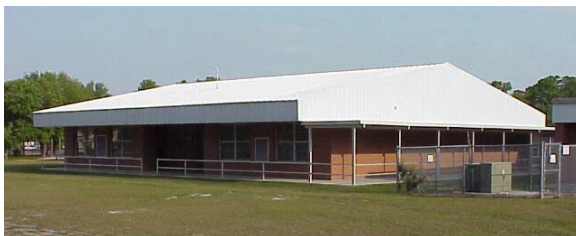
Increasing enrolment in grades K-12 coupled with the spiralling costs of construction has pushed school boards to develop more cost-effective classrooms, from the perspective of initial cost, long-term energy consumption, and ease of maintenance. To this end, the Polk County School Board has developed a four-quad permanent replacement classroom (Figure 1).

Figure 1 Typical quad classroom building

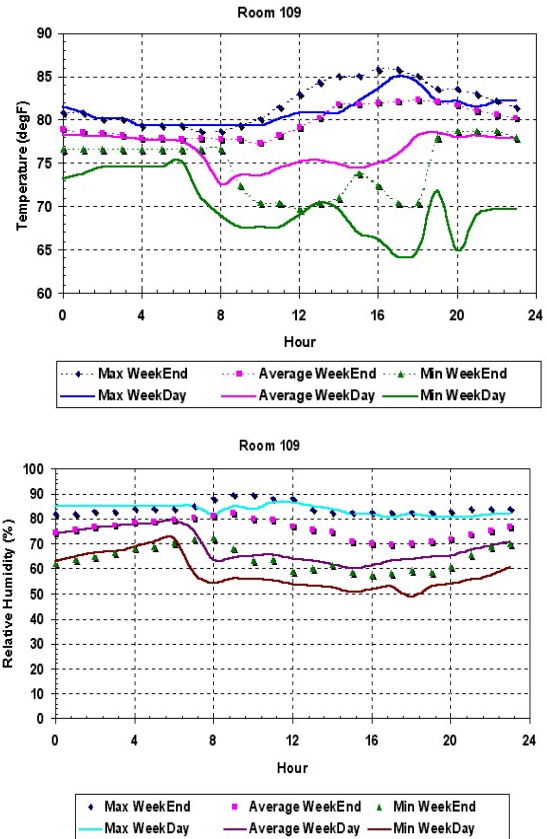
Three sets of four buildings were monitored during the summer of 1999 from March to September using a portable temperature and relative humidity datalogger for each location measured. The interior temperatures ranged from a low of 64°F to a high of 87°F and the relative humidity varied from 24% to 92% (Figure 4).

Figure 4 Typical hourly temperature and relative humidity hourly profiles.

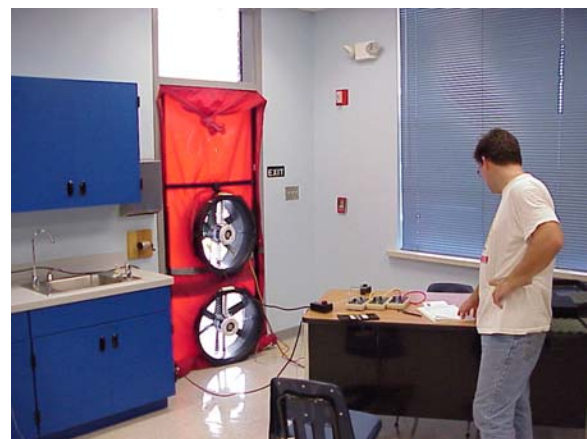
The blower door tests done on the twelve (type 2) buildings indicated that they were fairly leaky, averaging 25.8 ACH50 (Cummings, 1996) (Figure 5 & 6). This prompted the search for the source of the leak, especially since the walls were constructed on

Figure 5 Blower door testing being completed on one of the classroom buildings.

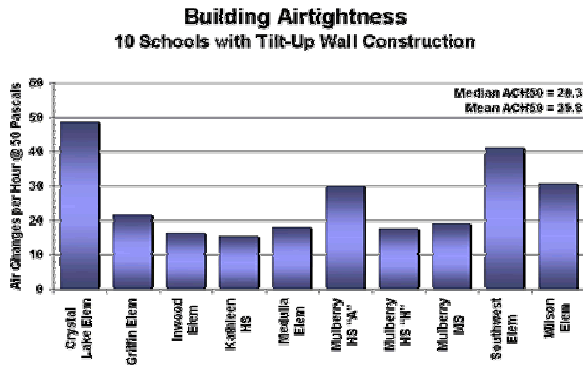
Figure 6 Graphic view of building airtightness in 10 schools.

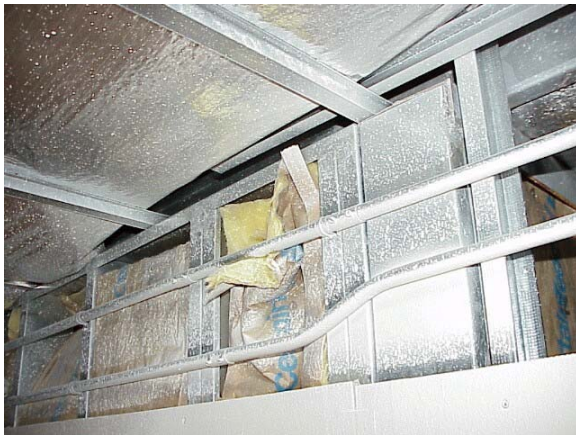
- an R-19 fiberglass batted insulation. The perimeter vertical section between the t-bar ceiling and the radiant barrier covered grid did not usually have a good air barrier, especially over the bathrooms (Figure 7).
- PTHP assembly - the unit is slid into place without a seal between the wall and unit. This gap varied in size depending on rough opening dimensions of wall and closeness of the unit to the wall (Figure 8).

Figure 7 Incomplete air barrier at connection of wall assembly to ceiling.

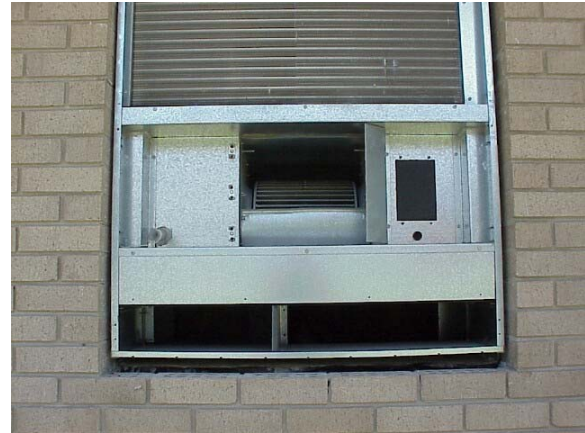
Figure 8 Exterior view of PTHP unit with grille assembly removed. Approximately 1 inch of clearance exists between the unit and the wall

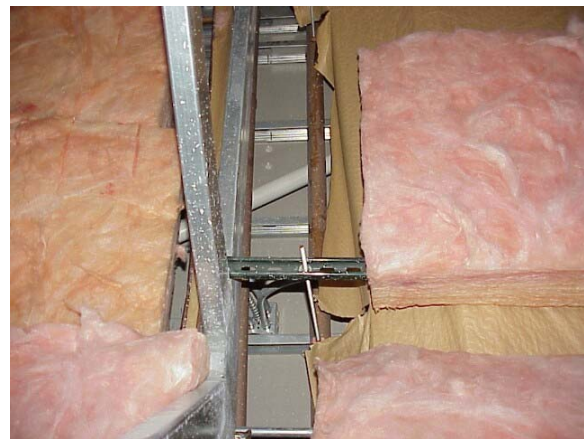
Figure 10 Typical insulation void approximately 25% to 30%.

The airtightness of Floral Ave was reduced by 32.5 % and Eagle Lake was reduced by 37.5 % by air sealing around the PTHP units and ceiling space (Figure 10-12). The buildings were maintained at a constant 75 °F temperature and the energy use of the PTHP units was reduced in Floral Ave by 11.0% (assuming a 10°F temperature difference between the conditioned space and outside ambient) and Eagle Lake Elementary had a 17.5% reduction.

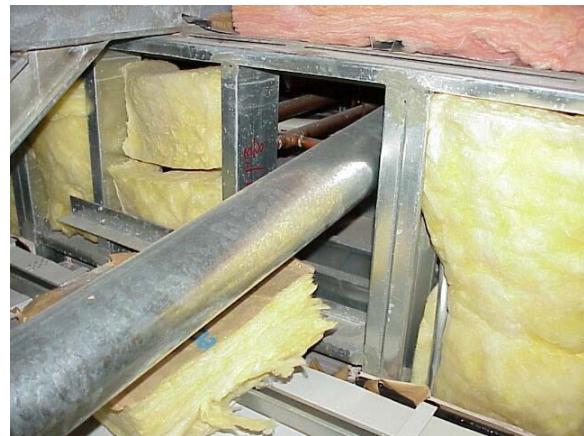
Figure 11 Vent pipe passing through the vertical wall section. Air and thermal barriers have been compromised

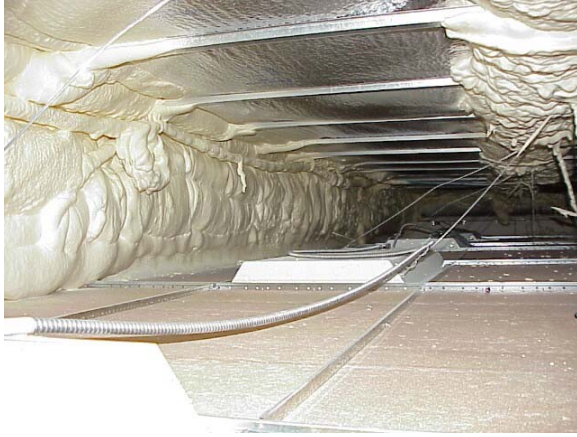
Figure 12 Attic space after foam was installed It can be seen along the bottom of the truss

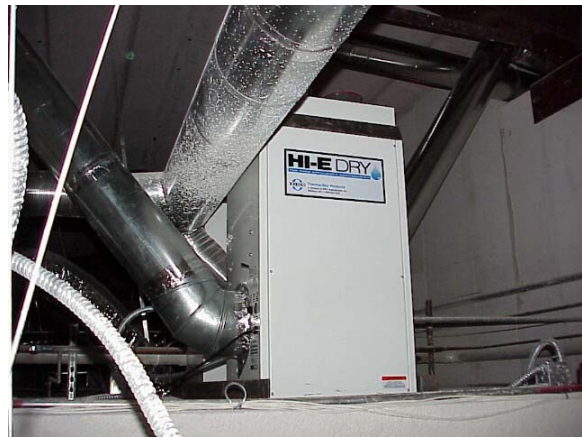
In an effort to control interior moisture conditions within the AAC buildings created by material drying and internal people loads, dehumidifiers (Figure 13) were installed. These units were set to maintain a relative humidity within the space of approximately 50%. A humidistat is located on the dehumidification unit, which was set based on a scale of high to low. The final position of the humidistat was arrived at by some trial and error settings until the building was operating in the range of 50% to 55% RH. There are four dehumidification units in each building - one for each classroom. Each unit has its supply and return hard ducted to the classroom, however, the humidistat control is located at the unit and is sensing the air surrounding it. This does not appear to have much effect on humidity control since the ceiling space is very well connected to the classroom space below. The dehumidifiers installed were the Ultra-Aire model manufactured by Therma-Stor Products. It has a rated capacity of 100

pints/day (80°F - 60% RH) and draws 6.8 amps on a 115-volt circuit. The dehumidifiers were maintaining the relative humidity (and dewpoint temperature), but with an energy penalty of about 750 watts per dehumidifier when they are operating. Additionally, the heat given off by the dehumidifiers was ejected into the conditioned space where it was removed by the PTHP units. The dehumidification units operated an average of 77.2% (2.3kWh/day) of the time in Spook Hill and an average of 52.7% (1.3kWh/day) of the time at Elbert. Assuming a 10°F temperature difference across the envelope, the two AAC buildings used on average 9.8% more PTHP energy than the metal-framed building at Floral Ave and 19.4% more than Eagle Lake.

Figure 13 One of four dehumidifiers installed in the ceiling space of a quad classroom building.
